SOME IMPACTS OF ROADING AND FLOOD DAMAGE ON SOUNDS ROADS

Part only –(this is a second report) –

Period 1985-2010

May 2016

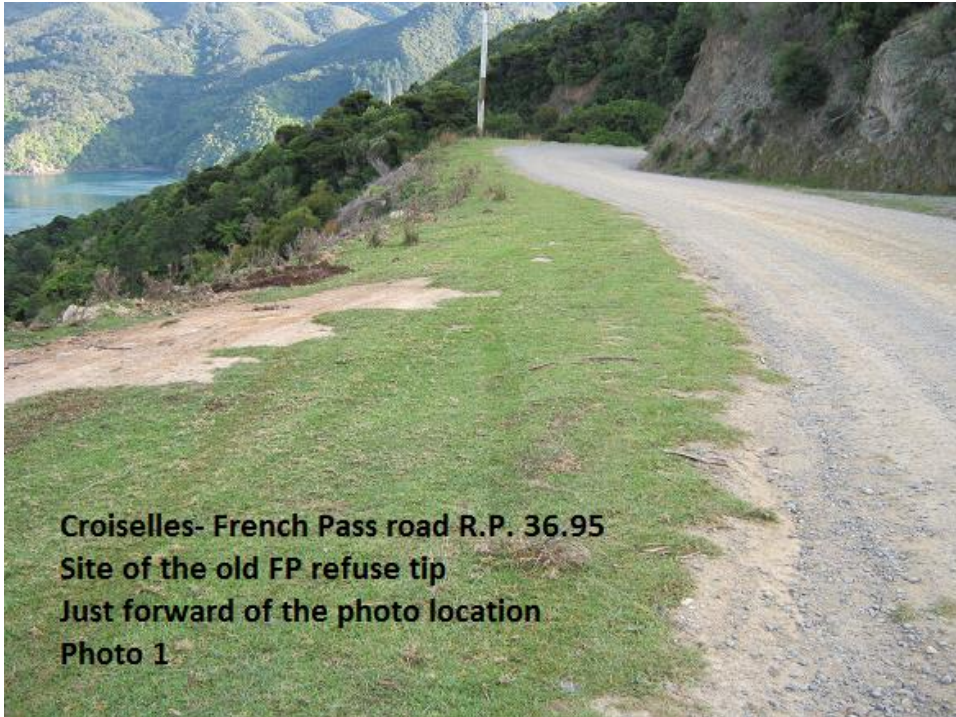
I am advised it was in operation from about 1970 (JW) until app. 1991 (unrelated to the 'weather bomb' event) heavy rainfall and perhaps just an instability of the site caused a dramatic collapse of the whole 'tip' down the gully and onto a lovely sandy beach below. Some light debris was strewn down the face but generally most material was on the beach or in the water.

Croiselles- French Pass road R.P. 36.95
Site of the old FP refuse tip
Just forward of the photo location
Photo 1

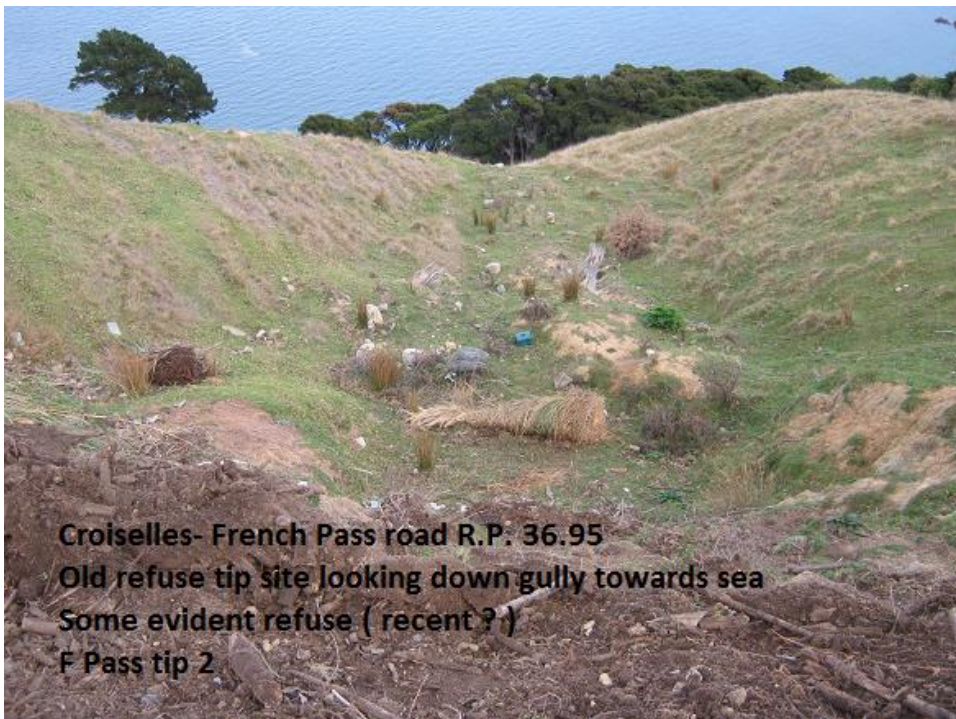
Croiselles- French Pass road R.P. 36.95
Old refuse tip site looking down gully towards sea
Some evident refuse (recent ?)
F Pass tip 2

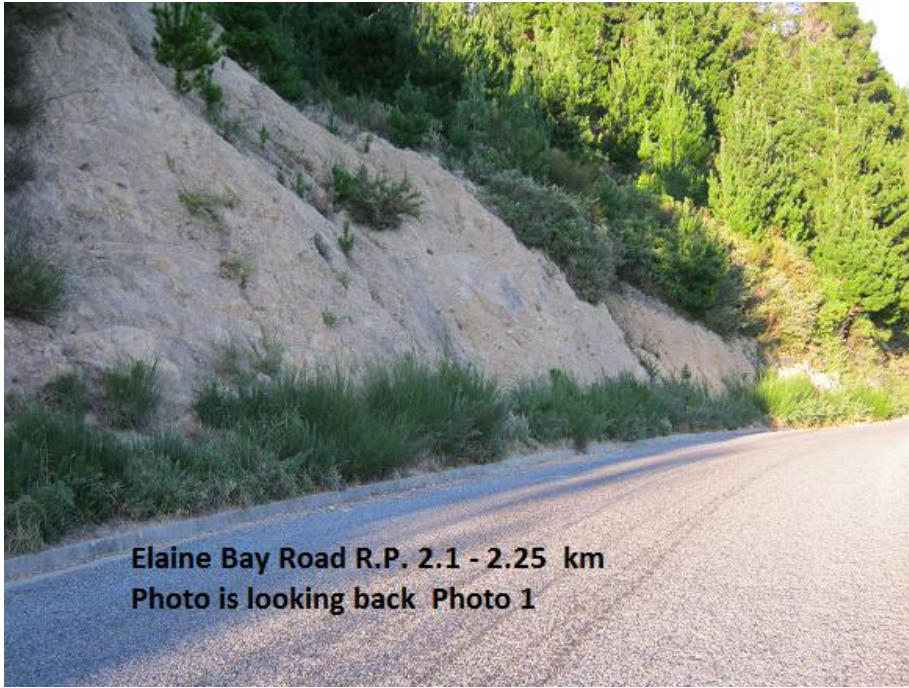
The damage occurred over some years starting in 1995 (collapsing outer edge) and finally permanently repaired following significant collapse of the face in app. 2004

**Elaine Bay Road R.P. 2.1 - 2.25 km
Photo is looking back Photo 1**

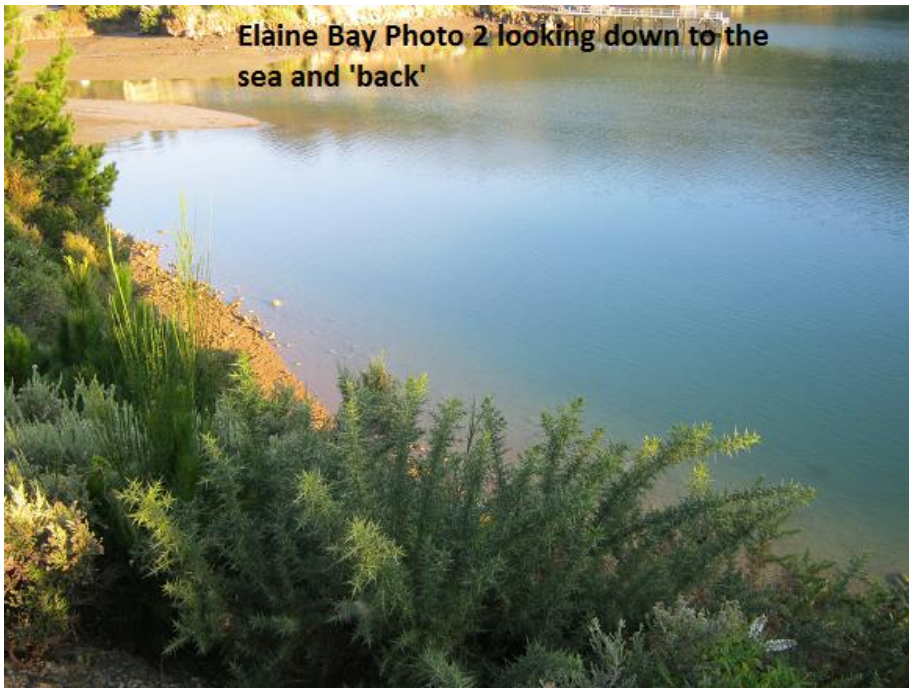
**Elaine Bay Photo 2 looking down to the
sea and 'back'**

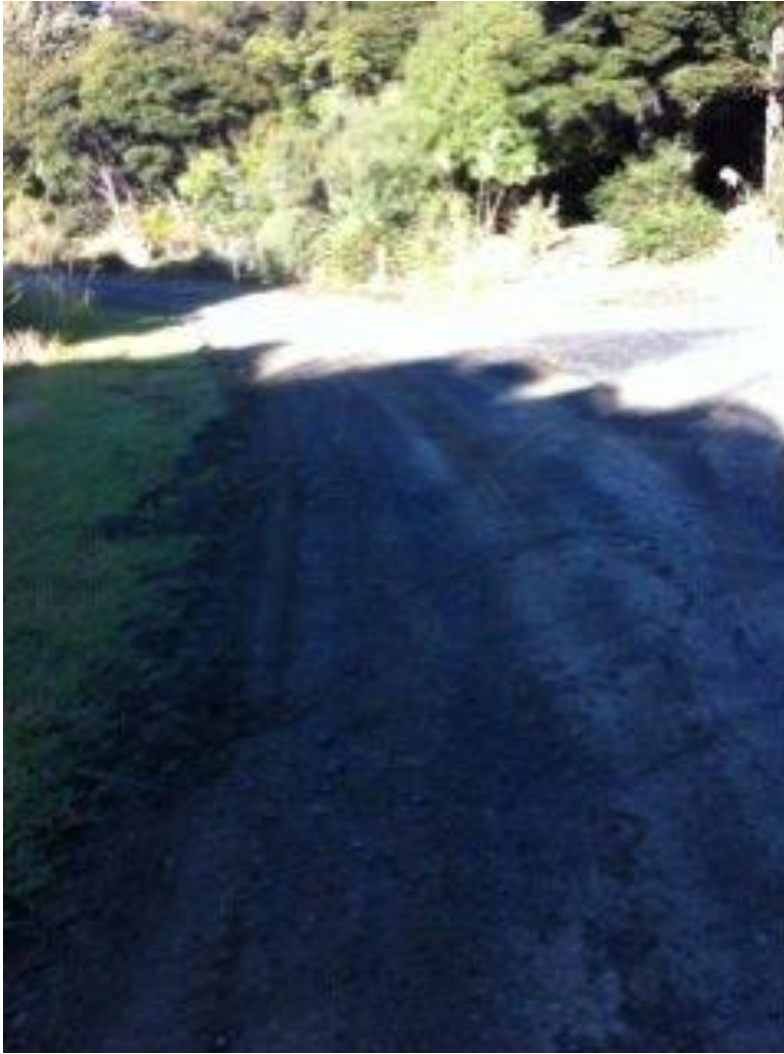
The road at the site was 'sheared' right through about 4 metres deep and over a length of near 20 metres ; the existing 1.8m dia Reinforced concrete culvert was strewn down the stream completely smashed into small chunks about 100mm sq. , some held together with the remnants of the spiral reinforcing . I have seen damage to culvert pipes before but never anything as dramatic as this event – all 4 pipes were now just like pebbles in the creek bed and banks !!

The damage was completely unrelated to any of the roading activities , the culvert capacity was never going to be big enough for the intensity of rain (the culvert has been replaced with 2 / 2 m dia. RC Culverts effectively increasing the capacity by 2.5x – I suspect one will never know if this capacity would carry the discharge from a similar event)

This photo is looking back towards the Wharf (start of the road) – extremely bright sun , and to culvert number 6 – the replaced structure. There is a recent access at photo right

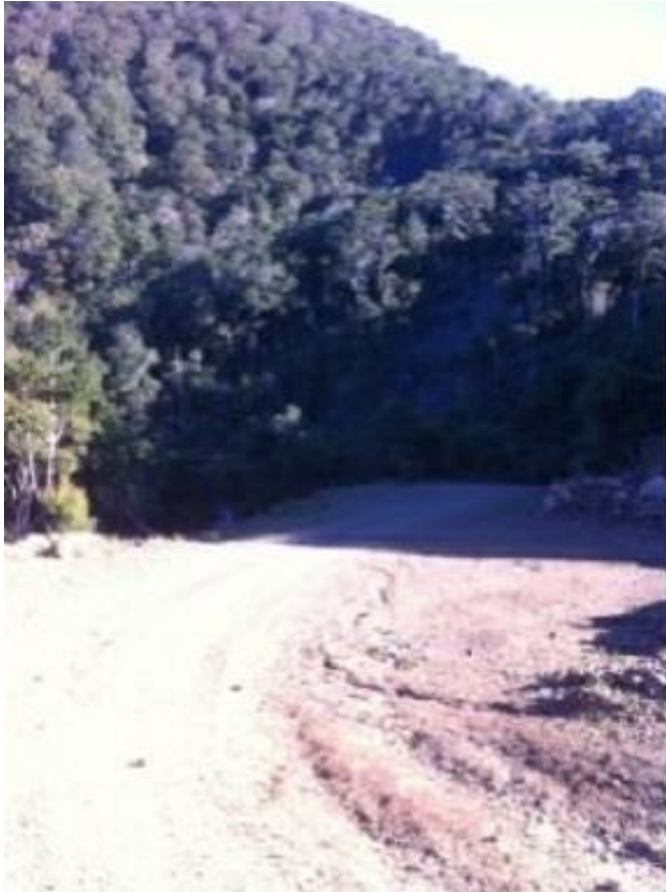
This photo (1) is taken from near the Trig on the north side looking up towards Attempt Hill

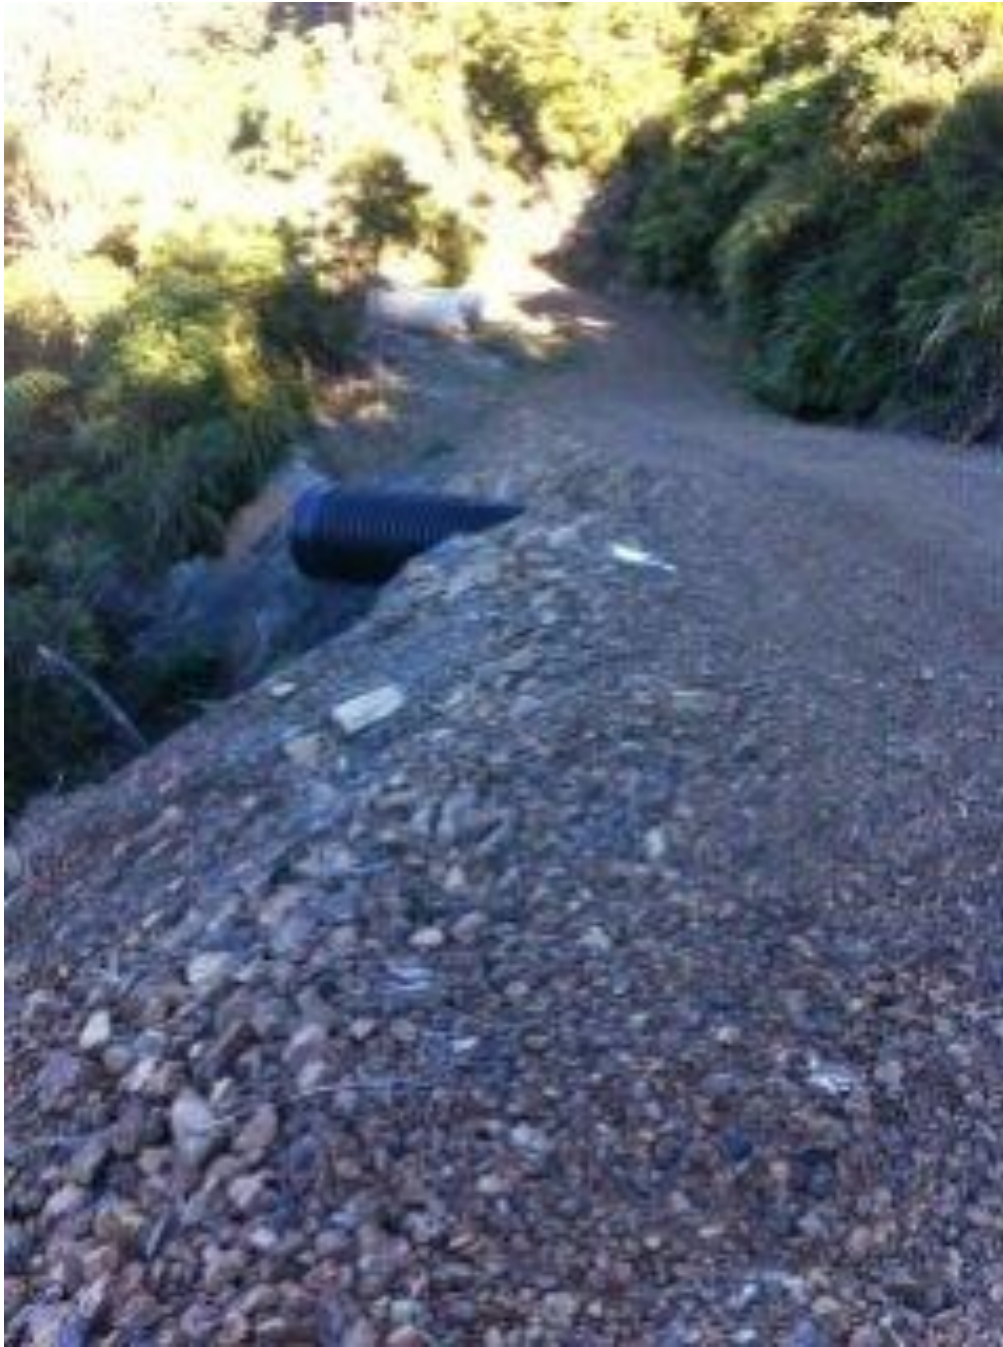
This photo (2) is taken from near the new Farmtuff culvert (one of two) recently installed. You can observe in the photo foreground some evidence of where the road was severed by the slip and has been 'ramped 'down. You can also see what, I assume, are the salvaged pipes from the previous culvert instillation near here (I am not aware as to why they have been replaced ?)

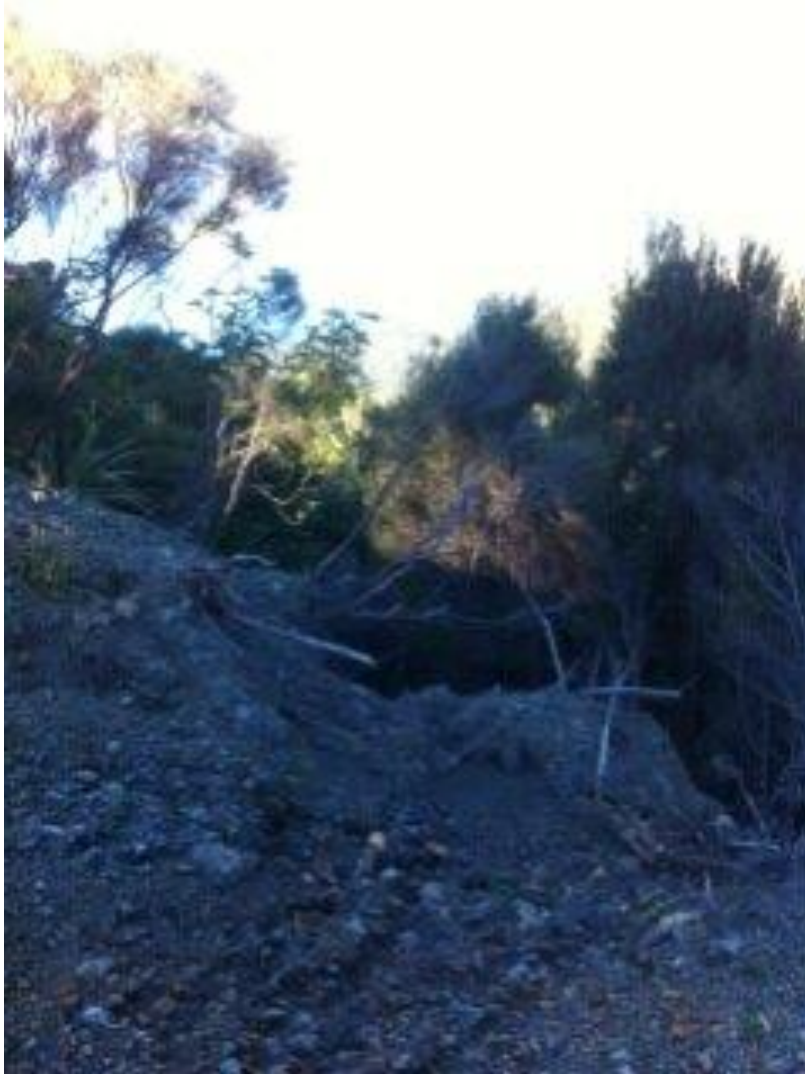
This photo is from near the large (2nd) Farmtuff looking to the outer edge and down off the road edge.

There are virtually no areas below the road that have not re-established vegetative cover.

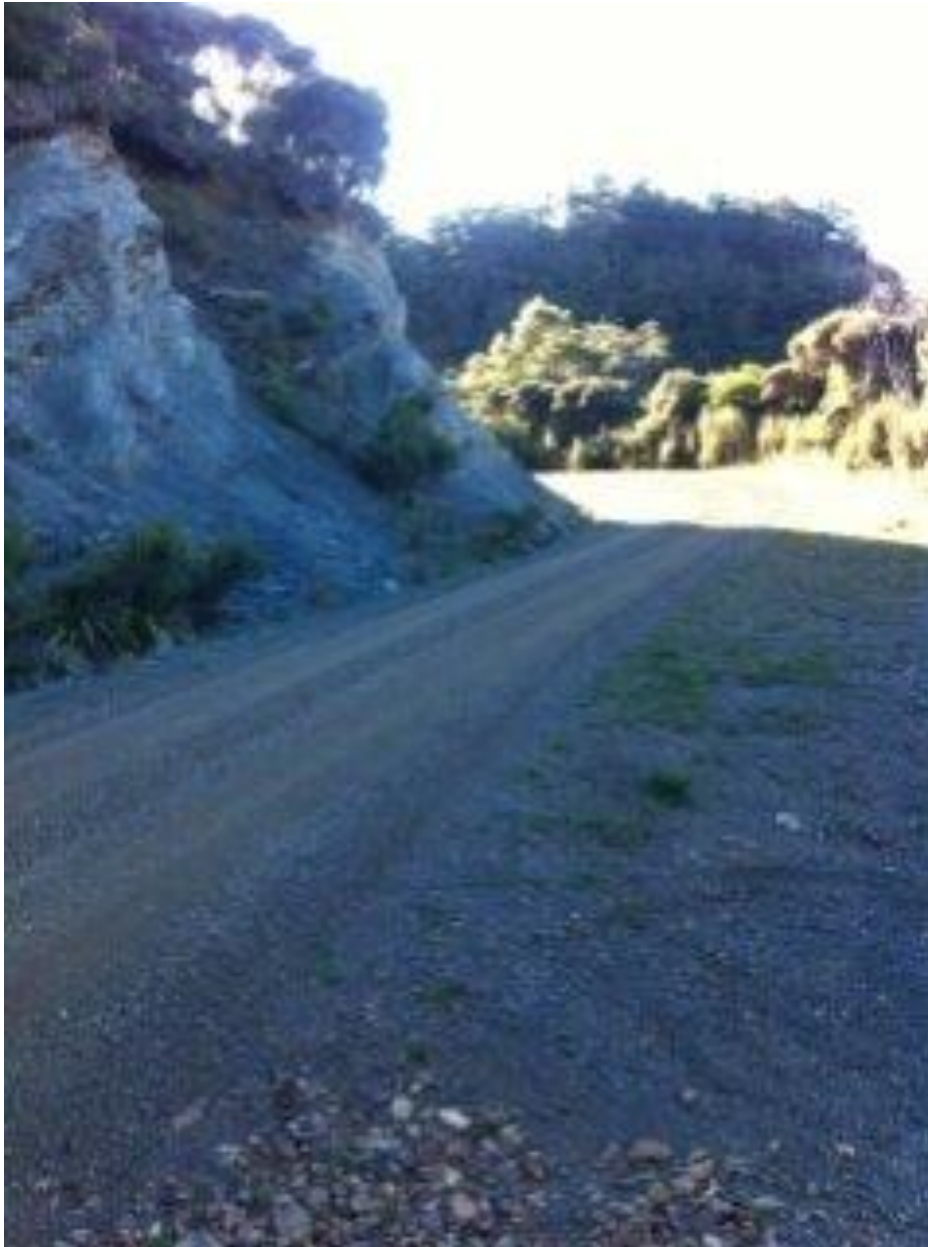
This photo is from near the large (2nd) Farmtuff looking towards the North showing part of the slip and the blue material.

Total length of slips above road is app. 140m
 Highest elevation of major slip above road is
 app. 120 m (MDC contours)

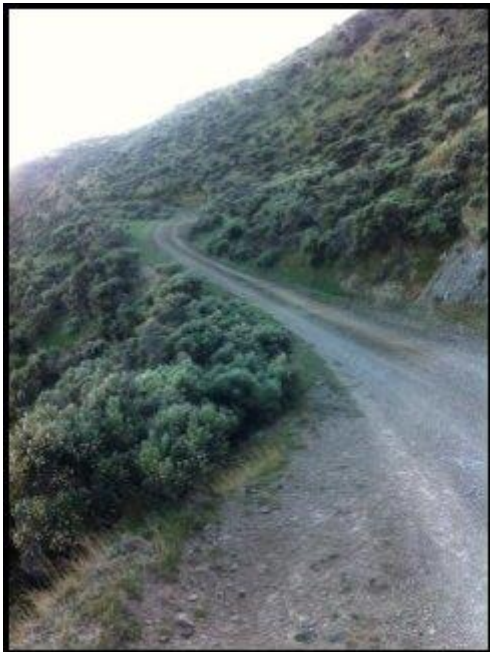
The movement can be observed by sighting along the line of poles and noting the sideways shift of the line , which is very obvious . I am advised by locals it still appears to be moving but it doesn't look very different to the initial movement to me.

The slip extends from here to the photo distance and above and below the road

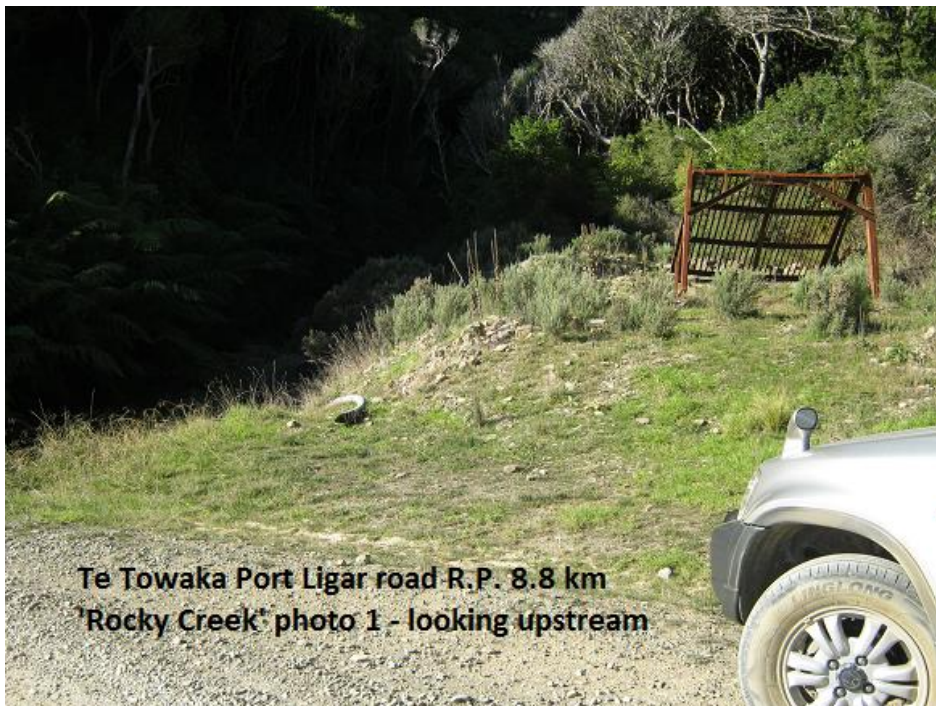
Note the material still above the creek at photo centre and right. (under screen)

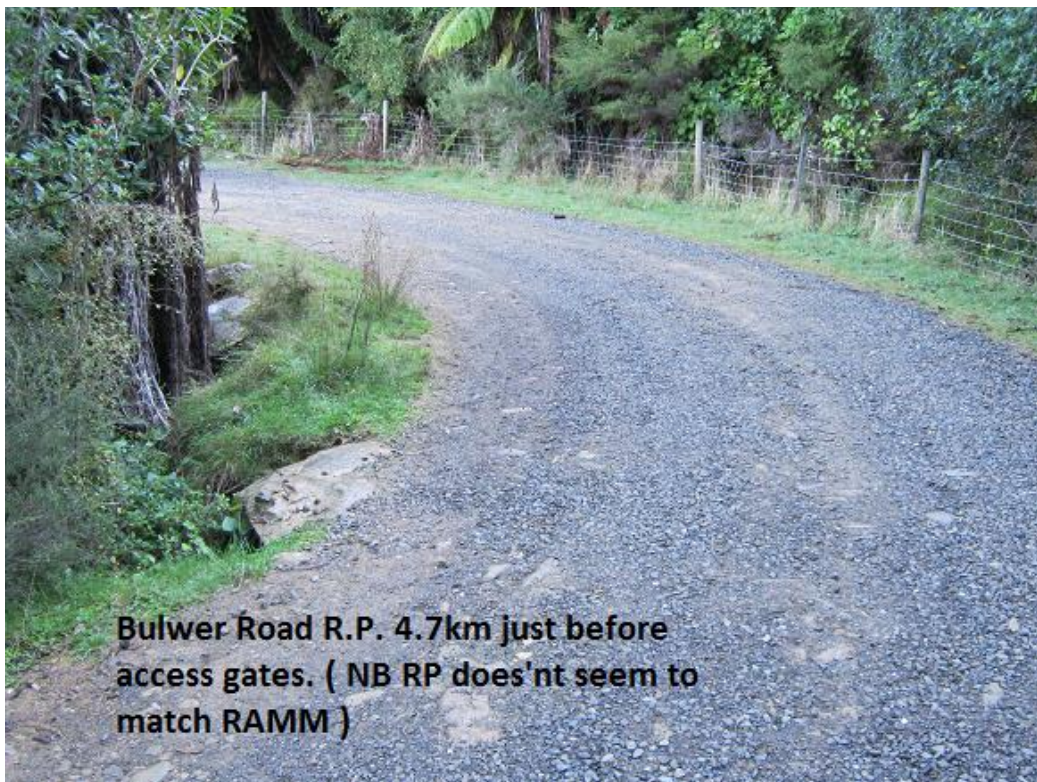
Bulwer Road R.P. 4.7km just before access gates. (NB RP does'nt seem to match RAMM)

I estimate there was about 4000m³ of slip of which possibly 1500 m³ entered the sea and the event may have been exacerbated by the unstable outer edge of the road coupled with the heavy rainfall.

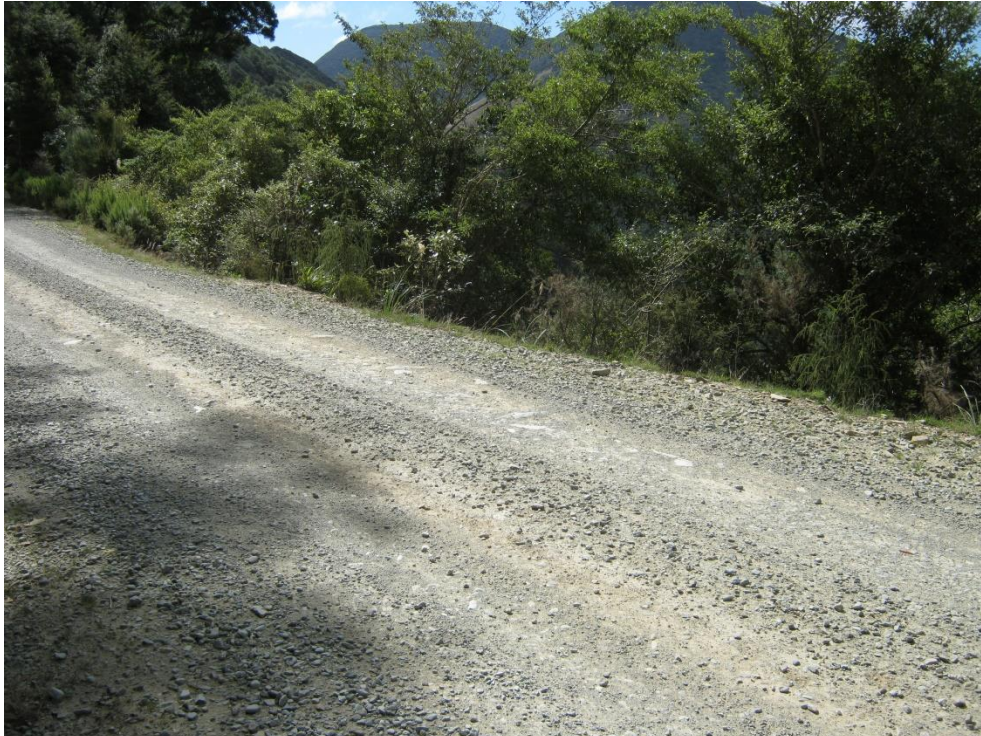
This photo is on the road – note second growth vegetation along edge.

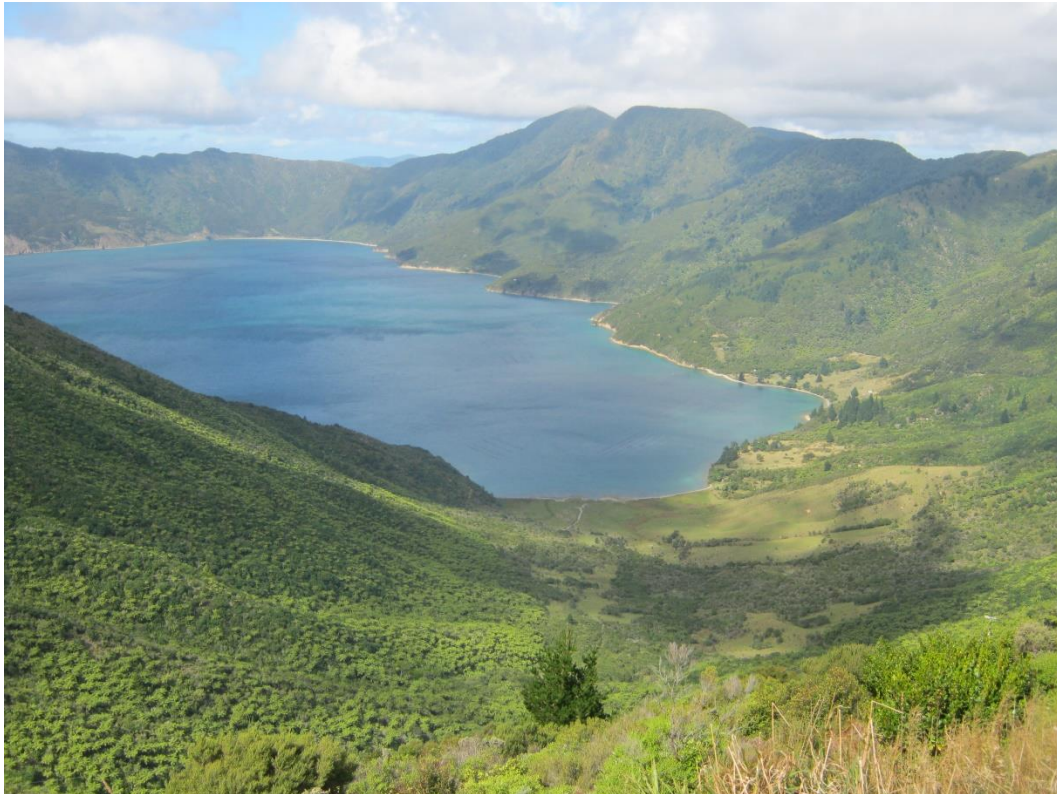
This photo is looking to Port Gore . The material flowed across near the photo centre to the sea.(I can't identify or recall exactly where)

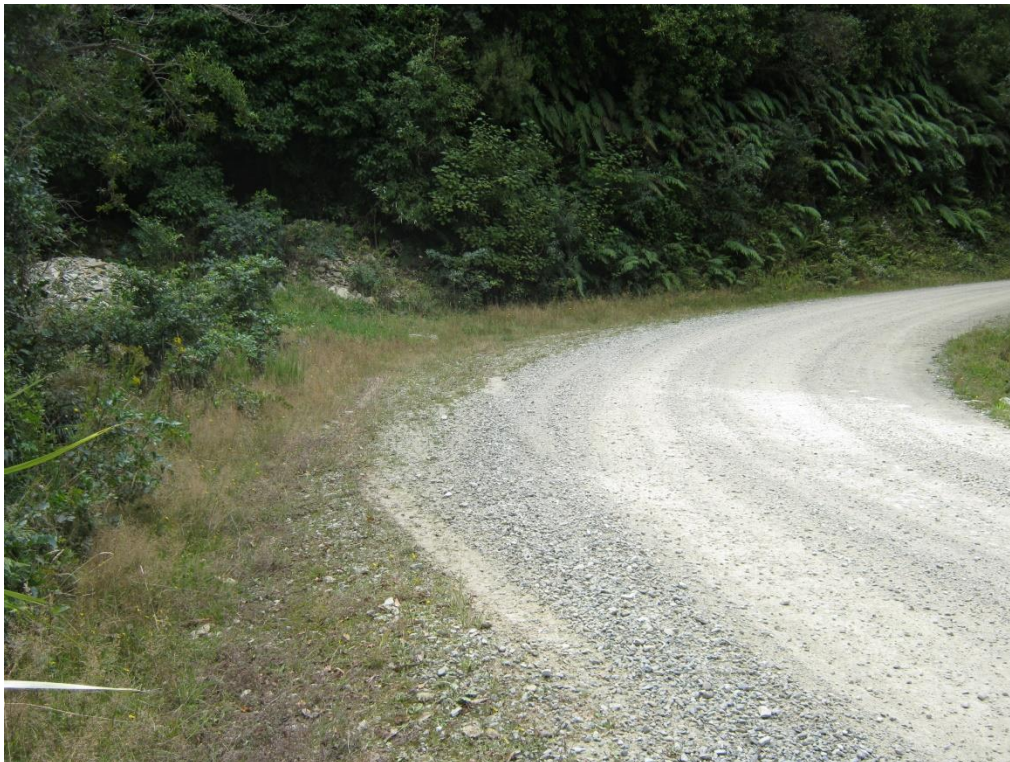
This photo is taken on Anakoha Road at Mount Stokes Stream – note the material on photo left just past the culvert – this is the type of material which flowed to the river below.

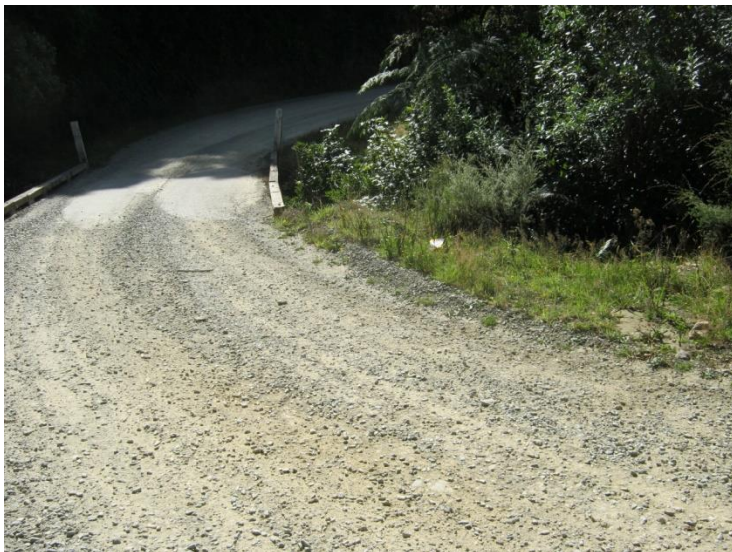
There was app. 2000m³ washed into the watercourse and I suspect the damage was caused by blocked culverts above the site which diverted water across the road and over the bank near the downstream abutment of the bridge.

Photo at the bridge site – the edge of the bank collapsed and the stream was severely scoured at the photo right area (quite apparent on the ground)

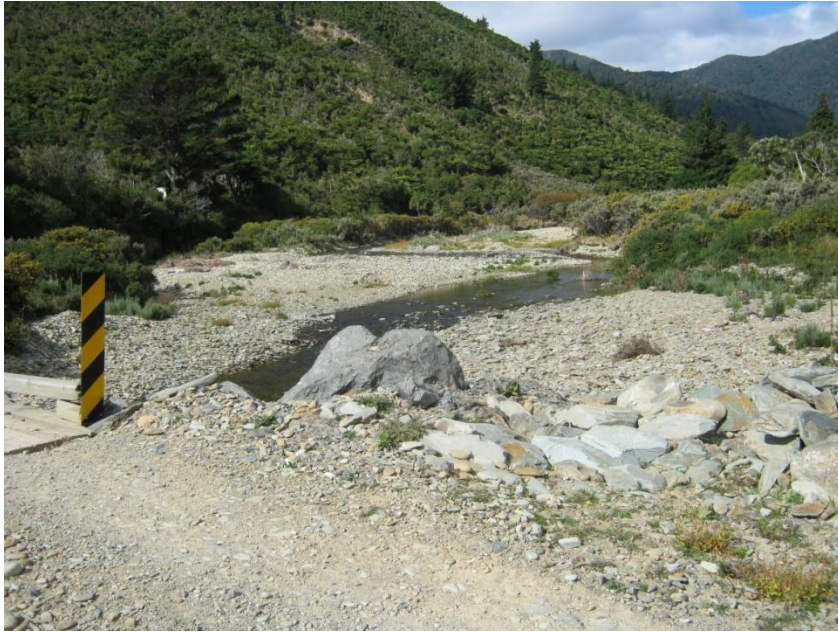
This event combined with the Site 11 material contributed to the aggradation of the stream AND the scour of the approaches to Kinders Bridge PLUS the discharge to the sea estimated at > 1000 m³ in total. The bridge on Kinders road had previously had a 'scour hole / swimming hole' on the downstream side about 3m deep ; the whole bed aggraded throughout the length of this stream and the bridge was left, bereft of approach fills and standing in the air, – post damage repairs including 'sheathing' the rail iron piles in R.C pipes together with new sheeting timbers and rock protection work at the abutments (still obvious)

This photo is at Kinders Road Bridge looking upstream – note rock abutment protection work in photo foreground and aggraded riverbed . The approach fills on both sides of this bridge were completely washed away and the bridge stood about 3m in the ‘air ‘suspended on its rail iron piles

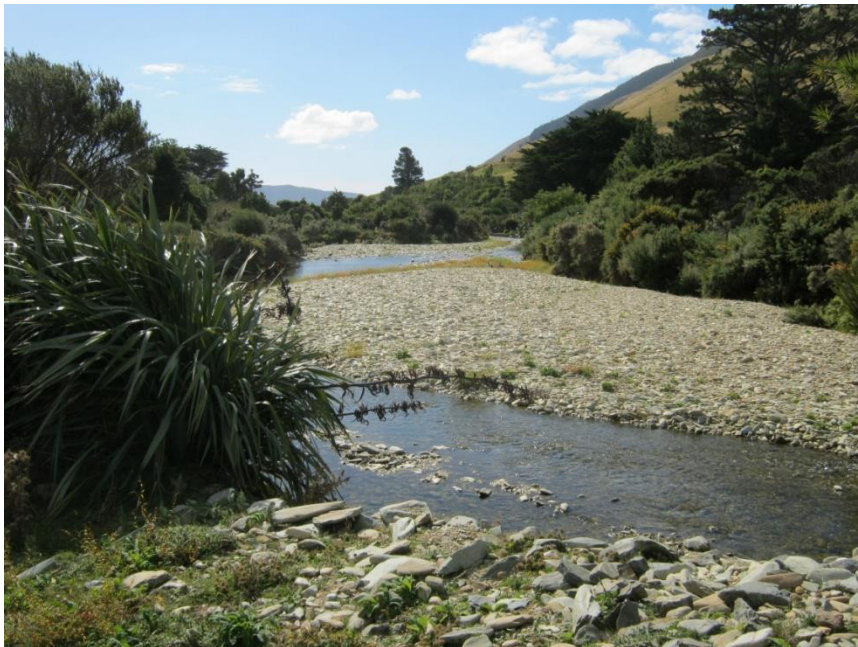
This photo is looking downstream from Kinders Road Bridge – the ‘shoal’ in photo foreground was the location of the 3 m+ deep swimming hole in this river and the whole creek has aggraded by 1-2 m + from its bed levels prior to the event.

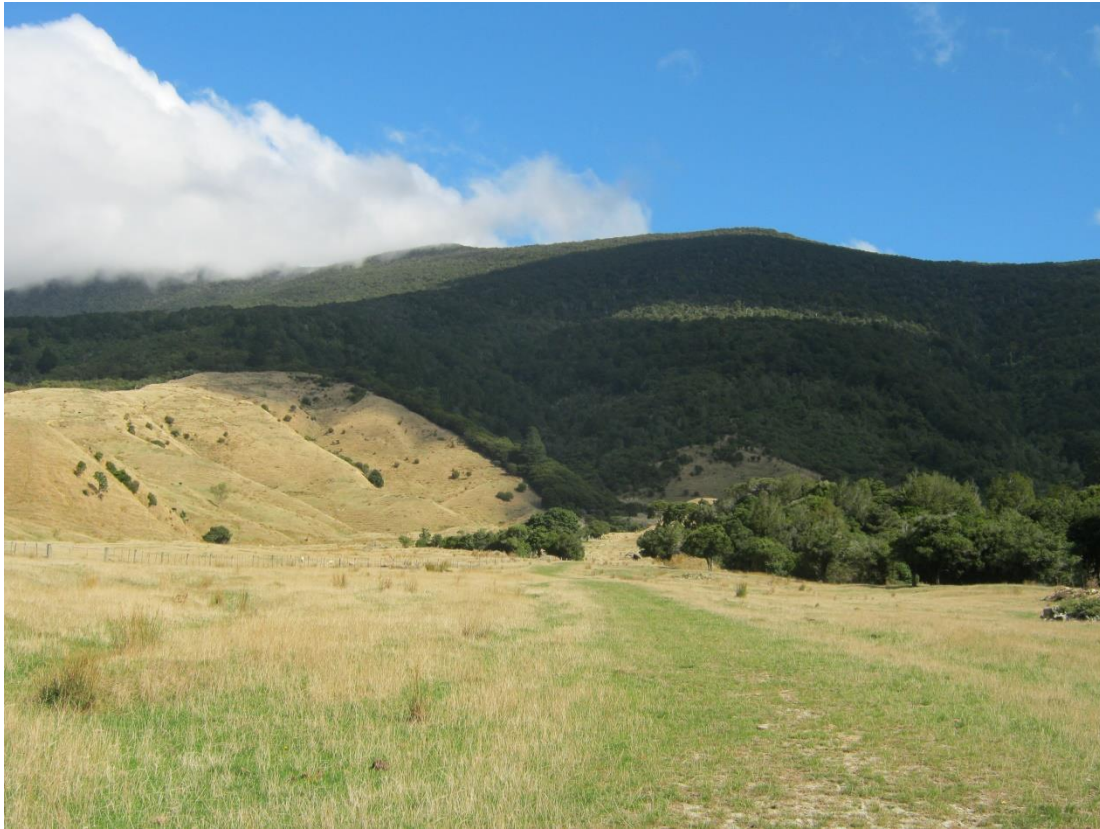
This photo is from near the access road looking towards Mount Stokes (obscured in cloud) the creek in photo centre has 2 slips – both occurred in the 1993 event . The creek on the photo right has another 1993 slip (see following photo)

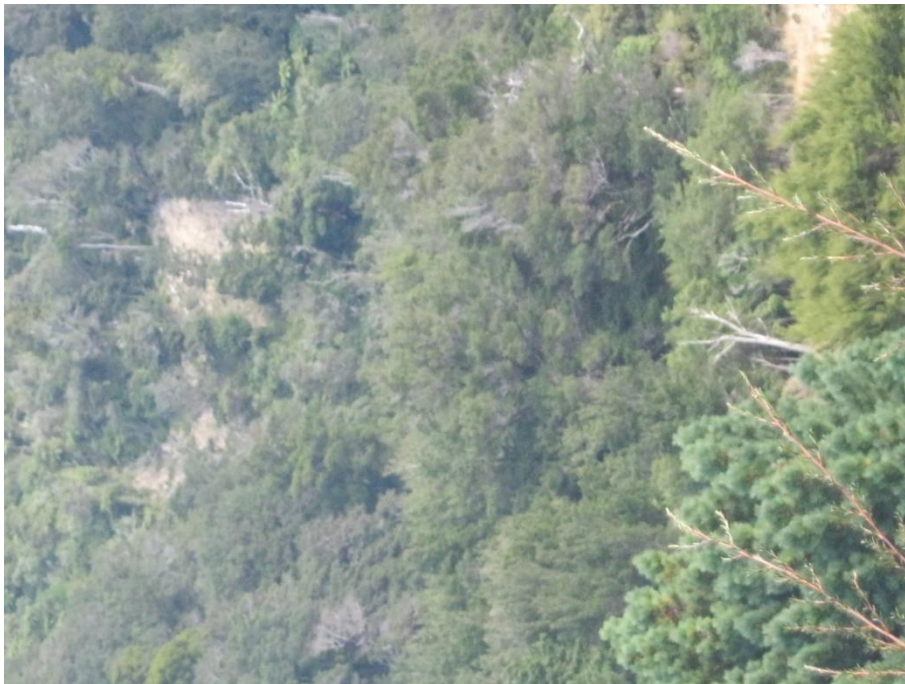
This is a poor photo off the RHS (western slip area)

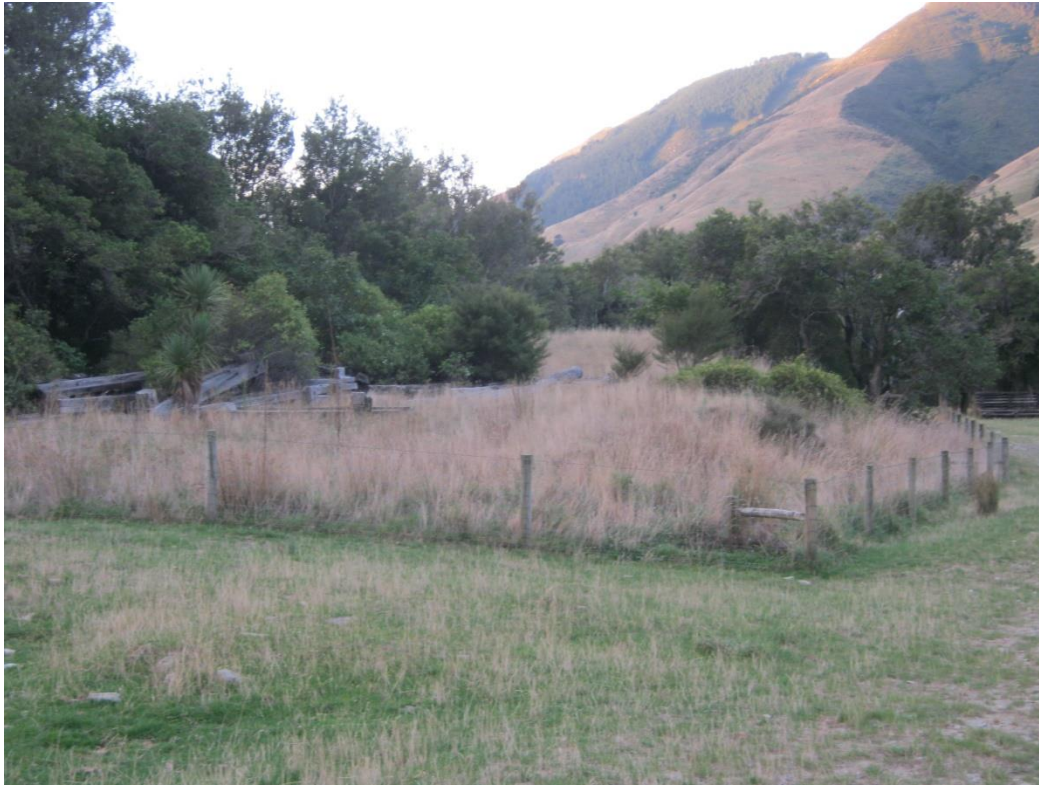
This photo is looking north towards the access road and shows some of the remaining stockpiled 8000 m³ recovered from the creek on photo left.

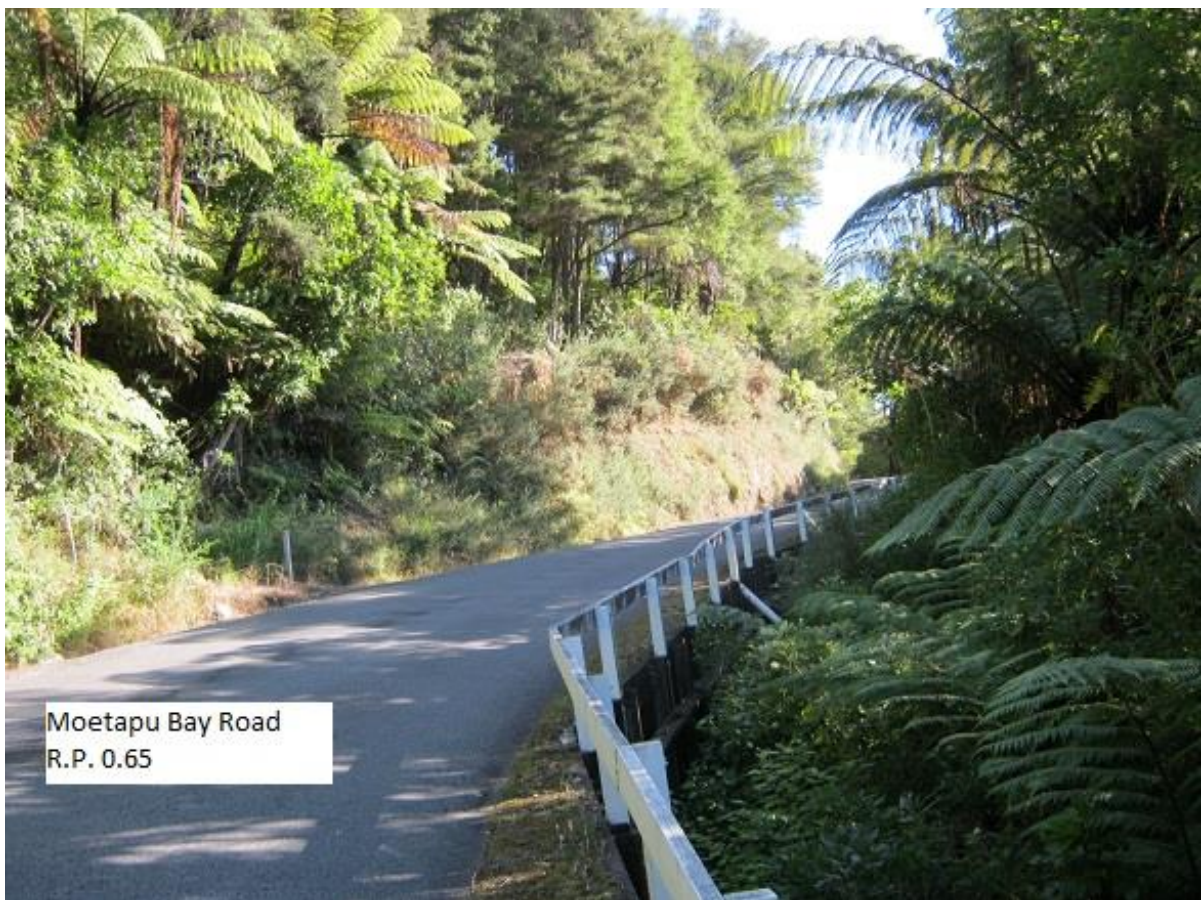
This damage occurred in app. 1992 and would have been a combination of the unstable hill side and the road activities , ie. steep batters and unstable edges.

See culvert 6 marker in photo Left

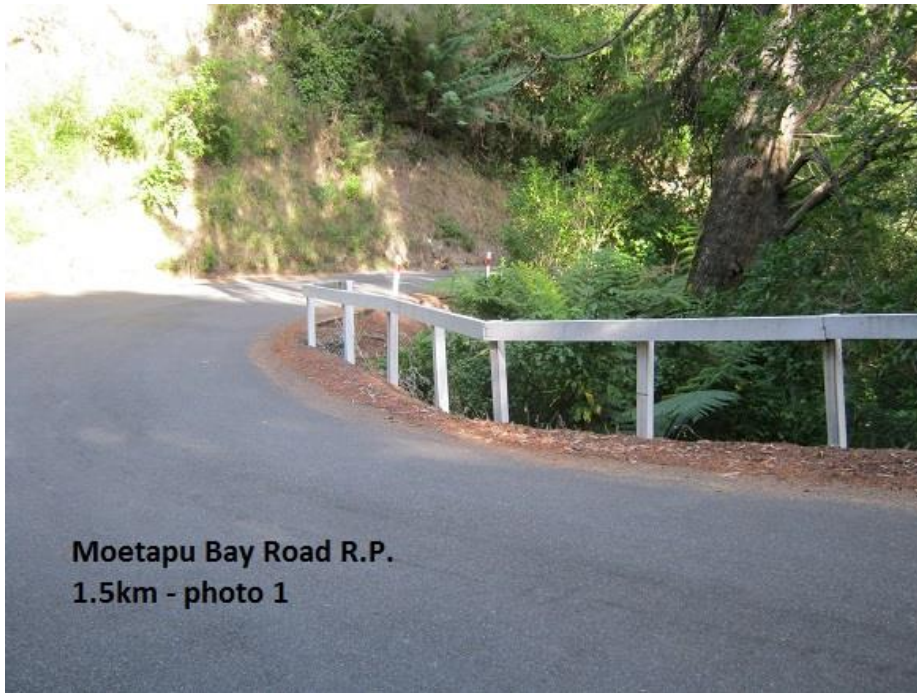
Photo 1 showing general view of site – watercourse is just near large Pine in photo Right.

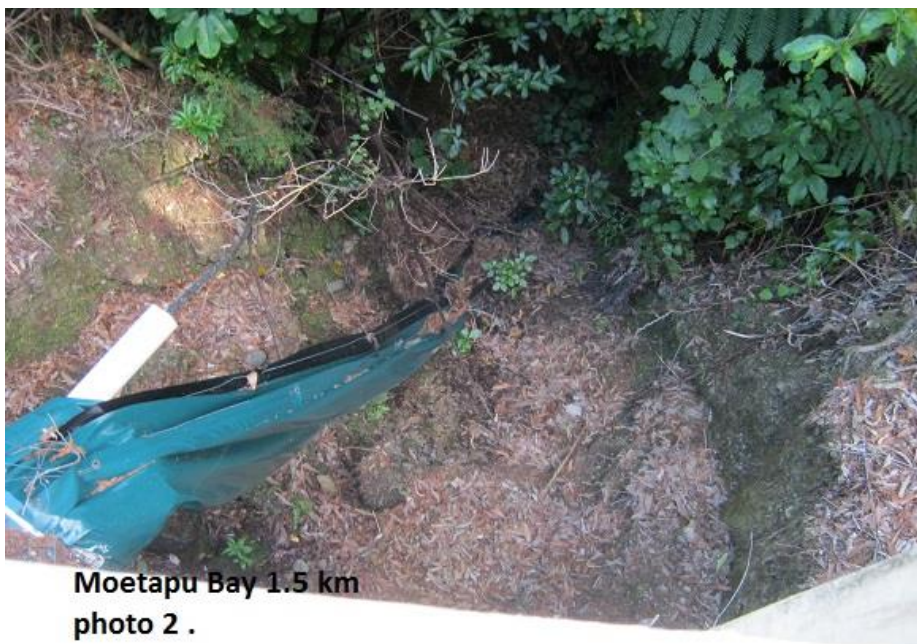
The watercourse is deeply incised in common with many Sounds watercourses and I am aware of many where property owners have installed various types of velocity drops and arresters to try and reduce the effects of this scouring on creeks beds , there will be many records and field notes of mine on property files and potential liability sites. At this site a large ' sock' has been placed to control and direct flows ; in some sites these instillations now reach almost ,or to , the coast line.(see photo 2)

This photo is looking below wall and shows the control 'sock' from the culvert outlet and the 'incised' watercourse. The conduit through the pipe carrying a water supply pipe is possibly an 'illegal' instillation (these commonly begin to trap debris and subsequently compromise the culvert capacity)

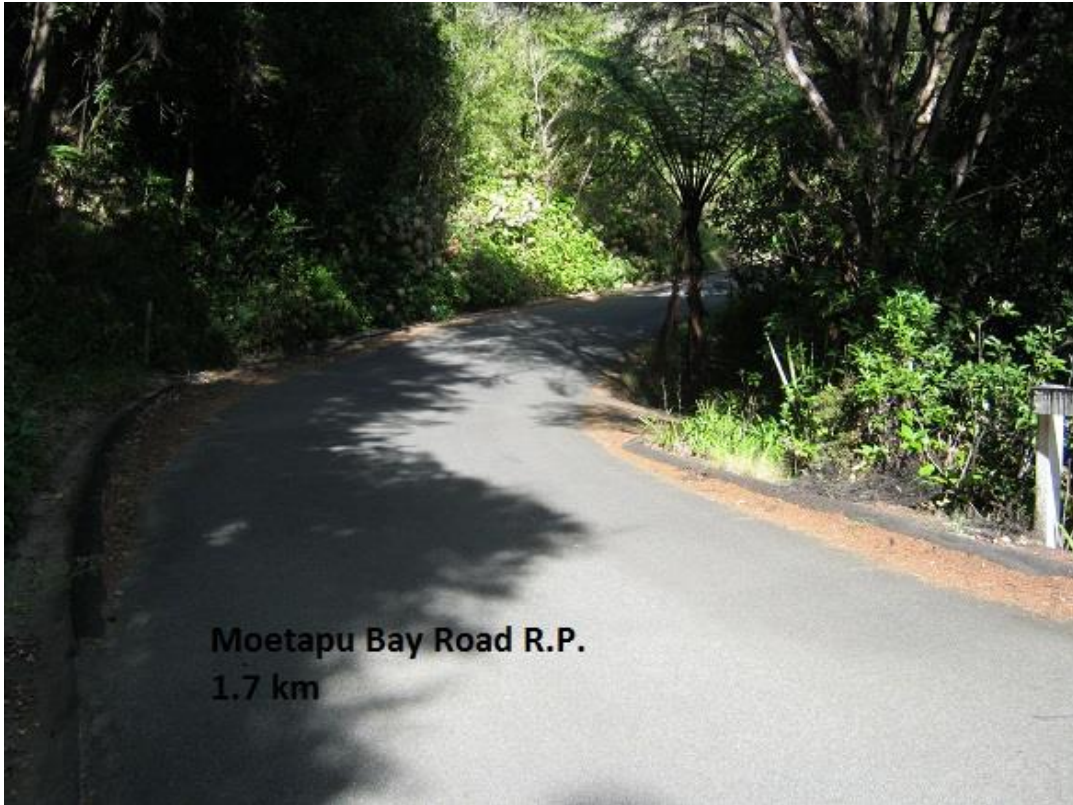
There was app. 600 m³+ that flowed to the sea , I suspect the road construction may have contributed to the collapsing LHS exacerbated by quantities of underground water that discharge along the LHS , note there was an extensive 'cutoff' subsoil drainage system installed along this LHS – I think it has been removed or compromised.

You can just observe in this photo the driveway to the RHS that was completely scoured out and has been rebuilt , as has virtually all of the road formation reconstructed post the event . See sketch following.

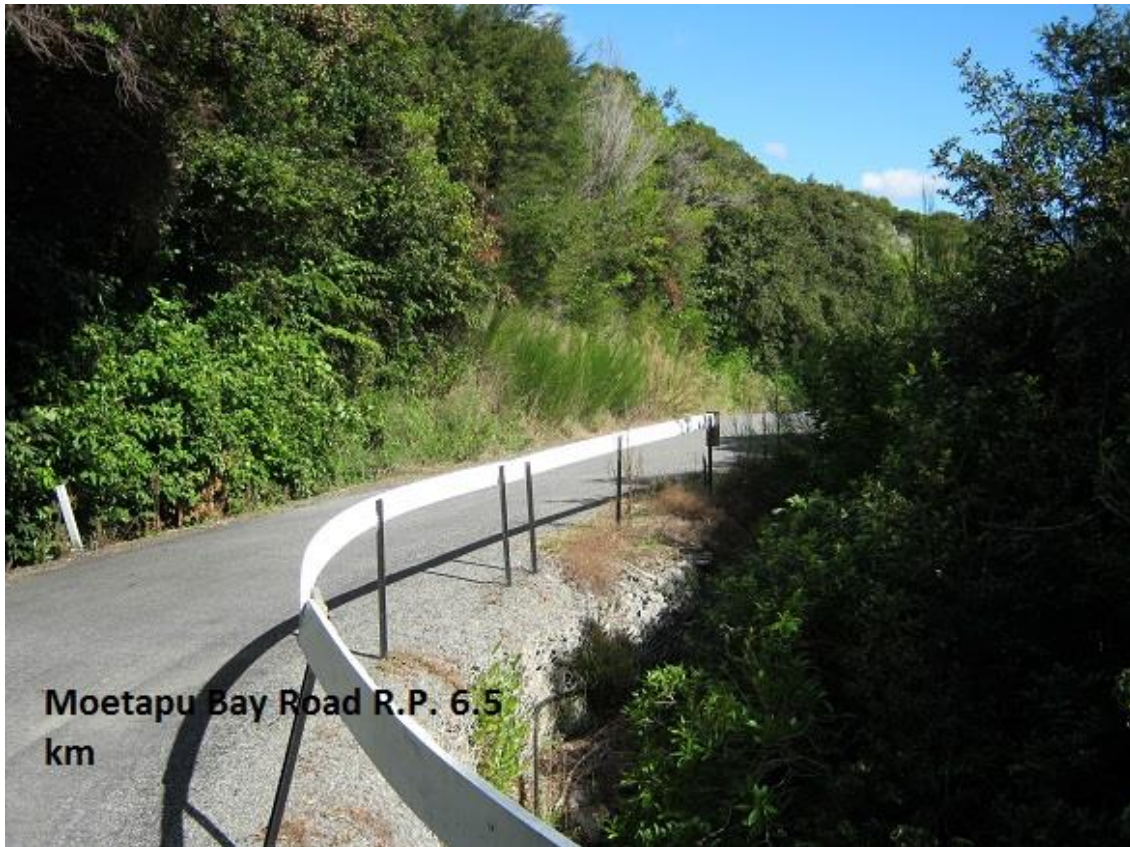
The fault seems to have been caused by erosion and collapse of the road batter but may have been affected by ground water which ran from the LHS bank for many years (and still may do so – was dry at my survey date)

In total there would have been about 2500 m3 to the sea , the event occurred in app. 2000

This photo is taken from near culvert 58 (next to culvert 57) the start of the slip area above the road commences near the broom bush – photo centre.

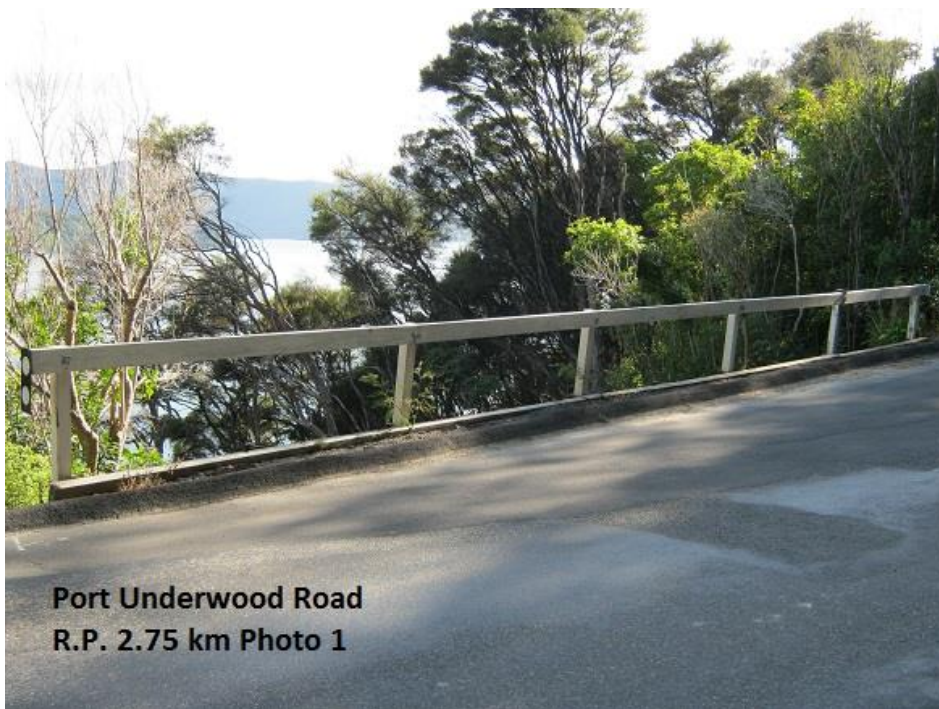
The damage is considered roading related ; the collapse of unsupported shoulders to the road and water ingress.

This is at the site of the event .See following photo 2

Note that new Stormwater manholes and corrugated conduits carry stormwater away from the road to deliver near the foreshore ; there are a number of such instillations towards Karaka Point. These are quite recent.
