SOME IMPACTS OF ROADING AND FLOOD DAMAGE ON SOUNDS ROADS

Part only –(this is a second report) –

Period 1985-2010

May 2016

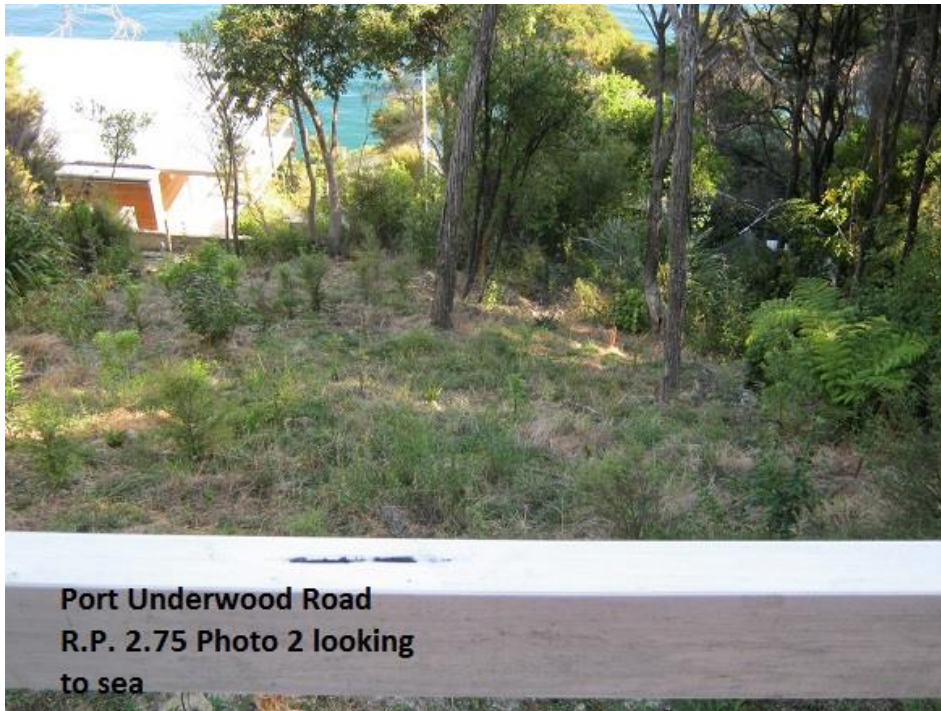
This photo is looking down the slip face towards where it flowed to the sea (to the photo right) the face has been planted to stabilise .

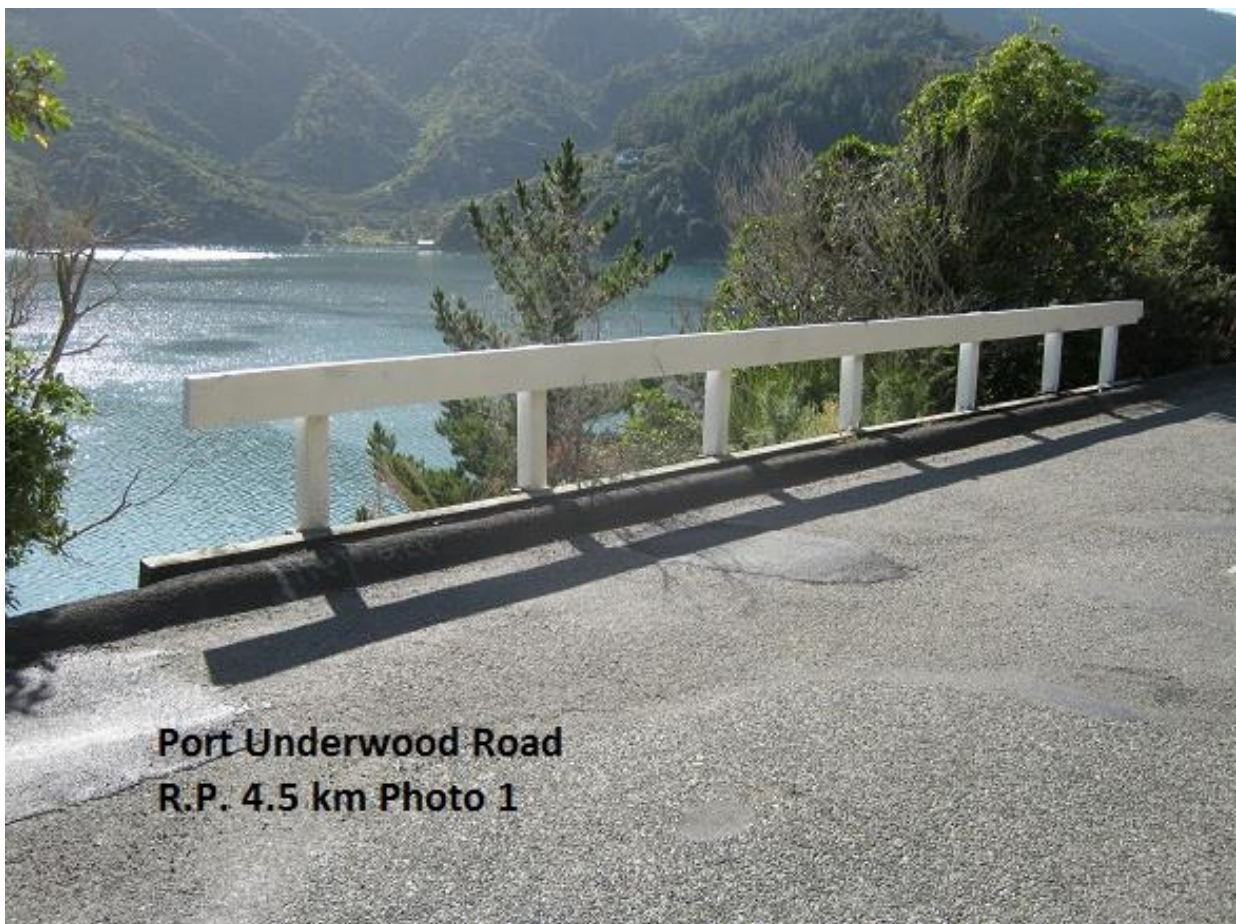
I could not observe any especial material deposited to the sea , very clear water at the time of my survey. There was approx 600 m3 at this site deposited to the sea , probably roading related damage and occurring app. 1994.

Note there was a 300 mm dia Armco culvert installed near the West side of the wall – this culvert has been undermined by approx.. 2—3 metres !!

Photo at the wall site See also photo 2 (follows)

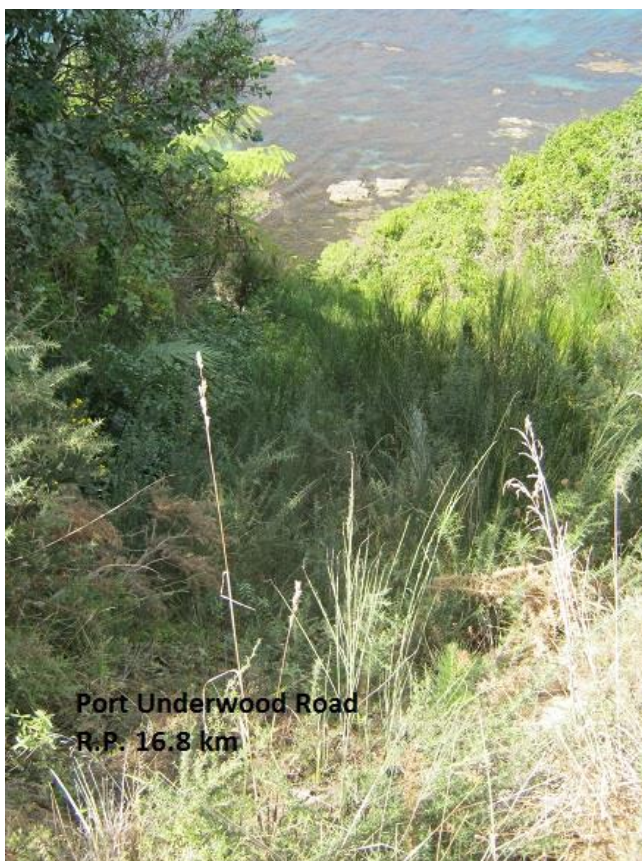
The damage is obvious and some material in the form of rocks was apparent in the sea at the time of my inspection (water was very clear) although I cannot be certain these were from the slip event.

Photo 1 looking down slip towards sea See over for photo 2

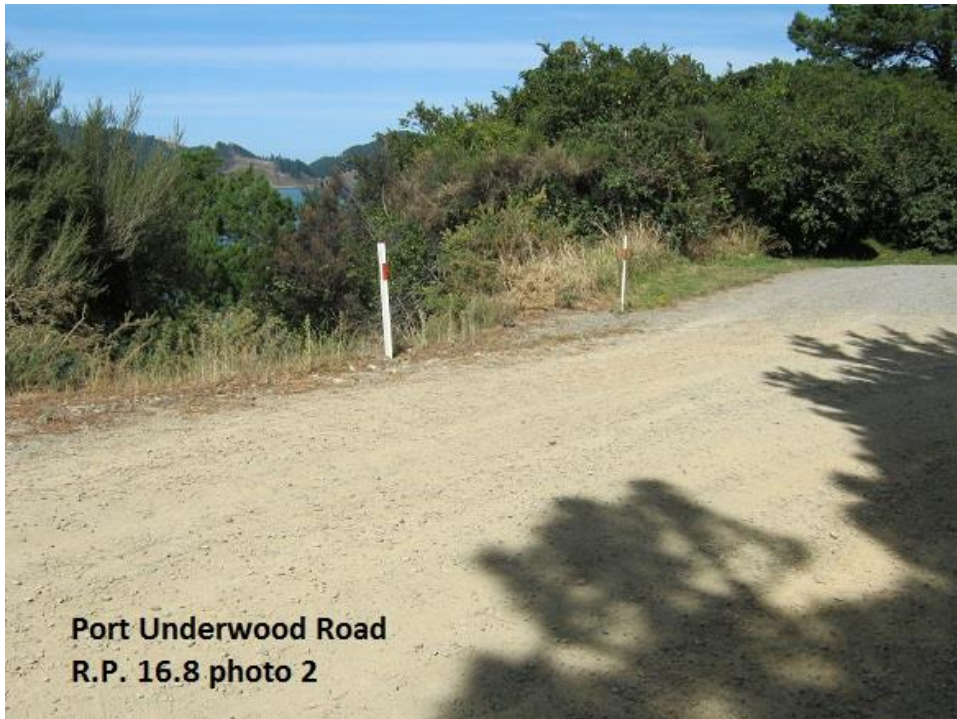
Site location Note turn area in photo centre foreground.

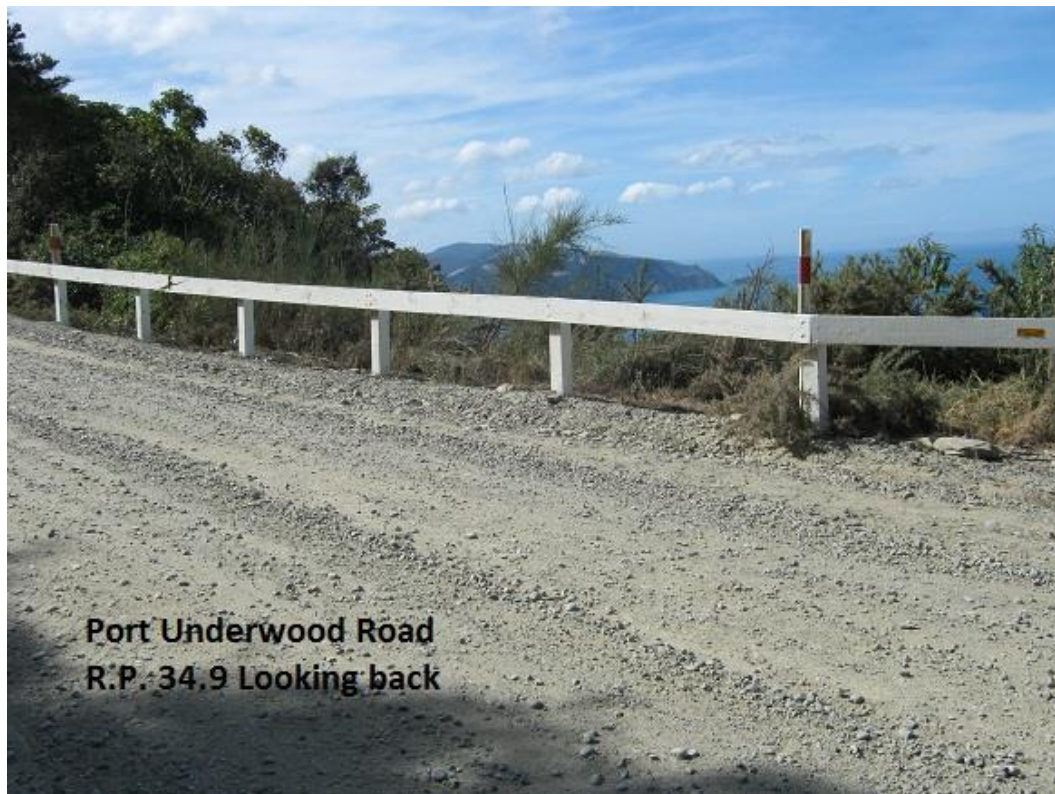
This is an old site typical of the collapse of the outer edge of the formation , as a result of the unbenched and uncompacted side cast material during the road construction (fairly typical of other damage in the area)

This picture is looking back up the road and shows Robertson Point in the photo background

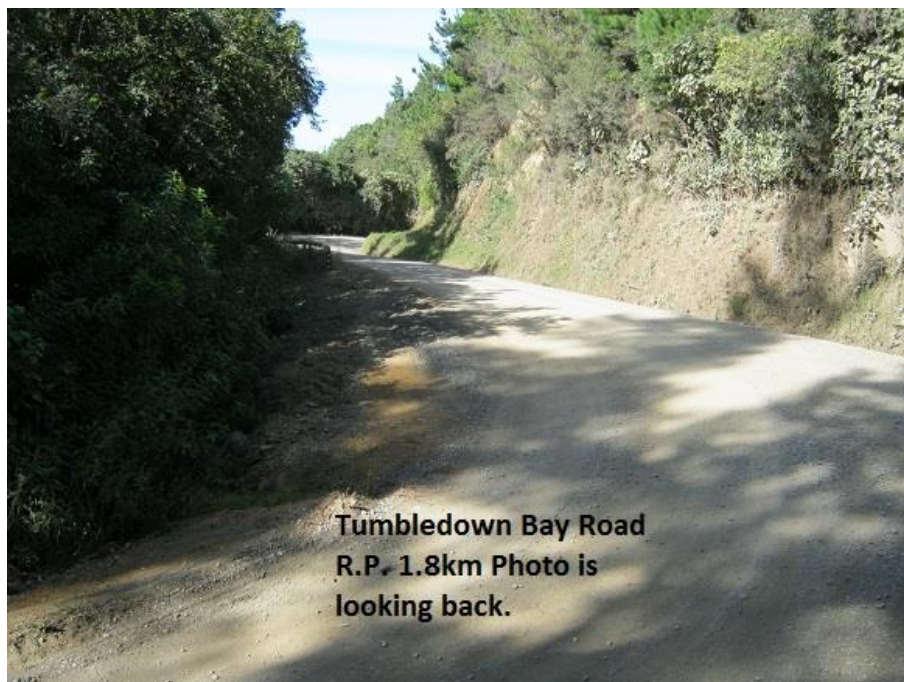
The material over the side extended from the photo left foreground all the way right through to the South end of the wall in the photo. There was also significant material from a gully right of this photo location.

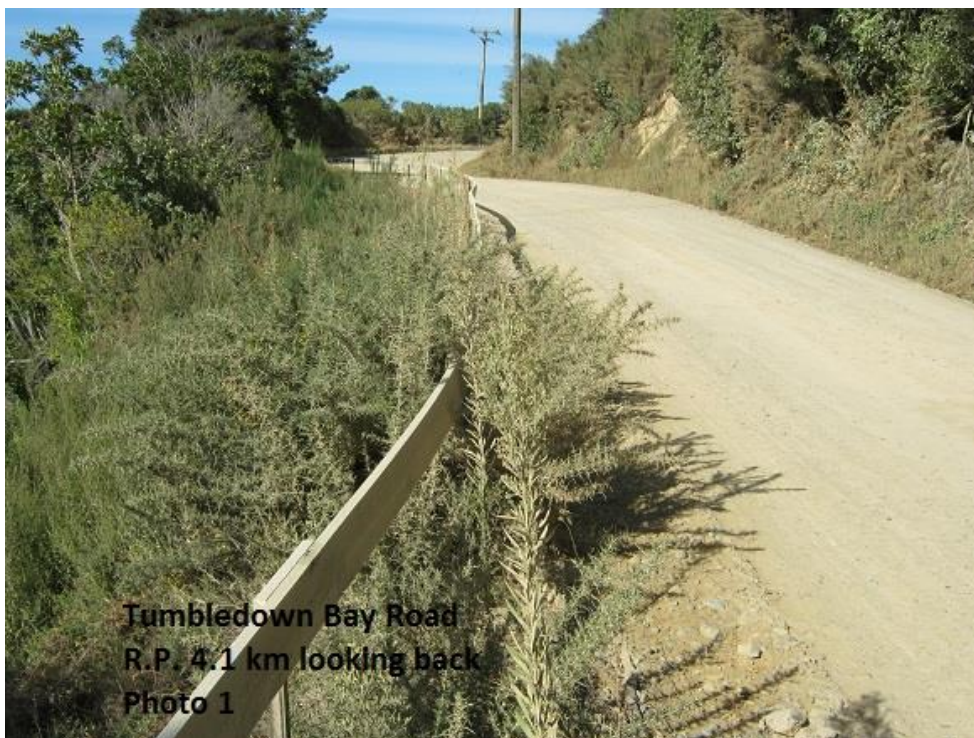
The cause was likely to be roading related and the event occurred app. 2005

This photo is at the site looking back to the South

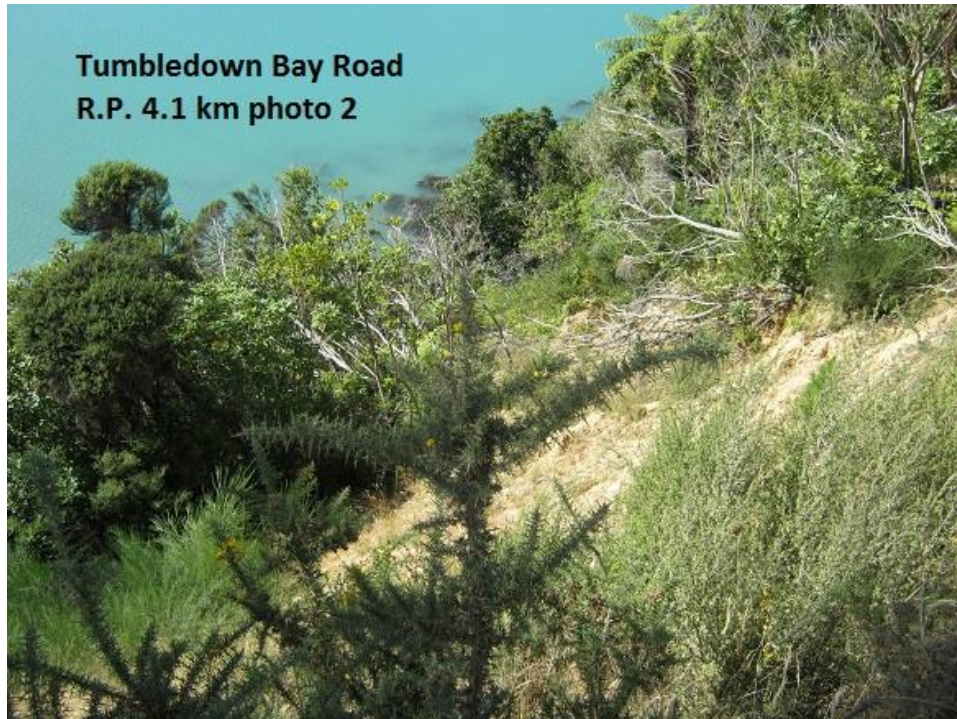
This photo shows the slip face to the sea ; still unstable ??

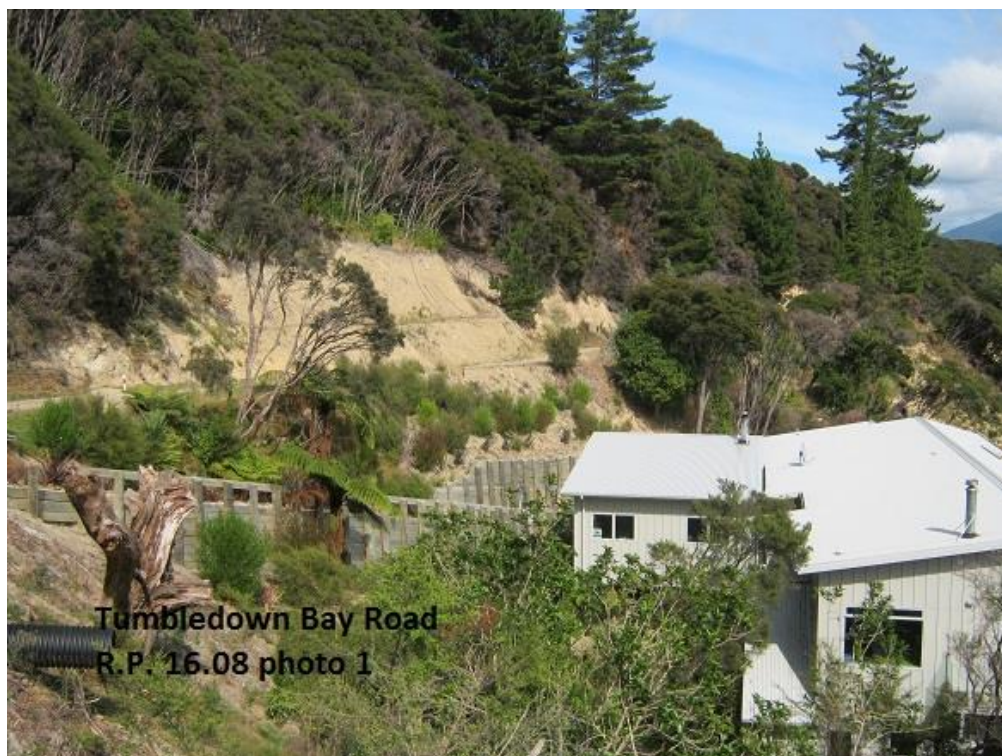
Note 'benching' of slip slope near photo centre , slip face below road is just
visible behind house . Earlier slip is at site of photo and before house access .
