# Ford's Cut History and Bank Erosion Assessment

Report prepared for Environment Bay of Plenty by

Philip Wallace

January 2008

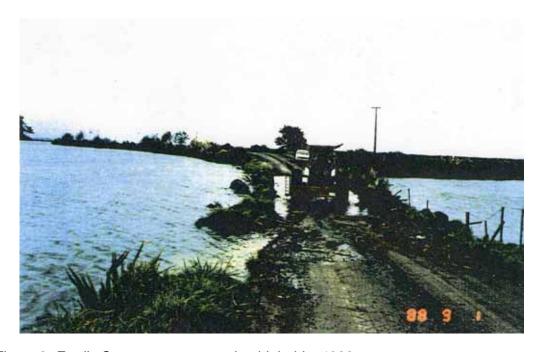
However, minor flows continued into the Ford's Cut, via seepage through the causeway, and during spring high tides and floods water spilled across the causeway (Figure 2). According to the submission of a local on the Ford's Cut consent application (see below), the seepage was as much as  $1/7^{th}$  of the river flow (Wilkinson, 1991). No evidence has been found to substantiate this quantity however. Figure 3 shows seepage flow in 1991.

Figure 2 Ford's Cut causeway at spring high tide, 1988

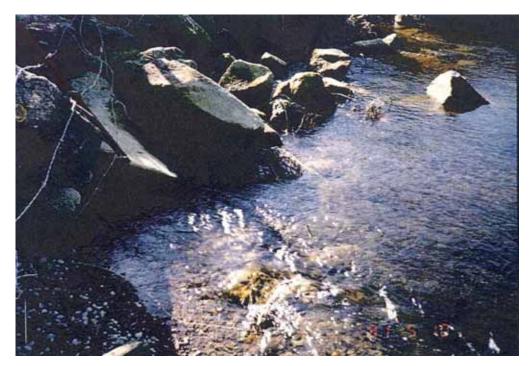
Figure 3 Seepage through causeway into Ford's Cut 1991

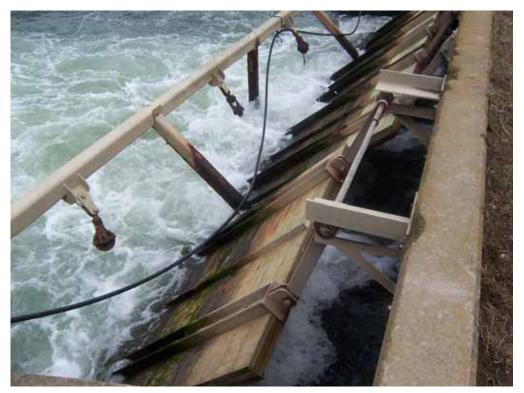
Observations made on 19 December, not long after high tide and when the culvert gates were open (Photos 1 and 2 of Appendix 3), showed that the velocity at the left bank water's edge was low – ranging up to about 0.3m/s. This confirms the low velocities quoted by Titchmarsh.

Photo 1 Gates fully open, falling tide, just after high tide

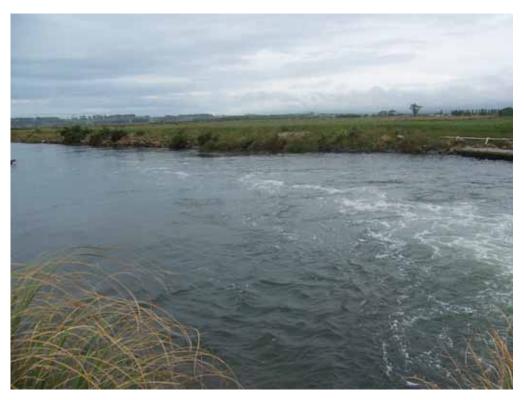
Photo 2 Flow in channel

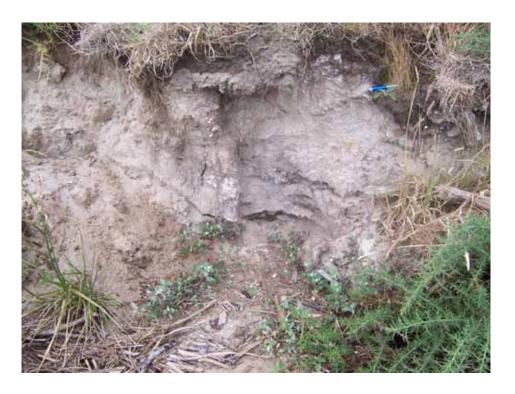
The left bank of the Ford's Cut channel approximately 1m high and consists of pumicey sandy silt (and therefore of limited cohesion) with some peat deposits evident (Appendix 2, Photo 3). This is much as described in BOPCC (1970). The bank has some covering of toe-toe and gorse, and in places old rock bank protection is evident. The bank is fenced at the top. The bank sits on top of a sand beach which, at the time of the site visit, was in some places becoming vegetated with a grass-like material.

Photo 3 Left bank material (pen for scale)

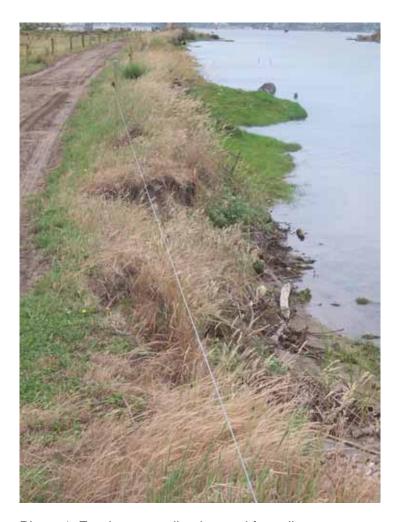
The bank has now been fenced, reducing the likelihood of stock contributing to the erosion. Nonetheless, there are some locations where the fenceline lies on the channel side of bank erosion (Photo 4 of Appendix 3) and some continued damage from stock is therefore possible.

Photo 4 Erosion extending beyond fenceline

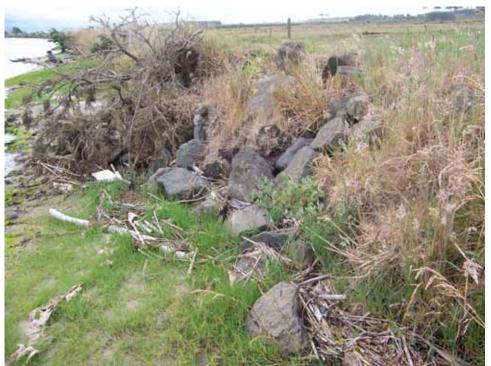
Photo 5 Isolated older rock protection. Grass-like vegetation establishing on beach. Note debris line indicating recent highwater mark

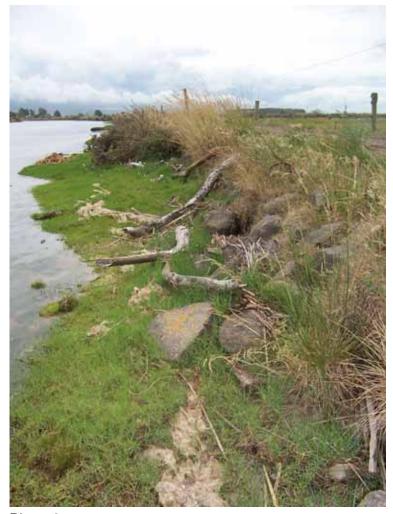
Photo 6

Clear and fresh evidence of bank erosion was observed during a site visit on 19 December 2007 (Appendix 2 photos). Photographs taken in August 2007 show similar erosion. Titchmarsh refers to photographs (not sighted) from 1988, 1995 and 1998 showing erosion.

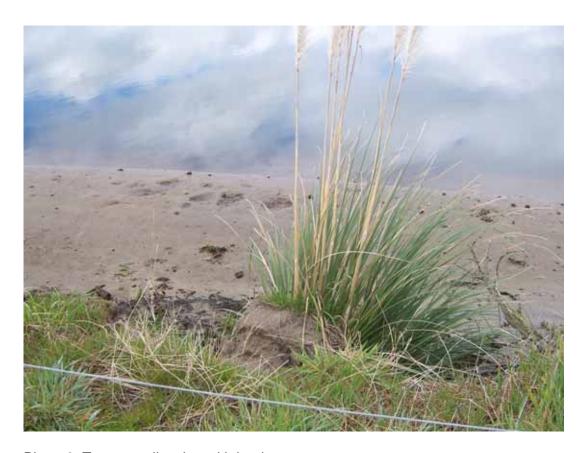
Photo 8 Toe-toe collapsing with bank

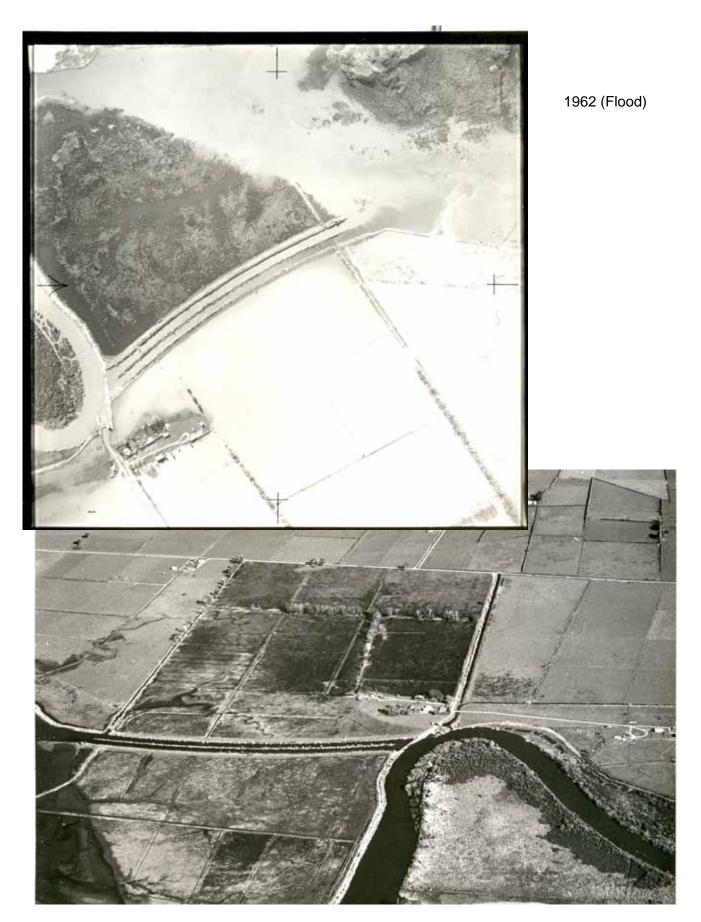
1977 (Oblique)

Table B of Titchmarsh suggests that the central island started disappearing between 1970 and 1980. The photograph of 1977 indicates that the disappearance started after that date. By 1994, the central island has more or less disappeared, and now the remnants are confined to below water level.
