Patea Beach Green Waste Management Strategy

Part 1 Coastal change and historical sand stabilization works

Report prepared for the South Taranaki District Council

Client Report 06/04

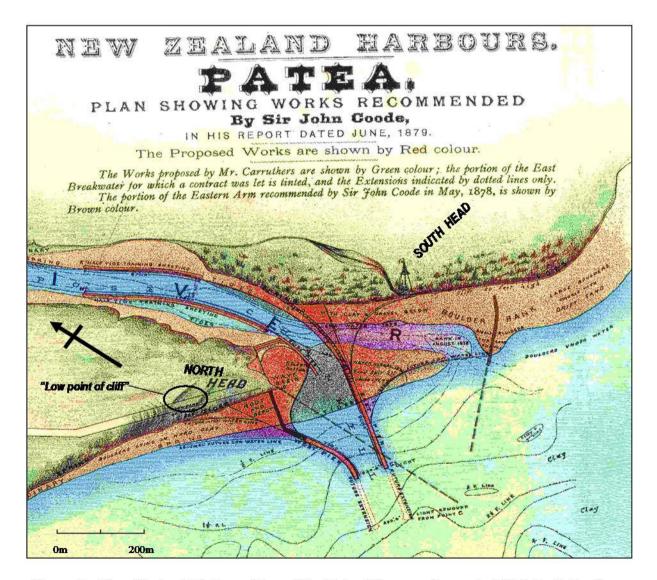
In the Coode Plan, the river is shown entering the sea along the same southward alignment as evident further upstream. It flowed seaward beneath that area where the south beach dunes now exist and past the South Head (Fig 2) which appears to be little changed today. The northwestern coastline was cliffed with a spit extending from the North Head some 400 m southward to the low tide rivermouth. Ordinary spring high tides are shown reaching the cliff-base along both the northwestern and southeastern

Figure 2 New Zealand Harbours Plan of the Patea Rivermouth area in 1879, depicting the harbour and entrance works recommended by Sir John Coode and others.

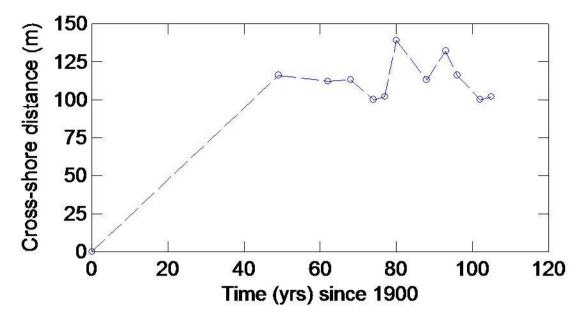
The North Mole acted as a sand trap for the predominantly northwest to southeast littoral drift, and the shoreline rapidly moved seaward – a now well recognized response to such structures. Indeed, by the time the first vertical aerial photograph was taken in 1949, the shoreline had adjusted to its present, albeit fluctuating, location as illustrated by the graph in Fig 3.

Figure 3 Shoreline change from base of cliff along a transect mid-way along North Beach. The cliff-base was approximated from the first (1949) aerial photo. Data points correspond to years of aerial photography. Shorelines were defined as the upper limit of the inter-tidal beach and this was delineated by intensity changes, with darker areas (heavier minerals or wet sand) denoting the beach face, and lighter areas marking the back-beach.

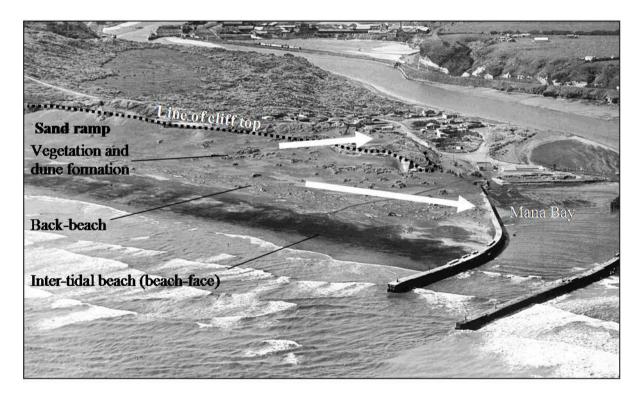
Figure 4 Oblique aerial photo from 1947 depicting the sand ramp up against the cliff together with several other features referred to in the text. Note the arrows denoting the transport route for wind-blow sand across the low point in the cliff line, and also along the back-beach into Mana Bay.

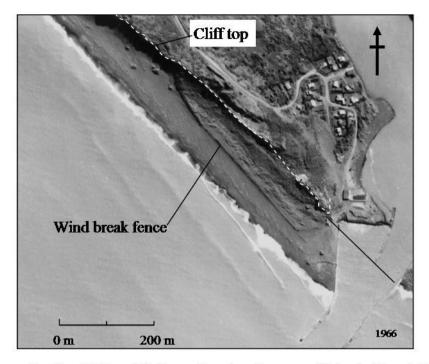
The 1958 aerial oblique photo (not reproduced) shows a windbreak fence and possibly conservation plantings. The 1962 aerial photo (Fig 5) clearly depicts this long shore-parallel fence which was constructed of vertically driven and wired mill slabs. These stabilization works resulted in a continuous shore-parallel foredune forming and, for the next 15-20 years, this minimized wind-blown sand from both threatening the settlement and blowing alongshore to reach Mana Bay. The 1977 vertical aerial photograph (Fig 6) illustrates this stable foredune.

Figure 5 The 1962 aerial photo showing shore-parallel wind-break fence and foredune development between fence and cliff.

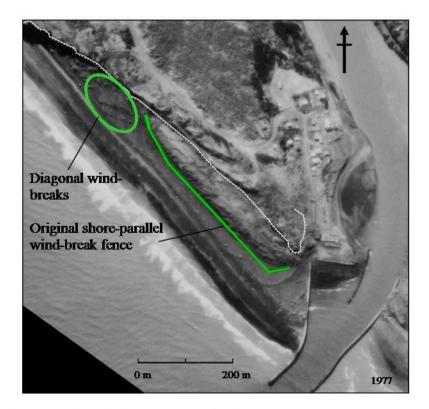
To the northwest of the shore-parallel fence, shorter diagonal wind fences were erected during the 1960s and 70s, and evidence of these can be seen in the 1977 aerial photo (Fig 6). However, they did not result in the formation of a significant and continuous foredune as in the centre-south of the beach, possibly due to the fence and planting design, or differences in sand supply and wind strength at the northern end of the beach. This fencing may well have contributed to the development of the discrete dunes orientated diagonally across the beach (and parallel to the prevailing wind) which still characterize this area today.

Figure 6 The 1977 aerial photo showing the location of the original shoreparallel wind-break fence (green line) and the well developed stable foredune between the fence and cliff. Note the earlier diagonal wind-break fences (green circle) to the north which were less successful in assisting vegetation establishment and dune formation.

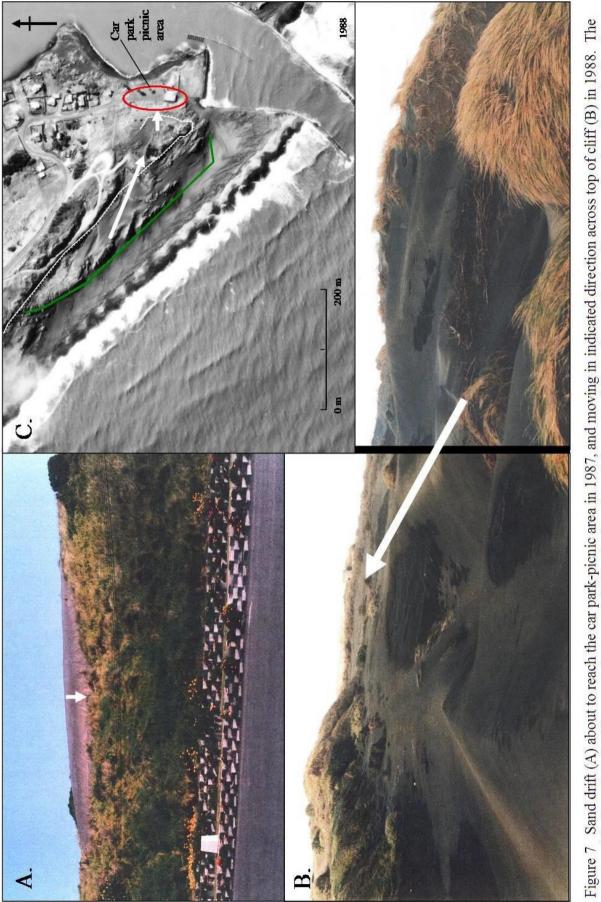
behind the original conservation fence (green line in C) was highly unstable. Note earlier (unsuccessful) windbreak fences across the path of the 1988 aerial photo (C) also illustrates these sand drifts. The location of the arrows in A and B are depicted in C. By 1987/88, the entire foredune arrow in C.

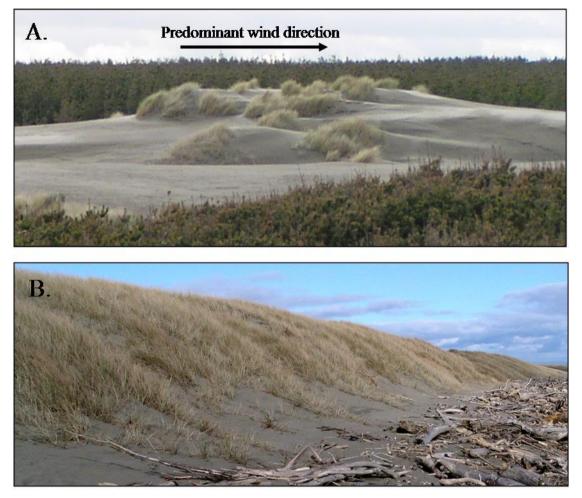
Figure 8 Hummocky dunes dominated by marram (A) compared with more uniform foredunes dominated by spinifex or pingao (B).

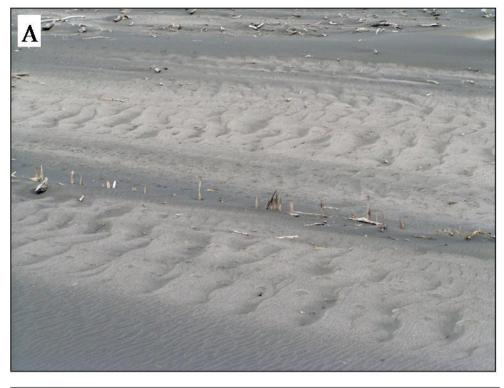
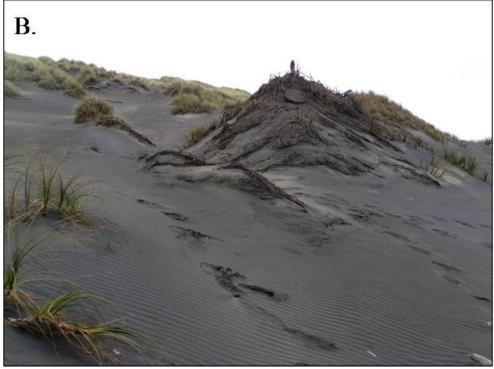
The <u>northern sector</u> is characterizesd by the pingao foredune, which is severely blown out in several locations (e.g. Fig 9). Behind the foredune are the discrete and hummocky dunes and erosion troughs aligned with the (topographically steered) prevailing wind. In several instances, foredune blowouts have merged with erosion troughs to the rear which extend up the ramp to the clifftop (see Figs 9 and 13).

Figure 9 Evidence of wind severity. Mega ripples (A) on the southern back-beach area, and wind burn (desiccation) of pingao on foredune blow-outs(B) at the northern end of the beach.

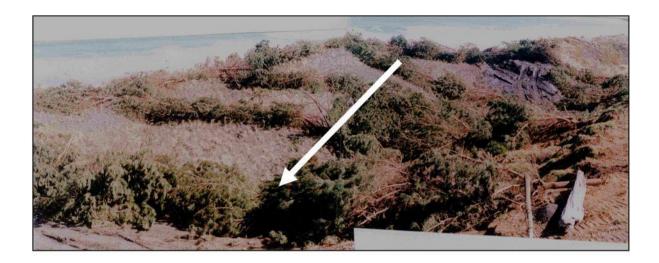
Stabilization methods in the central-southern section consisted of blocking the large erosion guts (blowout throats) using pine trees thinned from a nearby plantation. In

1988, wind-break fences were constructed over the sand drifts to the rear, and marram grass was planted between these structures (see Fig 10).

Fig 10 Sand stabilization works carried out in 1988. Pine thinnings were placed in guts and across the path of the prevailing wind (see arrow), with marram planted within the intervening spaces.

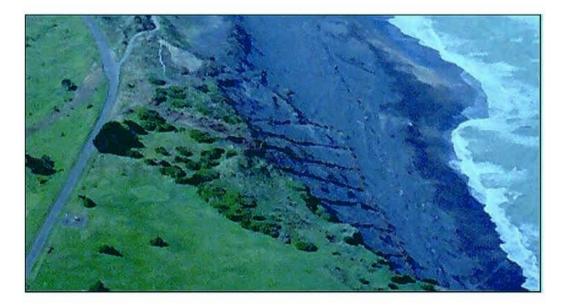
In 1992, wind breaks were constructed across the northern dunes and ramp (Fig 11) and planting carried out. This work was only partially successful and a proposal was put forward for further windbreaks in 1994. However, it appears that this work did not eventuate.

Figure 11 This 1992 aerial photo shows the just completed windbreak fencing at the northwestern end of the beach.

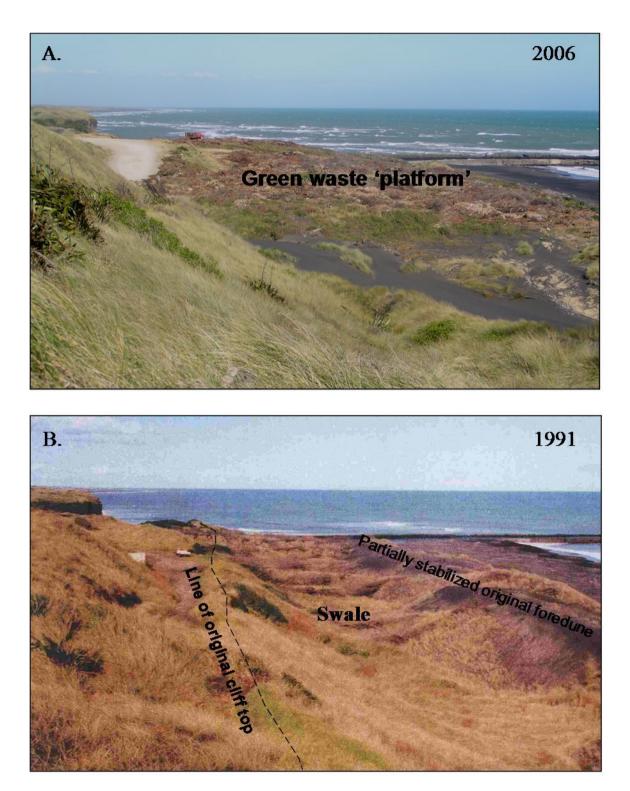
By the mid 1990s, the mobile sand problem had been largely contained; however, some unstable areas persisted. Covering the central-southern area with green waste continued and expanded to become a district-wide operation by the late 1990s. The swale between the cliff and original foredune-crest was slowly infilled (see Fig 12) with green waste, wind blown sand and then this was overlain with 'clay'. In addition clay tracks were formed to allow green waste to be placed in areas most affected by erosion or sand drift. In effect a 'green waste platform' has been created that has displaced the original cliff-face seaward by some 50 to 70 m.

Figure 12 By 2006, a green waste 'platform' had been created (A) by infilling the swale between the original cliff and the crest of the original foredune (B). Note driftsand at northern margin (in foreground) of green waste platform in A.

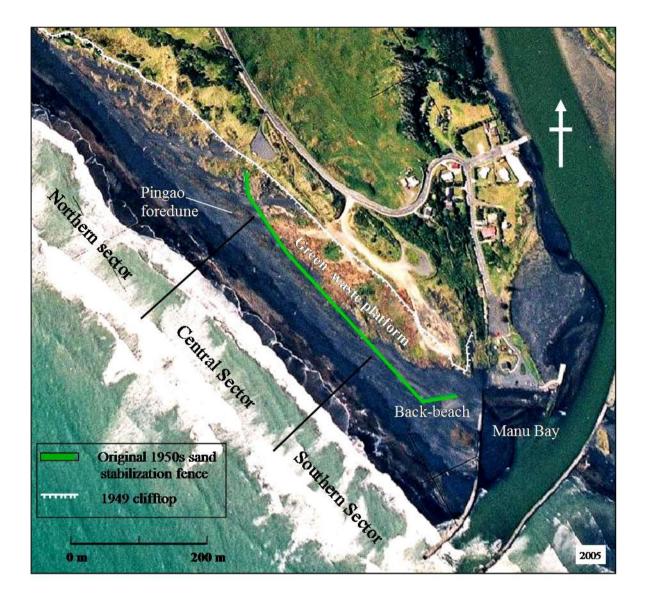
As is evident from the above description, the North Beach and dunes at Patea can be divided into three sectors based on present topography, developmental history and management regime. The longshore extent of these sectors are marked on the 2005 aerial photo in Fig 13, along with features and terminology used henceforth.

In contrast to the central sector, in the southern sector, the face of the green waste platform is well landward of the original foredune (see green line in Fig 13 and the dashed line, marking the 1950s fence remnants, in Fig 15). Such retreat in the southern sector is the result of erosion by southerly winds. These fence remnants are also evident in Fig 9A.

Figure 13 The 2005 vertical aerial photograph showing the three sectors of coast based on physical characteristics and management regimes. Several important physical features are marked.

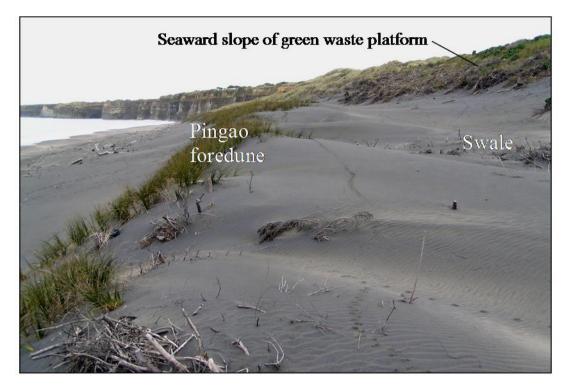
The <u>central sector</u> is also characterized by the pingao foredune (Fig 14); however, here it is less blown out indicating less severe winds. Behind this foredune, a swale occurs which broadens and lowers toward the south. To the rear of the swale is the seaward face of the green waste platform. This slope is characterized by patches of green waste and marram interspersed with bare sand. Some of these bare sand areas would rapidly develop into guts if it were not for the platform's green waste capping. The green waste and marram plants cladding the slope enable it to steepen beyond the angle of repose for dry sand and become more cliff-like.

Figure 14 This photo is taken of the central sector. On the seaward side is the pingao foredune. Note the green waste in the lower left, remnants of the wind-break used to shelter the pingao during its establishment. The slope up to the green waste platform is marked, along with the intervening swale.

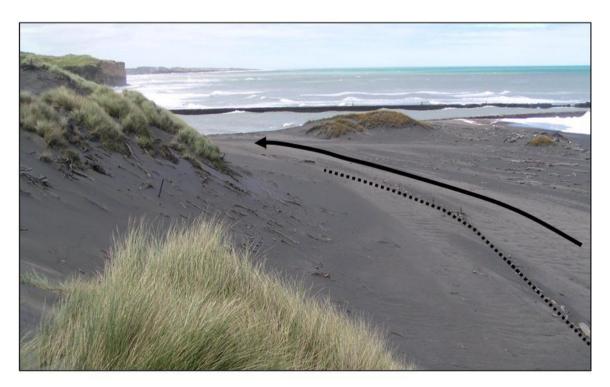
The <u>southern sector</u> has no continuous foredune, but comprises isolated dune hummocks of pingao located on the seaward side of the broad back-beach area (Fig 15). Behind the back-beach is the over-steepened slope fronting the green waste platform. The slope in the southern sector is also characterized by areas of marram, bare sand and green waste (as depicted in Fig 15); a combination which will facilitate the development of guts on the slope and sand drifts to the rear.

Figure 15 Southern sector characterised by isolated pingao hummocks to seaward, and the broad back-beach. On the left hand side is the slope up to the green waste platform. Wind-blown sand transport pathways (arrowed) along the back-beach and into Mana Bay are inferred by the ripples on the lighter sand streaks—see Fig 9A for greater detail. The dashed line locates remnants of the original wind-break fence of the 1950s (see Fig 9A for detail).
