PATEA BEACH SAND MANAGEMENT PROJECT

SUMMARY REPORT 2008 to 2015

A report prepared for the South Taranaki District Council

COASTAL SYSTEMS Ltd

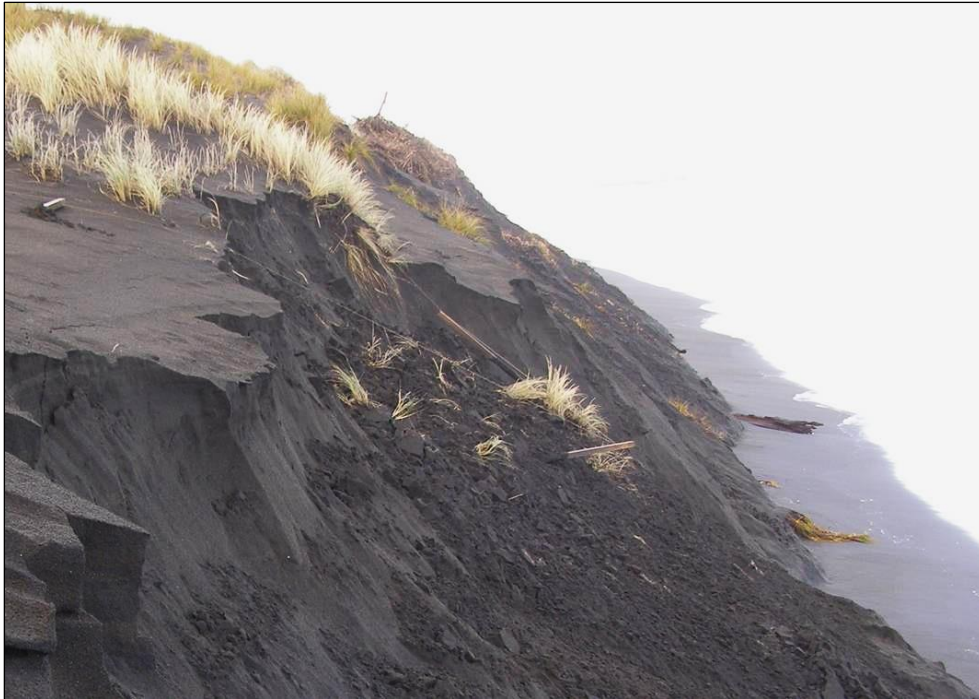
As alluded to above, the most recent shoreline data points in Figure 3B indicate the northern shoreline has been undergoing a significant episode of erosion and this is the case (e.g. see Figure 5). This episode has been closely monitored using both aerial and terrestrial photographs, and profile surveys. Results have been reported in Annual Reports since 2012 and the current situation is covered in Section 4.6 (Monitoring) of this report (Monitoring), along with consequential stabilization issues. Briefly, this erosion was initiated in 2011 by storm waves cutting into the base of the dune in the north of the dune system (900 m from the mole) and has been migrating southward with the leading edge now being some 300 m from the North Mole. In the north, the dune front has eroded landward some 30 m and the erosion face is up to 15 m high with wind-blown sand from the scarp face blowing inland to bury existing vegetation. Even when wave erosion of the scarp base ceases, and there are just now indications this may be occurring in the far north, the steep slope must adjust (under gravity) back to the stable angle for sand (34 degrees). Wind erosion results in retreat of the scarp top, i.e. surface instability will progress further into the dune system burying existing plants and leading to further wind erosion/wind drifts. If left unmanaged this process could affect the road, farmland and the beach settlement as occurred in the 1950s and 1980s. Additional monitoring has been carried out over the past few years to better understand and respond to this current episode of erosion.

Figure 5 An example of foredune erosion taken on 12-8-2014. The slip-face is 20 m long. A trial plot of spinifex on the left (light coloured grass) is being lost along with the protective fence (battens and rope evident in centre of photo). Pingao grass (yellow) is the predominant foredune plant cover and can be seen in the background where the litter the slip face.

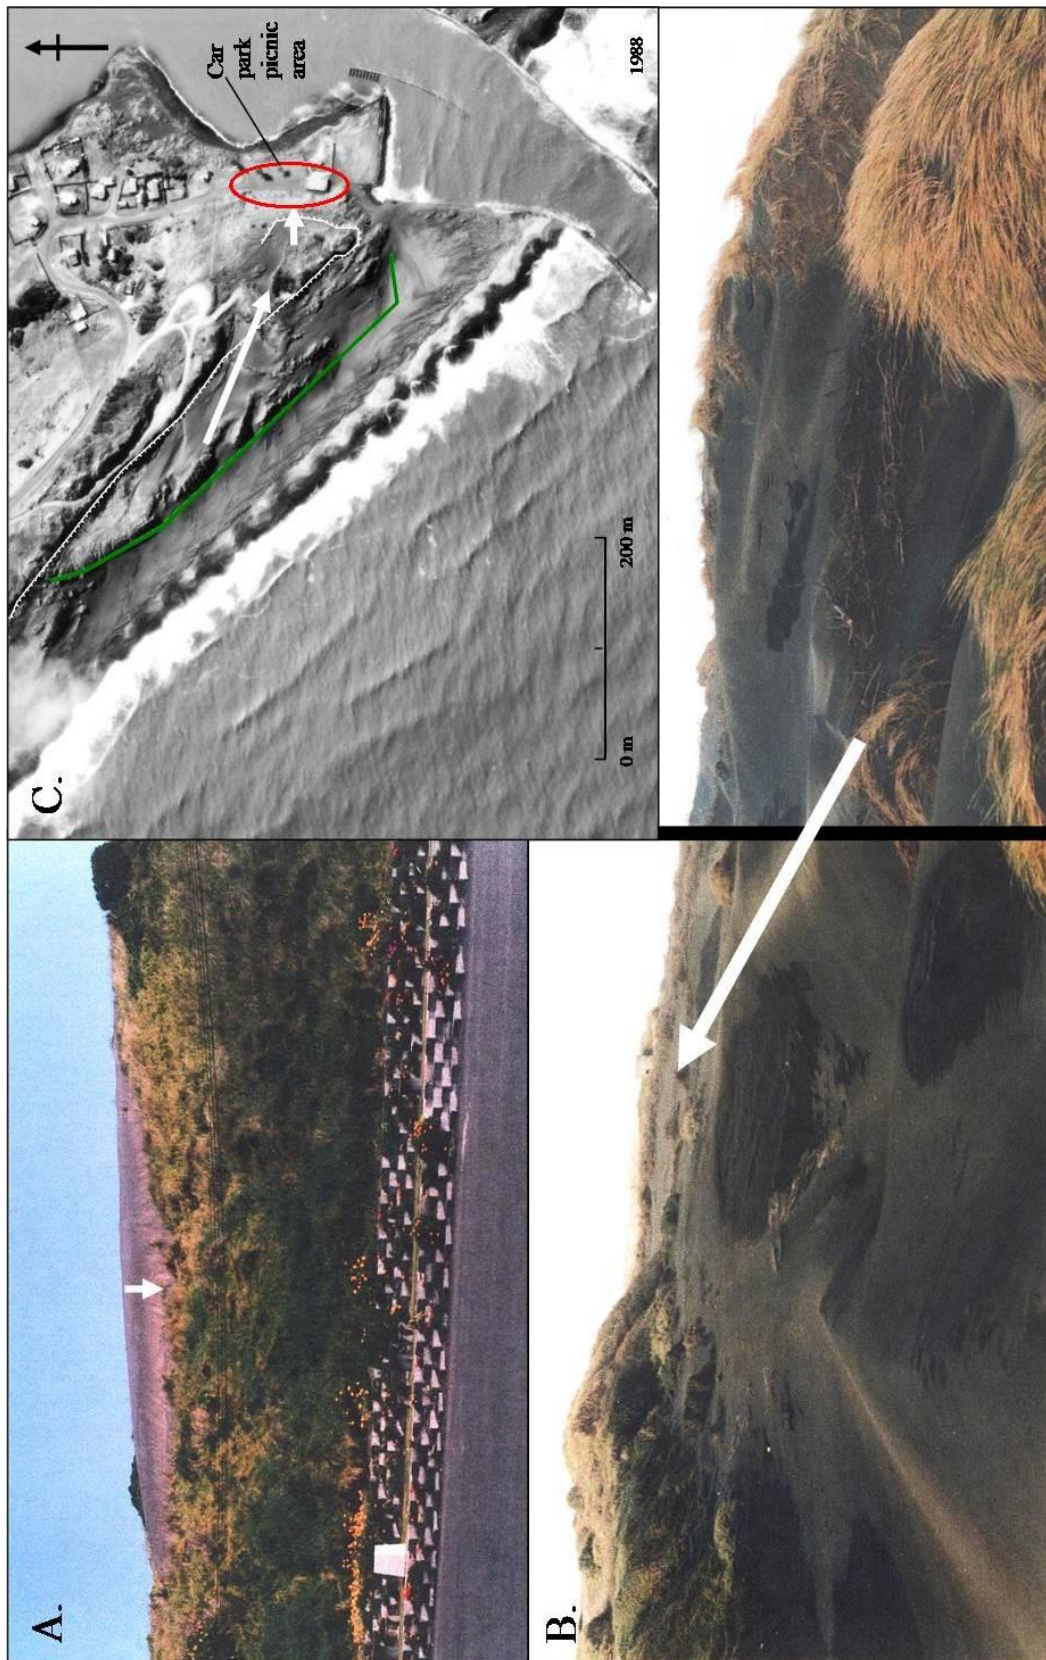
Figure 6 Widespread wind erosion and sand drifts in 1987/88. Figure 6A shows drift sand in 1987 about to descend into the car park/picnic area by the Surf Club building, after sand eroded from the then unstable foredune (Figure 6C) and formed wind drifts (Figure 6B). The green line in C locates the earlier mill slab wind-break fence that helped earlier dune establishment and growth.

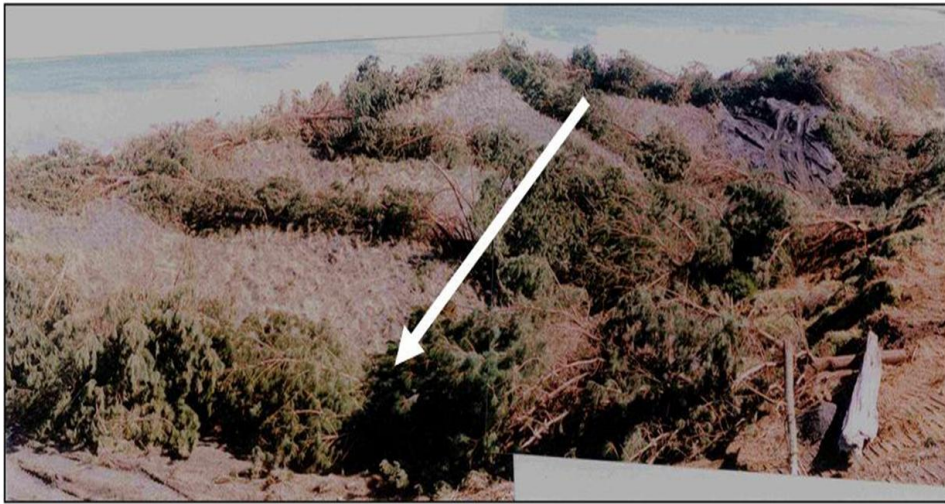
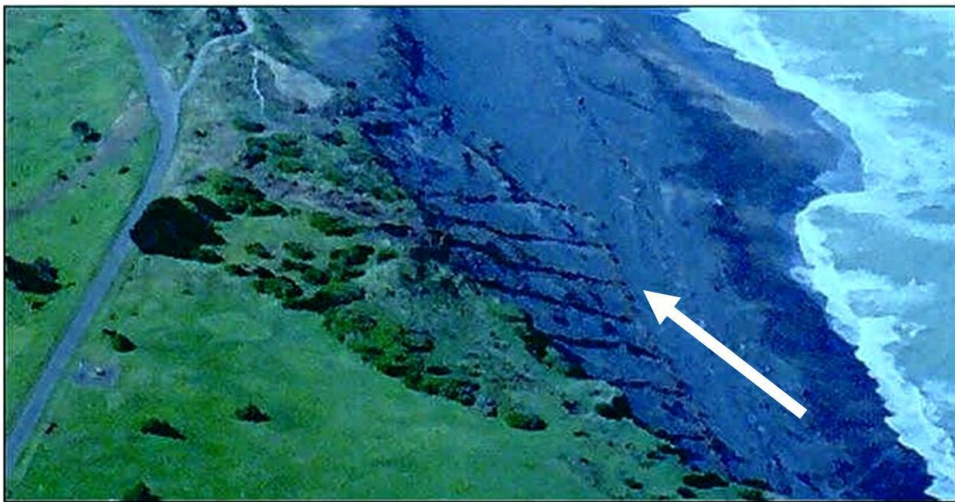
In the northern area, similar wind breaks and plantings were constructed across the unstable dunes and ramp (see Figure 7B). However, this work was only partially successful, possibly due to the wind-breaks being at a lesser angle to the prevailing wind direction. A proposal for further windbreaks in 1994 did not eventuate.

Figure 7 Upper photo (A) shows sand stabilization works in the eroding foredune area (NB C in Figure 6) where pine thinnings were placed in gullies and orientated across the path of the prevailing wind (arrow), with marram grass planted within the intervening spaces (photo 1988). In the northern area (lower photo B) sand instability was wide-spread and pine thinnings were used to erect rectangular fencing with marram planted in between (photo 1992).

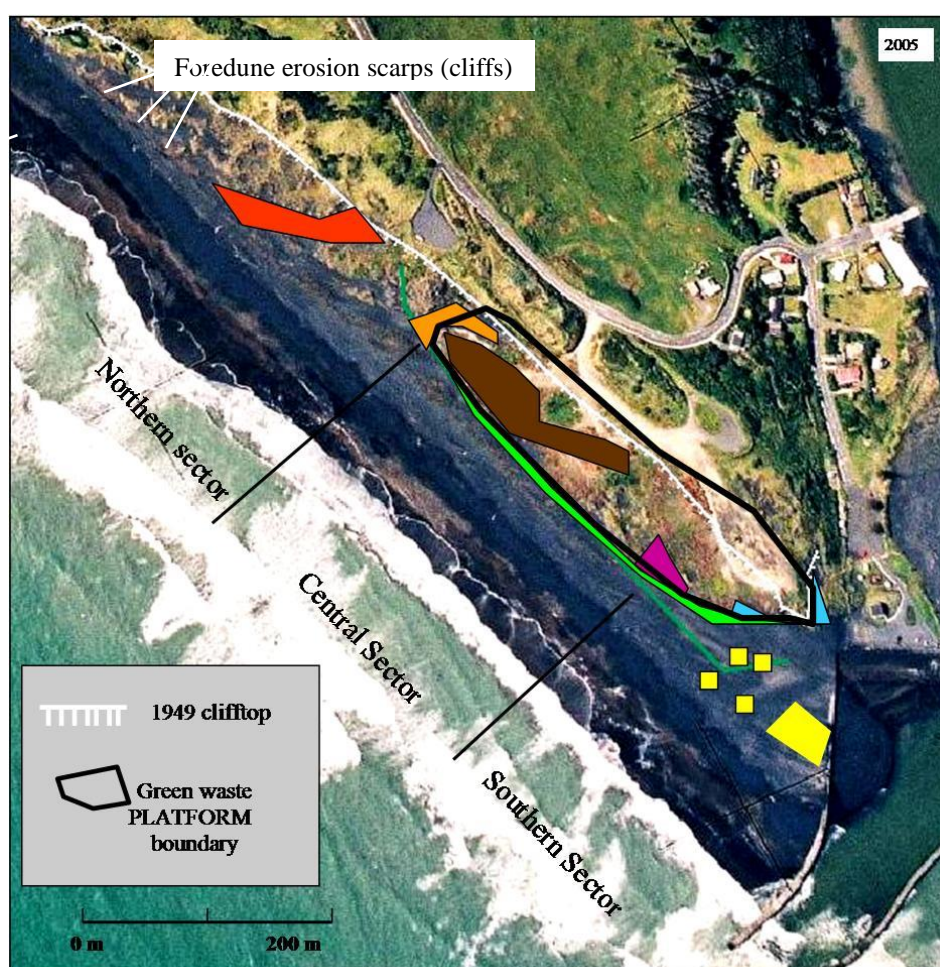
Figure 10 Physical features and areas requiring management at the beginning of the sand management project. Brown is the green waste drop-off area at 5 June 2008, orange required immediate stabilization, red, purple, aqua required stabilizing in the near future. Green marks the face of the GWP. The three sectors are based on differing physical characteristics and require differing management regimes. Yellow denotes areas of isolated dunes to be removed (to facilitate rather than obstruct sediment transport) and their vegetation transplanted to unstable areas. Note the dark green line locates the early the (1950s) mill slab wind-break fence and a foredune scarp in the Northern Sector is marked.

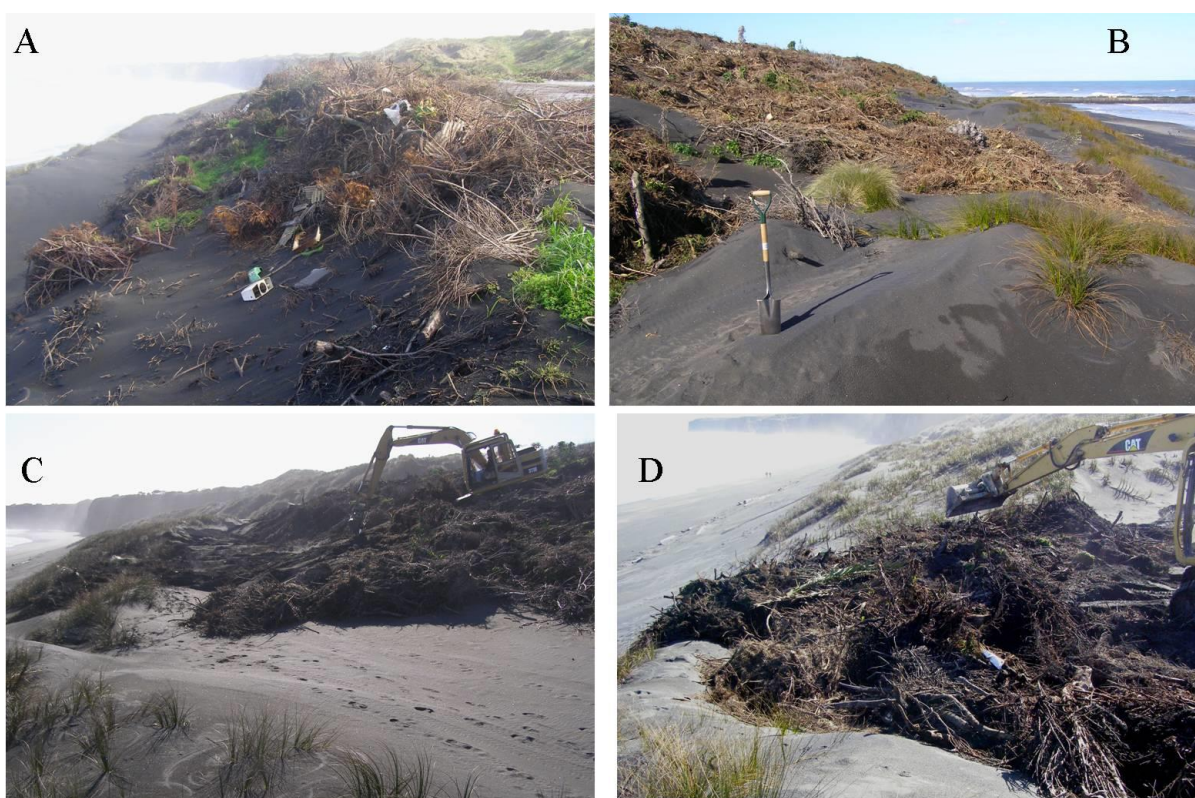
During placement, green waste often spilled into the swale between the GWP face and the crest of the Pingao Foredune (Figure 12B); this presented an obstruction to the swale's function as a conduit for sand transport toward the rivermouth. An objective of the sand management project [CSL (2007) Figure 4 and CSL (2010) p6] was to maximize sand storage capacity on the platform face while facilitating alongshore transport via the swale to the river. Swale obstructions which occurred during placement were therefore periodically removed (Figure 12C).

Figure 12 Green waste placement. Recently pushed to the front of the platform face in the Central Sector (A) with an earlier placement and sand infill in foreground. Green waste spilling down face of platform and across swale (B), and subsequent swale clearance (C) with waste being placed in guts on top of the pingao foredune (D)

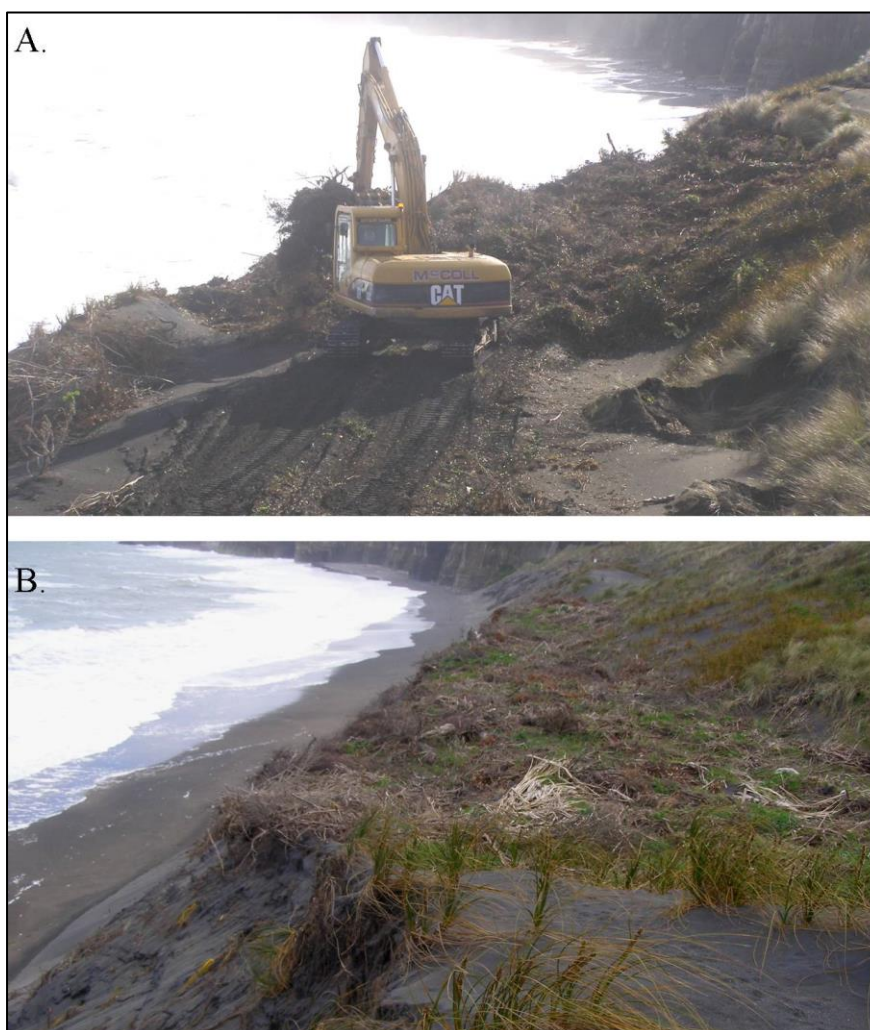
The current episode of foredune erosion that is affecting the Northern and Central Sectors, as discussed in Section 2. To minimize landward destabilization from gutting and landward vegetation burial, the scarp face and crest should have uniform relief with protective cover. However, this is not possible given the hummocky nature of sand dunes and their characteristic irregular vegetation, but a recent green waste trial is promising.

Figure 13 Green waste being placed along the scarp-top (A) in July, 2014. NB the extent of this scarp is evident in Figure 5. The stabilizing effect of the green waste treatment compared with vegetation (pingao) cover is indicated in B (October, 2014) where the pingau area in the foreground has greater scarp retreat and associated landward wind-drift.

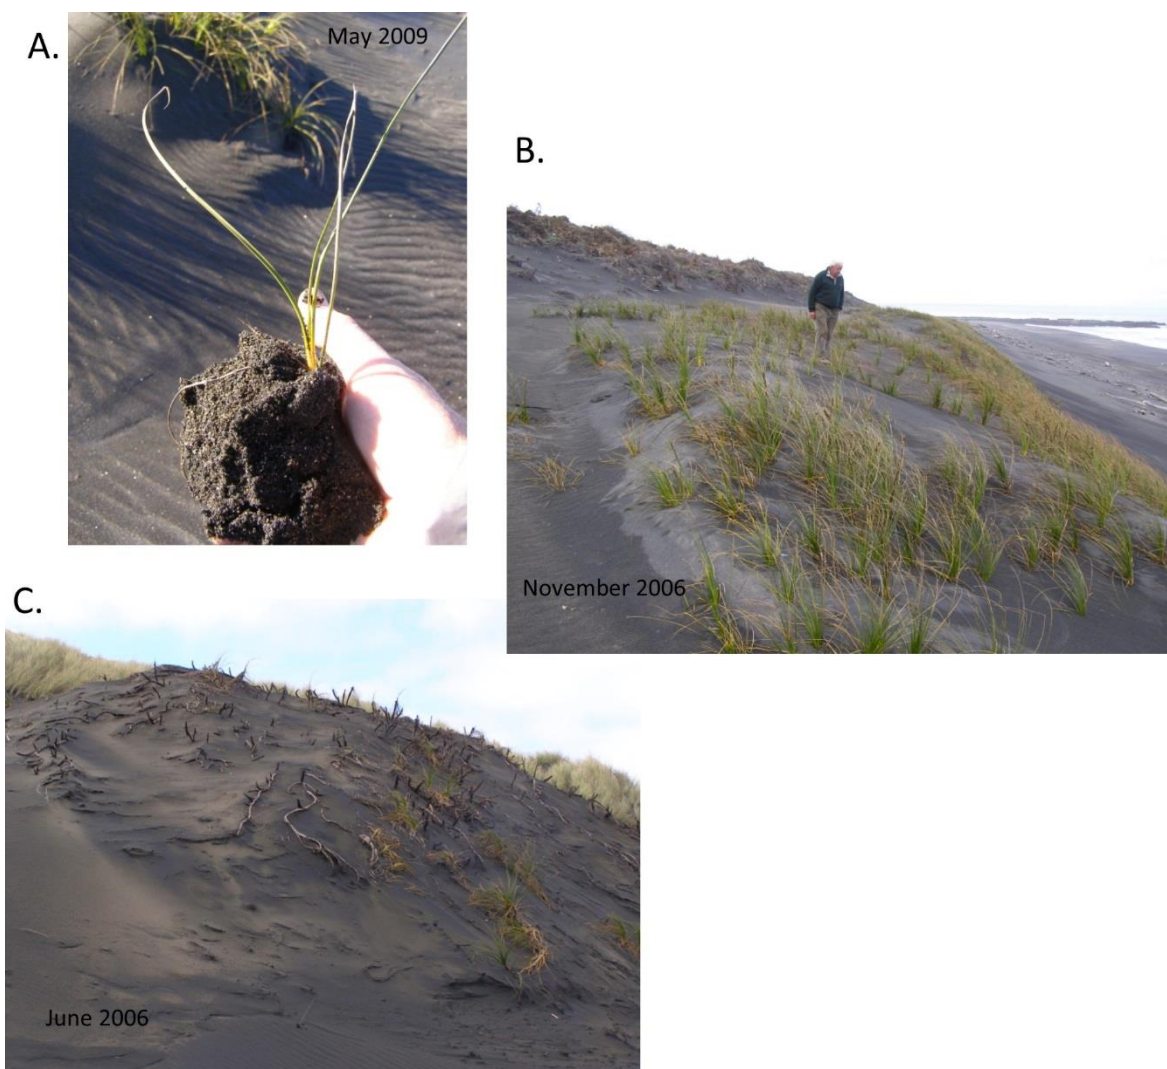
Figure 15 Pingao at Patea. New self-sewn seedling (A), foredune originator Mr Noel McColl inspecting healthy plants in the Central Sector (B), and wind desiccation in the Northern Sector (C)

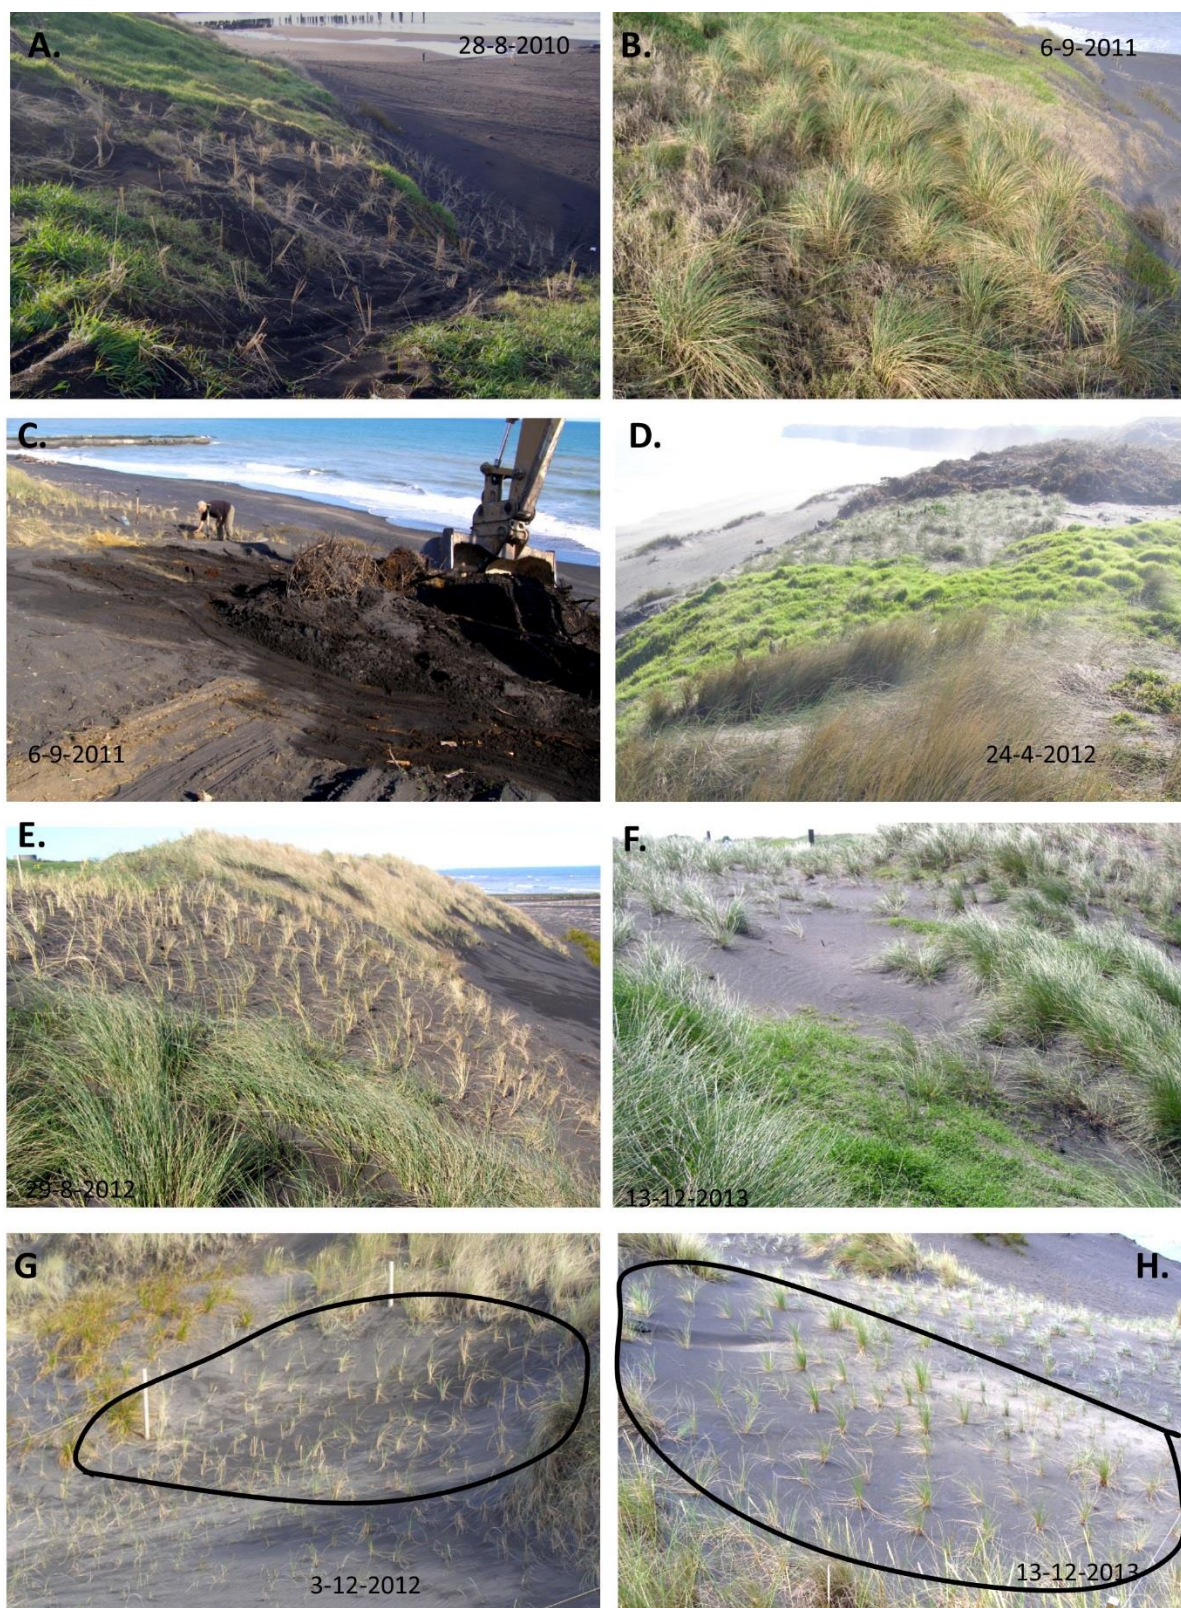
Figure 16 Marram trials. A and B show planting and follow-up photos for Site I (location in Appendix B4). C and D show planting and follow-up for initial GWP face planting (location yellow area in Appendix B5). The bright green area centre photo in D is kikuyu and this was mechanically removed and replanted with marram (E) with the result shown in F. G shows Lower Basin backslope planting trial and H the follow-up a year later (site marked in Appendix B6).

*Easternmost 10 m of the trial area (shown bright green in Figure 16D) failed to establish, being **outcompeted** and suppressed by kikuyu grass that had been dormant and not detected when the site was initially prepared and planted in 2011 (NB Figure 16C).

Both species established successfully in their respective environments: marram on the upper slope and spinifex on the lower slope (Figure 16H with marram encircled) despite very windy conditions during late spring/early summer then a prolonged drought during late summer and autumn. However, this site was affected by foredune erosion during 2014 and this is described in the spinifex section (4.3.2.2) which also contains additional photos of the combined marram and spinifex planting.

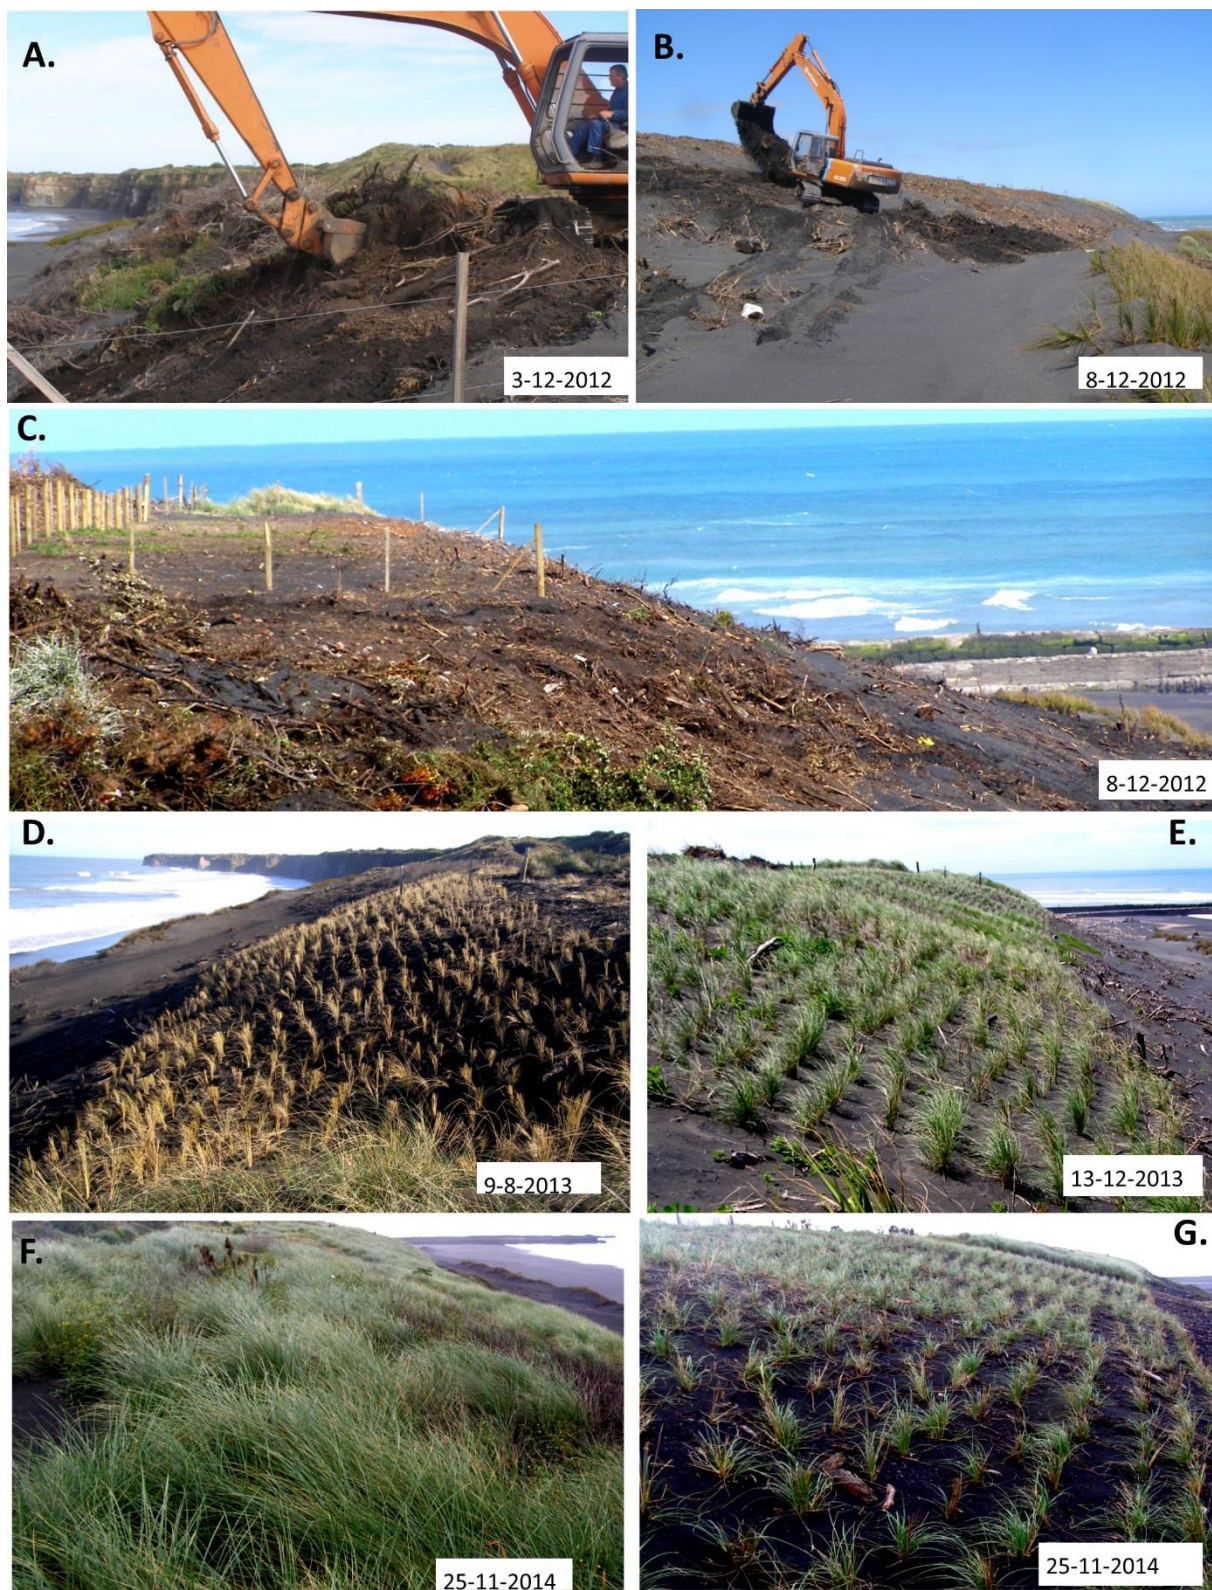
The 2014 planting occurred during extreme winter condition, but again they established and grew remarkably well. It is noted, however, that under extreme wind conditions sand blows through the planting and reaches the top of the platform surface where it is carried further across the platform; this area will slowly build up over time with the deposition needing to either be mechanically smoothed or completely removed from the site if necessary.

Figure 17 Marram block planting. Site preparation (A to C) carried out in December 2012 (fence and surface contouring). The 2013 planting is shown in D, after 4 months growth in E, and after 15 months in F. The 2014 planting after 4 months is shown in G with the 2013 planting visible in the distance. Locations are shown in Appendix B7 and B8.

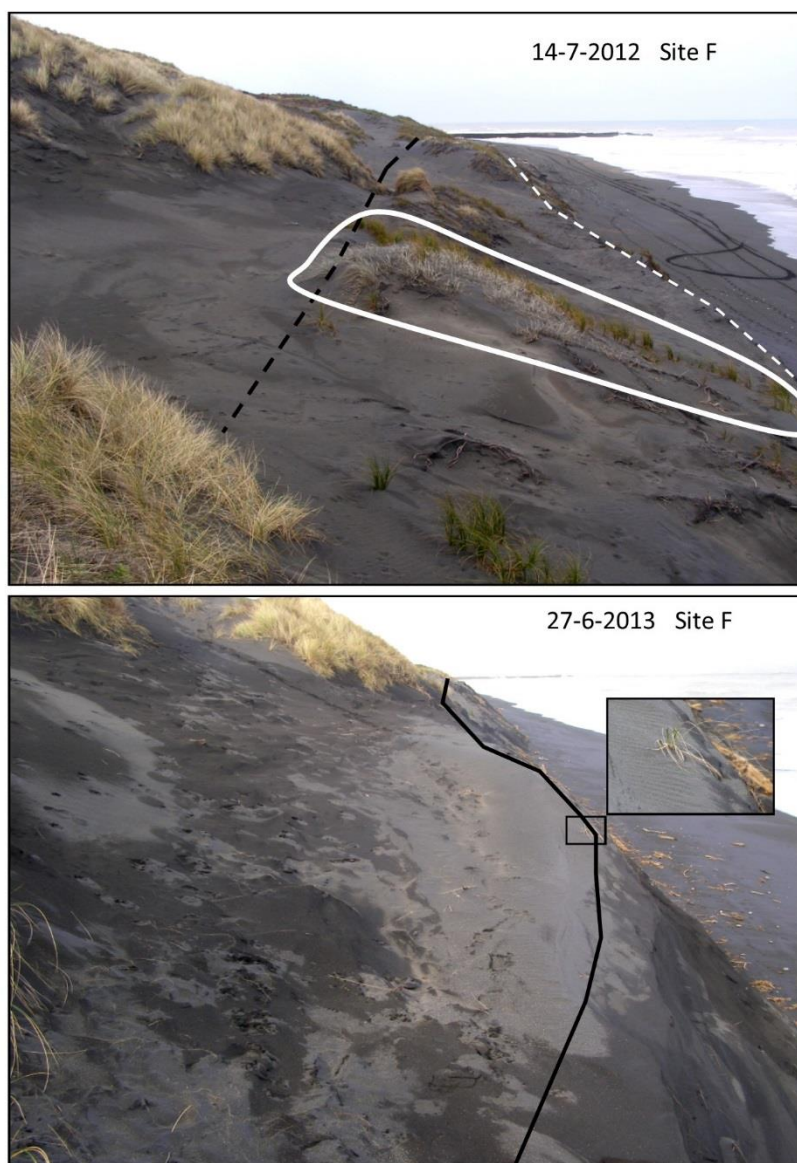
Figure 19 Site F continuing to establish in 2012 (top photo) with dashed white line locating the then scarp top and the dashed black line the scarp top a year later as depicted by the bold black line in the lower photo where a loan spinifex plant remains.

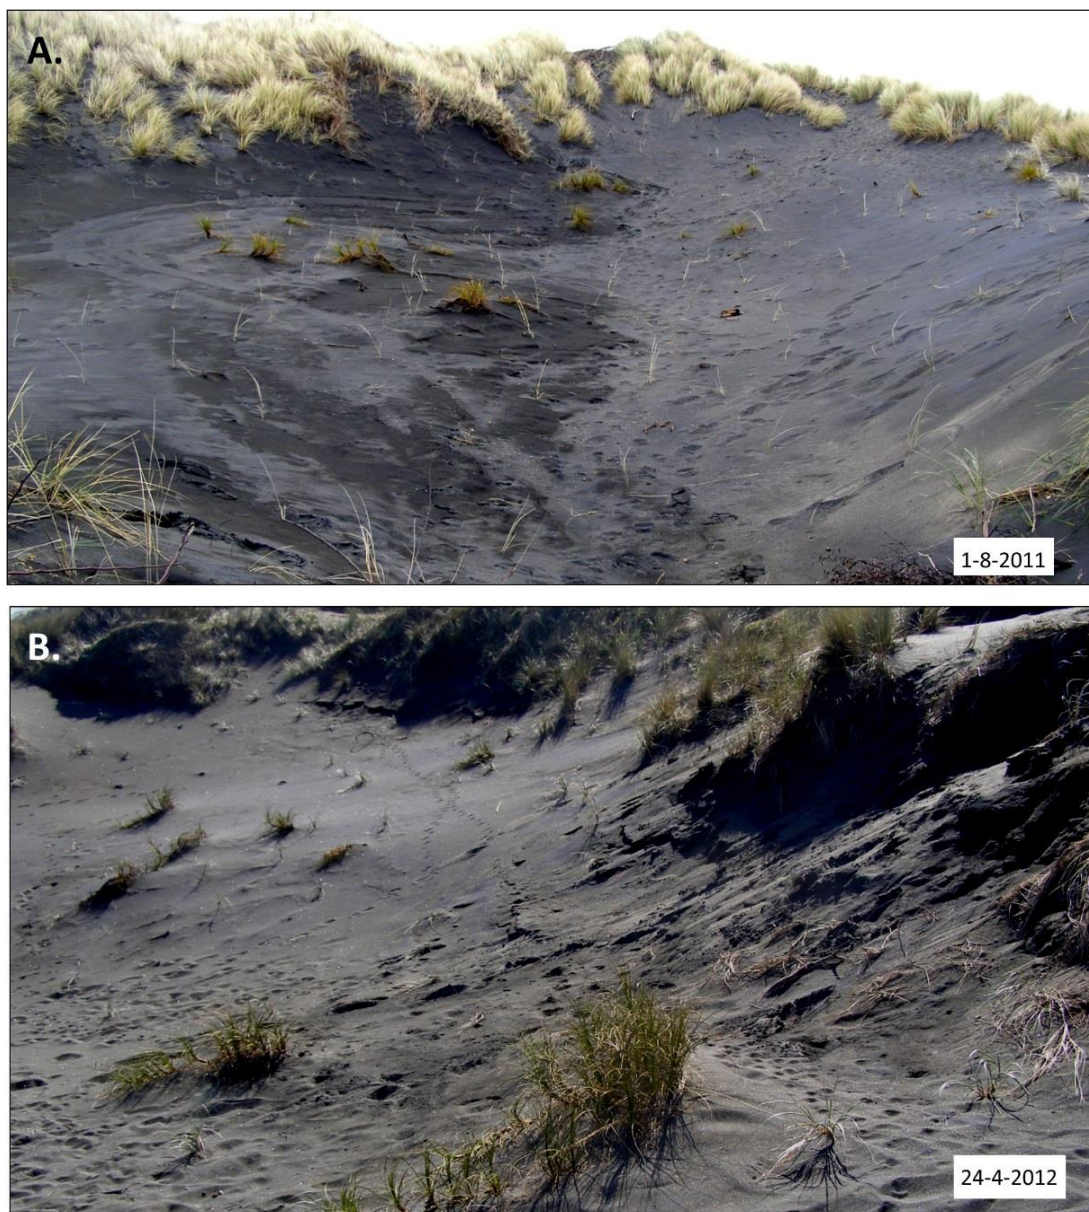
Figure 21 Upper Basin (see Appendix B5) spinifex trial planting in 2011 (A) and result in 2012 (B). Note the heavy vehicle and pedestrian imprints. Also note the surviving pingau which were planted in 2009 and further illustrated in Figure 22. Pingao plantings are described in the following Section.

The Upper Basin planting had been unsupervised with overly wide plant spacings up to 3 m. About 2/3 of these plants eventually succumbed to exposure (root scour or wind burn), but the others grew well within the spinifex planted in 2011 and 2012 (see Figure 22). About 20% of the 2009 planting on the GWP face in the Southern Sector survive today in this particularly exposed setting (Figure 24B), with the western half of the plants (furthest from the camera in Figure 24A) being lost during the first year. Today these survivors form a hummocky dune on the face (Figure 24B). Note also in the foreground in Figure 24B several marram turrets that have broken from the vegetation-front further up the slope and rafted to their present location. Isolated hummocks, regardless of vegetation type, can promote wind funneling which further facilitates erosion. This site will require additional treatment in the near future.

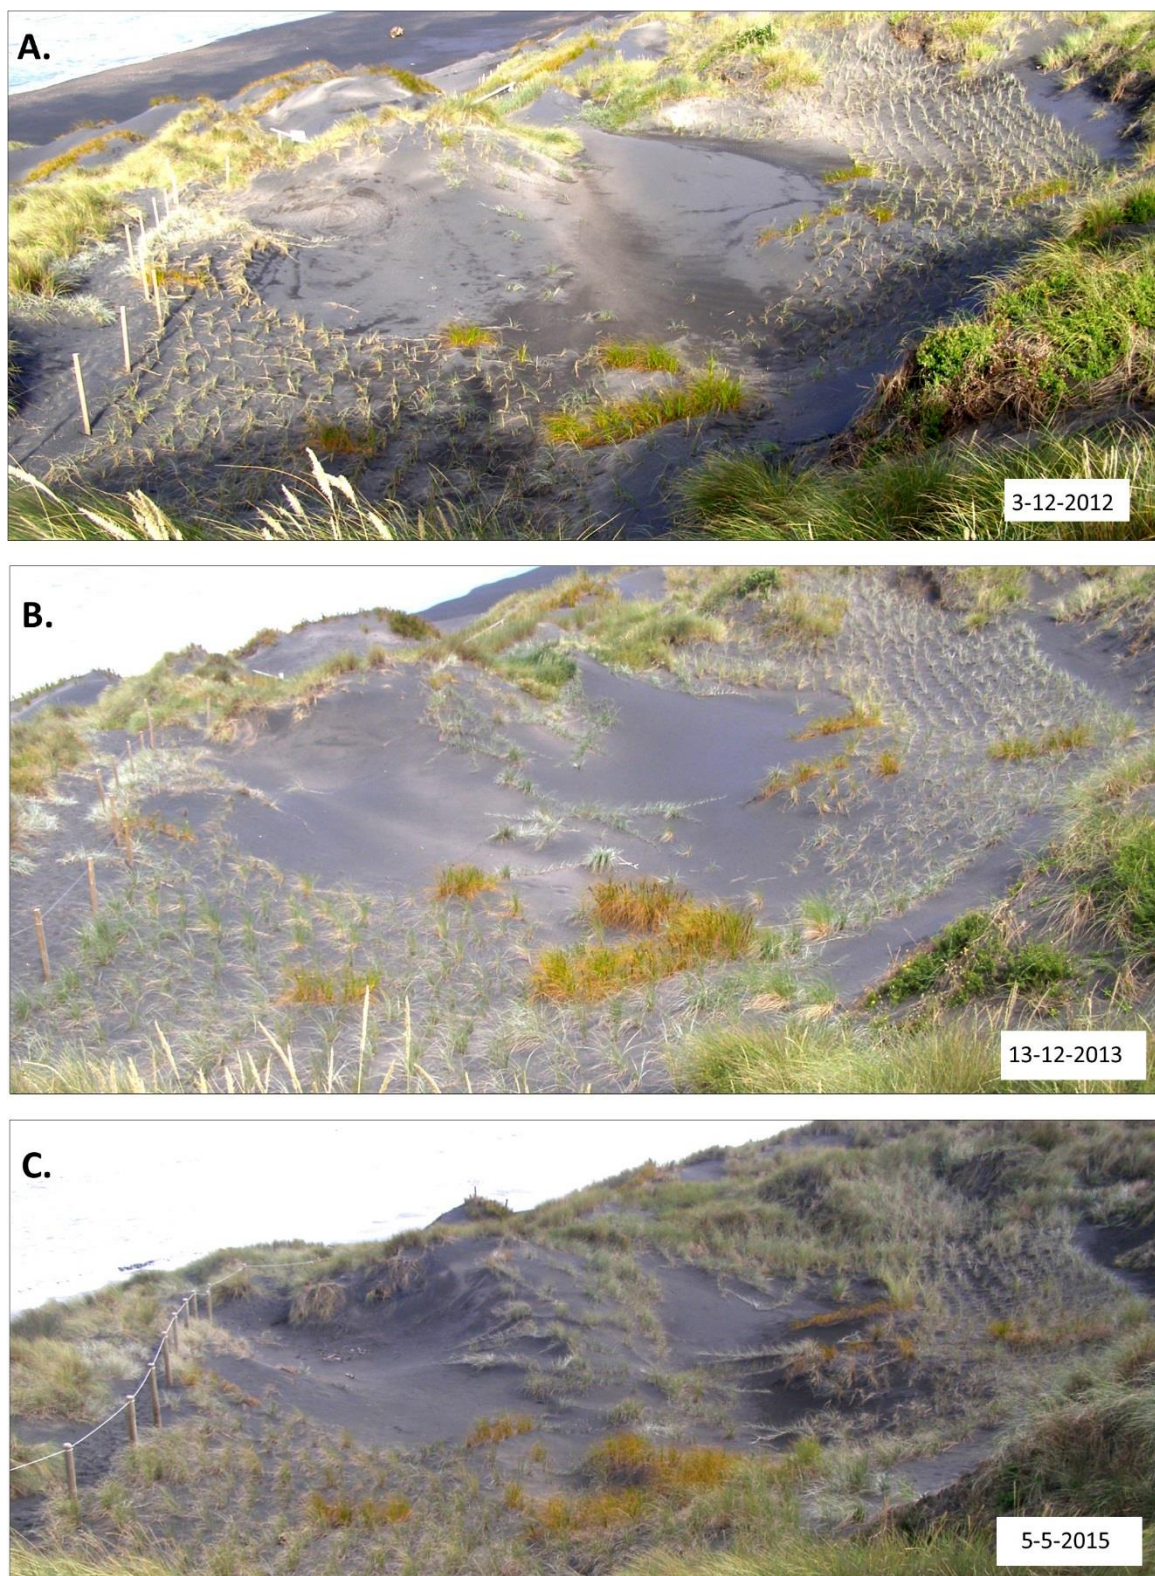
Figure 22 Block planting spinifex in Upper Basin in 2012 (A) and subsequent photos in 2013 (B) and 2015 (C). The rope and batten fences were erected at the time of planting in 2012. Note also the pingau transplanted from 2009, and the spinifex runners from the first 2011 planting. Few of the 2012 spinifex produced runners.

The spinifex established well despite very windy conditions during early summer then the prolonged drought during late summer and autumn (Figure 22B and 23B). However, unlike the earlier spinifex trials virtually no runners grew. This behaviour was noted by plant ecologist Dr David Bergin to have also occurred in new plantings on other coasts and he speculated that it may be associated with the sustained high temperatures and moisture stress during the growing season. It appears there has been little additional runner occurrence by 2015. This was disappointing as runners were expected to spread onto adjacent unplanted areas. Nonetheless, runners from the 2011 planting in the Upper Basin are spreading into the central unplanted area, as illustrated in the 2015 photo (Figure 22C).

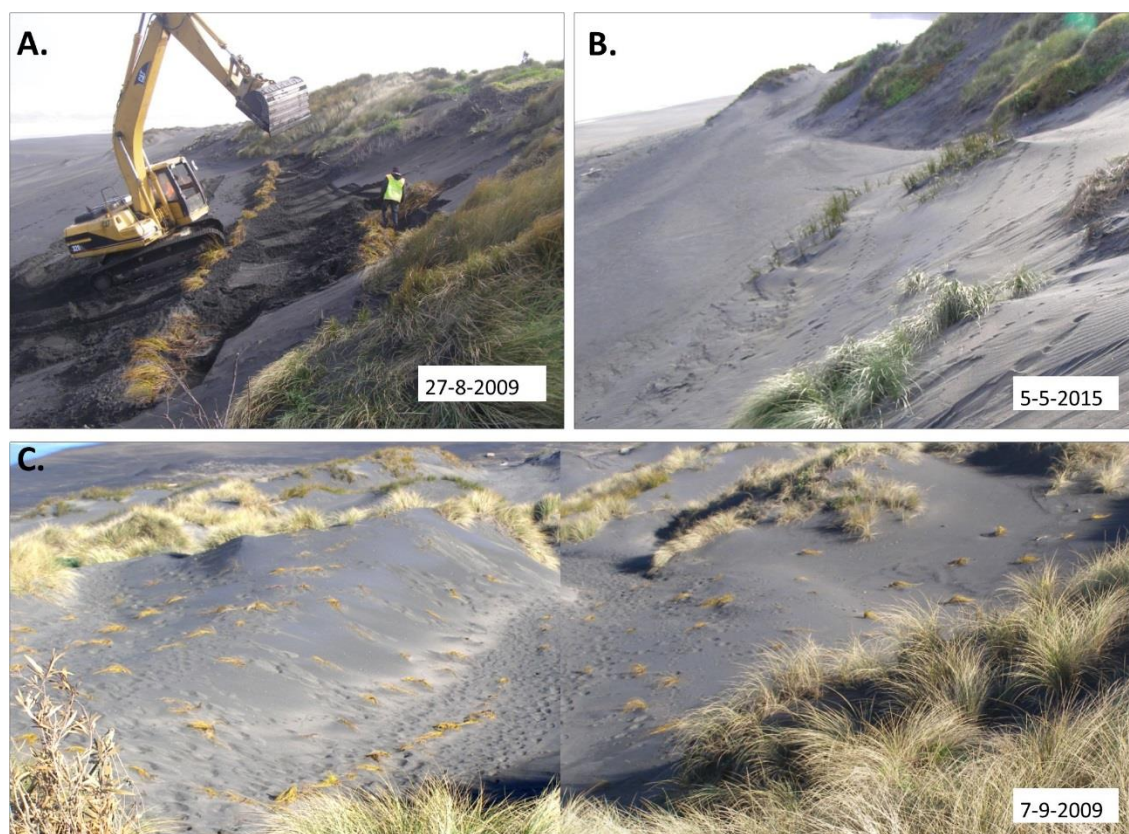
Figure 24 Pingao runner transplant trials in 2009 at Site 4b (Appendix B3) are shown in Figure A and what remains today in Figure B. The other trial site of note was in the Upper Basin (Site 3a in Appendix B3) and this is shown in Figure C with results for this site being illustrated in Figure 22.

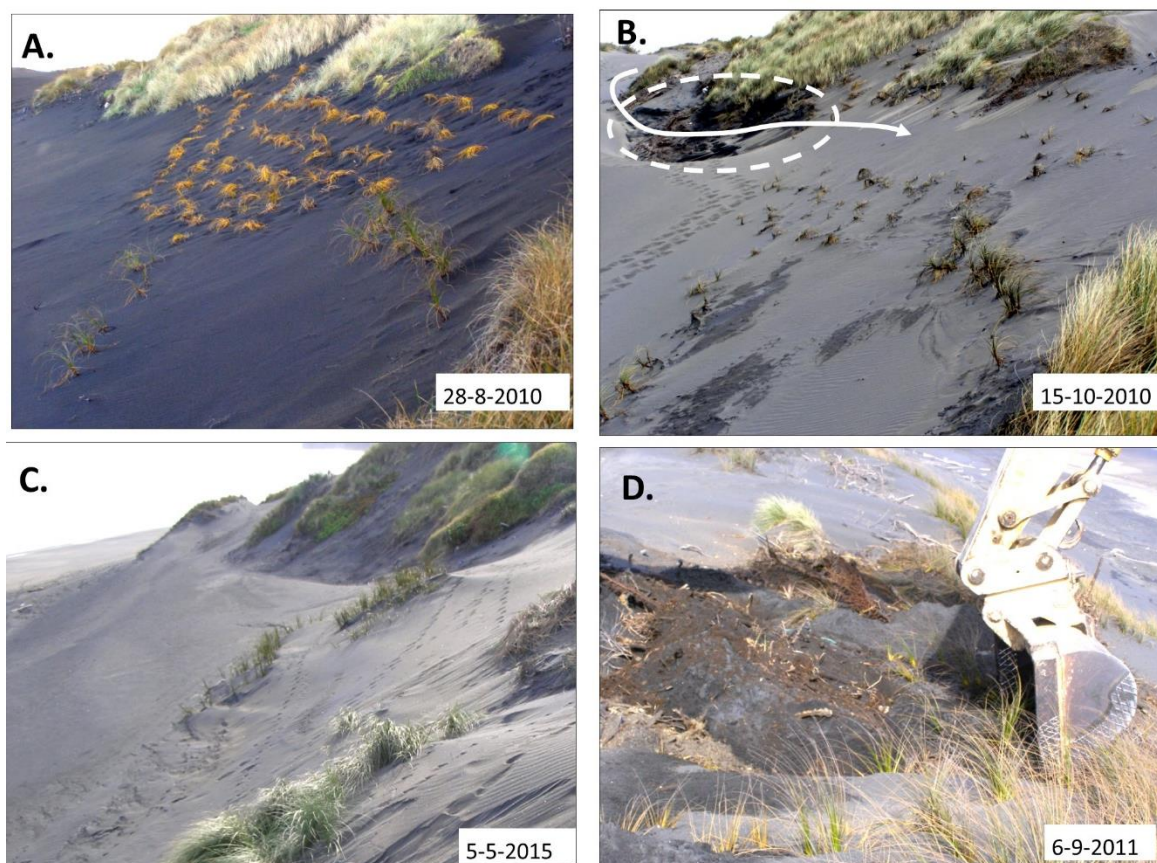
Figure 25 Pingao transplant trials 2010. At the GWP face (Site 4b) the western portion was replanted (Figure 25A). This site was renamed Site K for the 2010 planting (Appendix B4). Figure 25B was taken two months after planting and shows significant burial. Note the scour trough located within the dashed ellipse and the arrow defining the topographically controlled wind-flow pathway. Figure 25C (same as Figure 24B) shows the survivors today and their limited vegetation cover. Figure D shows the digger laying pingao clumps over previously placed green waste infilling an erosion gut along the crest of the Pingao Foredune.

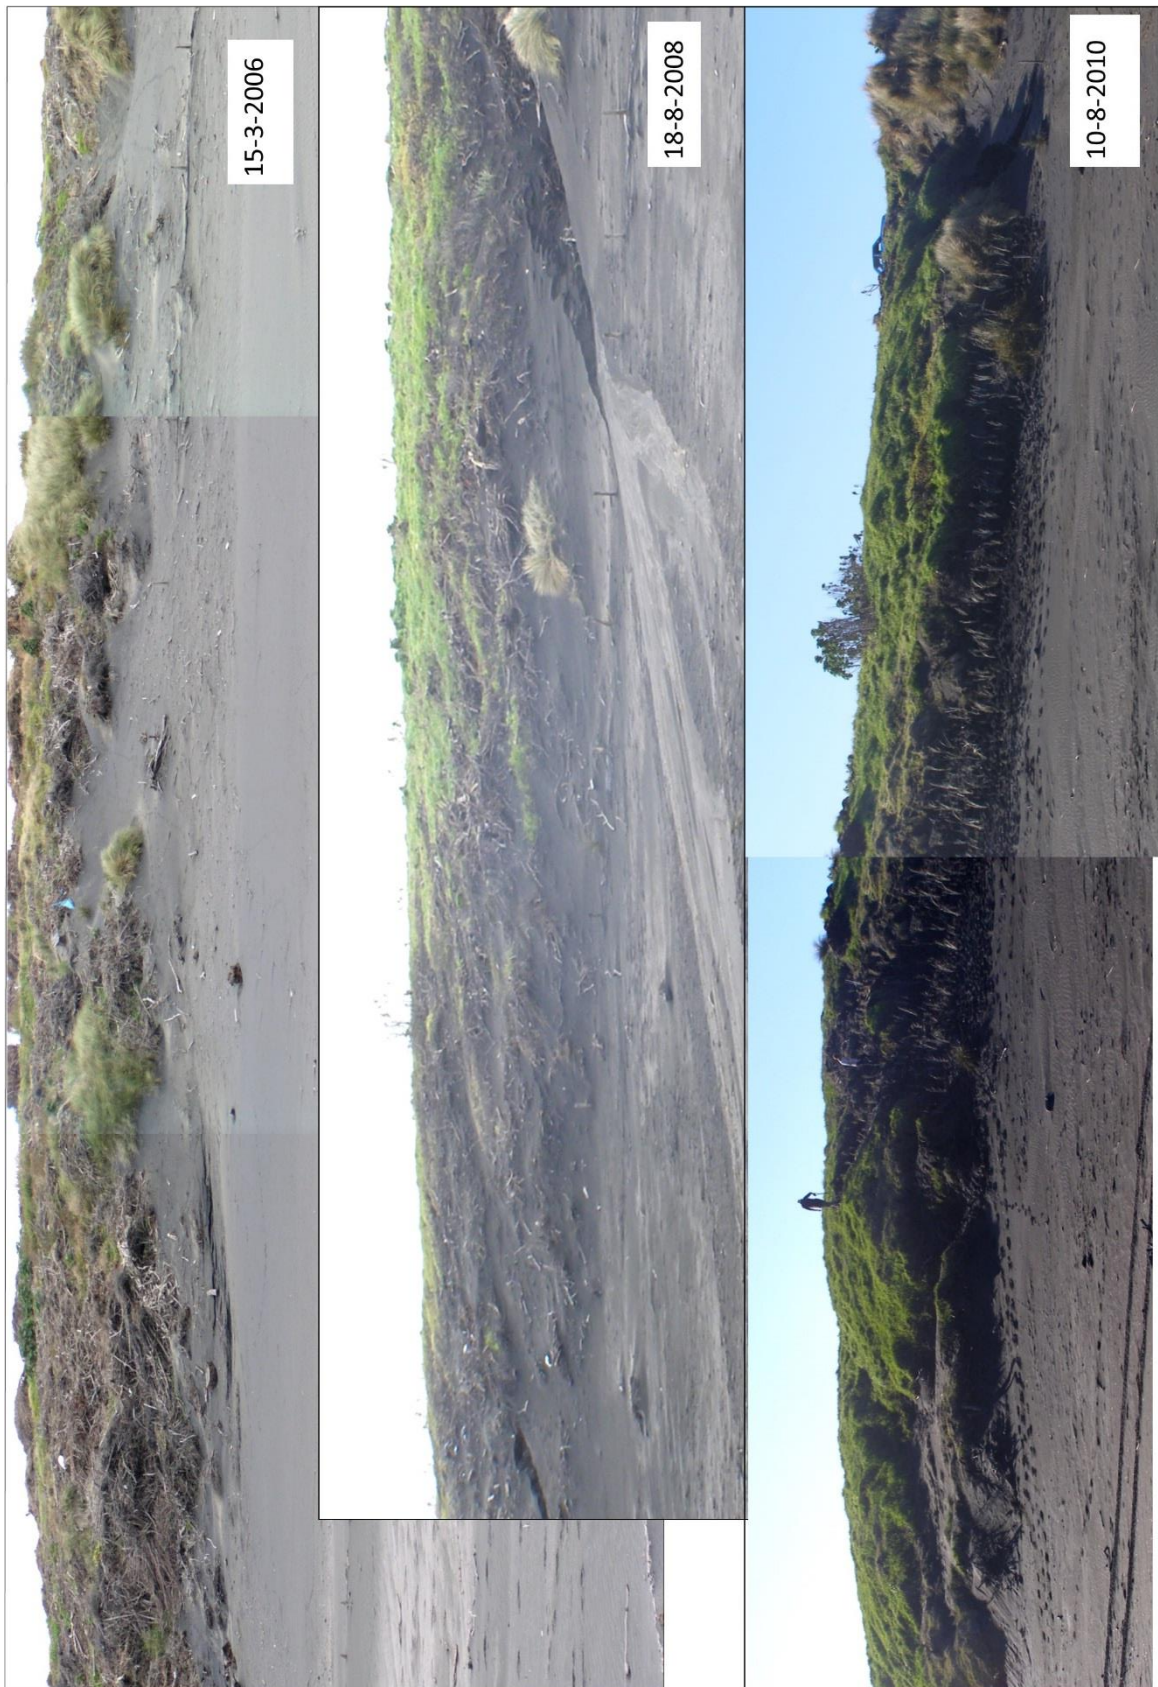
Figure 26 shows a comparative section of the Southern GWP face with photos from 2006, 2008 (when placement had stopped in this area) and 2010. In 2006 (Figure 26A) greenery within decaying green waste is quite possibly kikuyu. In the 2008 photo (Figure 26B) kikuyu appears to be well established along the top of the platform and spreading down the face. Coverage of the upper and mid faces was largely complete in the 2010 photo (Figure 26C), taken when the spinifex and marram trials (at Sites C and I) were carried out on two areas of bare sand (i.e. not yet colonized by kikuyu). At the time the objective of Site I was to see if marram could co-exist with kikuyu, a concern being that under severe burial, kikuyu would die first (being shorter), so the taller marram could be relied on to maintain sand stability.

Figure 26 Kikuyu spreading across the GWP in the Southern Sector between 2006 and 2010. Note green waste placement was still occurring in 2006 but not in the 2008 photo. In the 2010 photo workers are planting spinifex and marram on remaining bare sand (sites C and I, Appendix B4).
