PATEA BEACH SAND MANAGEMENT PROJECT

SUMMARY REPORT 2008 to 2015

A report prepared for the South Taranaki District Council

COASTAL SYSTEMS Ltd

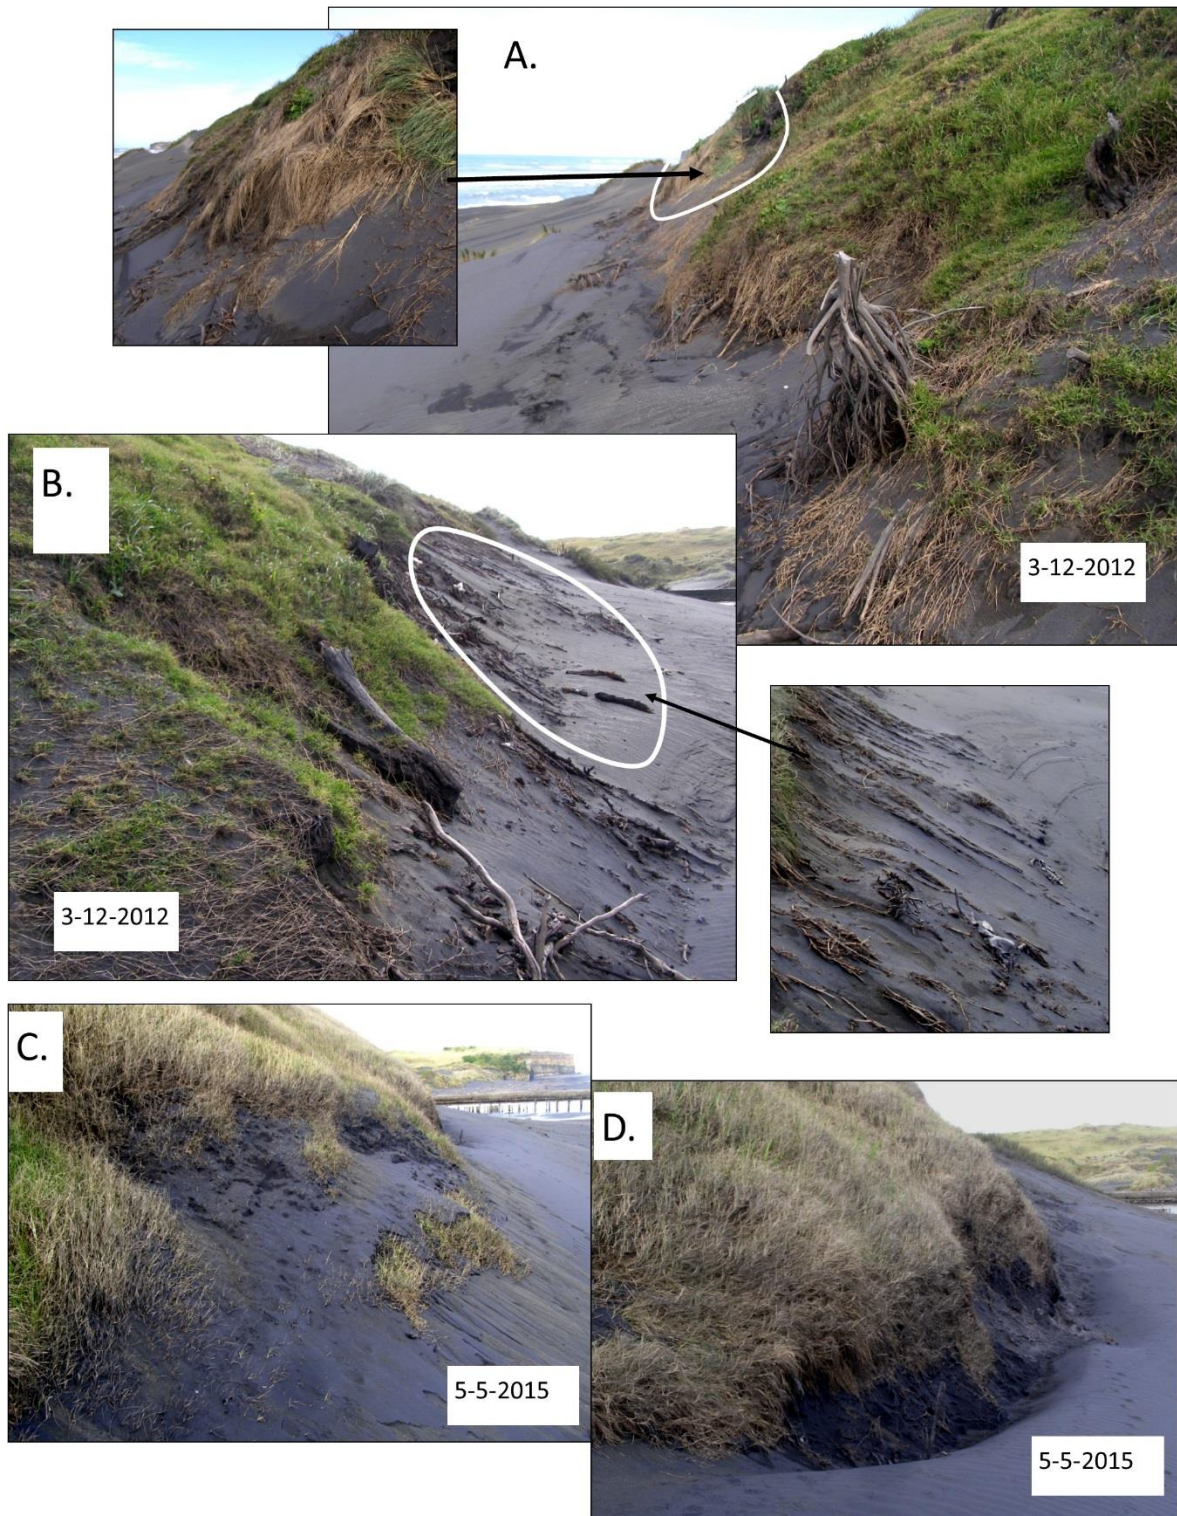
By 2012 kikuyu had extended down the face at least as far as existing marram and the spinifex runners of Site C (Figure 27A and B) Note these photos were taken after a period of strong winds and all three plant types had suffered wind burn and/or scour. These images show kikuyu can survive on the mid-lower dune front at least as well as marram (which succumbs to wind scour and slumping) and spinifex (which succumbs to runner scour and desiccation). Photos are also included (Figure 27 C and D) showing kikuyu at the vegetation-front undergoing burial and scour from which it can recover.

Figure 27 Kikuyu growth on the mid to lower slope of the GWP face after high winds, compared with marram (A) and spinifex (B); kikuyu coped at least as well if not better than the other grasses. Figure C shows kikuyu burial at the vegetation front and Figure D shows kikuyu wind scour, in each case the kikuyu recovers.

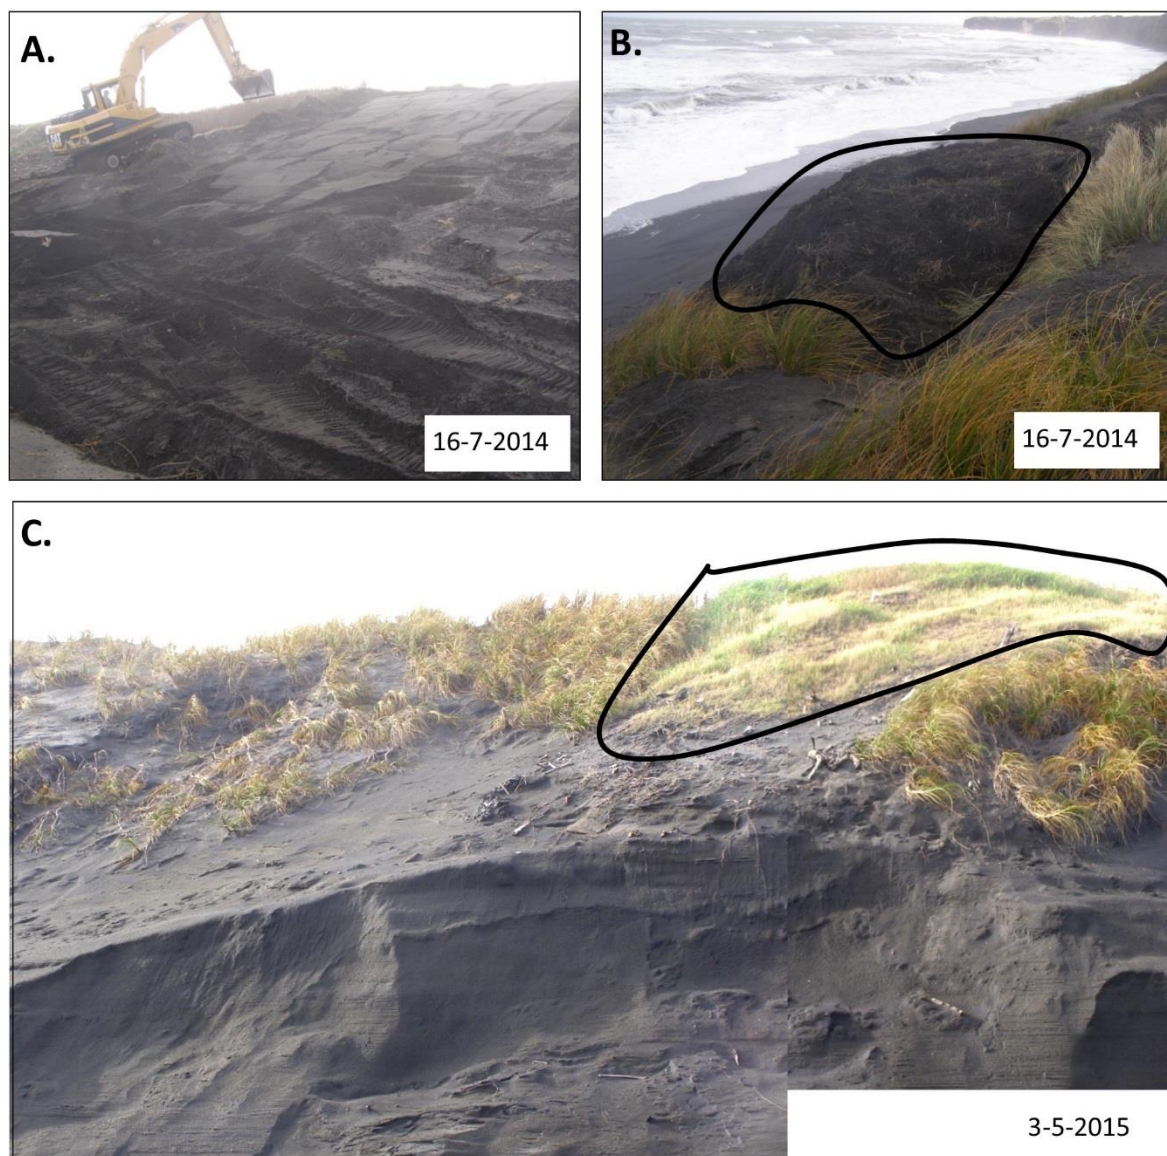
In 2014, while preparing the face for marram planting, a large area of established kikuyu grass was scraped off and replaced with clean sand (Figure 29A) with the discarded kikuyu grass placed in guts on the adjacent pingau foredune (Figure 29B). The objective of this exercise was to test kikuyu's resilience on the high exposure foredune compared with the existing pingao.

Figure 29 Preparing GWP face for marram planting in the Central Sector 2014 (A) by removing kikuyu cover that was about 0.5 m depth, then (B) placing excavated material in an erosion gut on the adjacent pingao foredune (encircled), C is the resulting kikuyu growth 10 months later (encircled)..

Observations in May 2015 (Figure 29C), indicates the low and uniform kikuyu cover appears better able to deter wind funneling and internal instability compared with the more open-- growing pingao. The kikuyu also appears as resilient as pingao to wind desiccation, although extreme conditions capable of effecting pingao, as observed in the Northern Sector (NB Figure 15C) in 2006 when the project was being scoped, have yet to be experienced.

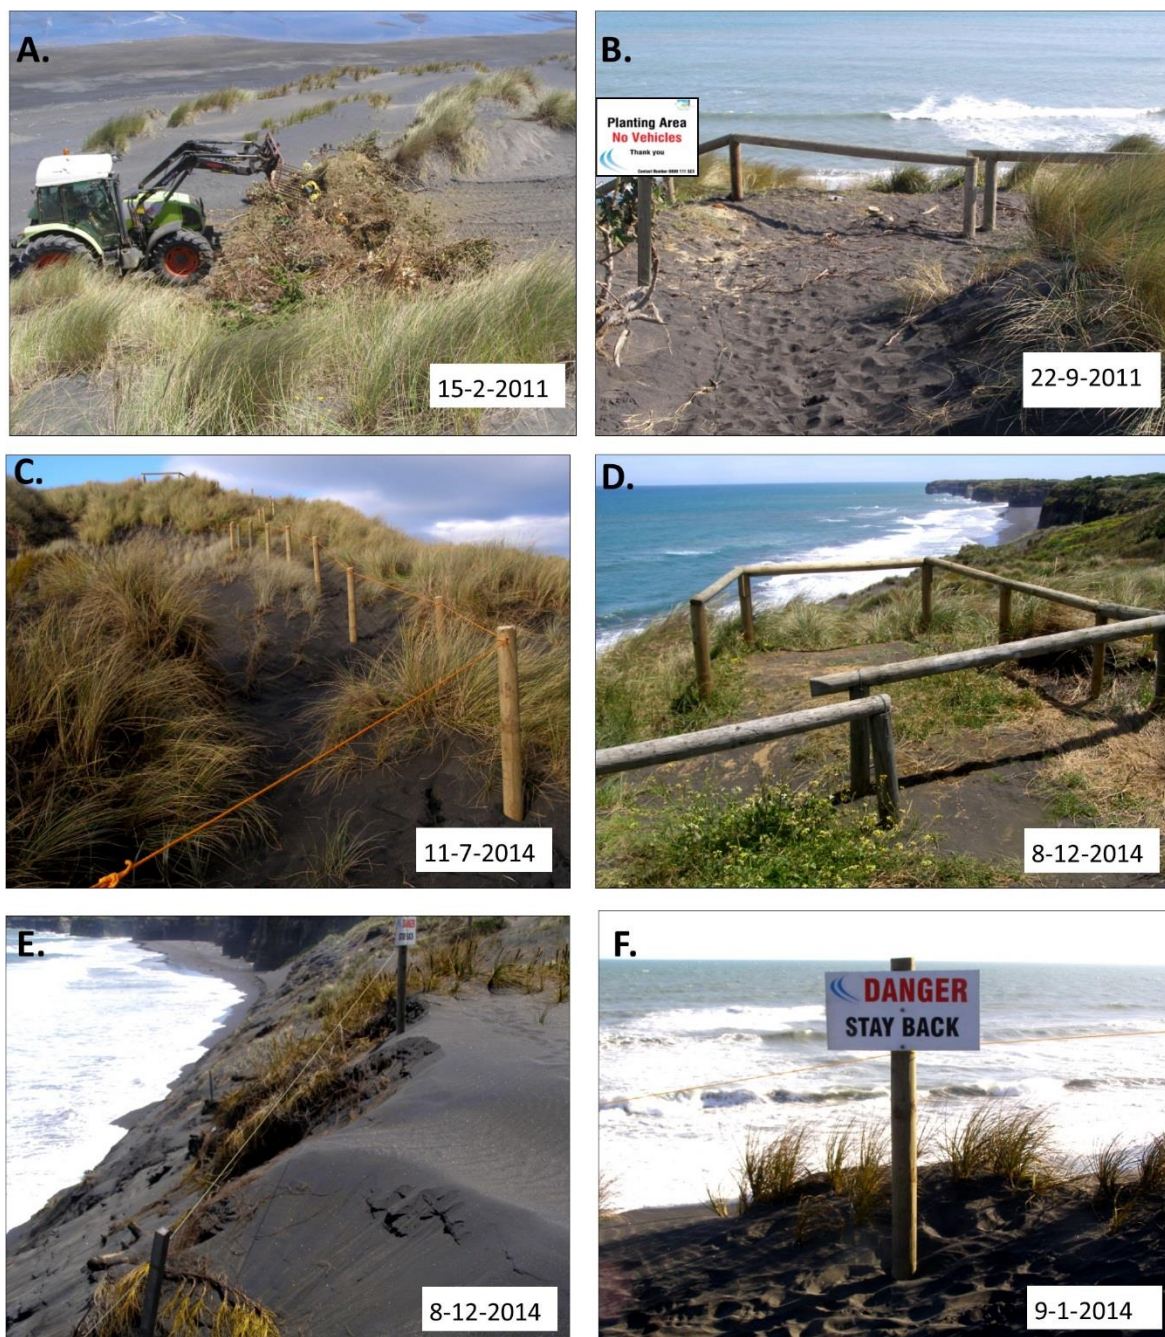
In 2014 the lightweight fencing around the upper basin planting was reaching the end of its life so was replaced with more durable materials (Figure 30C) and the upper carpark barrier extended to allow for better views while protecting the plantings (Figure 30D). By this time much of the Lower Basin had succumbed to foredune erosion processes and the original plant protection fencing was converted to hazard fencing which, along with signage, warned pedestrians of the erosion escarpment (Figure 30E and F).

Figure 30 Access control using green waste barrier (A), post and pole barrier and sign at Upper Carpark entry to Upper Basin (B), and perimeter pedestrian fence around Upper Basin (C). Expanded barrier fence and upper car park entrance to allow for view (D). The hazard fencing along top of erosion scarp (E) and hazard sign at top of erosion scarp (F) has had to be relocated on several occasions as erosion progresses landward.

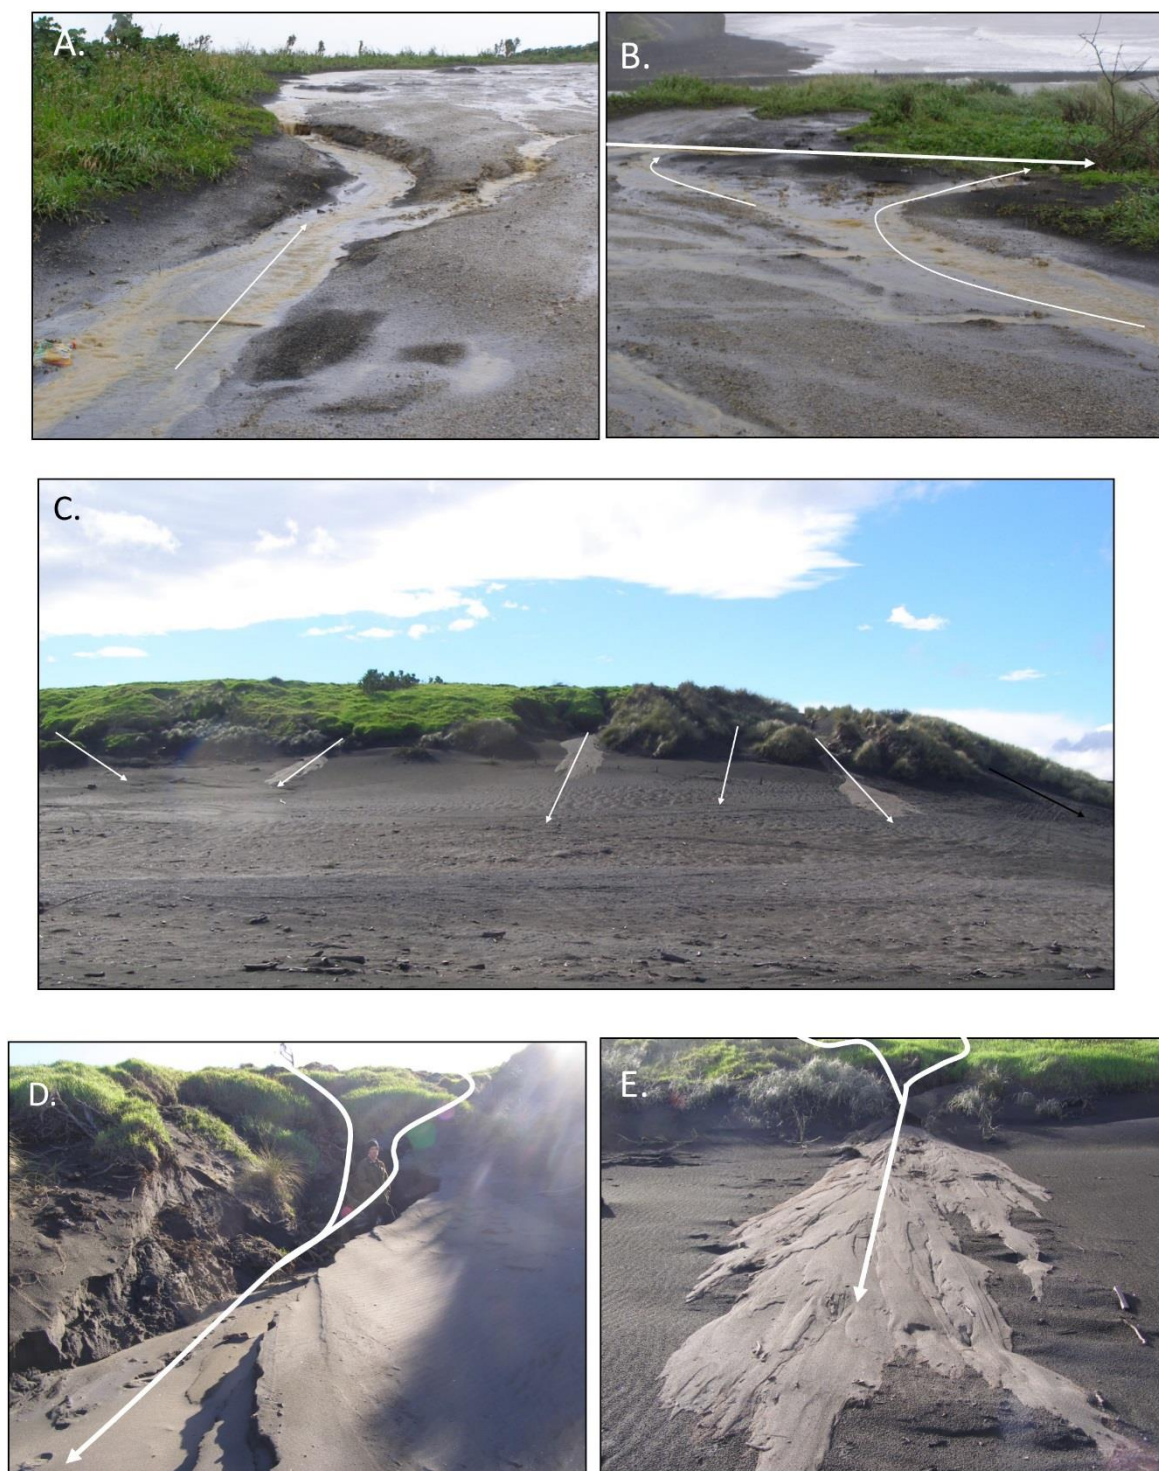
Managing storm water at the northern end of the GWP has required minimal intervention; however, at the southern end it has been an ongoing issue for the Council for several years due to storm water erosion of the clay surface cover. This erosion affects vehicle access and also causes guts to develop on the GWP face which in turn destroys vegetation and plantings on the steep (sand dune) slope; this is followed by wind erosion and sand drifting across the platform surface. The matter was discussed in the CSL 2009 Inspection Report #2 (from which Appendix B 3 was obtained) and described in some detail in the CSL 2011 Annual Report (from which Figure 31 below was obtained). At that time the simplest and cheapest option was carried out: this involved diversion by several earth bunds to reduce flow velocity. The result was relatively effective in the short term, but by 2014 the bunds had subsided and erosion was again occurring and by the end of 2015 severe gullying into the face of the GWP is once again occurring (similar to Figure 31C and D). As the resource consent requires effective storm water control, CSL were instructed in July 2014 to investigate a more permanent alternative in which surface water drains away to the rear of the green waste site. The draft report was completed for the council in September 2014 (CLS, 2014c) and is summarized below.

Figure 31 Photos illustrating drainage issues on the GWP in the Southern Sector. Surface runoff (white arrowed lines in A) and channel development on access road to southern (river) lookout (A). Channels cut into vegetation at top of platform (B) and this develops into gullies (or guts) as water flows down the upper face, thereby scouring plants (C and D) and facilitating later wind erosion. Eroded material is deposited as alluvial fans on the bare sand surface (E) as water flow slows due to infiltration.
