Waikawa Beach geomorphological assessment

A report prepared for Tonkin and Taylor Ltd on behalf of Horizons Regional Council

COASTAL SYSTEMS Ltd

Reference	2019-02 CRep
Version	2
Status	Open
Date	March, 2019

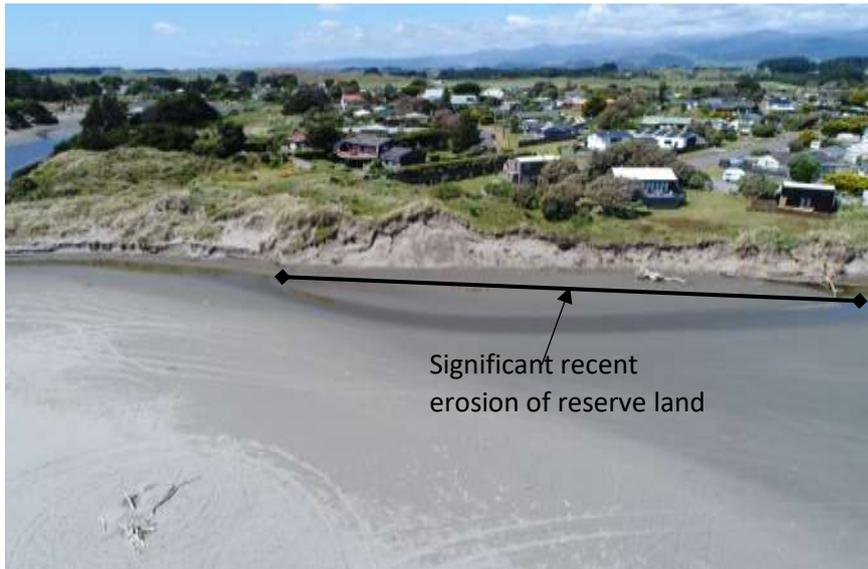
Figure 2: Dune erosion along shoreline at the back of the Waikawa Inlet

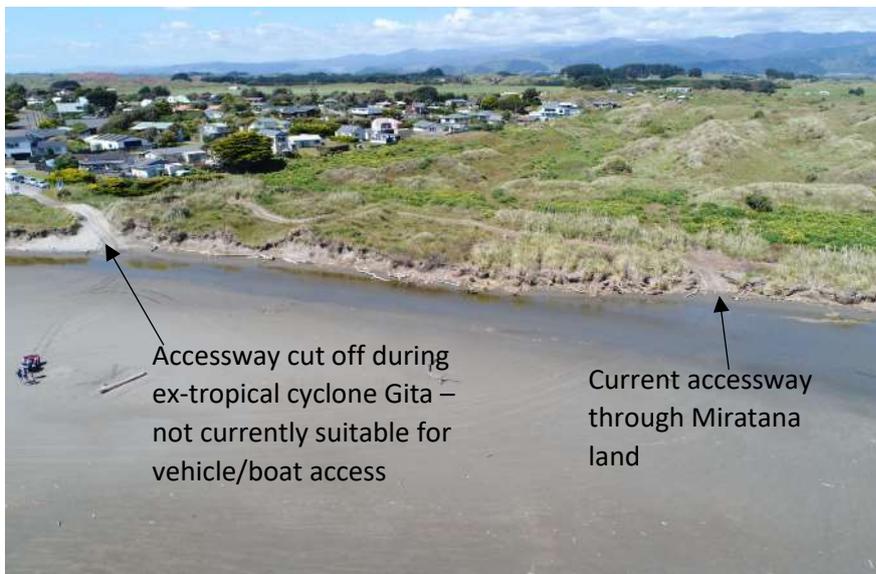
Figure 3: Current beach accessways at the southern end of Manga-Pirau Street

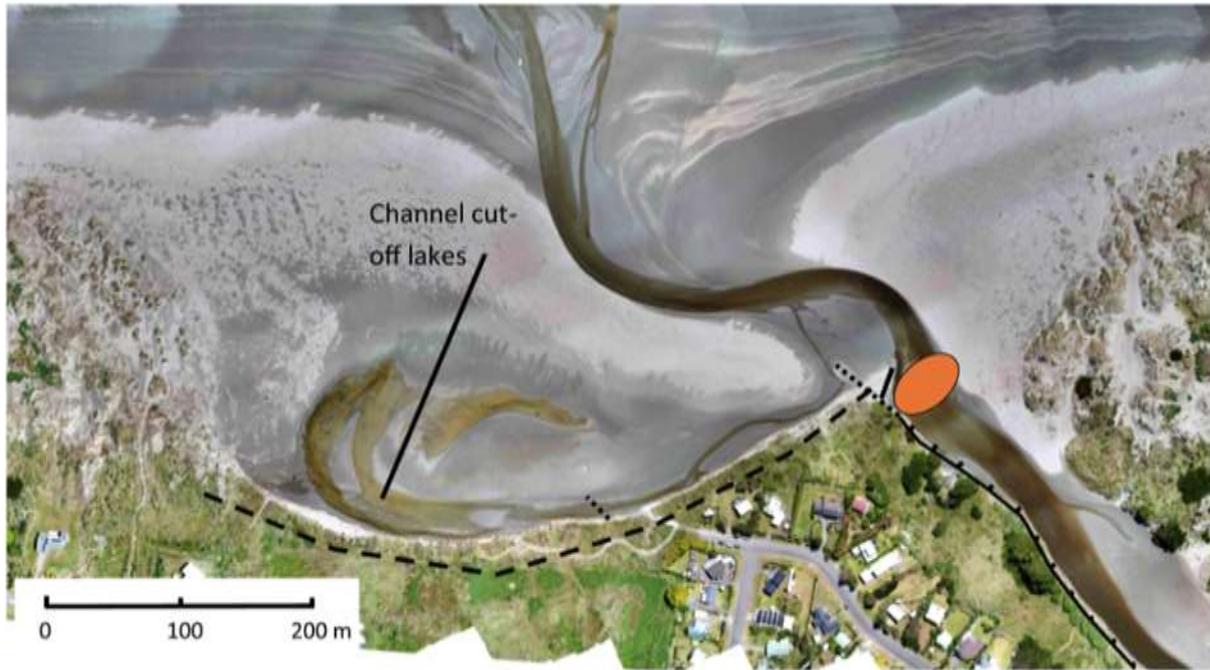
The throat (where the inlet shoreline meets the river) is fixed at the northern end of the inlet. At the time of the site visit on 2 November (Figure 4), the low tide channel width upstream of the throat averaged about 25 m, reducing to about 20 m as it meandered across the inlet to enter the sea some 200 m to the south. Small "cut-off" lakes, remnants of an earlier channel (examples in Figure 4) were evident at the southern end of the inlet against the inlet-margin sand dune. Much of the dune along the landward side of the inlet (the inlet bay region is indicated by a dashed line in Figure 4) was severely scarped. This inlet morphology is evidence of a particularly dynamic system.

Dredging at, and immediately upstream of, the throat was mentioned by residents at the November 2018 site meeting, and 2005 aerial imagery does indicate such activity (discussed further in Section 3.3). Shallowing in this area was evident at the time of the site visit (Figure 4).

Figure 4: Waikawa inlet at the time of the site visit on 2nd November 2018. Bold black line is current rock groyne, dashed black lines are remnants of the 1991 rock groynes, raked black line is rock-lined river bank, and orange oval is throat as defined in this study. “Cut-off” lake examples are marked, and the “inlet bay” is located by the dashed black line.

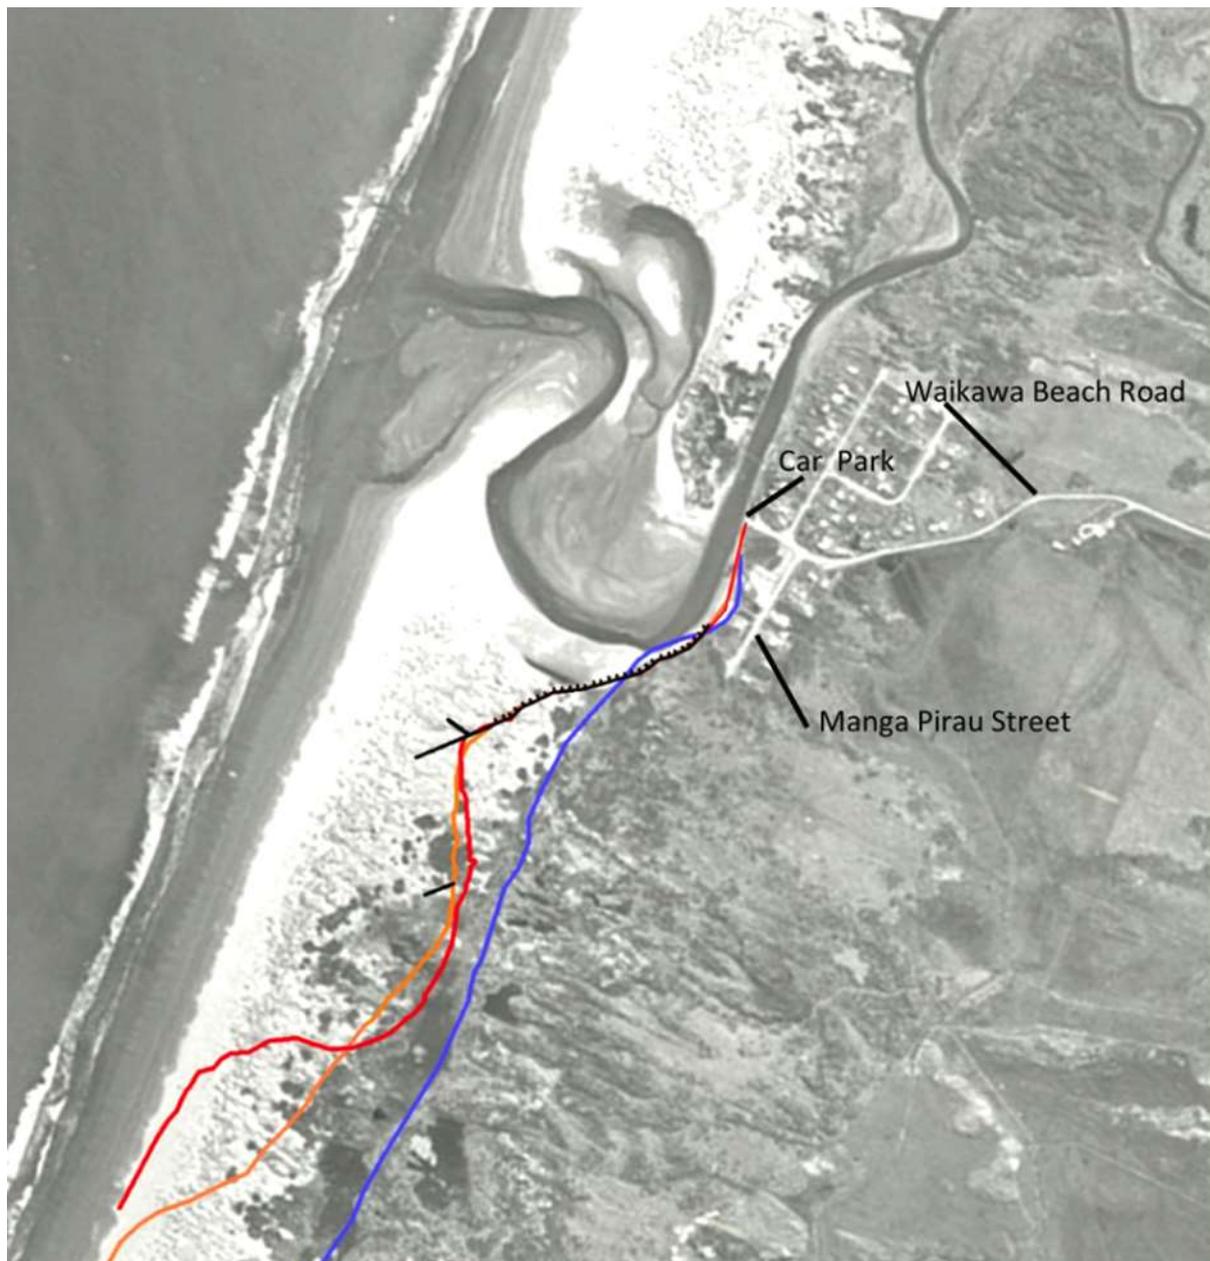
However, the 1957 to 1972 aerial photos show the channel beyond the diversion point meandering northward (for example see the 1957 aerial in Appendix E and the 1968 aerial photo in Figure 5) for some 500 to 700 m before turning seaward. Shepherd and Shepherd (1999) also note that beginning in the 1970s rocks were dumped along the bank immediately east of the car park as erosion was getting to close houses on Manga Pirau Street.

Figure 5: Typical post 1945-diversion response morphology on the 1968 aerial photo with the river meandering northward. The 1942 shoreline is marked purple, 1993 by orange and current 2018 by red. Structures are marked black as in Figure 4.

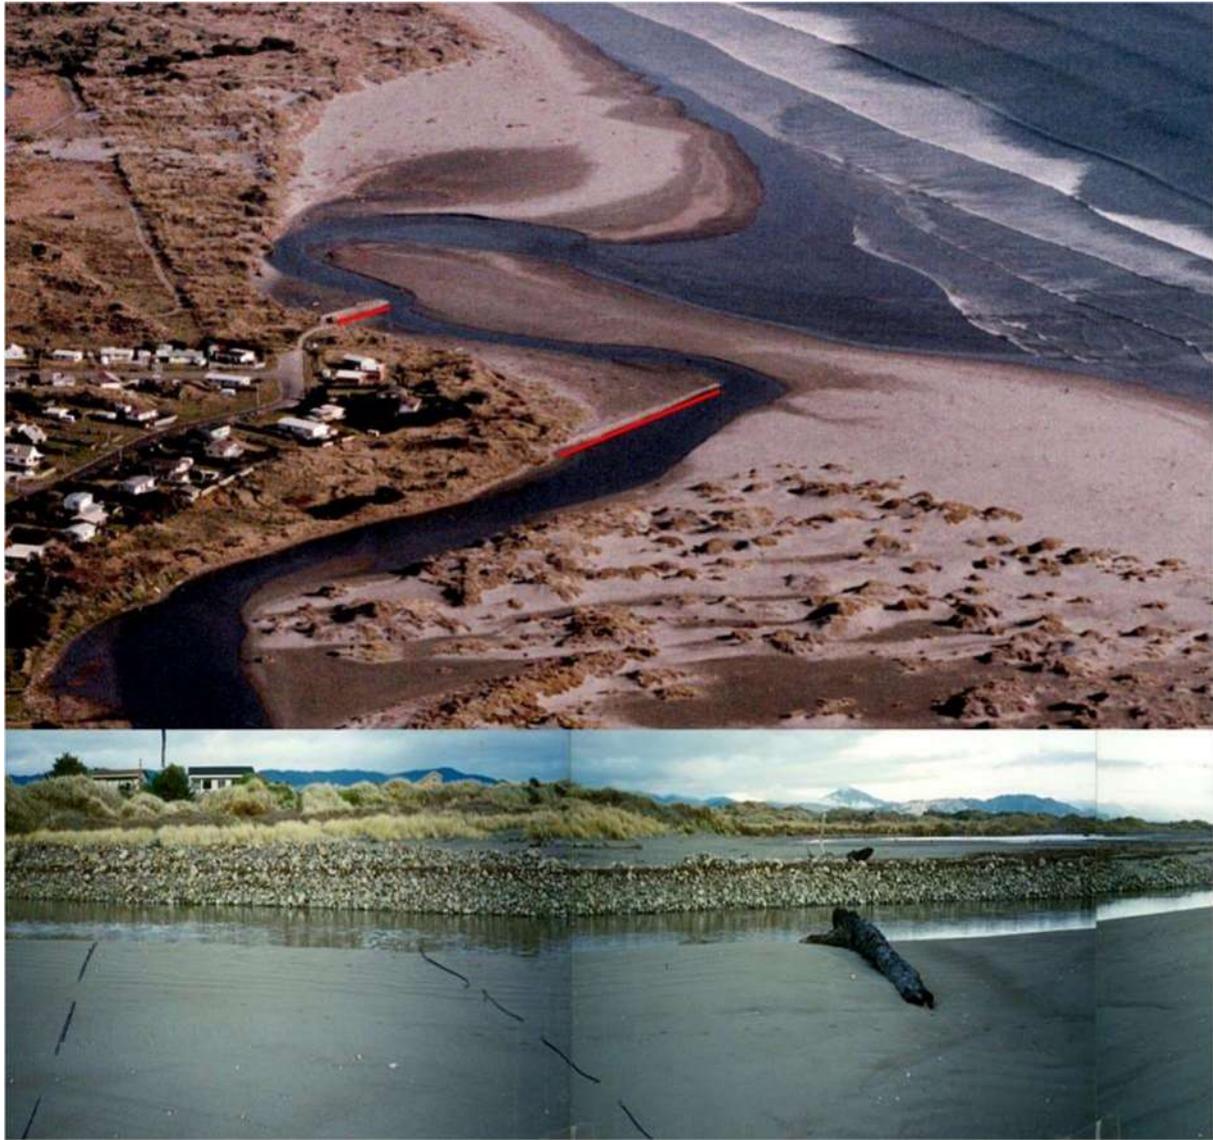
Analysis of historic aerial photographs show that the current southerly approach was artificially cut between 1972 and 1978 with rock lining fixing the southern bank in its present location (Figure 6).

Inspection of Figure 4 and Figure 6 show that while this groyne is an in-line continuation of the adjacent southern rock-lined riverbank, there is a misalignment about midway along the approach channel which could drive the flow line to the northern side of the throat; this is considered in greater detail in Section 3.3.3.

Figure 6: Upper photo (1996) shows the rock groynes (underlined red) that were constructed in 1991. Note the down-stream accretion behind each groyne. Lower photo shows the throat groyne in July 1994. Note the new dune development on accreting land on the far side of the groyne. (Source: kindly provided by Mr John Hewitson, Waikawa Beach).

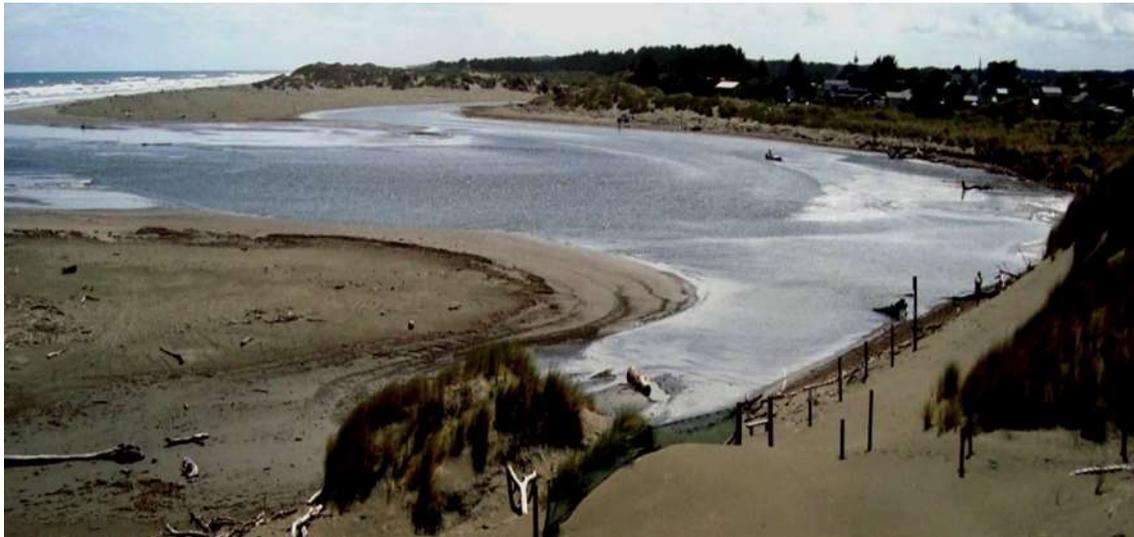
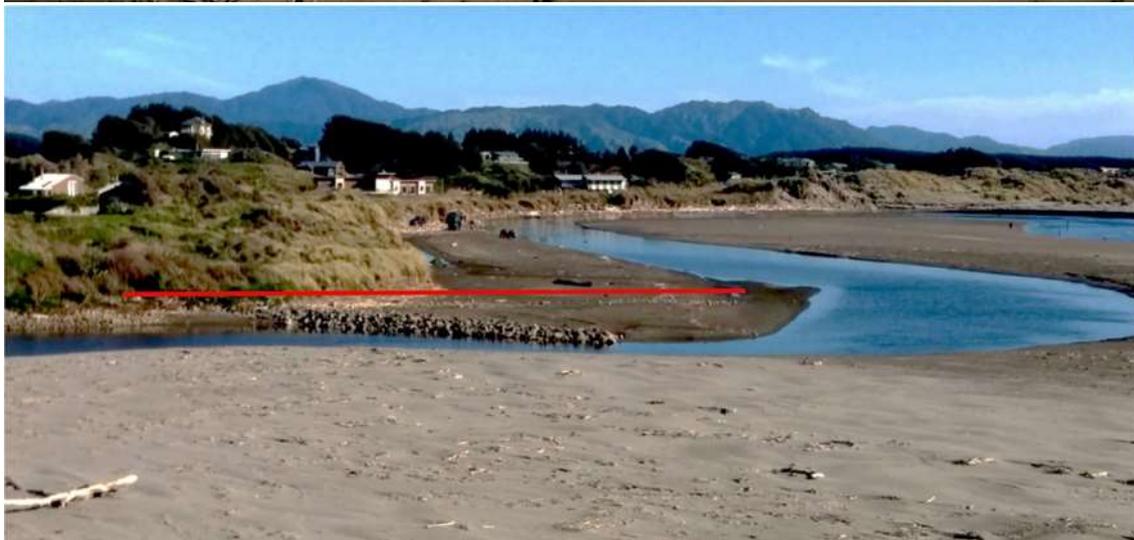
Another rock groyne was constructed mid-way along the inlet bay in the early 1990s (Figure 7). This structure was some 45 m long with a downflow offset which gave it a similar orientation as the longer throat or mouth groyne. Presumably this structure was to provide additional shoreline/dune protection along the back of the inlet by deflecting the channel further seaward. This groyne had reduced in length some 25 m by 2000 and was often covered by sand thereafter. Its remnants are still evidence at times.

This groyne was designed to be at 60 degrees to the current and attached to the existing groyne at its intersection with the then dune line along the back of the inlet (Figure 8 lower photo). The high-angle groyne was designed to protrude into the throat channel some 25 m (as-built 30 m). A consent for the high-angle groyne was granted in 2010 and construction was carried out in April 2012. At this time, HRC photos show there was no threat to the central and northern inlet bay dune line (for example see Figure 7 upper photo).

Figure 7: Upper photo (April 2012) shows the Waikawa Inlet at the time of the high-angle groyne construction. Lower photo shows the present high-angle groyne photographed in October 2016. Remnants of the original entrance groyne are just visible above the surface (below the red line). (Source: CSL)

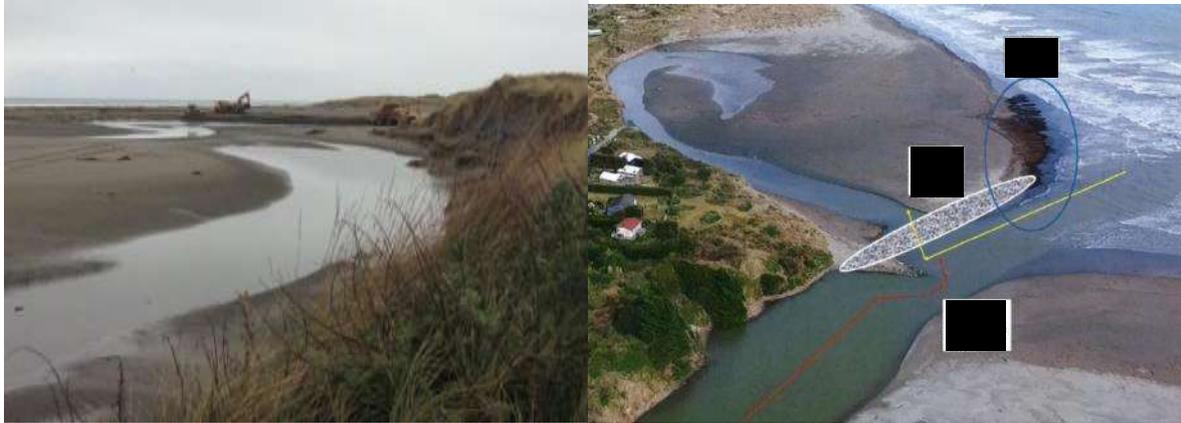
Mouth cuts were subsequently carried out in July 2013 (Figure 8 left) and July 2018 (Figure 8 right), each in response to the channel being in direct (or near) contact with the dune along the inlet bay. Note that the 2018 photo (Figure 8 right) shows the original groyne remnants still able to trap sediment on their downstream side.

Figure 8: The most recent mouth cuts. Left photo taken on 10 July 2013 (source HRC), and right photo taken on 31 July 2018 (source HDC) shortly after the mouth cutting operation. Note in both cases the pre-diversion channel was against/close to the dune line at the back of the inlet. Note we were unable to source the original HDC photo so included the one above with various annotations unrelated to this study.

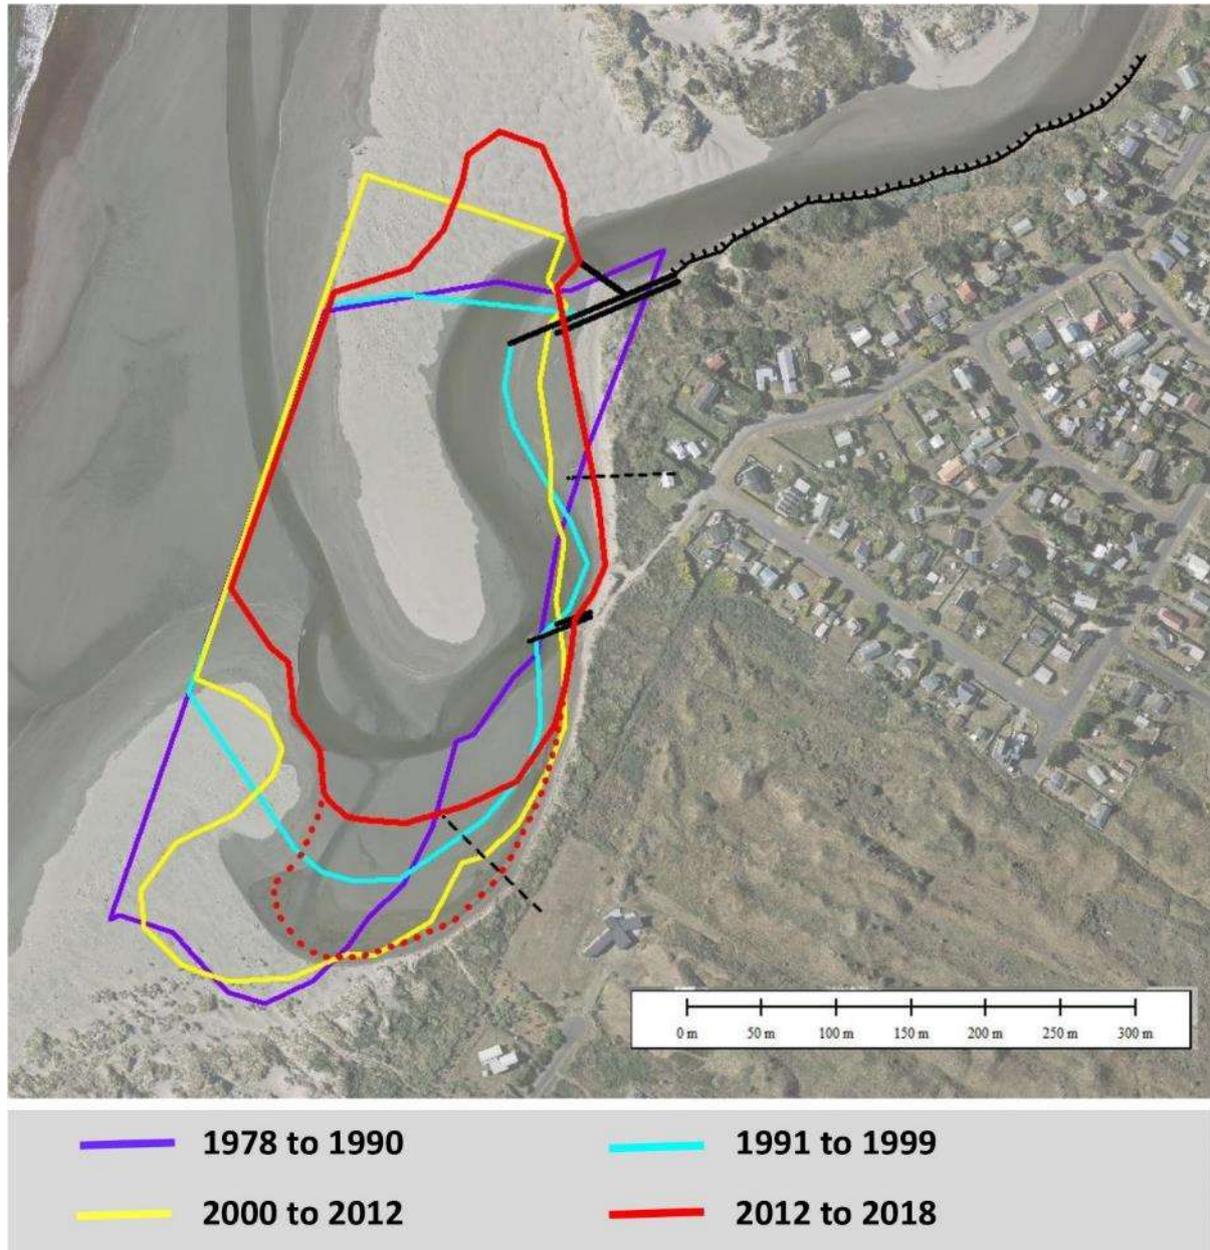
The channel envelopes for the different groupings are depicted in Figure 9 and suggest the following associations:

- 1 The longshore (southerly) extent of the channel maximised during the initial period with no groyne (1978 to 1990) and also during the shortened groyne period (2000 to 2012), while it reduced in extent during the long-groyne period (1991 to 1999) and minimised during the present period of the high angle groyne (2012 to 2018);
- 2 Along the northern inlet bay, there has been a systematic landward shift in channel location since construction of the long groyne in 1991;
- 3 Groyne length seems to correlate with downstream sediment entrapment/protection implying channel flow is effective, i.e. the structures are behaving as groynes subjected to alongshore flow. Photos in Figure 6, Figure 7 and Figure 8 demonstrate that the early groyne

remnants still have some influence on adjacent downstream sedimentation despite being in a very degraded condition, and

- 4 The northern channel excursions are likely influenced by mouth cutting.

Figure 9: Envelopes of main channel location for colour-coded time periods—these corresponding to differing structural controls. Raked black line = rock protected river bank (from pre- 1978). Paired solid black lines are rock groynes, original long groyne from 1991 and shorter remnants from 2000. Single black line is 2013 high angle groyne. The dotted red line denotes a flooded secondary (c.f. main) channel during the final time period rather than a main channel. Dashed black lines are transects (upper North and lower South) used to sample shoreline change along the inlet bay (see Figures 11 A and B)

- c Analysis of the channel locations (Figure 9) compared with the various control structures suggests that the channel is more often located closer to the inlet bay shoreline/duneline since construction of the high-angle groyne, and this correlates with increased shoreline erosion in this area (Figure 10A).

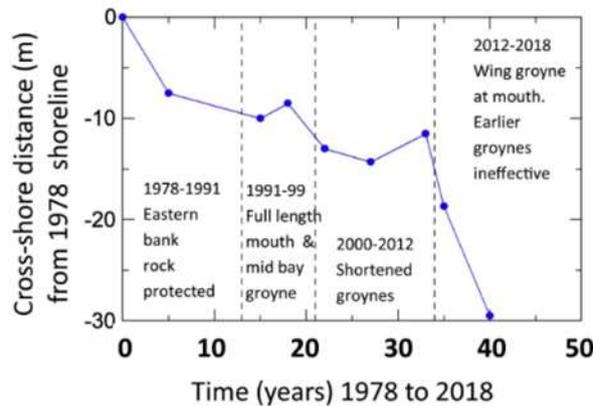
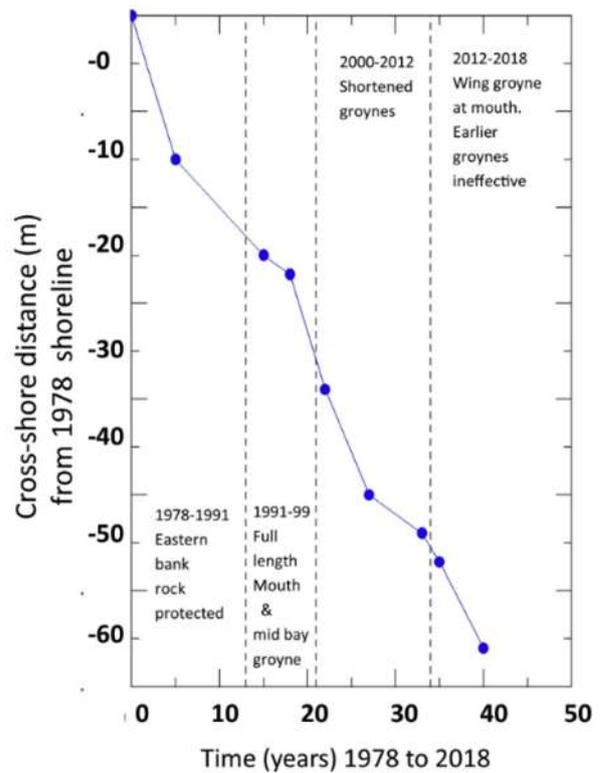
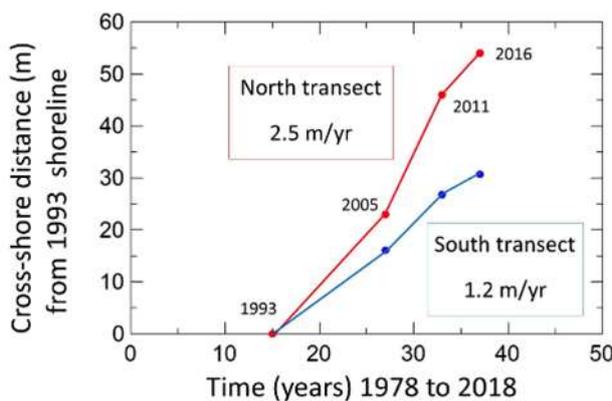
Figure 10: Shoreline change (based on vegetation-front) for the inlet transects (north Figure A and south Figure B) with locations marked in Figure 9. The period (1978 to 2018) covers the time since the inlet approach was fixed by rock lining of the southern bank in the 1970s. The periods of differing structural control are marked and annotated. Note graphs A and B have the same vertical scale to assist comparison. Figure C depicts shoreline-change on the open coast some 900 m north and south of the inlet (throat) over a somewhat shorter period (1993 to 2016) – this being required to avoid historical inlet behavioural response effects. All three graphs have the same horizontal (time) scale.

The results suggest that the inlet bay (Figure 10A and B) shoreline is subject to systematic erosion with the southern transect having undergone about twice the amount of retreat as the northern transect shoreline (60 m c.f. 30 m) during the 40 year sampling period. In addition, the northern transect data indicates an increased erosion rate during the final period under the high-angle groyne, while the southern transect shows more uniform retreat throughout the sampling period.

The open coast graph (Figure 10C) shows the shoreline is advancing on each side of the inlet with the northern rate of 2.5 m/yr being almost double the southern rate of 1.4 m/yr. Their averaged rate of ~2 m/yr is greater than the long-term rate of 1.5 m/yr reported in T+T 2013, suggesting the accretional trend is increasing. This could be related to inlet configuration changes during the late 1940s to early 1970s when the inlet was located to the north, or to inlet changes associated with the Ohau River further north. None-the-less, while shoreline advance is likely to persist into the foreseeable future, general shoreline response models related to predicted sea-level rise infer that the net rate may slow somewhat.

- b Shoreline analysis within the Inlet (Figure 10 A and B) shows that the inlet bay is characterised by long-term erosion with an increased rate of erosion evident in more recent years at the northern end of the inlet.

- e Accretion is occurring along the open coast (Figure 10C) with the average rate during the 1993 to 2016 period being 1.4 and 2.5 m/year on the southern and northern coasts respectively. This ongoing natural accretion of the open coast is likely increasing the area of wind-blown sand accumulation and the volume of the fronting sand bar making breaching and discharge more difficult and promoting southward channel meander and ponding. This natural accretionary process can be expected to continue in the future, although the rate of accretion may adjust to ongoing sea level rise and other sediment supply controls.

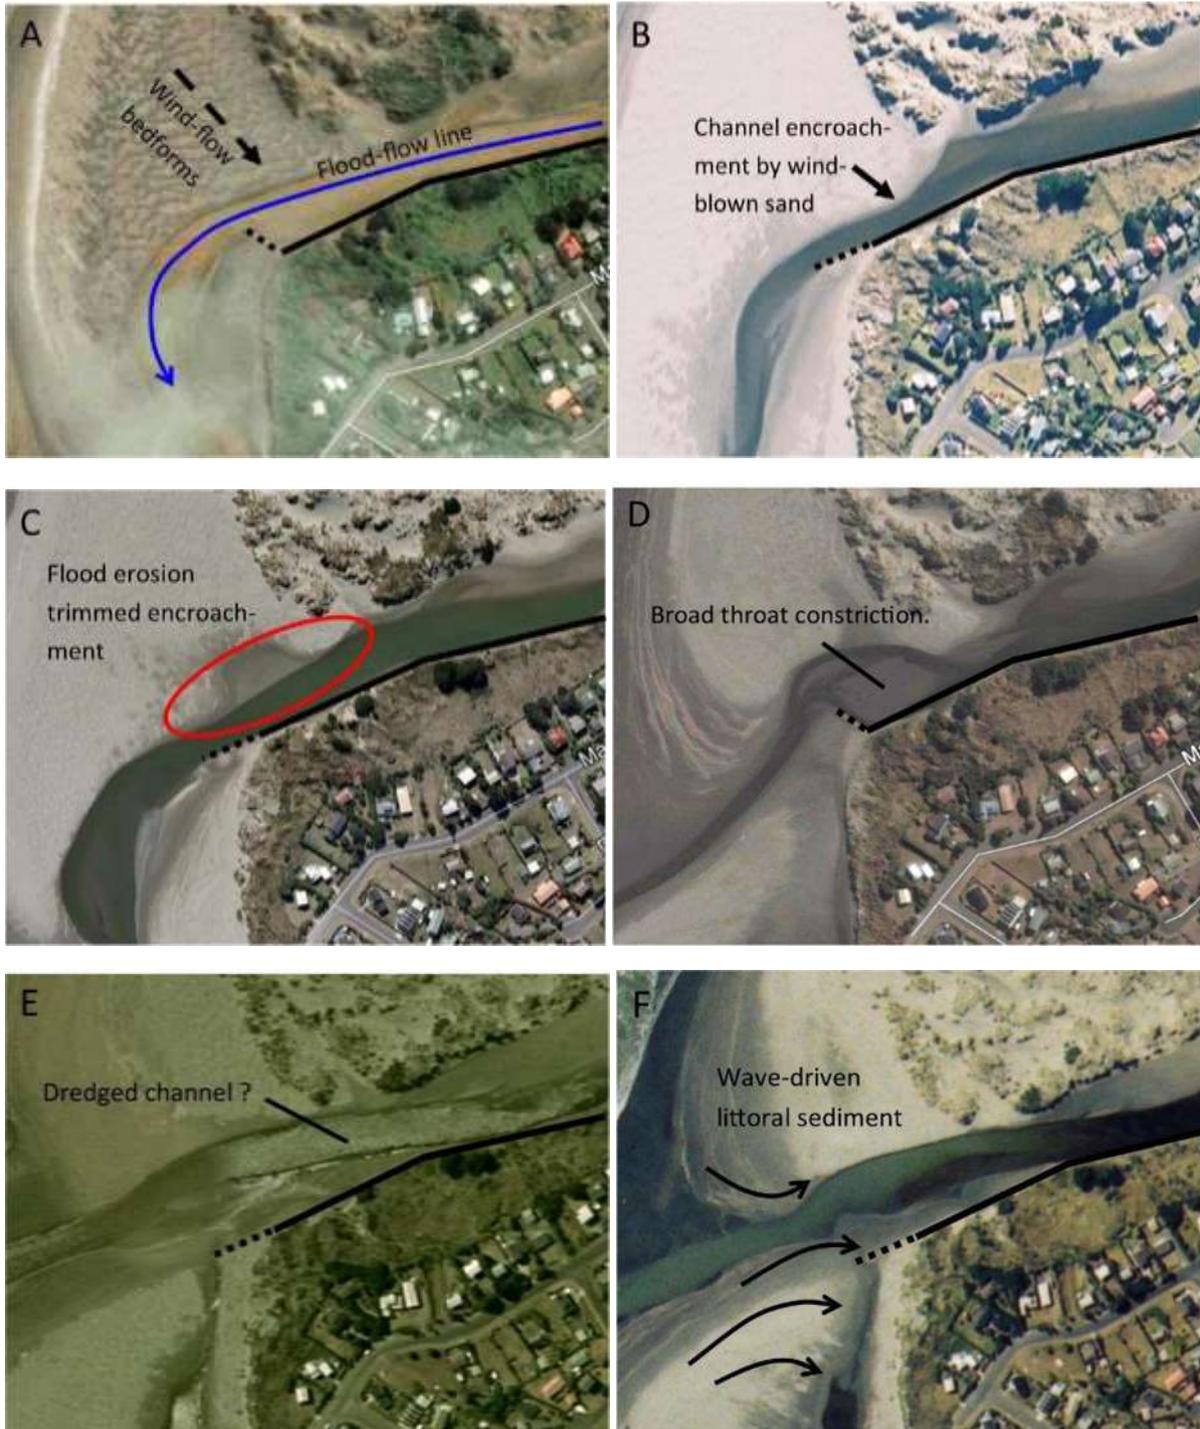
As noted in Section 3.2.6, there is a misalignment about midway along the approach channel which could drive the flow line toward the northern side of the throat. The misalignment appears to widen the throat channel and this could be expected to reduce flow concentration and thus jetting momentum under high flows which in turn would decrease scour potential across the fronting sandbank – a situation made more critical by the prograding (seaward trending) coast which increases the volume of this feature. Widening of the throat could also facilitate sedimentation within, and upstream of, the throat. The reduction in jetting and increase in sedimentation may also enable the channel to more easily meander toward the back of the inlet once past the groyne terminus. The current high-angle groyne may further exacerbate these situations as the flow is forced into an area of wind-blown sand accumulation (following paragraph), where it piles-up and has to redirect southward.

There is high potential for wind-blown sand to encroach upon the throat area from the northern beach as indicated by the bed forms in the vicinity of the dashed arrow in Figure 11A, and channel-margin bulge illustrated in Figure 11B. While it appears that flood-flows can clear the constriction in Figure 11C, significant shoaling within the throat can occur under more benign conditions (Figure 11D, and this could even necessitate dredging as appears to have occurred in Figure 11E (2005).

Littoral sand (i.e. beach sand) can reach the throat area under wave action along the channel margin during incoming tides (Figure 11F). However, this requires, the channel's sea-entry to be close to the throat rather than further southward along the inlet. It is noted that if the sea-entry is in the centre of the inlet, then littoral sediment can be transported landward at that location and potentially resupply the inlet bay. Furthermore, the recent lack of extreme southerly channel entry into the sea (indicated by the red envelope in Figure 9) prevents littoral sediment reaching this (southern) area; channel remnants (cut-off lakes) therefore persist and facilitate flood flow into this area as speculated earlier.

Figure 11: Configurations associated with throat constriction - see text for explanations. The black line defines the rock-lined southern embankment and the dashed black line marks the various entrance groyne. The bend mid-way along the southern embankment (black line) results in an approach channel misalignment with the original entrance groyne (dashed line in Figures B, C, E and F). Note the (apparently) dredged channel in E is more closely aligned with the upstream section of the marked southern embankment.
