Coastal Geomorphological Change at Opunake Bay, Middleton Bay and in the Vicinity of the Patea Rivermouth

Based on a report to the South Taranaki District Council

By Dr Roger D Shand

Reference	2022-9 CRep
Reviews	TDS (CSL), SB (STDC)
Version	1.0
Status	Final
Date	23 August, 2022

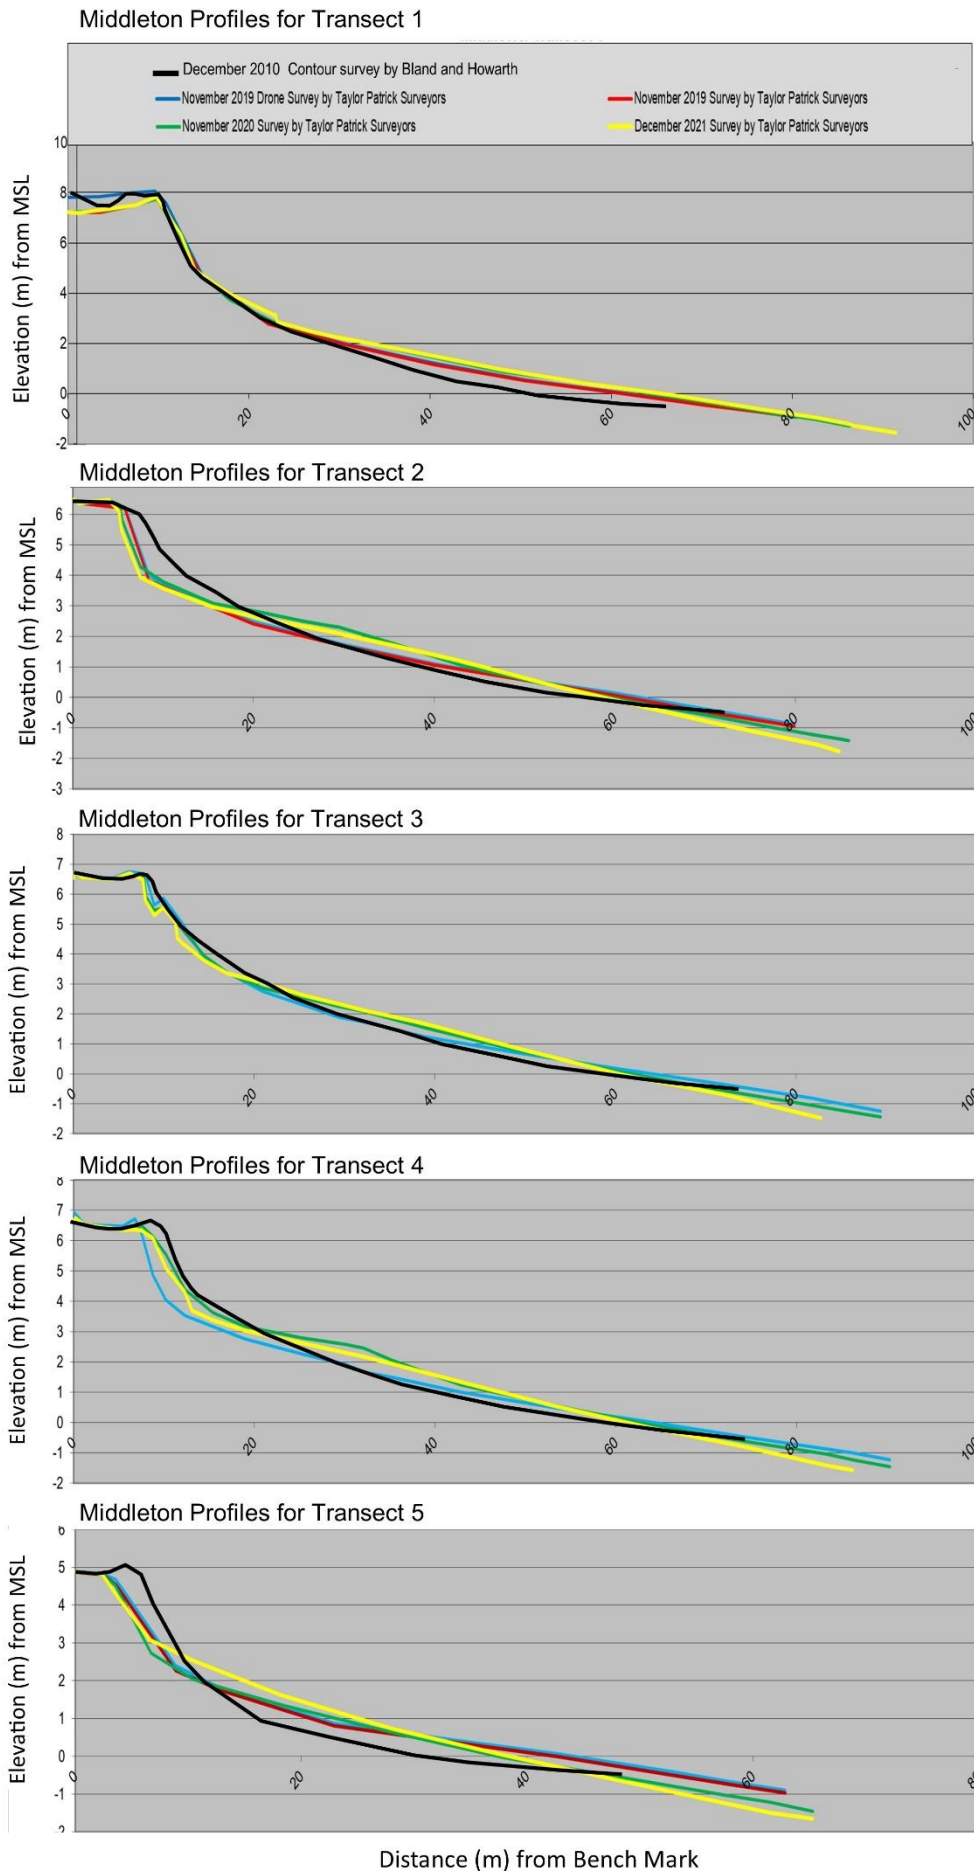
At Middleton Bay, profile change shows the northwestern end of the bay is stable but the central area has experienced erosion, this could be related to recent structure (revetment) modifications.

Figure 2.2 Superimposed profiles for the Middleton Bay's 5 transects surveyed in 2019, 2020 and 2021. The 2010 profiles were abstracted from a contour survey by Bland and Howarth.

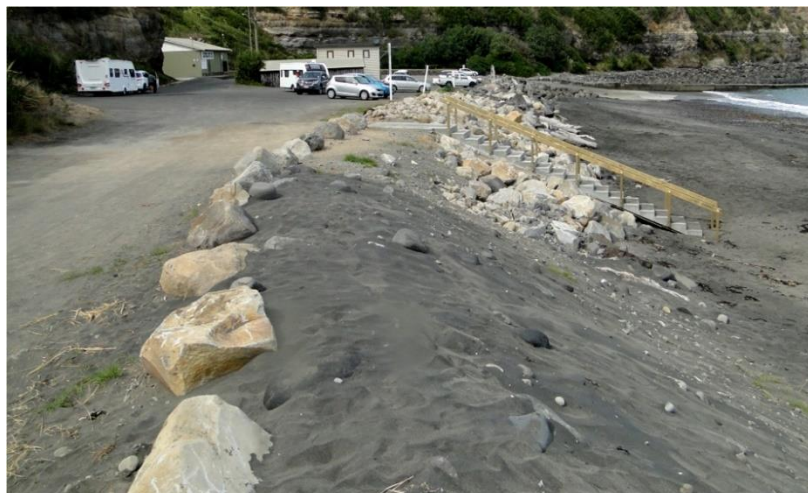
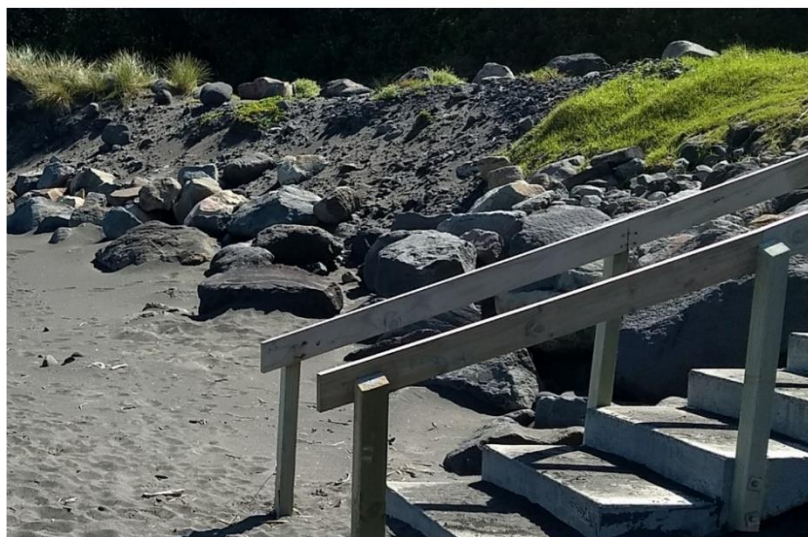
Since modification, the structure has undergone localized storm wave attack and erosion is evident in Figure 2.5 and in the 2019-2021 profile survey data. A structure effect/erosion enhancement is possible given that a wave turbulence-driven alongshore erosional beach response can extend up to $0.7 * \text{seawall length}$ (McDougal et al., 1987).

Figure 2.5 As-built photo taken 16-3-2020 (top) showing steps and newly place stone with battered bank (dune) in foreground. Lower photo taken 17 February 2022 showing stairs and area immediately northwest indicating past erosion. This area was identified by BECA as in urgent need of armour rock. It is also this area was designated to have a “return” build in to avoid future outflanking. Photos CSL

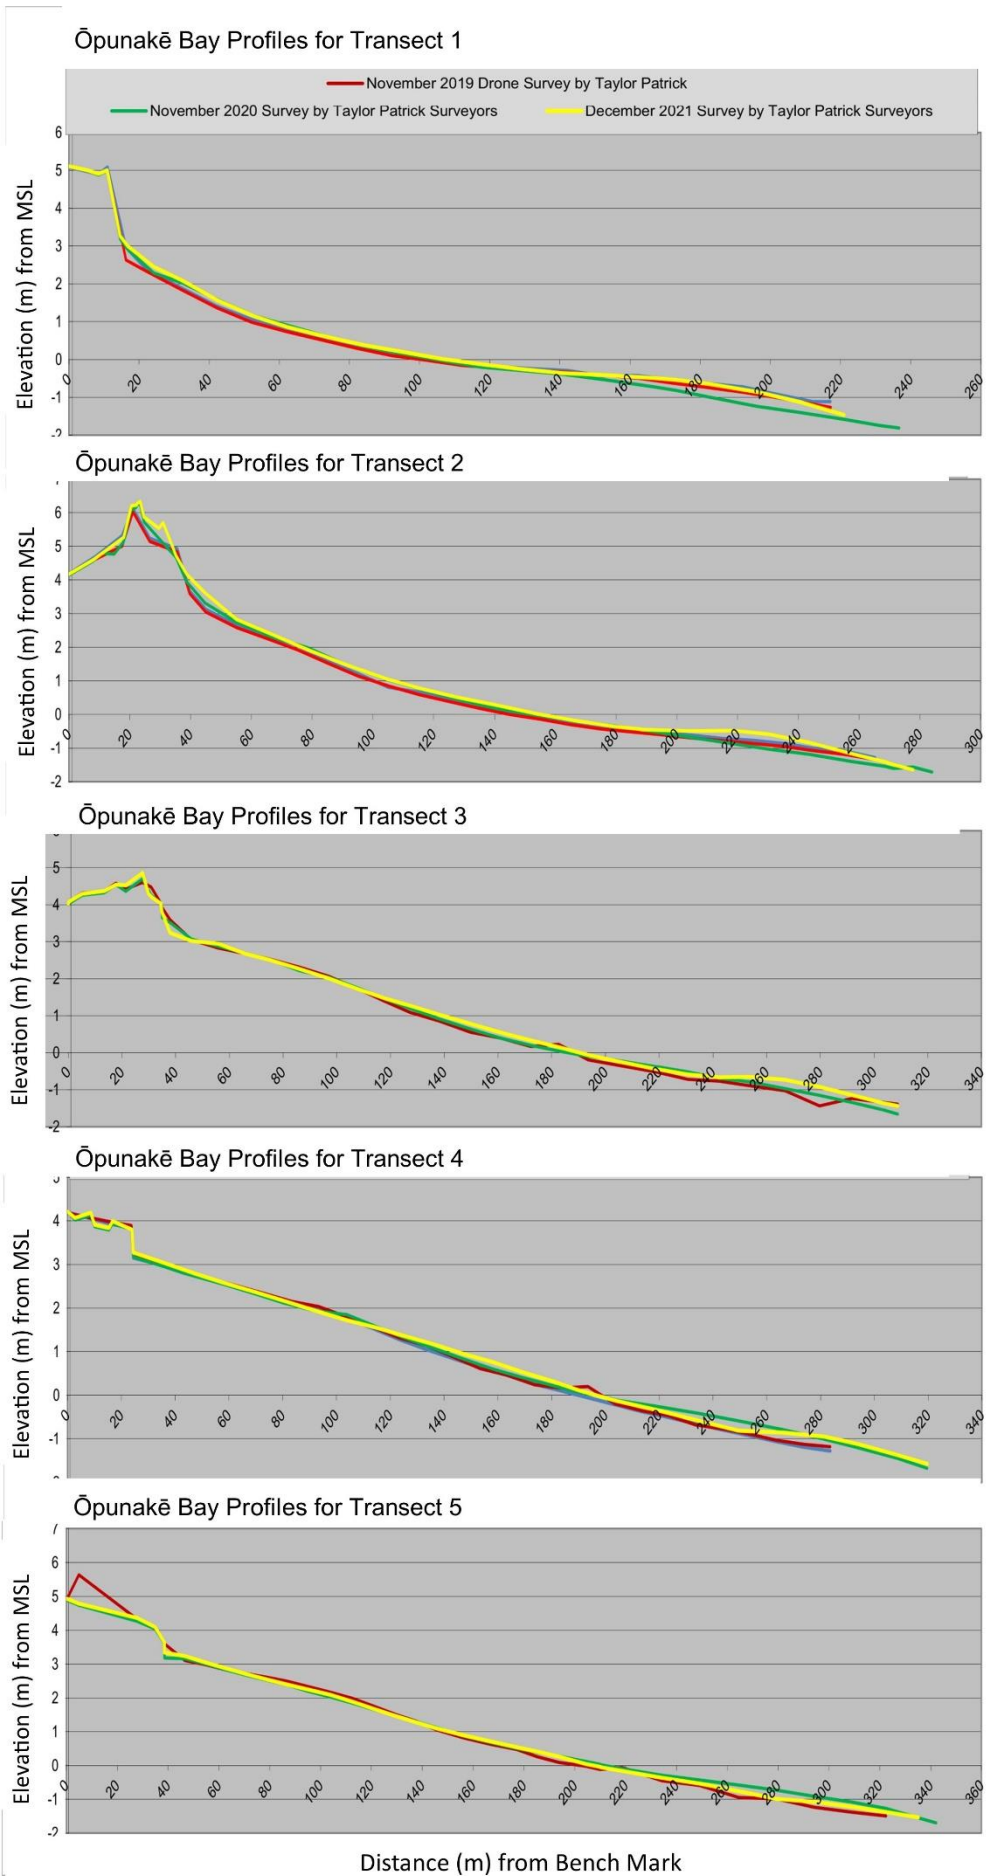
Beach behaviour fronting the retaining walls (T3-5) is more complex with T3 retreating slightly (0.5 m), T4 advancing about 4 m after previously undergoing a slight retreat, and T5 also showing a moderate and consistent advance of 2 m/year. The T5 deposition in particular may be being facilitated by outflow cessation from the power station tailrace which stopped operating in 2018 after several decades of flushing sediment seaward at the eastern end of the beach. The dramatic upper beach accretion at T4 following previous stability suggests localised beach behaviour possibly related to the T5 accretion. The contrasting behaviour (slight erosion) at T3 is consistent with this area carrying the seaward return flow from storm-wave overwash from the more elevated central upper beach and possibly also from the recent T4 accretion.

Figure 3.2 Superimposed profiles for the Ōpunakē Bay transects surveyed in 2019, 2020 and 2021.

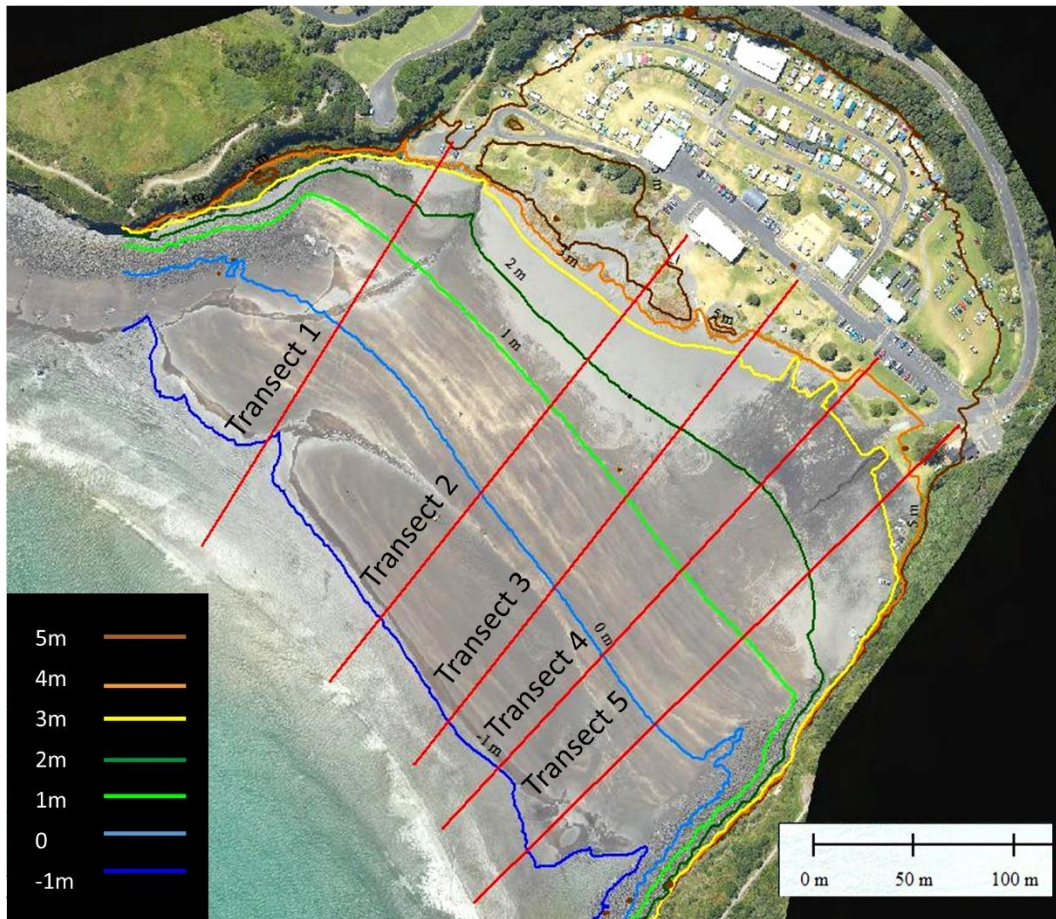
Figure 3.4 The Landpro aerial orthographic photo with contours marked at 1 m elevation increments across the beach, foredune and backshore. There is no evidence of the power station tail gate and tail race.

The profile and aerial surveys identified morphological change (deposition) at the south eastern end of the beach which appears to result from recent non-operation of the power station tail race. As noted in Section 3.3, should this continue then there will be environmental consequences, in particular relating to drainage.

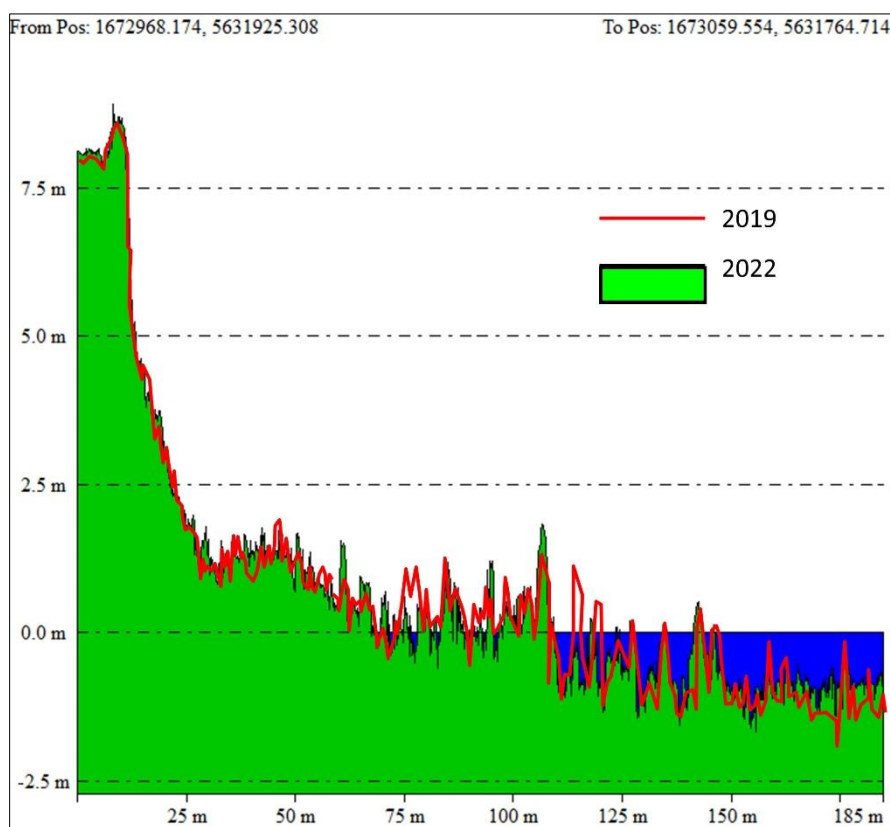
Some maintenance to the breakwater and boat ramp appear to have been carried out in the early 2000s in preparation for constructing an artificial surf reef. TPL and Landpro aerial surveys in 2019 and 2022 respectively, found the breakwater's present crest elevation reduces from about 1.5 m above MSL at the landward end to about 1.0 m below MSL at the seaward end (Figure 3.7).

Figure 3.7 Longsection of the breakwater comparing 2019 TLP drone-based photogrammetric 3D data with 2022 Landpro LIDAR. Sampling occurred along the axis marked in Figure 3.6.

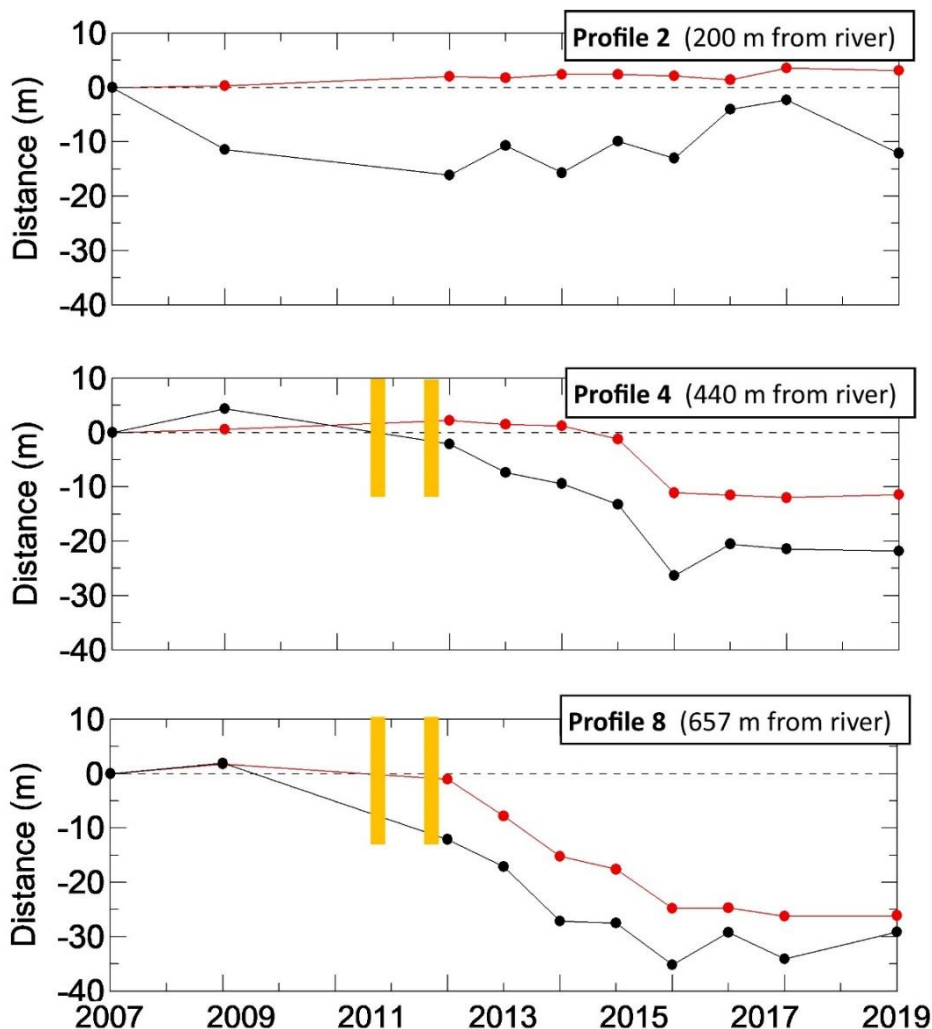
Time-series line graphs for the dune toe (MSL +4 m) and mid dune face (MSL +10 m) clearly define the erosion episode at T4 and T8, but it is not apparent closer to the mouth. However, it could be that the shoreline impact here was masked by the arrival substantial quantities of eroded sediment from further updrift (T4 and T8), a possibility supported by the more recent deposition which is evident in the T2 time-series graph.

Figure 4.6 Time-series for Transects 2, 4 and 8 along the northern coast. **Positive values=accretion, Negative values=erosion** The dune toe (MSL +4m) is represented by **black line** and mid/upper foredune face (MSL +10 m) by the **red line**. The vertical **orange bars** mark initial observations of foredune erosion in October 2010 and June 2011. Source: CSL (2022)

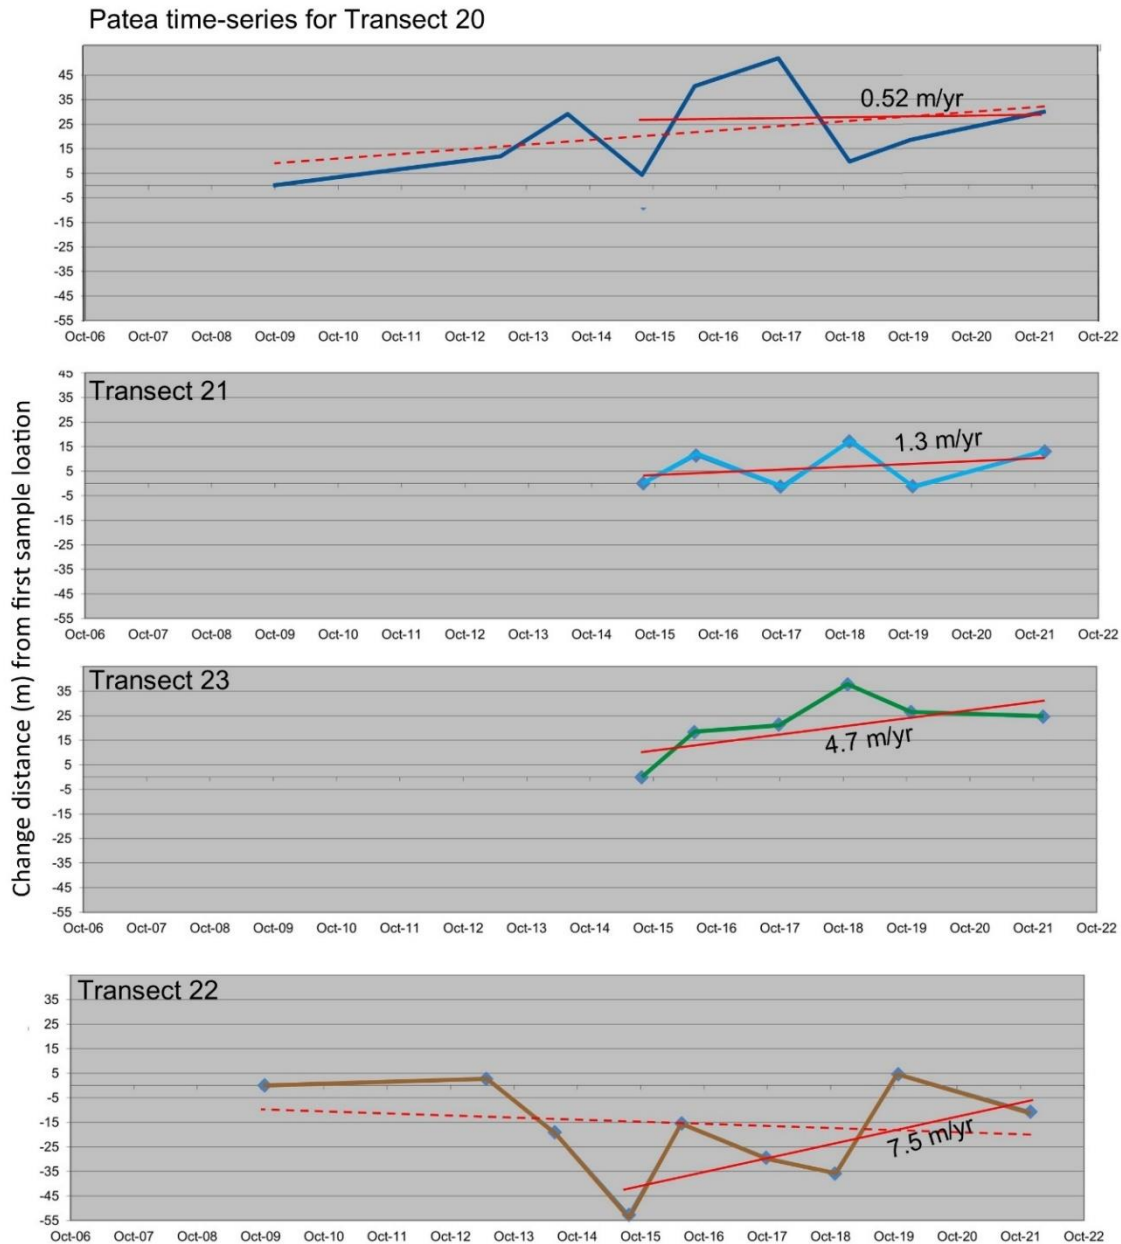
Time-series for the MSL +1 m elevation for T20, 21 23 and 22 (in order moving upstream) are shown in Figure 4.8. All sites contain samples from 2015 to the present and the associated regression models are shown in the graphs by the bold red lines. The average rate of change is also marked and shows shoreline accretion at all sites with the rate increasing systematically upstream from 0.52 m/y at T20 up to 7.5 m/y at T22.

Figure 4.8 Time-series for inlet Transects 20 to 23. Top graph (T20) is nearest mouth and T22 at base is furthest upstream (NB transect locations shown in Figure 4.4). Regression models have been fitted to the 2015 to 2021 data common to all sites (bold red line), and to the 2009 to 2021 data available for T2 and T22 (red dashed line).

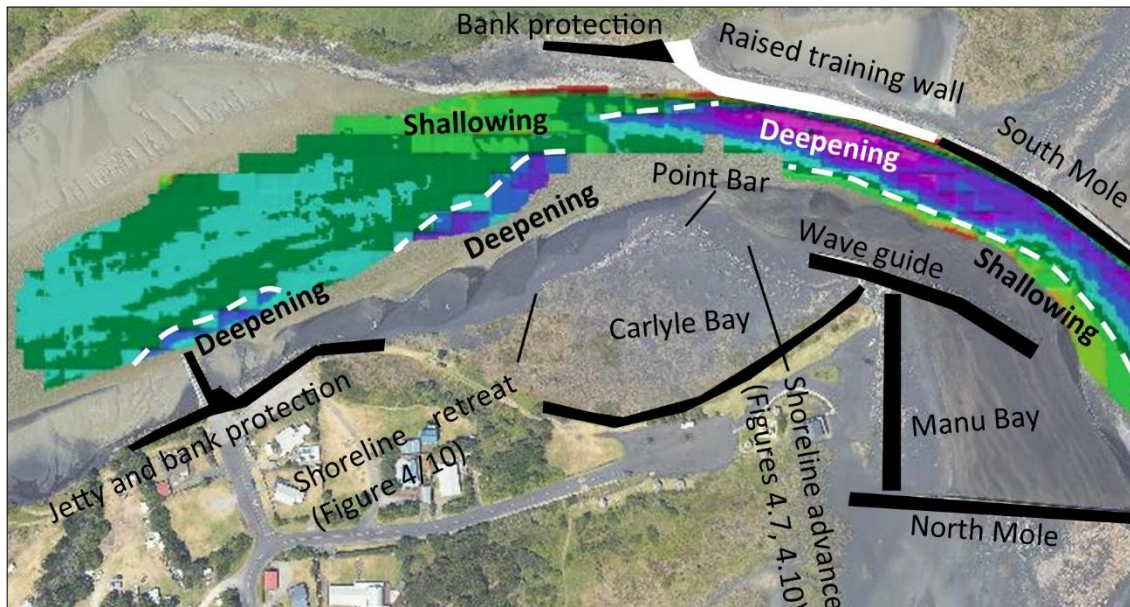
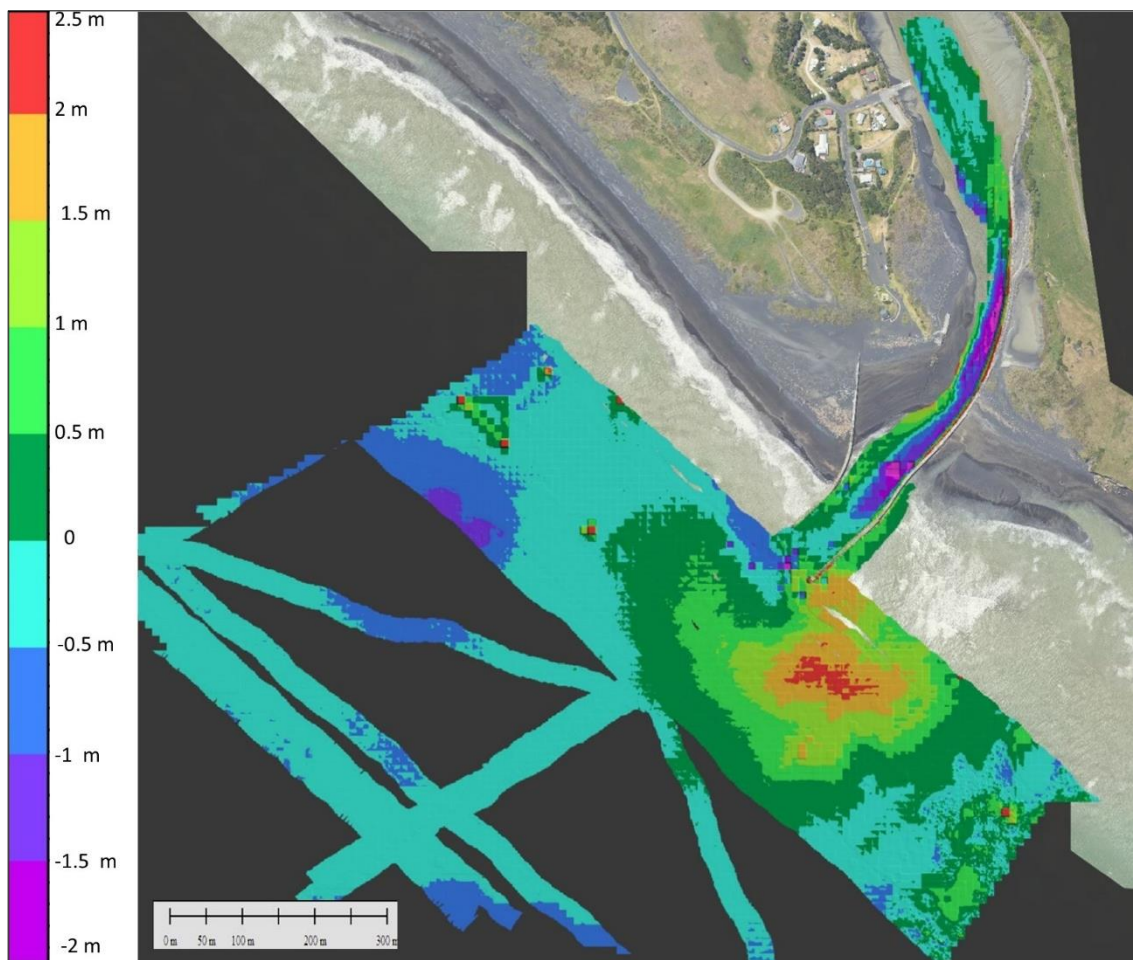
Within the Patea inlet, bathymetric change (Figure 4.14) shows channel deepening (2 m) has occurred adjacent to the raised (2 m) river training wall, and also deepening has occurred along the adjacent South Mole. This appears to have resulted in greater wave penetration into the inlet which caused bank erosion immediately upstream of the raised training wall with bank protection subsequently being carried out. In addition, deposition has occurred along the village side of the channel from Manu Bay, along the wave guide wall and the Carlyle Bay frontage where infill and dune establishment and growth have occurred. This process may also result from the increase in wave penetration.

Channel deepening then appears on the opposite side of the river, adjacent to the raised training wall where a sustained excavation depth of 2 m occurs (marked). Deepening continues along the South Mole, with a local 2 m maximum some 170 in from the mole

Figure 4.14 Bathymetric difference surface between the 2003 and 2022 surveys. Negative values (cyan to magenta) indicate deepening while positive values (green to red) indicate shallowing.

end (Figure 4.14 lower image) before trailing off closer to the mole ends. Such intense deepening along the raised training wall (constructed in 2006/7) and its continuance (albeit less intense) along the South Mole supports a cause and effect process. In particular, the heightened training wall concentrates flood flows which had previously been able to dissipate energy across mudflats beyond the original half tide wall. Such bed lowering adjacent to these structures could impact structural integrity and should be a focus of future monitoring.

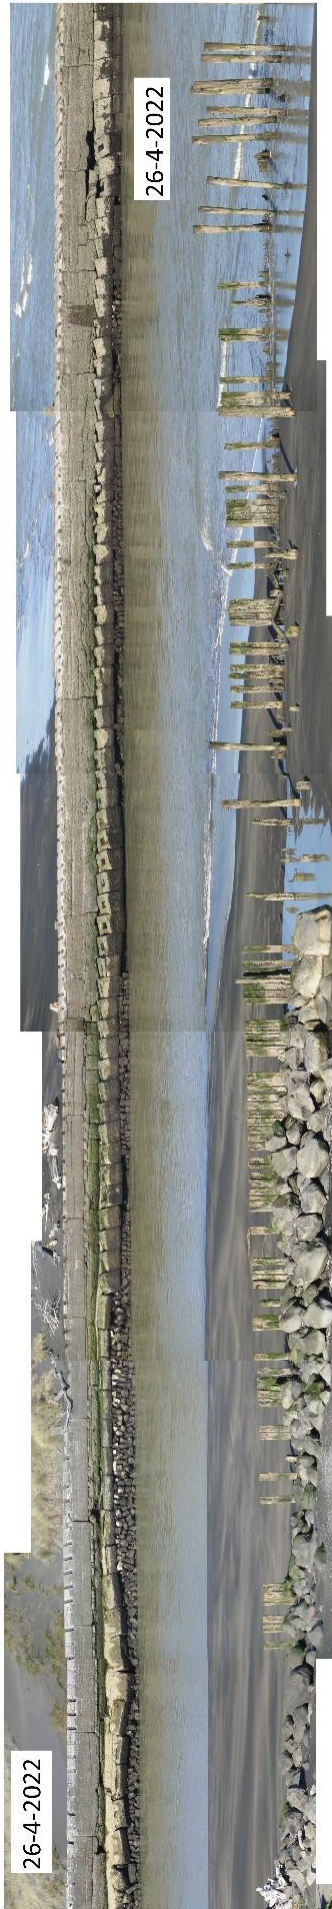
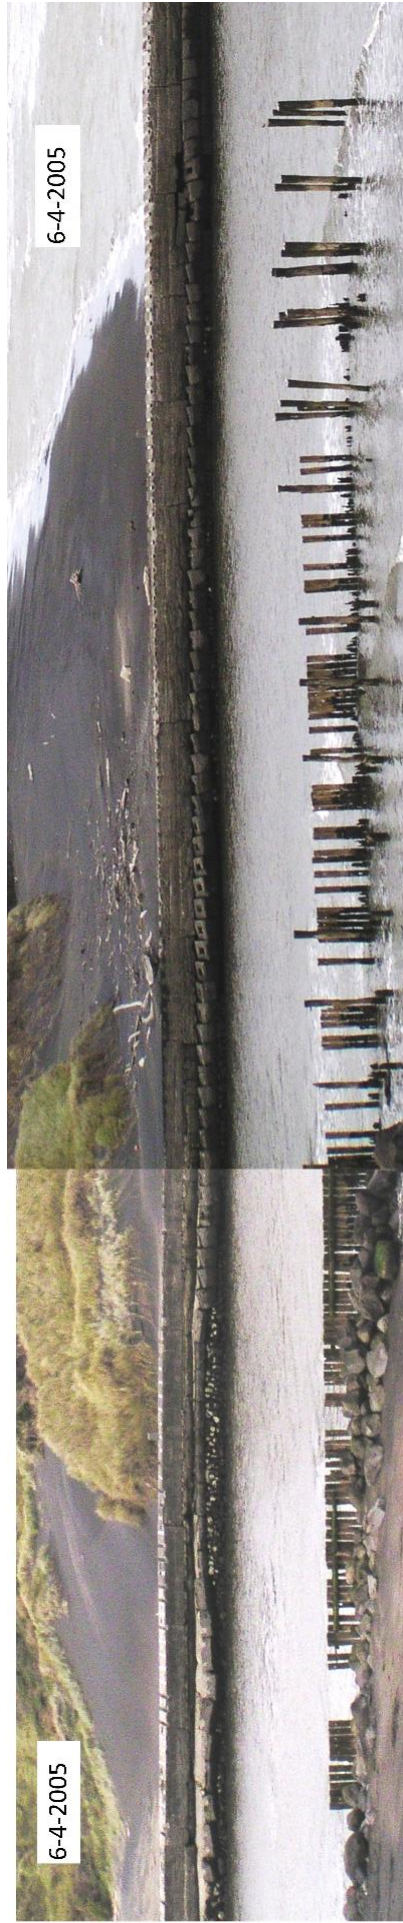
BECA's coastal structure condition survey stressed the urgent need for protection works on the mole ends and investigation of concrete block misorientation along the South Mole. We (CSL) provided photographic evidence (Figure 5.1) that the rotated blocks have been stable since at least 2005, but given the channel deepening in this area we recommend more frequent riverbed and mole surface monitoring be carried out along the raised training wall and the rotated block section.

Figure 5.1 Patea South Mole rotating block comparison 2005 cf 2022. Photos from CSL
