Minor Coastal Structures: Consent Compliance, Asset Integrity and Hazard Management

A report prepared for the South Taranaki District Council

By Dr Roger D Shand

Reference	2022-8 CRep
Version	1.0
Status	Final
Date	19 July, 2022

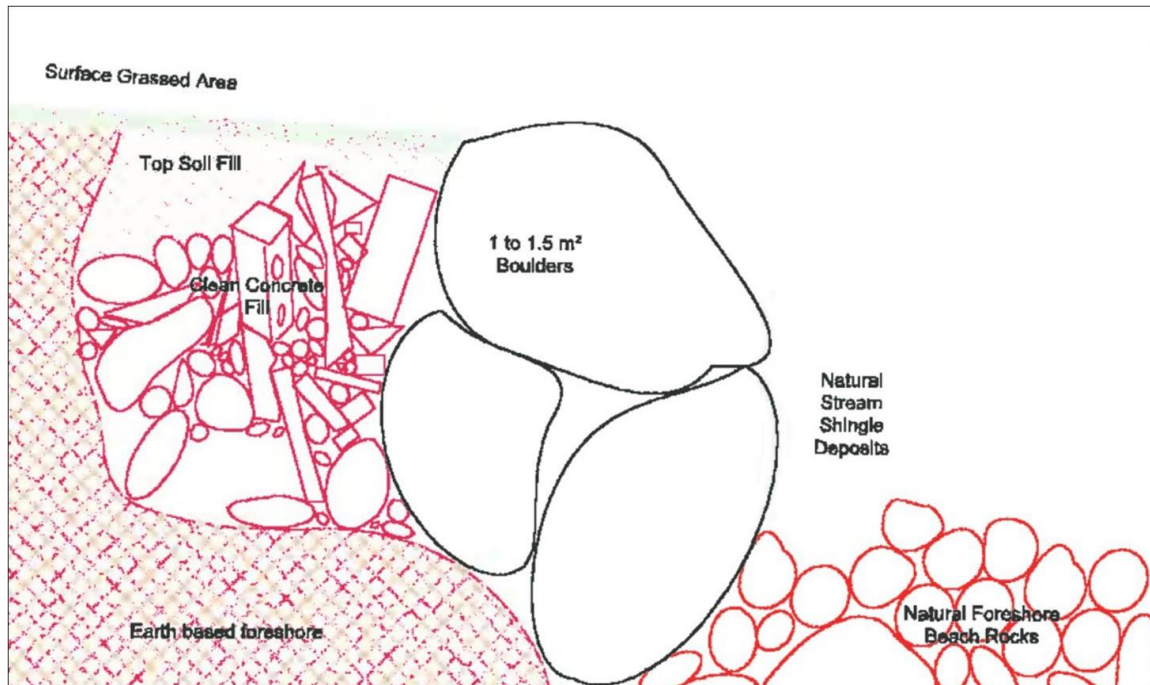
Figure 2.3 Cross section design from 1999 AEE and 2016 consent reapplication.

The design does not meet coastal engineering standards (e.g. PRIF, 2017), lacking the following: a filter (geotextile) layer, consideration of the strength shape and grading of materials in keeping with environmental conditions, and the relevant batter slope.

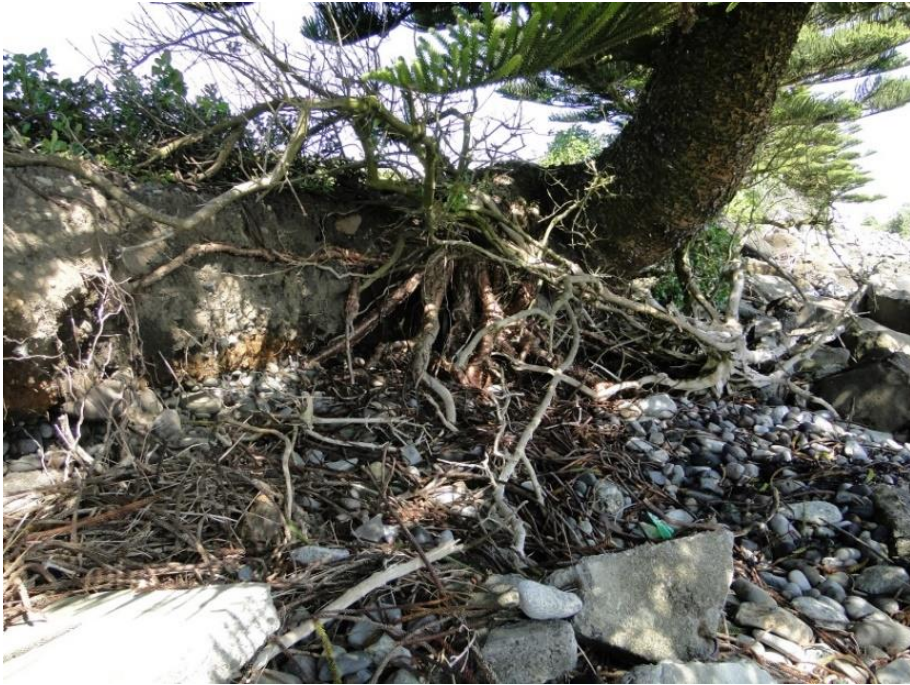
Figure 2.4
 Typical upper bank exposure and undermined Norfolk pine trees at 60 to 80 m chainage.

Between 40 to 60 m: exposed upper bank and large trees being undermined creates an urgent intervention scenario. Rock and fill are needed to restore the structure, stabilise the large trees, and give long-term protection to the significant recreation area. Existing material should be removed down to a stable foundation level and a geotextile layer installed. Suitably graded armour rock placed with the appropriate stable slope, and backfilled with material of lesser size.

STDC plans to remove the large Norfolk pipes in financial year F24/25, this is based on condition and risk. If further erosion occurs this work may need to be done earlier.

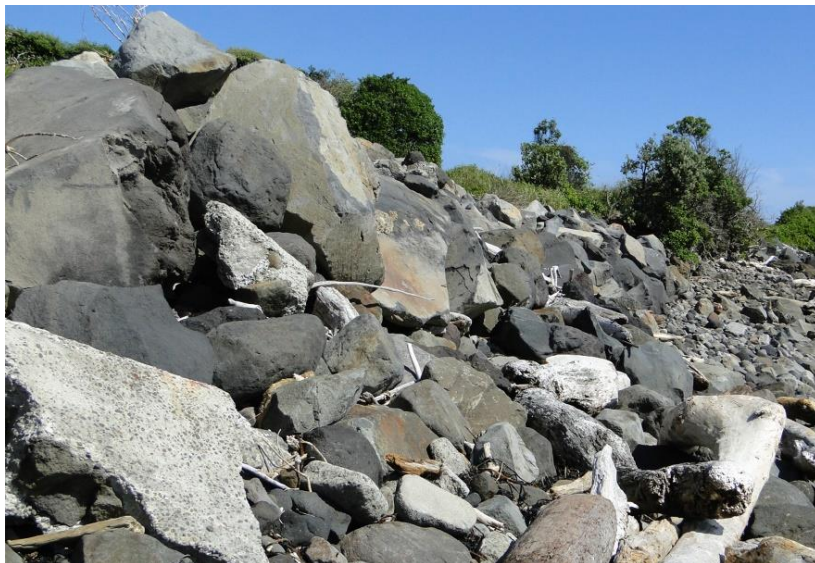
Figure 2.5
 Overly steep recent rock placement at 150 to 180 m chainage

The 150 to 180 m section section also requires extending alongshore at each end to join with the existing sections of the existing wall. Excavation, a geotextile and suitably graded armour rock at the appropriate slope should also be used along the extensions. The above recommended remedial works (between 60 and say 190 m) are shorter-term interventions as the overly steep face is potentially hazardous.

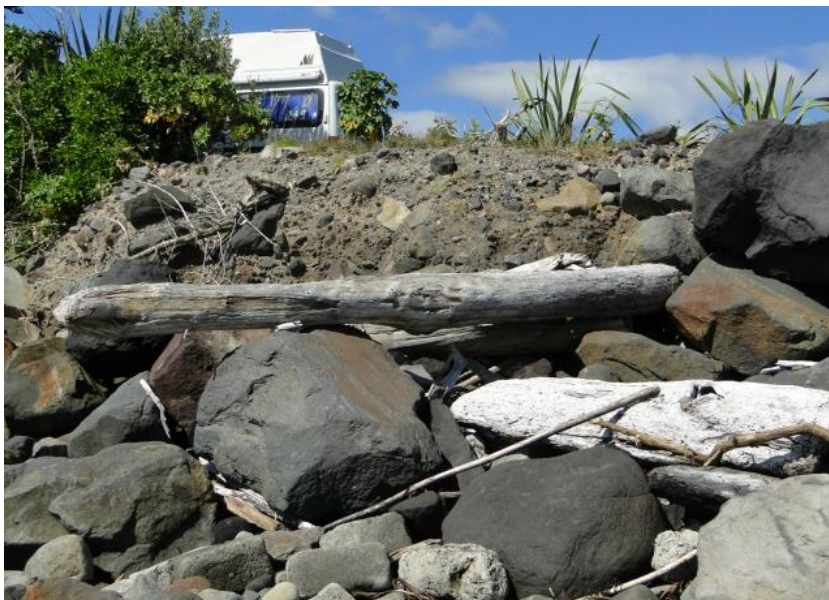
Figure 2.6
 Unconsolidated and erodible material at the northern end of recent rock placement at 140 to 150 m chainage.

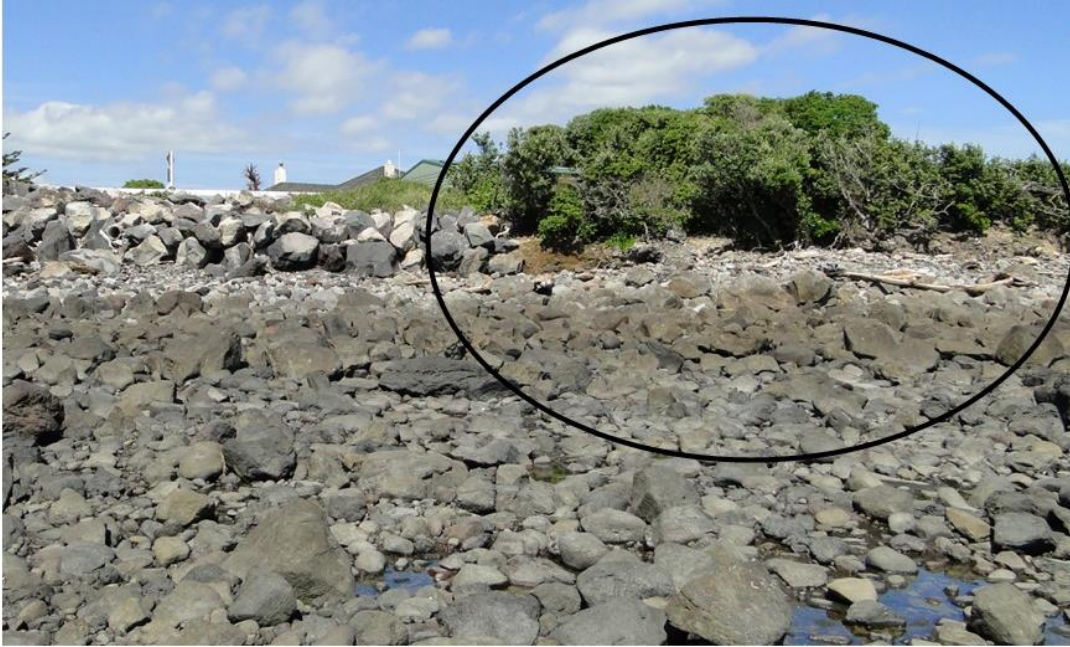
Figure 2.7 Exposed upper bank (circled) at southern end of the recent rock placement on the left side of photo (180 to 200 m chainage).

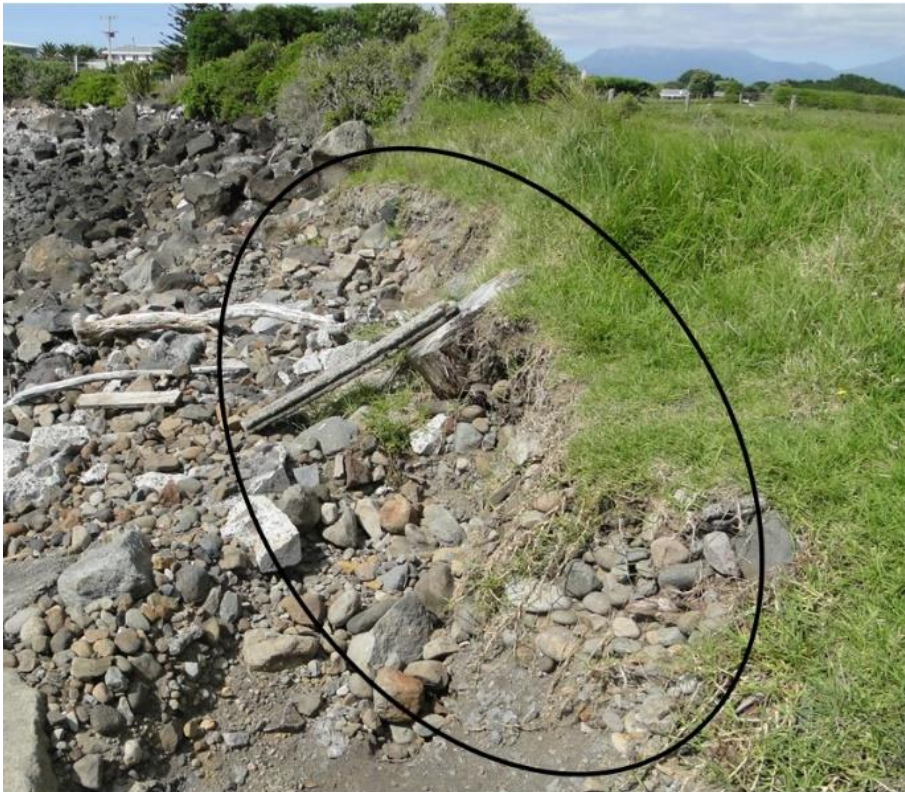
Figure 2.8 Exposed upper bank at southern end of seawall (260 to 275 m).

Between 260 to 275: the existing structure needs extending 10 to 15 m southward to reach to the stream/small car park. Again excavation, a geotextile and graded rock should be used with the appropriate frontal slope. This is a longer term intervention.

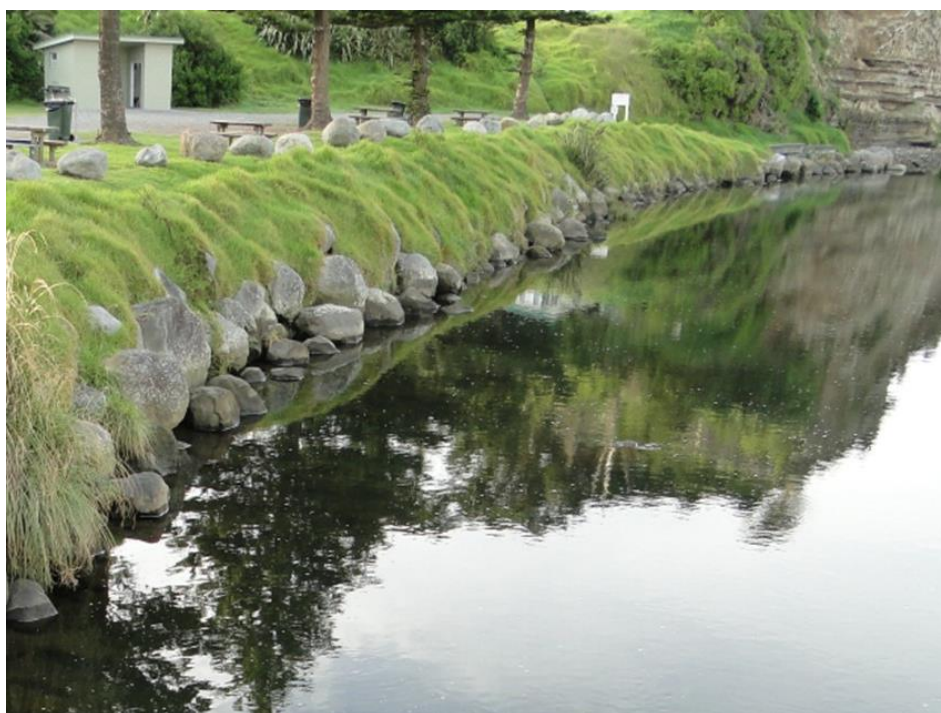
The boulder protection wall is composed of large boulders. While the face is overly steep, it is well vegetated and there was no evidence of localised failure (Figure 3.2). The stability of the structure is further demonstrated by its resistance to high flow during the extreme rainfall event some week prior when both the natural bank upstream of the structure, and the bluff immediately downstream were both subject to significant failures (Figure 3.3). Slumping and rock slides at the bluff resulted in pedestrian access to the coast becoming hazardous and a report was made to STDC officers (Appendix A).

Figure 3.2 Kaupokonui boulder protection wall post flood with bluff in background.

The wall is overly steep and toe support may be inadequate. For both consent compliance, asset management and hazard avoidance, a more detailed engineering inspection is recommended in the shorter term.

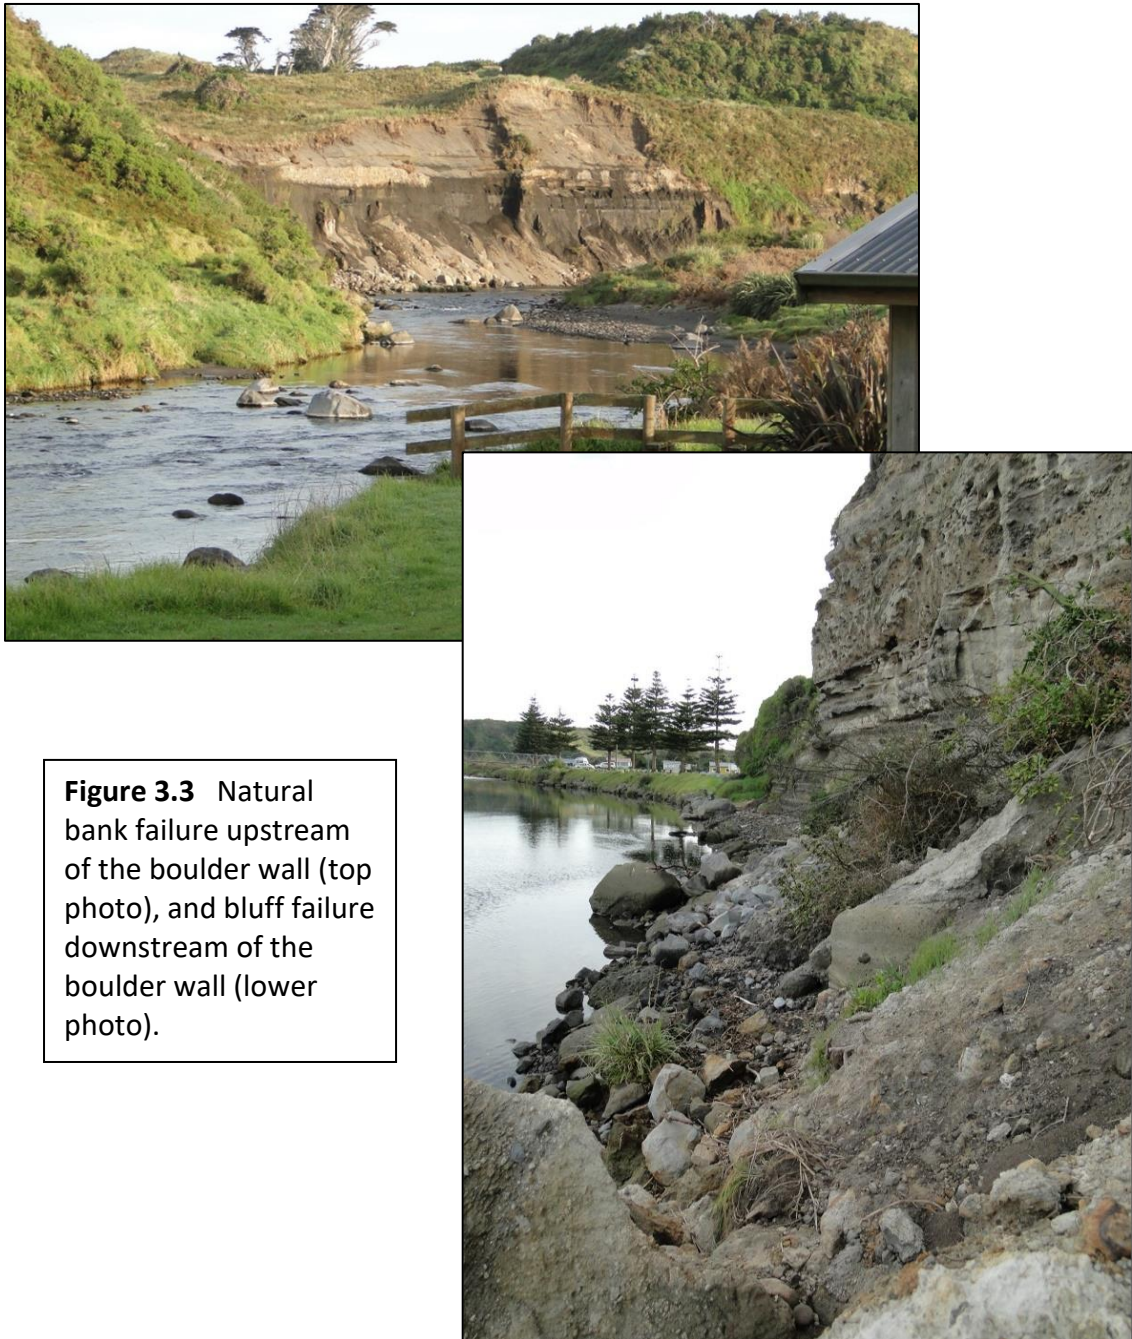
Figure 3.3 Natural bank failure upstream of the boulder wall (top photo), and bluff failure downstream of the boulder wall (lower photo).

The bluff accessway condition requires urgent STDC attention to ensure public safety. The south beach access should be closed until the rock fall is stabilised - possibly by water sluicing, and then a long-term solution is required.

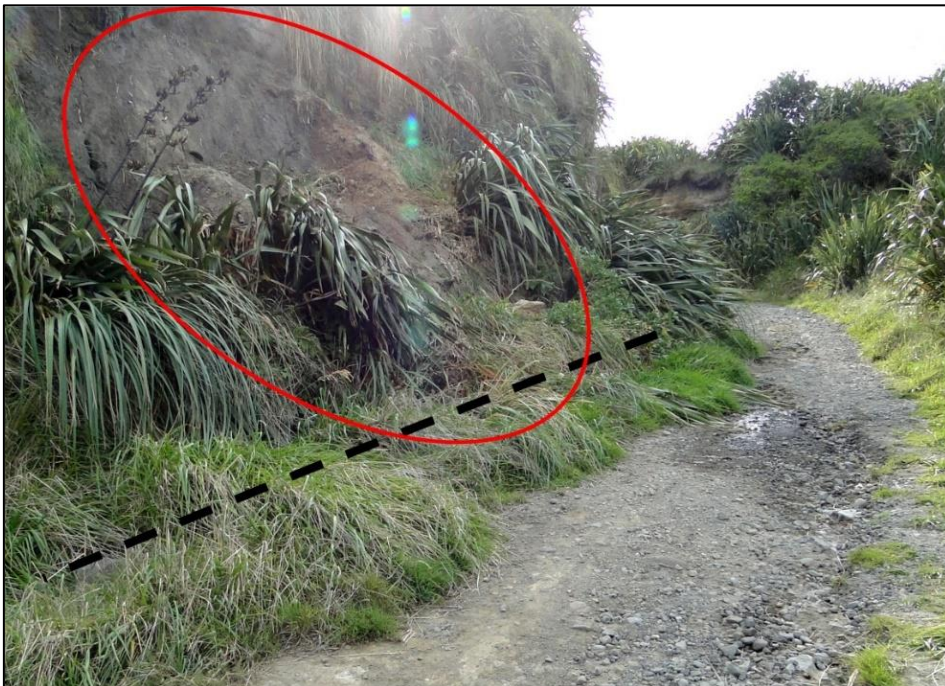
Runoff from the hillsides had caused considerable slippage with vegetation accumulating in the stream courses and reaching the beach. Post-storm photographs appear in Figures 3.1 to 3.3. Slips had also blocked the drainage channel along parts of the upper access track and the unconfined storm water was eroding the track surface, forming rills and covering the path with loose stone.

Figure 4.1 Waihi Beach access track showing slumpage (circled) and blocked drainage channel (dashed line) with resulting rills (focused erosion) developing on the track

The council's ongoing maintenance programme needs to keep the track clear of storm debris (urgent responses) if the track surface is to remain safe and intact.

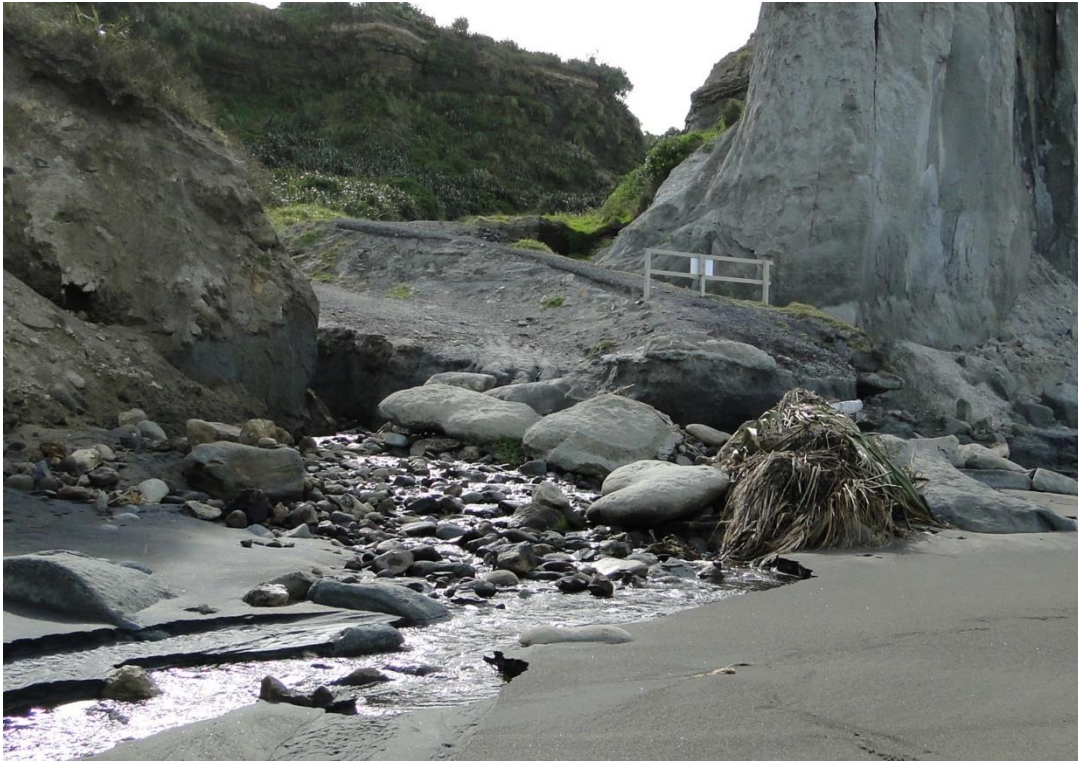
Figure 4.2 The barrier marks the location of the original consented gabion-based access structure. The alternative lower accessway (from 2018) is evident as is the escarpment at its base caused by stream flow and waves. Boulder-hopping is now required to access the beach.

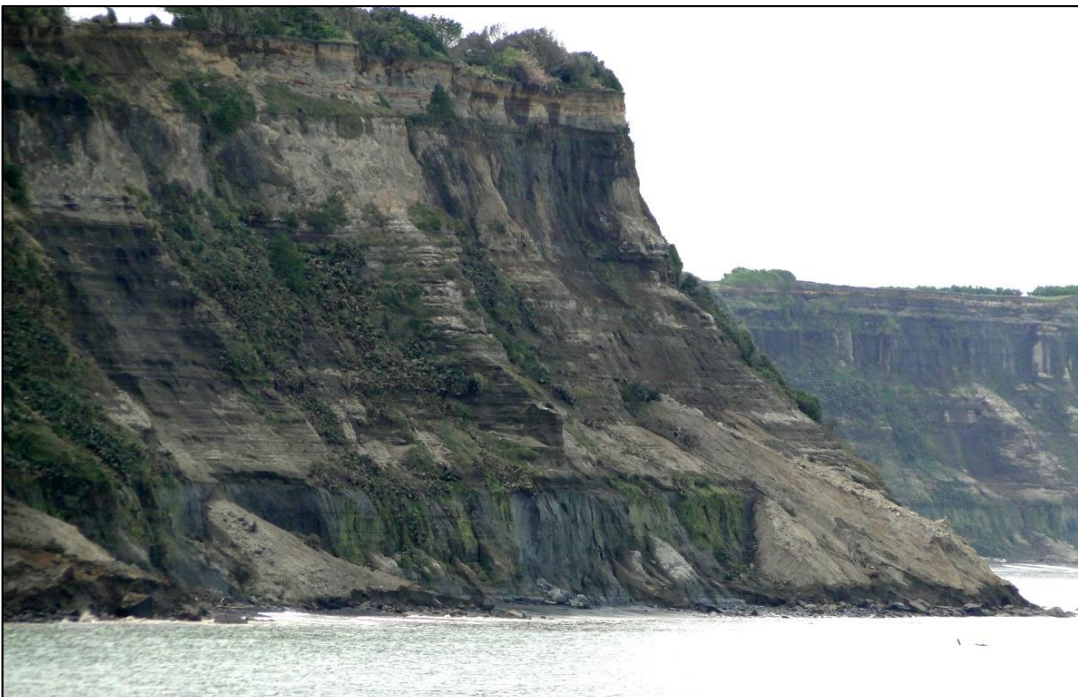
Figure 4.3 Recent coastal cliff erosion and debris spilling across the beach between Waihi and Ohawe Beaches.

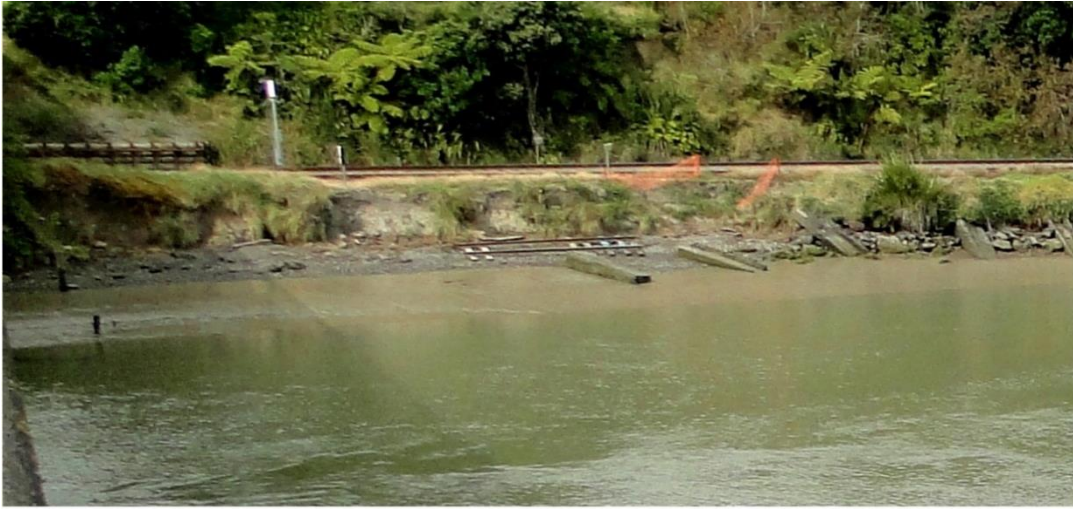
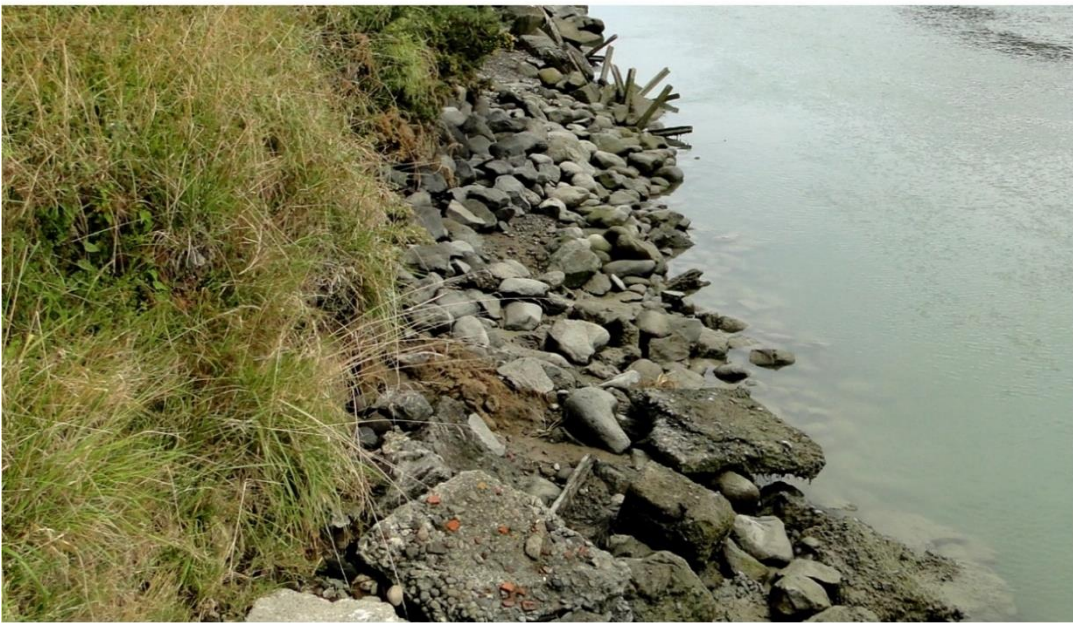
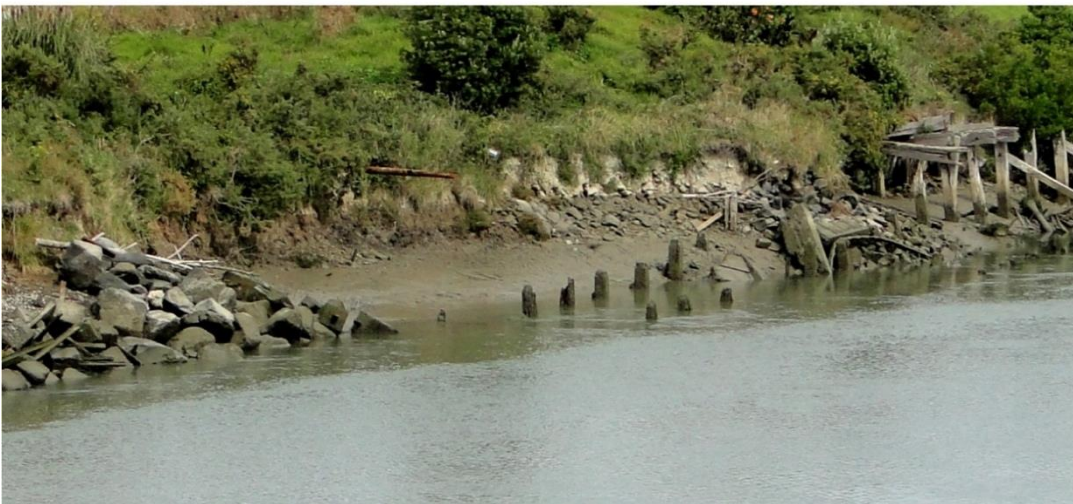
Figure 5.2 Upper photo: Rip-rap near the bridge comprising variety of materials with no coverage in places. Middle photo: more complete rip-rap protection but hazardous iron rails in distance. Lower photo: variable riprap at the rip-rap/wharf juncture.

Between chainage 0 to 30 m, the rip-rap protection varies in condition from nothing to minimal coverage (Figure 5.1 upper photo), moderate coverage occurs between 30 m to 170 m with isolated sections having full coverage (Figure 5.2 middle photo). Minimal coverage occurs around the small embayment 170 to 200 m (Fig 5.2 lower photo). The shape of this embayment is characteristic of end-effect erosion from the 170 m revetment termination. Protruding railway iron is evident in the middle and lower (Figure 5.2) photos.

The upstream rip rap protection fails to meet consent, asset and hazard management requirements regarding safe, sound and functioning condition. A shorter-term intervention is required for both consent compliance and asset/hazard management purposes that upgrades the revetment using correct design, materials and placement.

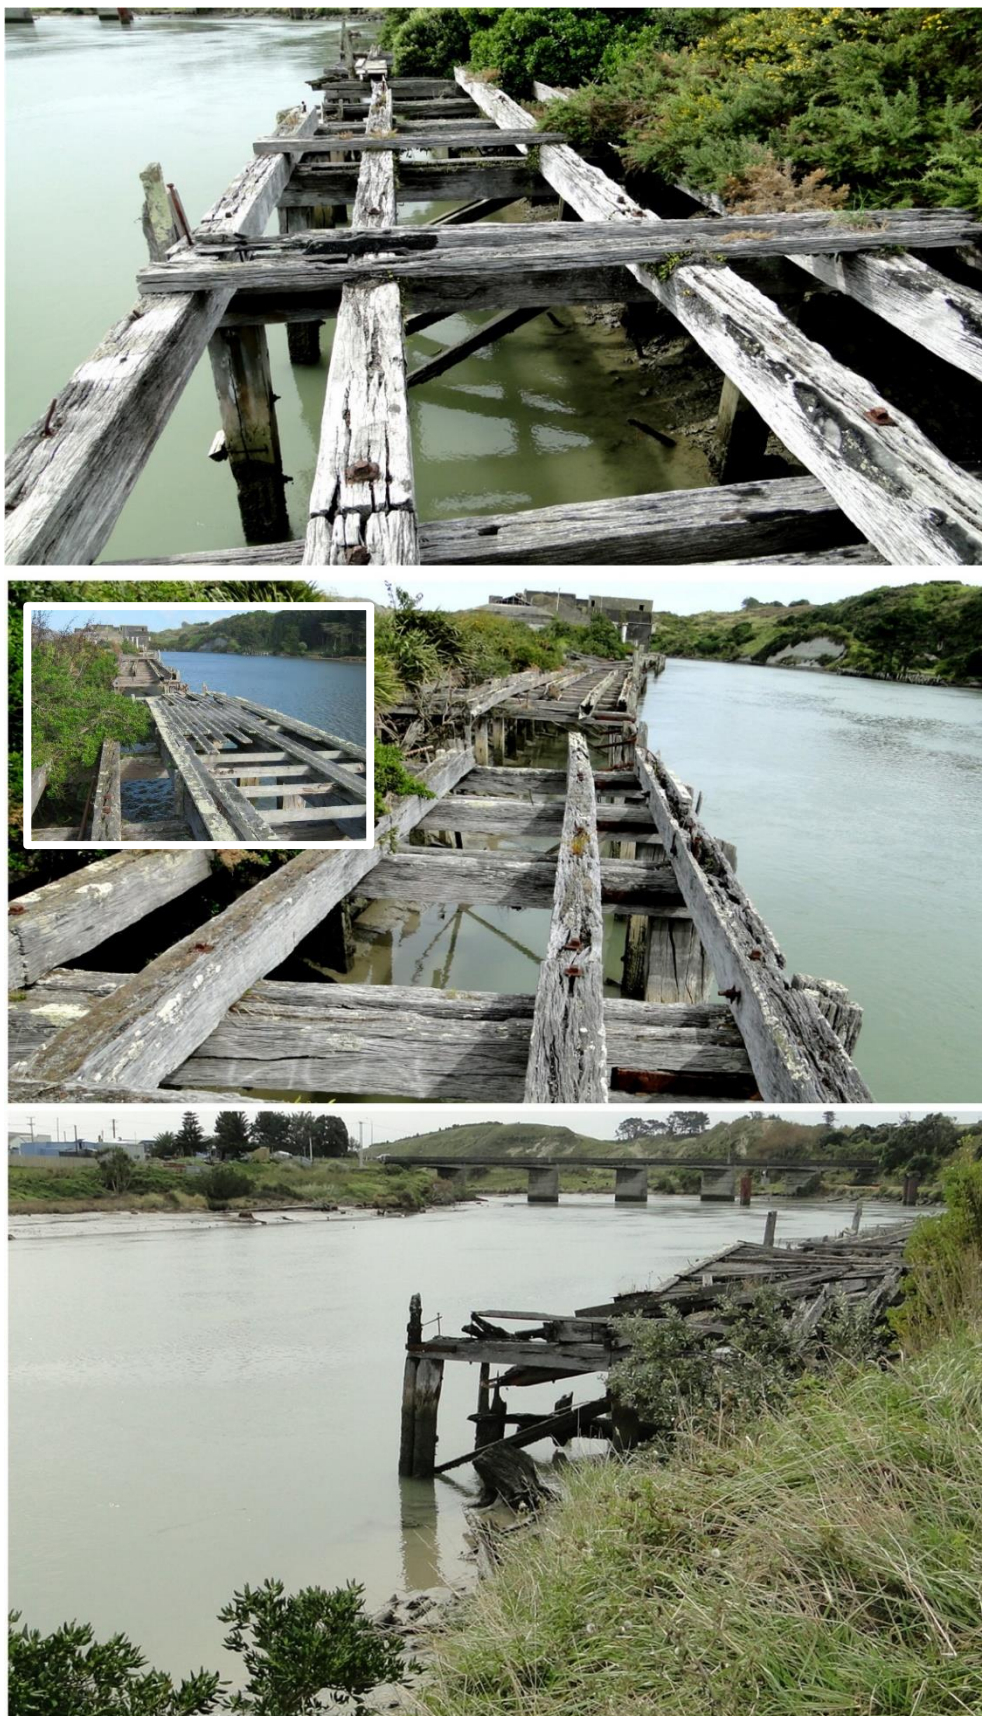
Figure 5.3 Upper photo: upstream section of dilapidated wharf 250 to 200 m. Middle photo: superstructure 290 to 350m, inset for comparison is TRCs 2013 photo. Lower photo: collapsing structure at 360 m with no wharf having been constructed along the next 50 meters.

The wharf may have once extended to about 170 m chainage as evident by the pile stubs in Figure 5.2 lower photo. The wharf structure begins at about 200 m (Fig 5.2 lower photo) and extends more or less intact to chainage 360 m (Figure 5.3 photos). However, there are gaps in the super structure which in some places is highly dilapidated and is hazardous to the public, and in particular to fishers who appear to use this area.

Gaps within the wharf structure together with the unknown state of the lower piles or what lies beneath the superstructure could affect navigability. It was not possible to satisfactorily inspect these areas visually from safe access and a thorough inspection from a boat and involving a diver and port engineer is recommended as a short-term intervention.

This highly dilapidated wharf presents a considerable hazard risk to the public who clearly use it and the buildings for fishing and other forms of recreation. From a hazard mitigation perspective, the STDC needs to give urgent consideration to warning signage and physical barriers.

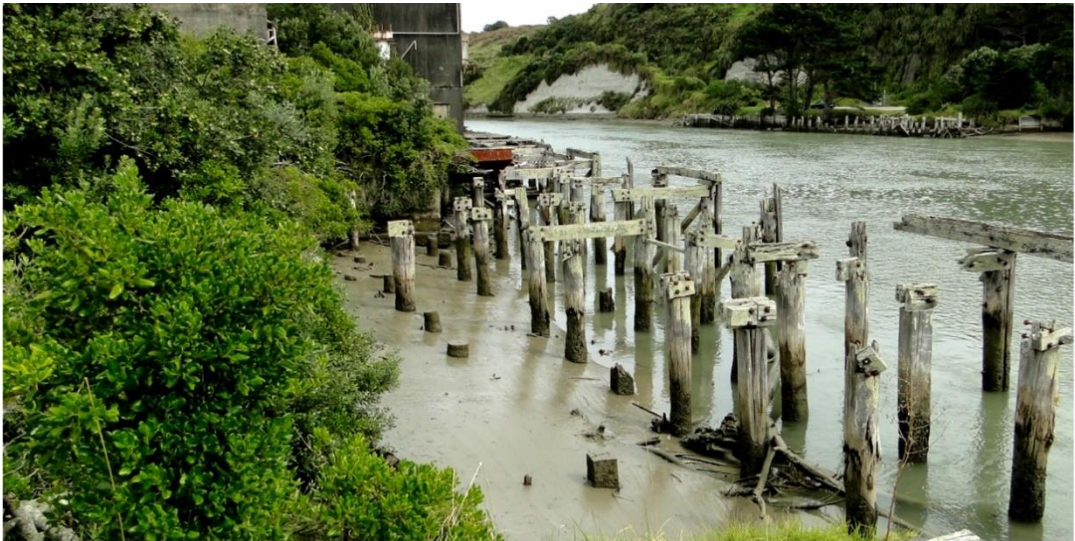
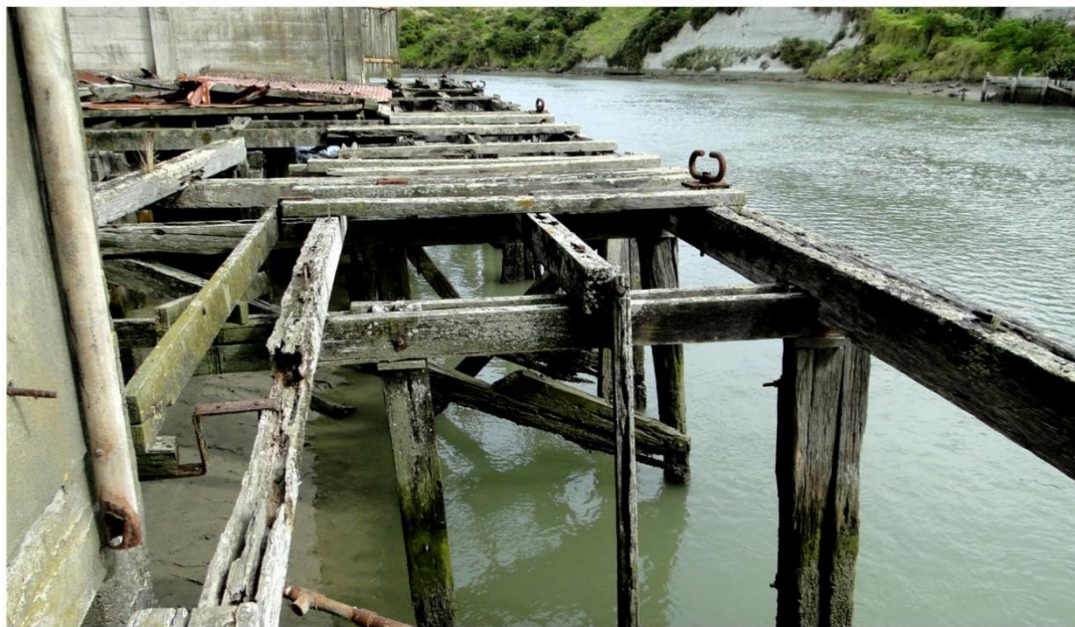
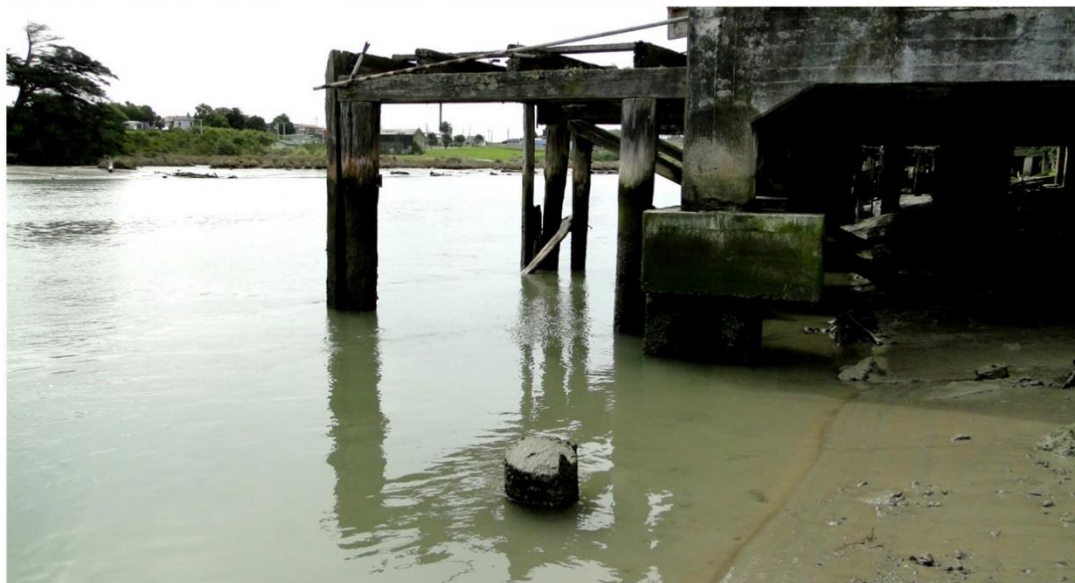
Figure 5.4 Upper photo: piles in the vicinity of the wharf buildings - between 420 to 465 m. Middle photo: superstructure fronting the wharf buildings at about 500 m chainage. Lower photo: downstream end of wharf (530 m).

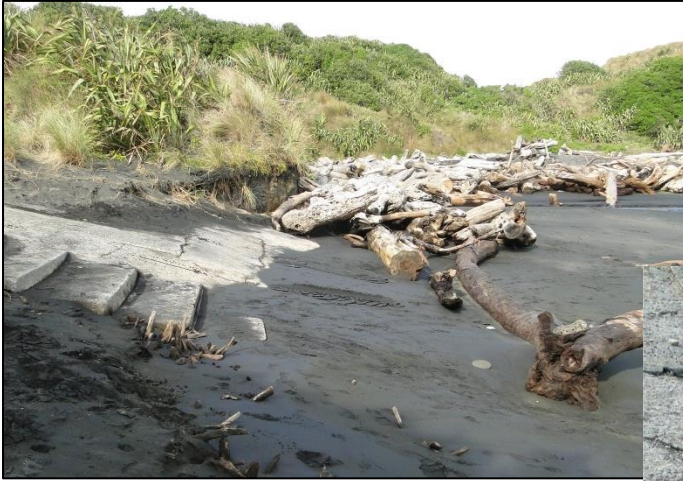
Figure 6.2 Log accumulation fronting the stream and extending to the ramp. Fresh shoreline erosion is evident just beyond the ramp.

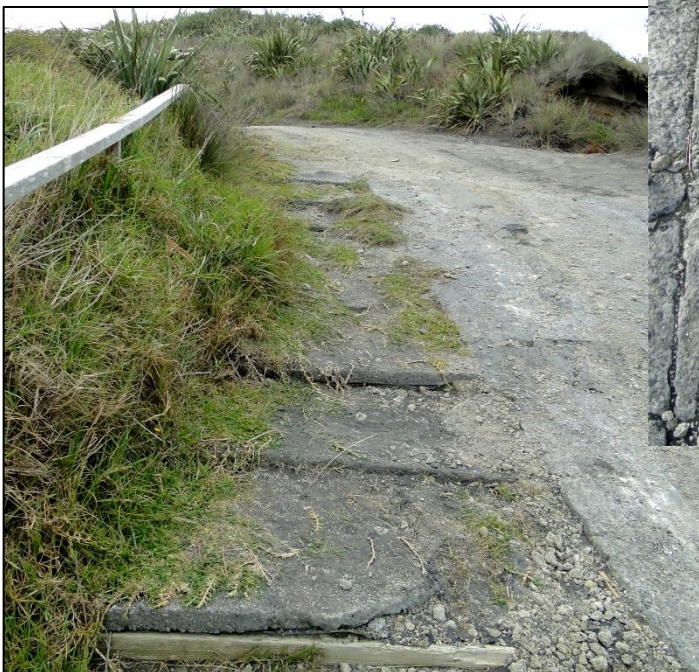
As noted in previous TRC monitoring reports, the vehicle ramp is in a degraded state with sections having differing elevations and compromising functionality (Figure 6.3). The steps are also in an increasingly degraded state with sections of concrete broken and sand and vegetation making the handrail unusable (Figure 6.4). These situations are worsened by shell rock from the access road above washing down the ramp and steps with the finer particles making the ramp particular slippery and hazardous (Figure 6.4). The shell rock coating may well have been exacerbated by the preceding rain storms as rill and incipient gullying were evident on the access road (Figure 6.5).

Figure 6.3 Degraded condition of the beach access ramp.

Both the ramp and steps are in need of maintenance and given the hazard potential this should be treated as a shorter term intervention.

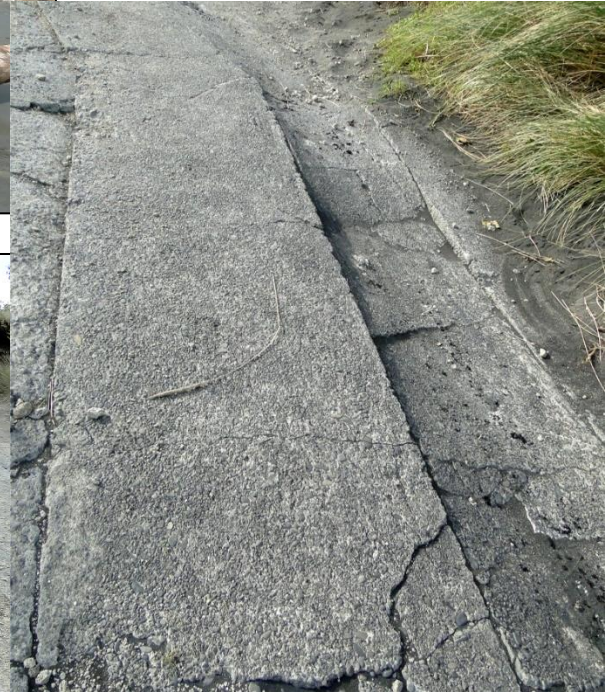
Figure 6.4 Dysfunctional access steps and handrail, with fine shell rock coating the ramp and steps.

Given the compromised functionality and potential hazard caused by fine shell rock originating above the structure, surface drainage should be improved immediately. In the longer term, permanent paving above the ramp could be considered.

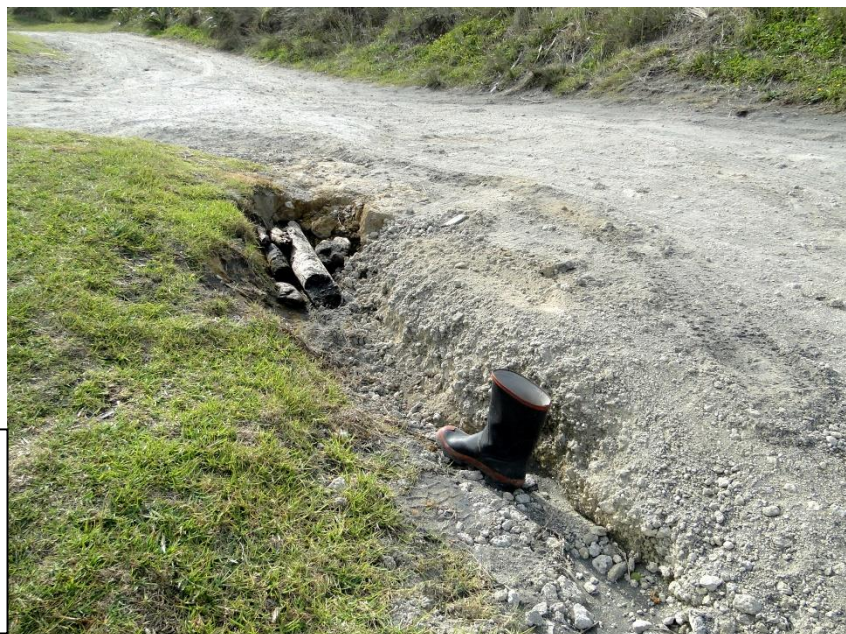
Figure 6.5 Stormwater drainage issues above the structure.

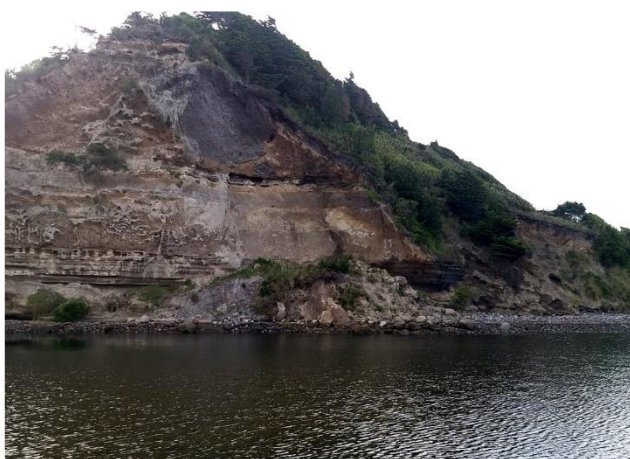
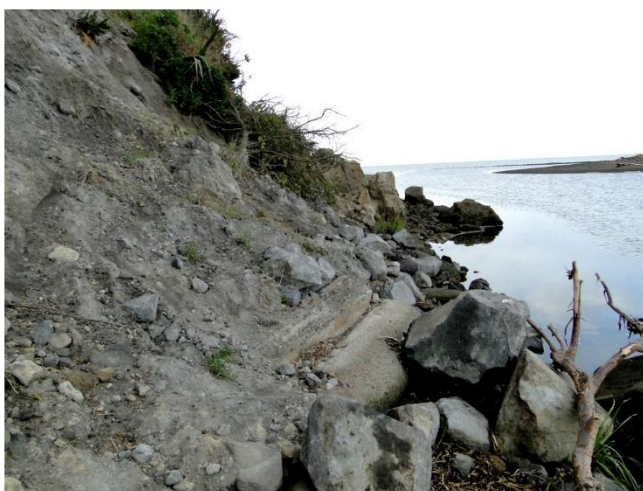
Kaupokonui

Issues Access from the reserve/campground to the southern beach has been blocked by rockfalls which extend into the river. The camp custodian says some dropped down as recently as a week ago. Adjustment to the instability may continue for some time. To access the beach it is necessary to climb over unstable rock with the threat of further falls from above. The northern beach cliff has also been substantial subject to significant erosion.

Recommendations. Close the southern accessway with hazard fencing and erect warning signs. As this is a popular accessway, restoration may well be required. The council/officers should obtain advice of an experienced coastal engineer (for the South Taranaki coast). Erect signage warning of unstable cliffs as the public cross the bridge.

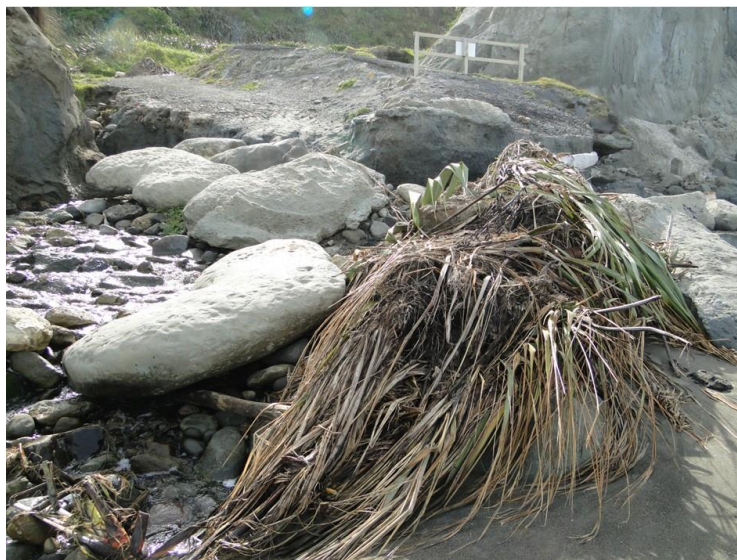
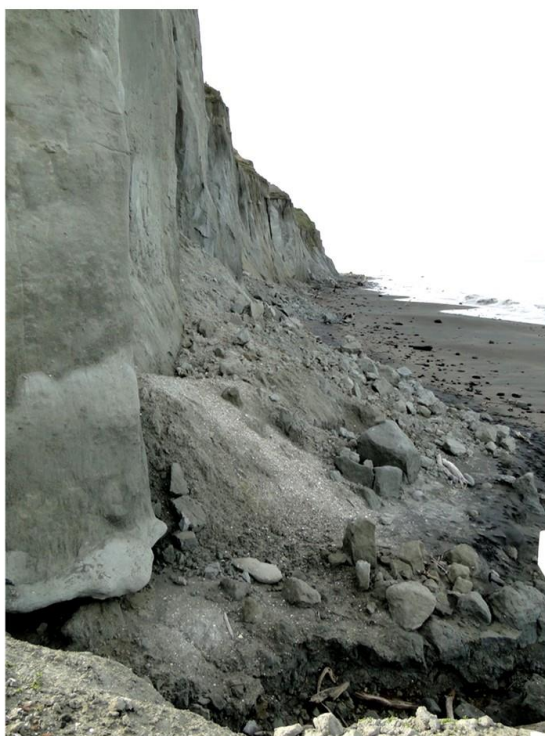
Waihi Beach (Denby Road)

Issue Runoff from the rainfall events have caused stream scour and surface erosion such that getting onto the beach difficult and somewhat hazardous. Closer to the carpark, hillside slips have blocked the drainage channel along the access path and the uncontained storm water is eroding the accessway forming rills and covering the path with loose stones. Along the coast (the advertised walkway to Ohawe Beach) the cliffs have been subject to severe erosion and walkers need to use this area when tides are higher.

Recommendations Ideally, beach access should be closed until safer access can be implemented. Again, a lasting design will need input by an experienced coastal engineer. However, given the site's popularity, an interim solution may be needed which could include (temporary) handrails, (strongly worded) signage, and clearing the drainage channels on the upper accessway. Unstable sea cliff warning signs are also recommended.

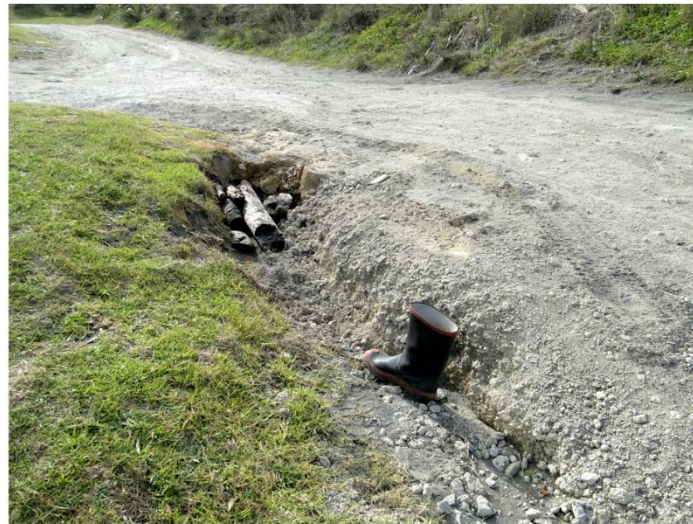
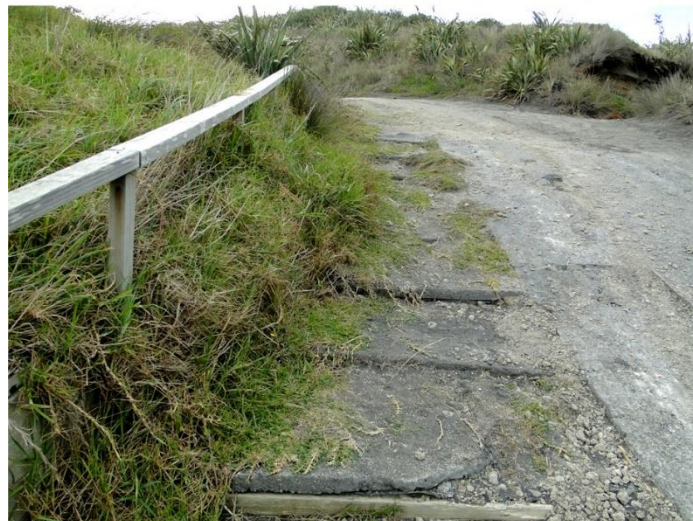
Caves Beach Access (Waverly)

Issue Surface runoff on the unsealed approach to the beach access steps and ramp has resulted in surface, rill and gully erosion. This impedes vehicle operation. However, of greater concern is the loosened shell rock which has been washed across the concrete ramp and steps creating a hazard for vehicles and pedestrians. Indeed, I slipped heavily on the ramp and without warning and was most fortunate to come away bruising.

Recommendations Infill the existing erosion depressions on the unsealed access road approach and reform to safely channel/exit drainage at the margins.. Remove shell rock debris from the ramp and steps (repeating as necessary) and excavate sand and vegetation around the hand rail, i.e. make it usable). A longer-term solution would be to seal the approach. Erect warning signs.
