PATEA BEACH SAND MANAGEMENT REPORT

January 2021 to May 2022

A report prepared for the South Taranaki District Council

COASTAL SYSTEMS Ltd

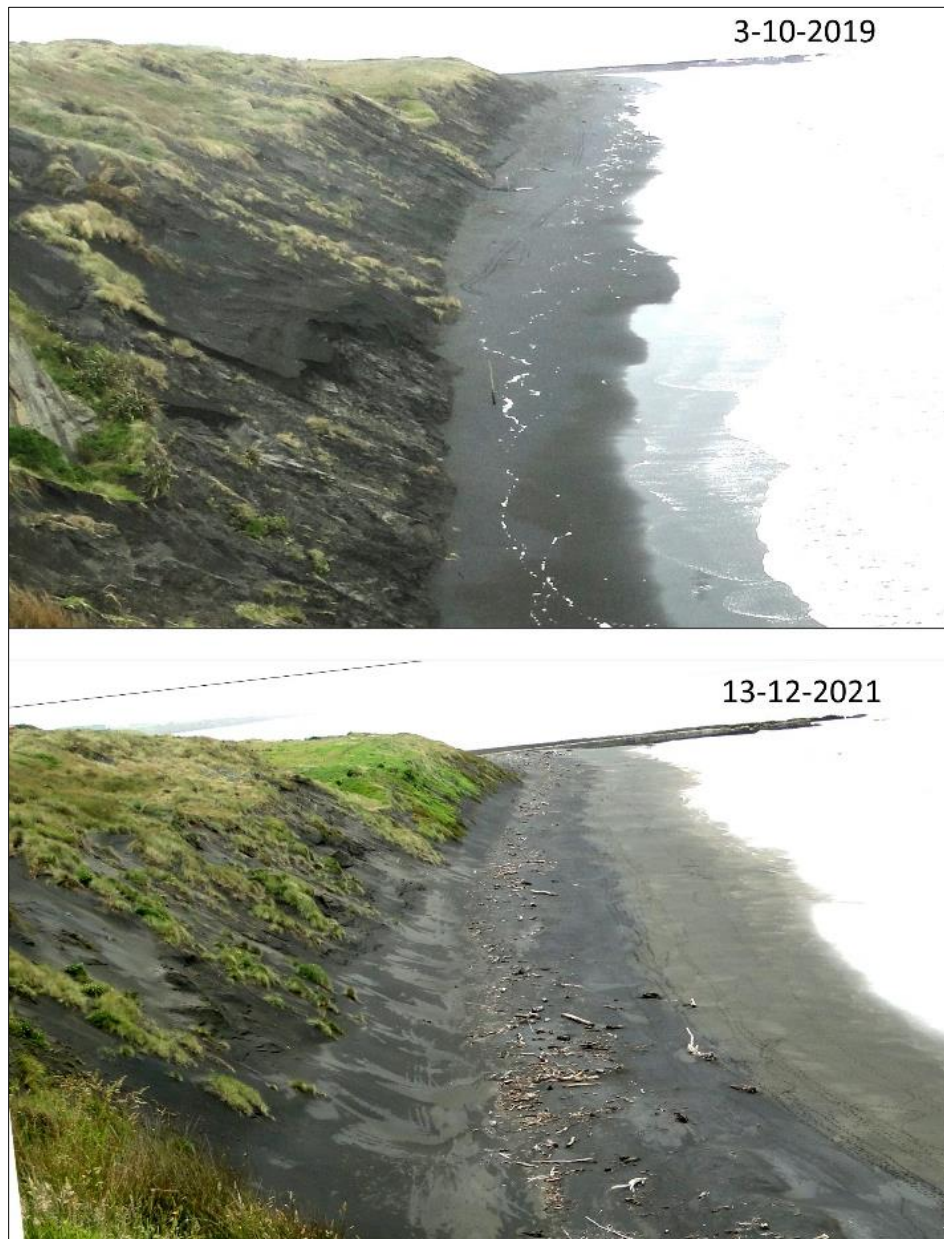
Figure 2 The continuous erosion scarp in late 2019 (upper photo) with the high tide intersecting the dune toe indicating a sand deficit on the beach and hence exposure of the dune to wave erosion. By comparison, in late 2022 (lower photo) vegetation mantles the scarp as the slope stabilises. Clumps of vegetation have slide downslope (rafted) as the slope adjusts toward the stable angle of repose. Note the debris between the high tide line and the base of the dune – indicating a recovery in the volume of beach sand and this protects the base of the dune from further wave erosion.

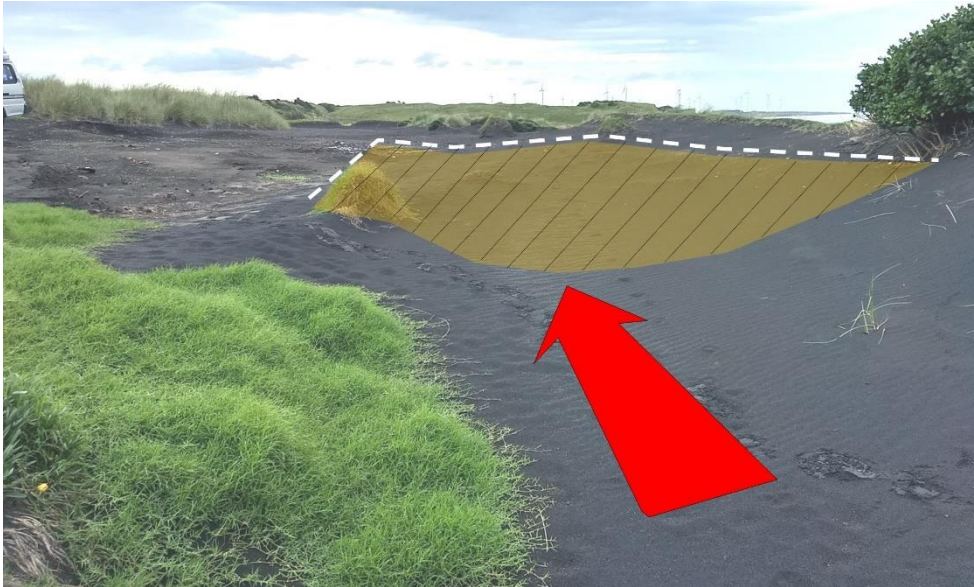
However, by the end of 2021 the area landward of the June 2020 placement had undergone significant erosion (Figure 3) and further placement of green waste was required. This placement was carried out in late April 2022 and is described in Section 4.2. In addition, the road accessway and stormwater drainage were impacted and this is described in Section 4.3.

Figure 3 Erosion at Site D in December 2021 was undermining the rivermouth lookout car park (location marked in Figure 4), destroying the local stormwater drainage channel, and was about to impact the dune face just beyond right side of photo. Arrow denotes predominant wind direction while white dashed line and light yellow are denote the 2019 surface and vertical erosion extent (also see Figure 8).

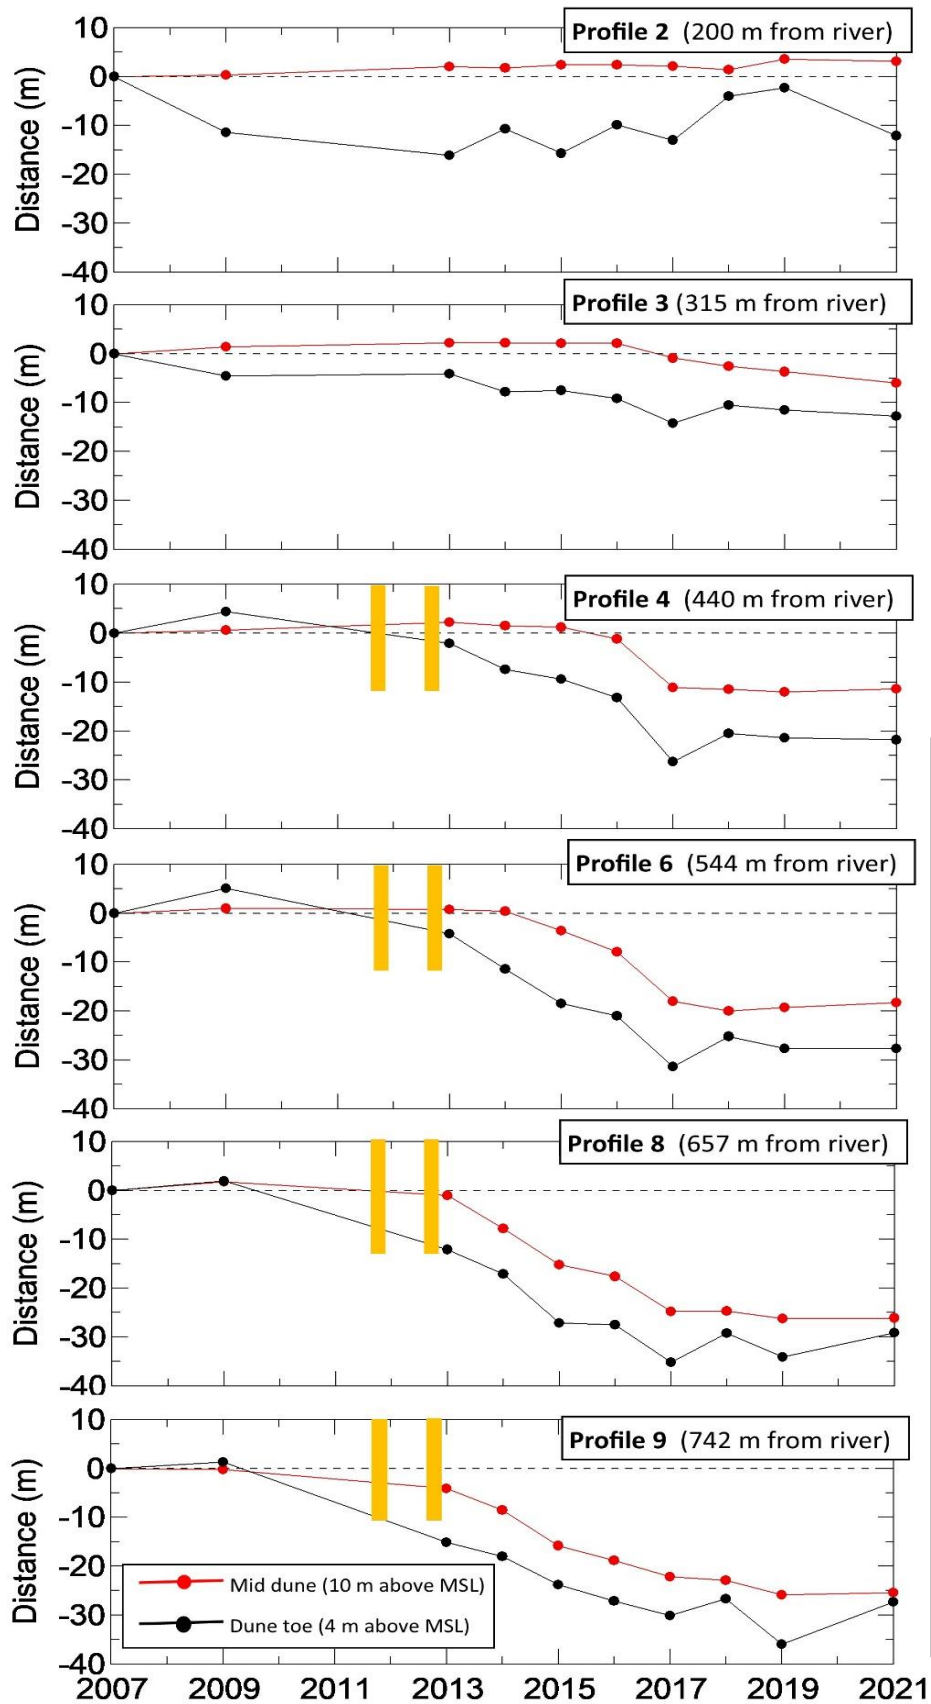
Figure 5

Time-series line graphs for the dune toe (MSL +4 m) and mid dune face (MSL +10 m) extending back to 2007 are depicted in Figure 5. The MSL +4m elevation has clearly moved seaward in the northern sector (lower graphs). The superimposed set for profile 9 is shown in Figure 6 and confirms the onset of accretion and accompanying buildout of the beach. Stability of the lower dune in the central section further supports an end of the decade long episode of erosion. In addition, the relative stability of the upper dune (MSL +10 m) indicates slope adjustment is progressing smoothly and this is considered further in the following section on aerial data. While recent data for the southern sector closer to the rivermouth (profile 2) shows erosion at the lower level (MSL +4m), which could be associated with the southern translation of the erosion episode, it may equally be associated with rivermouth behaviour which tends to be erratic.

North Beach cross-shore change at the profile locations marked in Figure 4. Note that change is relative to the first survey in 2007.

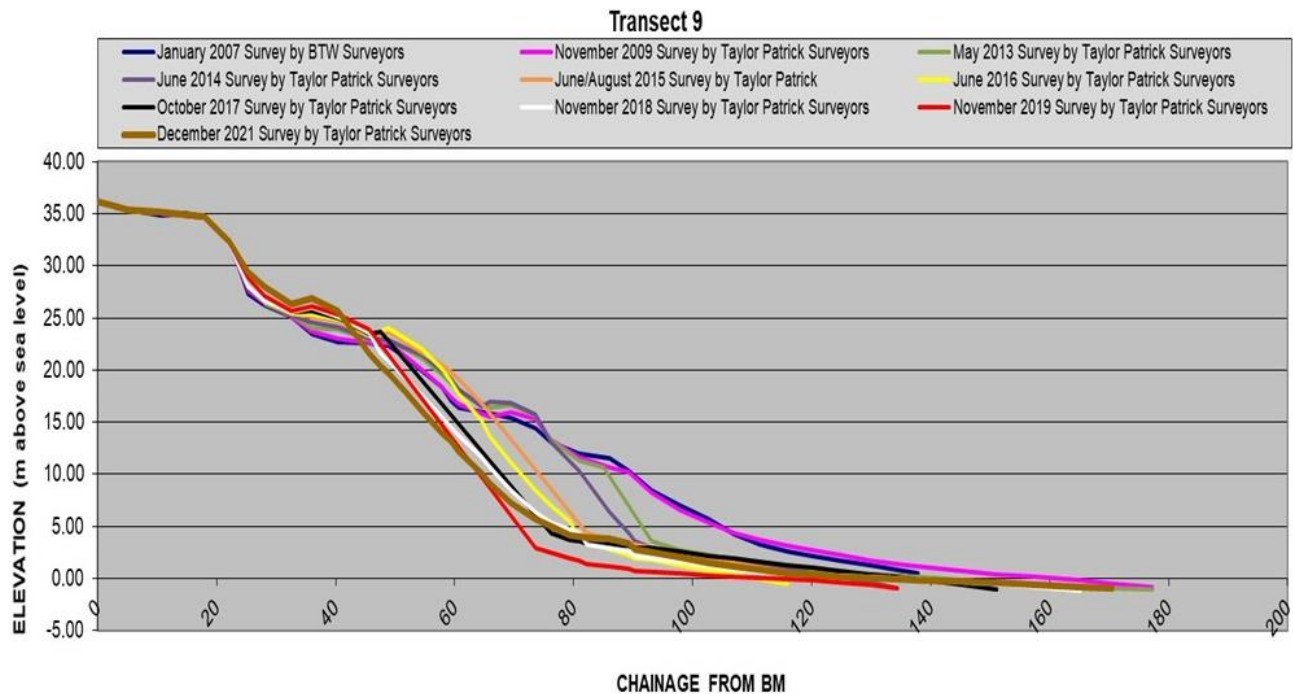
Figure 6 Superimposed profiles for the northernmost transect (9) with the most recent profile Dec 2021 brown line) showing significant infill at the dune base and buildout of the beach compared with the 2019. This figure also clearly illustrates the extent of the decade long erosion episode with, for example, the 5 m elevation (approximate dune toe) having retreated some 34 metres.

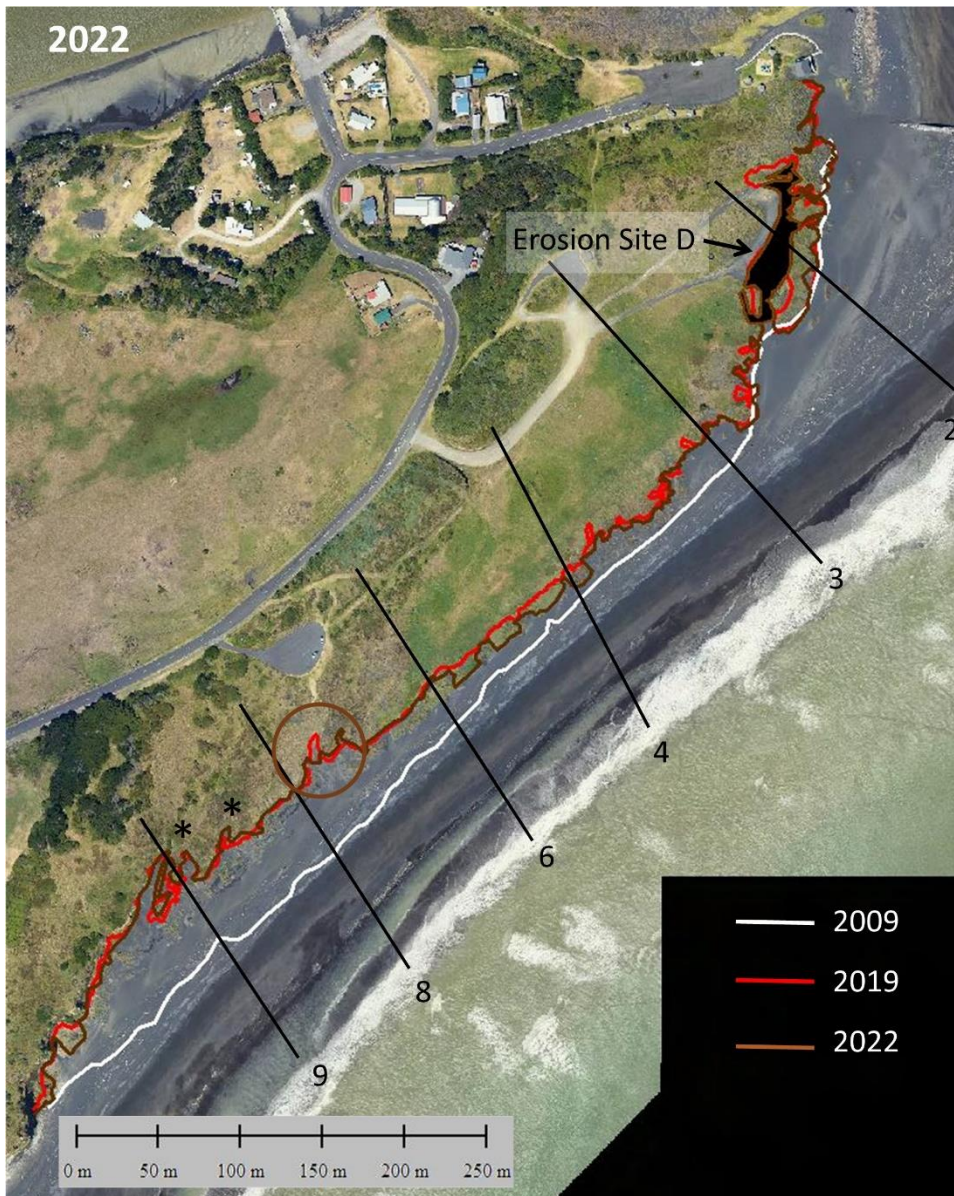
The problematic Site D is infilled black in Figure 7. This 1260 m² area of bare sand contains some erosion and some deposition. Comparing this value to 1559 m² in 2019 and 1314 m² in May 2021 indicates the instability is becoming less active. However, the reduction is associated more with benign weather (discussed earlier in Section 2) when vegetation is able to spread. In addition, an area of severe surface erosion has occurred landward of the placement made in June 2020 (and illustrated in Appendix C). This erosion is defined by long section and cross section comparisons depicted in Figure 8. Over 1 m of surface lowering has occurred and this process would result in destruction of the accessway/car park and the seaward dune face with wind-blown sand ramifications for the settlement beyond if not arrested. At the time of the February 2022 site inspection and decision to undertake a green waste placement, however, there was insufficient green waste available at the Transfer Station. This situation is described in the following section (4.2).

Figure 7 Vertical aerial photo taken on 14th January 2022 and overlain with vegetation-fronts from 2009 (before the erosion episode began), 2019 and 2022. Profile lines are marked 2 to 9. Brown circle locates instability fronting the upper car park which may need further treatment, and asterisks locate unstable areas further north which may need treatment in the future.

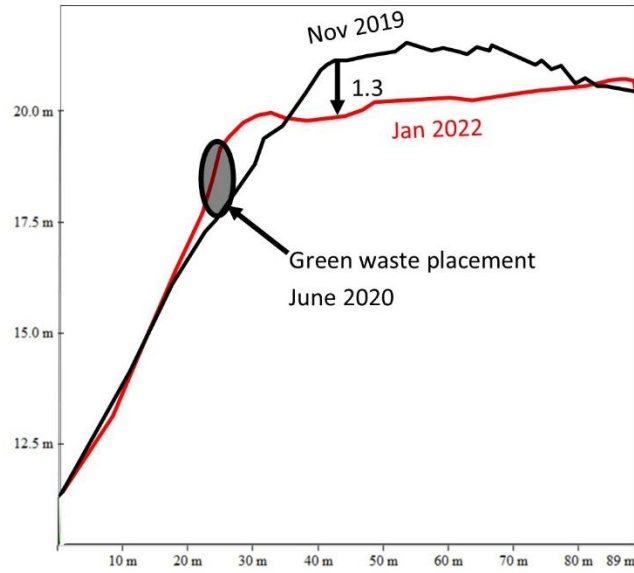
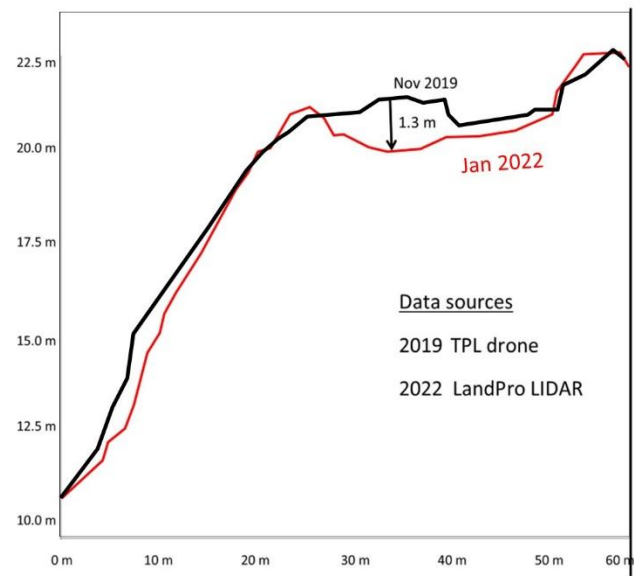
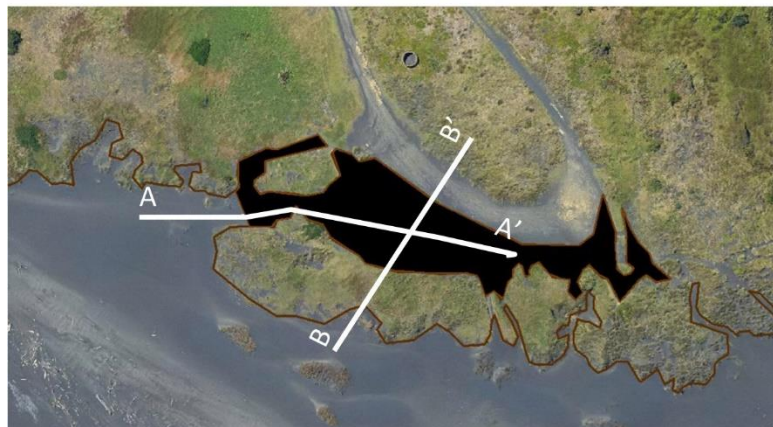
Figure 8 Erosion Site D surface behaviour between November 2019 and January 2022, thus incorporating the June 2020 green waste placement. Top figure depicts the long section (A-A') comparison with placement parked. Central figure depicts cross section at B-B'. Sources: TPL drone Digital Surface Model data (2019) and Landpro LIDAR (2022)

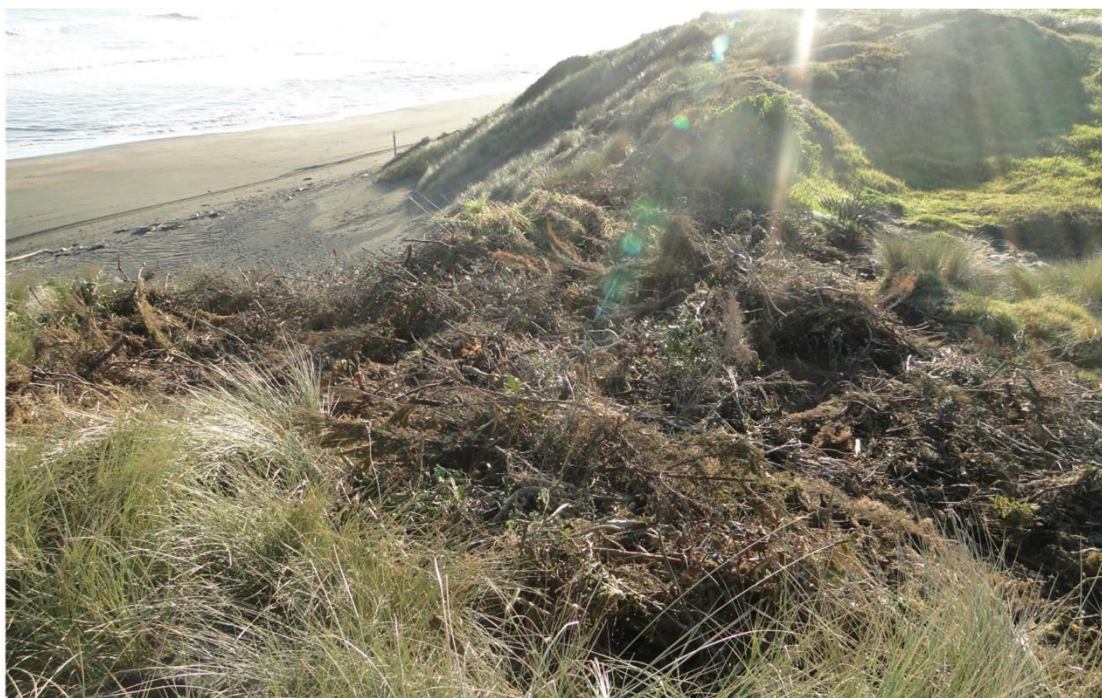
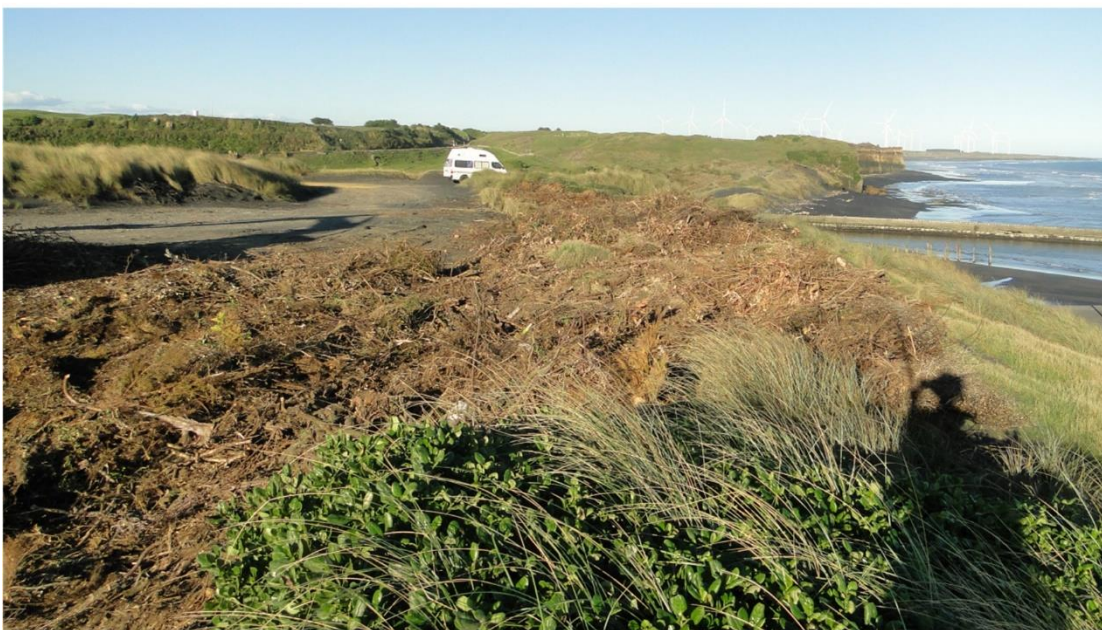
While there was a growing need to place green waste at site D during 2021, there was a lack of available material at the site upon inspection on 4 February 2022. It was decided that Mr Denton would try to have waste imported from other transfer station under emergency provisions to bypass resource consent restrictions. However, this was not required as a week later an extreme storm event hit and district and the council opened the transfer station for a week of free green waste drop-off. This resulted in an additional 350 m³ boosting the stock pile to 500 m³. Placement was carried out on 29 April 2022 , with the very satisfactory result shown in Figure 9. Once the waste settles, planting of marram may be required if the surrounding kikuyu is unable to provide ground cover fast enough.

Figure 9 Green waste placement made on 29-4-2022 at Site D. The top photo shows green waste filling the gut at the dune crest filled with green waste, while the lower photo shows green waste infilling the landward erosion area illustrated in Figure 3.

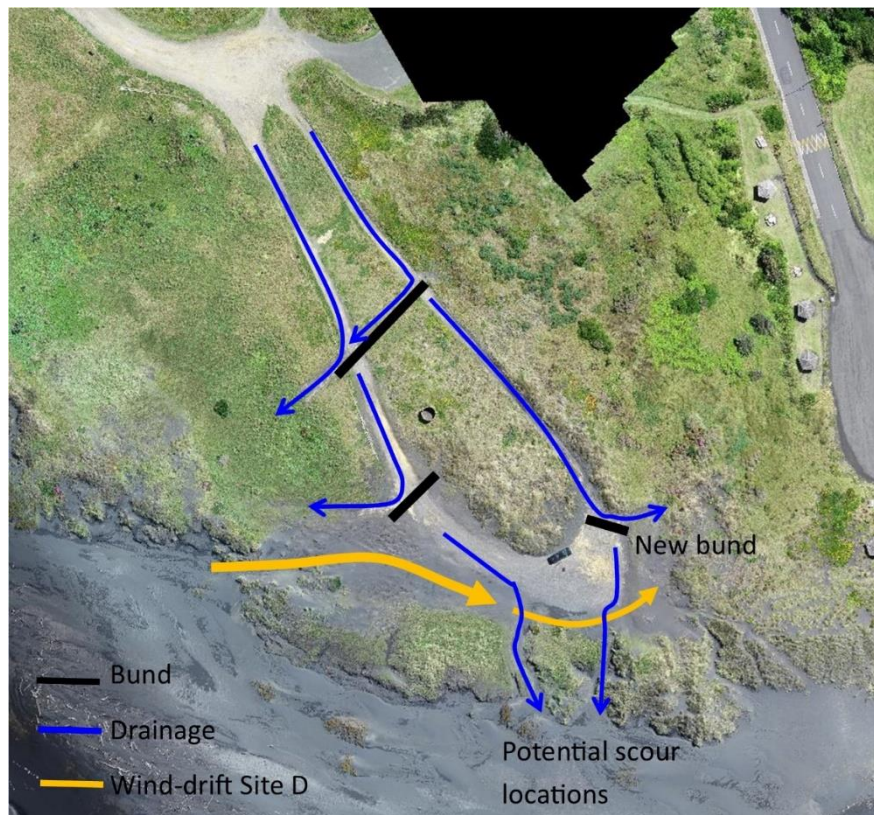
As noted earlier in Section 2, the Site D erosion had compromised the road access and surface stormwater drainage system. If left unchecked this situation could rapidly form guts on the dune face and significantly increase wind erosion, potentially becoming hazardous to the beach infrastructure, situations which had occurred in the past. Figure 10 shows the existing surface drainage regime. However, the bund close to the O (which happens to be an old water tank) had become ineffective and stormwater was reaching the Site D dune face. The other bunds, designed to intercept and disburse stormwater within well vegetated dune hollows, had subsided through vehicle compaction, and other arrowed exits were inoperable due infill by wind-blown sand.

Figure 10 Drainage layout and traffic accessways (reproduced from the 2019 Annual Report) to the rivermouth lookout car park (location in Figure 4). The two seaward bunds were first established in 2011 , with the landward “New bund” being established in 2019 to trial the landward disbursement of stormwater.

Maintenance was therefore also carried out on the 29th April during the green waste placement. While this will avert the imminent risk of stormwater erosion, the accessway and bunds urgently needs replenishing with metal. Hayden McColl suggested “road digout” material could be trialed as this will bind together due to some bitumen being present. He also offered his time free of charge to place this material.

However, the drainage system outlined in Figure 10 was only ever designed as a temporary fix and a more sustainable system was proposed in 2014¹. The associated concept design is illustrated below as Figure 11. This design kept only one of the loop accessways with stormwater reaching the car park being redirected landward into the marked soakage areas with the possibility of connecting into the settlement's stormwater infrastructure or direct river exit if needbe. However, trialing since 2019 indicates that simple soakage areas in well-vegetated dune hollows may suffice.

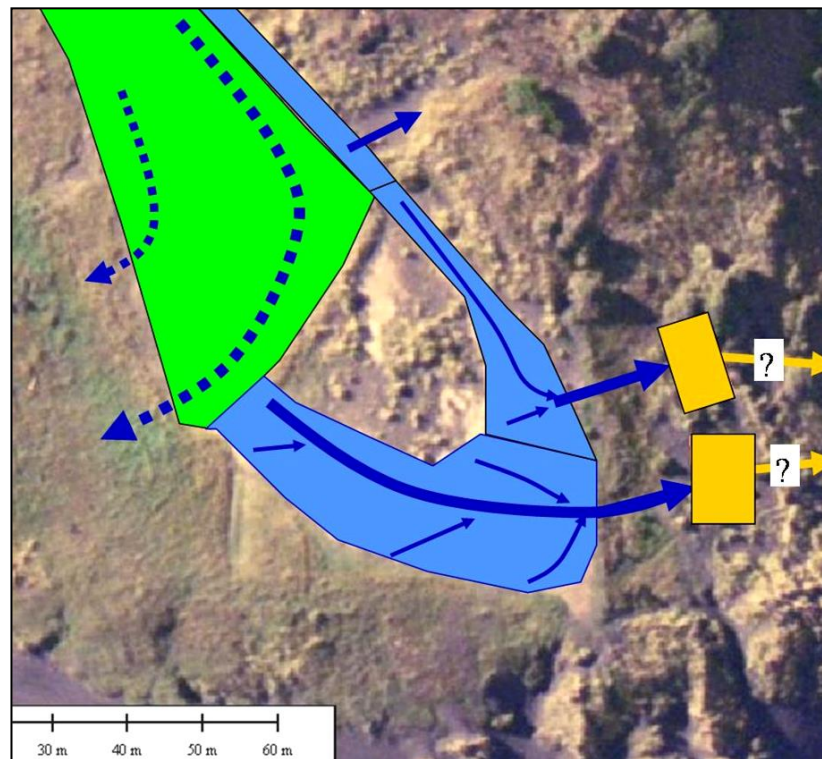
Figure 11 Concept design plan from the CSL 2014 draft Drainage Report¹. The green area is retired from vehicle access and planted as required. The dashed blue lines on the green area indicate expected subsurface flow pattern. The blue area is re-contoured as required so drainage water flows landward to be collected in “soakage areas” (yellow) in which water is retained to enable infiltration/sediment deposition.

Based on the 2022 LIDAR, an average infill of some 0.25 to 0.5 m would be required to reverse the fall across the rivemouth lookout car park.

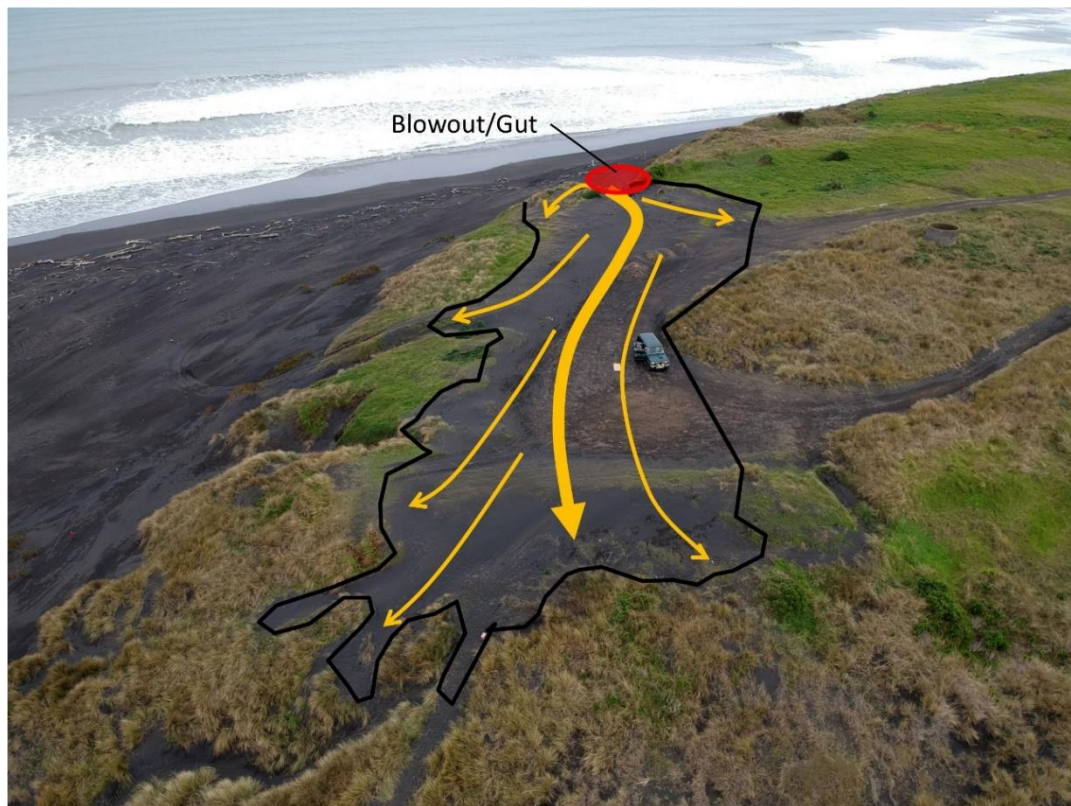
Sand instability Site D, see Figure 1 which is from the 2019 Annual Report: Patea Beach Sand Management Project, consists of a blowout (gut) through the dune crest and extensive wind drift to landward. The area is increasing in an exponential manner from 47 m² in 2016, to 140 m² in 2017, to 337 m² in 2018 and to 1260 m² in 2019 with sand now spilling down toward the beach utilities (Figure 2). Such a nonlinear increase in area is common when sand dunes become unstable, for example see Figure 3.

Figure 2 Gut (red), wind-drift direction arrows and extent on 17 June, 2020.

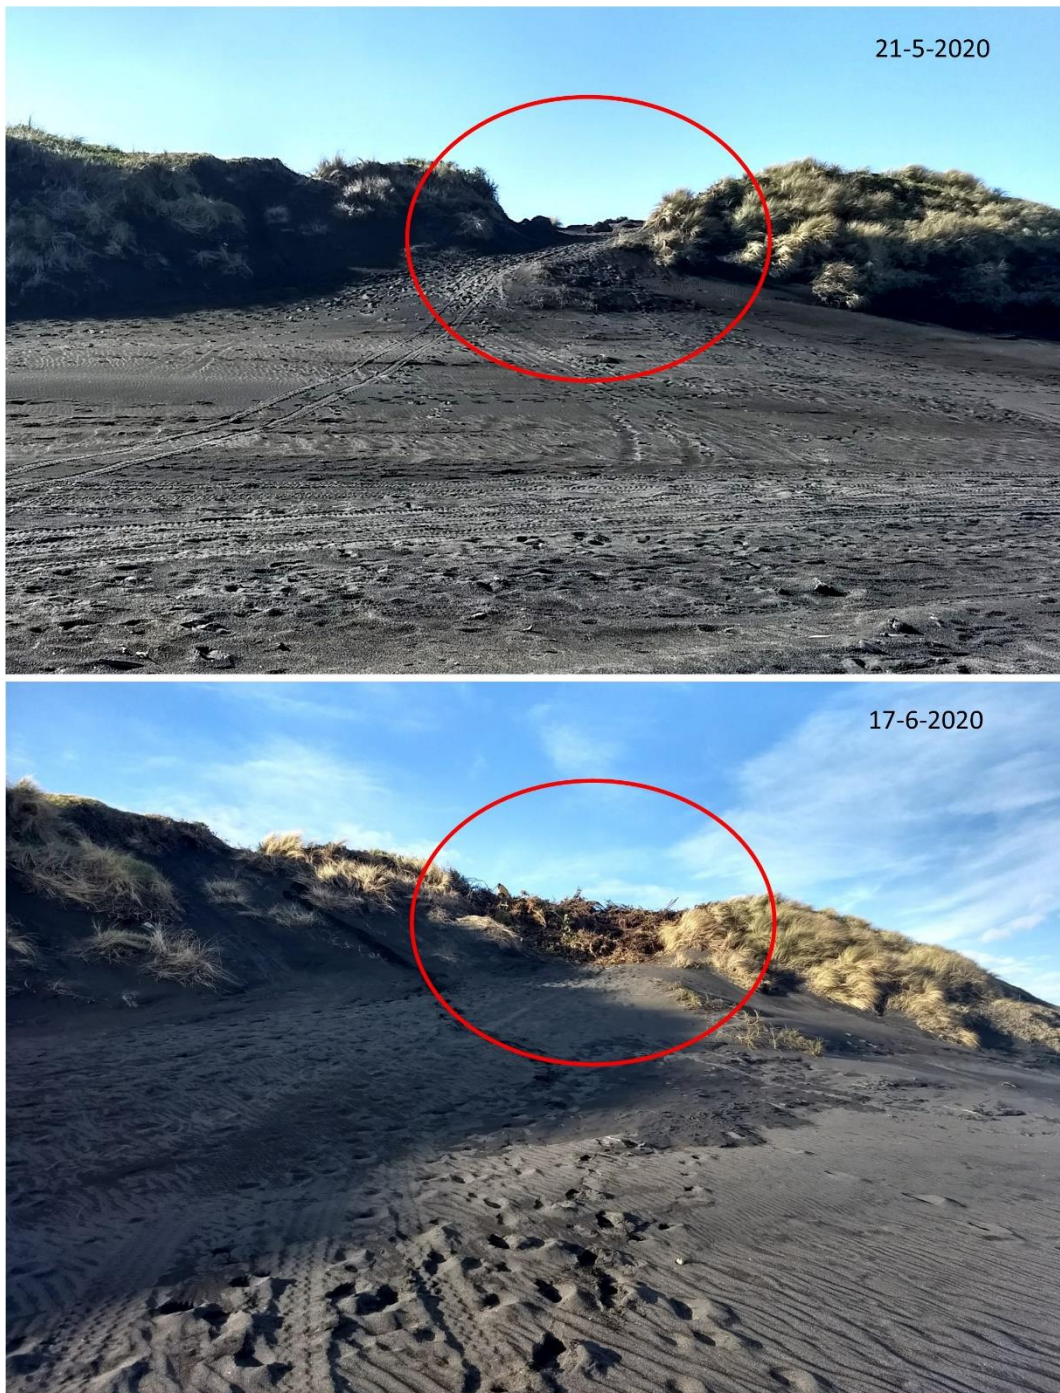
On 17 June, McCole Contracting carted the green waste to the site and placed it within the gut. (see Figure 4 photos). The gut consumed the full amount of green waste leaving the bare sand of the landward wind drift still exposed. In addition, as illustrated in Figure 5, the excavator exposed further sand while transporting/placing the waste.

Figure 4 Gut before (upper photo) and after (lower photo) green waste infill.

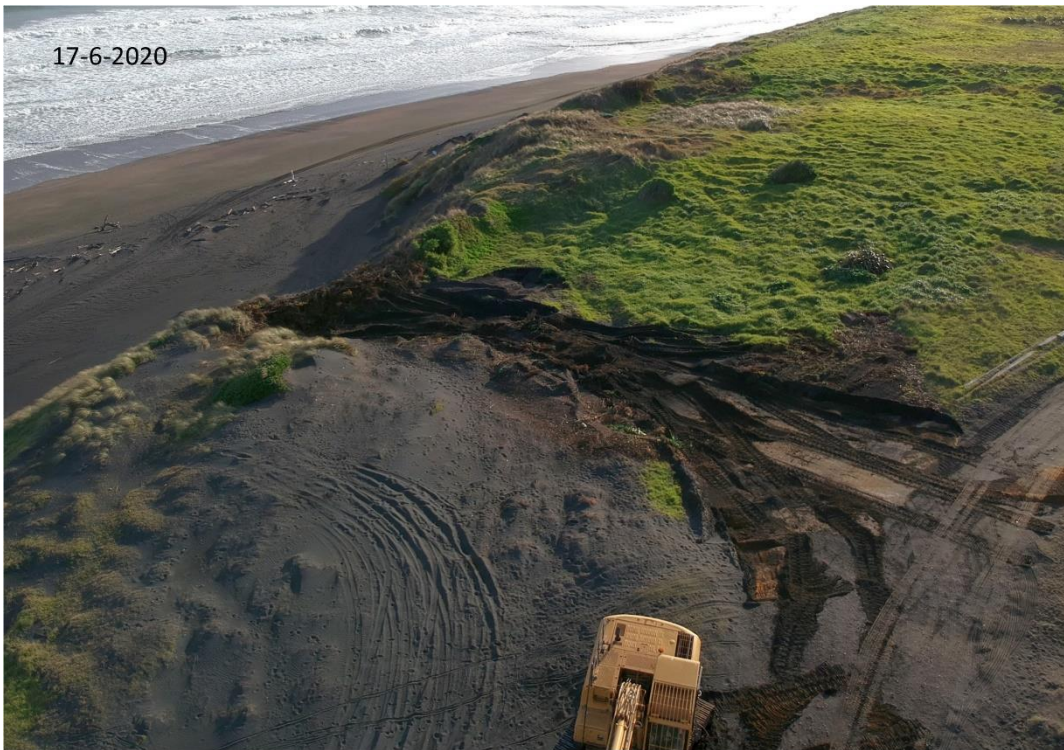
While the infilled gut will reduce local windspeed and trap sand blowing up from the beach, the bare sand to landward will continue to move and advance downwind. During the remaining winter further green waste should be acquired and placed over the wind drift surface in anticipation of a dry, windy spring.

Figure 5 Surface disruption by digger during green waste placement.
