Southland Coastal Hazard Assessment

Prepared by Dallas Bradley, September 2009

1. Introduction

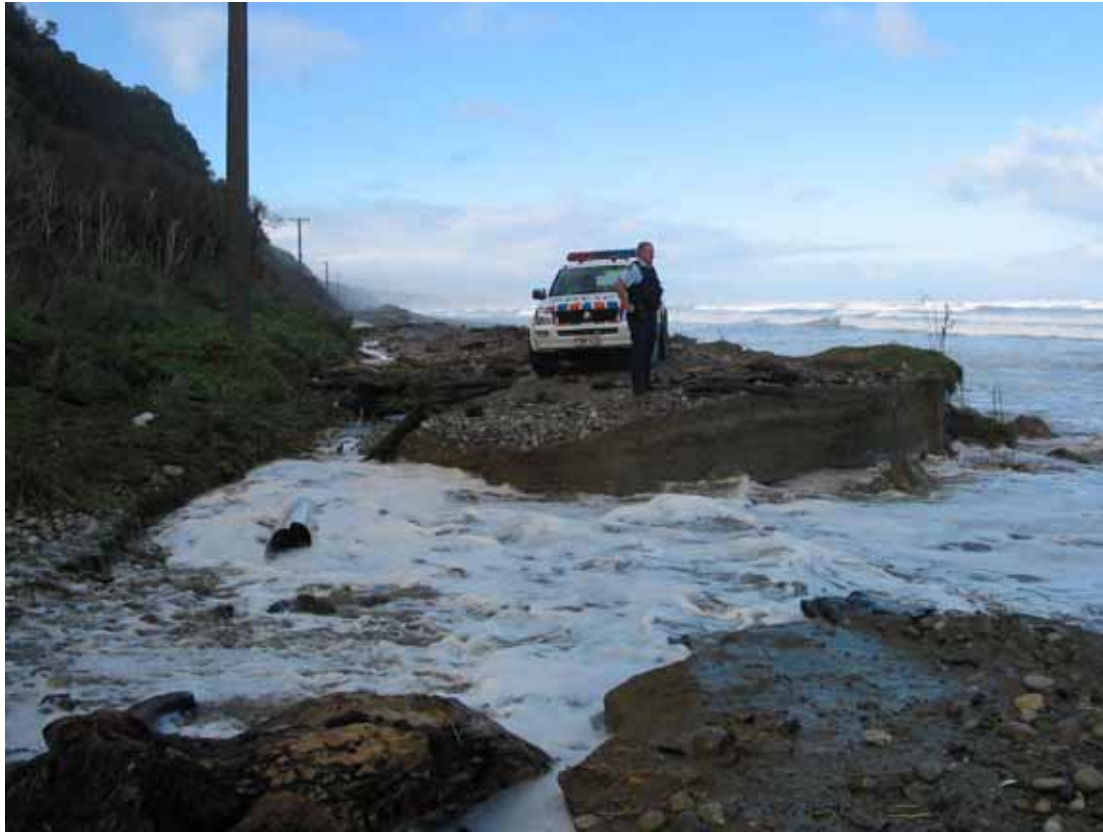
Te Waewae Bay (Waikoau River to Rowallan Burn)	Boulders transitionin g from west to gravel then sand	Western half steep, eastern half narrow flat bench with steep land/terrace above	Hump Track walk begins about half way along this reach.	Road on bench above beach was eroded in 2007 (See Figs 2a & 2b)to the point where it was replaced in 2009 by a new inland road.	Active erosion post 1981 See Fig 2	substantial accretion 1947 -1981 See Fig 2	Negligible erosion	definitely, debris on road from time to time	Ditto	Net westward longshore sediment transport. ¹ "the longshore drift direction varies with wave regime, although in the long term may be more generally to the south east." ¹⁶	2. Berryman K (2005) "Review of Tsunami Hazard and Risk in NZ" Institute of geological and Nuclear Sciences Ltd.
Te Waewae Bay (Rowallan Burn - Waiau Mouth)	Sandy from Rowallan to Groveburn, gravelly from Groveburn to Waiau	Cliffs or steep from the Rowallan Burn to Grove Burn, wide bench backed by cliffs from the Grove Burn to Waiau Mouth. Degrading gullies in and behind - land has an uplifted appearance.			Active erosion post 1981. See Fig 3	Generally accretion 1947 -1981. See Fig 3	Slight Wind Erosion	probable but at present tends to be confined to southern margin of bench.	Ditto	There used to be a road at the top of the beach along the western part but it has been completely eroded away. Net westward longshore sediment transport. ¹ "the longshore drift direction varies with wave regime, although in the long term may be more	3. NZAM Aerial Photograph Runs 1247 - 1253 (1947), Environment Southland Aerial Photo Runs A0423 & A2182. 15. Halliday Consulting, August 2004. Stability of Proposed Building Sites at Croymans Subdivision, Papatotara;

Figure 2a Papatotara Coast Road west of the Rowallan Burn, 17 May 2007 (Southland Times Photo)

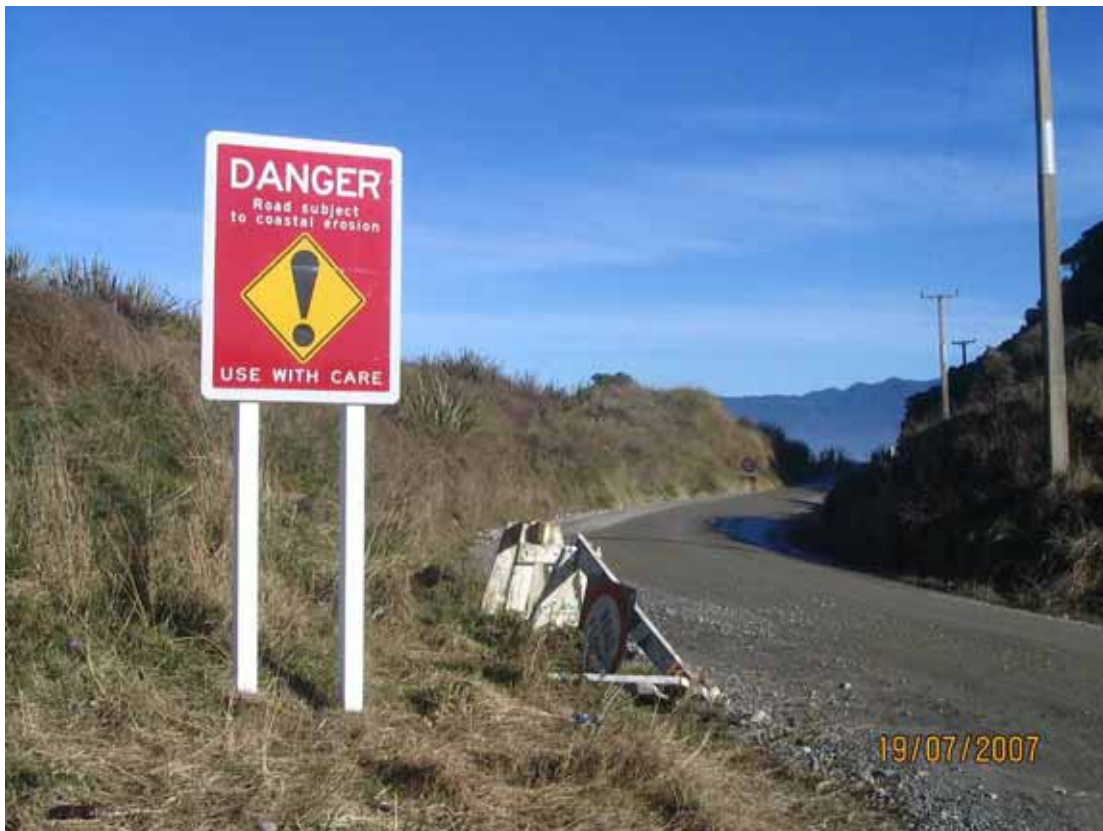
Figure 2b Papatotara Coast Road west of the Rowallan Burn, 19 May 2007

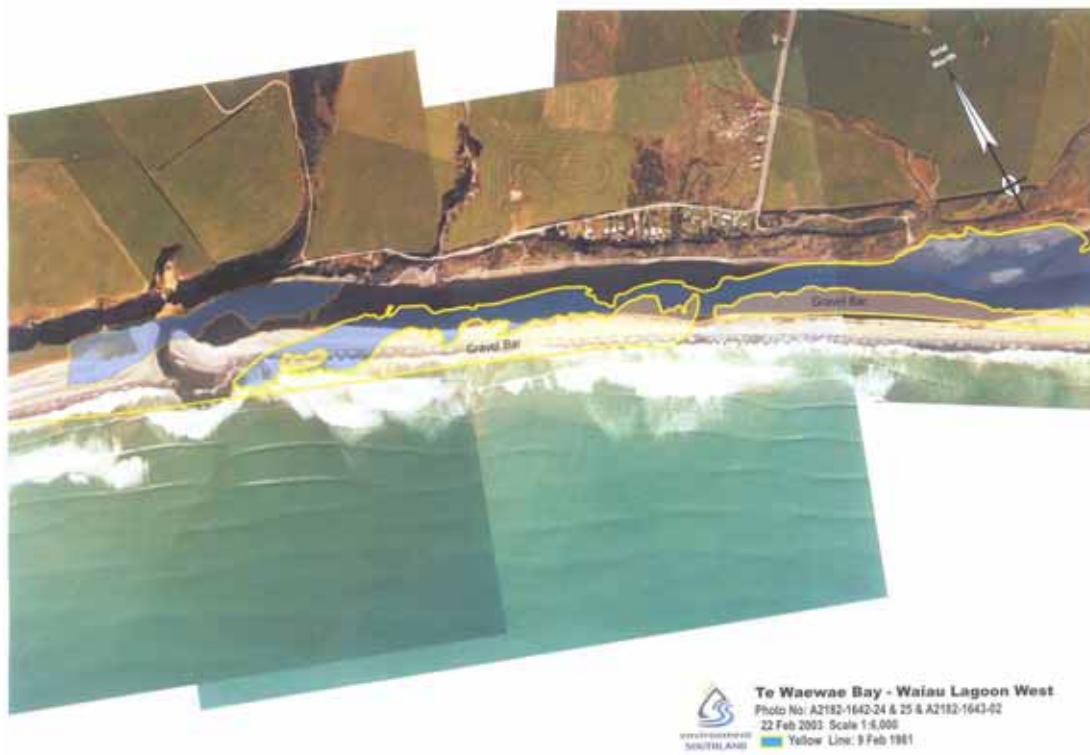
Figure 4 Position of the West Waiou Lagoon as of 9 February 1981 overlaid on a 22 February 2003 photograph.

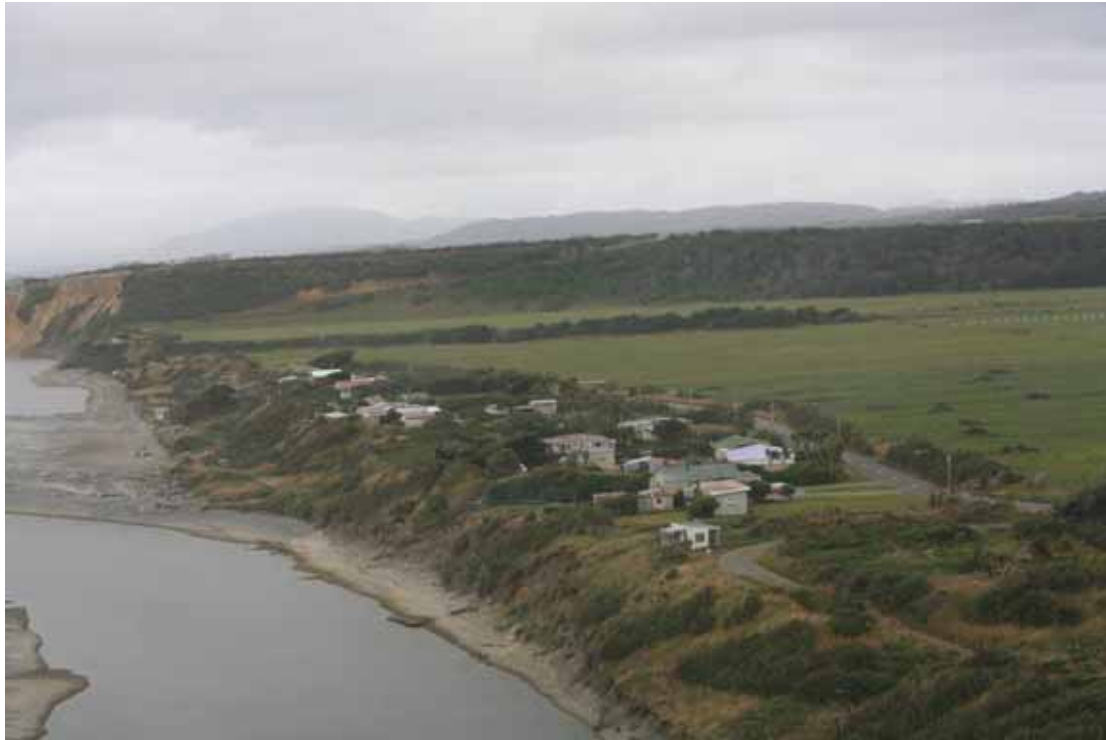
Figure 5 Cribs on terrace above the Waiau River mouth (west bank) 4 February 2009

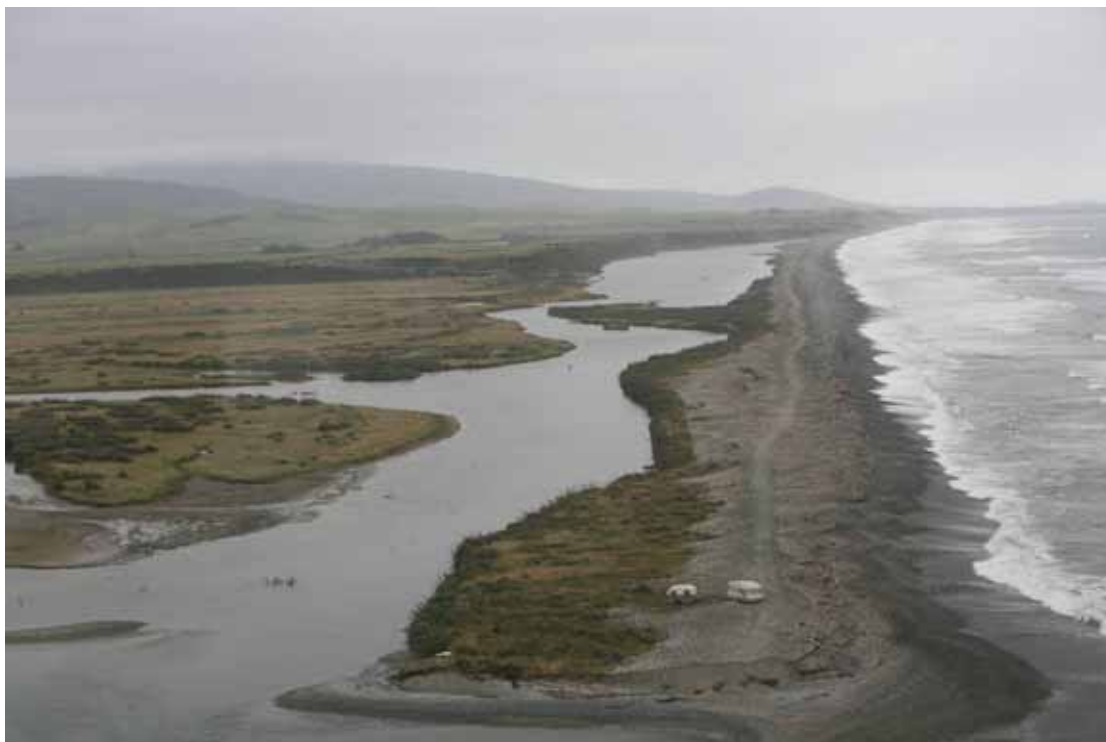
Figure 5a Waiau River Lagoon east of the Waiau River mouth 4 February 2009

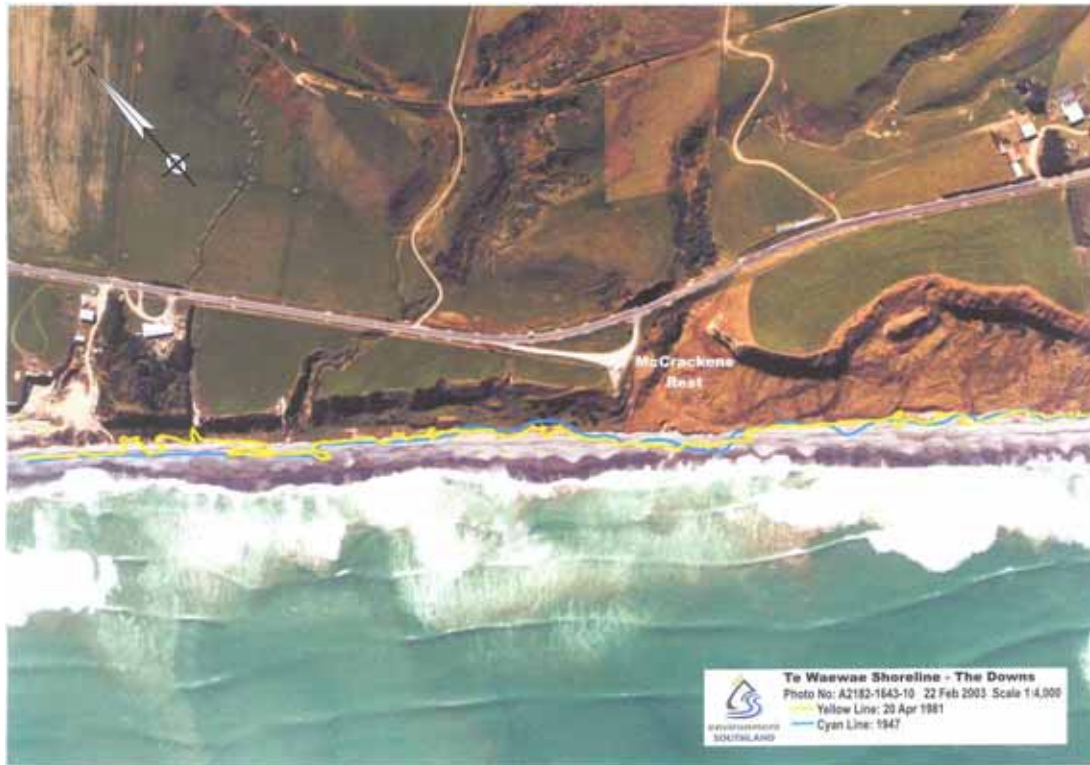
Te Waewae Bay (Waiau Mouth - Waimeamea Stream)	Gravelly	Cliffs or steep slopes above a narrow bench. Past slipping/slumping of slopes between McCracken's Rest and Grindstone	McCracken's Rest,	SH99 in close proximity to top of cliffs or steep slopes	Active erosion along full length (See Figs 6 & 7)	No	Slight Slumping and Wind Erosion	No	Ditto	It appears that the Te Waewae Bay coast east of the Waiau is under supplied with sediments and is consequentially erosional. ¹ "the longshore drift direction varies with wave regime, although in the long term may be more generally to the south east." ¹⁶ Pattern of erosion could change over time as bench erodes to the point where erosion attacks the bottom of cliffs. Coastal processes dominate.

Figure 6 Coastline positions as of 1947 & 9 February 1981 overlaid on a 22 February 2003 photograph.

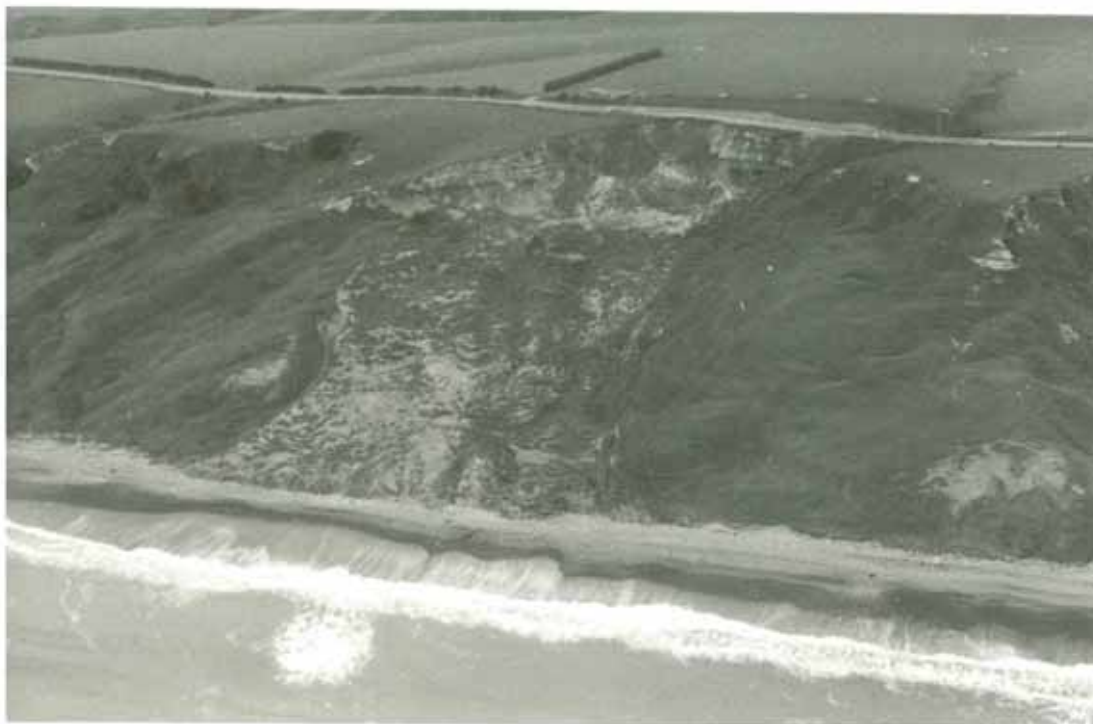
Figure 7

Te Waewae Shoreline - West of Grindstone Creek
19 November 1980

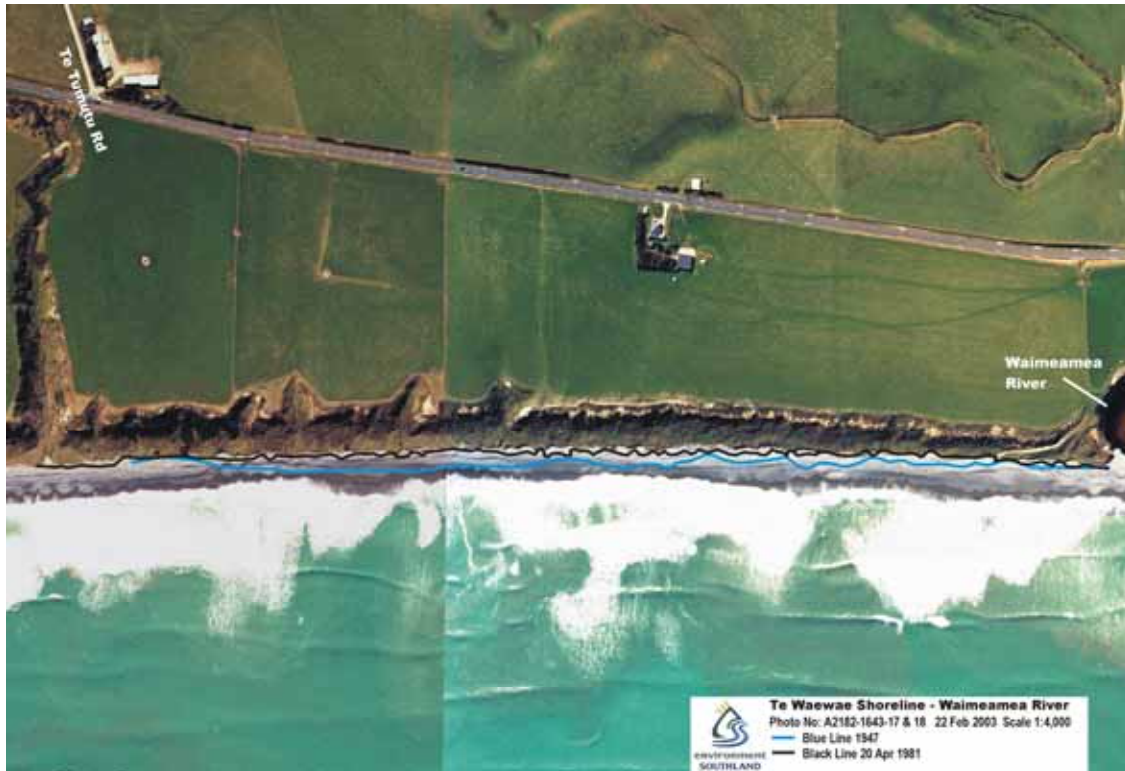
Figure 8 Coastline positions as of 1947 & 9 February 1981 overlaid on a 22 February 2003 photograph.

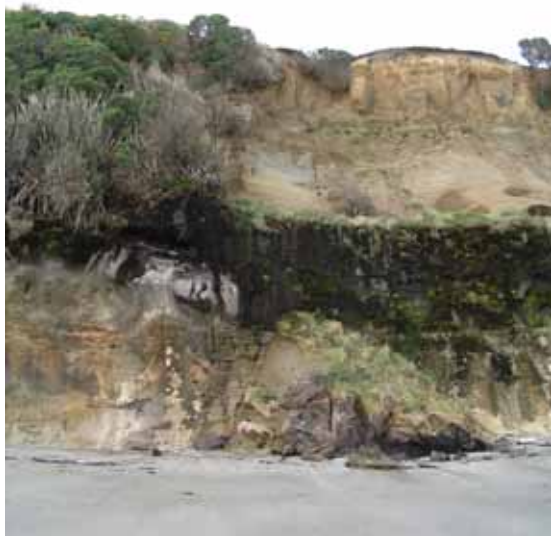
Figure 8a Cliff Slumping west of Dudley St, Orepuki, 9 September 2006

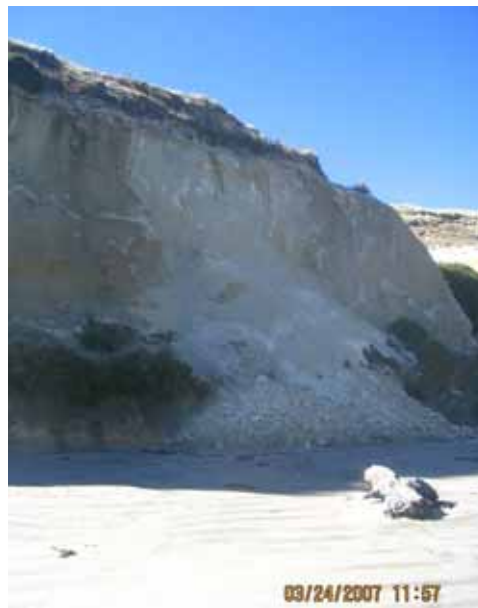
Figure 8b Cliff slumping on the south side Kaitangata Point, March 2007

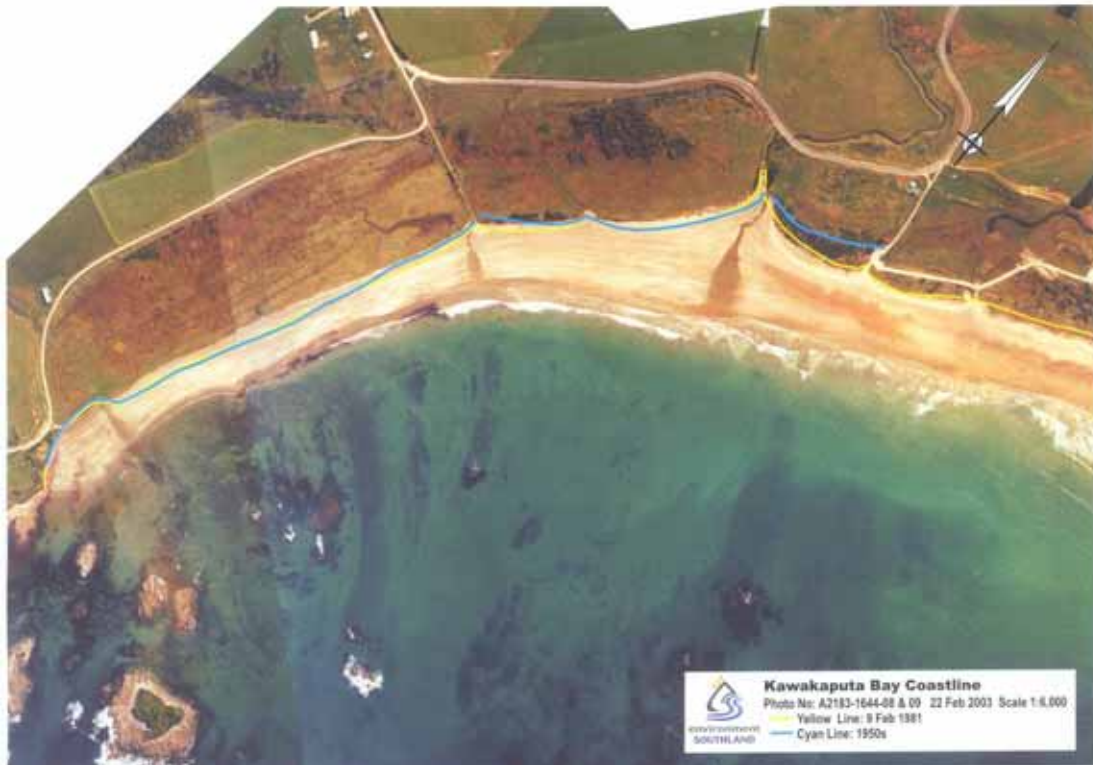
Figure 9 Coastline positions as of 1950 & 9 February 1981 overlaid on a 22 February 2003 photograph.

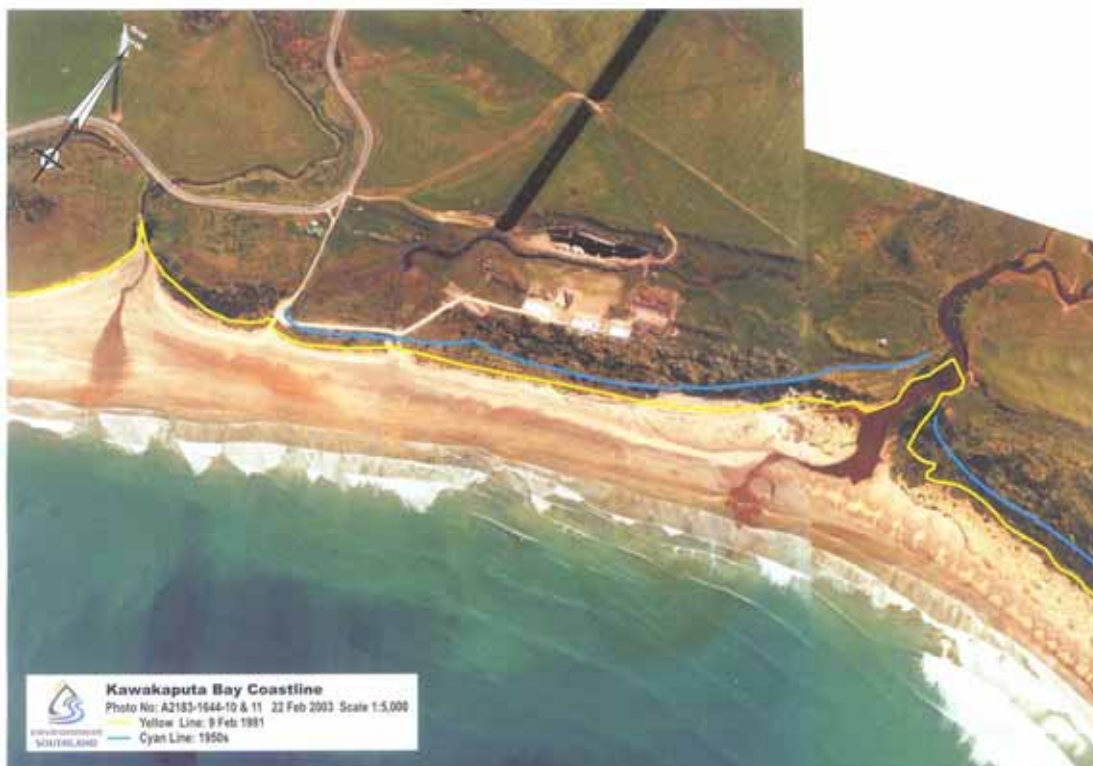
Figure 10 Coastline positions as of 1950 & 9 February 1981 overlaid on a 22 February 2003 photograph (Pouahiri Stream on left, Ourawera Stream on right).

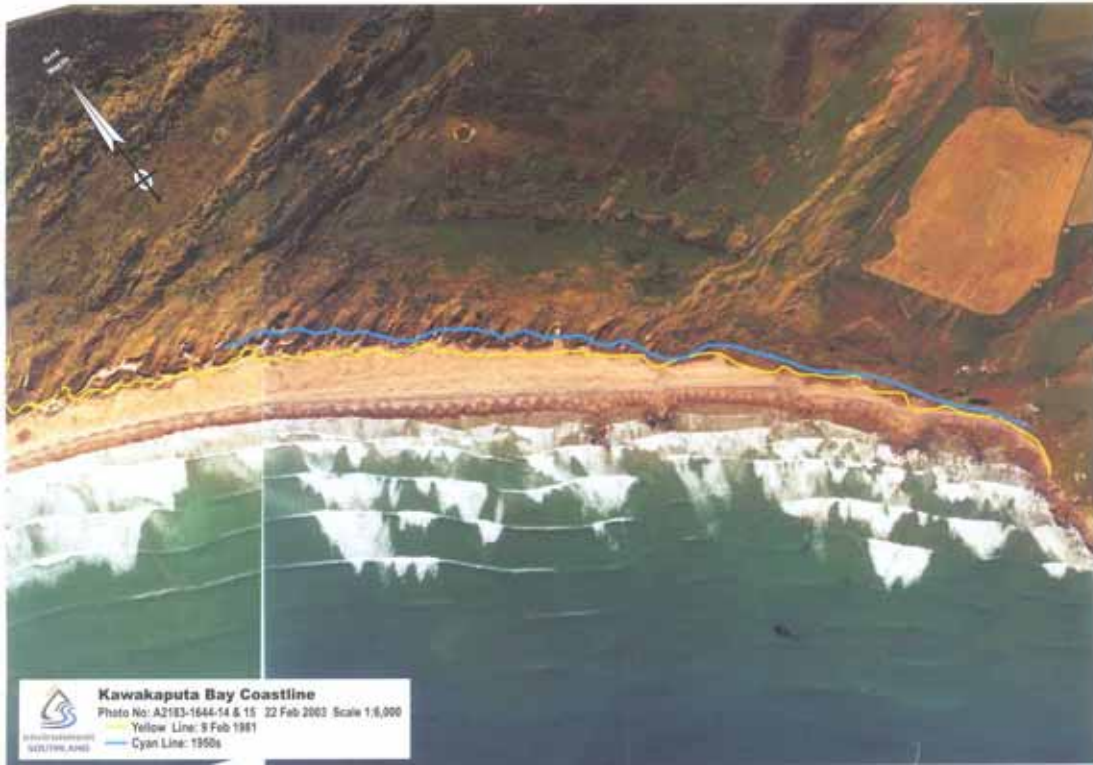
Figure 11 Coastline positions as of 1950 & 9 February 1981 overlaid on a 22 February 2003 photograph of the south east end of Kawakaputa Bay.

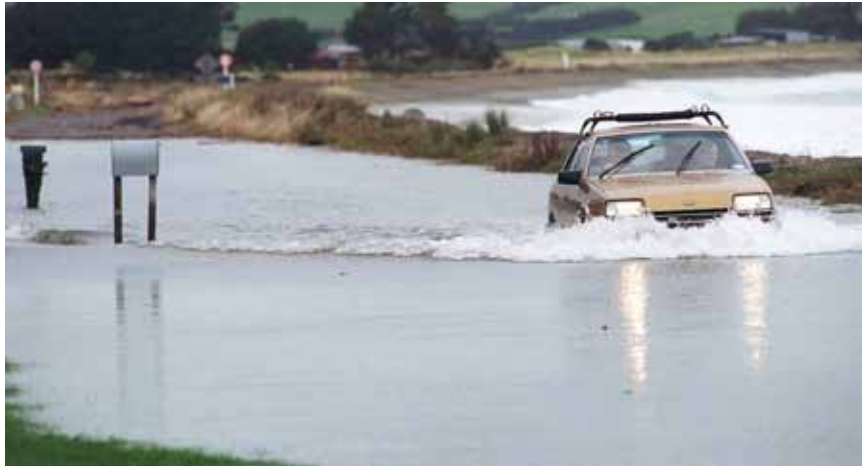
Figure 13 Marine Inundation, Colac Bay, Date 16 April 1999 (Southland Times photo)

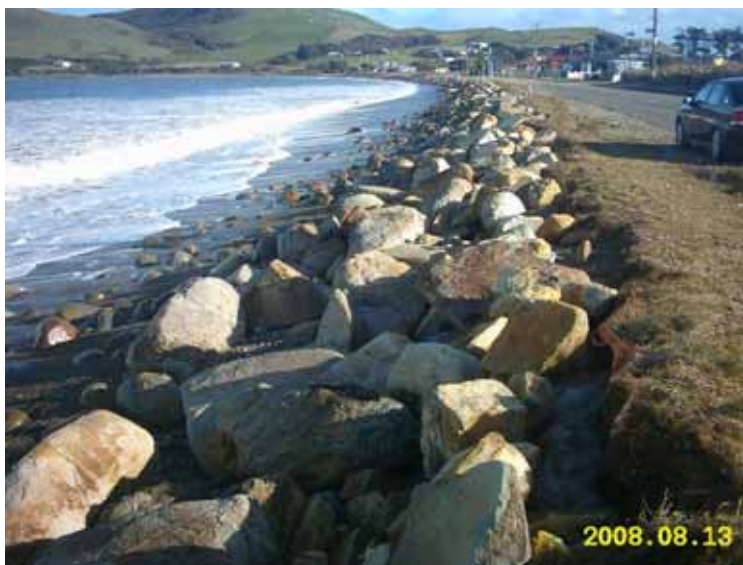
Figure 14 Damaged rock protection, Colac Bay - Photo: Bruce Halligan

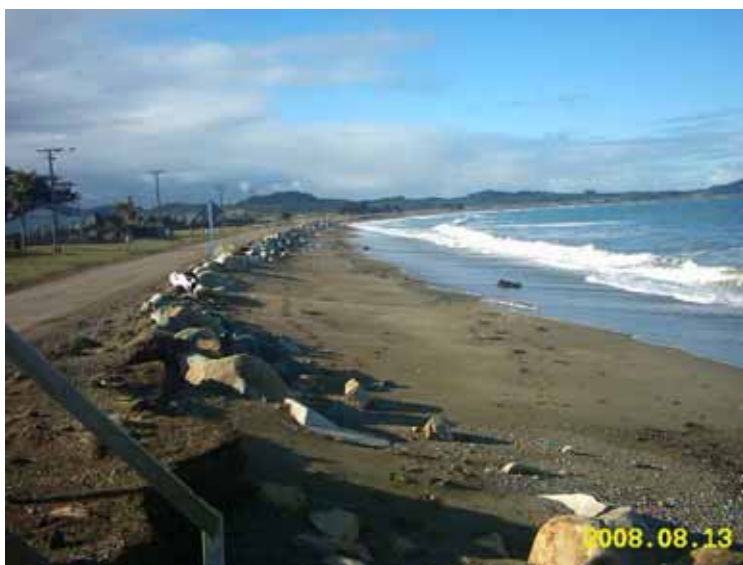
Figure 14a Damaged rock protection, Colac Bay - Photo: Bruce Halligan

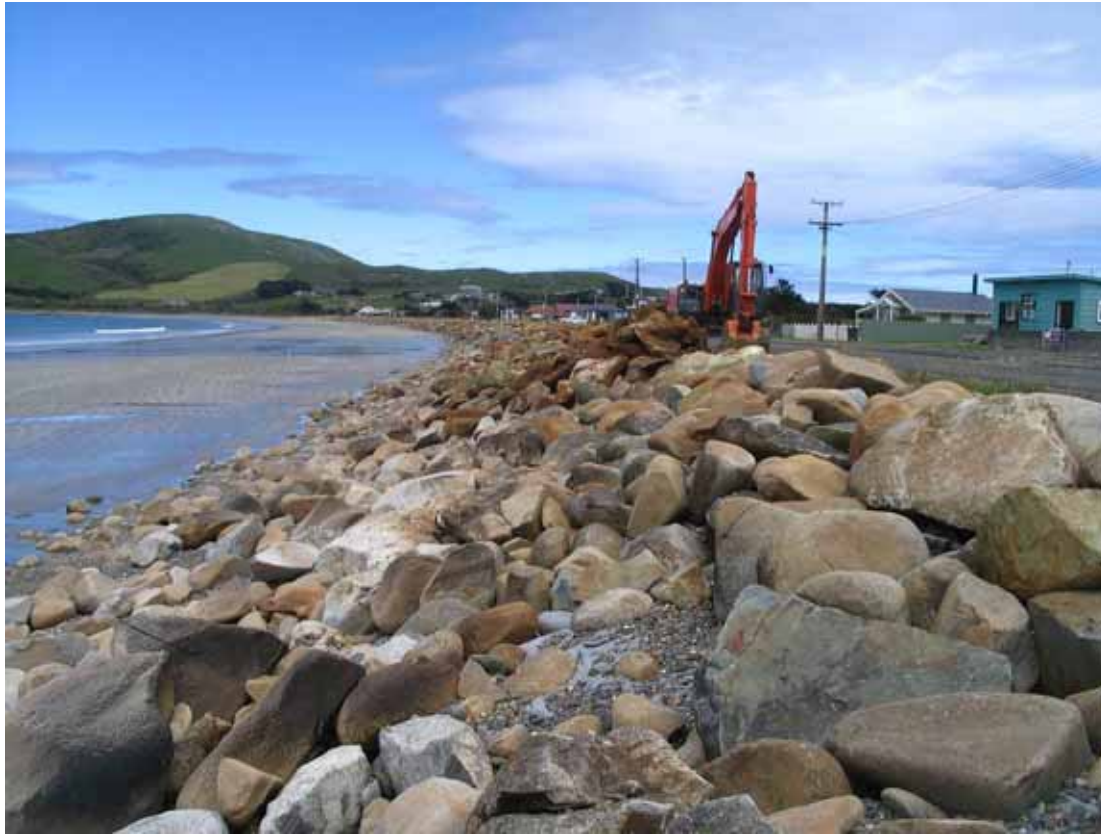
Fig 15 Rock protection under repair - 17 December 2008

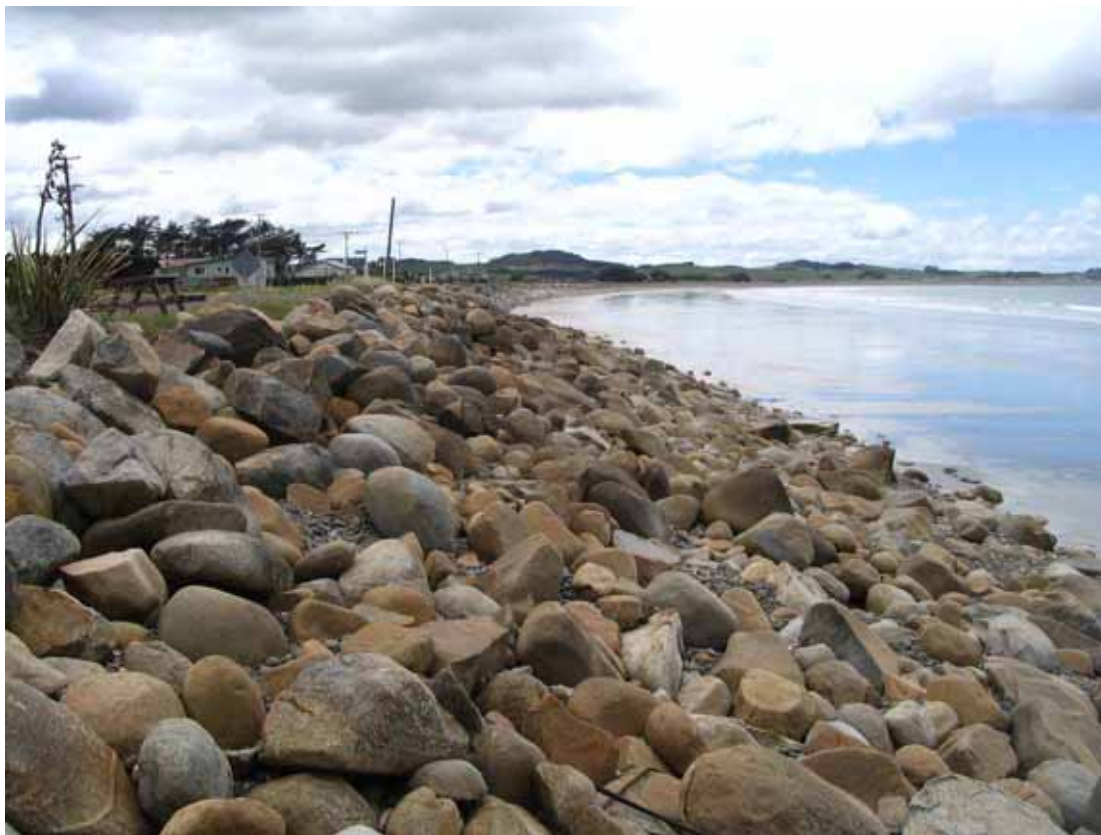
Fig 15a Rock protection awaiting repair - 17 December 2008

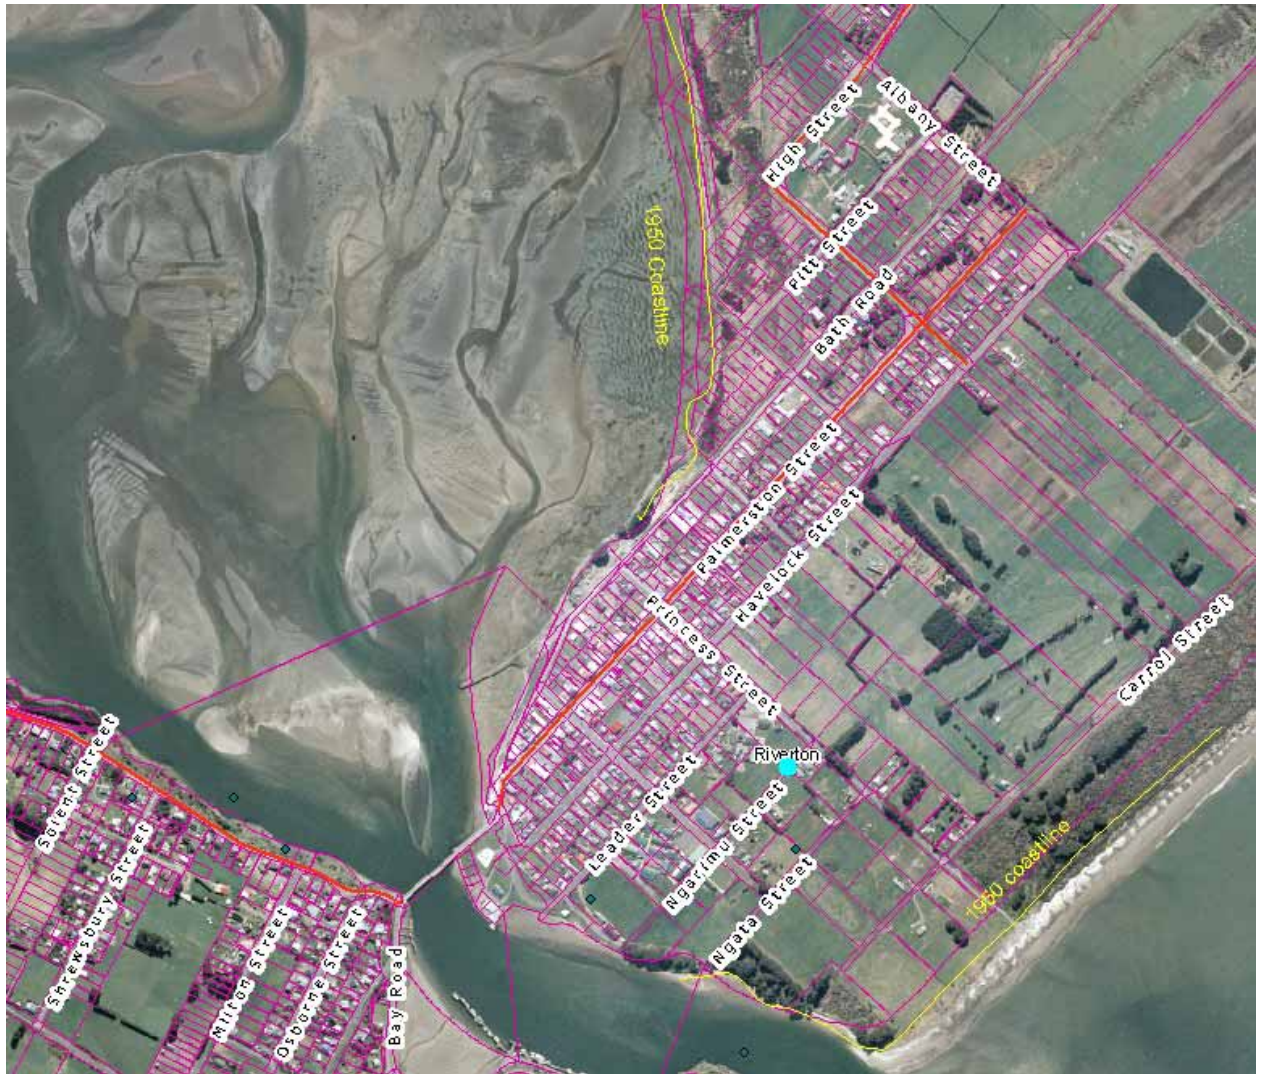
Jacobs River Estuary	Generally estuarine	Generally rolling farmland or part of urban Riverton		Wharves, road bridge, some adjoining roads	Yes, particularly on the east side of the upper estuary and downstream of bridge on the nith side where ongoing erosion threatens an urupa. See Fig 16. Some existing erosion protection work in places.		Generally negligible erosion risk.	Potentially, but not extensive - most susceptible at eastern end.	Yes ^{2,6,12} Records recall the 1868 and 1877 tsunamis affecting the harbour	Riverton Township - The town has a network of bench marks that first levelled by Duffil Watts & King for the Wallace County in terms of an assumed datum. These bench mark heights have been adjusted by Don Moir, Reg'd Surveyor for SDC, and ES to heights in terms of mean sea level using Riverton Trig (120.73m) as an origin of levels). A connection between these bench marks and the mean level	12. Western Star 12 May 1877. "...a succession of no less than seven tidal waves rolled into the Riverton Harbour between 7 and 12 o'clock yesterday. About 9 o'clock a wave, between three and four feet high, rolled up the river ..."

Figure 16 Riverton (Jacobs River) Estuary – Partial comparison of 1950 coastline with that of 2008

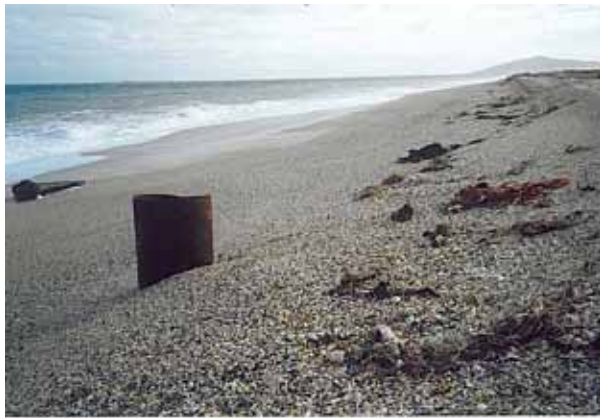
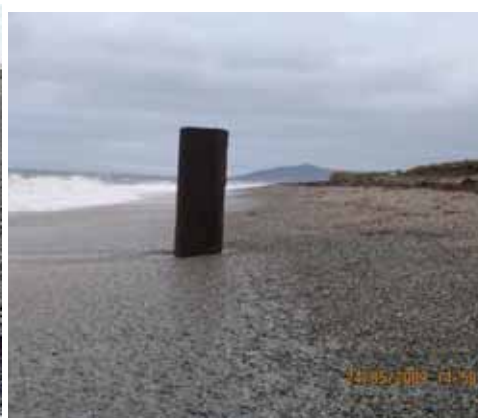
Figures 17d & 17e Large steel pipe on foreshore in Sept 2000 and May 2009 respectively.

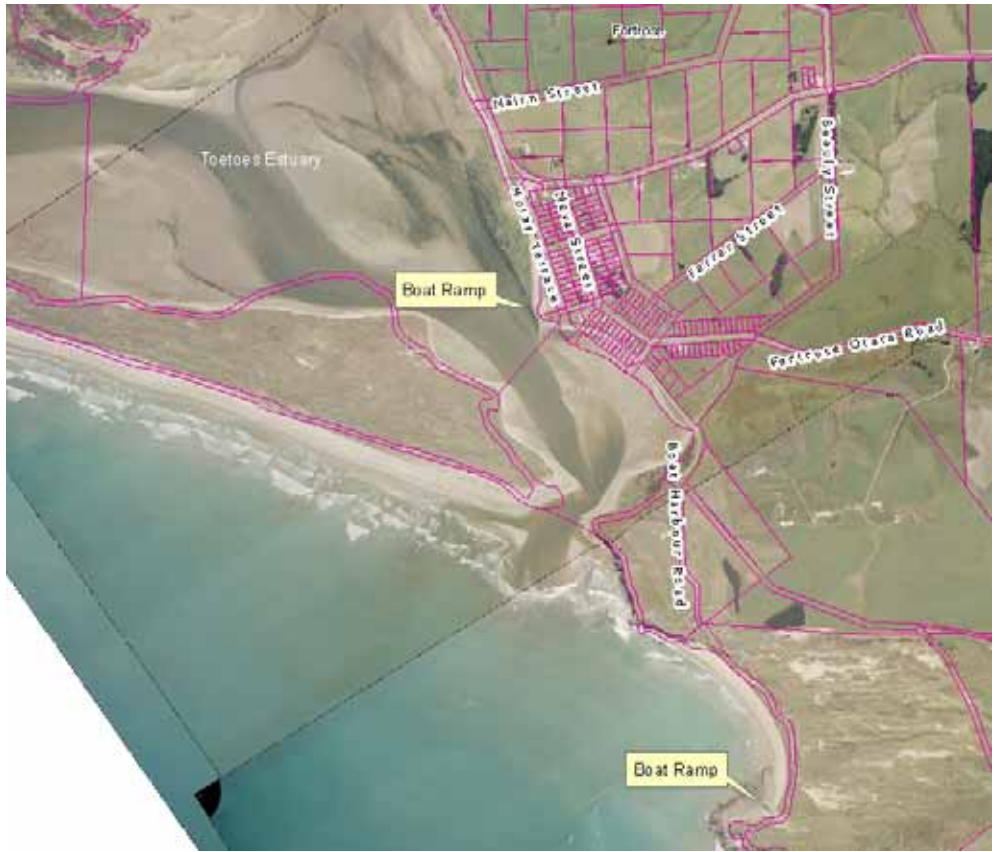
Figure 18 Fortrose – Comparison of cadastral boundaries with the 2008 coastline position.

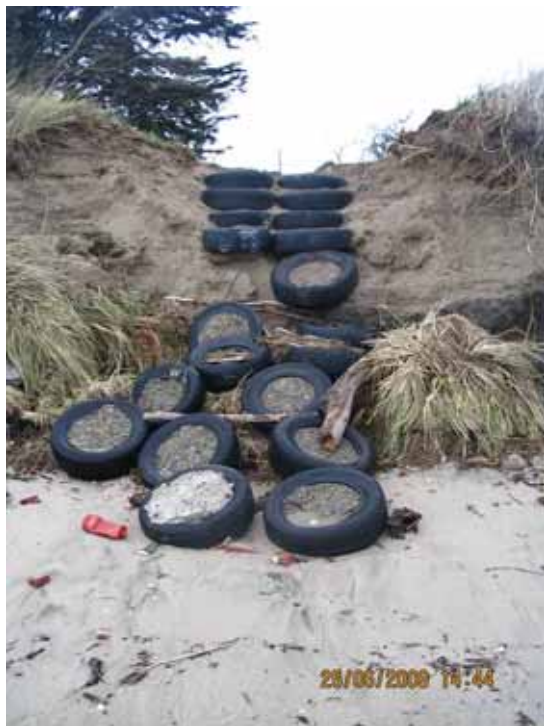
Figure 18a Recent erosion at Fortrose

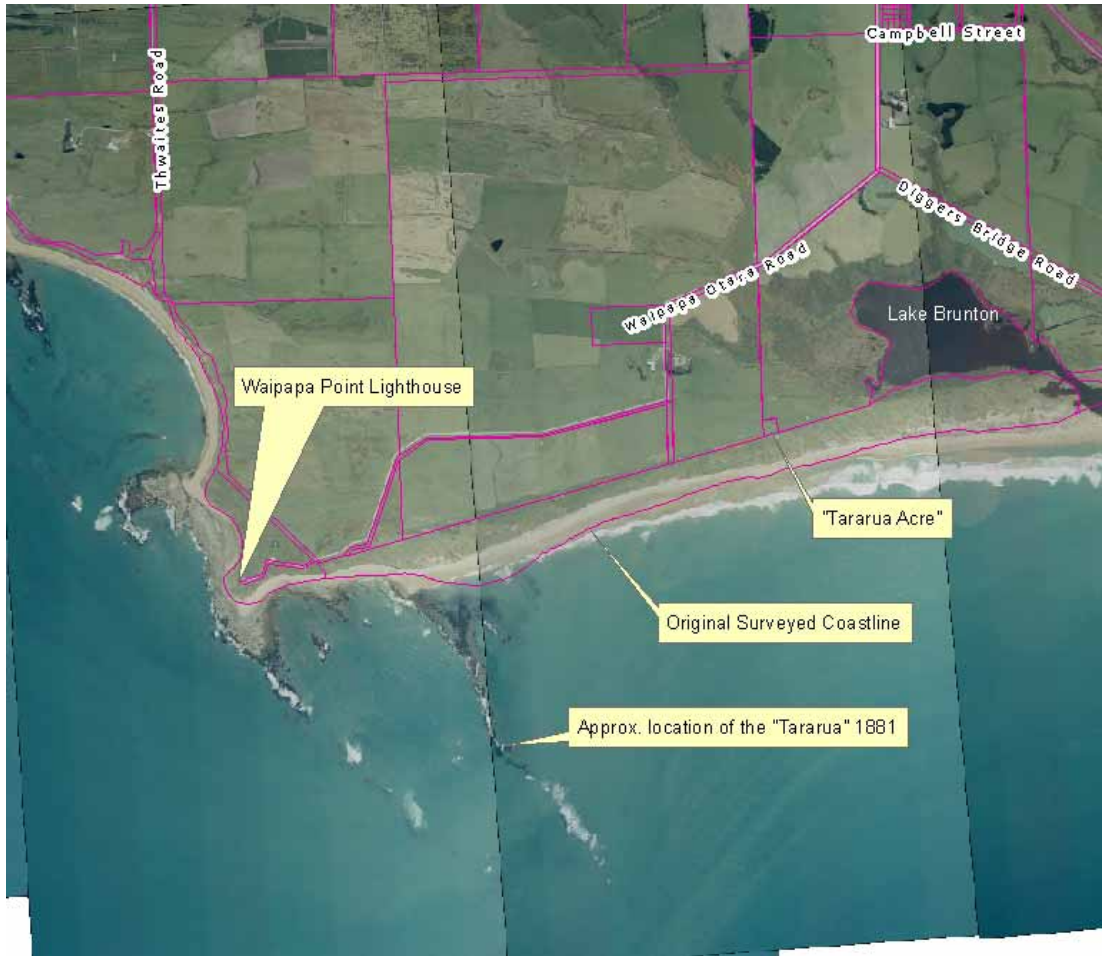
Figure 19 Waipapa Point – Comparison of cadastral boundaries with the 2008 coastline position.

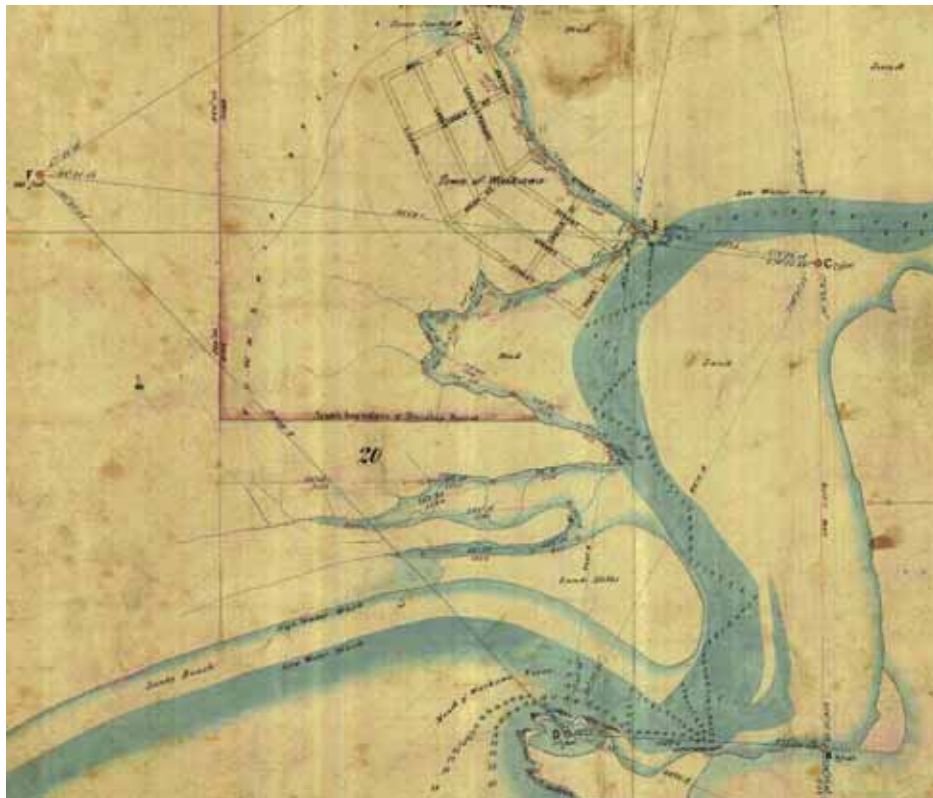
Figure 21 SO 461 - Original Survey of Waikawa (1864). Note: Antrim St surveyed across the foreshore.
