Prioritisation for restoration of out-flow stream habitat of coastal wetlands on the west coast of the Manawatu- Wanganui region

A report prepared for Horizons Regional Council, May 2009

Dr Alex James and Dr Mike Joy

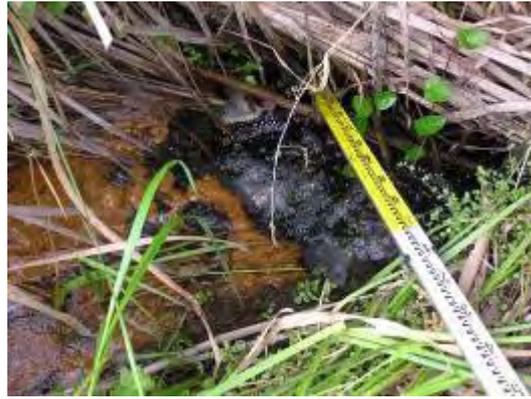
Above: A natural perched fall near the Artillerie Swamp lake. It may become submerged when water levels are high.

Below: This feature was only discovered amongst the raupo by the sound of running water.

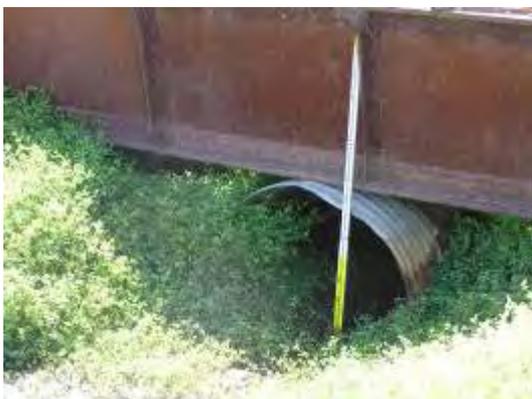
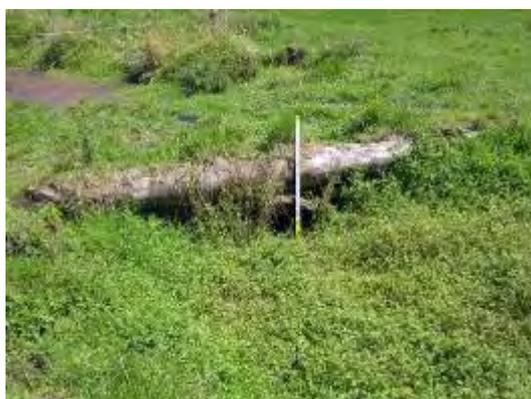
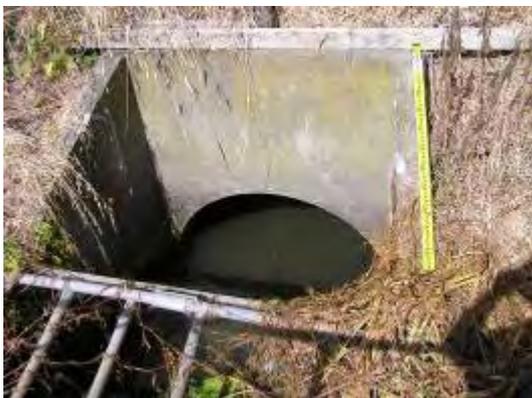
Forest Road Wetland outlet stream selected structures

Top left: Relatively new culvert installed on top of two older ones to add higher flow capacity.

Middle left: A large diameter culvert.

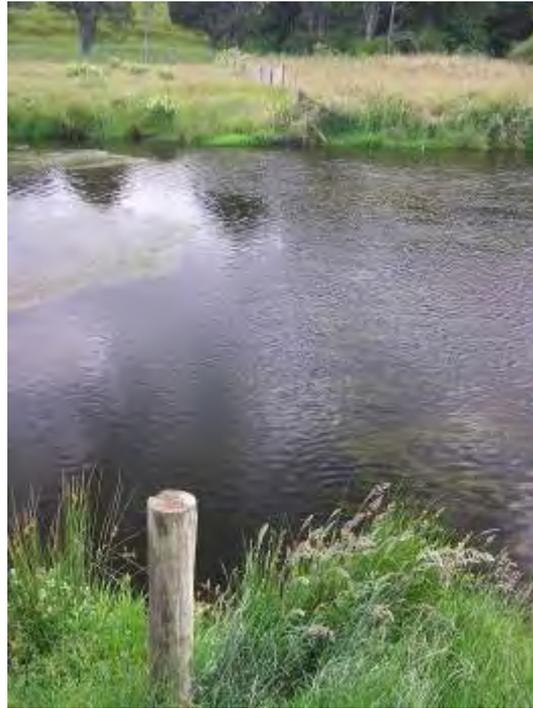
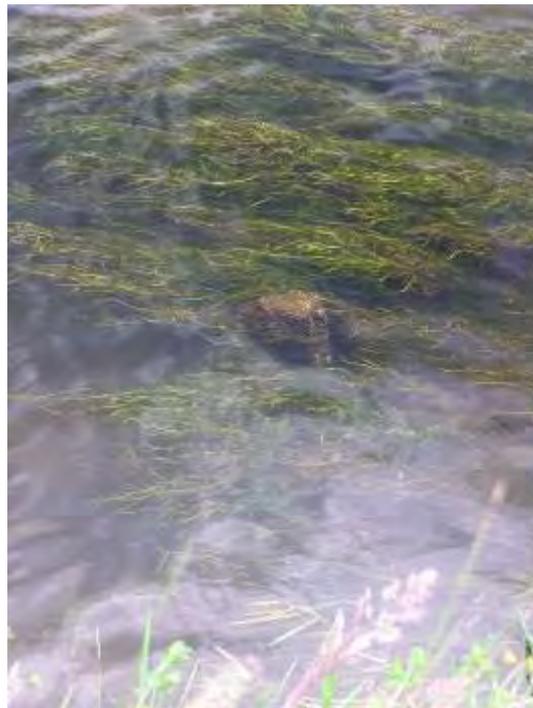
Top right: The Lake Horowhenua water level weir was underwater at the time of assessment.

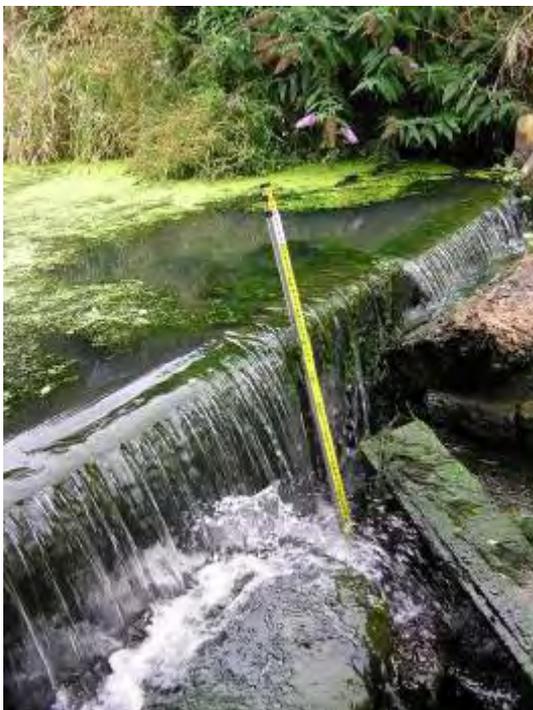
Top, bottom and left: The weir structure in the Kaikokopu Stream adjacent to the entrance to Himatangi Beach. A large amount of concrete rubble has been dumped at outlet presumably to prevent scouring of the stream bed.

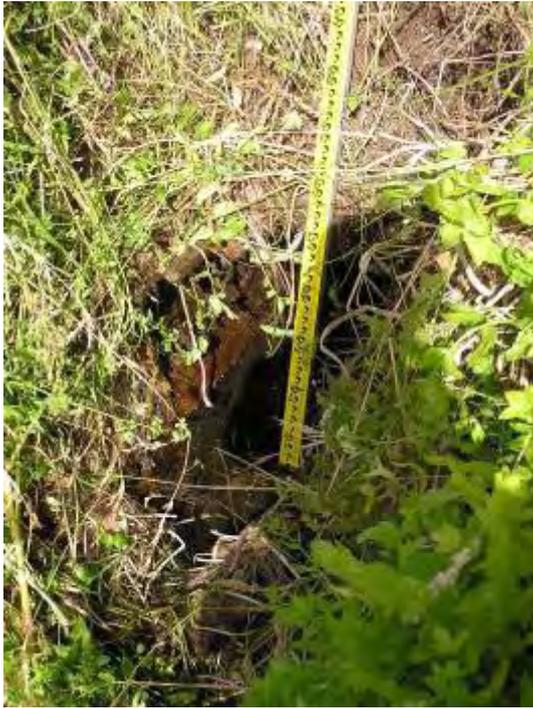
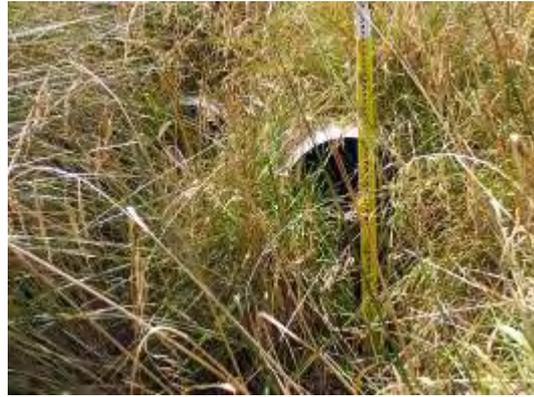
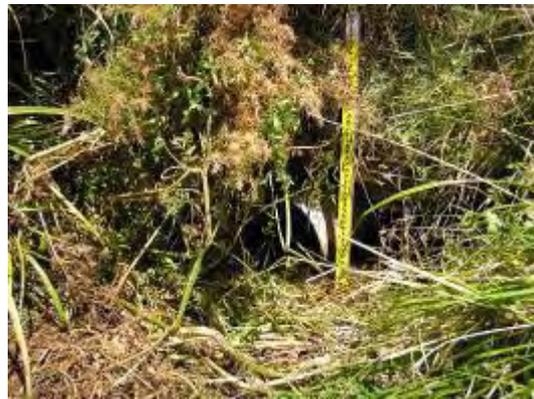
Knottingly Swamp outlet stream structures

Left: The upstream most culvert. This culvert was overgrown and very difficult to find. It appeared to be made from wood. This was the only culvert of three that had water.

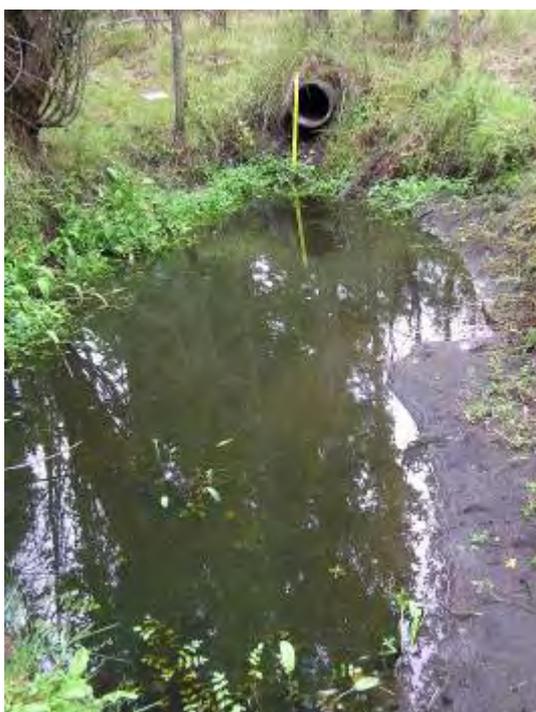
Top: Inlet of first culvert downstream of lake.

Left: The large pool (up to 0.75 m deep) at the culvert outlet presumable caused by scour at high flows.

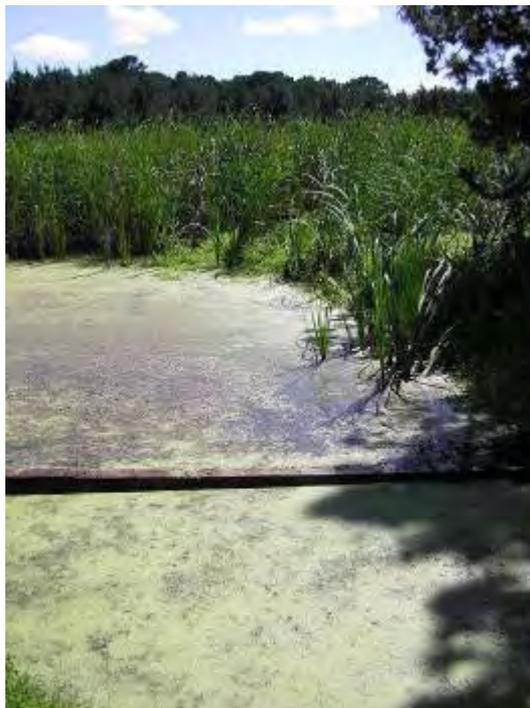
Top and bottom right: The Lake Koputara water level weir. At the time of visit water was pooled on either side with only a slight trickle flowing over the weir.

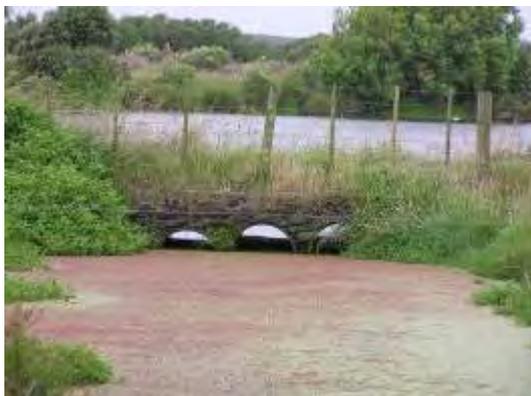
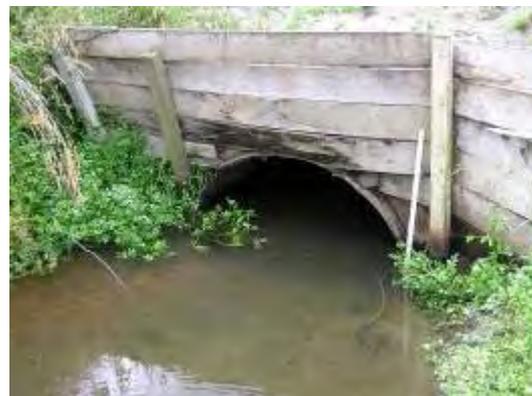
Above left: This triple culvert at the outlet of Lake Omanu poses no issue for fish passage.

Above right: A large school of inanga was observed swimming through this culvert below Palmer Rd.

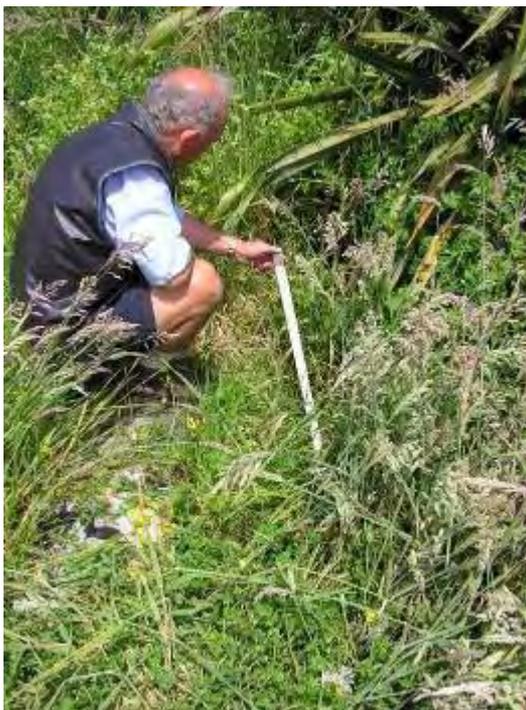
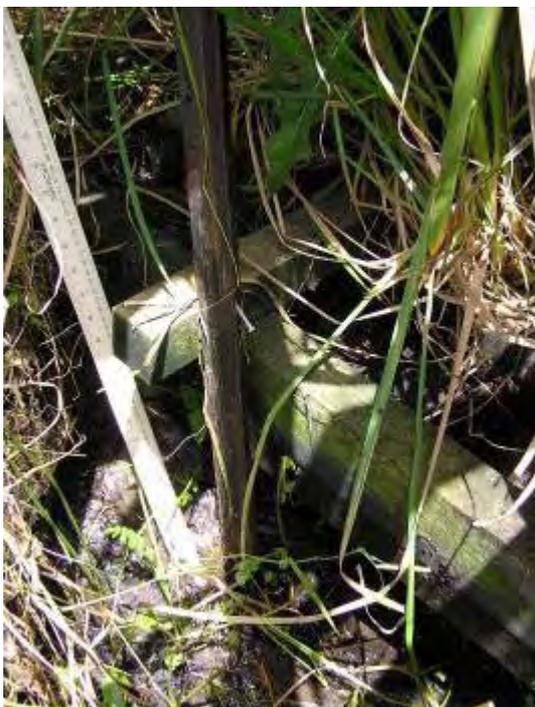
Top: The overgrown lake level weir where the Waiwiri Stream exits Lake Papaitonga

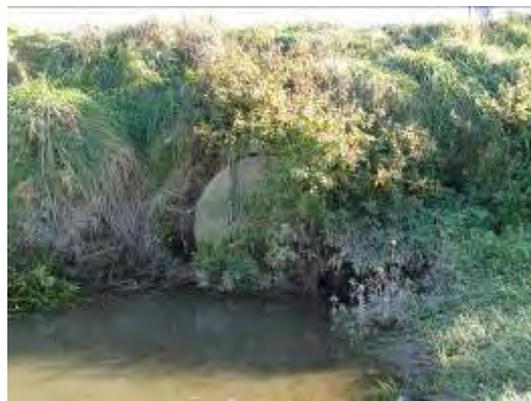
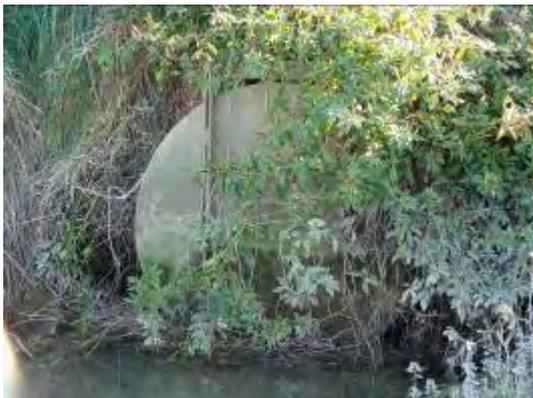
Top*: The Ohau Loop flood gated culvert was not visited but would likely be a barrier at low flows when water flow is insufficient to keep the gate open wide enough to allow fish passage.

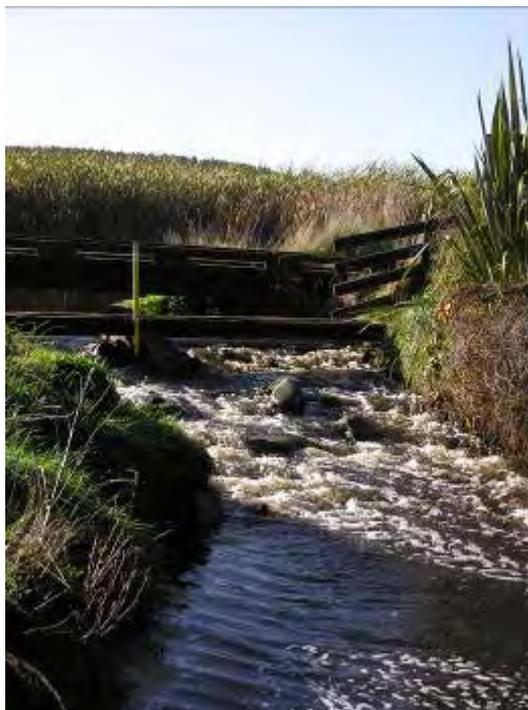
Top, bottom, top left, bottom left:
The Pukepuke lake level weir. A fish ramp has been installed this summer to improve the fish passage potential of the weir. There may still be fish passage issues during lower lake levels when the water level is below the lip of the weir and no water flows down the ramp.

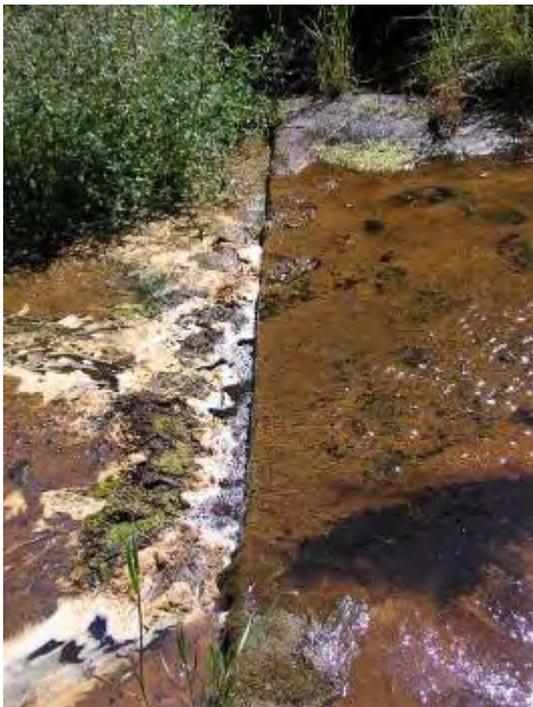
Top: This old weir structure has had the middle knocked out of it sometime in the past but still is a perched barrier.

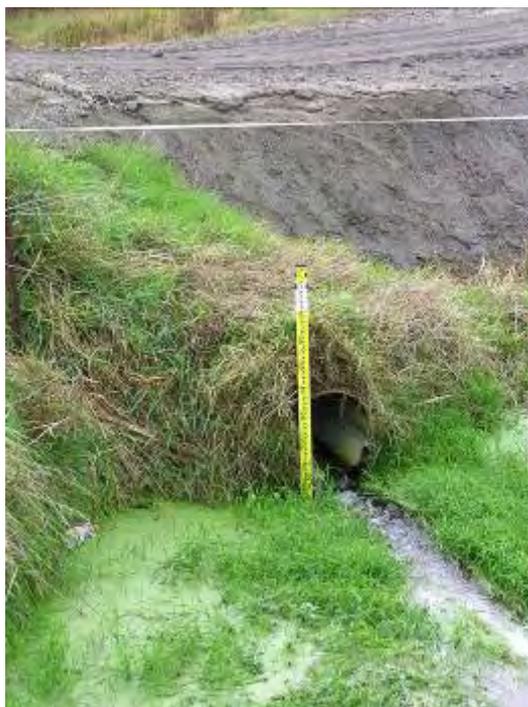
Top: The main vehicle crossing culvert perched outlet.

Bottom: The main vehicle crossing culvert perched inlet concealed by vegetation.

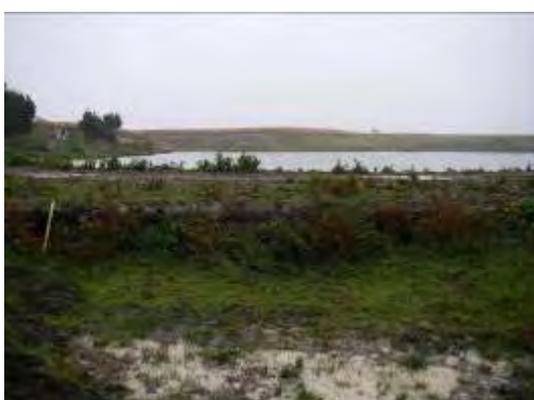
Left: The wide earth dam at the outlet of Lake Waipu. Two culverts were visible and at the time of assessment they were dry. Water would only flow when the lake level is higher.

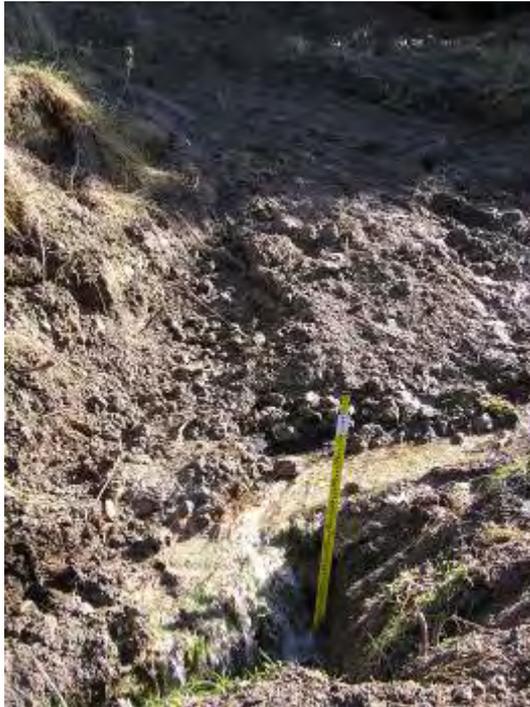
Above and bottom: Recent earthworks on a vehicle crossing just upstream of the Waipu outlet confluence with the Turakina River. The soil has been removed exposing the mudstone bedrock and the stream has created a fall over this.

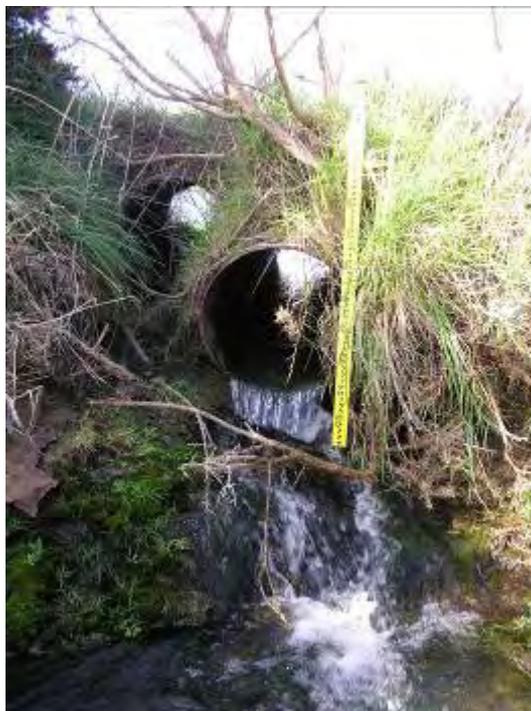
Top: The dam culvert inlet.
