**REPORT ON AN ARCHAEOLOGICAL INSPECTION OF
MR MCKENNA'S PROPERTY, TAIPA**

**BY
JAMES ROBINSON
AND
JOAN MAINGAY**

**Department of Conservation
Northland Conservancy**

February 1991

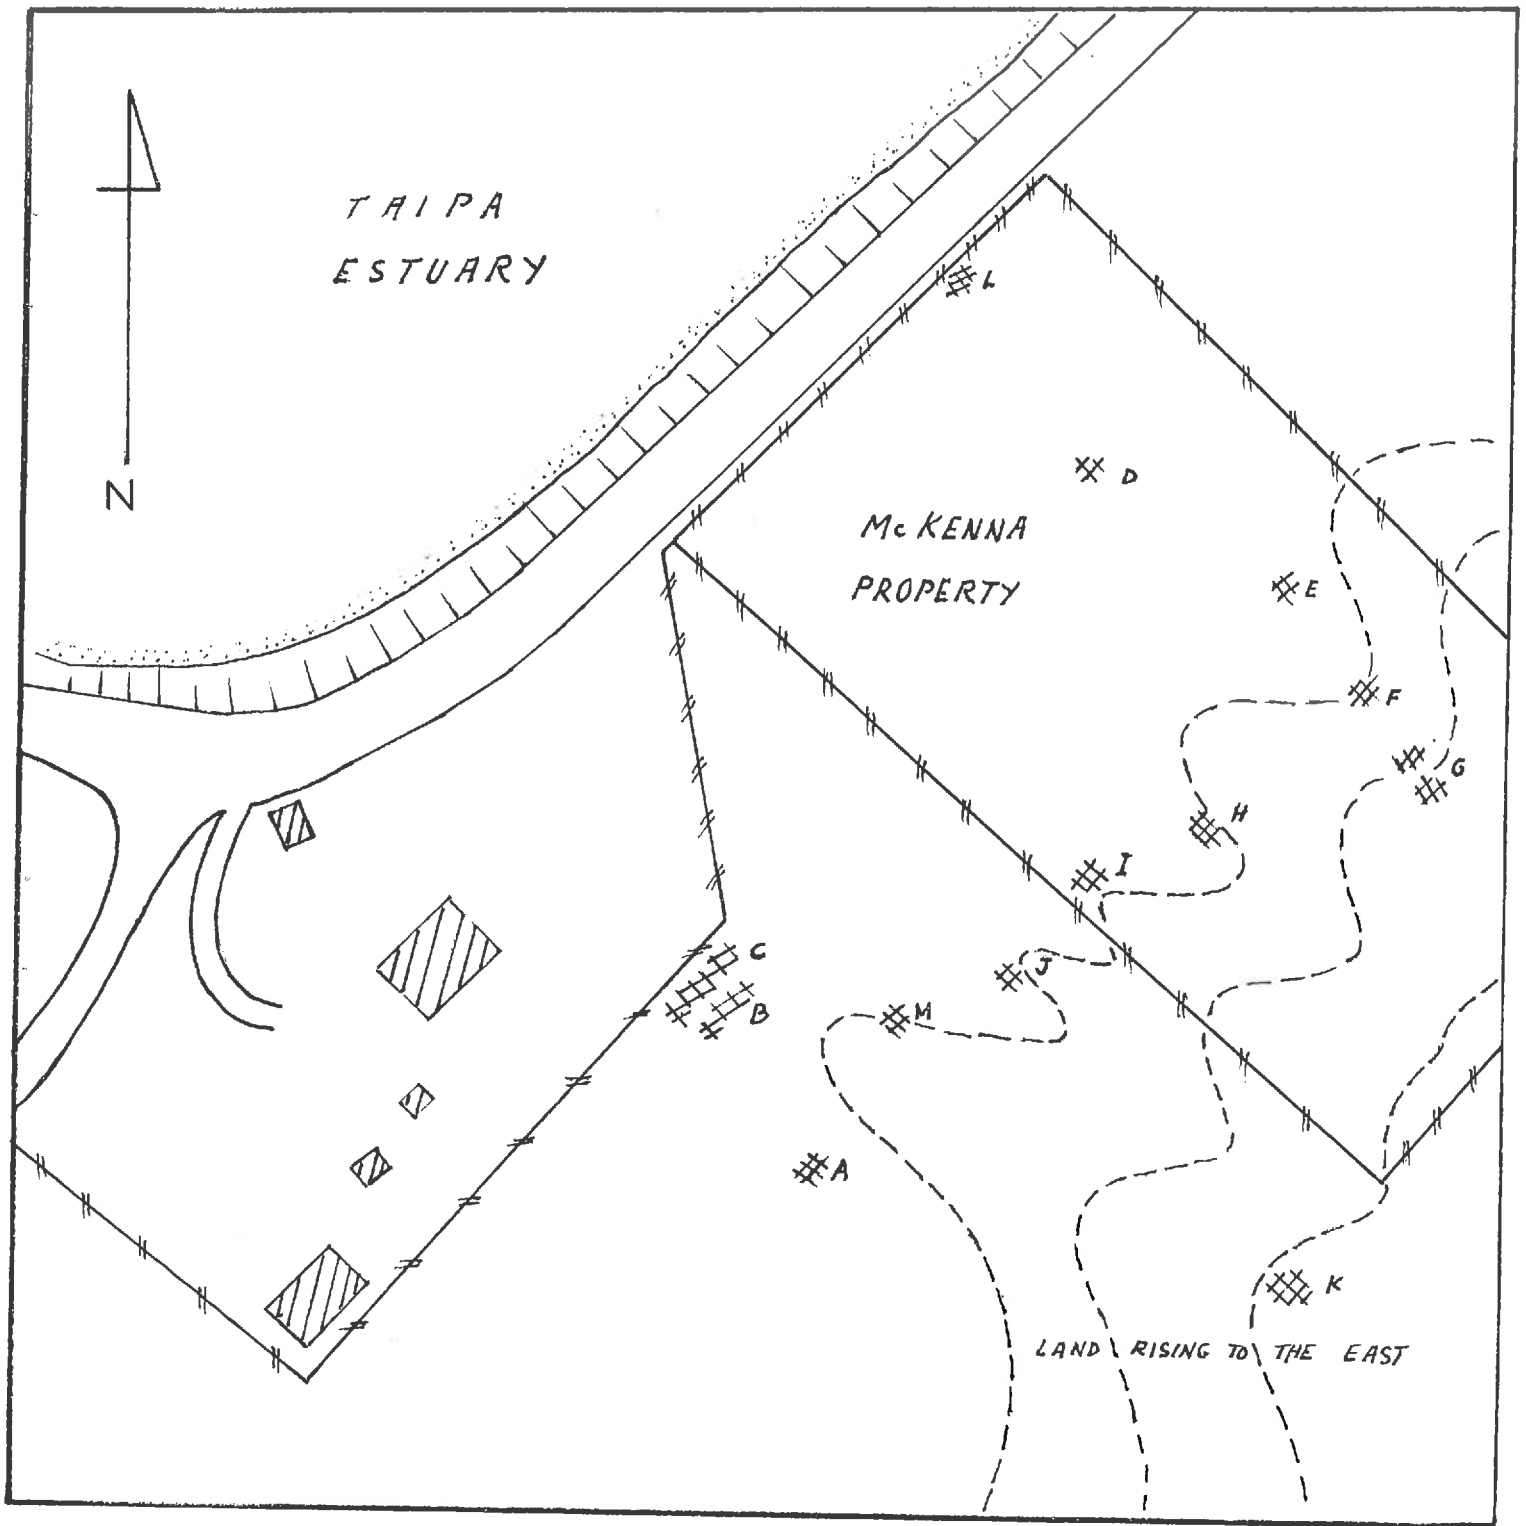
FIG.2 SKETCH MAP OF SITE N7/253, Taipa

Several archaeological sites have been recorded in this area. A pa site N7/10 on the ridge end north of the property, pits on the ridgeline, and numerous midden on the slopes below. Patches of exposed shell, part of site N7/253, were noted on the property when this and adjoining land was surveyed in 1978 (see Fig 2 and attached site record form). The recent inspection was undertaken to determine whether the site would be modified by Mr McKenna's proposal.

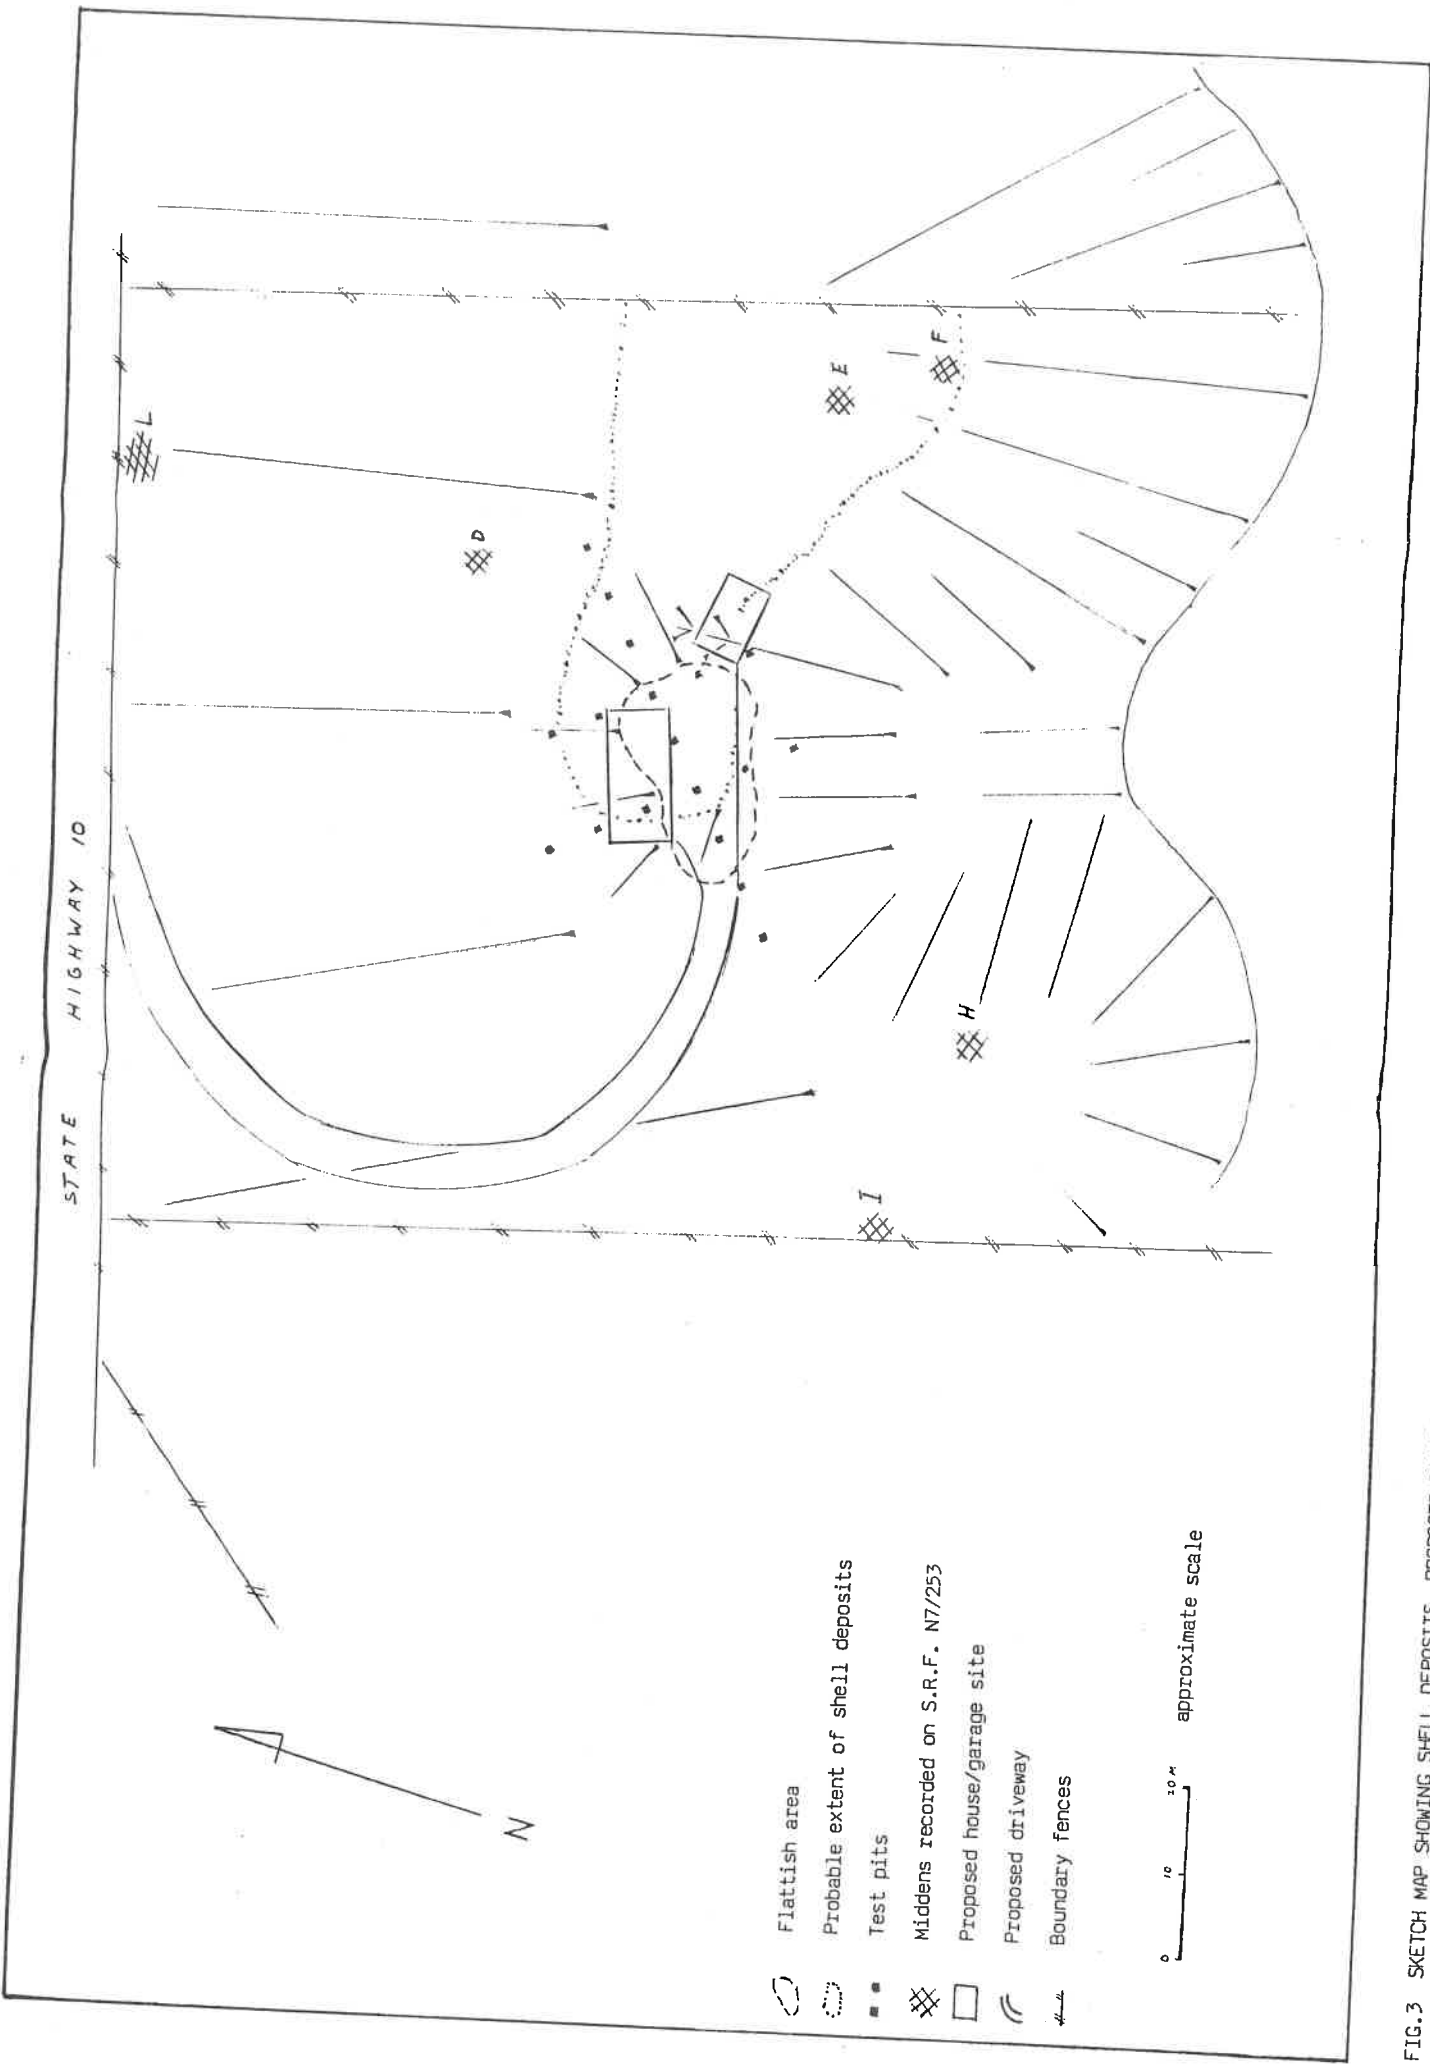
FIG.3 SKETCH MAP SHOWING SHELL DEPOSITS, PROPOSED BUILDINGS AND DRIVEWAY

Test pits along the driveway revealed no archaeological evidence. In contrast, pits dug across the proposed house and garage site indicated that shell deposits cover approximately two thirds of this flattish area, they extend about 5m downslope to the north and north-west, and for an undetermined distance to the east (Fig 3).

The shell level is more even than the present ground surface and lies 10-20cm below it. It is composed mainly of pipi (*Paphies australis*), charcoal and ash, and is over 50cm thick in the area eroded by cattle.

The proposed location for Mr McKenna's house and garage appears to have been a Maori habitation site. Evidence from test pits suggests that it was deliberately levelled with shell to form a terrace of approximately 20 X 30m, and that during occupation shell midden was dumped down the slopes to the north and east. The extensive shell deposits continuing to the east could also indicate soil modification for gardens on these lower slopes.

The erection of a Lockwood house on Mr McKenna's property would entail drilling holes for the foundations and trenching for a drain to run behind the terraced area. Apart from levelling surface irregularities it would be unnecessary to excavate the section of

driveway adjacent to the house and garage. Essentially subsurface disturbance would be limited to the house foundations and drain.

This would involve slight modifications to part of site N7/235, but given the apparent extent of the site it seems impractical to suggest an alternative location. Inevitably this would still result in some site disturbance.

1. Mr McKenna should apply to the NZ Historic Places Trust for an authority to modify site N7/235.
2. Unless there are objections from the tangata whenua the application should be approved with the following conditions.
3. The section of driveway abutting the house and garage should be constructed by laying metal on the surface. Levelling of surface irregularities should be kept to a minimum.
4. An archaeologist should be present to monitor subsurface disturbance and record any exposed archaeological evidence.

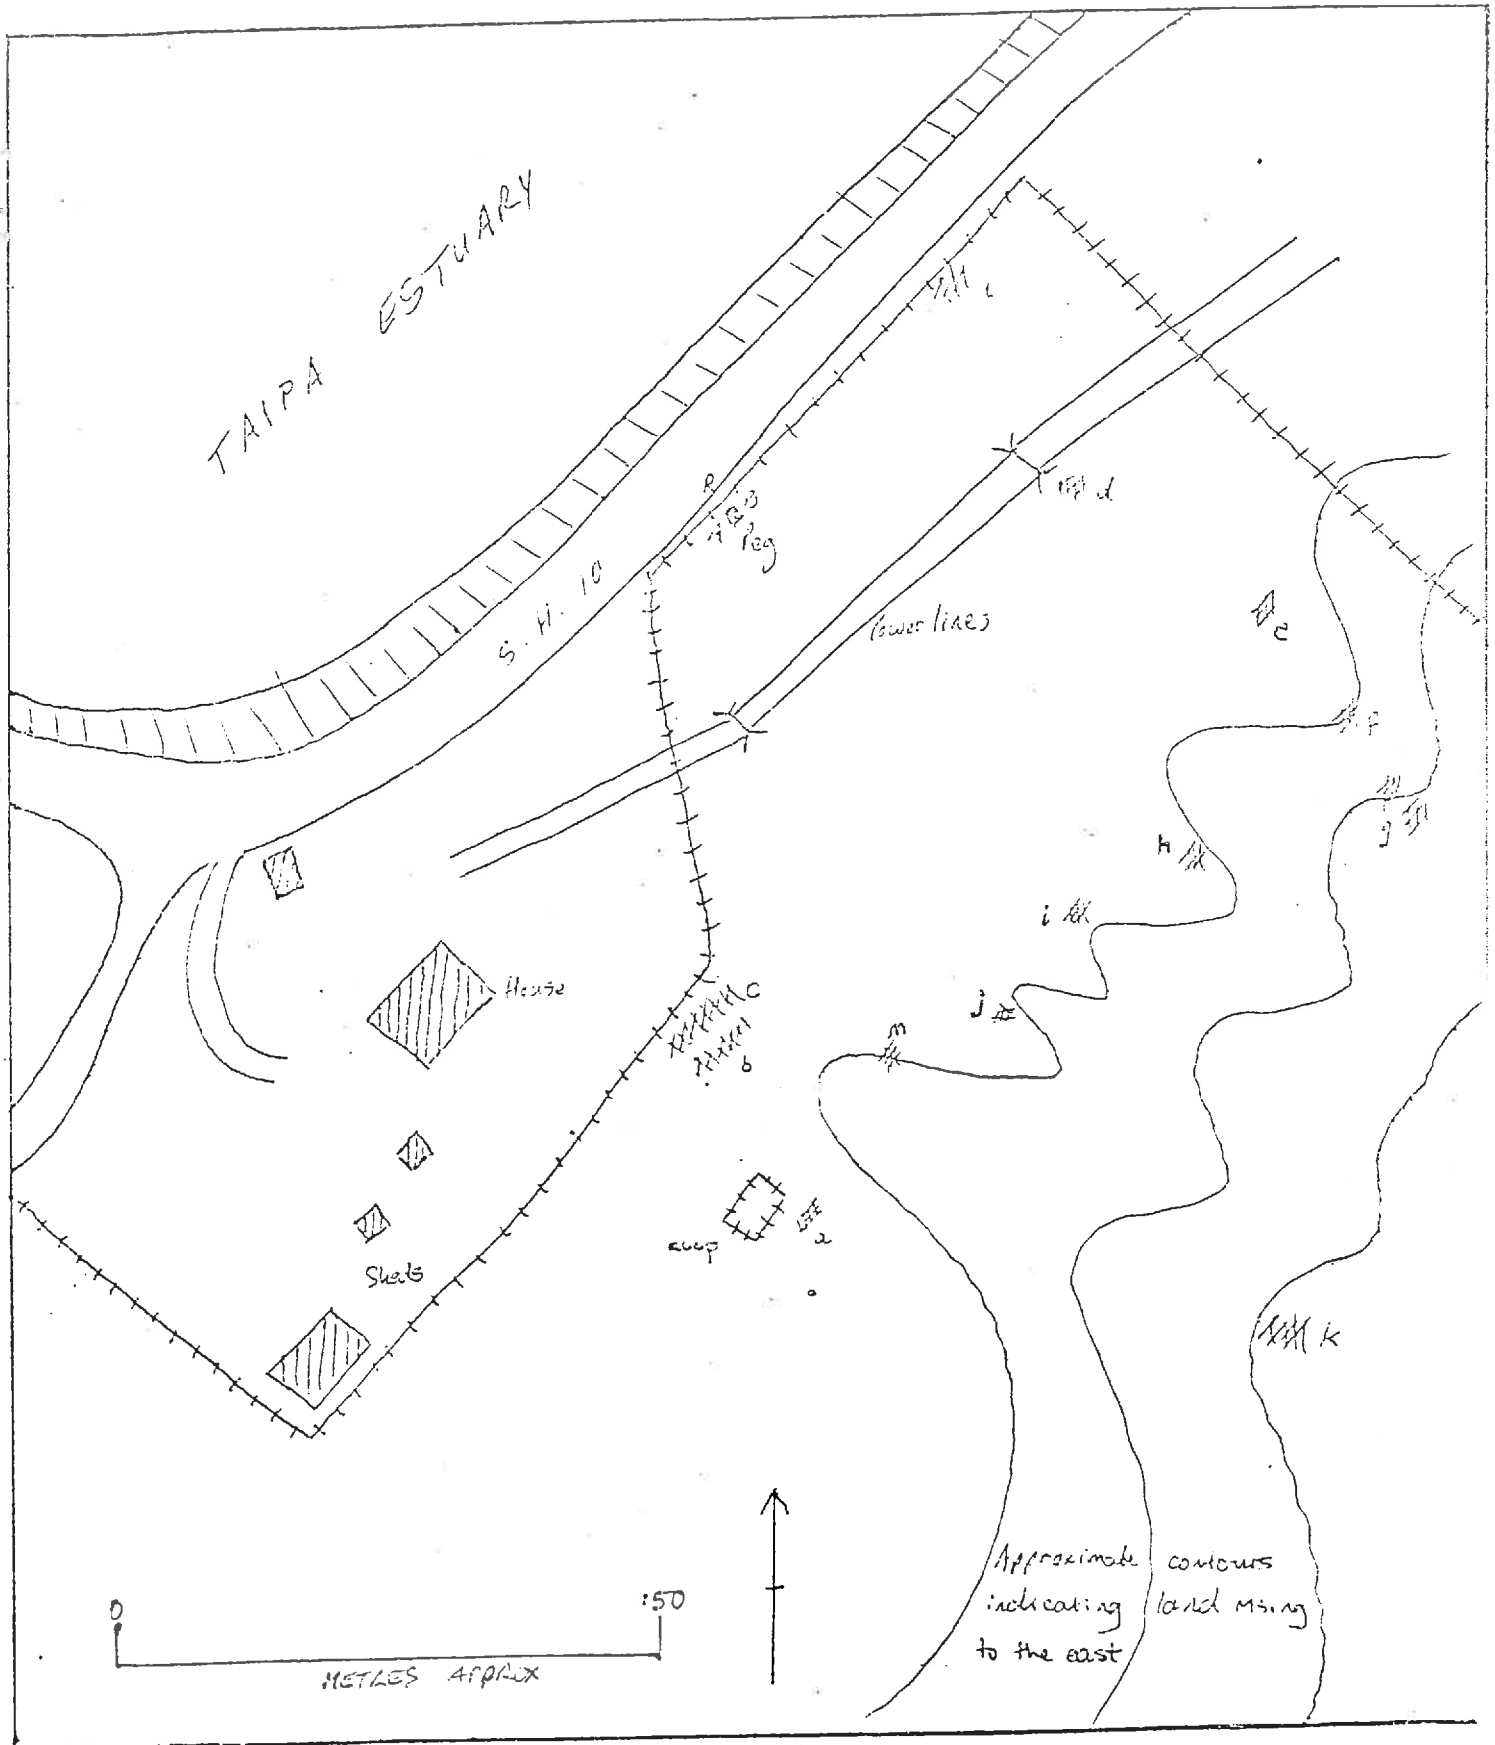
SKETCH MAP OF ARCHAEOLOGICAL SITES, TAIPA (WAIPANA)

The following notes apply to the points marked in the accompanying map.

- (a) Sparse surface matter of shell midden in stock track.
- (b) Dense shell midden in small exposure in stock track : layer 6cm thick, 5cm beneath the surface.
- (c) Sparse surface scatter of shell midden in disturbed soil.
- (d) Dense shell midden in pylon support exposure : layer 8cm thick beneath turf.
- (e) Surface scatter of shell midden exposed to stock track.
- (f) Superficial shell midden deposit.
- (g) Shell midden exposed by stock track.
- (h) Shell midden exposed by soil creep.
- (i) Shell midden exposed by soil creep.
- (j) Shell midden scatter.
- (k) Three pits side by side on narrow ridge, 2 x 4, 2 x 4, and 2 x 3 paces, all about 40cm deep.
- (l) Shell midden exposed by stock track.
- (m) Shell midden scatter.

All shell middens appear to contain cockle and pipi of relatively small size. Most appear to be disturbed deposits in unstable ground. Undergrowth, scrub and grass were rank in places and visibility was limited to soil exposures. Most areas where the ground was disturbed showed shell midden.

The area contains many midden deposits doubtless reflecting the presence of adjacent unlocated settlement sites. All may be beyond the limits of the proposed development. No archaeological sites were found in the densely vegetated home paddock, an area which appears to have been thoroughly disturbed in the historic period.
