## **GNS SCIENCE IMMEDIATE REPORT**

**DATE:** 2 March 2011

**SUBJECT:** Report on Landslide Reconnaissance Flight on 24 February 2011 following the  $M_w$  6.3 Christchurch Earthquake of 22 February 2011

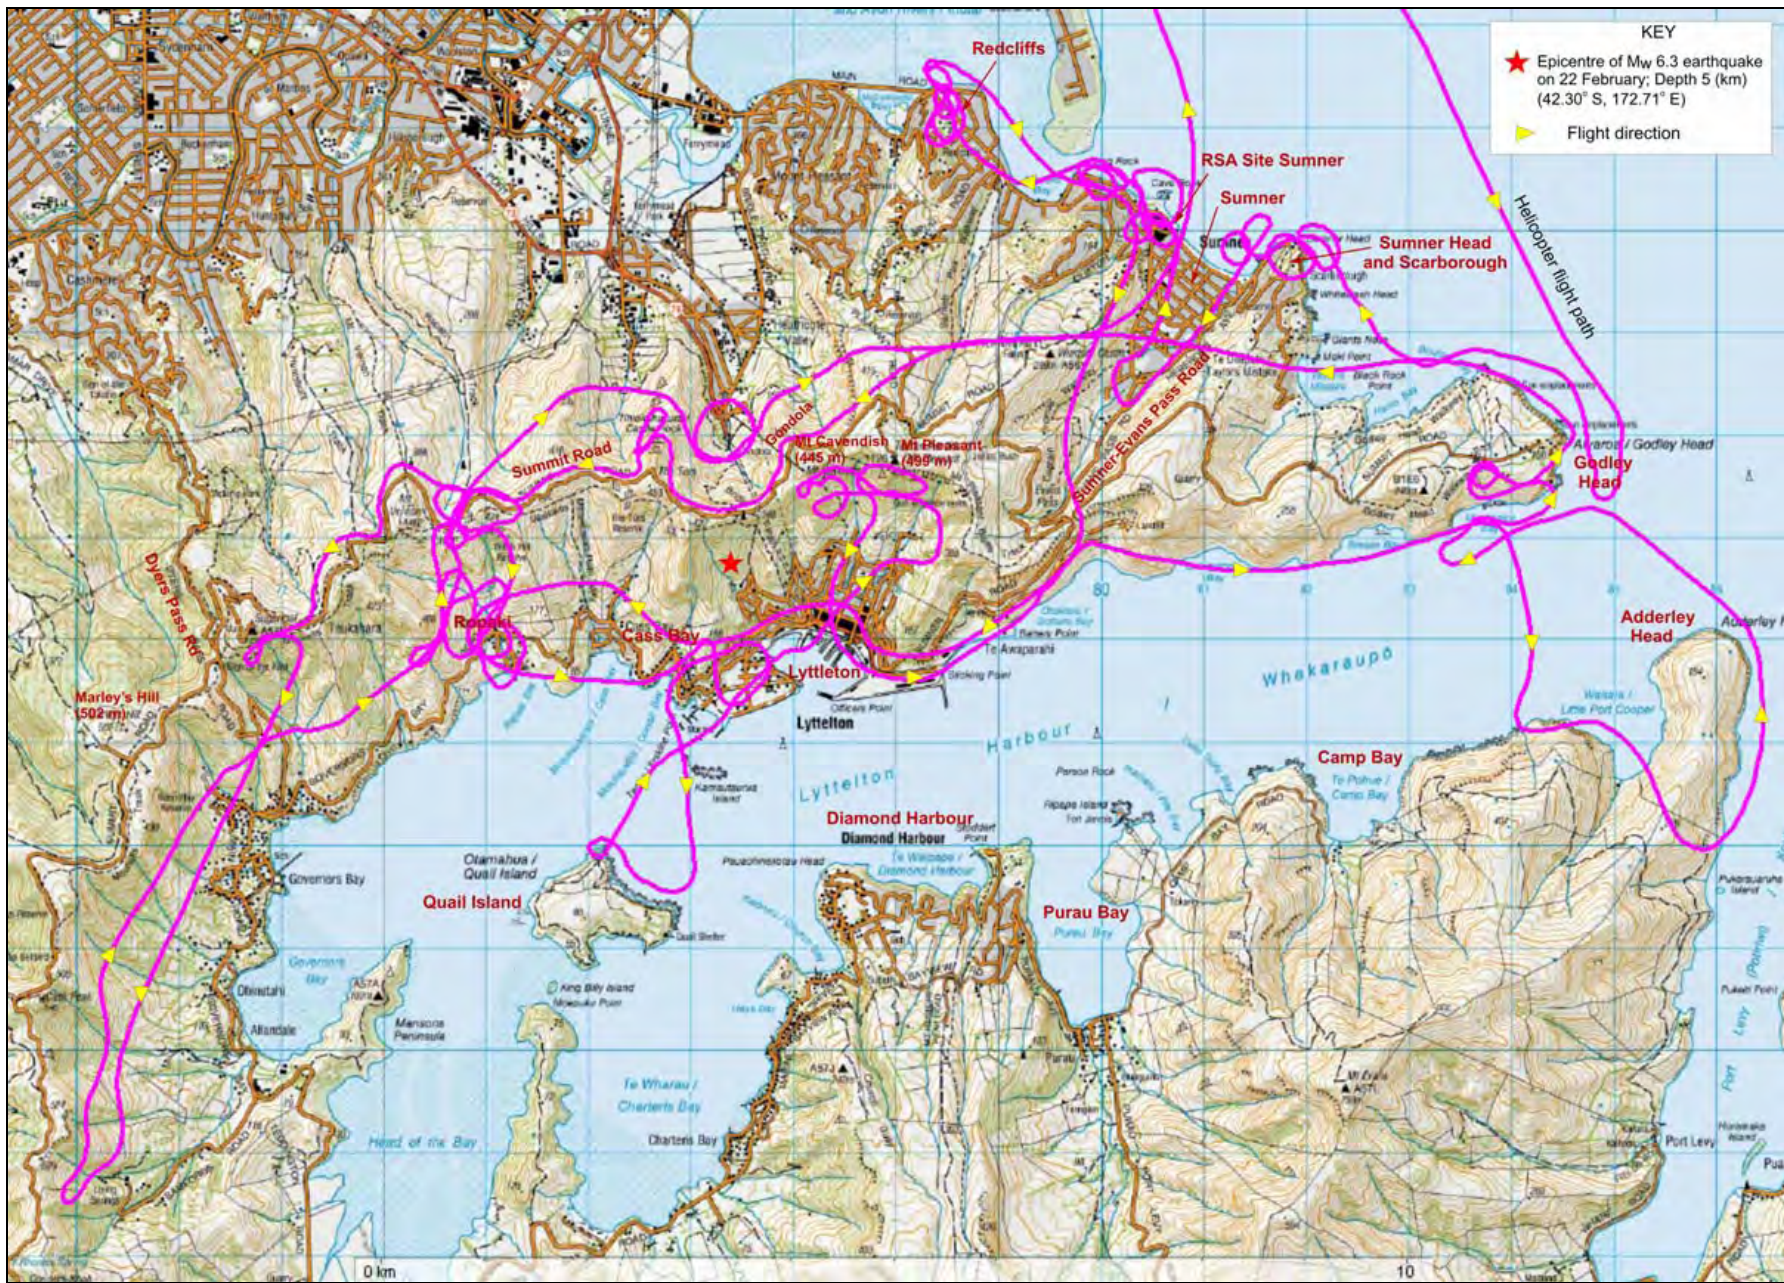
Figure 1. GPS track log and directions of the landslide reconnaissance helicopter flight on 24 February 2011.

No evidence for surface fault rupture was seen in the Port Hills area covered by our flight path (Figure 1). Several low altitude passes were made over the Port Hills region in the epicentral area and we saw no evidence for surface fault rupture (specifically we spent a fair bit of time over the Summit Road area – over about a 1 km swathe either side of road – between about Evan Pass in the east to Witch Hill Reserve and to Mt Vernon in the west. We did not fly along the northern base of the Port Hills because (1) this was restricted air space; and also because (2) the earthquake epicentre, as we understood it, is located to south of that between Lyttelton and Sumner, so that was where we focused our attention with regards to looking for possible surface fault rupture.

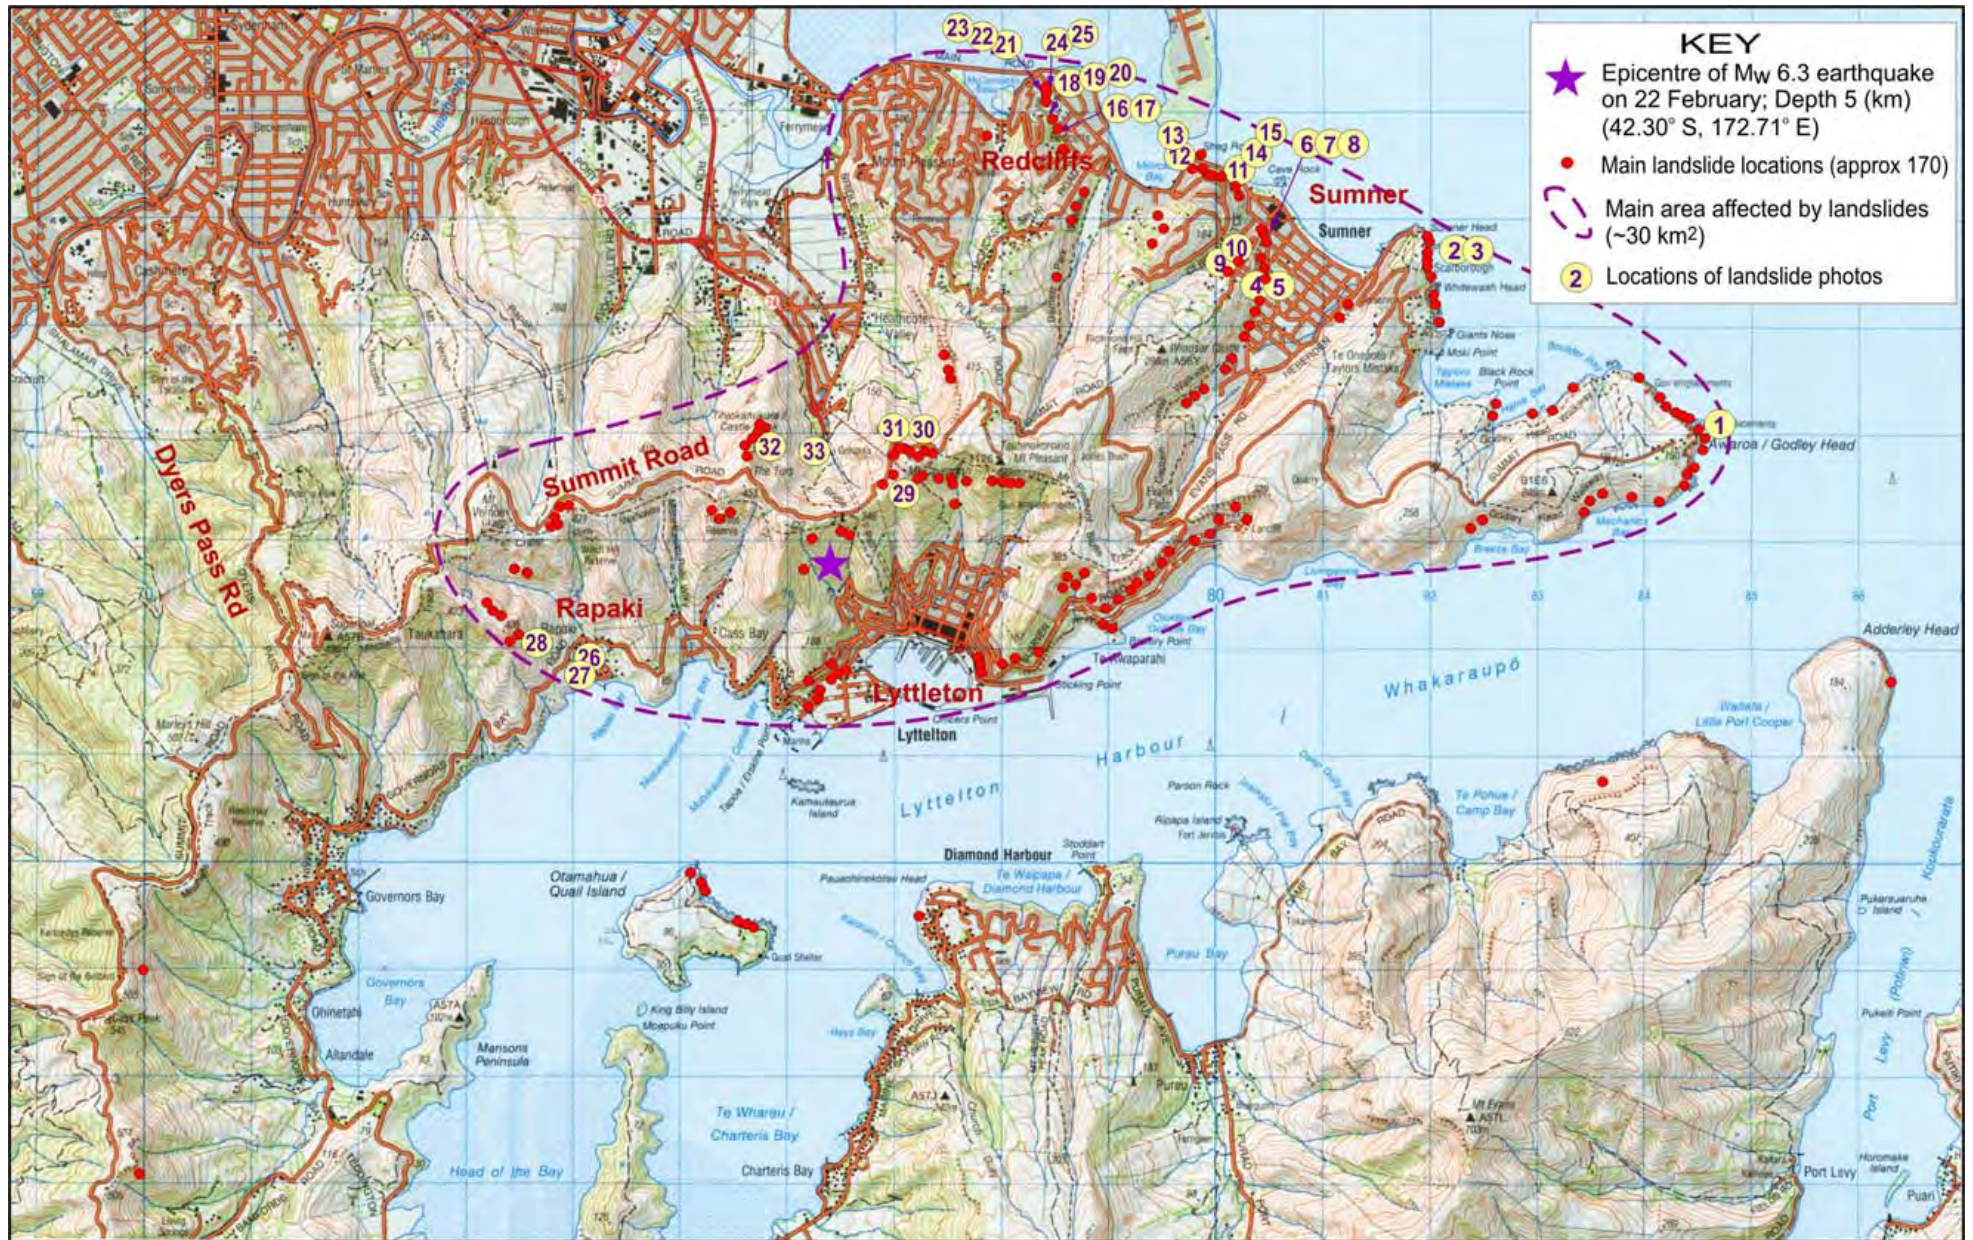
From our observations and photos taken on the 24 February helicopter flight approximately 170 landslides that were clearly triggered by the earthquake have been located and plotted on NZTopo50-BX24 topographic base map to produce an initial landslide distribution map for the 22 February earthquake (Figure 2). This map also shows the main area (~30 km<sup>2</sup>) affected by landsliding, and the locations of selected landslide photos which illustrate the nature of the landslides and the damage that they caused (Photos 1 to 33 at back of report). Figure 3 shows both the main area affected by landslides triggered by the earthquake and the estimated total area that appears to have been affected (~150 km<sup>2</sup>).

- (2) About 170 landslides occurred in the main area affected by landsliding, spread over ~30 km in the epicentral area. On the south side of Lyttelton Harbour only a few small, non damaging slope failures on steep cliffs and road cuttings were seen within 3–8 km from the epicentre (Figure 2). This distribution is consistent with that reported earlier by GNS Dunedin staff (Jongens et. al. 2011). The total area affected by landslides triggered by the earthquake is estimated to be about 150 km<sup>2</sup> (Figure 3).

Figure 2. Map showing the distribution of landslides triggered by the 22 February earthquake, the main area affected, and locations of landslide photos.

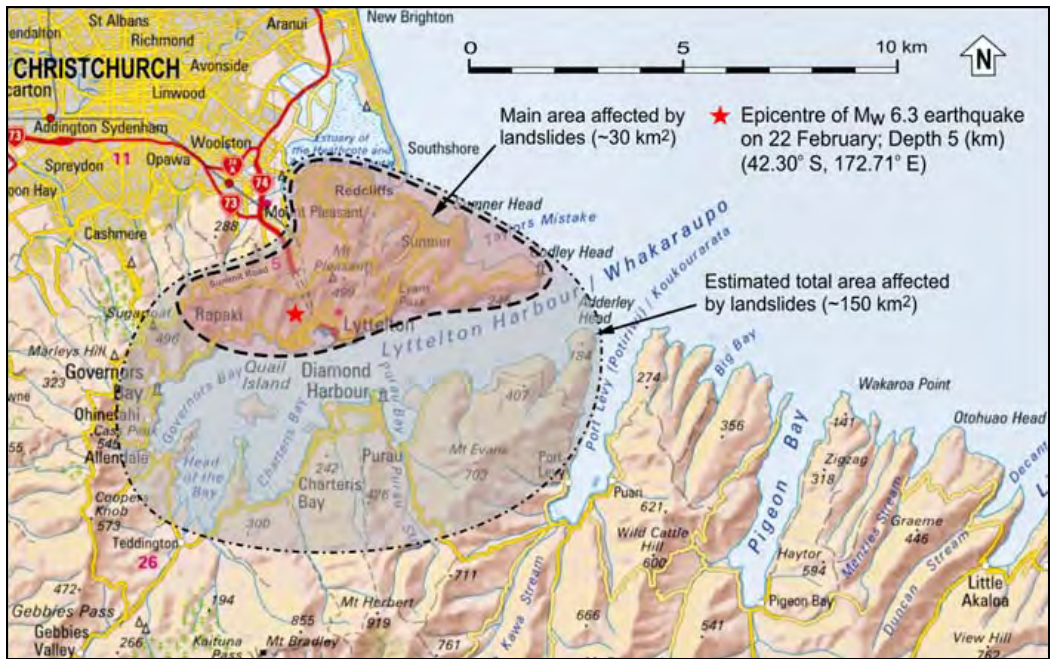
Figure 3. Areas affected by landslides triggered by the 22 February 2011 earthquake.

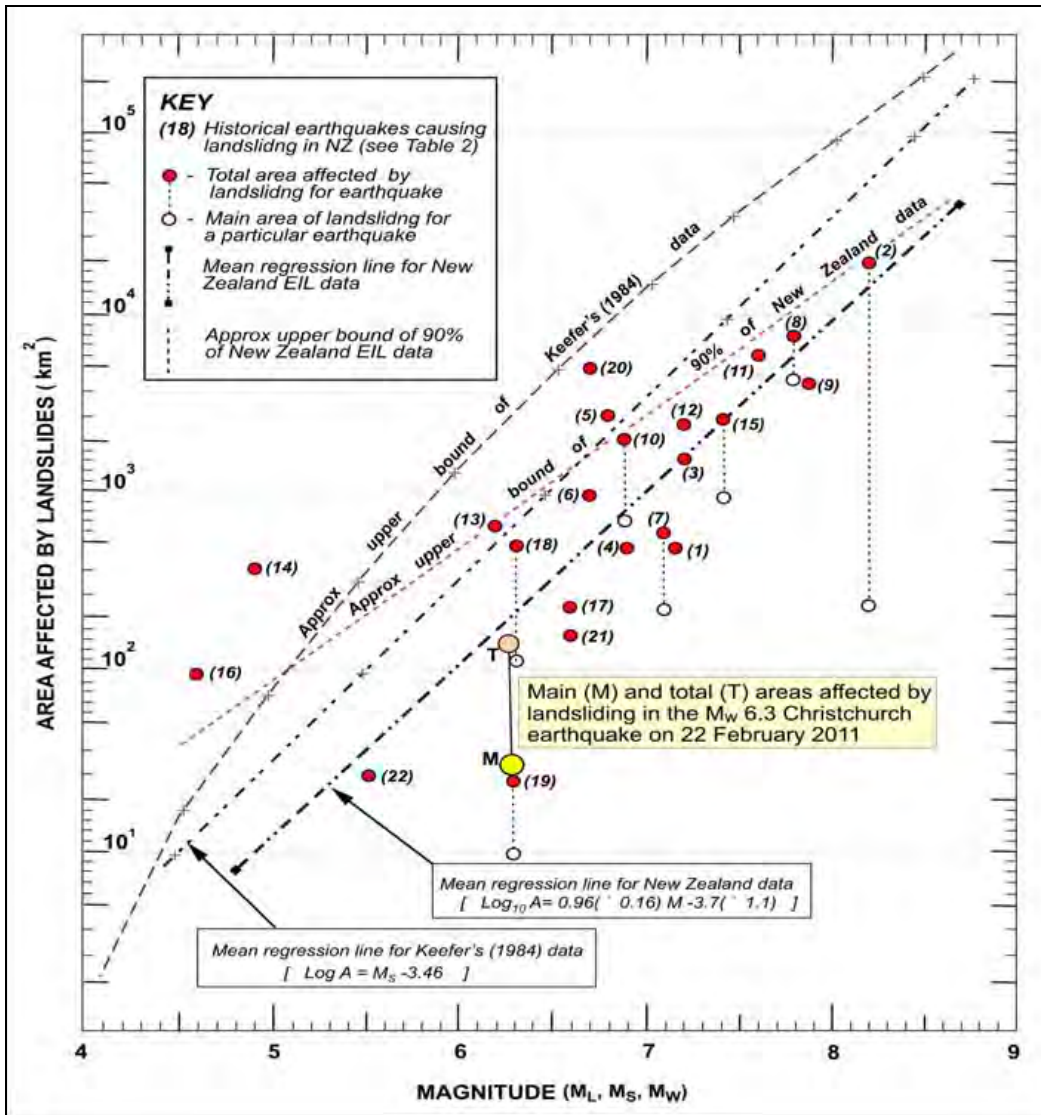
Figure 4. Graph showing the main area ( $\sim 30 \text{ km}^2$ ) and estimated total area ( $\sim 150 \text{ km}^2$ ) affected by landsliding during the  $M_w$  6.3 Christchurch earthquake of 22 February 2011 compared to areas affected by landslides during earthquakes in New Zealand (as determined by Hancox et al. 2002).

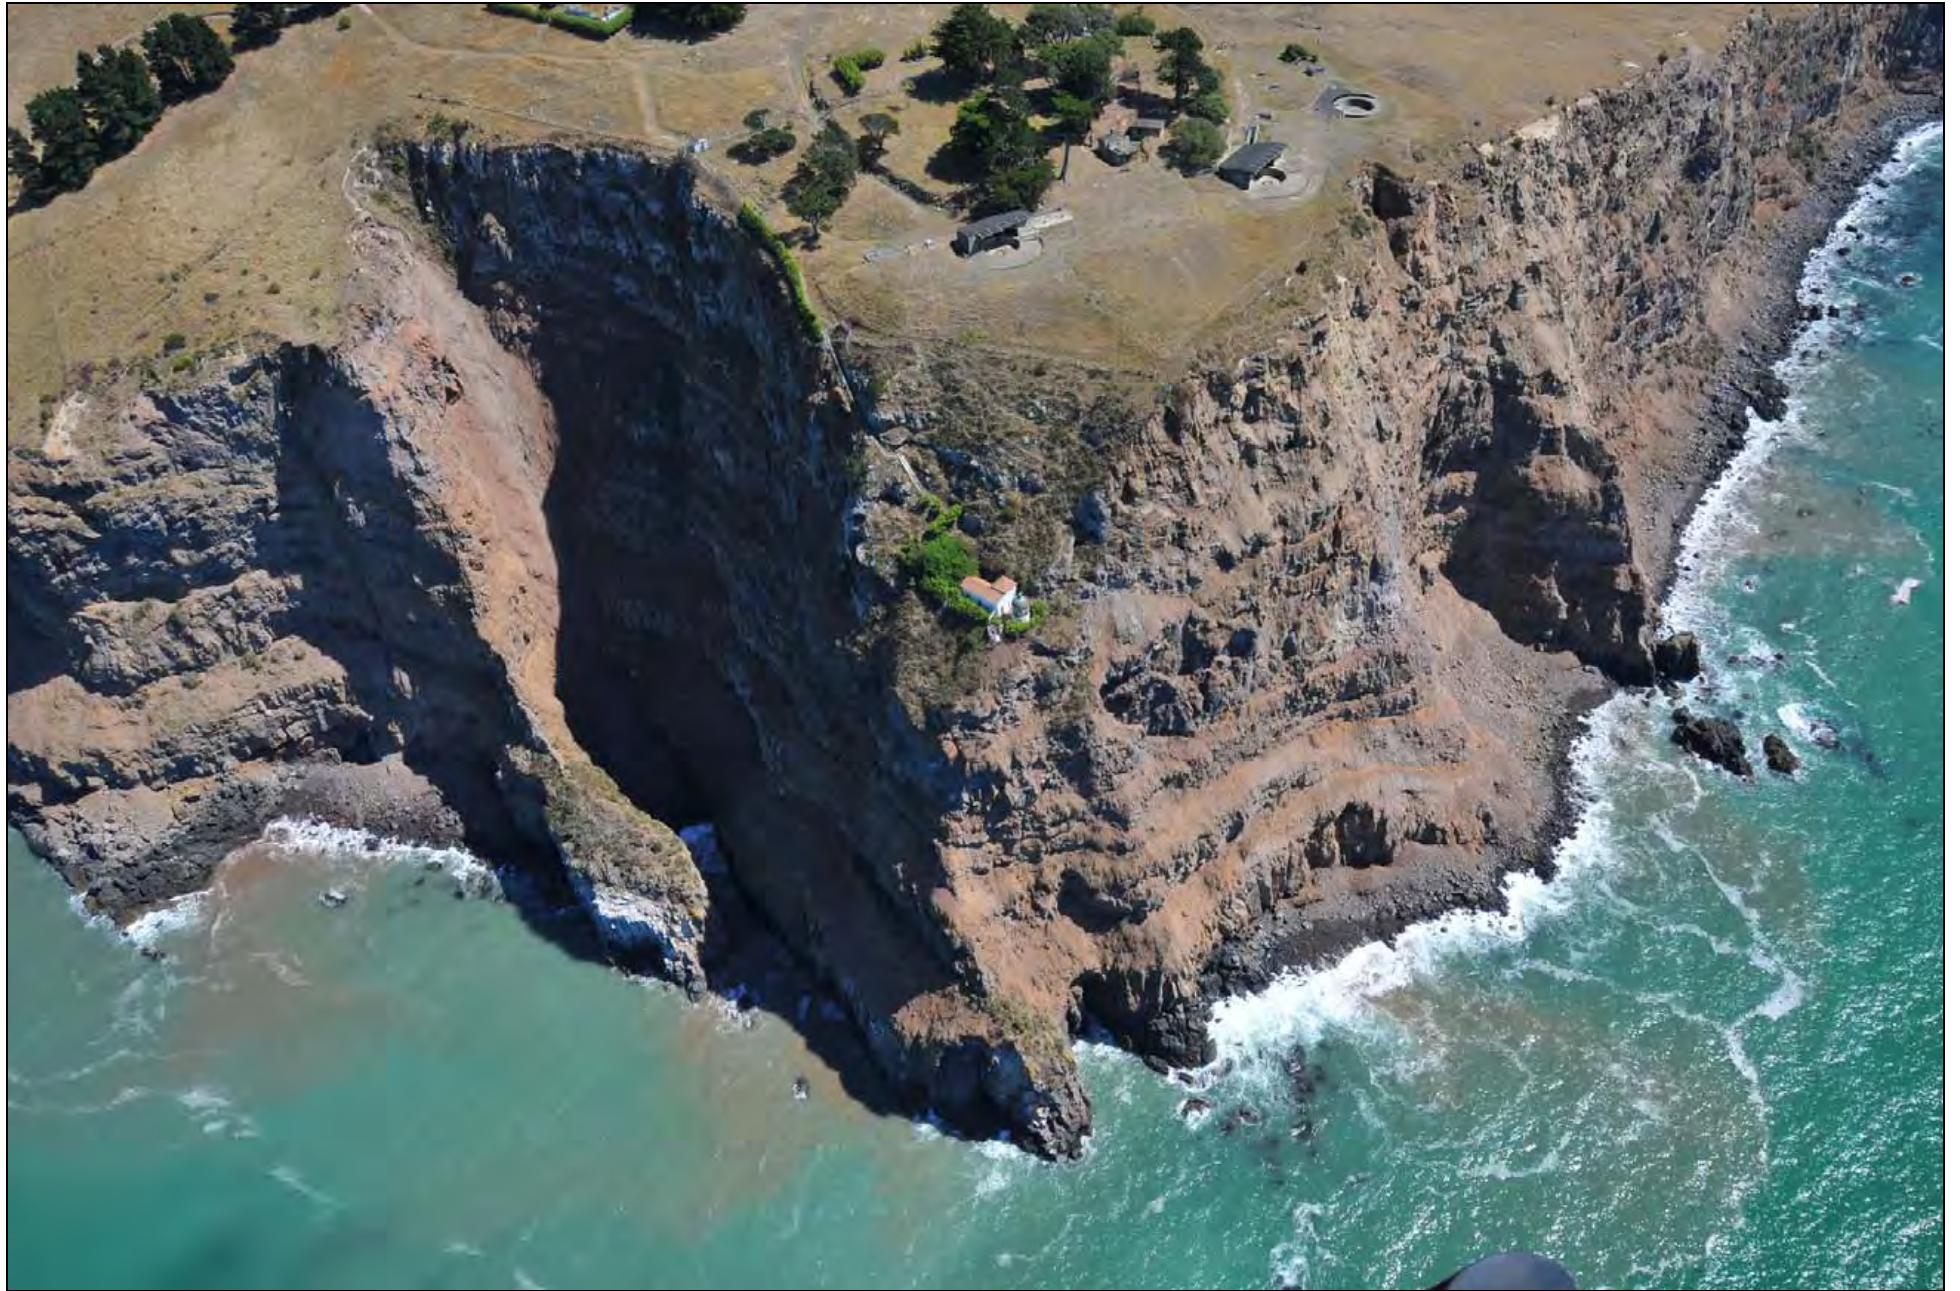
**Photo 1.** Small rock and debris falls on ~100 m high sea cliff at Godley Head (*GNS Photo-GTH\_5622*).

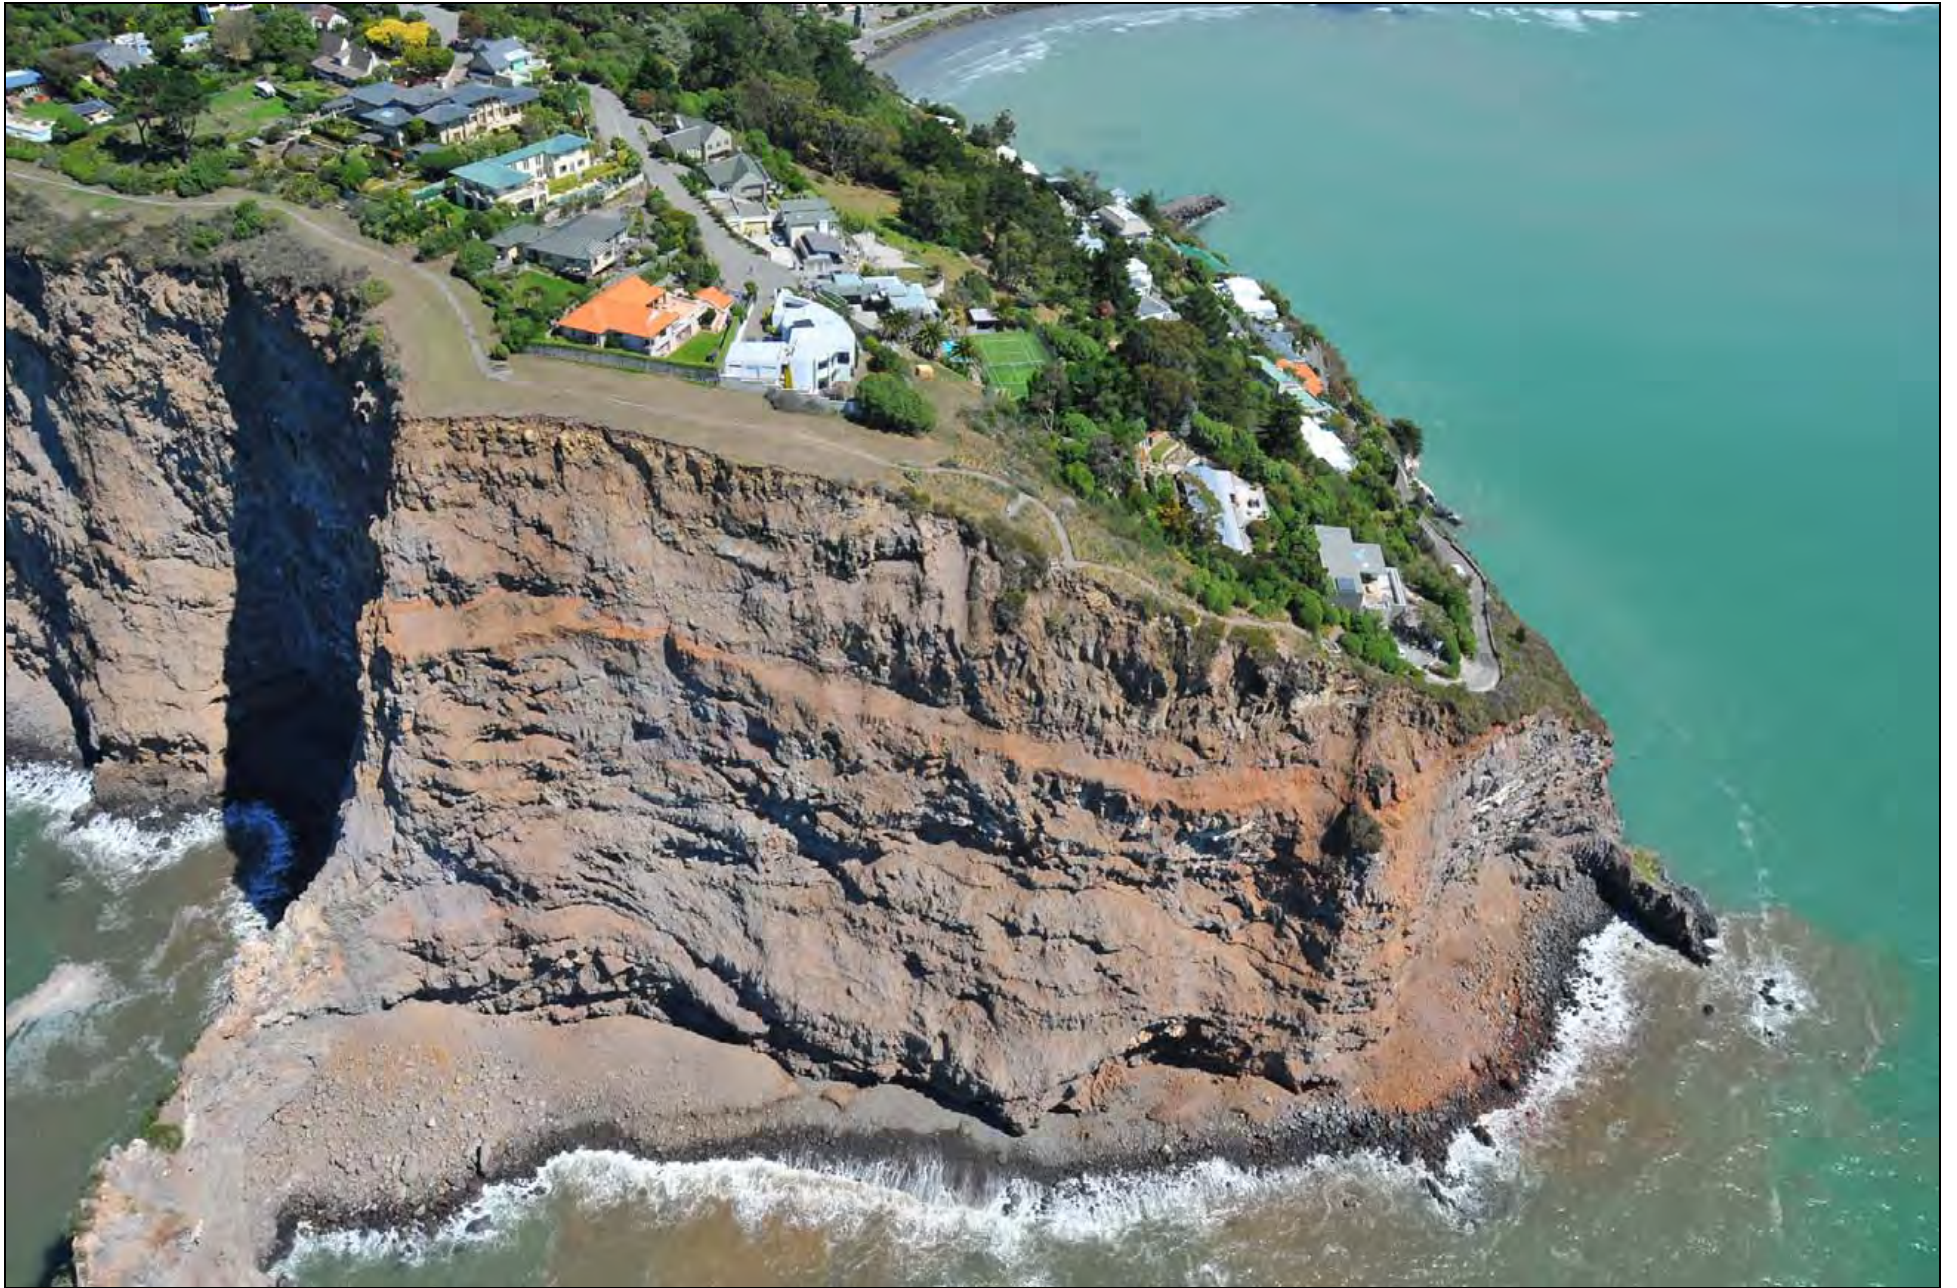
**Photo 2.** Small rock and debris falls on ~100 m high cliff below Searidge Lane at Sumner Head, Scarborough (*GNS Photo-GTH\_5654*).

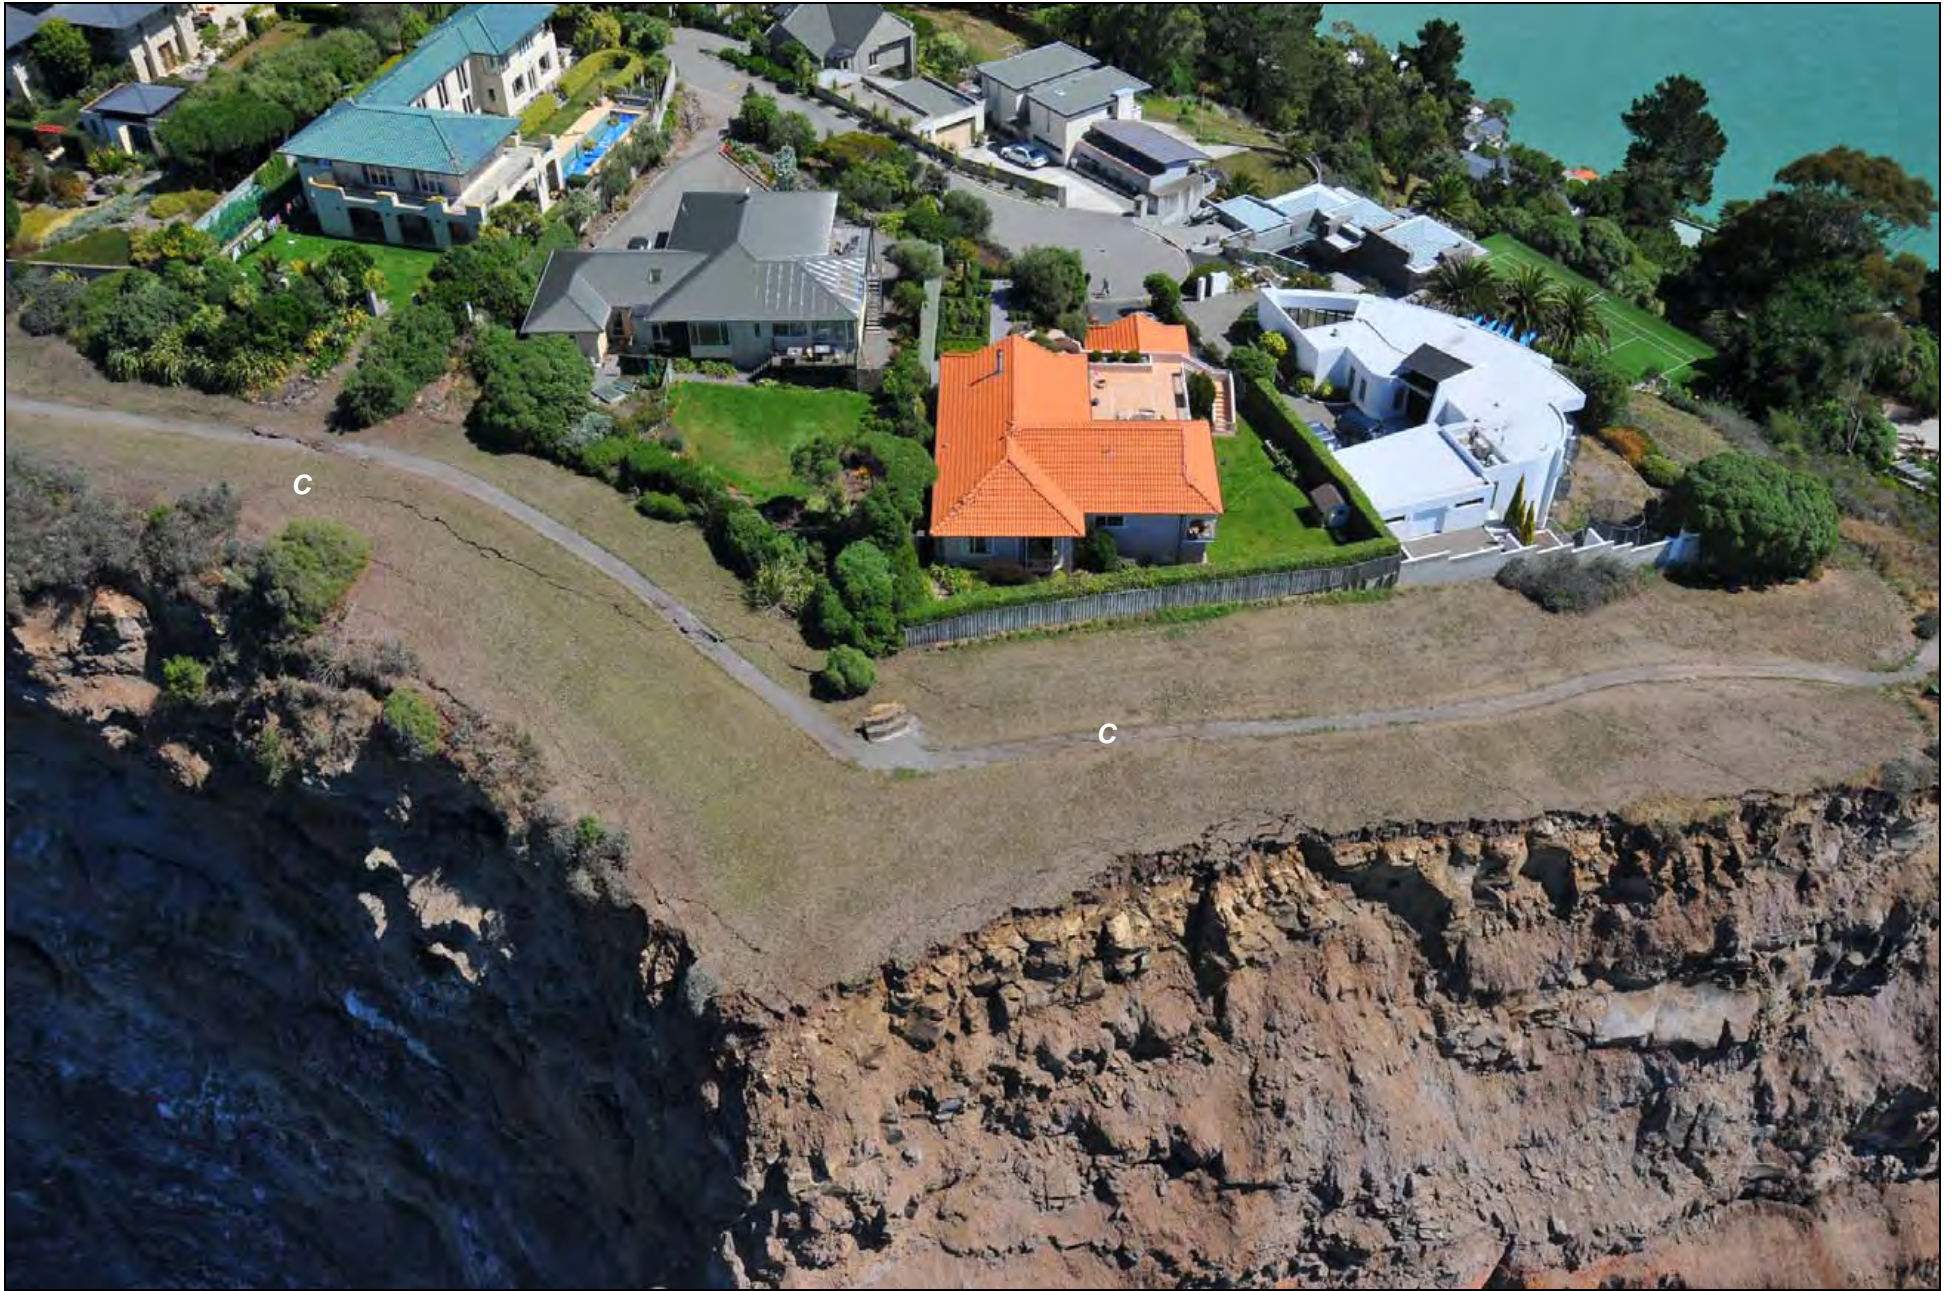
**Photo 3.** Tension cracks (C) along the cliff edge close to houses on Searidge Lane at Sumner Head (GNS Photo-GTH\_5661).

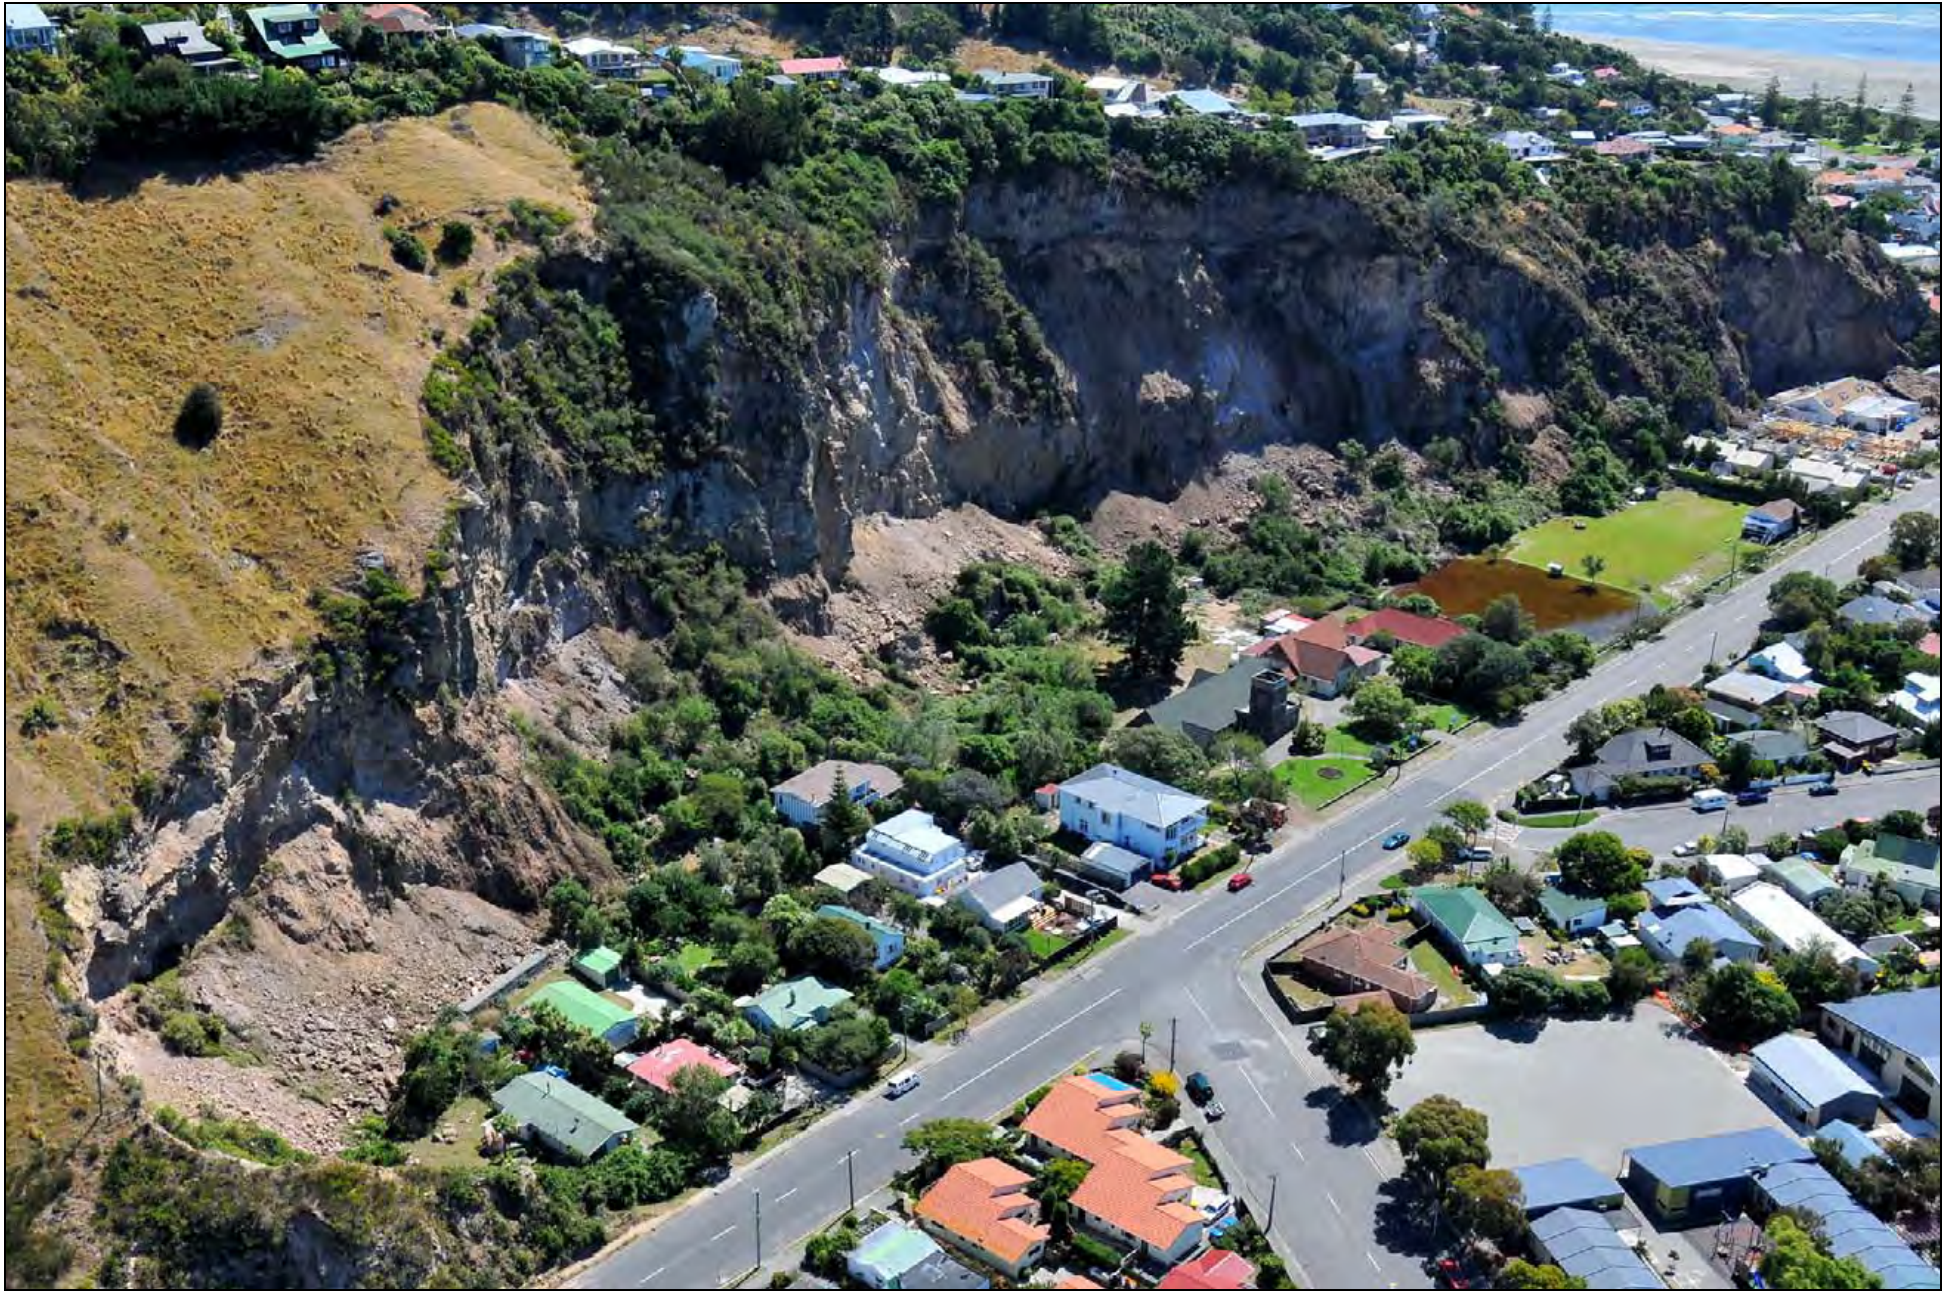
- (4) Some rock falls caused substantial damage to houses and other buildings built very close (~5–15 m) to the cliff face, and some of these houses were totally destroyed by rock falls (Photos 4 to 25). The runout hazard zone from cliff failures was typically limited to an area about 5–30 m out from the base of the cliff (or about  $\frac{1}{2}$  -1 times the cliff height). Two or possibly three fatalities in the Sumner-Redcliffs area have been attributed to rock falls (Photos 6 and 17), and another two fatalities due to rock falls were reported on walking tracks above Lyttleton (Photo 29). The potential for further rock falls in all of the damaged areas during aftershocks is thought to be very high. Any new failures could result in more damage to houses and injuries to occupants, and possibly further fatalities.

**Photo 4.** Rock and debris falls on ~50 m high cliff behind houses at the north end of Wakefield Ave, Sumner. This is an old quarry site (*GNS Photo-GTH\_5699*).

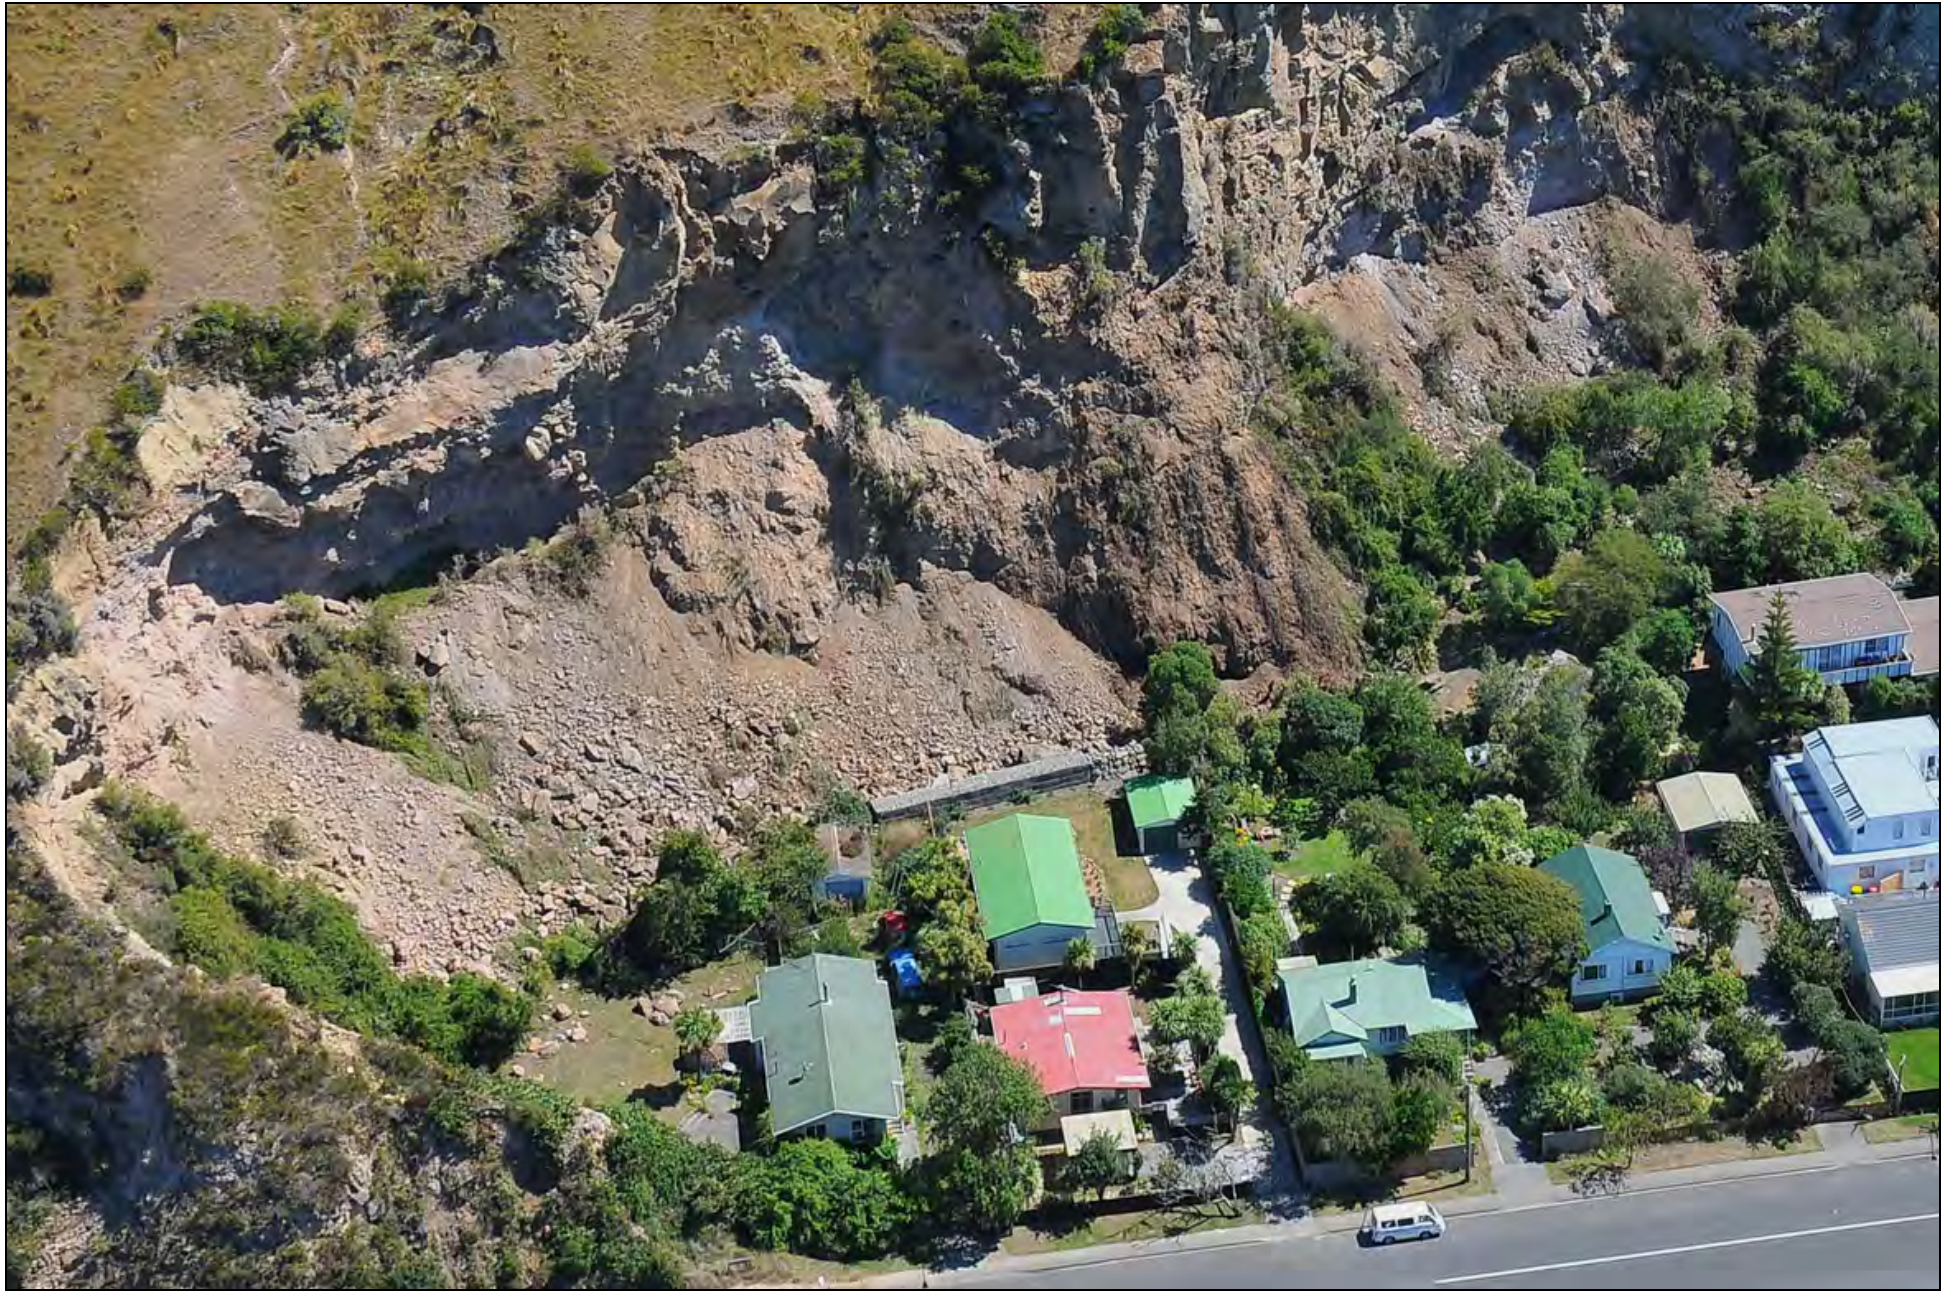
- (5) There were also many falls of multiple and individual boulders up to 1 or ~2 metres across on to roads, especially on the very steep south-facing slopes on the north side of Lyttleton Harbour, and above the Sumner-Evans Pass Road and Summit Road. Many boulders hit and damaged houses (Photos 5, 8, 9). In one case a car-sized boulder travelled ~600 m laterally and 350 m vertically down a steep slope and went through a house at Rapaki (Photos 26 to 28), which was fortunately unoccupied at the time. On the northern side of Lyttleton harbour the boulder fall hazard runout zone extended many hundreds of metres downslope from the source areas, typically on lava bluffs near the ridge crest.

**Photo 5.** Small rock falls and boulders on gardens close to houses between Arnold and Colenso streets, Wakefield Ave, Sumner (*GNS Photo-GTH\_5700*).

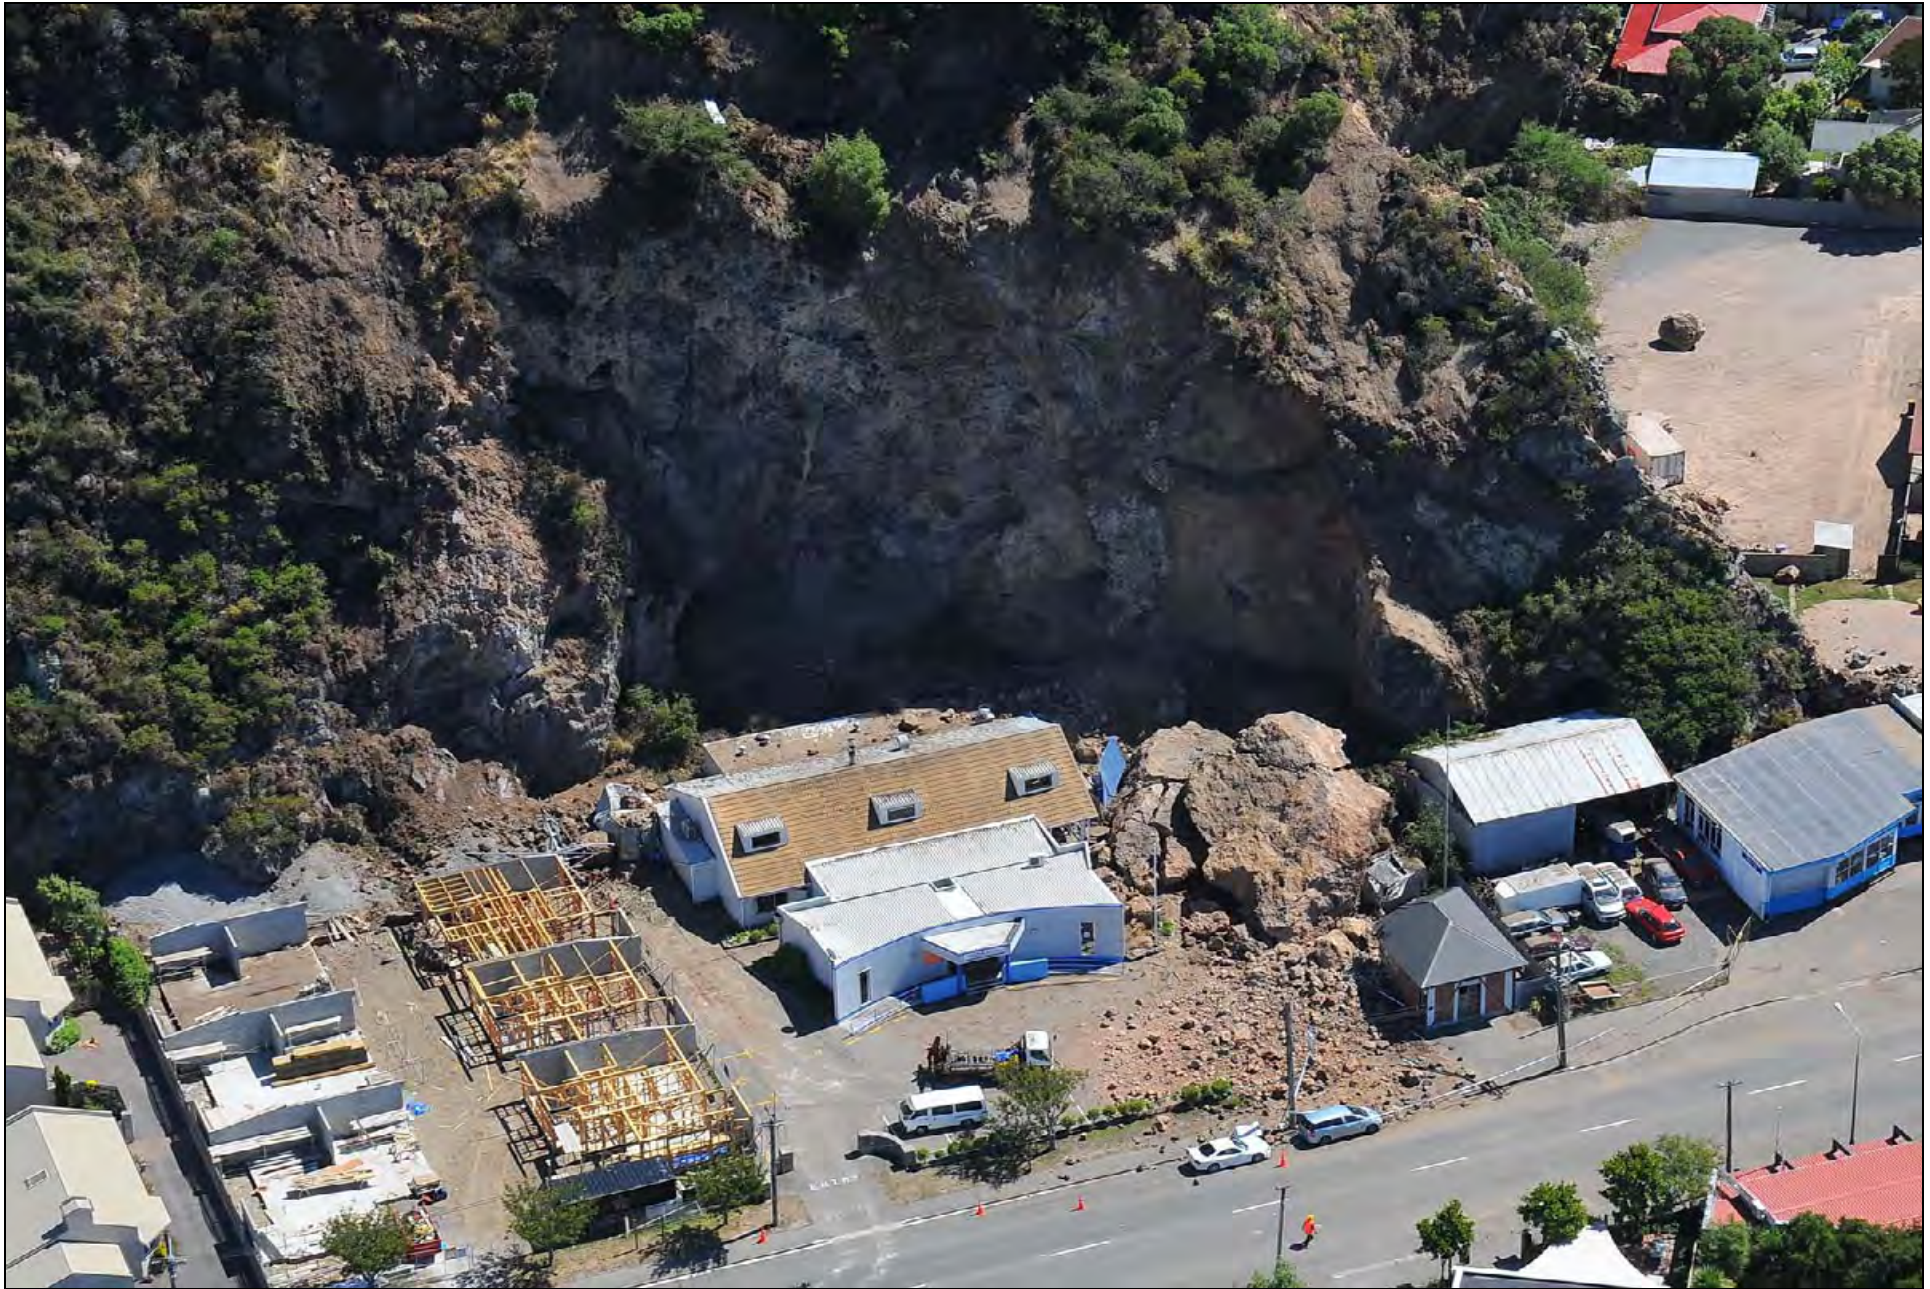
**Photo 6.** Large rock fall behind the RSA Building at 34 in Wakefield Ave, Sumner (rock fall fatality reported at building site left) (*GNS Photo-GTH\_5708*).
