## **GNS SCIENCE IMMEDIATE REPORT**

**DATE:** 2 March 2011

**SUBJECT:** Report on Landslide Reconnaissance Flight on 24 February 2011 following the  $M_w$  6.3 Christchurch Earthquake of 22 February 2011

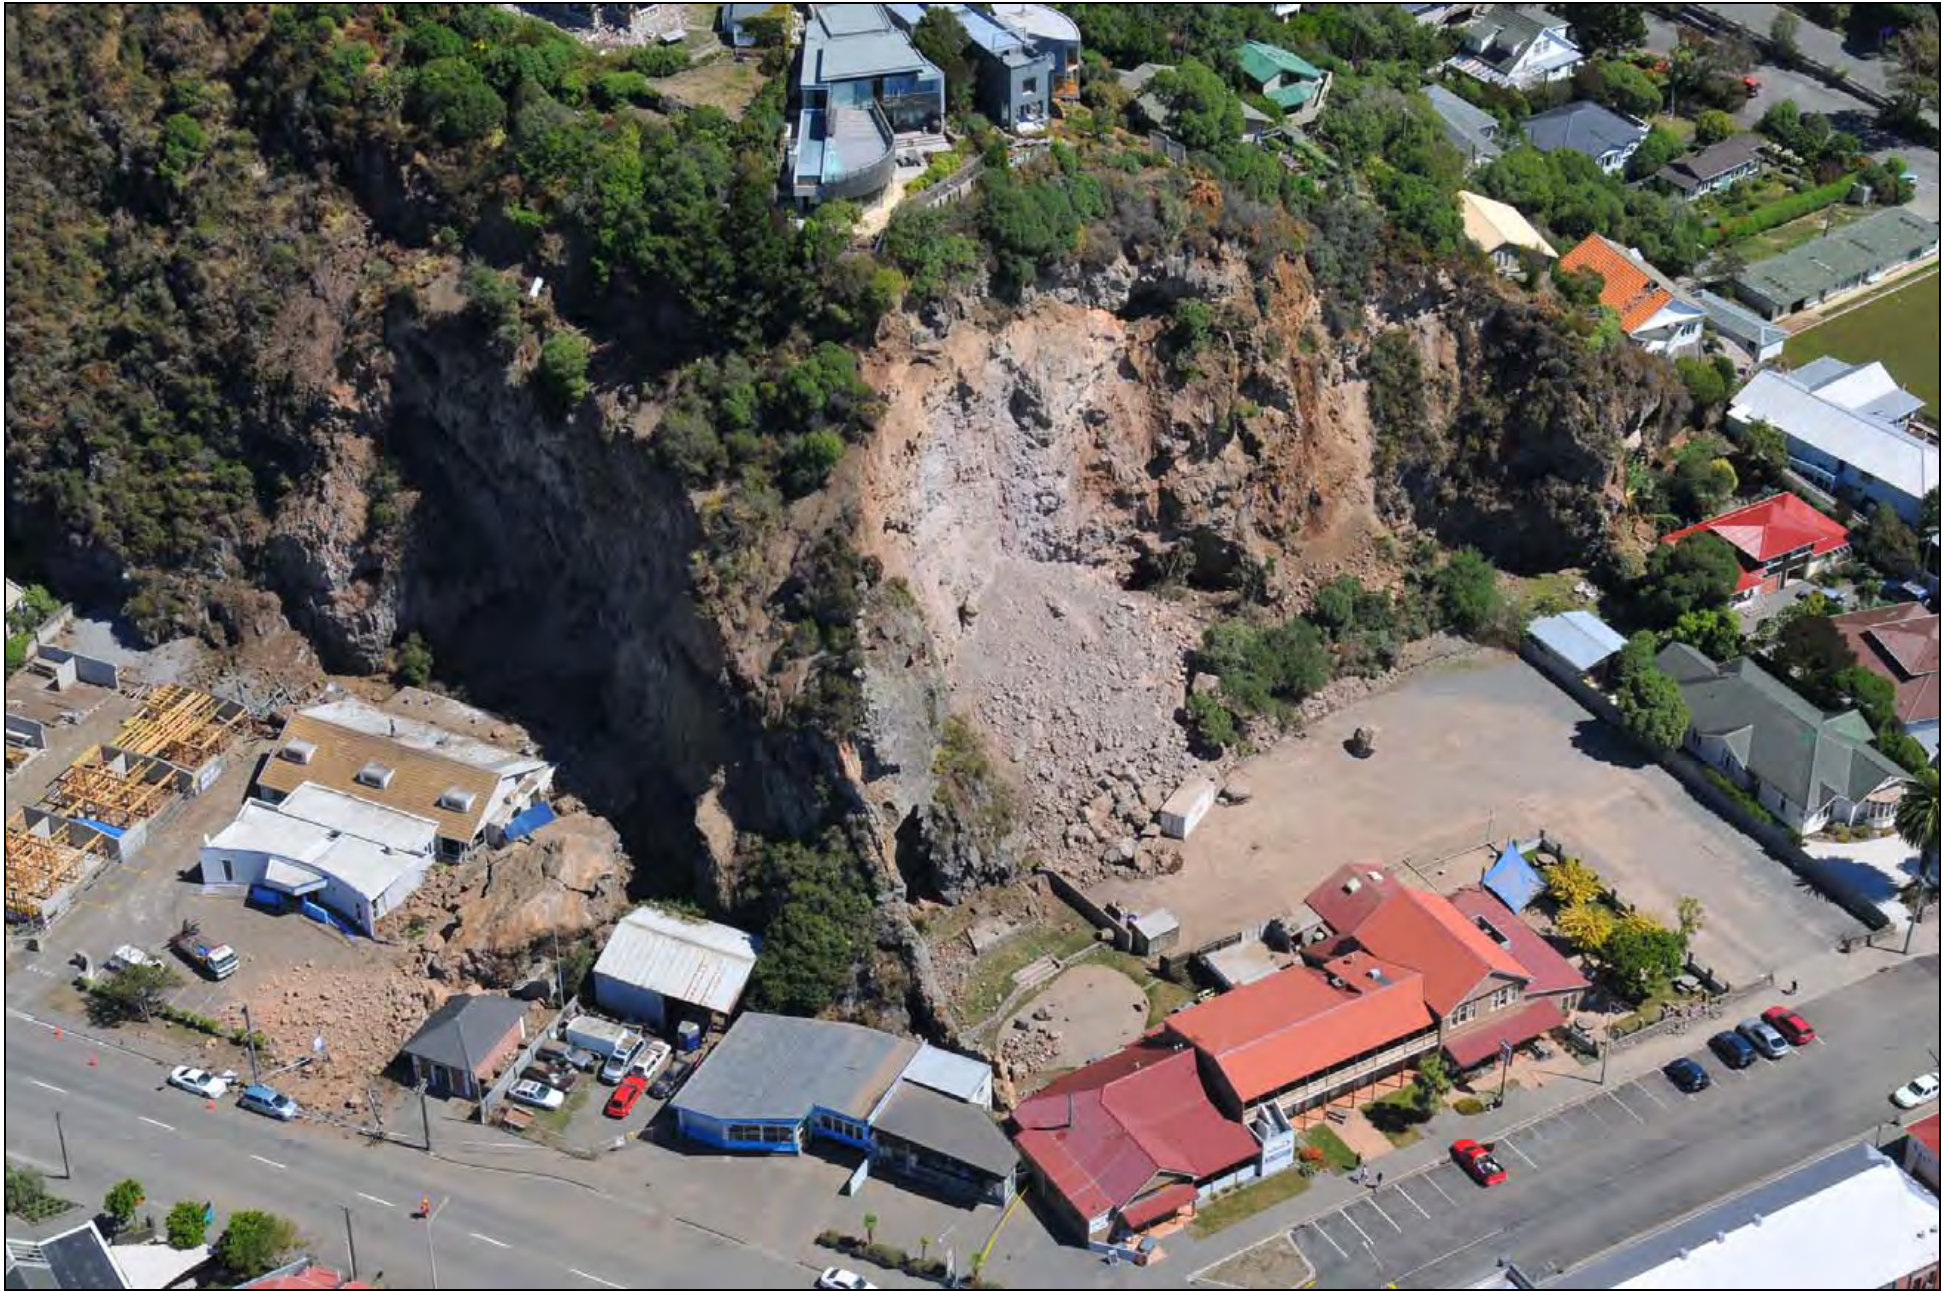
**Photo 7.** Rock falls on cliff face behind RSA and Backpackers buildings at corner of Wakefield Ave (left) and Nayland Street (right), Sumner (*GNS Photo-GTH\_5712*).

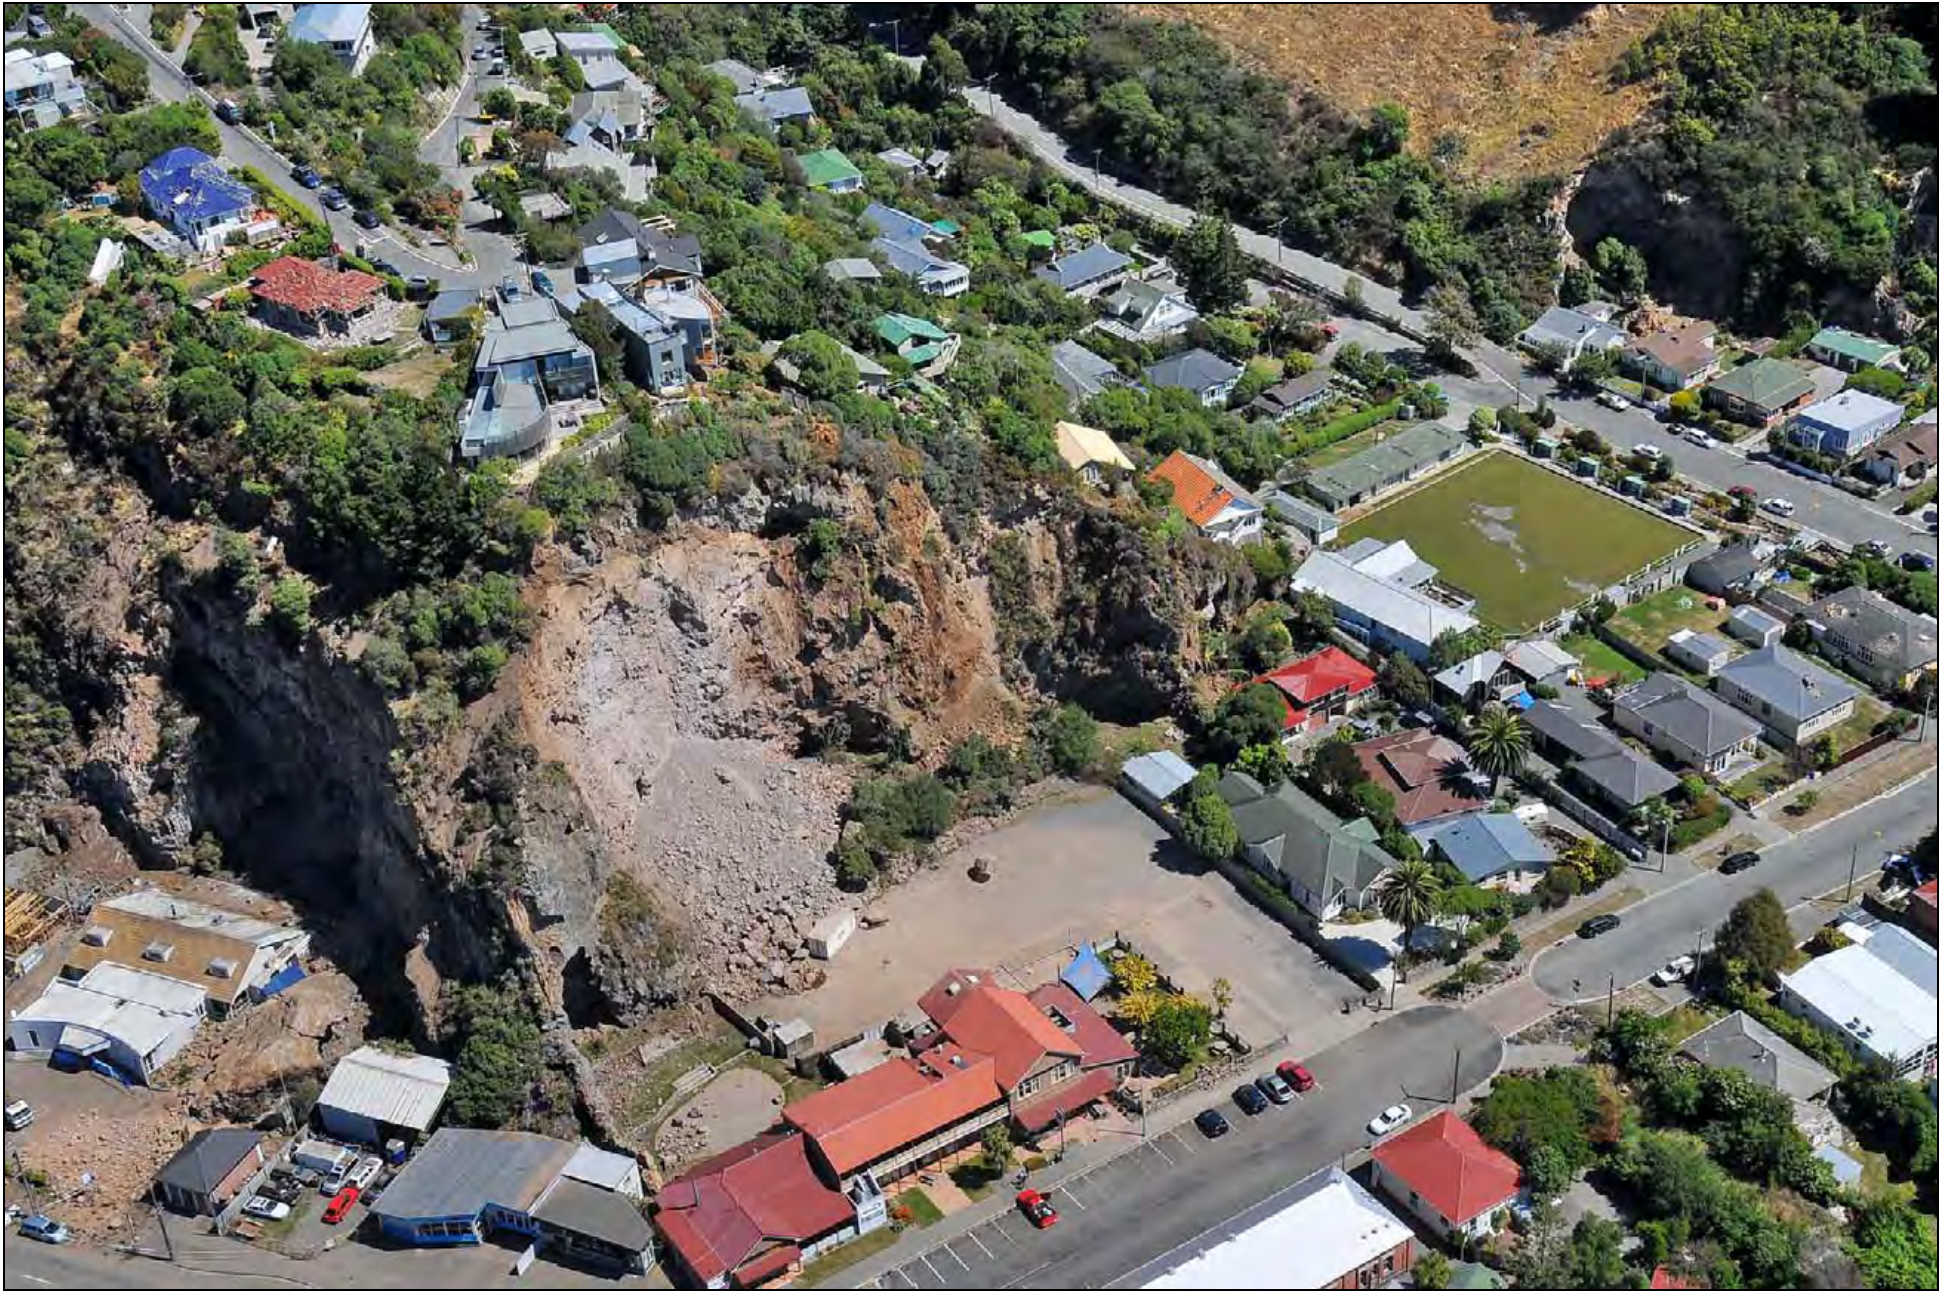
- (5) There were also many falls of multiple and individual boulders up to 1 or ~2 metres across on to roads, especially on the very steep south-facing slopes on the north side of Lyttleton Harbour, and above the Sumner-Evans Pass Road and Summit Road. Many boulders hit and damaged houses (Photos 5, 8, 9). In one case a car-sized boulder travelled ~600 m laterally and 350 m vertically down a steep slope and went through a house at Rapaki (Photos 26 to 28), which was fortunately unoccupied at the time. On the northern side of Lyttleton harbour the boulder fall hazard runout zone extended many hundreds of metres downslope from the source areas, typically on lava bluffs near the ridge crest.

**Photo 8.** Rock falls at RSA and Marine Backpackers site, Sumner (*GNS Photo-GTH\_5714*). Note badly damaged houses top left (see *Photo 8a*- same location as *Photo 8*).

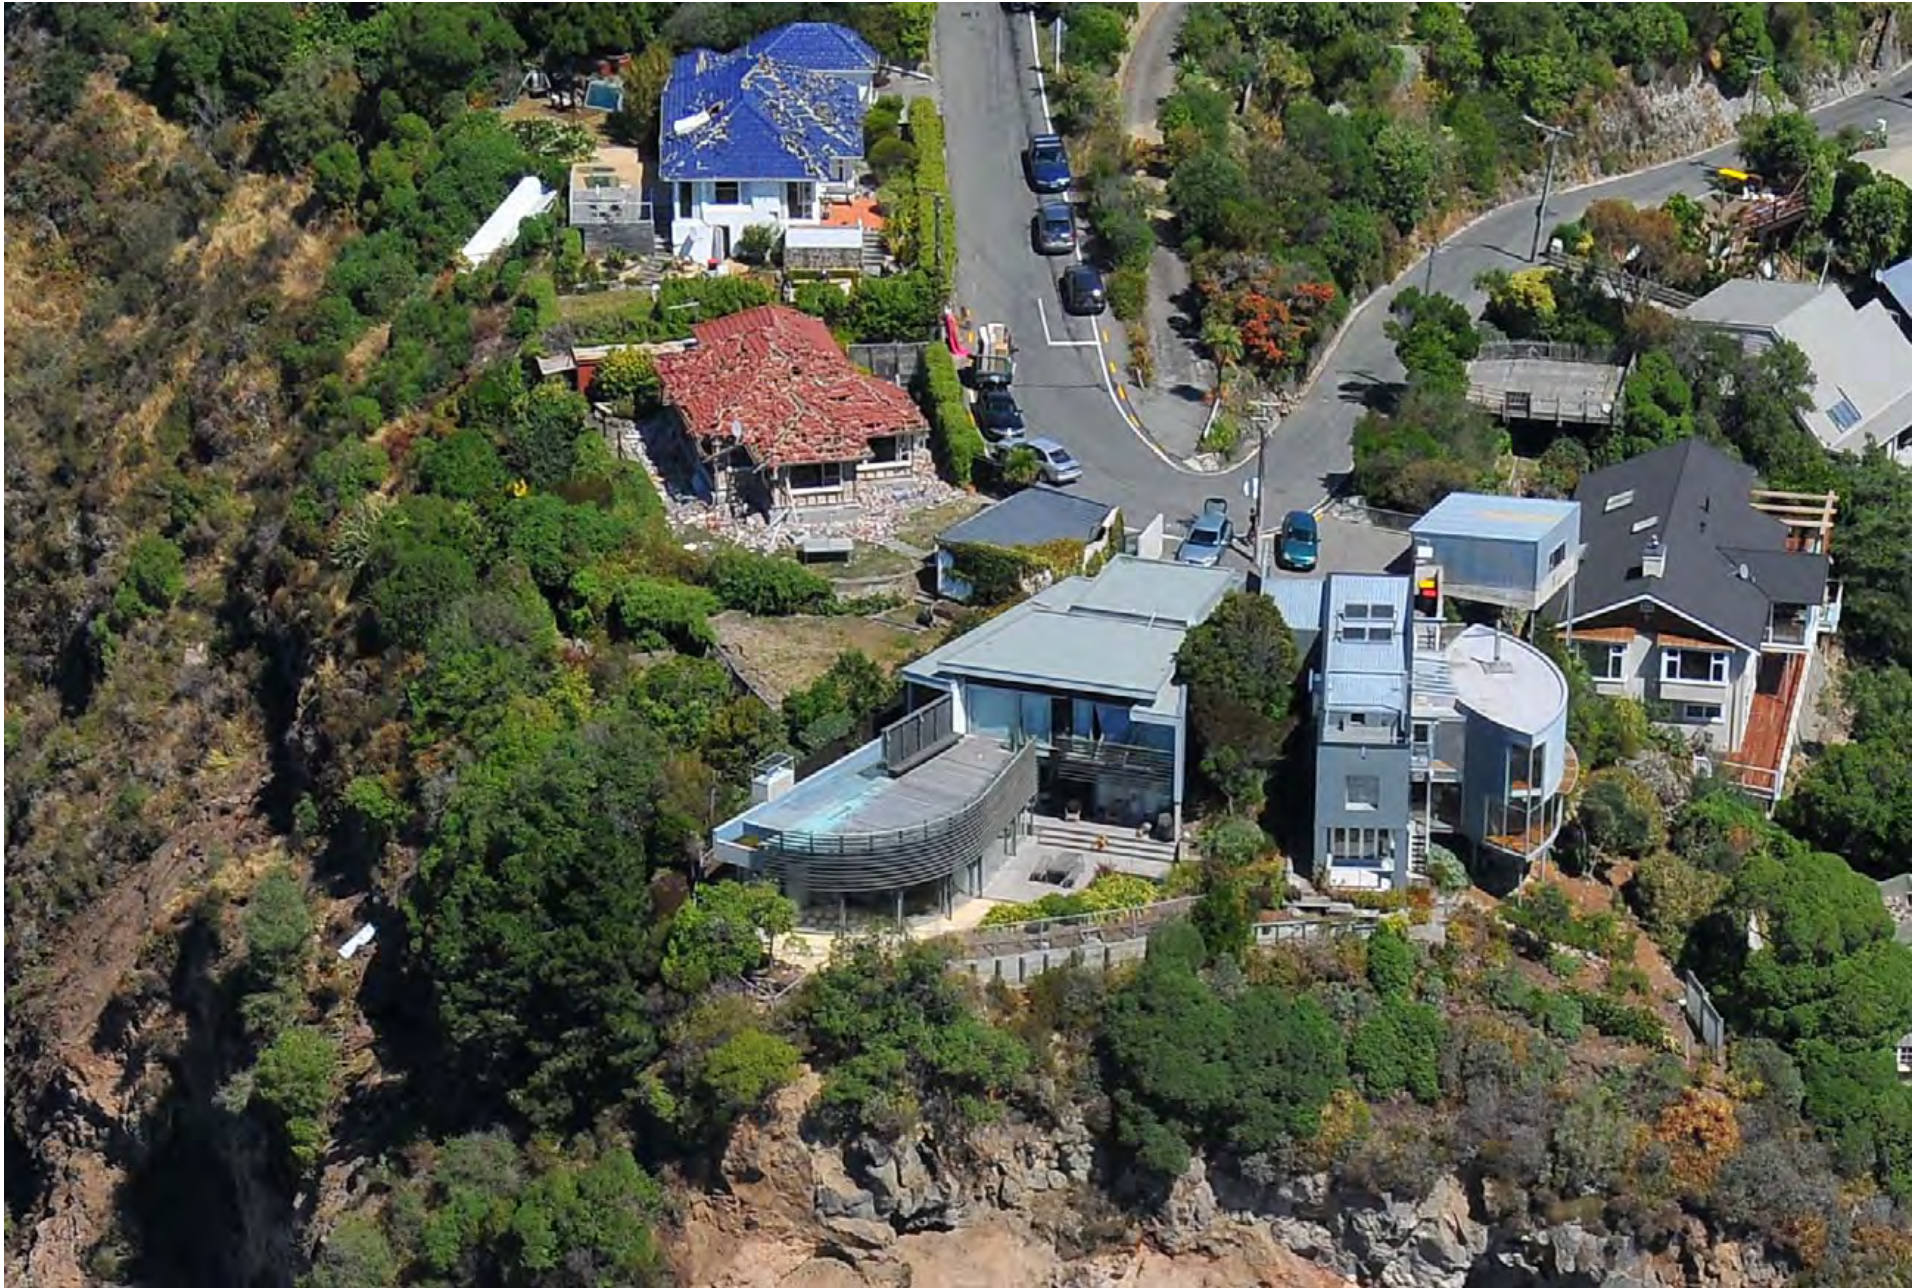
**Photo 8a.** Houses on Richmond Hill Road badly damaged by strong shaking at top of 50 m high cliff above RSA building at Sumner (*GNS Photo-GTH\_5723*).

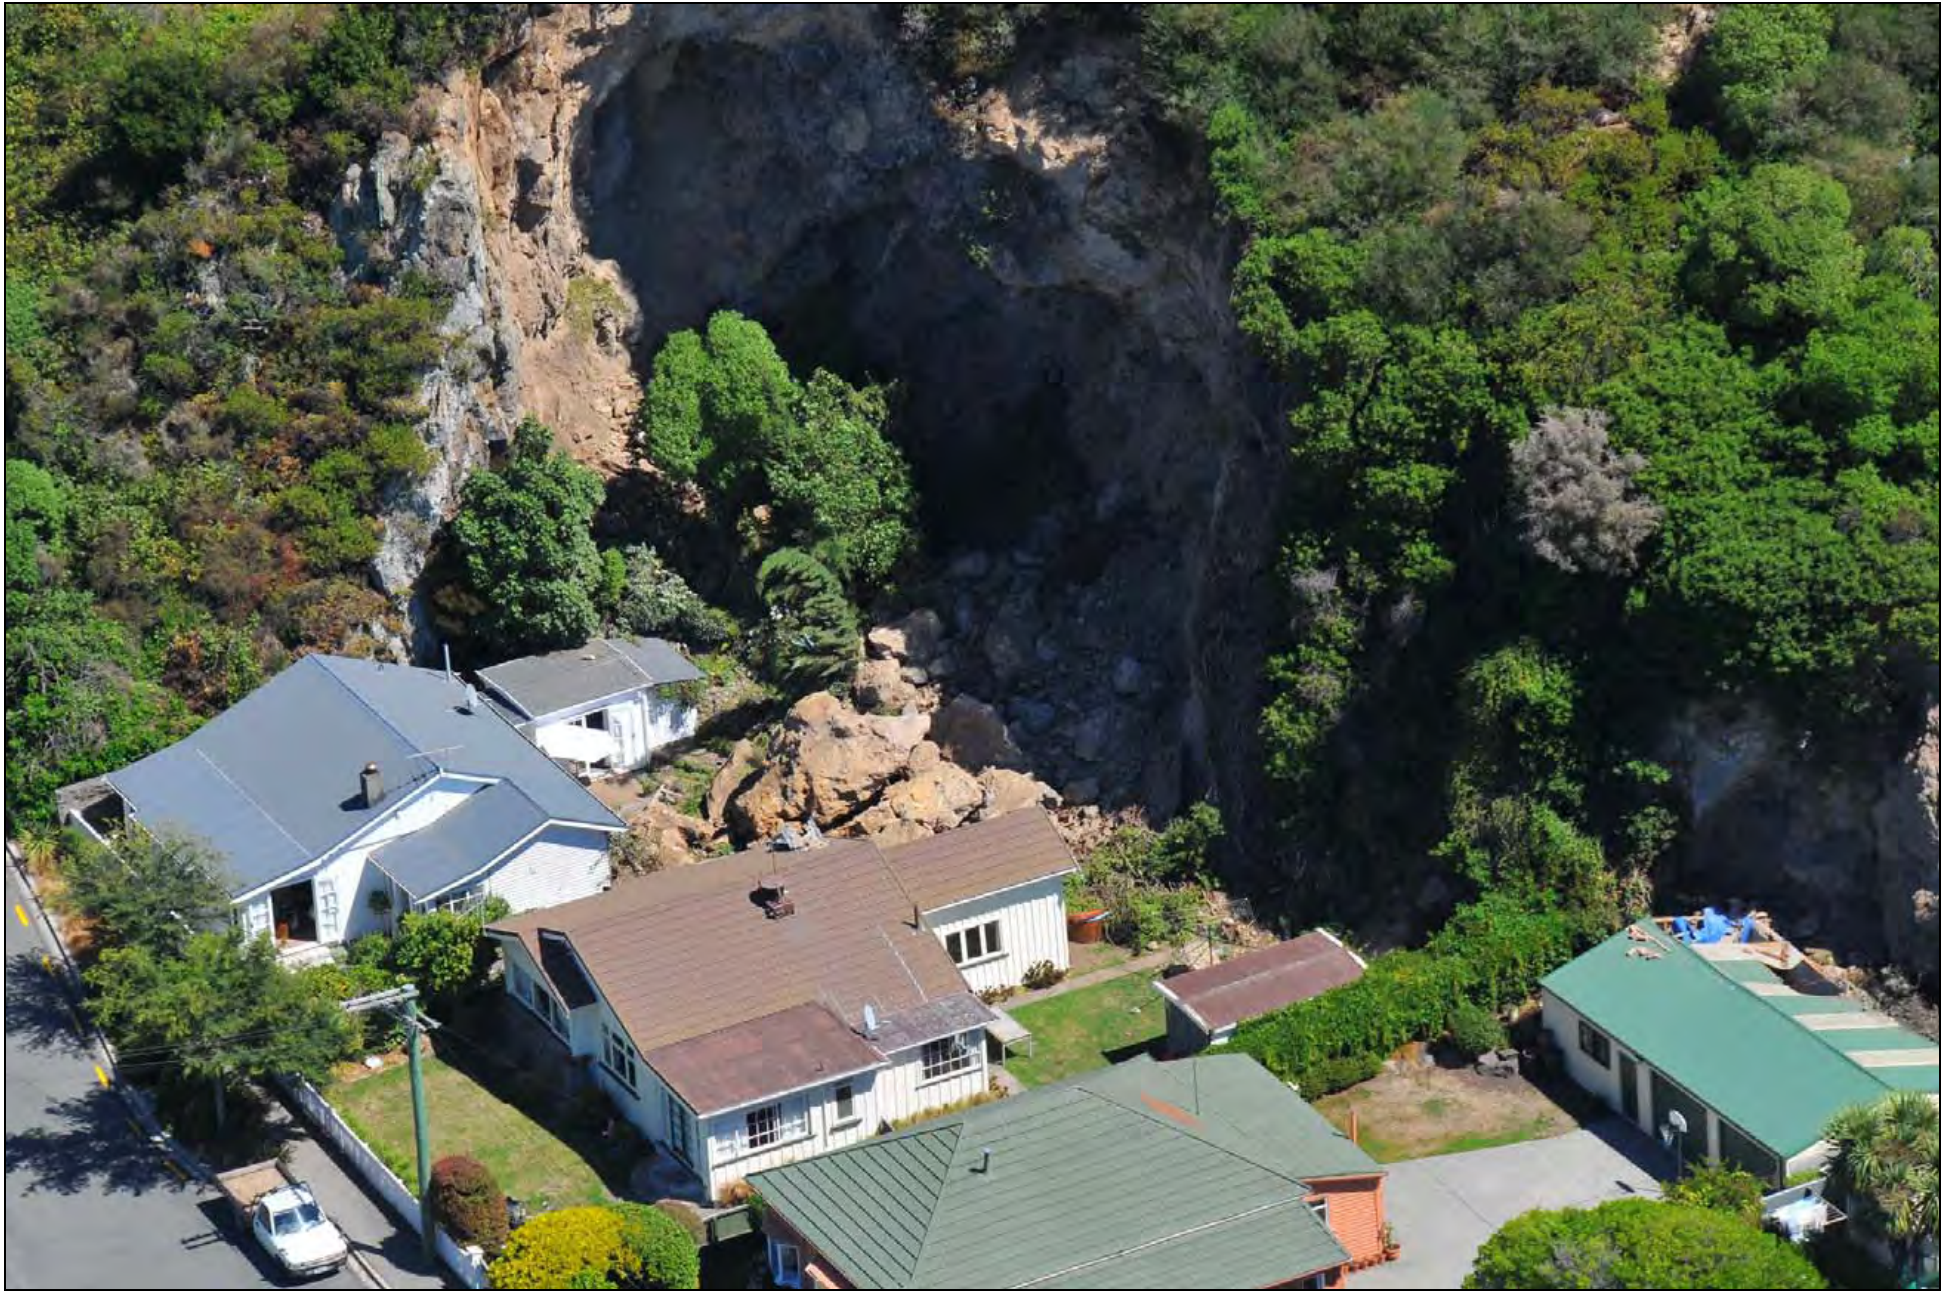
**Photo 9.** Fall of large boulders at the back of damaged houses at 11 (left) and 9 (centre) Richmond Hill Rd, Sumner (*GNS Photo-GTH\_5727*).

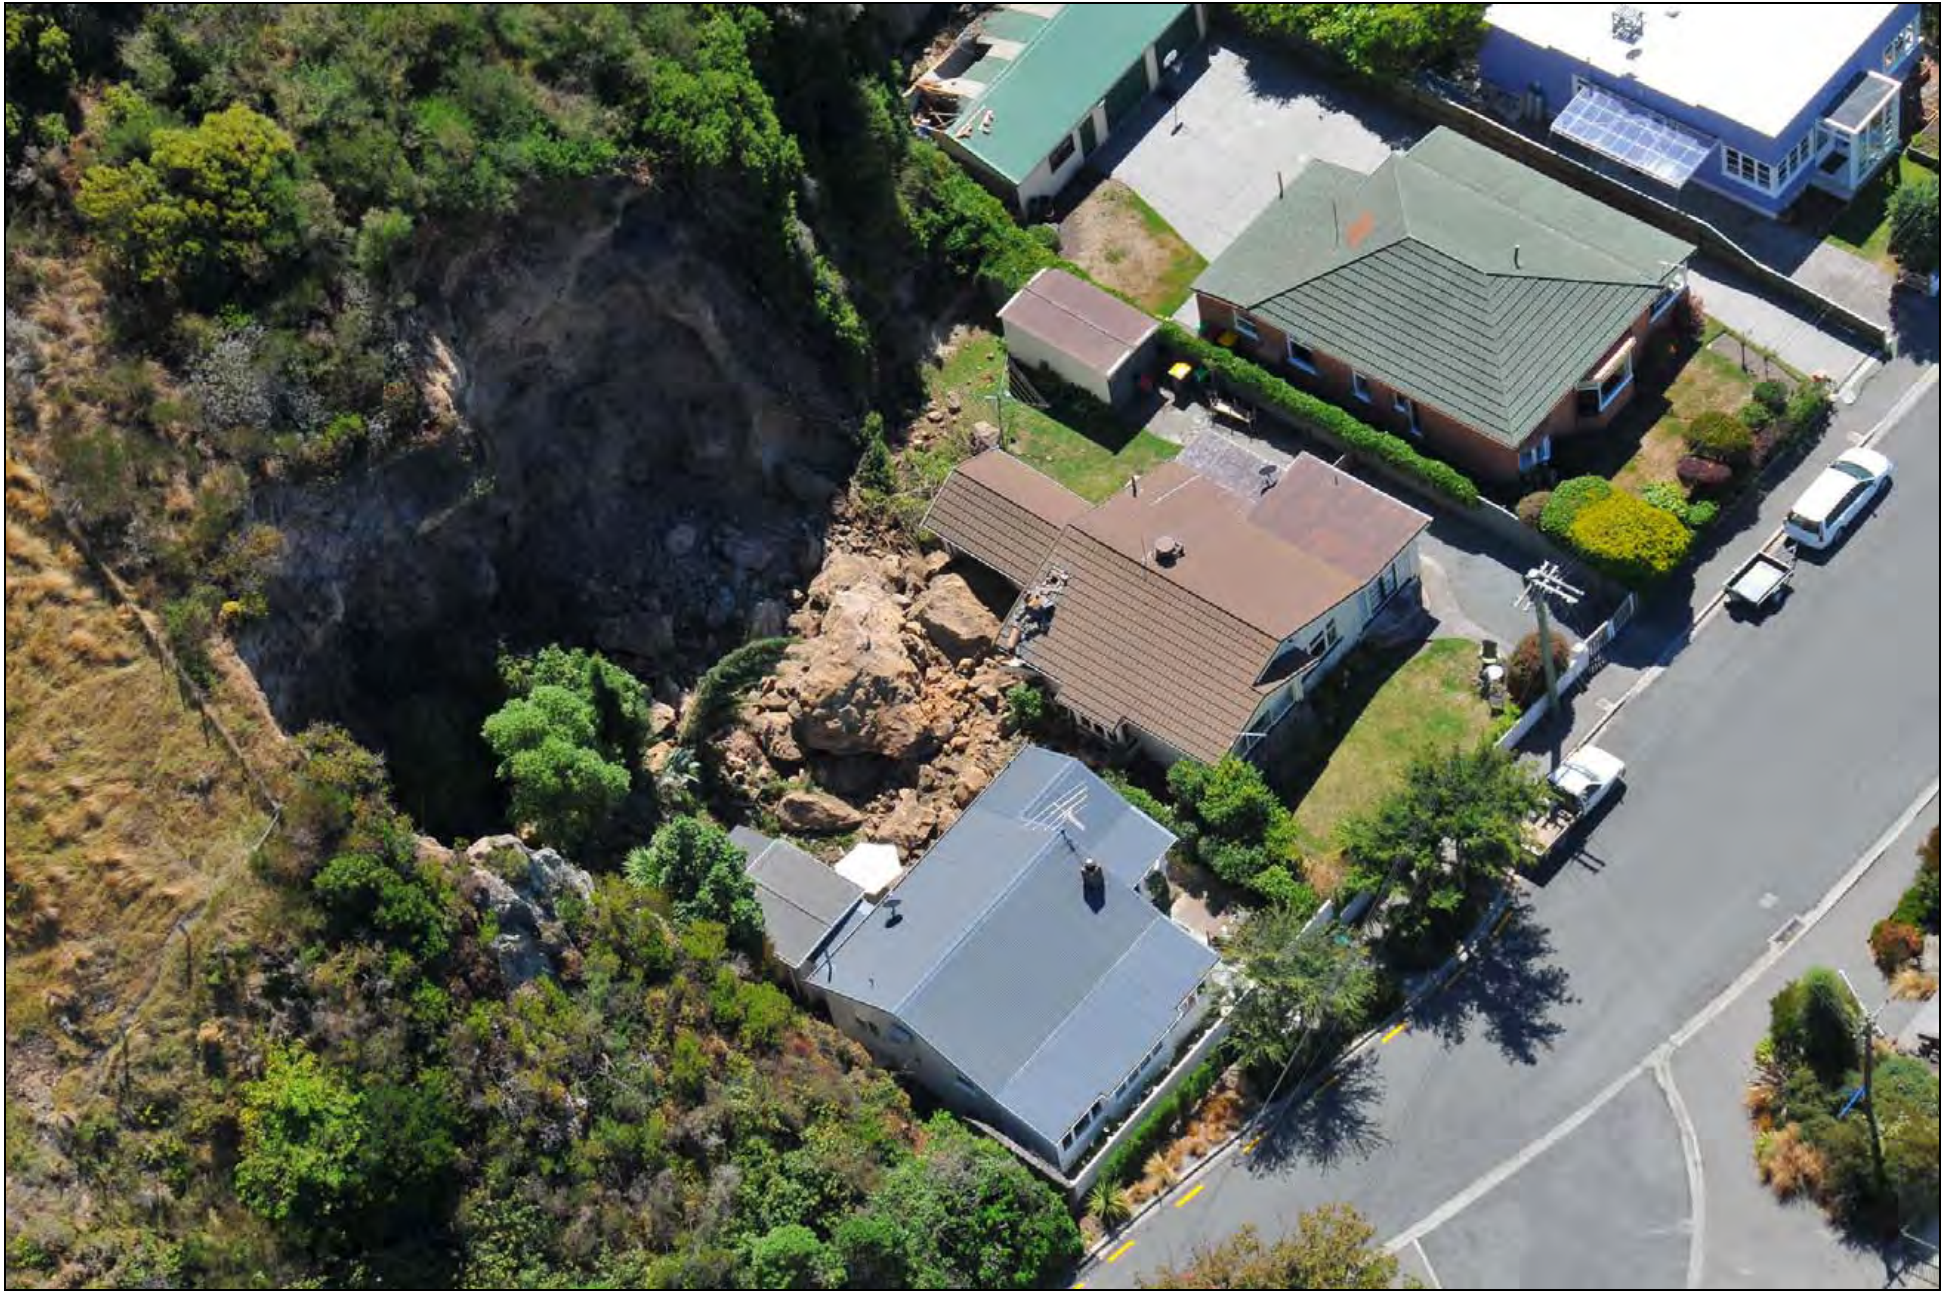
**Photo 10.** Fall of large boulders at the back of damaged houses at 11 (bottom) and 9 (centre) Richmond Hill Rd, Sumner (*GNS Photo-GTH\_5736*).

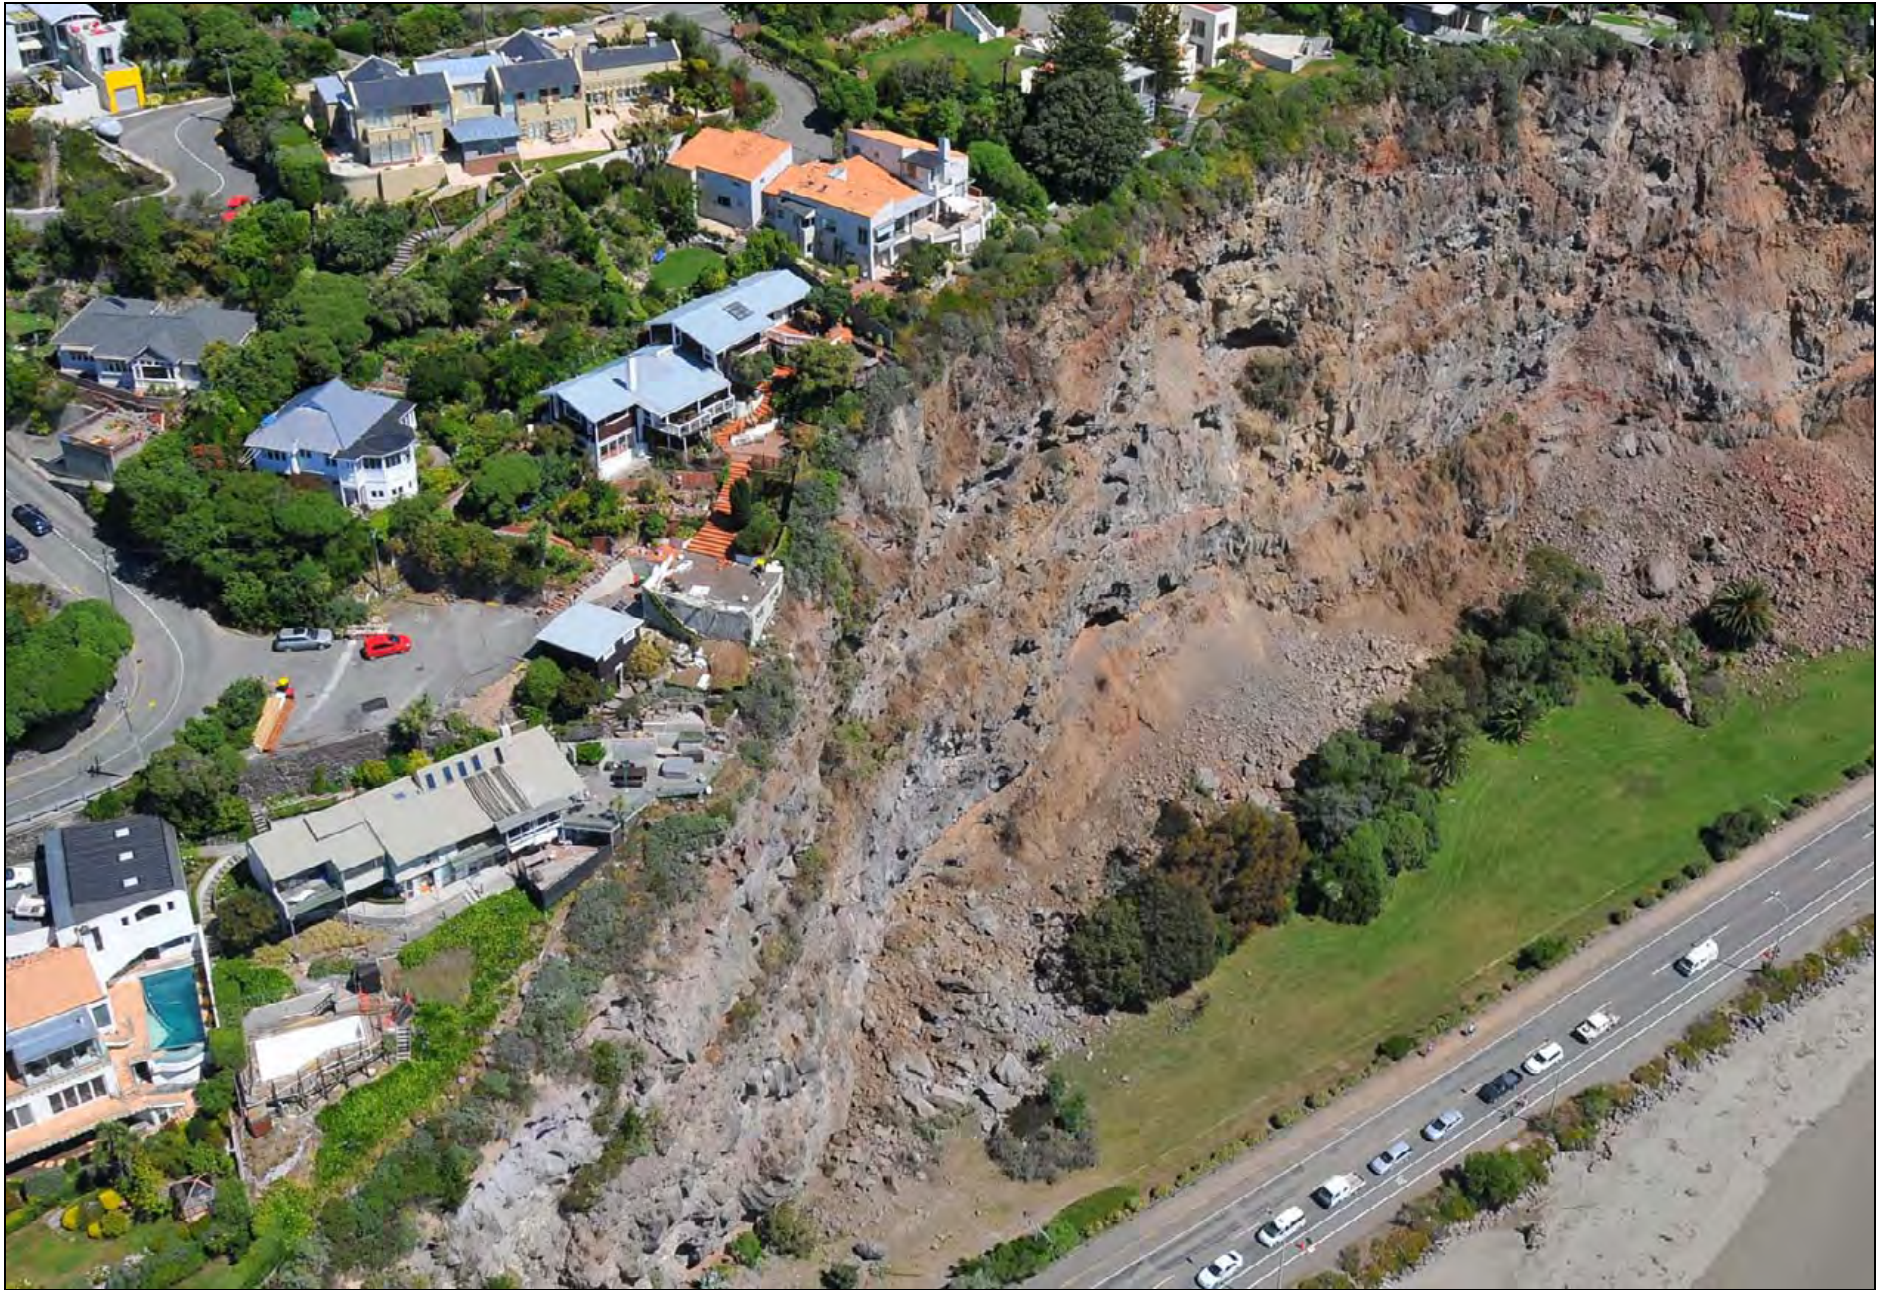
**Photo 11.** Rock falls on cliff face below Kinsey Tce on to 'Peacocks Gallop' reserve along Main Road between Sumner and Moncks Bay (*GNS Photo-GTH\_5745*).

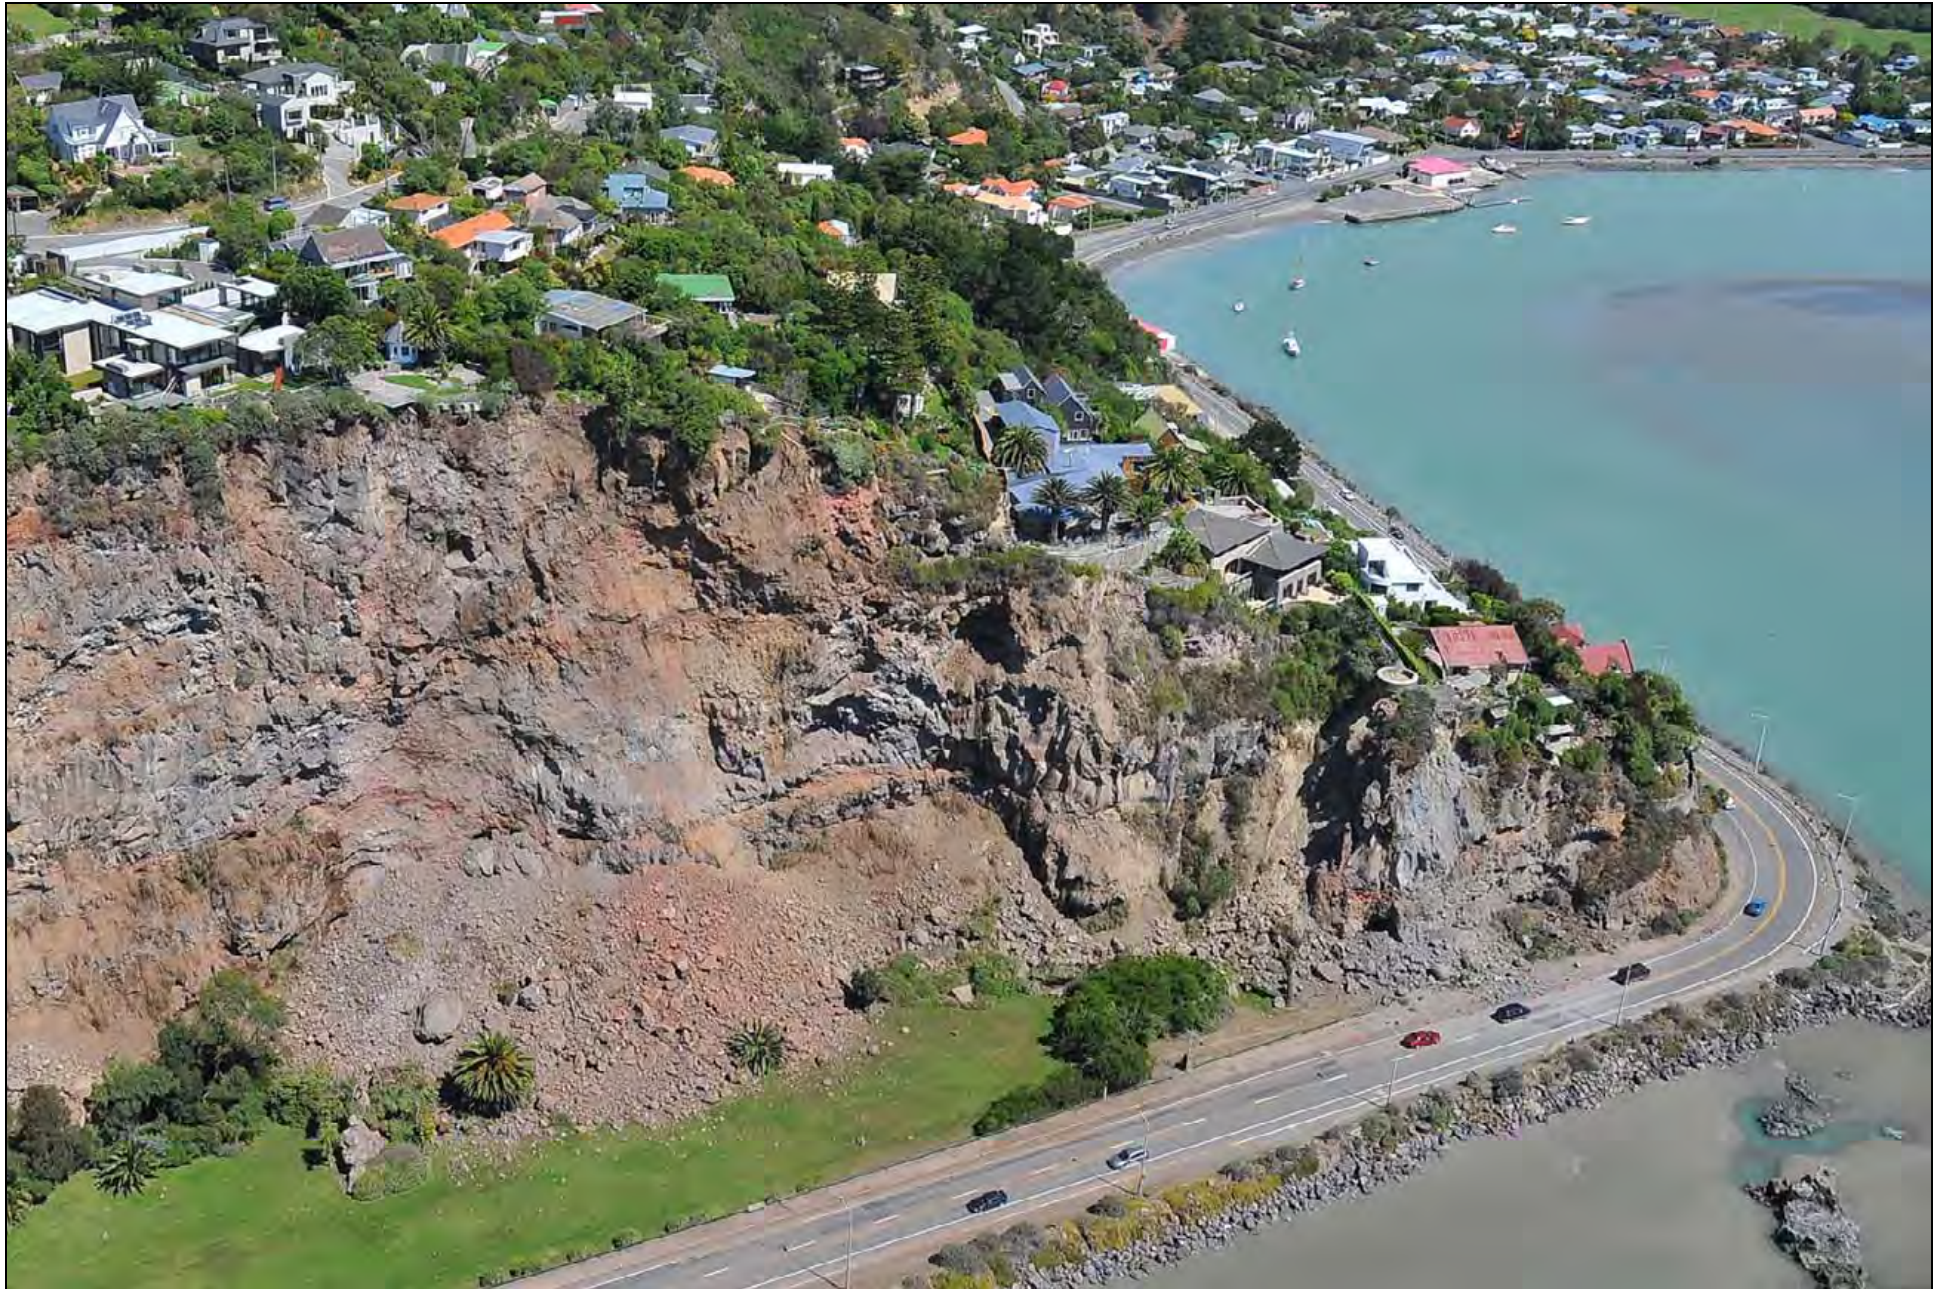
**Photo 12.** Rock falls on cliff (a former quarry site) below Kinsey Terrace on the Main Road between Sumner and Moncks Bay (right). (GTH\_5749).

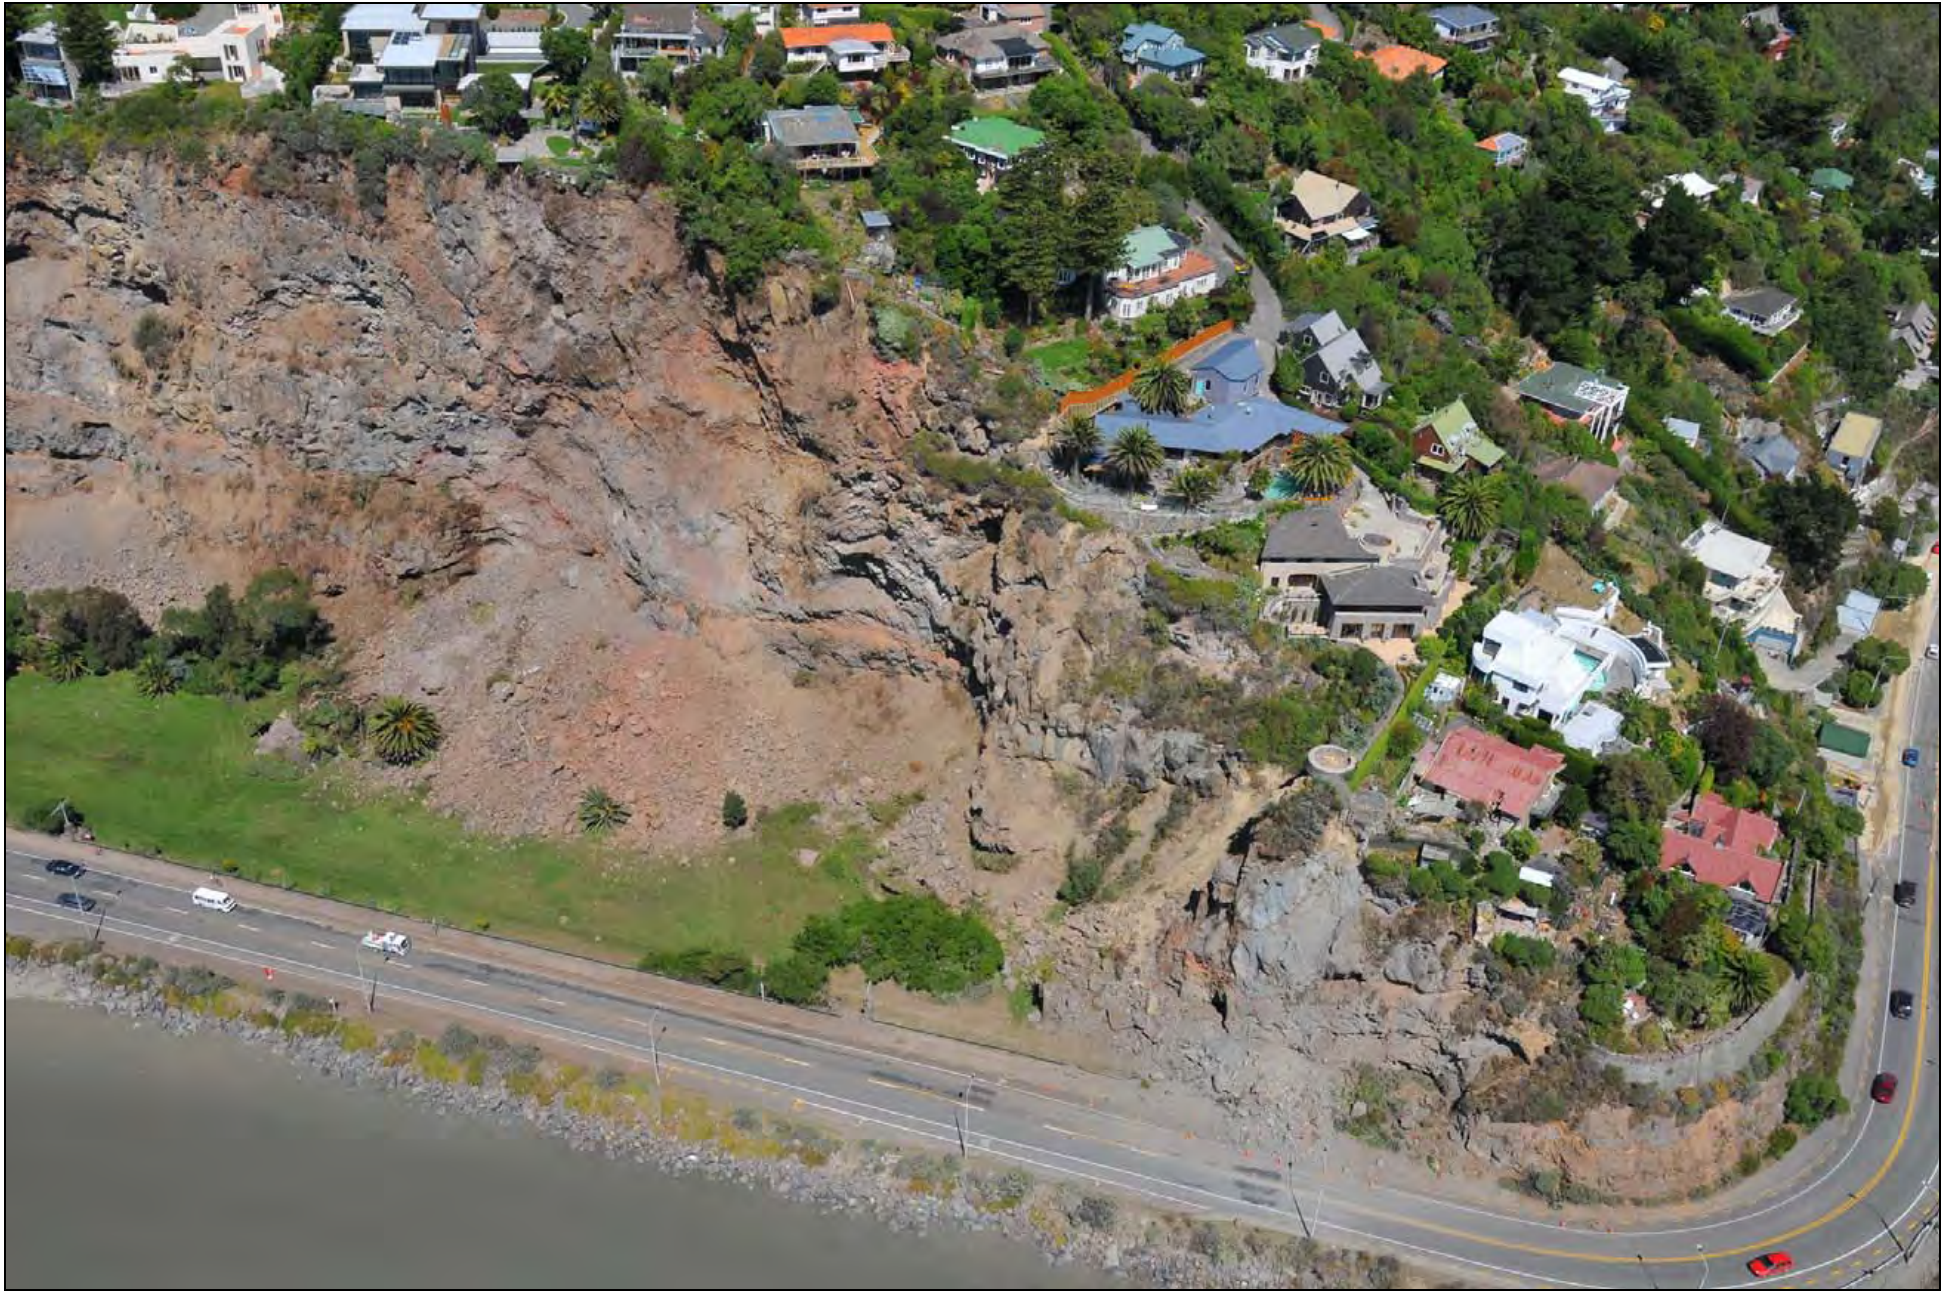
**Photo 13.** Rock falls below Kinsey Tce on to the Main Rd at the Moncks Bay–Shag Rock headland at Sumner (*GNS Photo-GTH\_5753*).

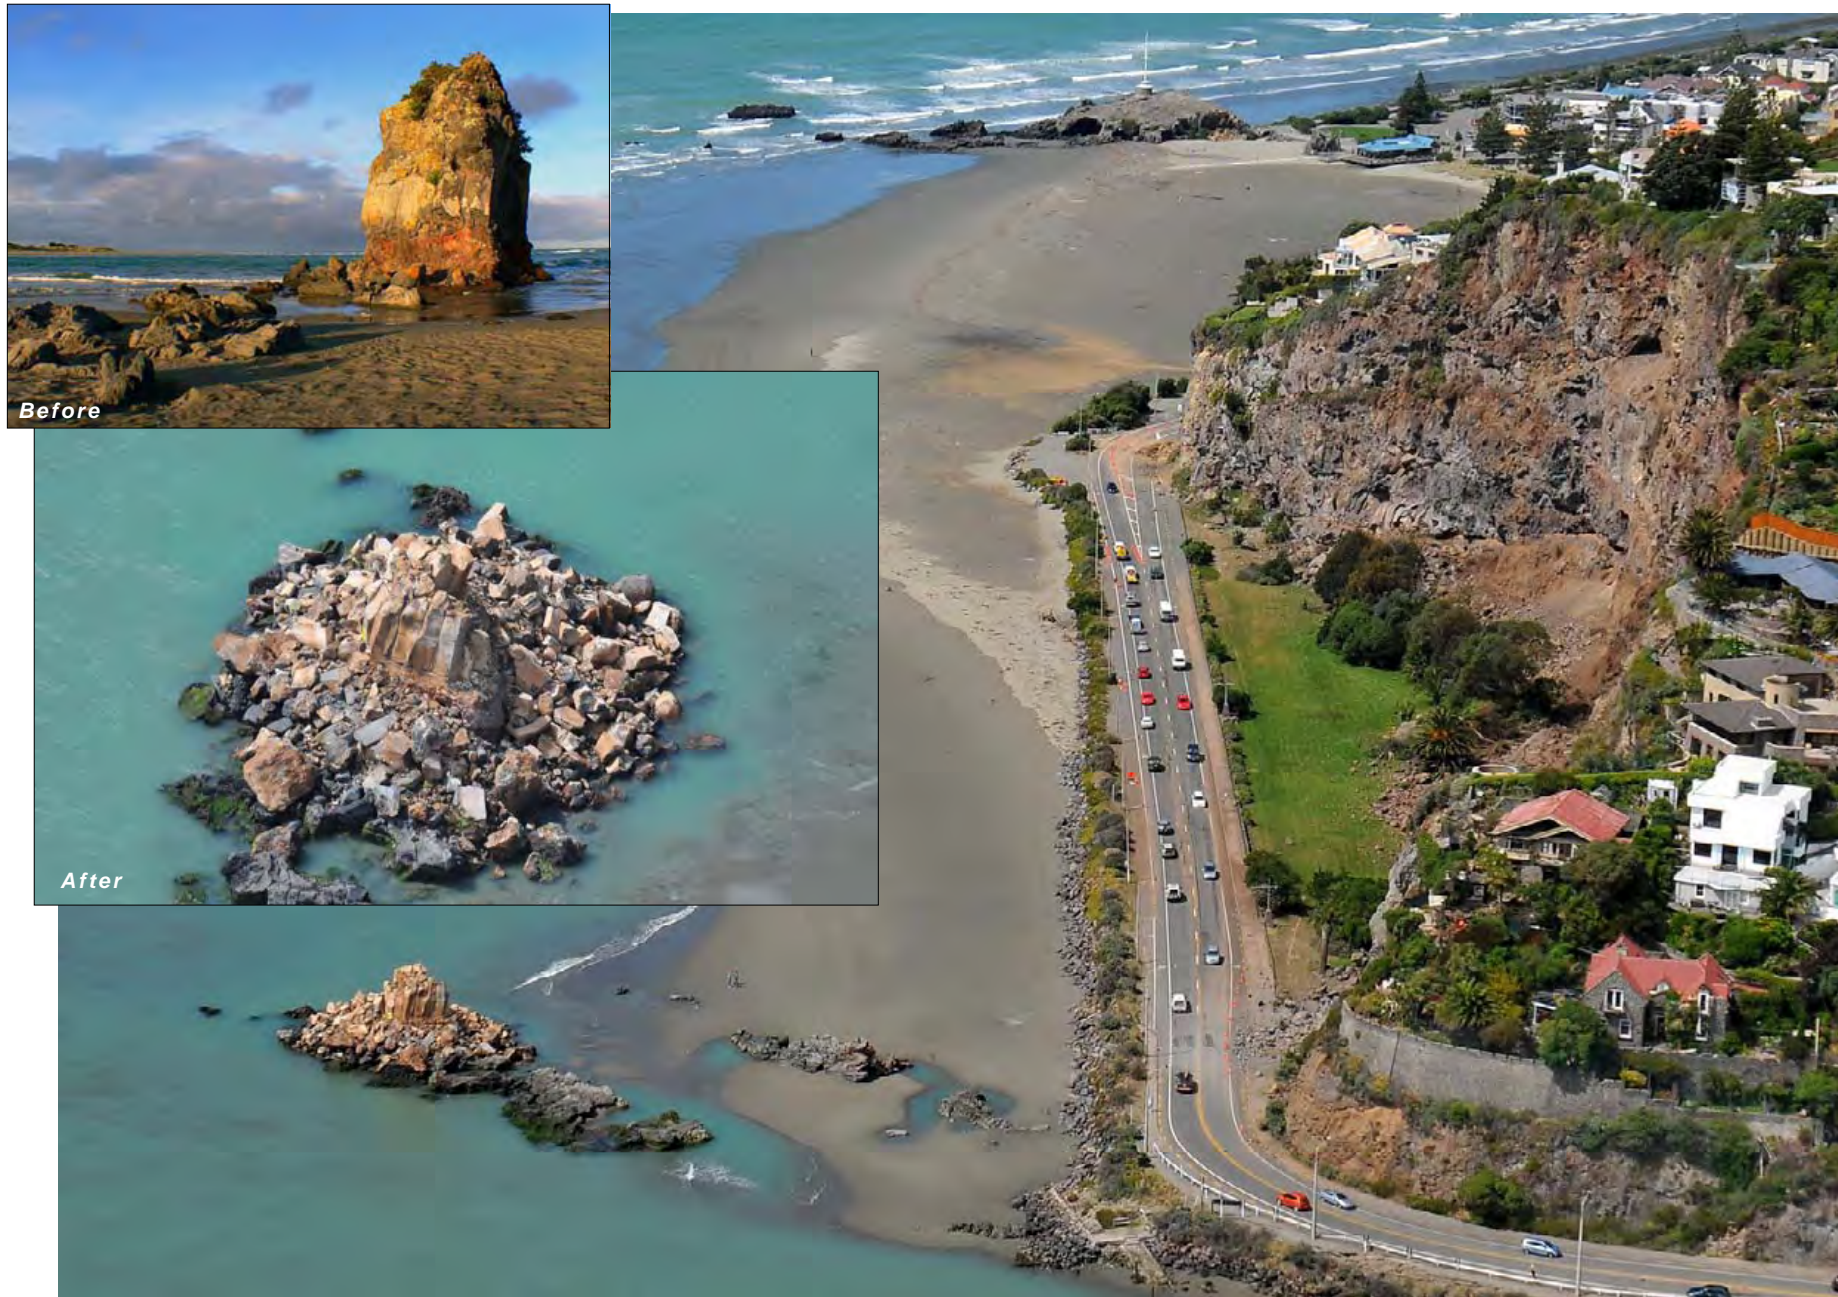
**Photo 13a.** The earthquake also shattered the well-known Shag Rock at Sumner (*GNS Photo-GTH\_5836, after 5837; before by Webphotos- location same as 13*).
