## **GNS SCIENCE IMMEDIATE REPORT**

**DATE:** 2 March 2011

**SUBJECT:** Report on Landslide Reconnaissance Flight on 24 February 2011 following the  $M_w$  6.3 Christchurch Earthquake of 22 February 2011

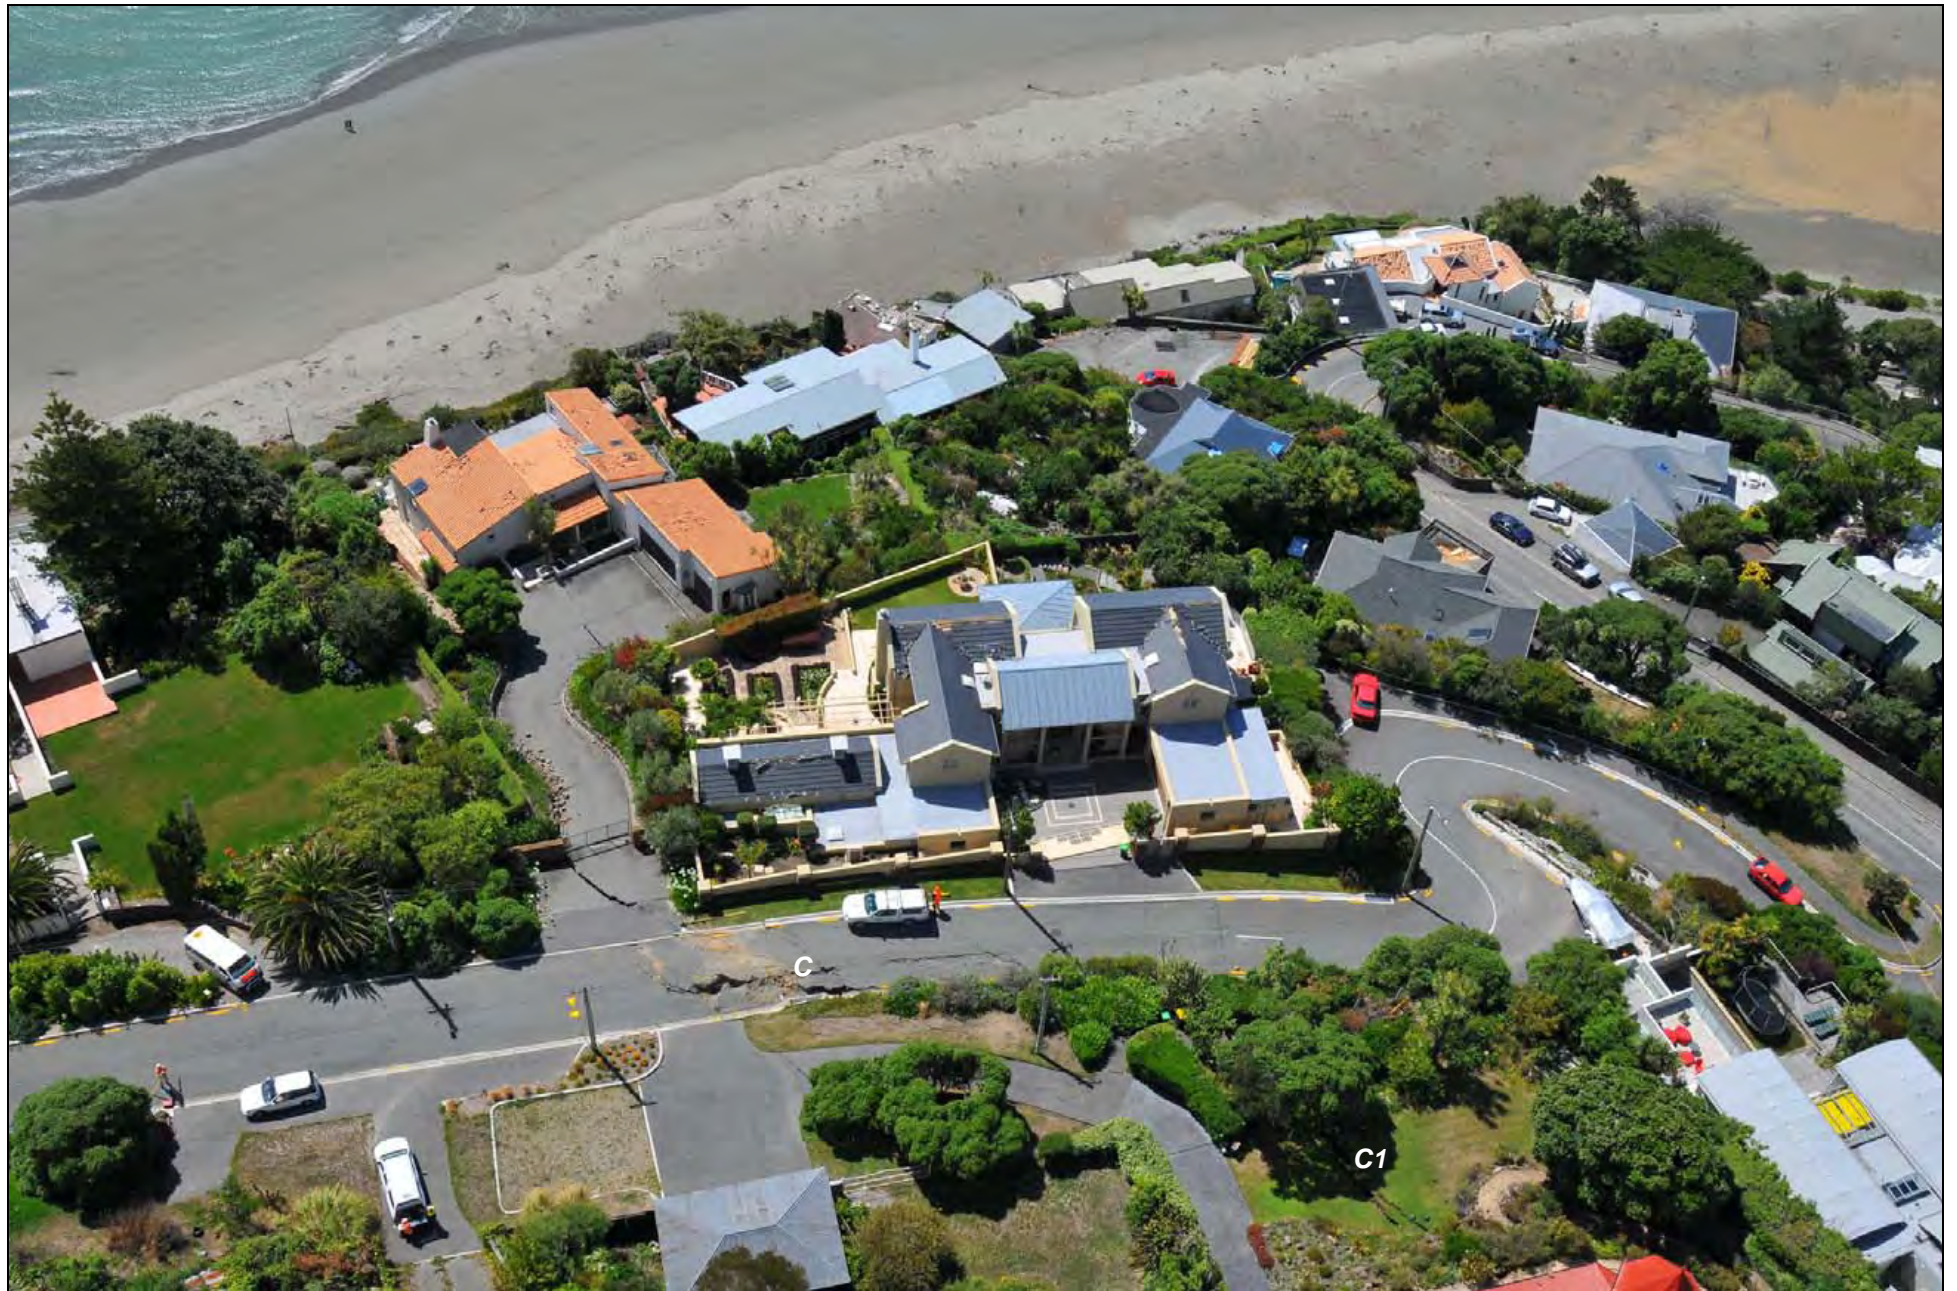
- (7) Several of the major rockfalls on the cliffs at Sumner and Redcliffs exhibit significant crown cracking along the cliff edge, especially in the areas of Clifton Terrace, Kinsey Terrace, Glendever Terrace (Photos 14, 22, and 23). In these areas there is potential for further rockfalls from the cliff edge, especially during large aftershocks. A similar hazard exists along the edge of the cliff top at Sumner Head, where extensive incipient cracking has developed in front of houses in Searidge Lane on Taylors Mistake Road, Scarborough (Photos 2 and 3). GNS Science staff and other geotechnical experts are currently assessing the stability of these areas on the ground.

**Photo 14.** Cliff top cracking (C) along the cliff edge and affecting houses (C1) in Kinsey Terrace on Moncks Bay headland (GNS Photo-GTH\_5771).

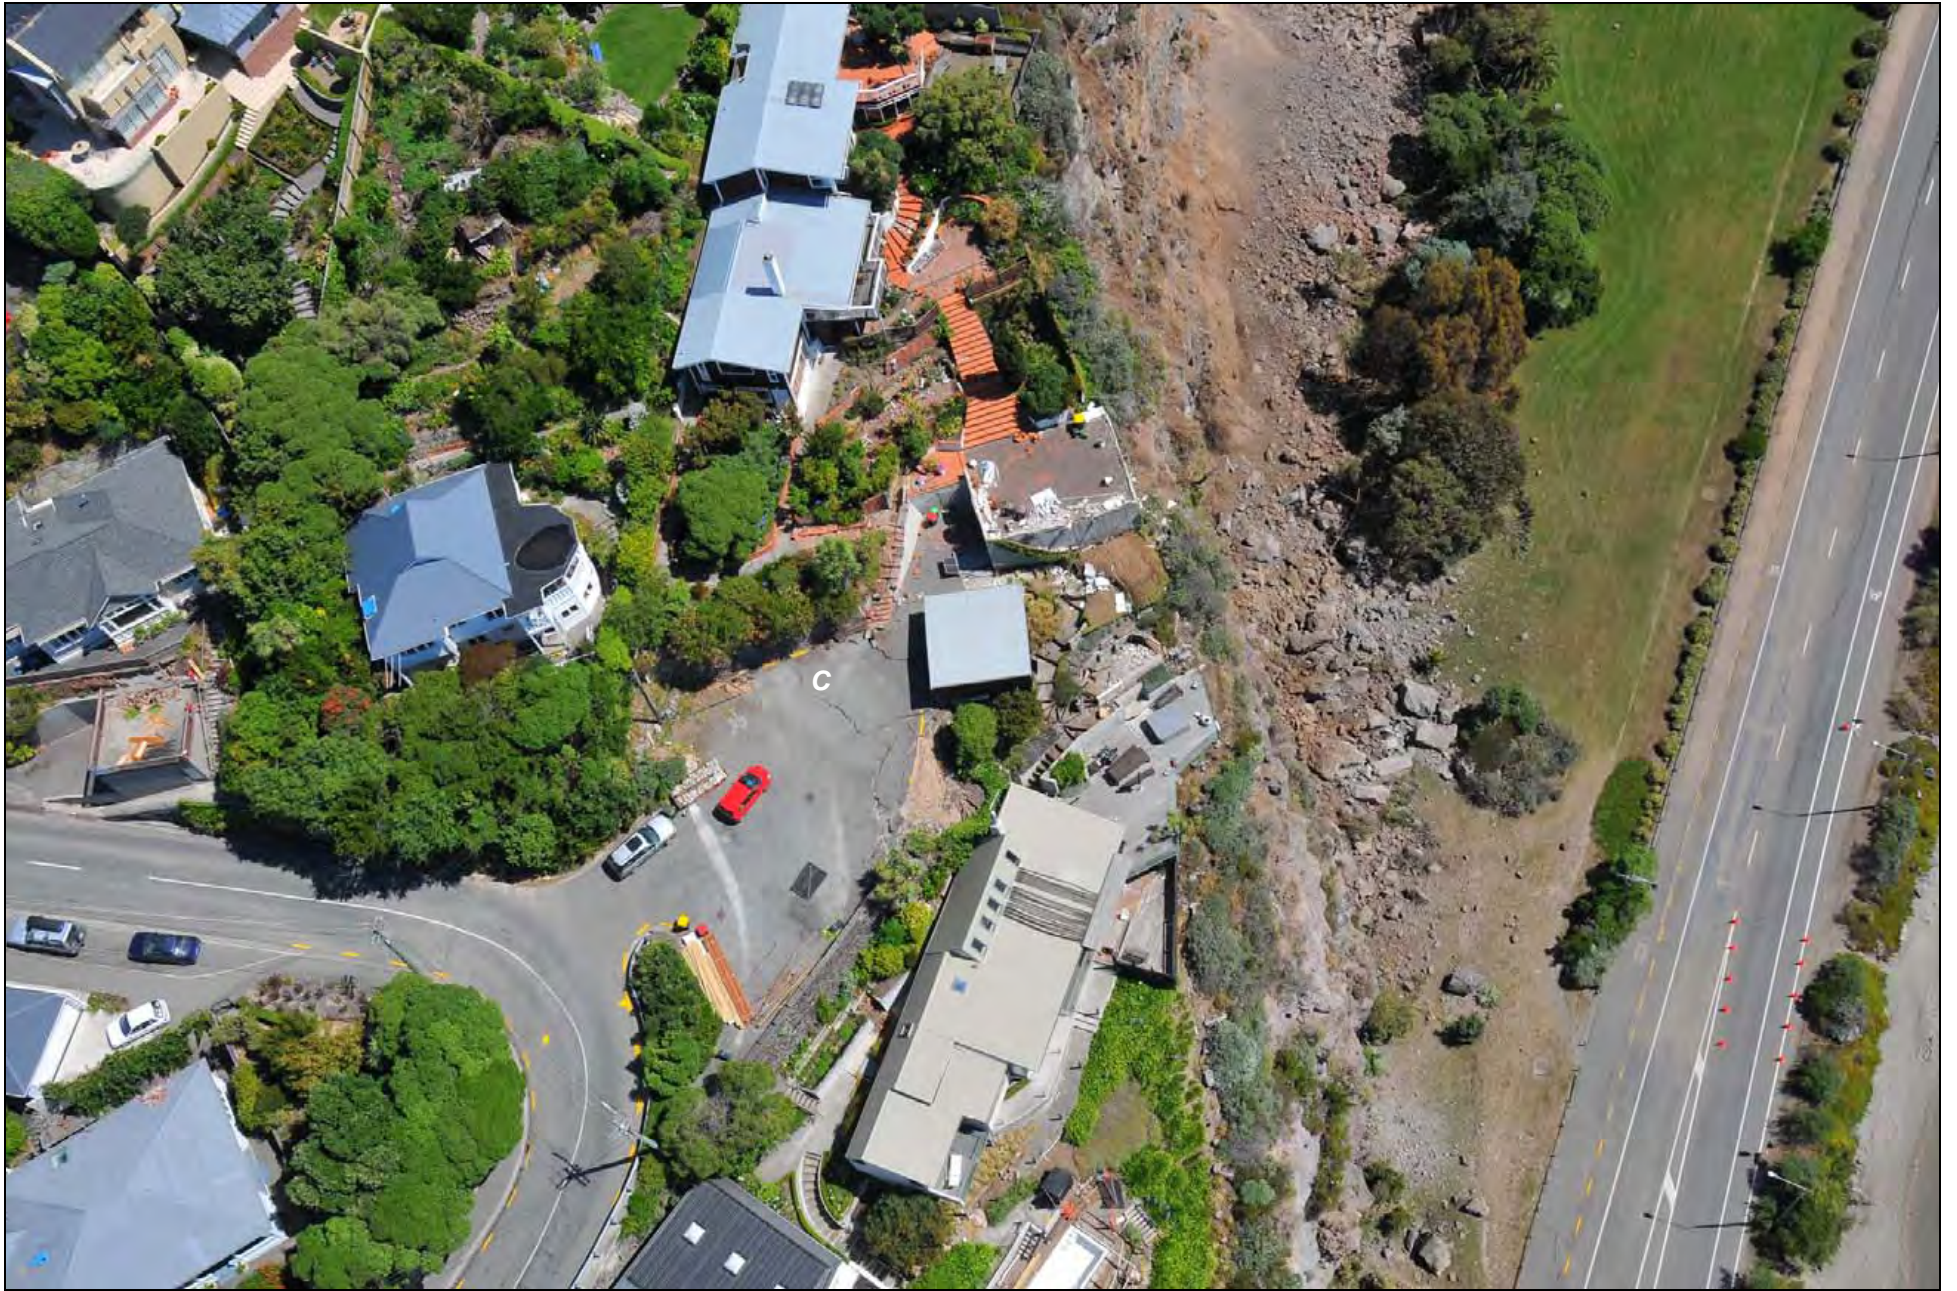
**Photo 15.** Rock falls and cracking (C) in Kinsey Tce, Moncks Bay (GNS Photo-GTH\_5775).

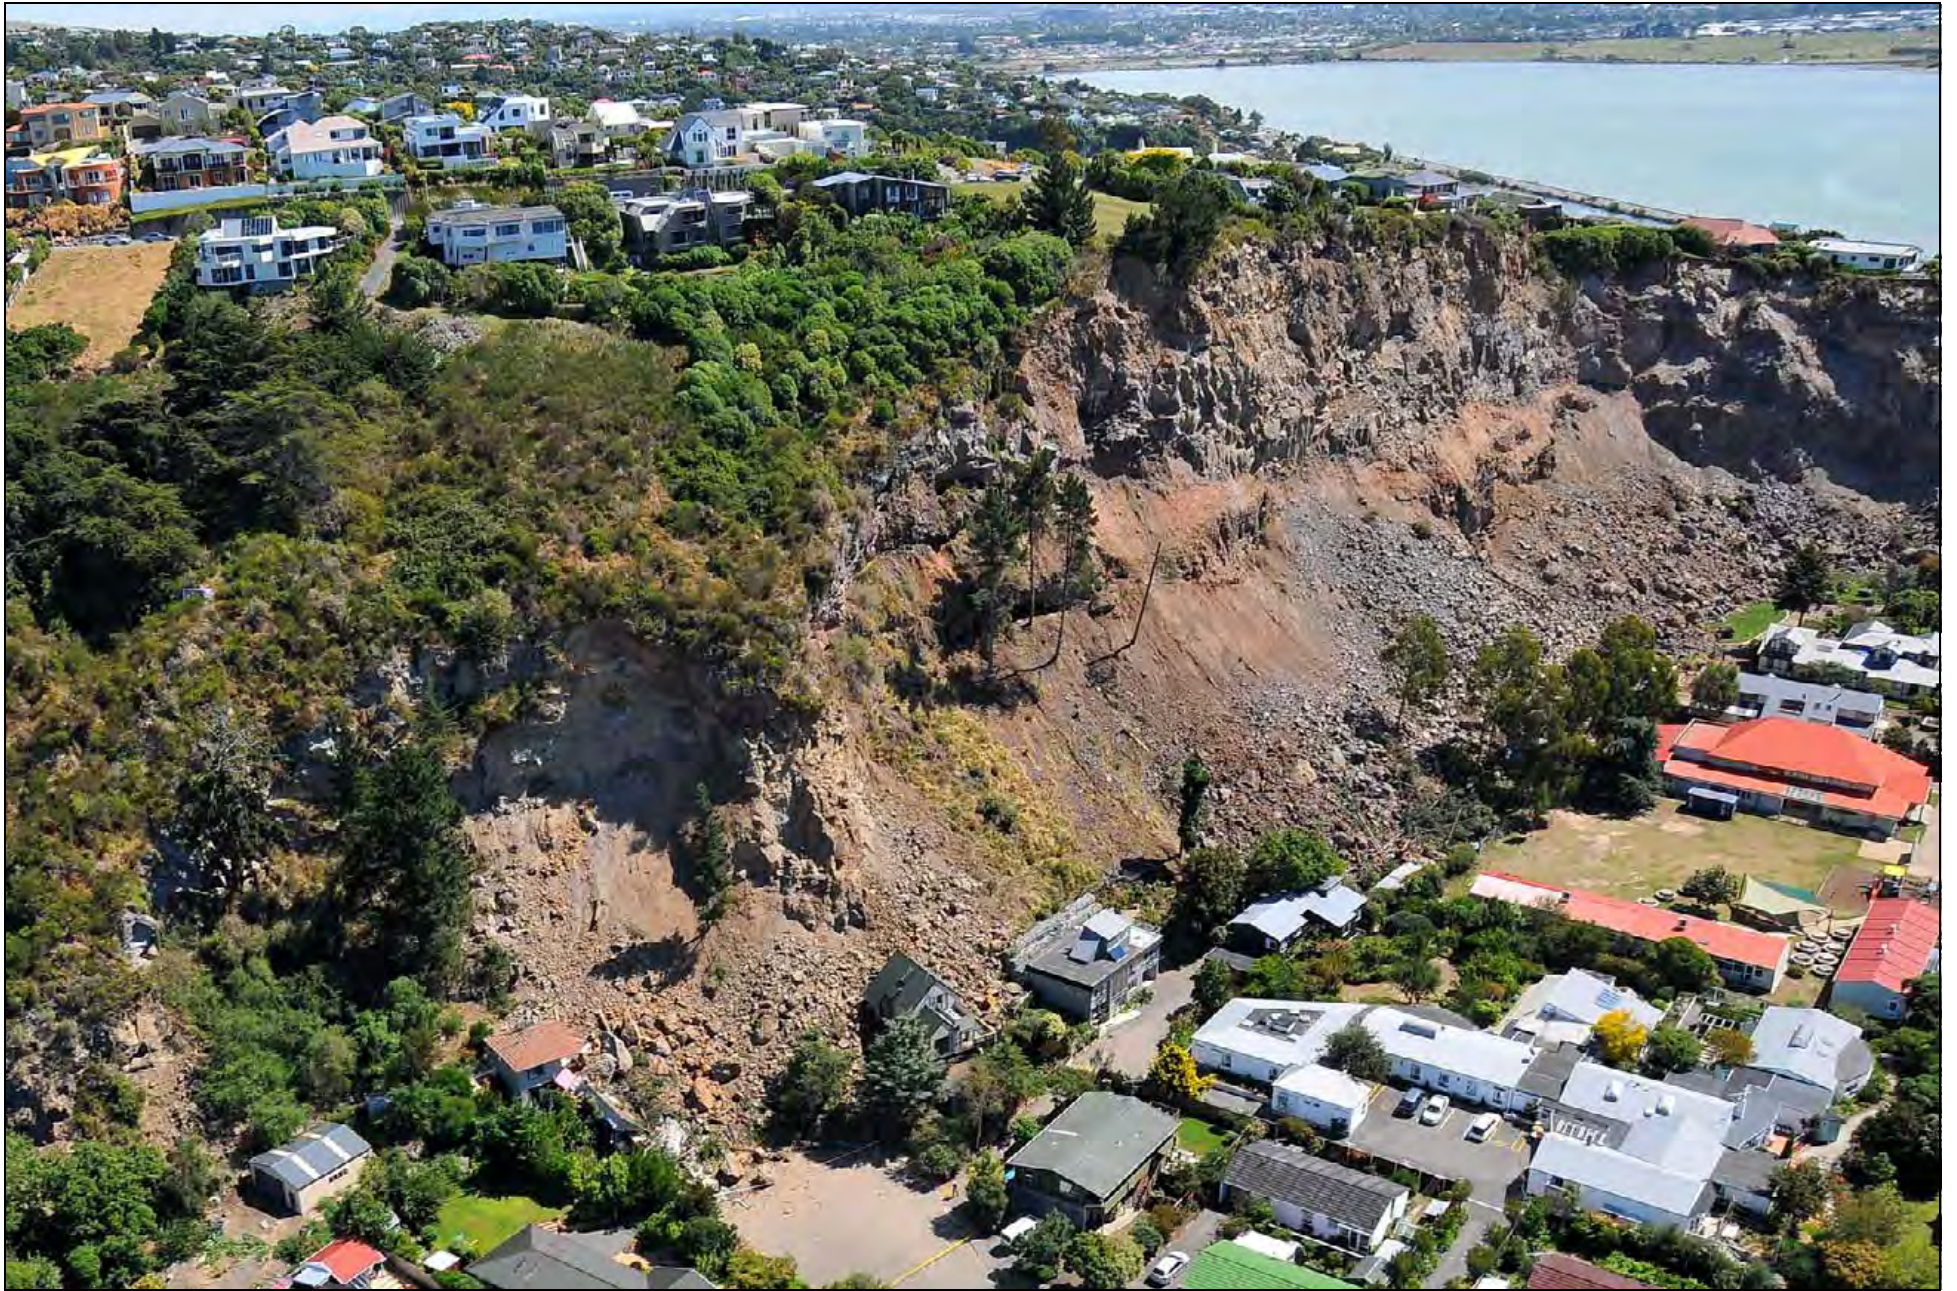
**Photo 16.** Large and damaging rock falls behind Redcliffs School (right) and houses in Raekura Place (left) in Redcliffs (also an old quarry site). (*GNS Photo-GTH\_5785*).

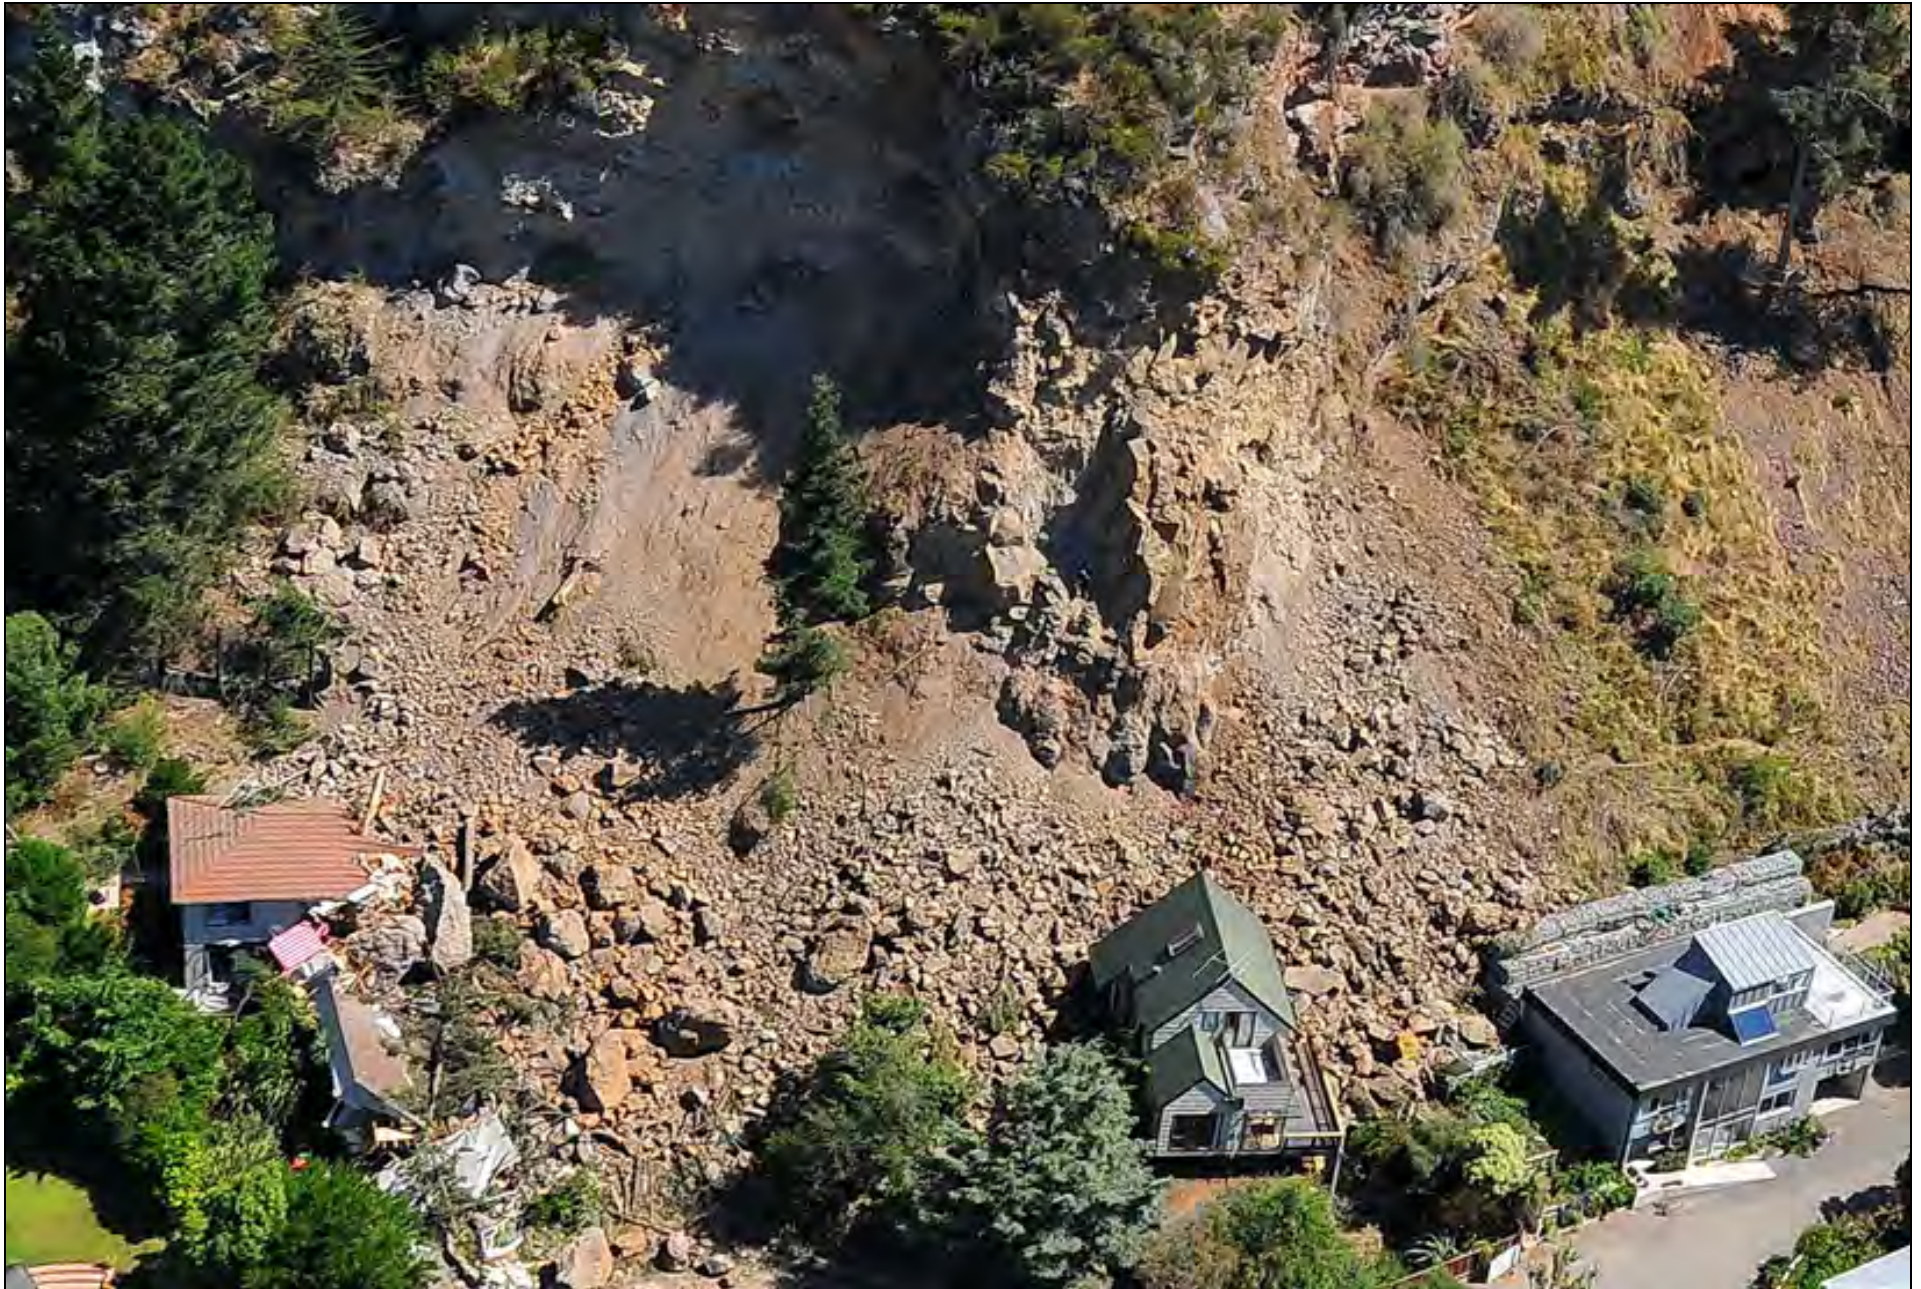
**Photo 17.** House destroyed by rock fall in Raekura Place at Redcliffs. The houses left (#54) and centre (#44) are reported fatality sites, (*GNS Photo-GTH\_5787*).

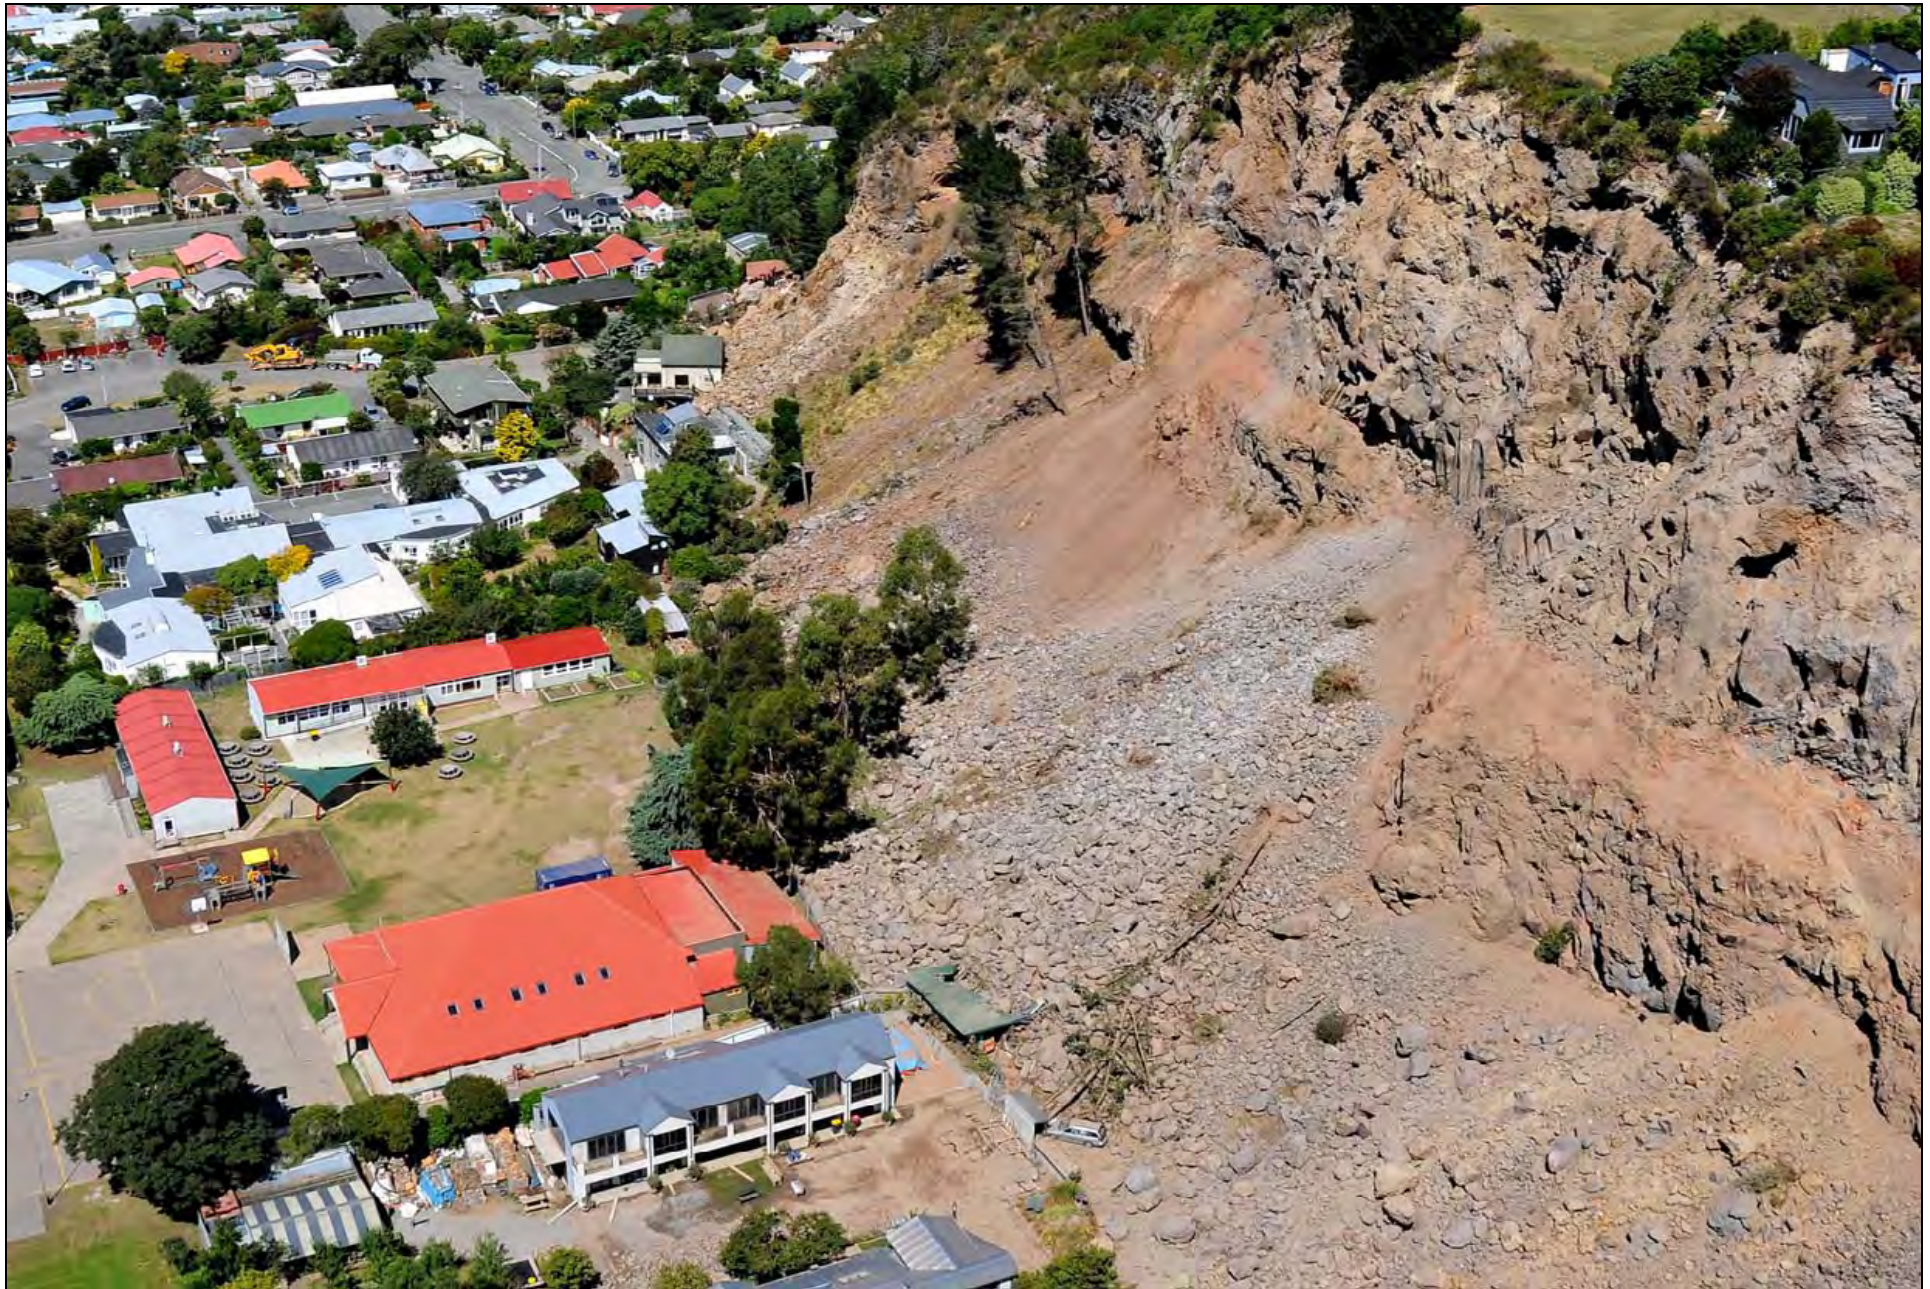
**Photo 18.** Large rock and debris falls on the ~60 m high cliff face behind Redcliffs School (*GNS Photo-GTH\_5801*).

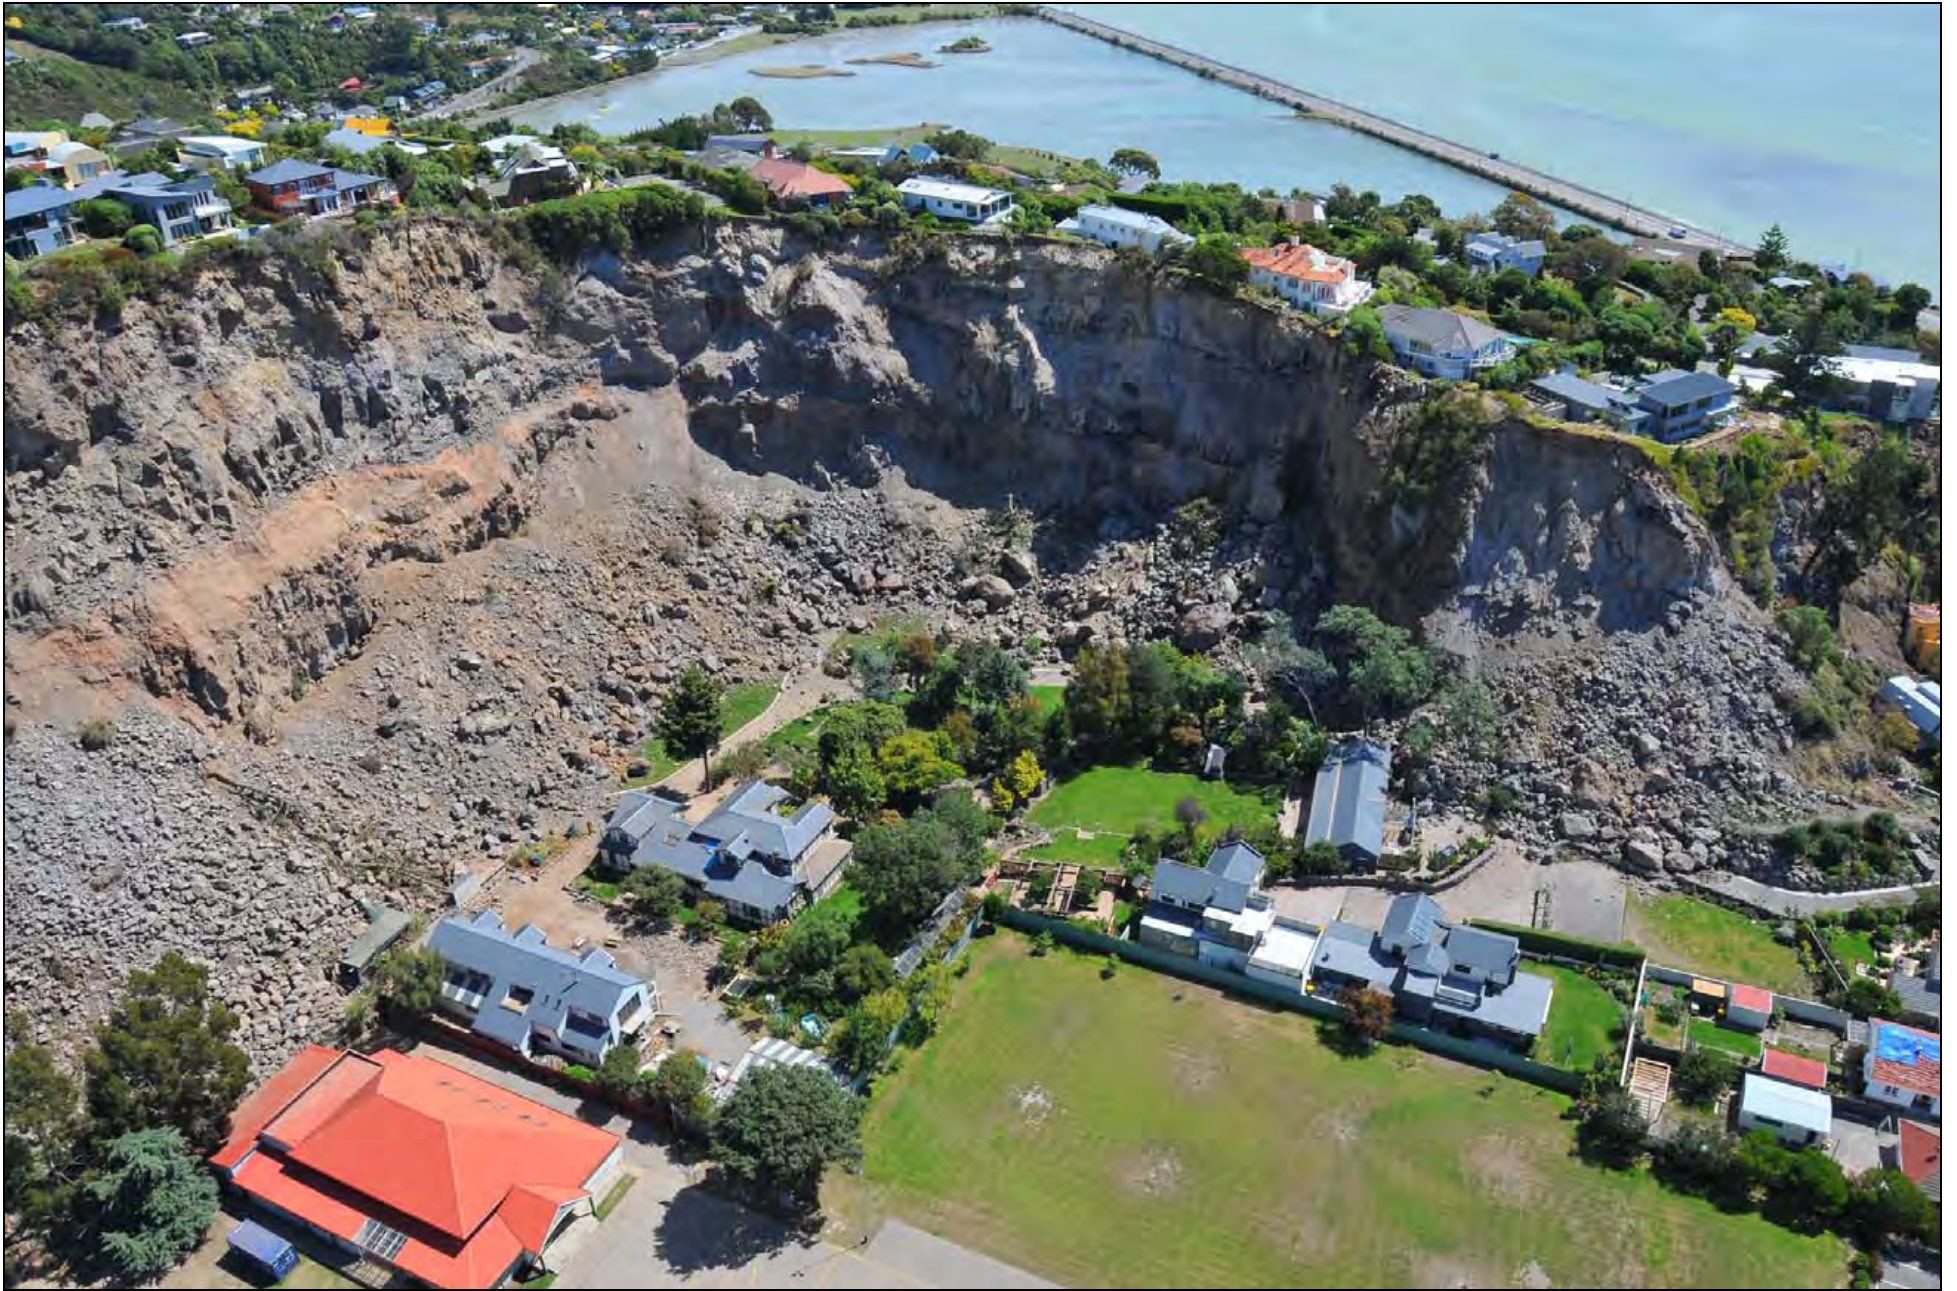
**Photo 19.** Large rock falls on the cliff behind Redcliffs School and Moa Cave Guest House, Redcliffs (*GNS Photo-GTH\_5792*).

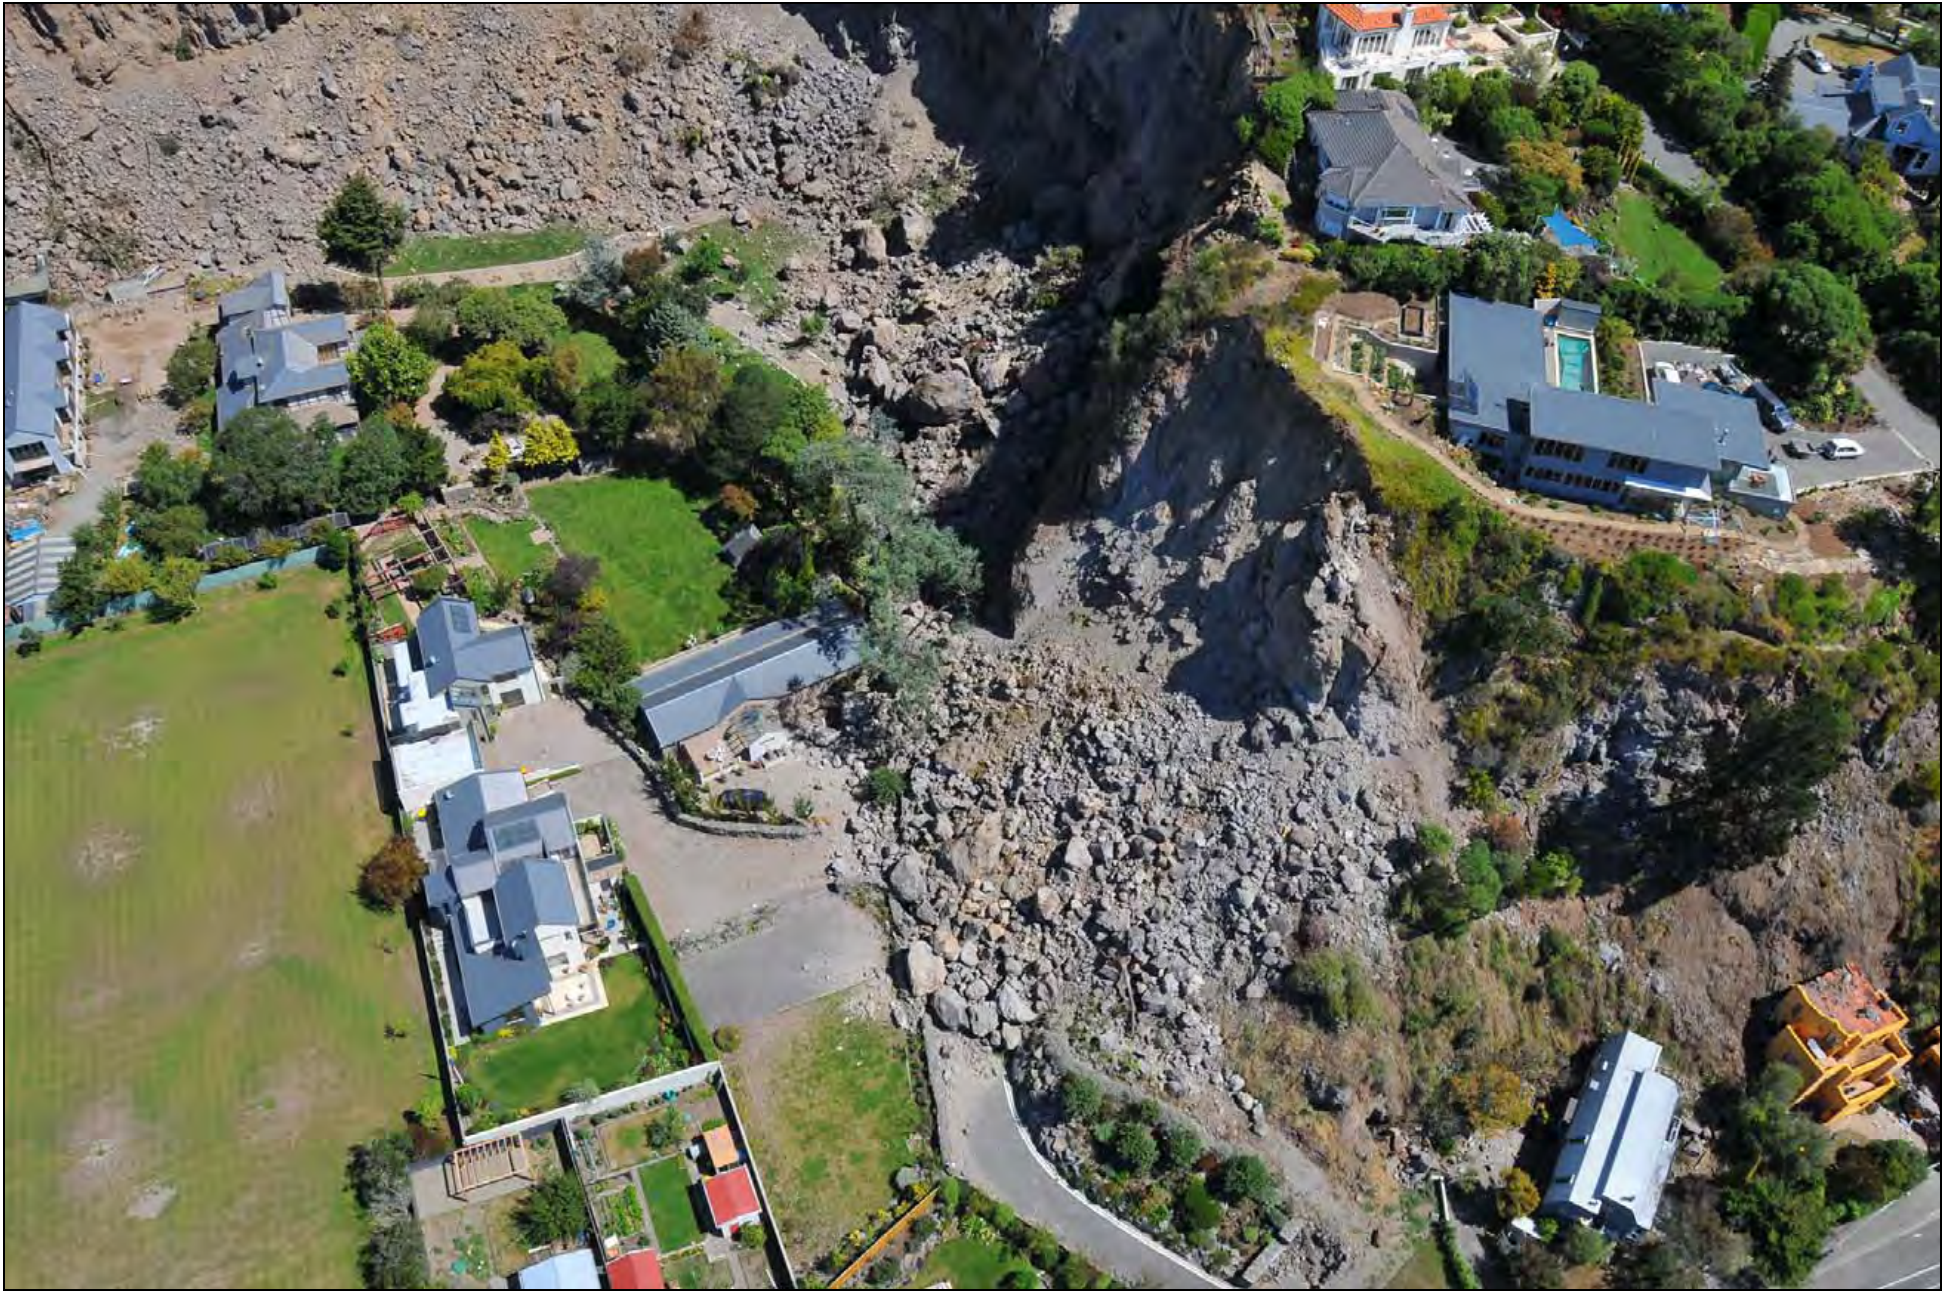
**Photo 20.** Rock falls on cliff face into Moa Cave Guest House grounds, Redcliffs (*GNS Photo-GTH\_5796*).

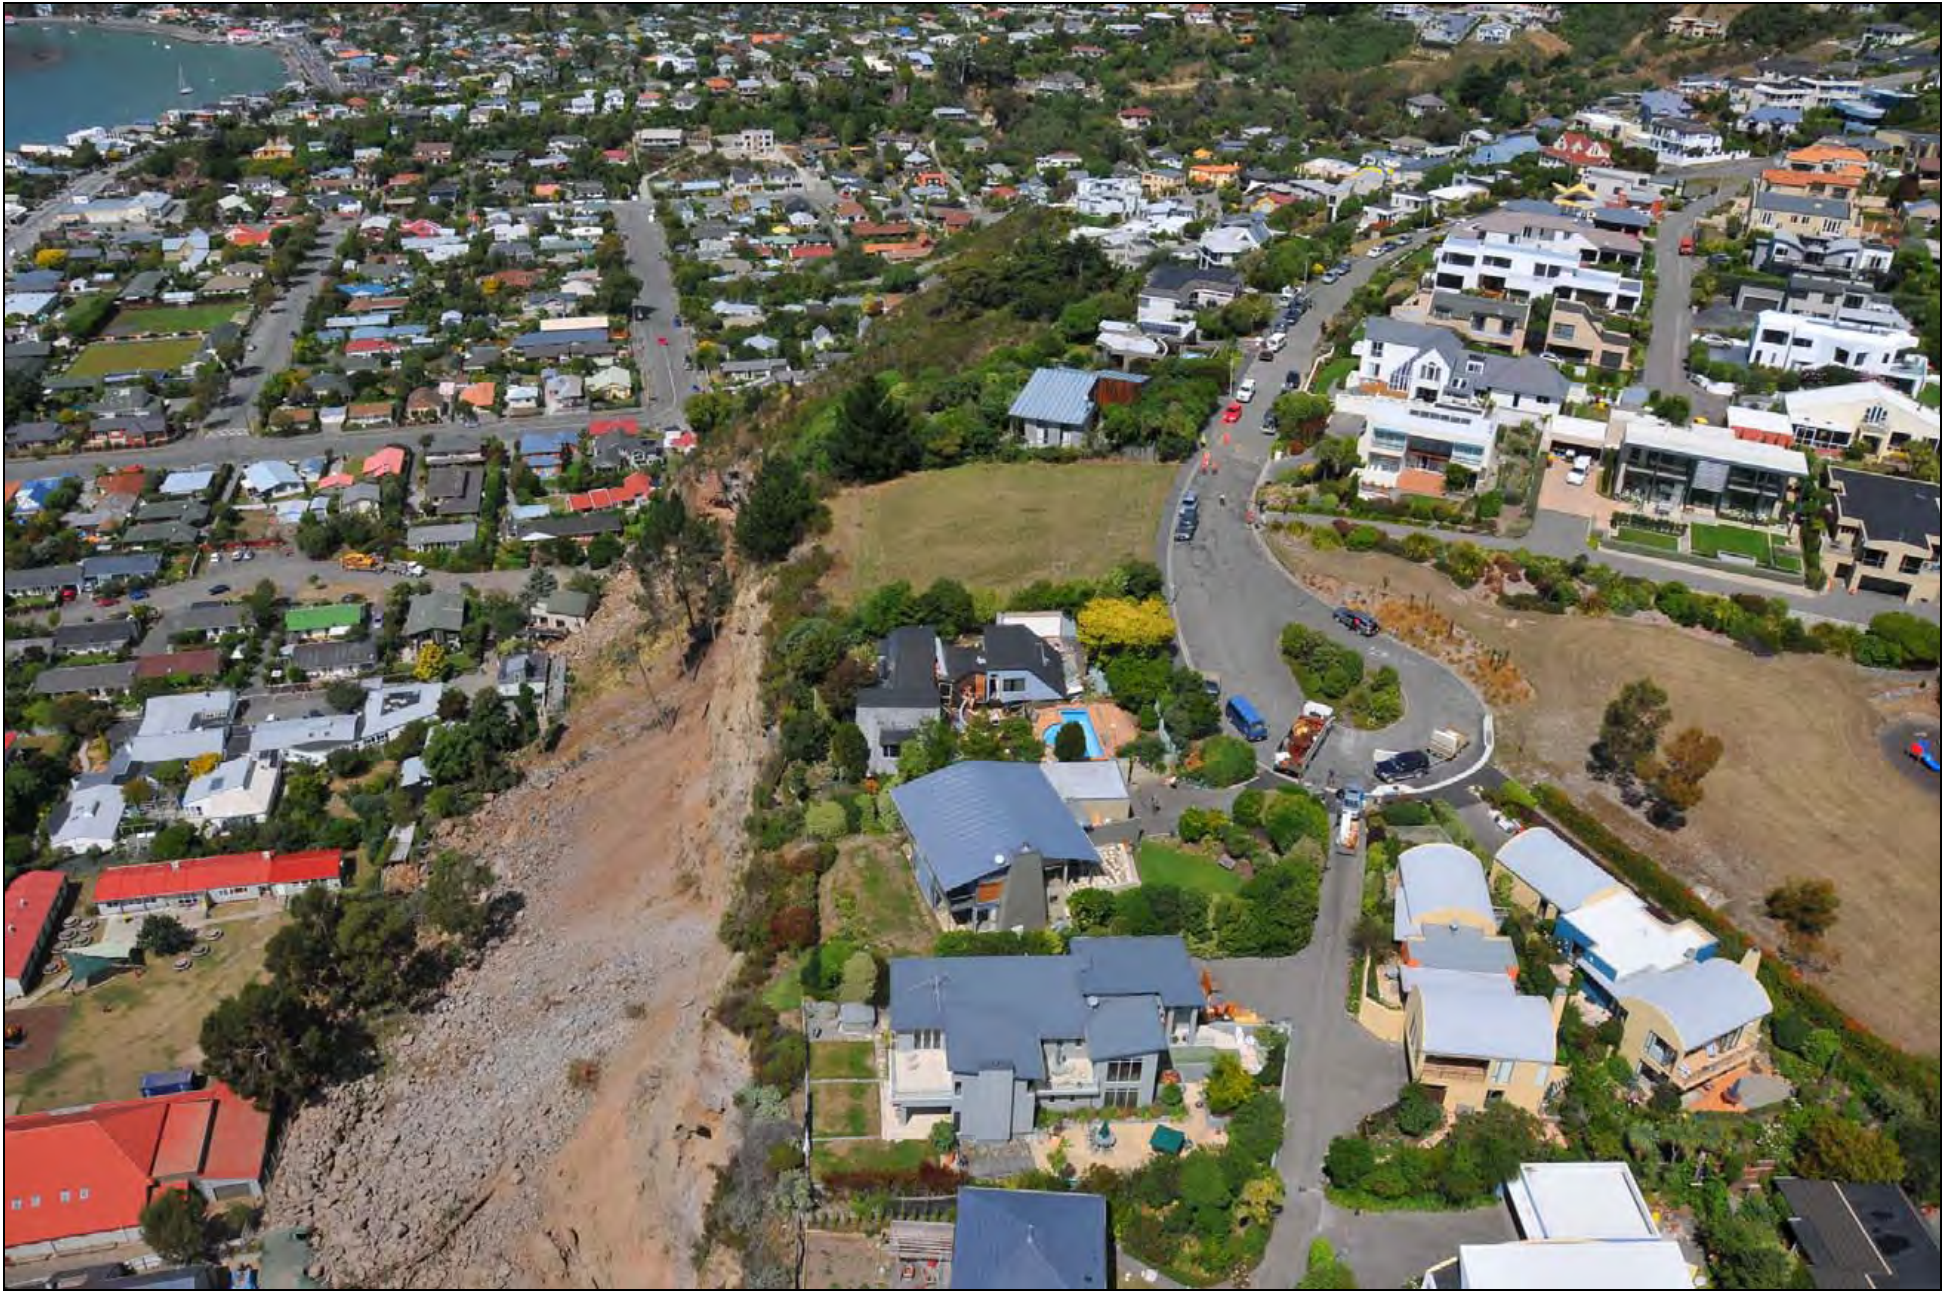
**Photo 21.** Rock falls on cliff behind Redcliffs School below Glendevere Terrace at Redcliffs (*GNS Photo-GTH\_5814*).
