## **GNS SCIENCE IMMEDIATE REPORT**

**DATE:** 2 March 2011

**SUBJECT:** Report on Landslide Reconnaissance Flight on 24 February 2011 following the  $M_w$  6.3 Christchurch Earthquake of 22 February 2011

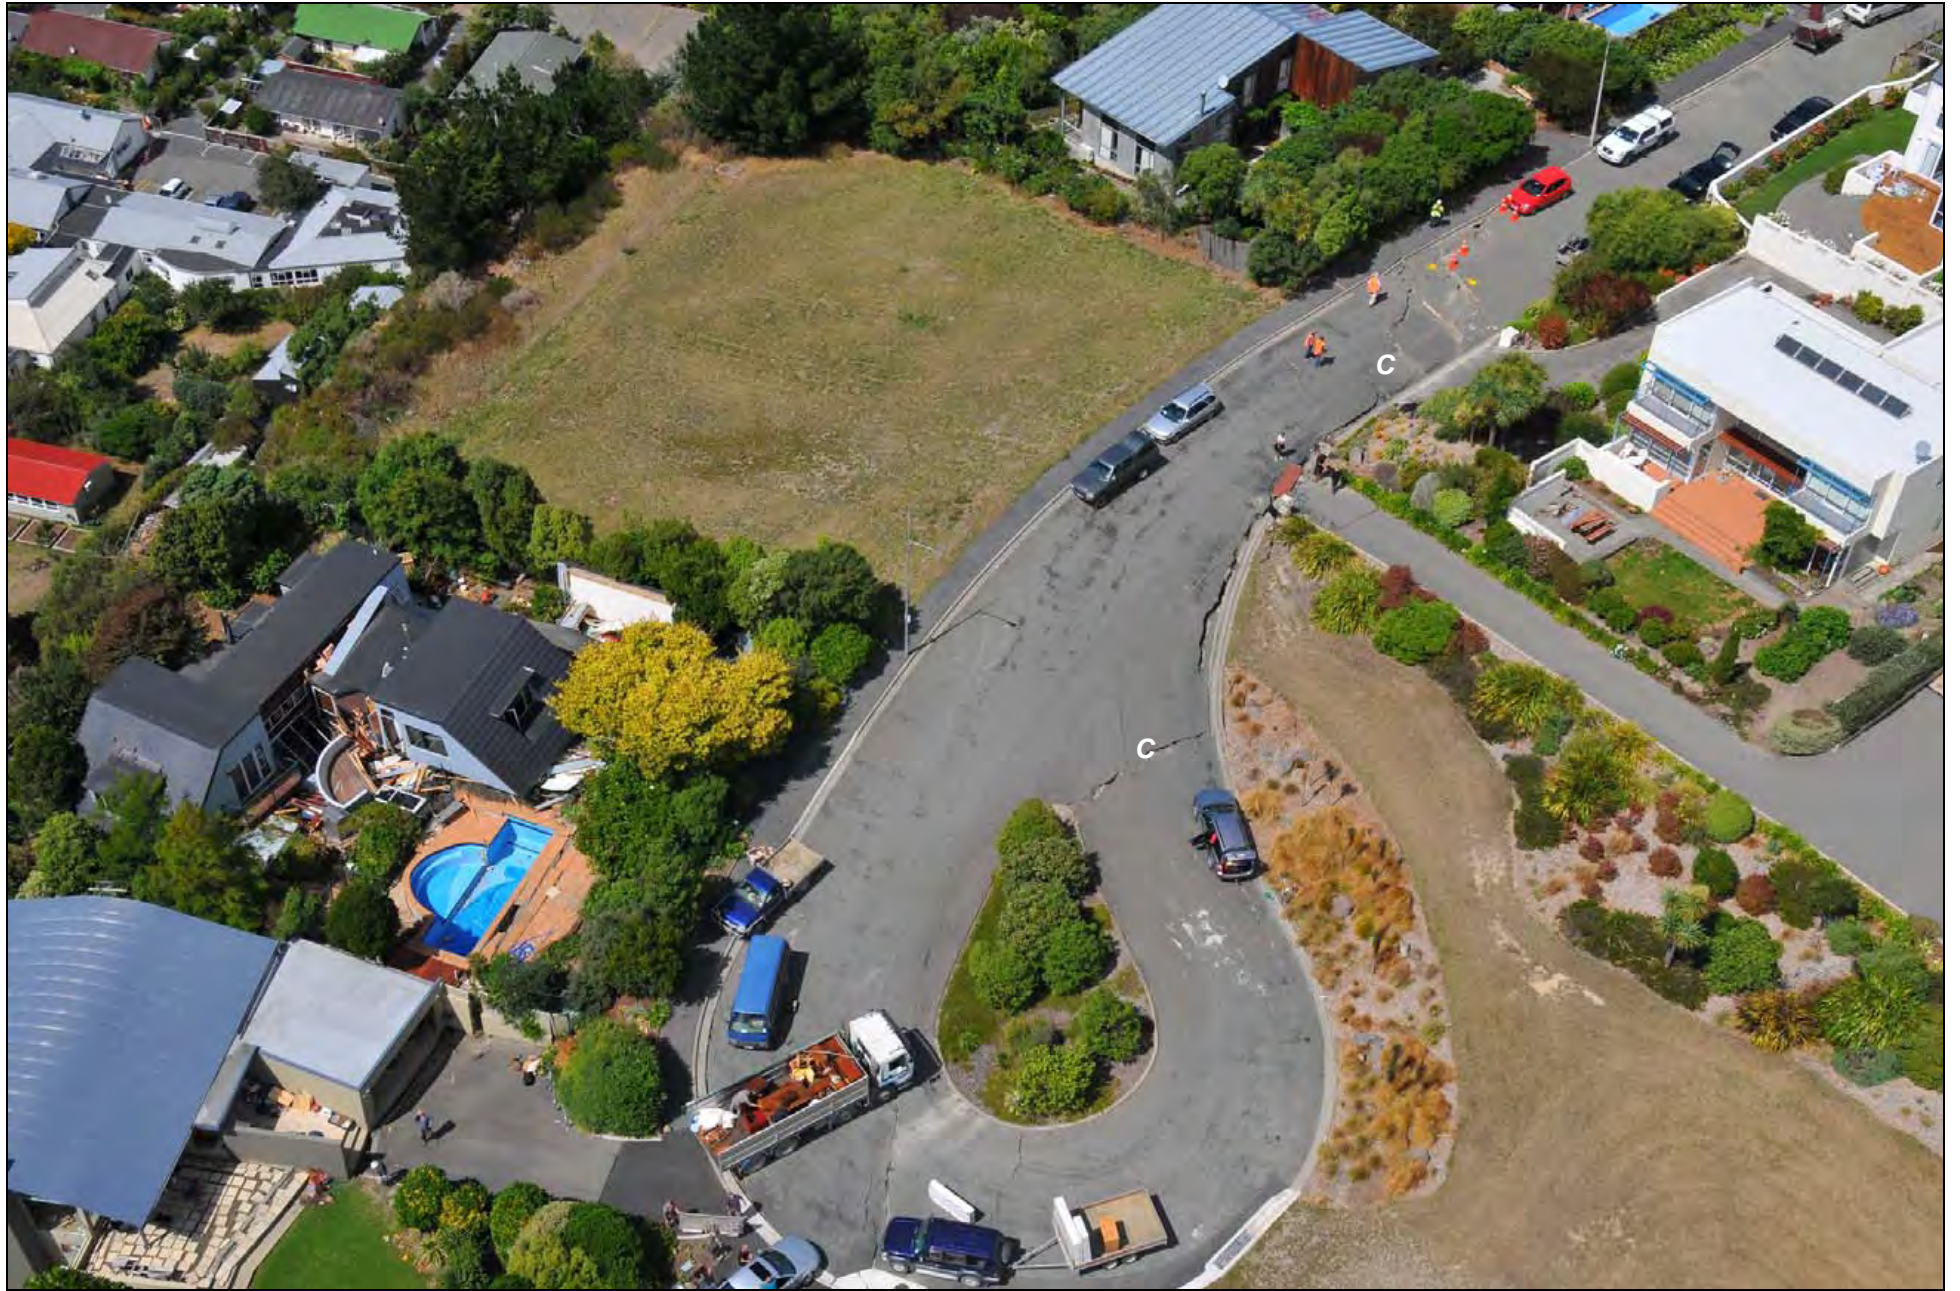
- (7) Several of the major rockfalls on the cliffs at Sumner and Redcliffs exhibit significant crown cracking along the cliff edge, especially in the areas of Clifton Terrace, Kinsey Terrace, Glendever Terrace (Photos 14, 22, and 23). In these areas there is potential for further rockfalls from the cliff edge, especially during large aftershocks. A similar hazard exists along the edge of the cliff top at Sumner Head, where extensive incipient cracking has developed in front of houses in Searidge Lane on Taylors Mistake Road, Scarborough (Photos 2 and 3). GNS Science staff and other geotechnical experts are currently assessing the stability of these areas on the ground.

**Photo 22.** Cliff-top cracks (C) in roads and affecting properties in Glendevere Terrace, Redcliffs (GNS Photo-GTH\_5816).

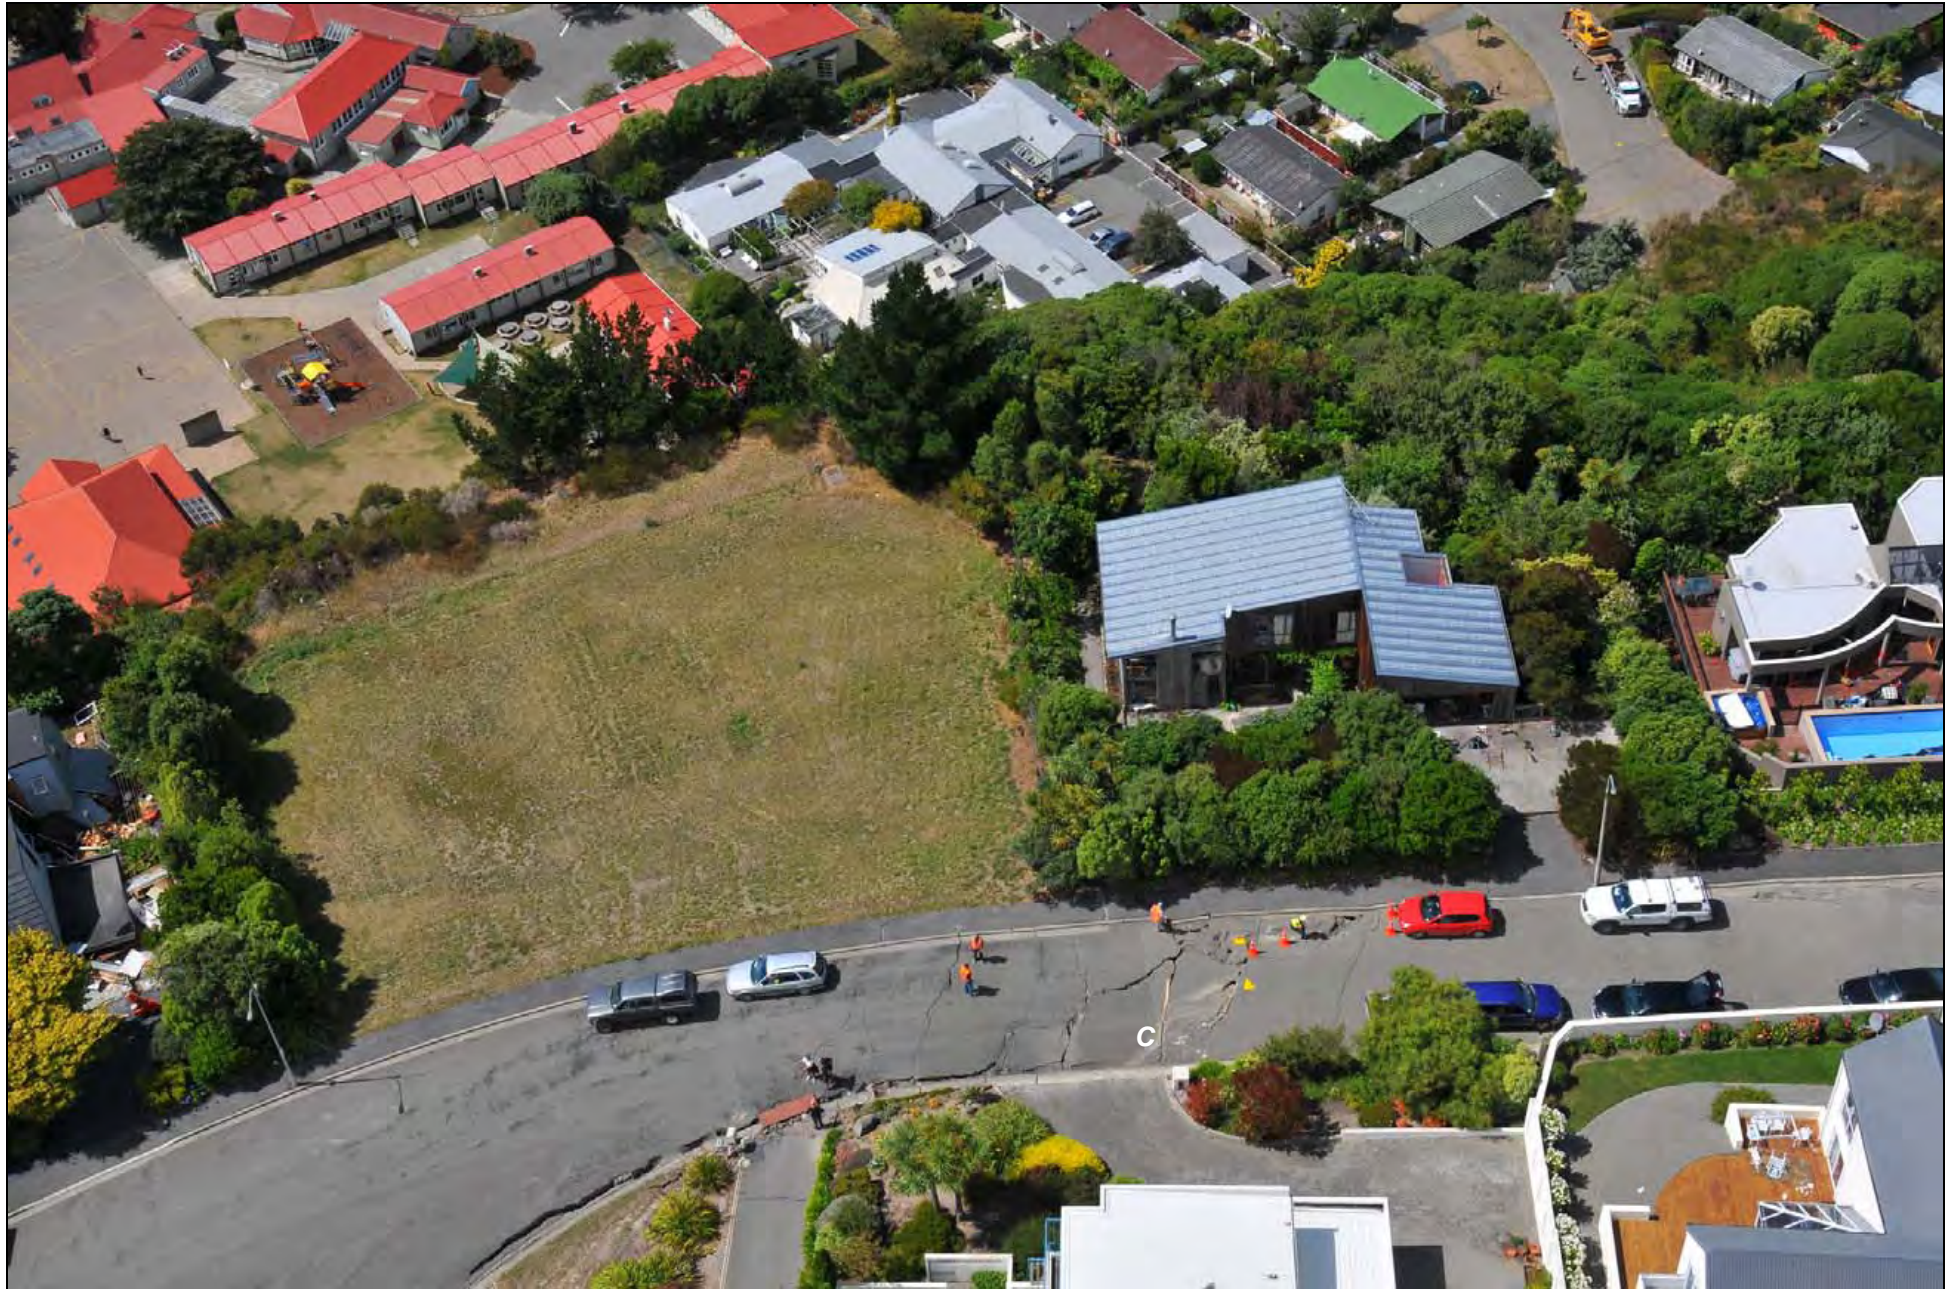
**Photo 23.** Cliff-top cracking (C) in Glendevere Terrace, Redcliffs (*GNS Photo-GTH\_5819*).

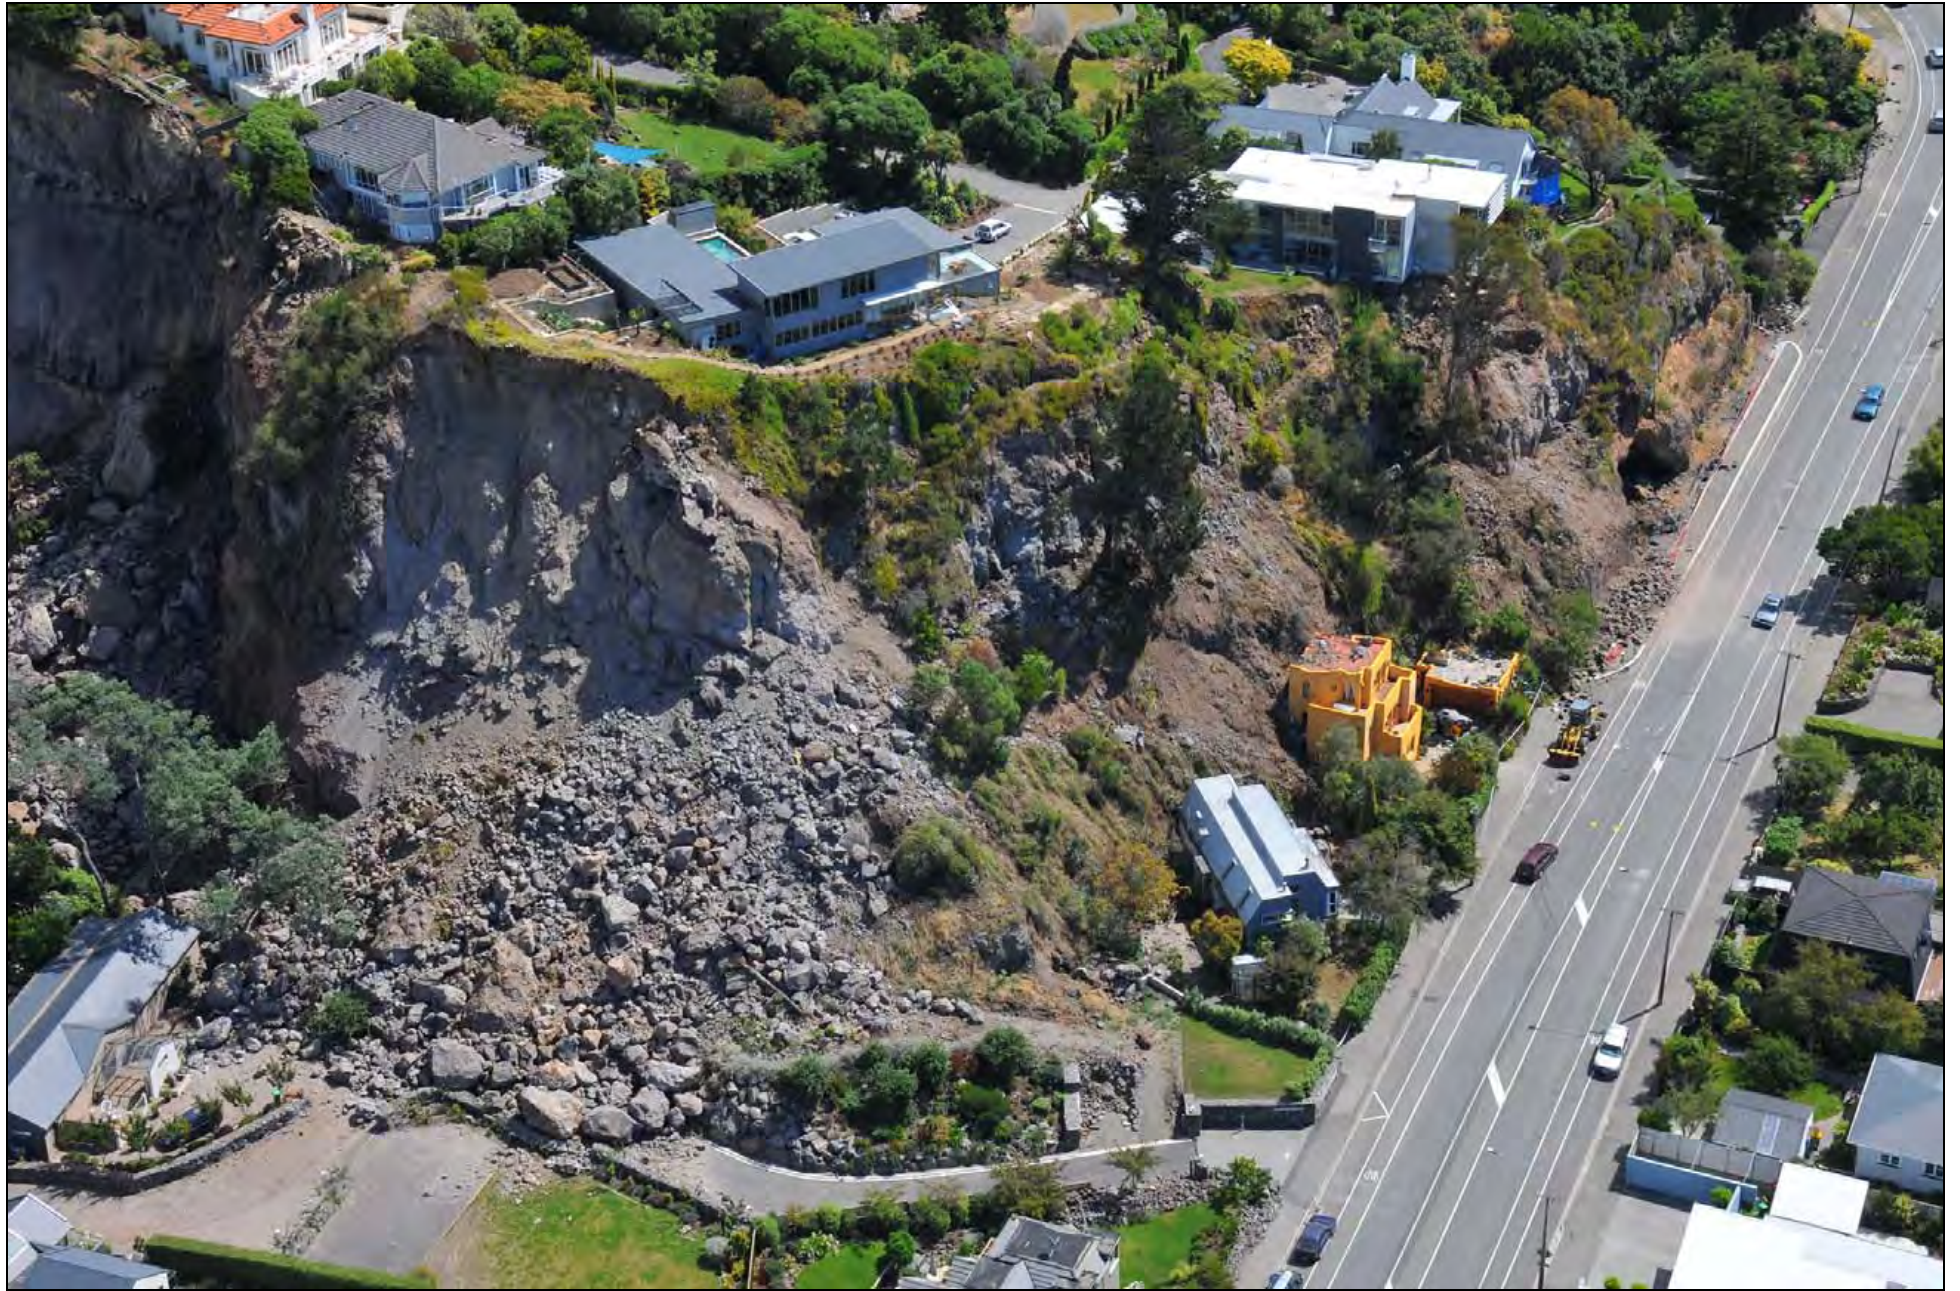
**Photo 24.** Large rock fall at Moa Cave Guest House, Main Road, Redcliffs (*GNS Photo-GTH\_5822*).

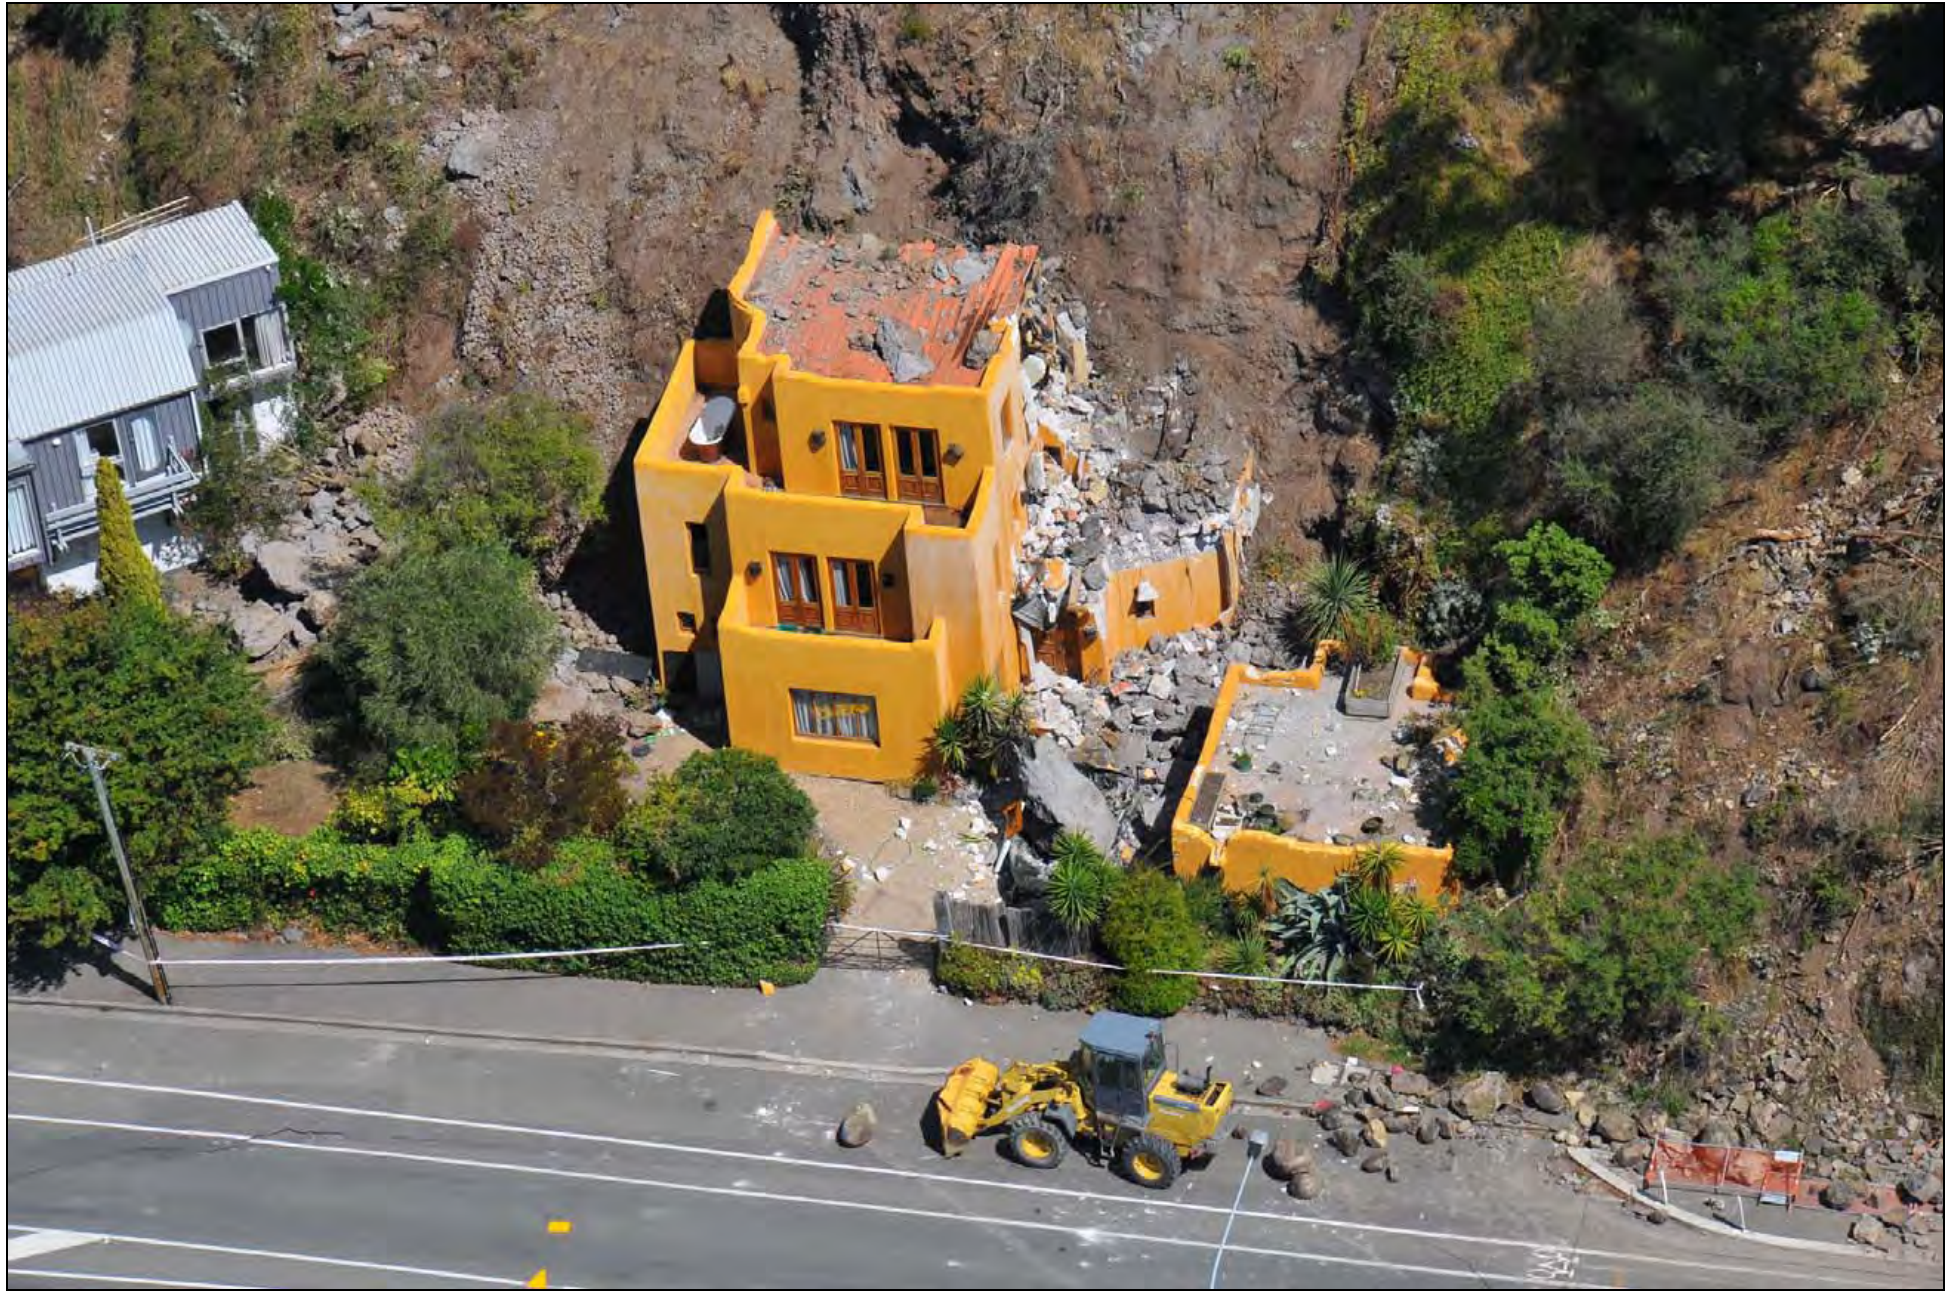
**Photo 25.** Rock fall on to house at 116A Main Road, Redcliffs (*GNS Photo-GTH\_5823*).

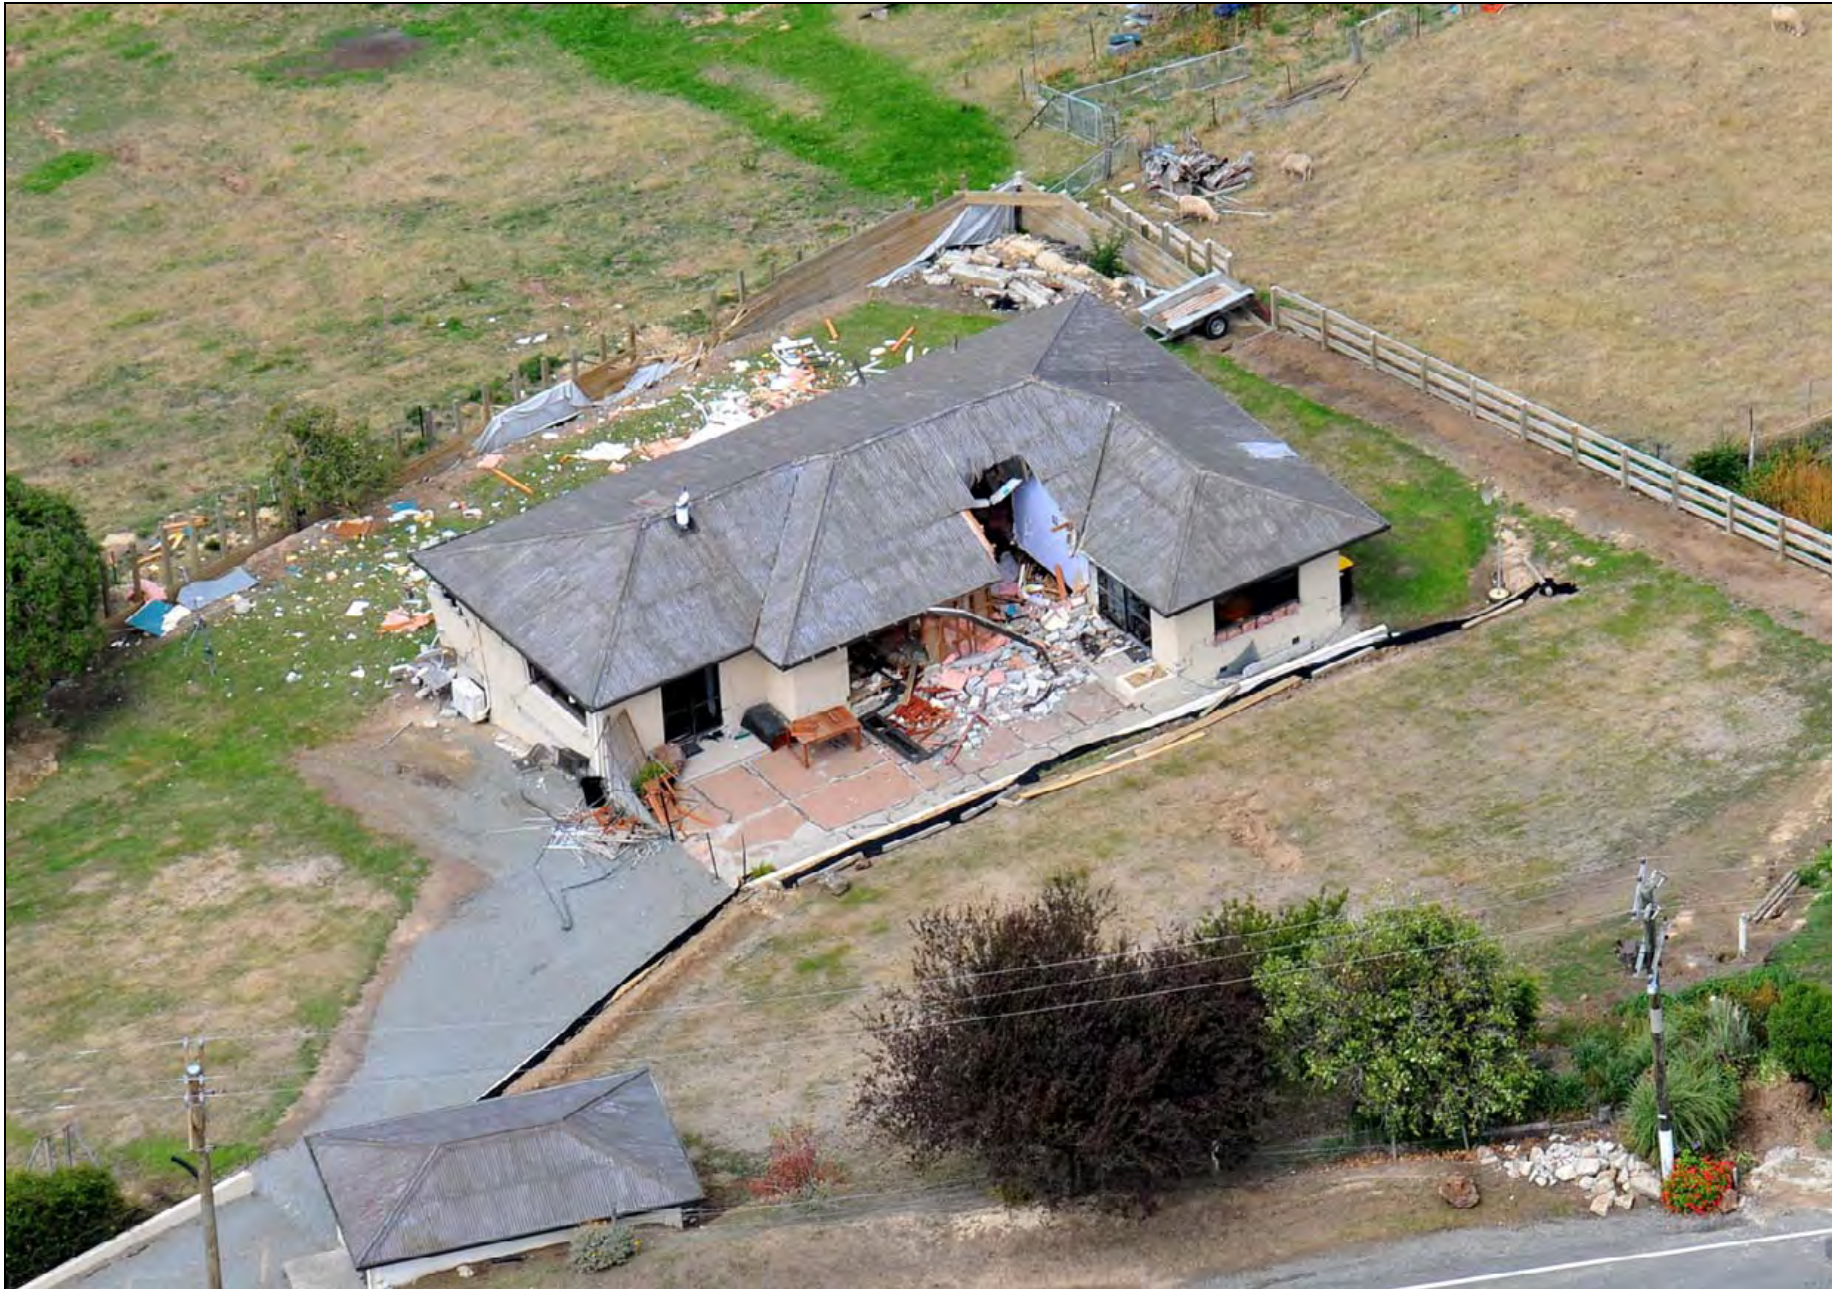
**Photo 26.** House at 241 Governors Bay Road, Rapaki, hit by a large (~3 m long) boulder 3 km west of Lyttleton (*GNS Photo-GTH\_5842*).

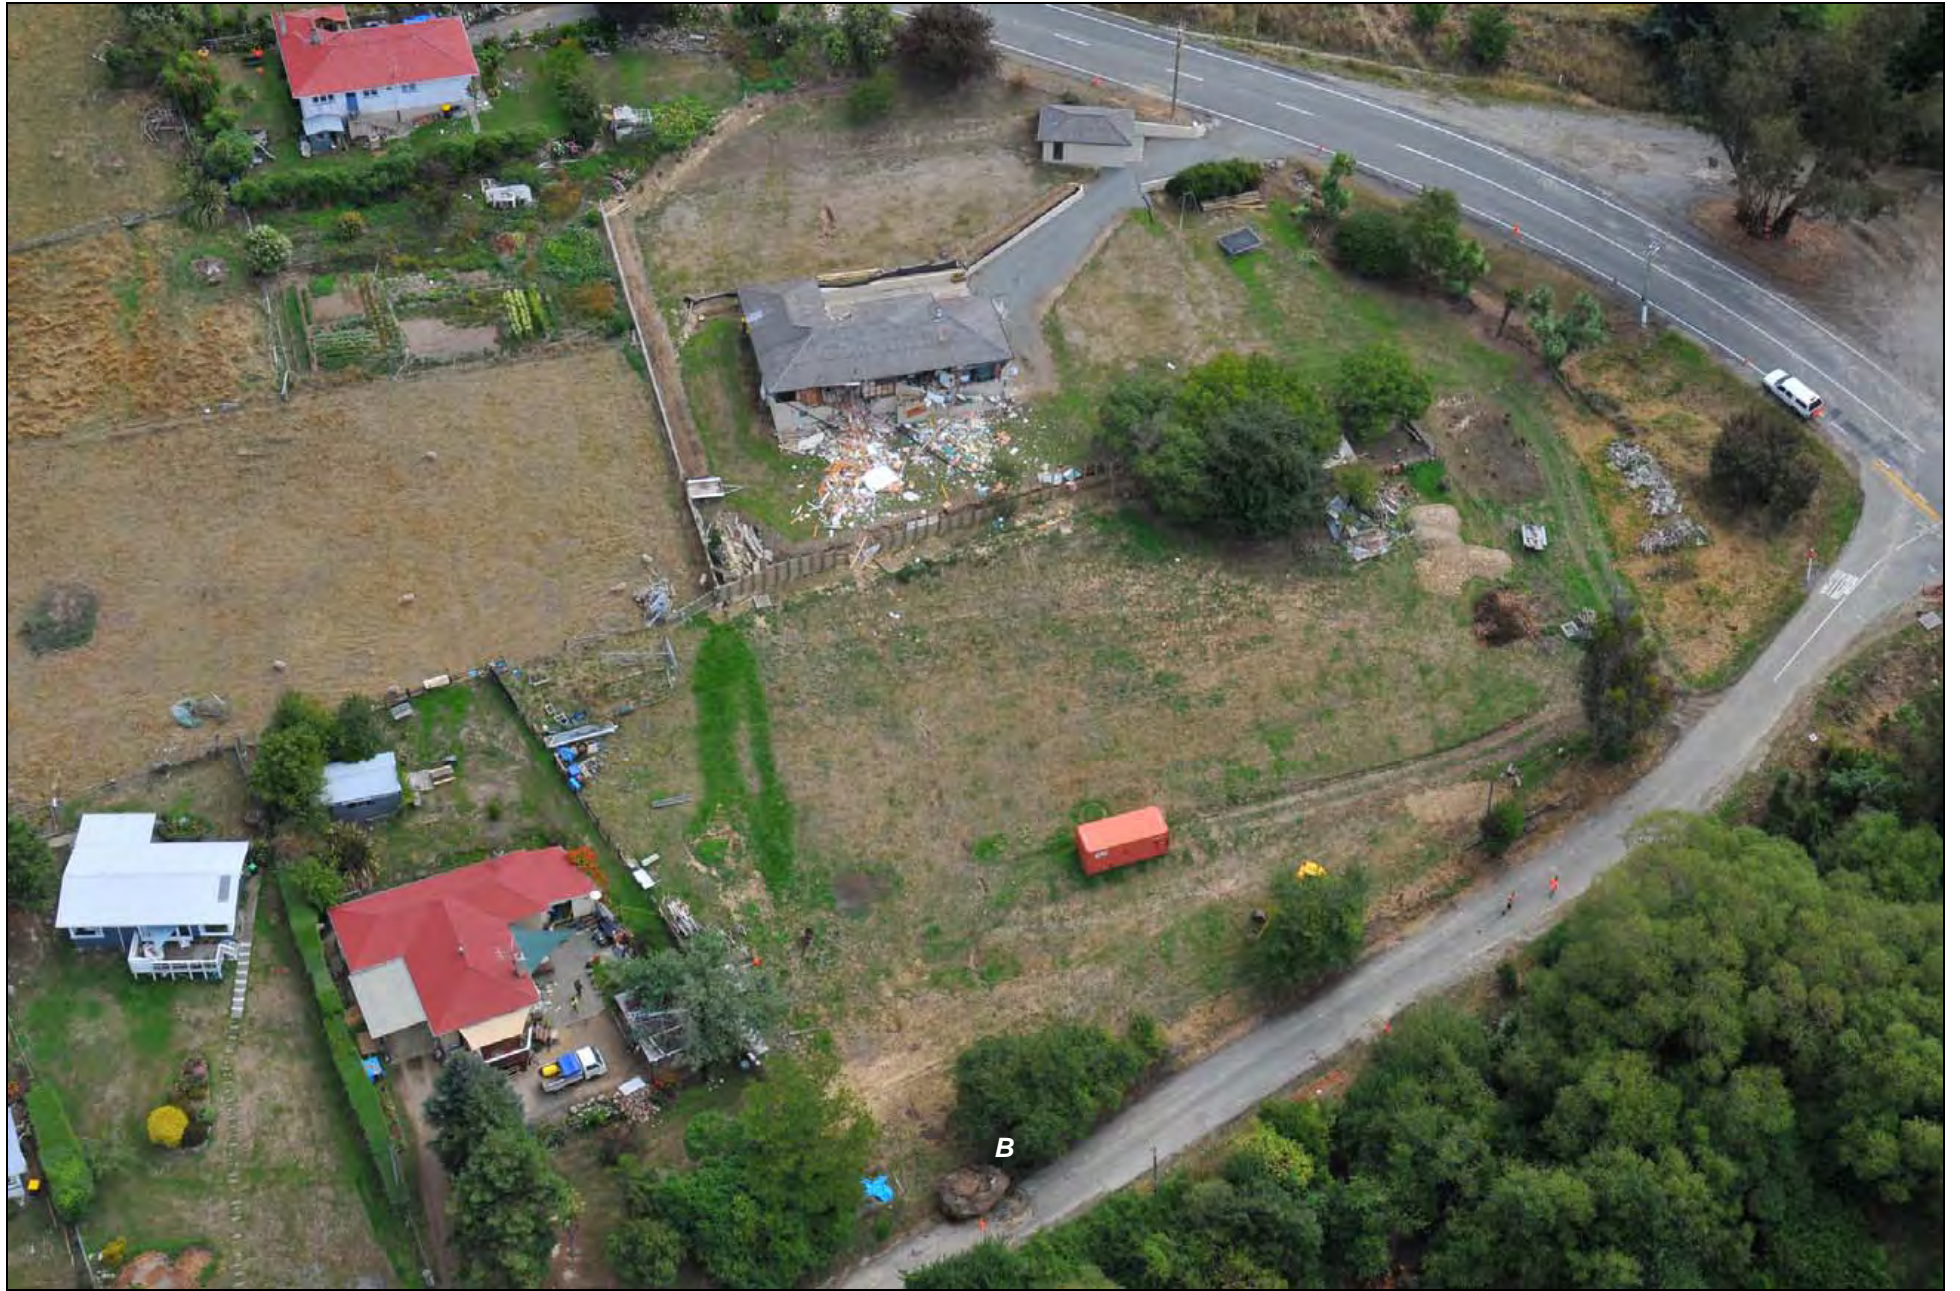
**Photo 27.** House hit by large boulder (*B*) at Rapaki (*GNS Photo-GTH\_5846*).

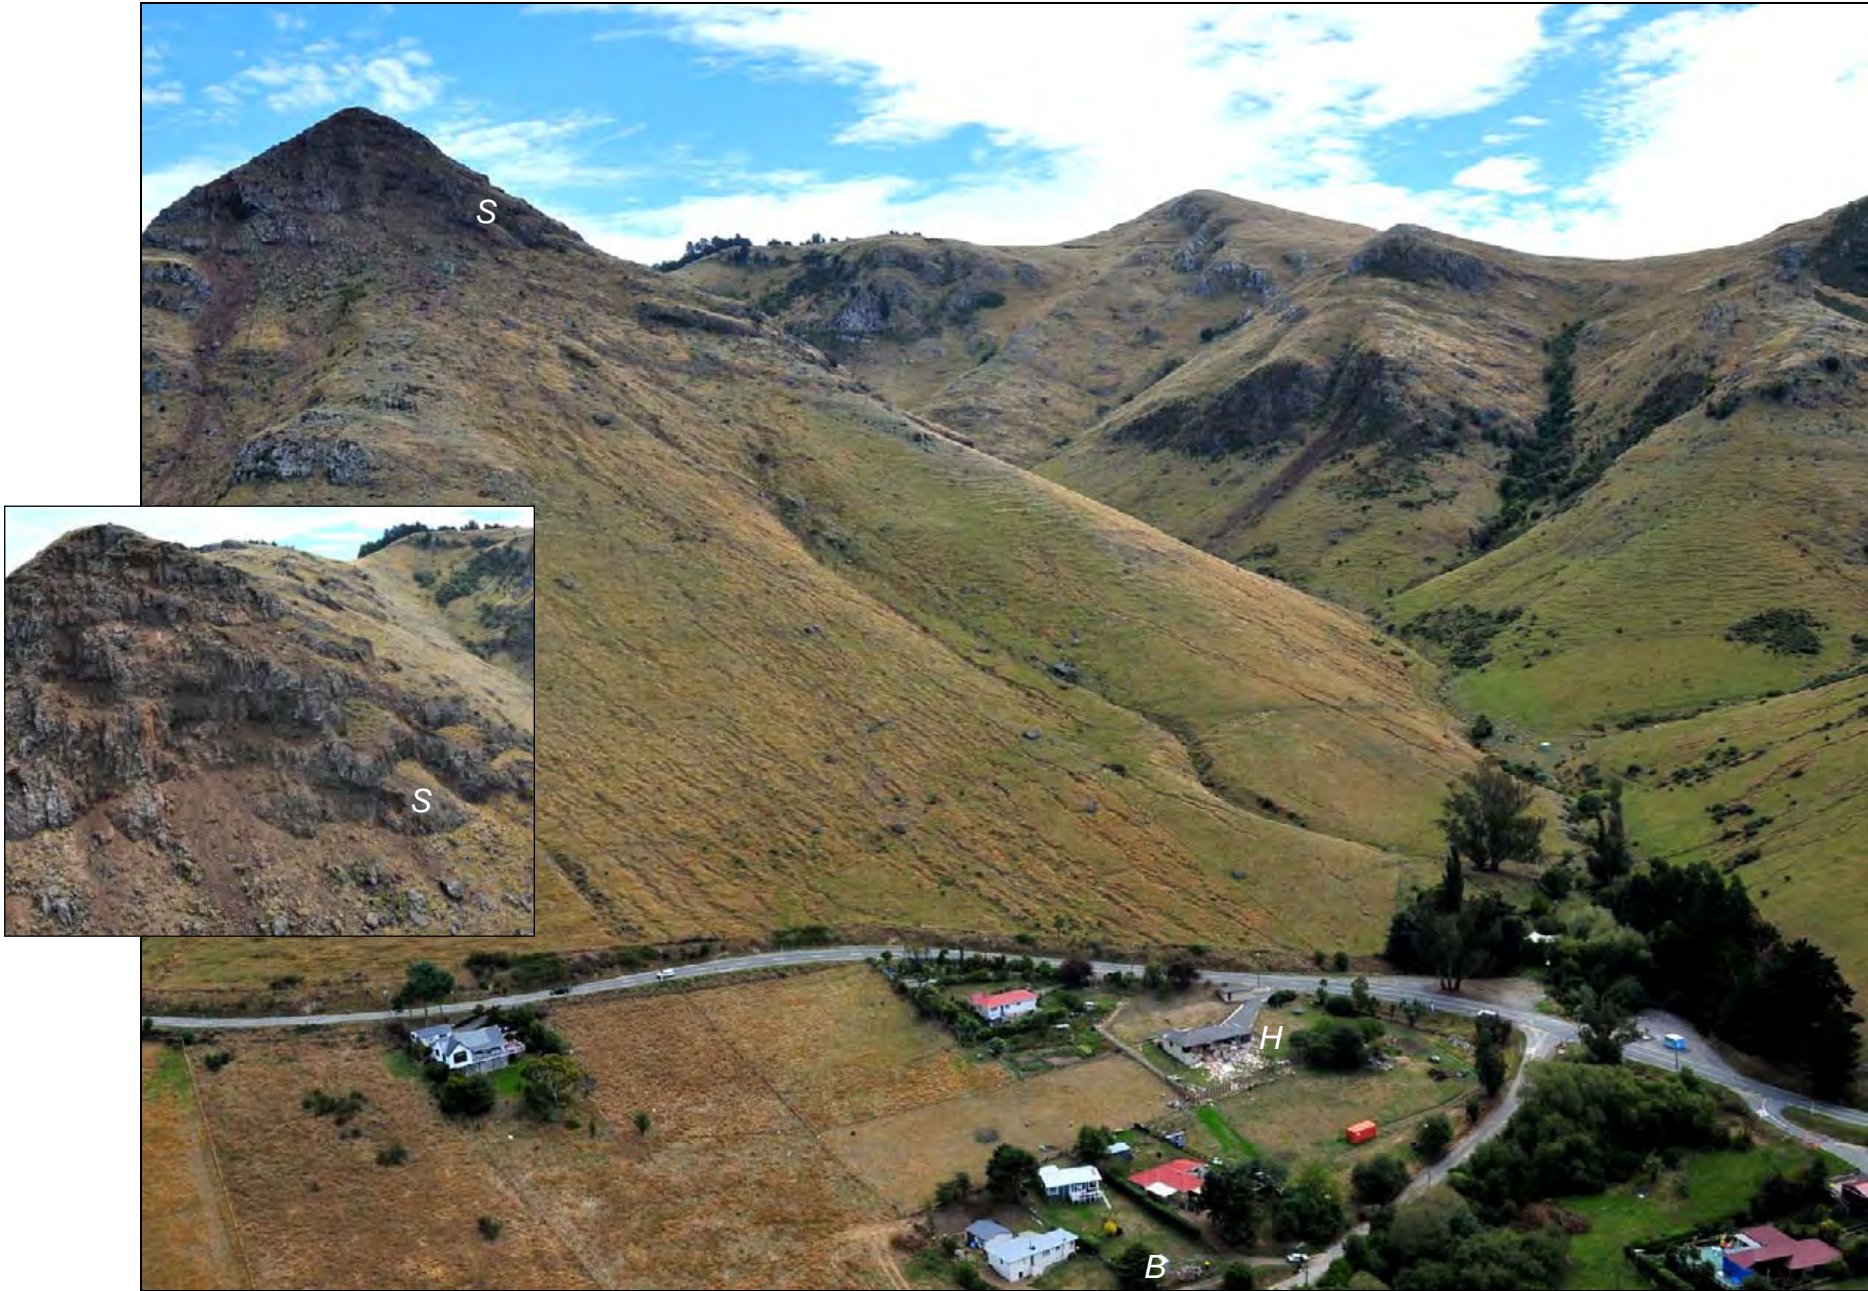
**Photo 28.** Source area (*S* on 405 m peak) and travel path of the boulder (*B*) that hit the house 241 Governors Bay Road (*H*) at Rapaki (*GNS Photo-GTH\_5853*).

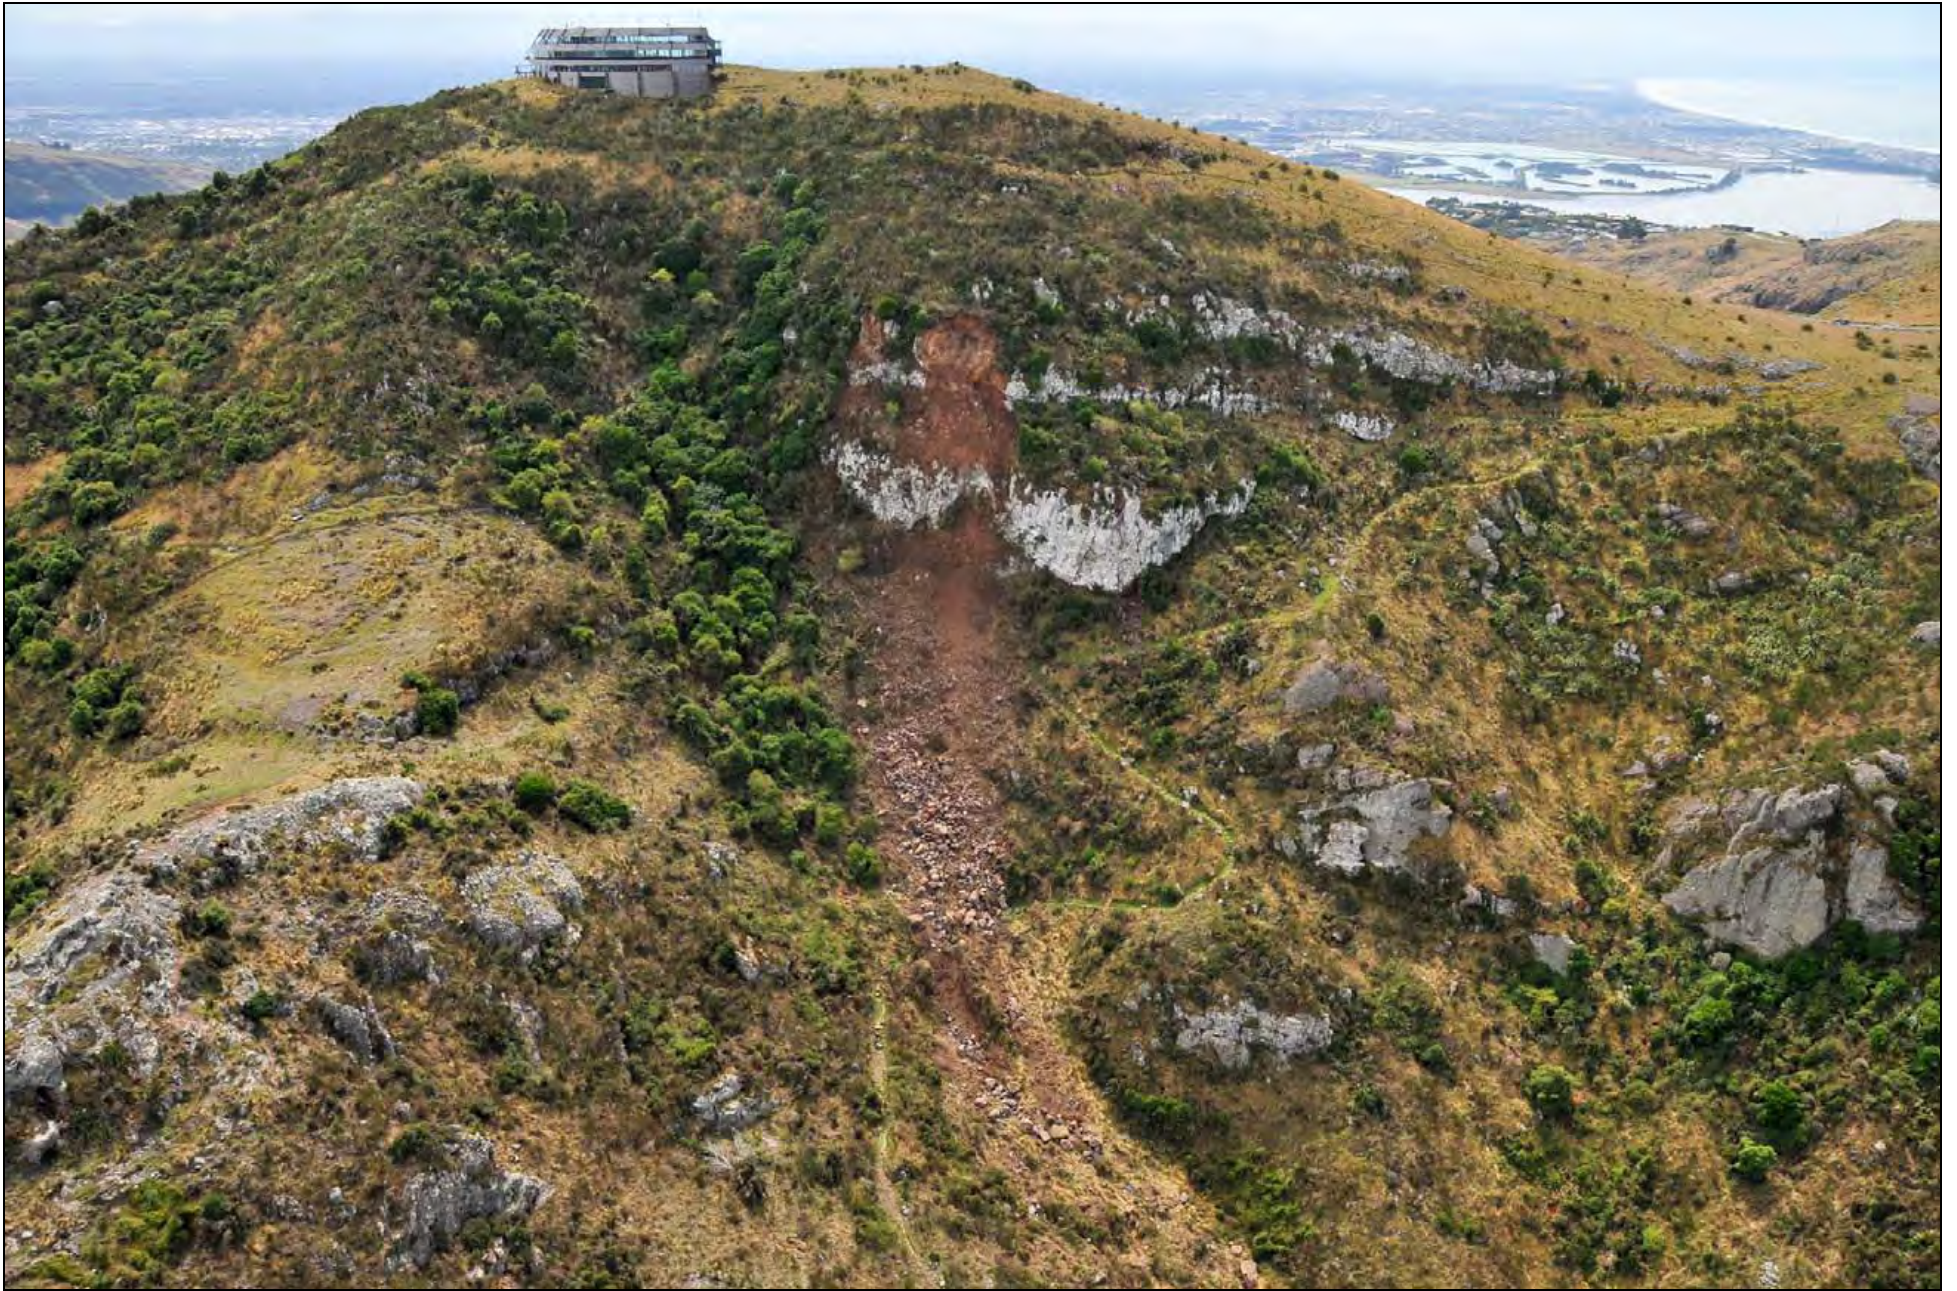
**Photo 29.** Rock fall on slope and walking track below Gondola Building (possible fatality site) (*GNS Photo-GTH\_5933*).

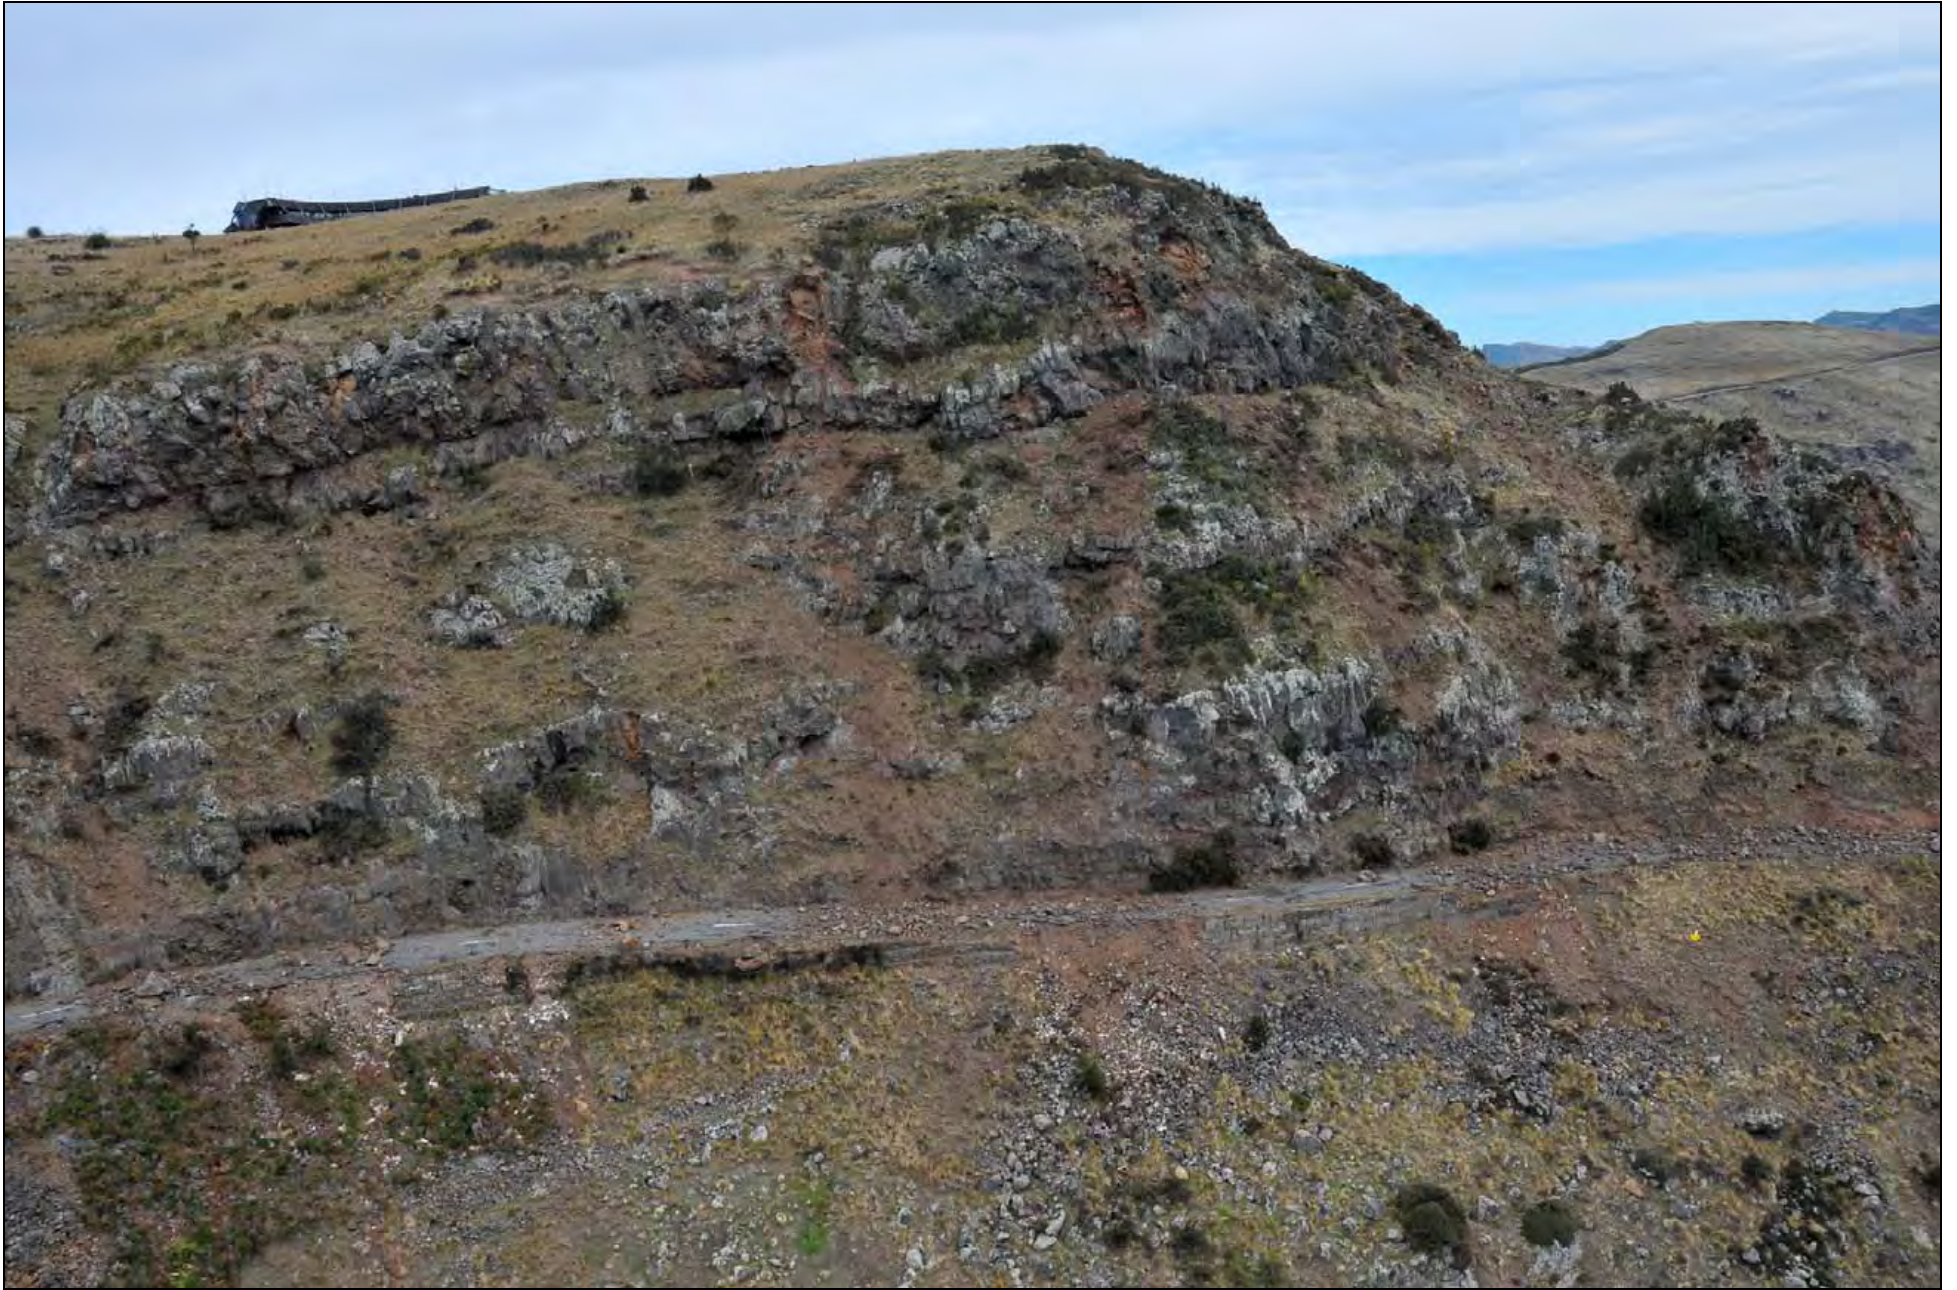
- (6) The intensity of rock falls on a short section of the Summit Road in The Tors area (Figure 2) was particularly noteworthy, with the road completely covered by large rocks over a length of several hundred metres (Photos 30 and 31). The other intense rockfall area was on the south side of Evans Pass where a tanker was stopped by rocks on the road. Elsewhere the rock falls are more scattered.

**Photo 30.** Numerous small rock falls from lava bluffs on to Summit Road near the Gondola Building (*GNS Photo-GTH\_5993*).
