## **GNS SCIENCE IMMEDIATE REPORT**

**DATE:** 2 March 2011

**SUBJECT:** Report on Landslide Reconnaissance Flight on 24 February 2011 following the  $M_w$  6.3 Christchurch Earthquake of 22 February 2011

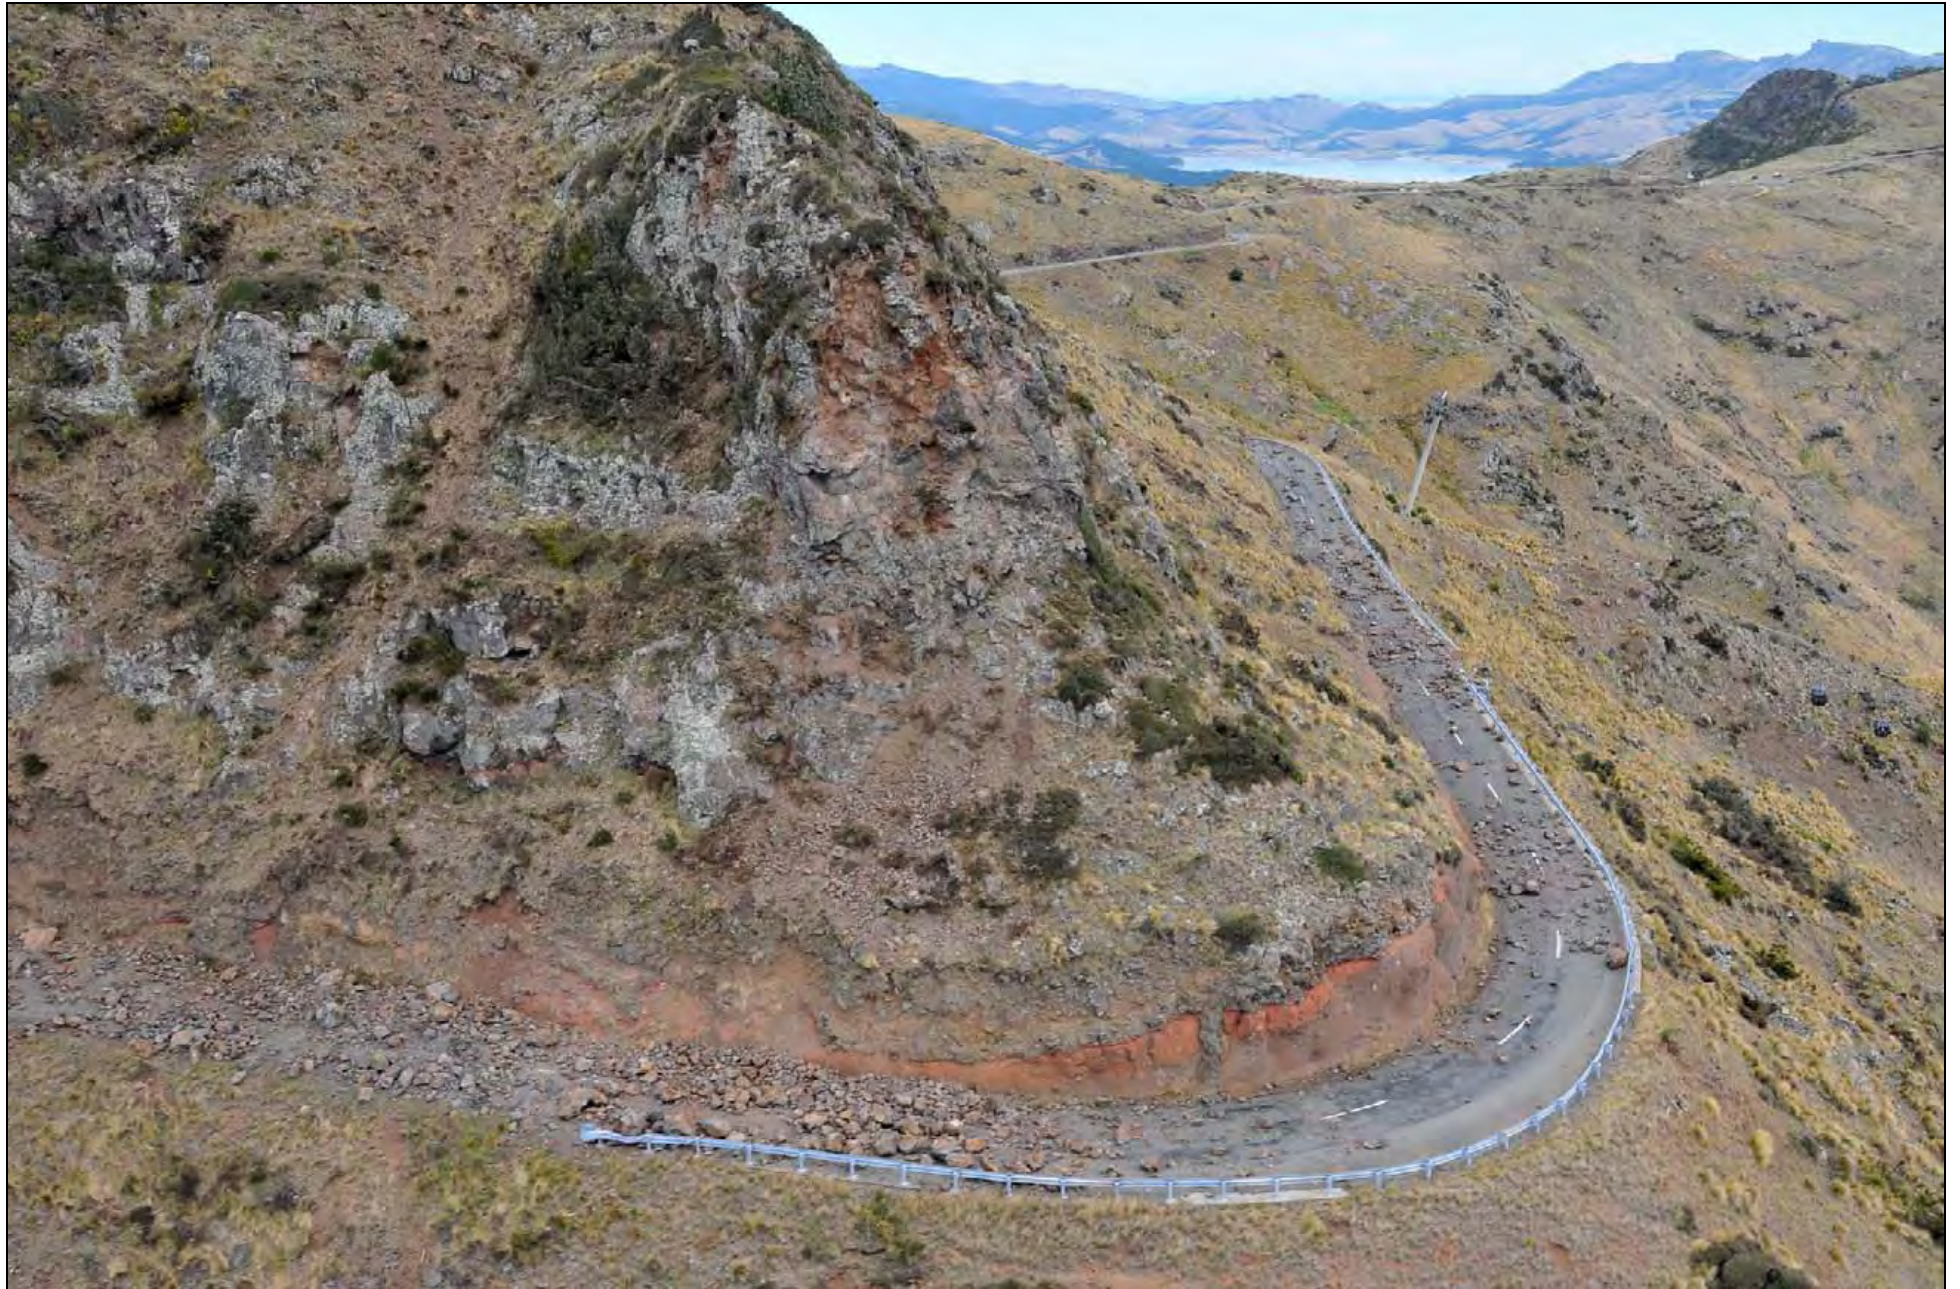
- (6) The intensity of rock falls on a short section of the Summit Road in The Tors area (Figure 2) was particularly noteworthy, with the road completely covered by large rocks over a length of several hundred metres (Photos 30 and 31). The other intense rockfall area was on the south side of Evans Pass where a tanker was stopped by rocks on the road. Elsewhere the rock falls are more scattered.

**Photo 31.** More rock falls on to Summit Road (*GNS Photo-GTH\_5998*).

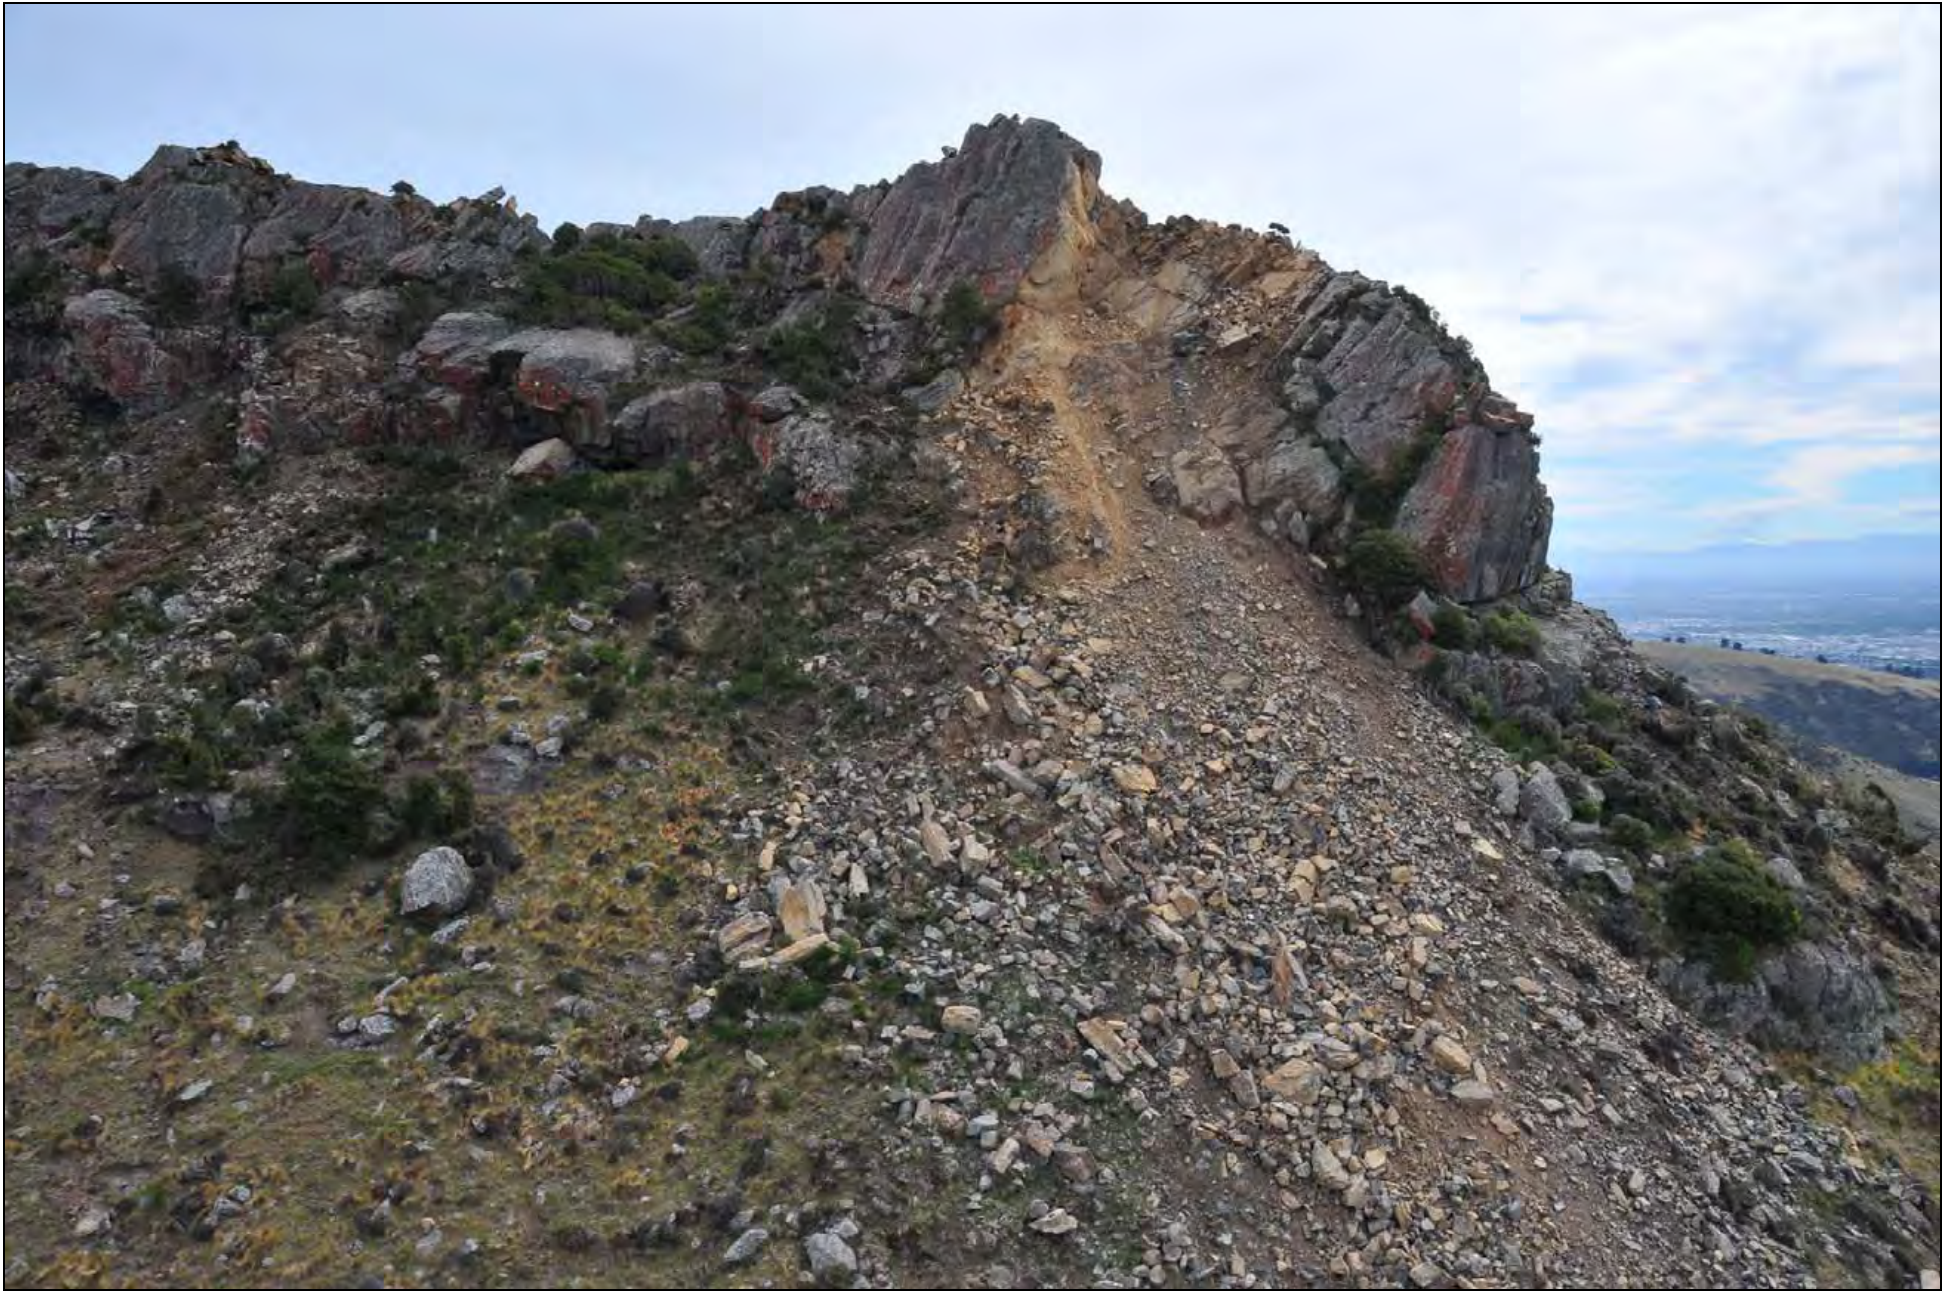
**Photo 32.** Rock falls from Castle Rock on to old talus slope. Most are from the 4 Sep 2010 earthquake, with some from the 22 February event (*GNS Photo-GTH\_6017*).

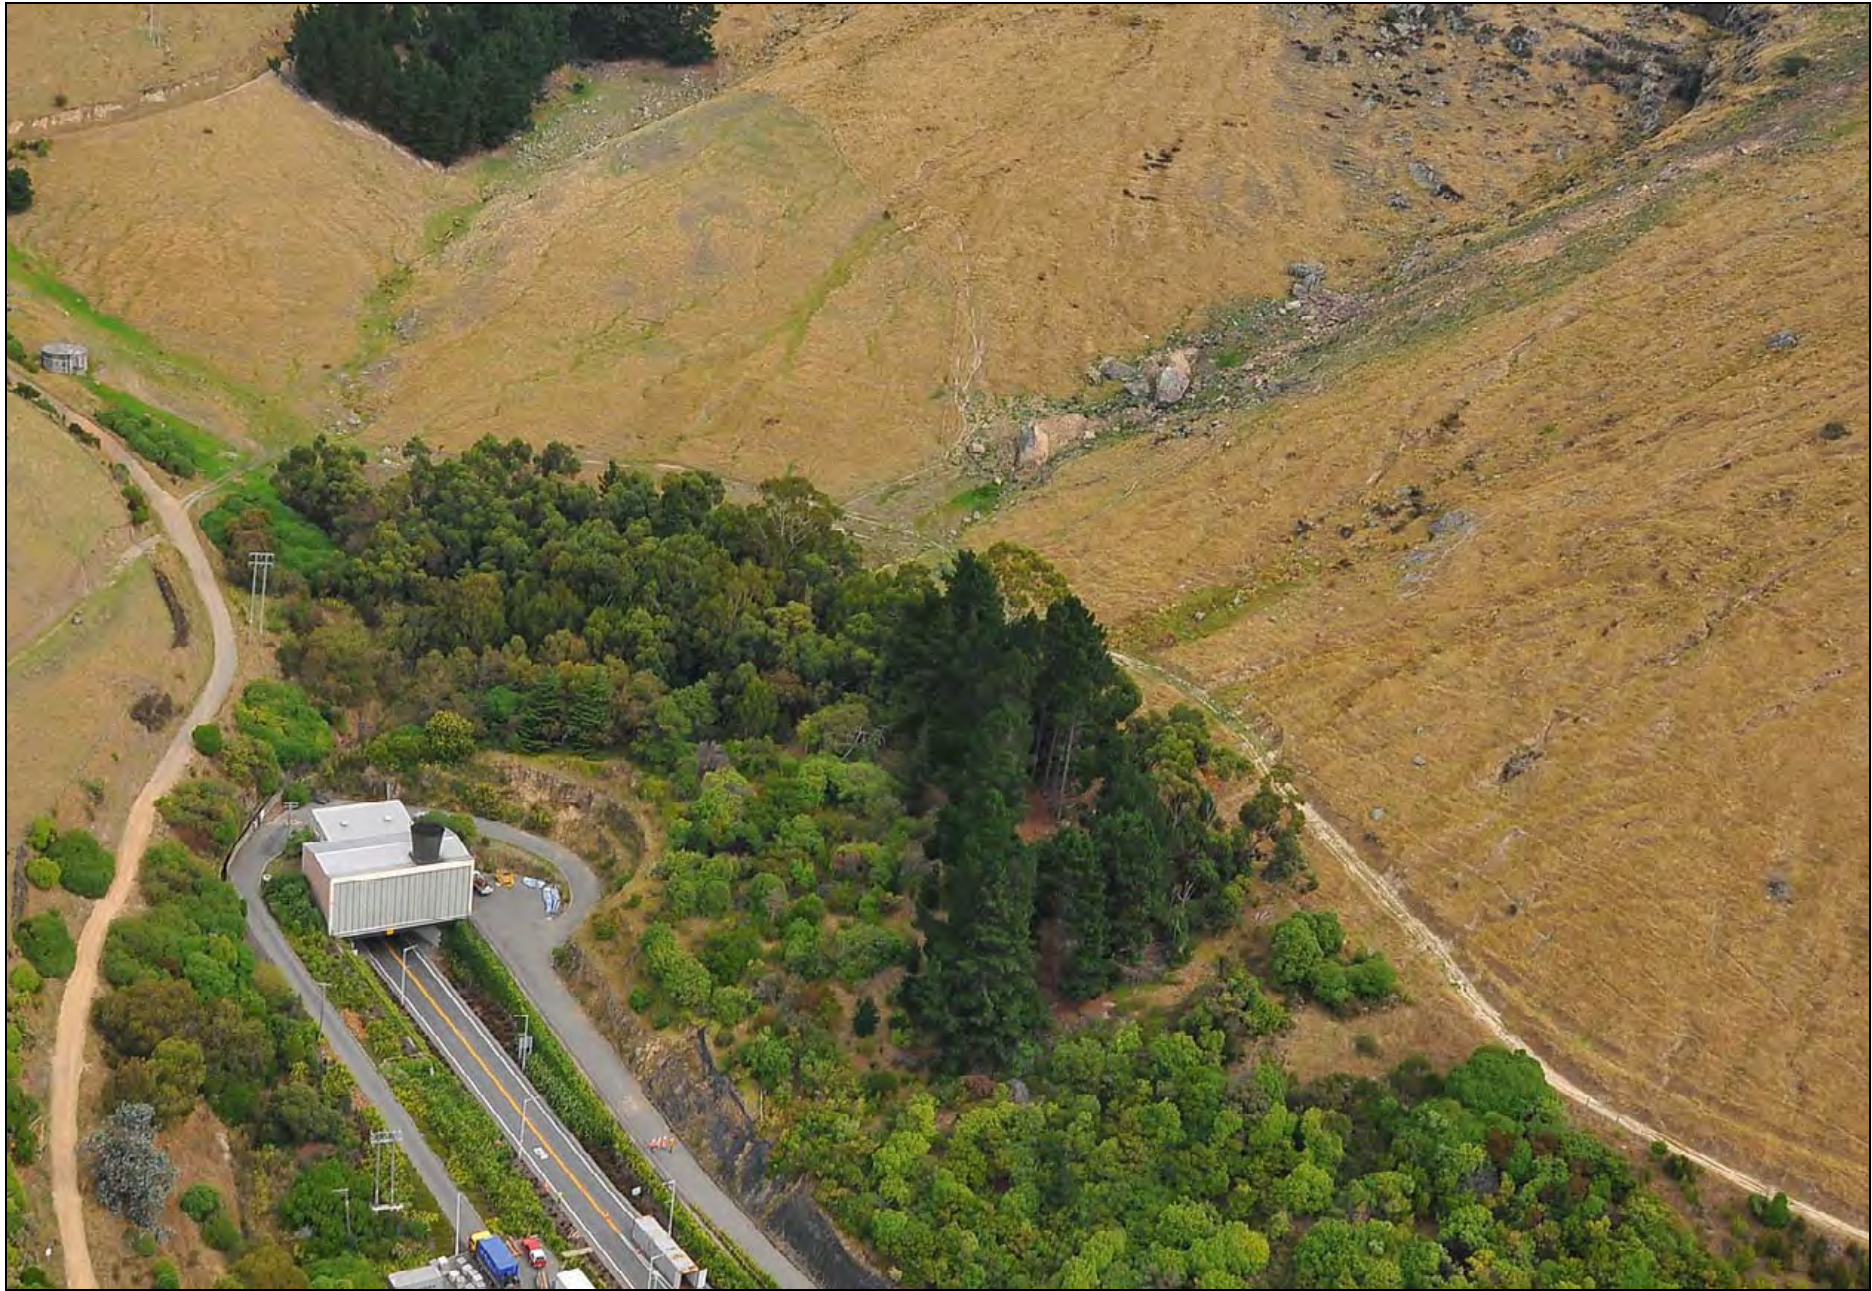
**Photo 33.** Large boulders from rock falls on Castle Rock (mainly during the 4 September earthquake) near west Tunnel Portal (*GNS Photo-GTH\_6084*).
