4.0 COASTAL EROSION HAZARD ASSESSMENT

Assessment of Coastal Hazards

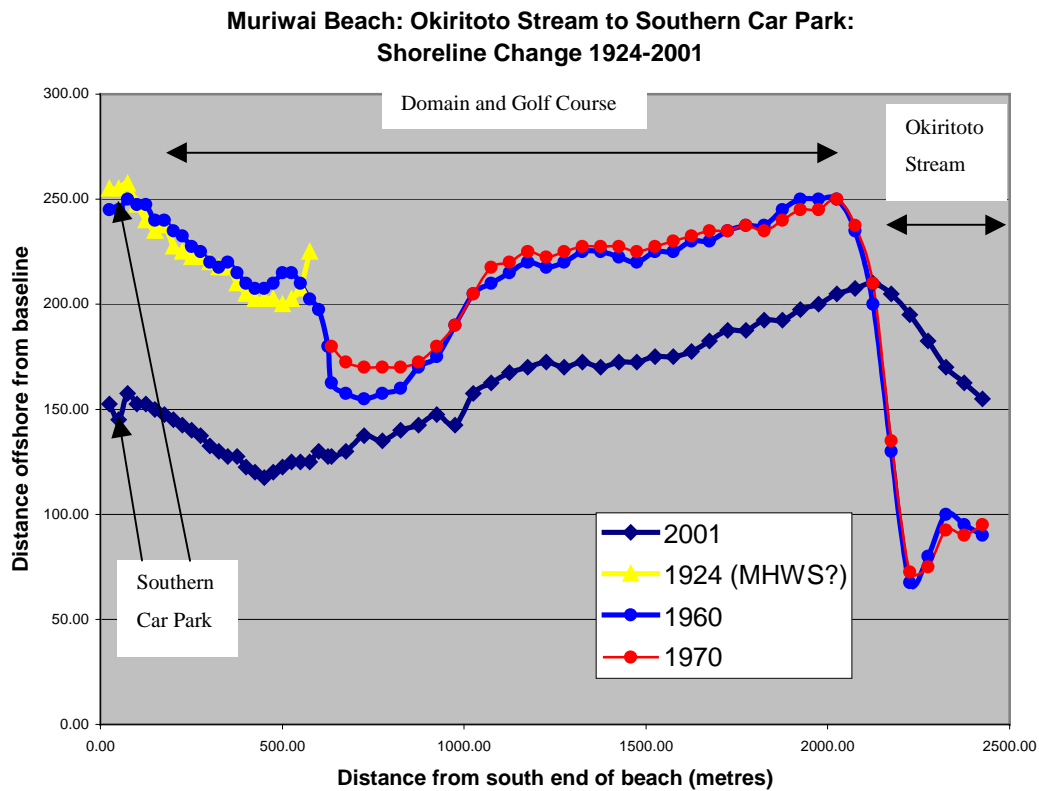
- **Little to no net shoreline change in the period from 1924 to 1960.** The average erosion between these two surveys being only 8m, which is within the margin of error of the comparison.
- **Very significant erosion over the period since the 1970 survey,** with the mean high water mark having retreated by about 100m in front of the car park – an average of 2.4m per year.

The data suggests that the trend for serious coastal erosion probably commenced after 1960. Prior to this period, the shoreline appears to have been in dynamic equilibrium, probably fluctuating in position in response to periods of shore advance (e.g. during periods of low swell) and shore erosion (e.g. during storms), but with no net change in shoreline position over time.

Figure 10: Shoreline changes at southern end of Muriwai beach as indicated by available historical surveys (see Appendix A).

Little net shoreline change in the period from 1960 to 1970, the average shoreline change over this area being within the margin of error of the comparison.

Significant erosion 1960 to 2001. The erosion has averaged 86m over the 600m shoreline fronting the Domain or 2.1m per year. Over most of the length of the Golf Course, the shoreline has retreated by 55-60m, an average of 1.8m per year. However, in a limited area towards the southern end of the Golf Course, the total erosion has only been in the order of 25-40m (Figure 10).

The relatively limited erosion in the period from 1960-1970 tends to suggest that the most serious erosion has occurred since 1970.

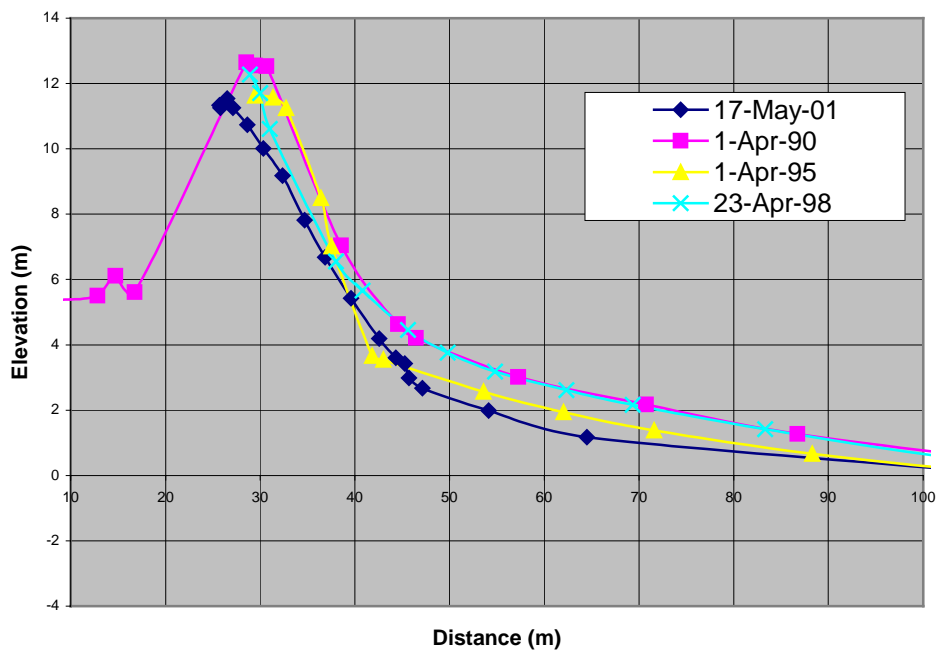
Muriwai: Site P4

This site (P4) is most representative of the Car Park area. The trends at this site are difficult to distinguish (Figure 11), but suggest ongoing net erosion. The difficulty in interpreting the data largely relates to collapse of the over-steepened dune profile after storms, which tends to mask the erosion trend. Dynamic variations also mask longer-term trends over the relatively short period of the record.

Figure 11: Beach profile data for site P4.

For instance, between the initial survey in April 1990 and the survey of April 1995, the toe of the dune retreated by about 9-11 metres, an average rate of 1.8-2.2 metres per year, a significant rate of erosion (Figure 11).

However, at the time of the April 1995 survey, the eroded dune face was markedly over-steepened (Figure 11) – suggesting that the severe erosion had occurred shortly before this survey. Subsequently, the over-steepened dune face collapsed. Together with short-term beach recovery, this resulted in some net accretion between April 1995 and April 1998 (Figure 11). Since April 1998, further erosion of the beach and dune has occurred, together with further retreat of the overall seaward dune face (Figure 11).

Overall, it appears that the toe of the dune retreated by about 9-11m between April 1990 and May 2001, suggesting an average rate of erosion of about 1 metre per year. The further erosion since that date (Section 4.3) suggests the trend for erosion is presently continuing.

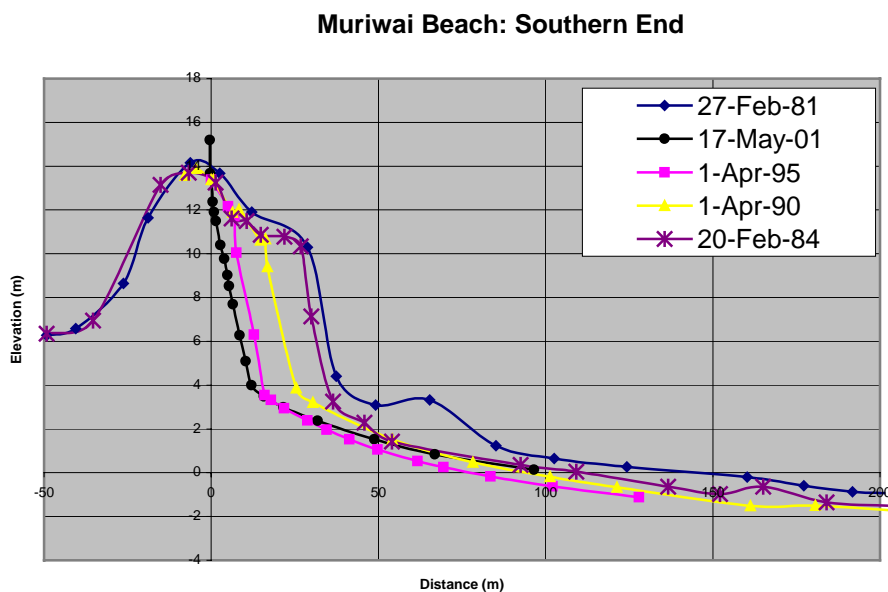
This site has shown a clear and consistent trend for beach and dune erosion over the 20-year period since monitoring commenced (Figure 12). For example, in May 2001 the toe of the dune (then at about RL 4m) lay 26m landward of the same elevation in the February 1981 survey, an average rate of retreat of about 1.3 metres per year.

Figure 12: Beach profile data for site P3

This is slightly lower than the average rate of erosion in this area derived from comparison of the 1970 and 2001 surveys (1.5 metres per year). The average rate of erosion in the 1980's (February 1981 and April 1990) at 1.4 metres per year was also slightly higher than the average rate of 1.2 metres per year in the subsequent period (April 1990 to May 2001). Collectively, these figures could suggest that the rate of erosion is slowing over time. However, in the 11 years between the surveys of February 1984 and April 1995, the average rate of erosion was 1.8 metres per year. Therefore, the differences could equally represent dynamic variations over time, rather than a trend for the rate of erosion to decrease with time.

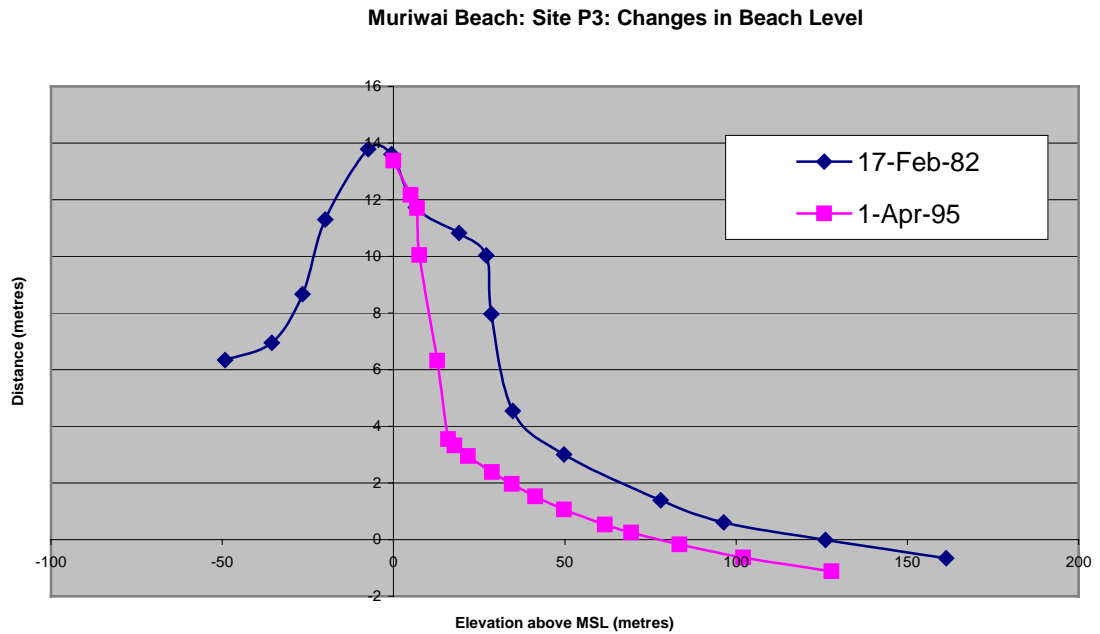
It is difficult to draw any firm conclusions in respect of net trends in beach level due to dynamic variations in profile shape. However, plotting the two surveys that are most similar in profile shape (February 1982 and April 1995) does suggest a trend for beach lowering (Figure 13). The average lowering of the upper beach (adjacent to the dune) is about 2m and the average beach gradient in this area is about 1:13. Therefore, the apparent beach lowering is of the scale that would be expected to give rise to the observed dune retreat (25m) between these two surveys.

Figure 13: Changes in beach levels between 1982 and 1995.

This evidence tends to suggest that the ongoing trend for severe dune erosion relates to an ongoing trend for net loss of sediment from the beach system fronting the dune.

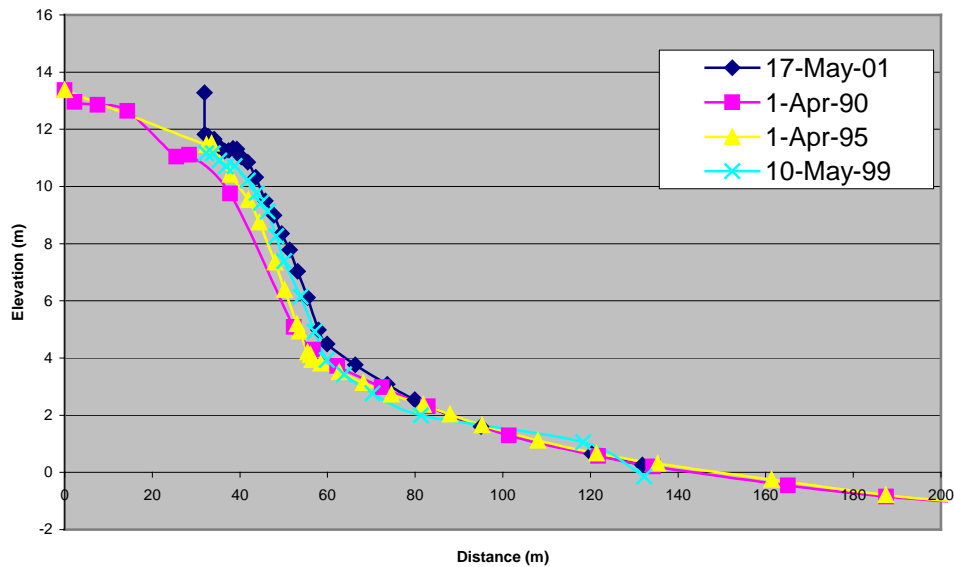
Muriwai: Site P2: Rimmer Road

The data suggests the shoreline is slowly prograding at this site (Figure 14).

In May 2001, the toe of the main frontal dune (approximately RL 4.5m) lay about 5m seaward of the equivalent elevation in April 1990 (Figure 14), suggesting slow net seaward advance of about 0.45m per year.

Figure 14: Beach profile data -site P2

The prograding dune face is very steep and appears to have become slightly steeper over the 10 years of monitoring (Figure 14). For instance, the main part of the dune face, between RL 4 and RL 10m, increased in slope from 1V: 3.2H in 1990 to 1V: 2.8H in May 2001. This is likely to give rise to increasing instability problems as the dune grows in height. The steep seaward face is almost certainly a function of the marram vegetation that dominates the frontal dune.

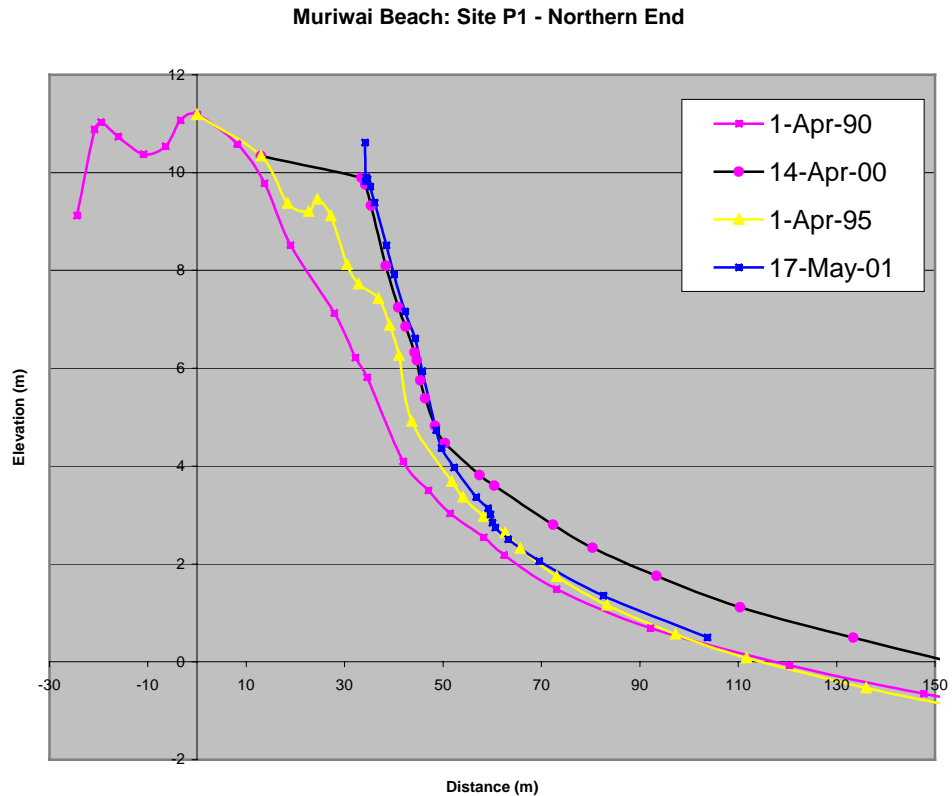
This site shows a clear trend for seaward dune advance over the 11-year record (Figure 15). The dune toe in May 2001 (about RL 4m) was located 14m seaward of the equivalent elevation in April 1990, indicating an average rate of dune advance of about 1.3 metres per year.

Detailed examination of the full data set (11 surveys between 1990 and May 2001) indicates that the trend for dune advance has been consistent throughout the period, though occasional storm erosion is also evident (e.g. April 1995 survey).

Figure 15: Beach profile data for site P1

The advancing dune has also steepened over time (Figure 15). In the period between the surveys of April 1990 and May 2001, the average gradient of the seaward dune face (between RL 4m and RL 10m) increased from 1V: 5.5H to 1V: 2.7H.
