2017-01 LRep  
Status: Open  
20 January, 2017

Prepared for:  
Tonkin and Taylor Ltd

## Background information: Whanganui Port Basin management assessment

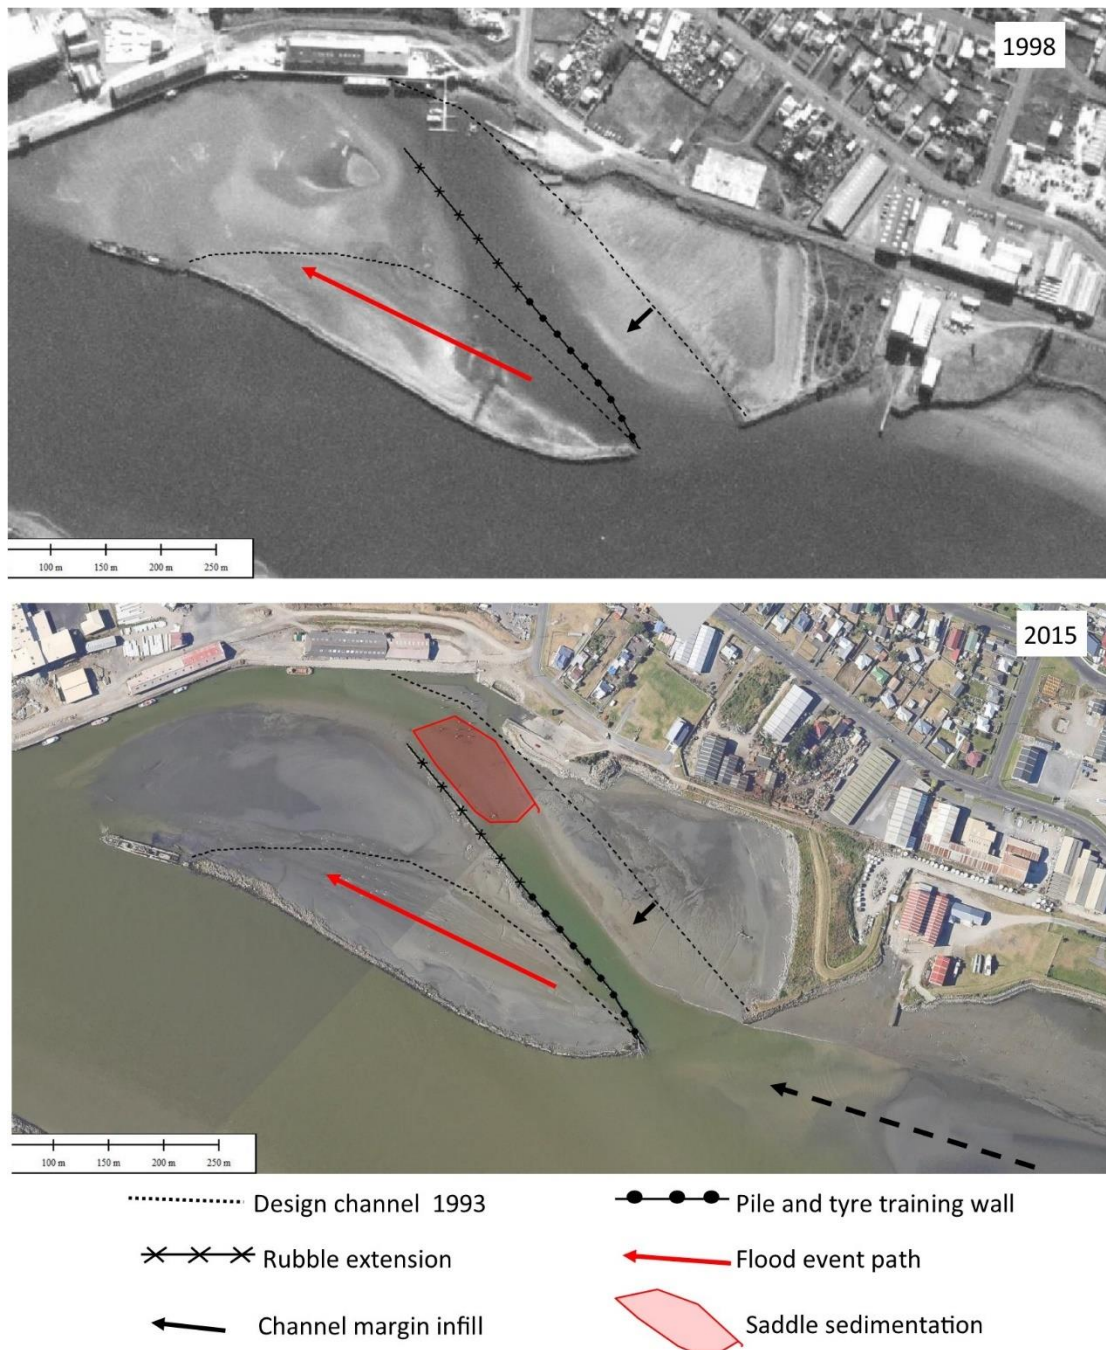
**Figure 1** Design channel and training wall locations superimposed upon 1998 and 2015 aerial photos. The flood event (erosional) pathway is marked by the red arrow; this resulted in substantial erosion of the tidal flat and meandering of the channel depriving the wharves of breach-diversion flow. The pile and tyre training wall was constructed in 1999.

System responses we have identified suggests both Professor Raudkivi and Mr Steel under-estimated scour within the Basin as the channel proved to be particularly unstable and prone to meander, requiring subsequent structural control (Figure 1). The scour action appears to extend not much beyond the pile training wall (Figure 1 and also 2015 bathymetric chart contained in the 2016 Baseline Study) with maintenance dredging required beyond.

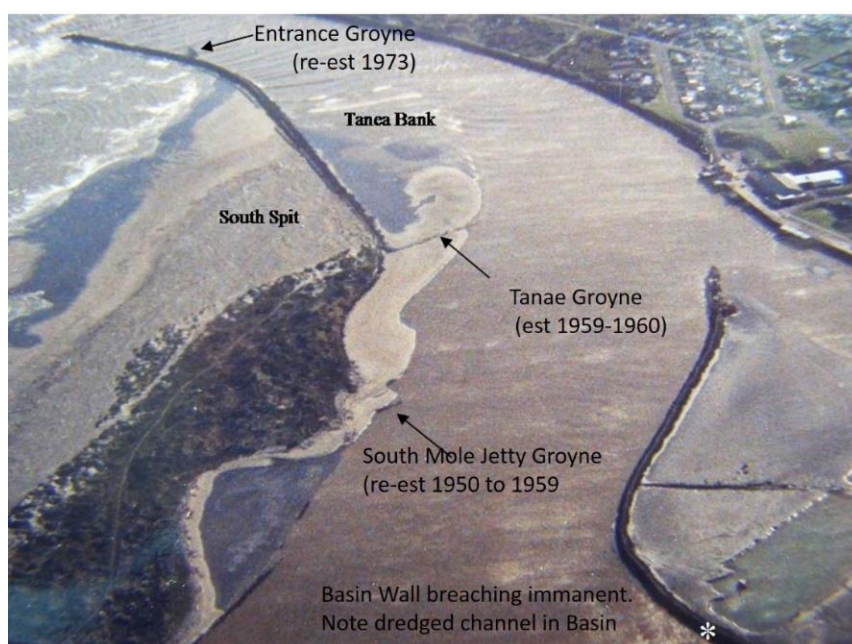
**Figure 2** Excavation of the Basin Channel prior to breaching the wall.  
Source 2016 Baseline Study, Figure 12.

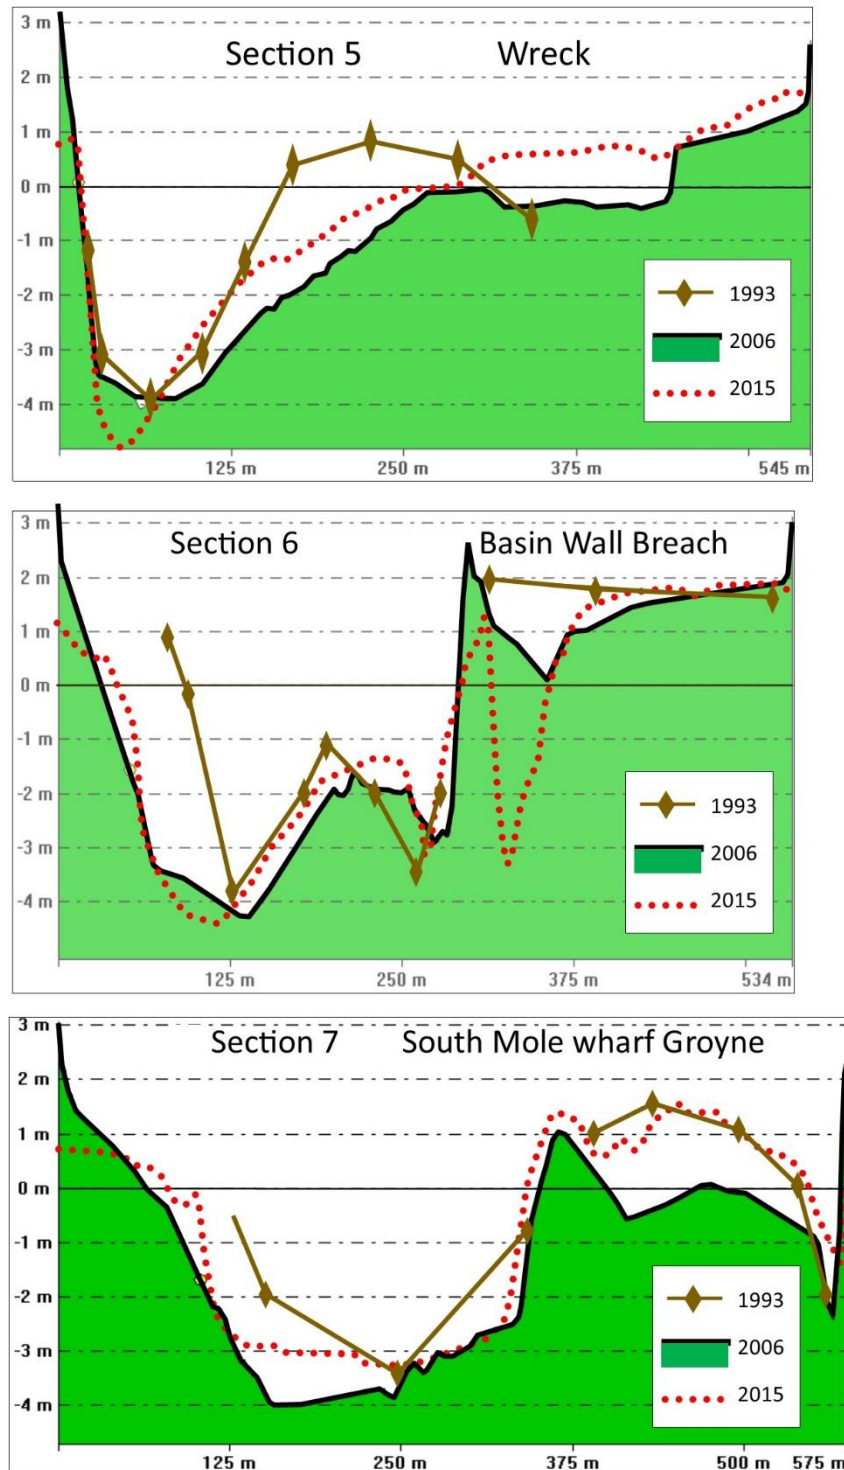
The 2006 profile shows considerable erosion in the main river channel (between 100 to 150 m from measurement datum at the South Spit) and indicates a lesser, albeit well defined, northern channel (between 300 to 400 m) persists from 1993. This north channel is better defined here than at sections further upstream, and this may be associated with local strengthening of river flood flows through the breach immediately downstream. However, the 2015 profile shows shallowing of the north channel by up to 1 m, and this is further illustrated by the sediment body (lobe) evident in the bottom right of the 2015 aerial photo in Figure 1. Sequential aerial photos (not shown) show this sediment is migrating downstream and possibly beginning to affect the breach area. Monitoring is required to determine whether sediment enters the Basin or if the

**Figure 4** Section graphs for 1993 (pre-breach), 2006 and 2015 superimposed upon the 2006 profile. Note the constant scales in all graphs enable direct comparisons. Source 2016 Baseline Study, Figure 16, with the original graphs also including earlier data.

The profiles shown in Figure 4 depict substantial post-breach erosion against the South Spit. However, as described in the 2016 Baseline Report, this appears to be more likely a result of larger scale sediment supply variation than an effect of the breach. By contrast, on the western side of the main channel, i.e. the Basin Wall side, the well-defined pre-breach channel along the river side of the Basin Wall, referred to as “the basin wall channel”, had reduced in size in the 2006 and 2015 profiles. These changes are more likely related to the breach diverting flood flows through the Basin and thus reducing flow along the basin wall channel.

Within the Basin, the 2015 profile shows the diversion channel immediately downstream of the breach is now over 3 m below Chart Datum. However, the 2006 profile shows it was still near the design depth of CD plus 0.5 m (see Breach Bathymetry section below). The right side of the channel had migrated into and across the design centreline by 1998 (Figure 1) with the 2006 and 2015 profiles indicating that this side of the channel is now relatively stable. There is little difference in pre-breach and present elevation across the tidal flat.

As occurs at Section 6, the left side of the Main Channel had moved significantly towards the South Spit. However, on the right hand side of the main channel at least 1 m of erosion had occurred by 2006, and this was essentially unchanged in 2015. This may be associated with the erosional adjustment to the onset of deposition at the adjacent upstream section (6). Note, deposition and erosion typically alternate along sediment transport pathways.

Within the Basin itself, the 2015 profile indicates a shallowing of about 1 m against No 3 Wharf, and 0.5 m of deepening on the tidal flat near the Basin Wall between 1993 and 2015. The latter change possibly relating to the flood event pathway marked in Figure 1. While the 2006 profile shows the same pattern, it is over 1 m deeper, indicating a slow response to the post-breach erosive flood events.

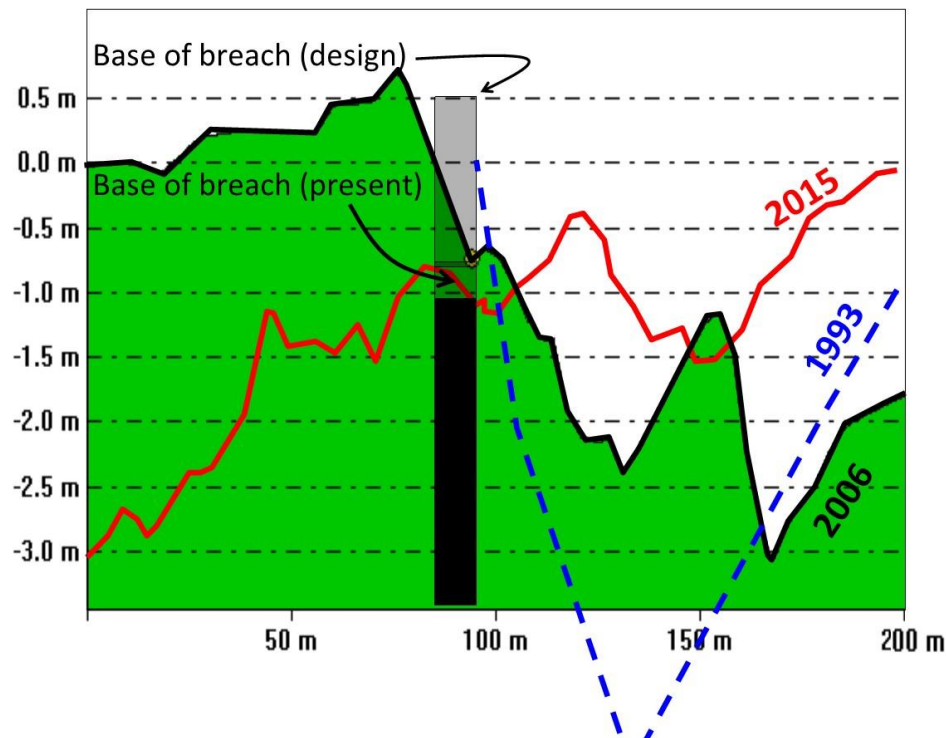
Figure 5 shows bathymetries for 1993, 2006 and 2015 along the Basin channel, crossing the breach and extending 100 m upstream of the breach – this 200 m long transect has been marked blue in Figure 3.

The 4.8 m depth immediate upstream site of the breach as well as depicted by the 1993 elevation line, was crucial to the Wanganui Engineering slipway operation.

These data do not show whether or not the 1994 breach was constructed at the design depth of 0.5 m CD, as the 2006 data is 12 years post event.

While the breach invert was about 1 m below design level in 2006, the channel across the Basin appears to be at design level suggesting subsidence may have affected the base of the breach following its opening. Upstream of the breach, the 2006 bed level has risen some 2.5 to 3.5 m.

The 2015 breach invert appears to be up to 1.5 m below design level and there are contrasting bed level changes on each side of the breach, with levels in the Basin eroding 2 to 3 m (close to the training wall) and up to 2 m of deposition occurring on the upstream side of the breach. The 2015 lines in Figure 5 show that the sediment accumulating on the upriver side is higher than the breach invert and beyond the graph range the bed level increases to 1m CD. Sediment may well enter the Basin unless the invert is raised.

**Figure 5** Bed level comparisons on each side of the breach (Basin on left, upstream on right). The breach is depicted by the black bar. Graph includes about 100 m of channel into the Basin (left) and about 100 m upstream of the breach (right). 1993 is pre-breach bed level and maximum depth was 4.8 m.

Furthermore, the training wall is being placed under increasing strain due to channel scour possibly aided by slow encroachment of the right side of the channel. Inspection with a view to maintenance and strengthening should be carried out immediately and regularly thereafter.

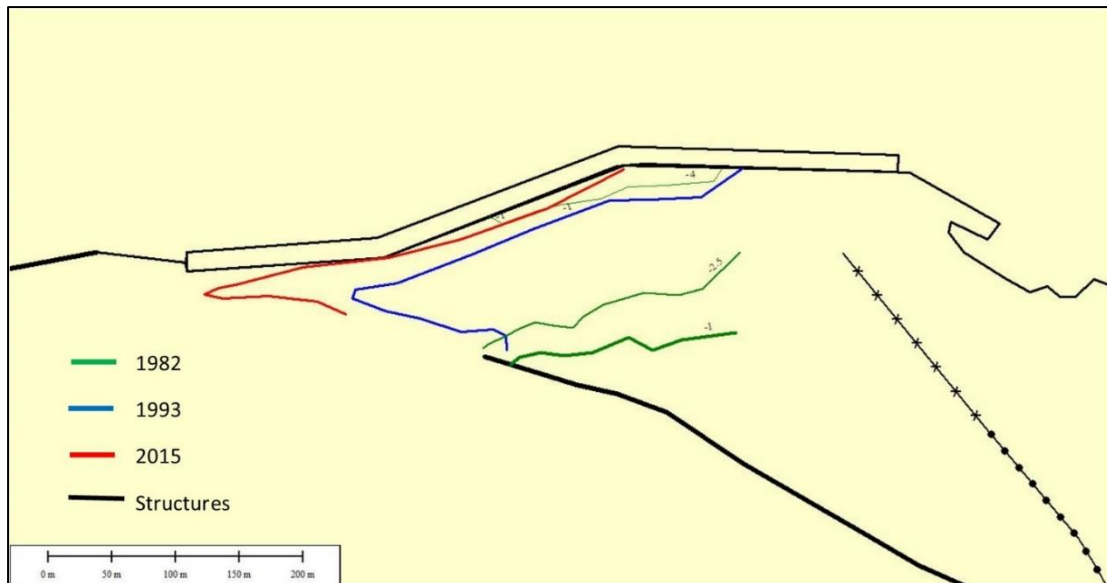
The 1993 contour in Figure 6 shows reduced depths had occurred when the company breached the Basin Wall in 1994. Trevor Gibson (Section 4 below) considered much of the reduction had occurred by 1990.

companies operate the port had saved the community \$6 m between 1988 and 2004. However, the matter of deferred maintenance remained contentious and the Wanganui District Council itself took over the lease in 2010” (2016 Baseline Report, p57). The 2015 contour (-1m CD) in Figure 6 indicates an overall reduction in depth has occurred during the lifetime of the breach.

**Figure 6** Plan view of Basin elevation change 1982 to 2015. Contour lines at -1m CD are shown for all samples, with -2.5m CD and -4m CD also depicted for 1982,
