Middleton Bay Long-term Management Strategy

A report prepared for the South Taranaki District Council

Reference	2020-3b CRep
Version	1.2 (FINAL)
Status	For council use
Date	7 August, 2020

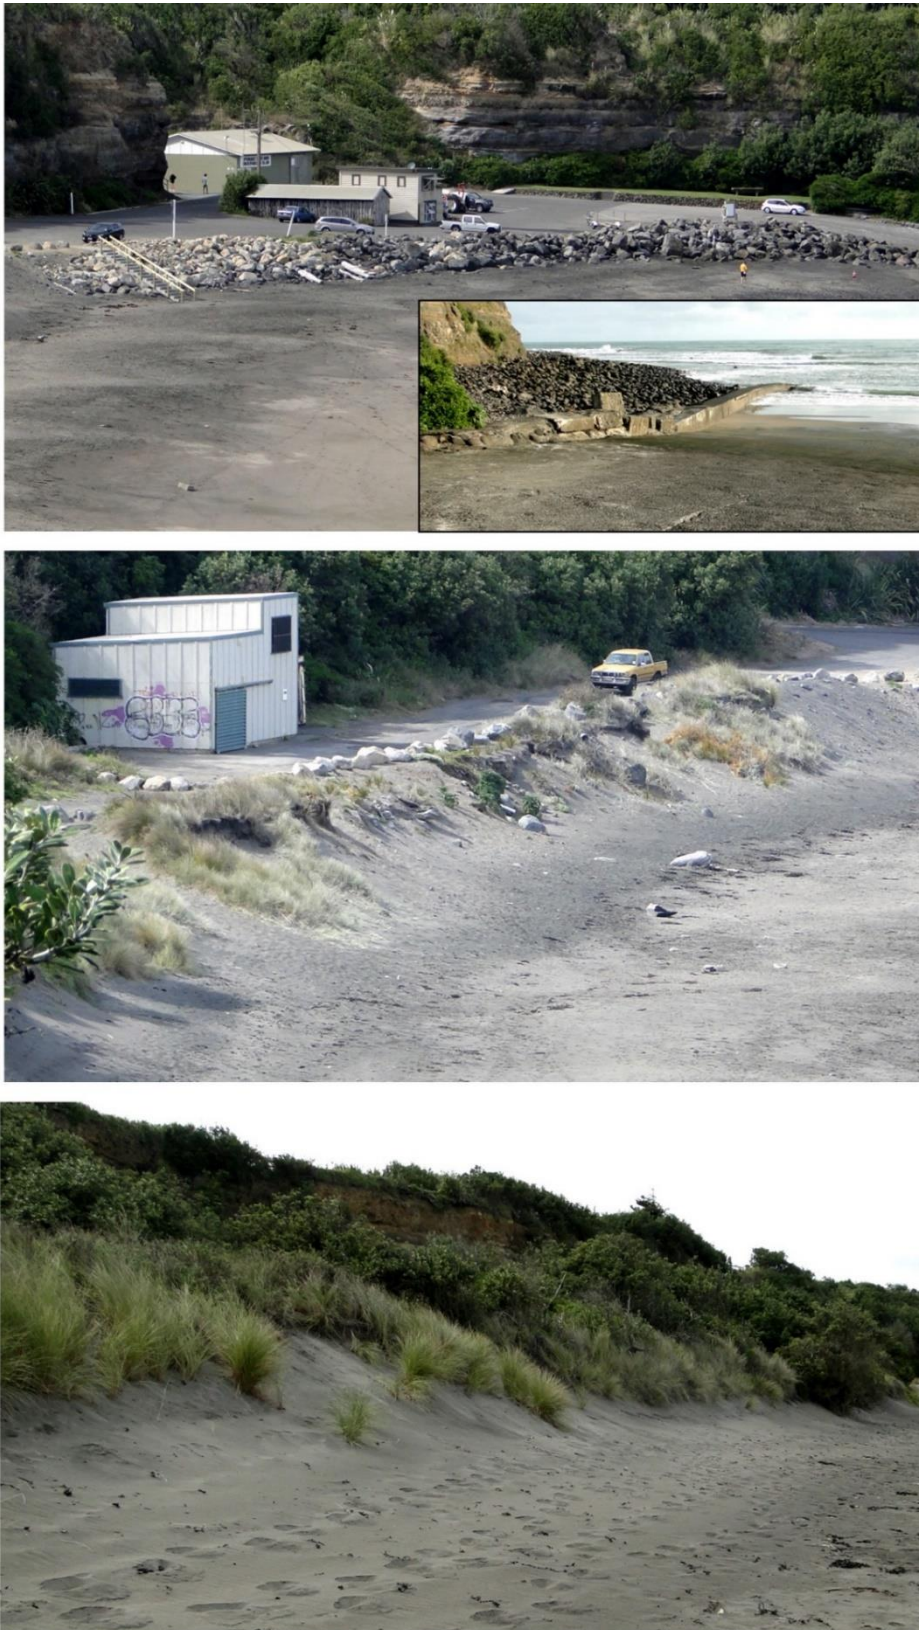
Figure 4 The three physically contrasting sectors; developed SE Sector in upper photo (inset is the ramp wall on the south side of the boat ramp); the transitional (Central) sector in middle photo, and the natural (NW) sector in lower photo. All photos were taken on 16 March, 2020.

Boulder pile-up between the southeastern cliff and ramp wall protecting the boat ramp (Figure 4 inset) indicates a local current flows landward along the southeastern headland – likely driven by breaking storm waves. Gibb (1998) noted that such interception was reducing sediment availability for the landward beach area perhaps making it more erosion-prone. However, the primary source of beach sand is undoubtedly of littoral origin and is transported onto the intertidal beach by the dominant clockwise wave-driven current marked in Figure 5 under fairweather conditions. Most of this sand will later be swept seaward to rejoin the southward directed littoral stream under storm conditions.

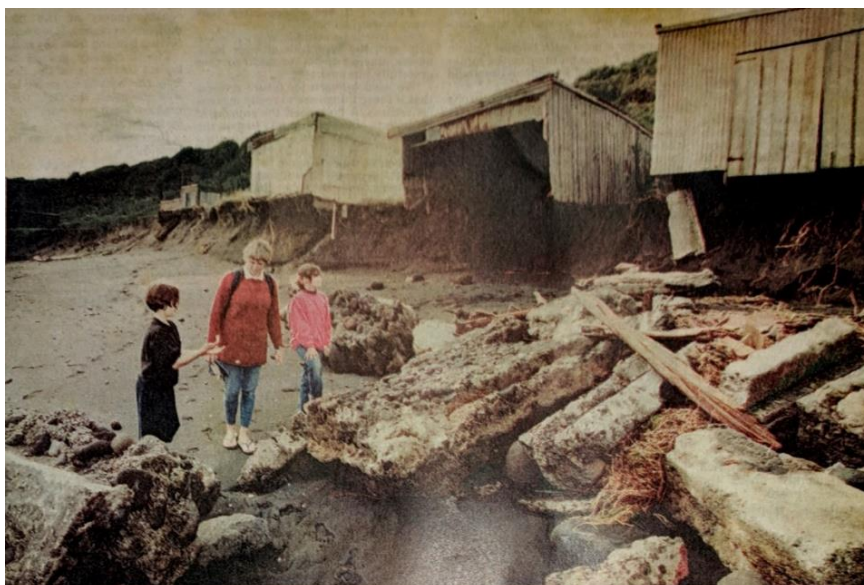
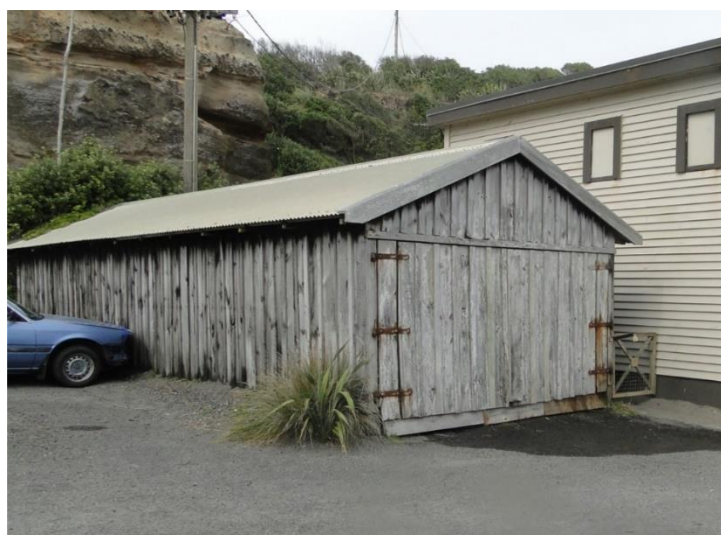
Figure 8 The top photo shows 3 boat sheds undermined by the March 1999 storm (source: Taranaki Daily Mail, 19 April 1999). Note rubble littering the beach – this was originally placed against the bank to provide wave protection. Lower photo shows the last remaining boat shed at 16 March, 2020.

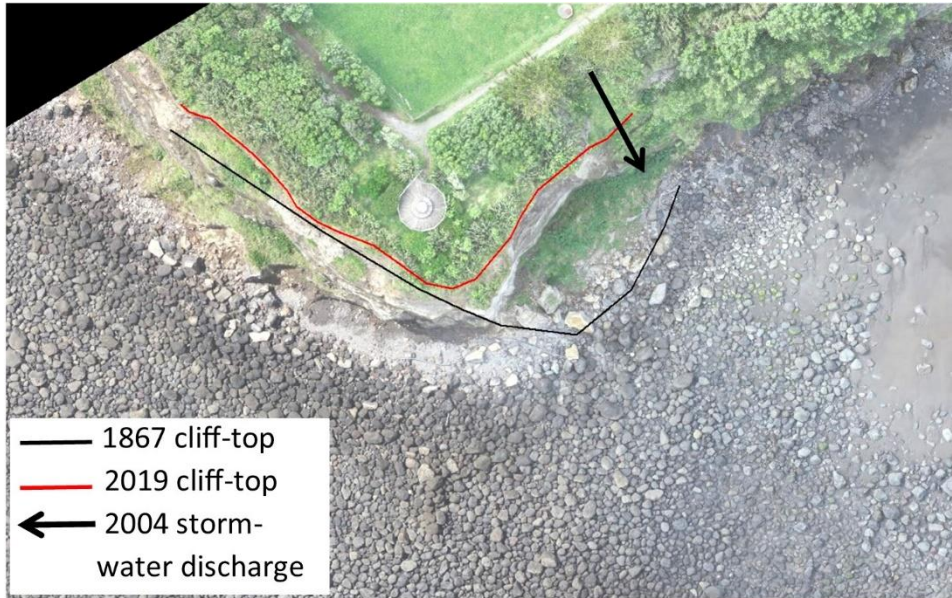
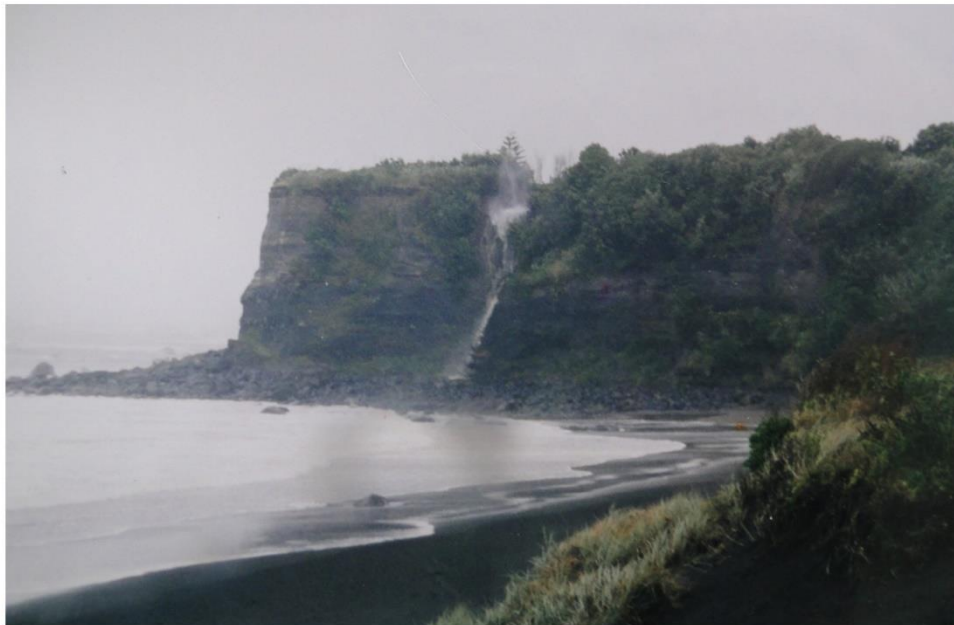
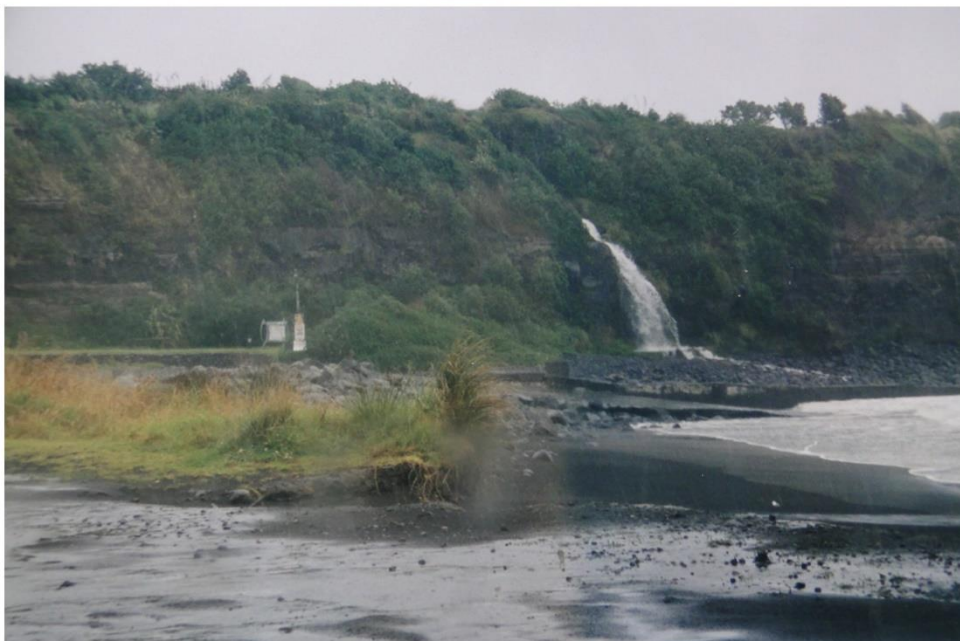
The seaward face has eroded 0.6 to 2.8 m over the 152 year period with a mean value of 1.5 m or 0.02 m/yr. By comparison the cliff top facing the Bay has undergone 10.5 yr 13.6 m with a mean of 11.0 m or 0.08 m/yr. These values are at lower end of Gibbs range. This result indicates that the seaward face of the cliff is considerably less erosion-prone than the adjacent side facing into the Bay. Such a result is helpful and welcome as it indicates the headland length is changing very slowly so there will be minimal additional wave energy entering the Bay in the foreseeable future to drive beach-dune erosion. The contrasting seaward and bay-facing rates may result from geological (boulder concentration) variation observed during the site visit, variation in wave energy around the headland, and for a brief period in the 2000s, stormwater drainage down the cliff face (Figure 13).

Figure 13 Upper figure compares the NW headland's cliff-top location in 1867 and 2019, and also locates the 2004 stormwater discharge which is shown operating in the central photo taken in February 2004. The lower photo shows the present SE stormwater discharge operating. Middle and lower photographs supplied by Mr Brian Vincent.

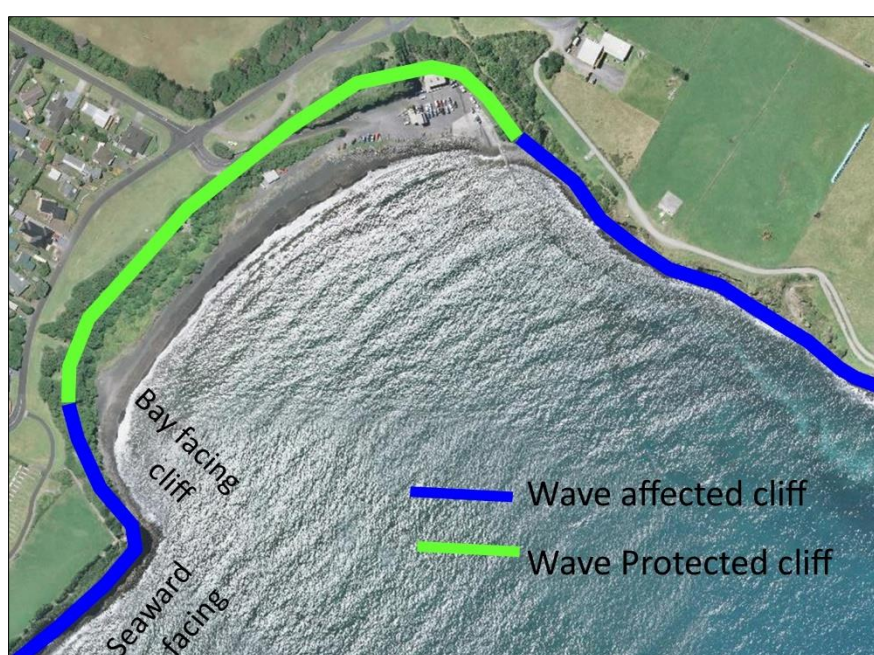
The cliffed environment can be divided into the seaward sections along each headland where wave action effects the base, and a landward section where dune and seawall protect the base from wave action (see Figure 16). Higher values would be expected

along the seaward sections. It would seem reasonable to assume that Gibb's higher rate of 0.26 m/yr applies to the active seaward cliff. However, as noted earlier, this value may result from localised gully erosion and may not be more widely applicable. Further doubt comes from 0.09 m/yr maximum value derived in the present study for the Bay-facing section of wave affected cliff (13.6 m/152 yr). A more robust cliff-top erosion assessment is recommended.

Figure 16 Sections of cliff affected by wave processes at Middleton Bay with the wave-affected cliff having higher erosional rates of change.

As most of the cliff is now heavily vegetated obtaining SS values from the 2019 drone data could be compromised. More accurate results may be obtained from photogrammetric historical data as would be available if an accurate long-term cliff change assessment were to be undertaken, or from a LIDAR survey. A regional LIDAR survey in conjunction with the TRC is presently in the planning stage.

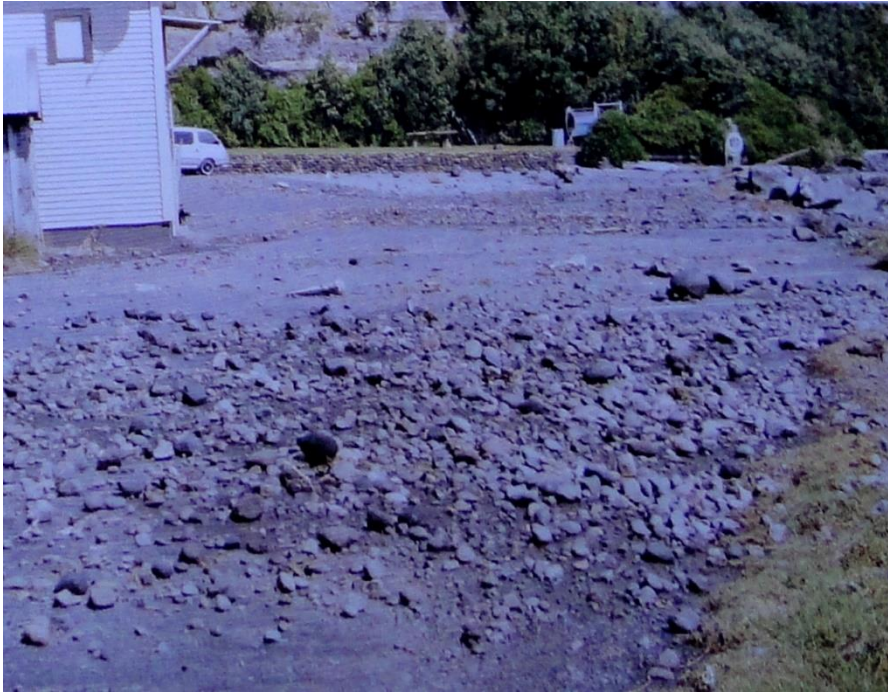
Both Mr Vincent and Mr Bourke agreed that at present the seawall is overtopped and stones are thrown across the car park some 2 to 3 times per year on average. This is photographically illustrated in Figure 18, and while the landward extent is not shown, the stones reached the historical boat shed some 13 m from the seawall. Mr Bourke said severe events occurred about every 3 years and Mr Vincent said the occurrence of water reaching the Boat and Underwater Club rooms was becoming more common. The New Plymouth Daily News article of 19 April, 1999 describing the March 1999 storm quoted club member, Mr Neil Drought, as saying "water had been lapping at the door of the new headquarters (club rooms)". Given that the car park had not been sealed at that time, wave attenuation would have occurred more quickly, so this was indeed a significant event.

Figure 18 The aftermath of wave overtopping the seawall during a storm event in February 2018. Mr Brian Vincent's photo.

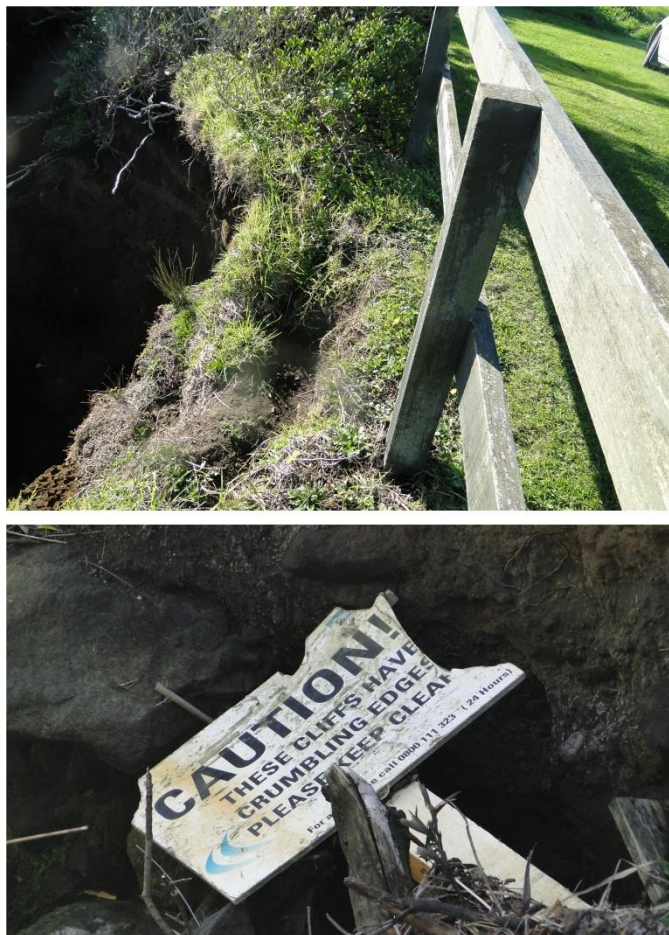
Of particular urgency is the stormwater drainage gully on the south eastern cliff which presents a particularly high hazard risk as illustrated in Figure 20. The upper part of the gully has a vertical face and is eroding at 0.2 m per year on average. The safety fence is now on the edge of the cliff and the first rail is too high to restrain young children. The warning sign now lies partway down the gully. Mitigatory action is required forthwith and consenting of the present system should also be investigated.

Figure 20 Southeast cliff stormwater gully showing the upper edge, barrier fence and state of the warning sign in May 2020.

- *cliff stabilization by removing loose material, benching or cutting back the upper slope,*
- *erecting protective fences or barriers,*
- *installing warning signs, and*
- *pipng (and consenting) the SE stormwater down the cliff as done at the NW end of the Bay.*

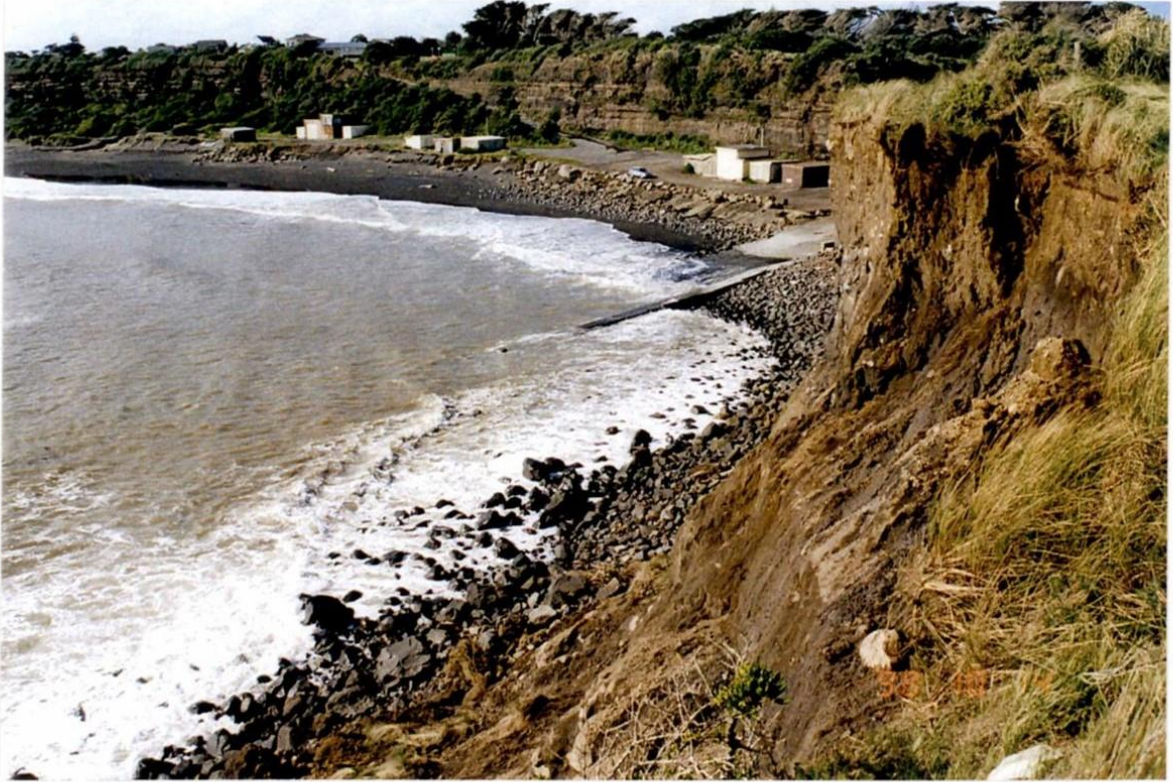
Figure 2: Recent landslip SW of the boat ramp and boulder beach providing some protection to the seacliffs from sea erosion (Photo: 14 October 1998).

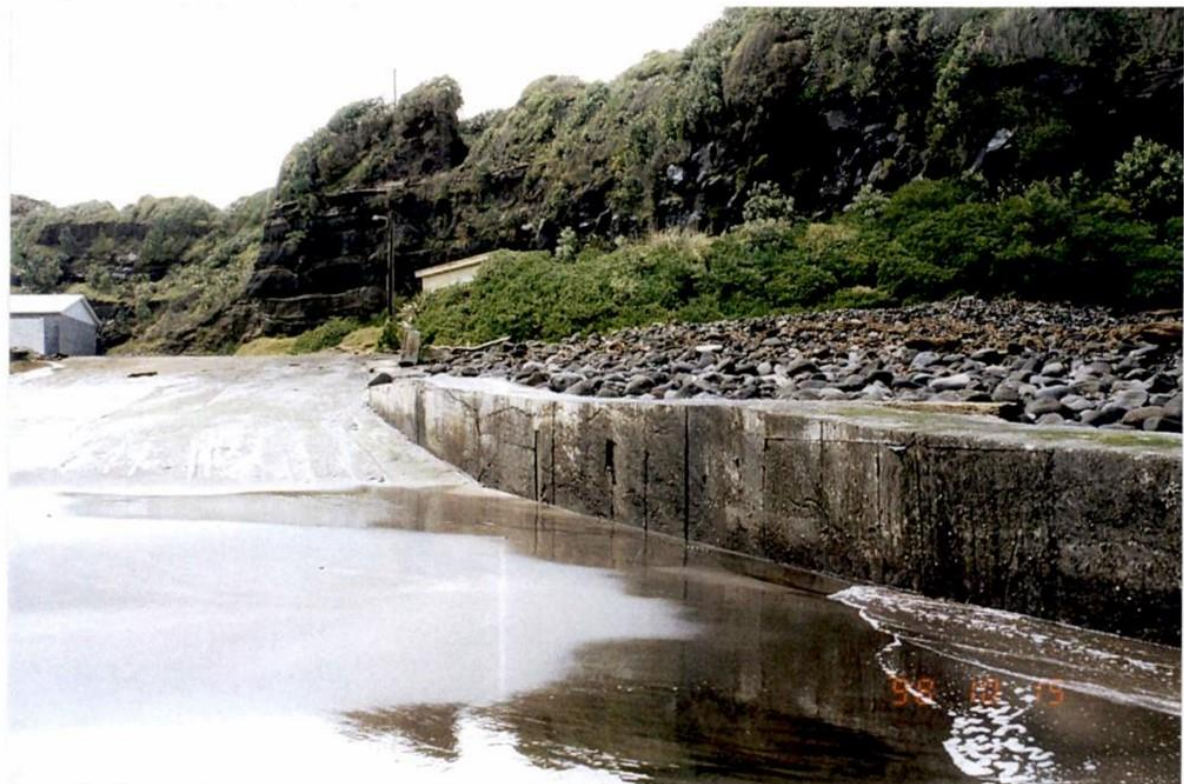
Figure 5: Concrete boat ramp and groyne, which has trapped cobbles and boulders on the S side (Photo: 15 October 1998).

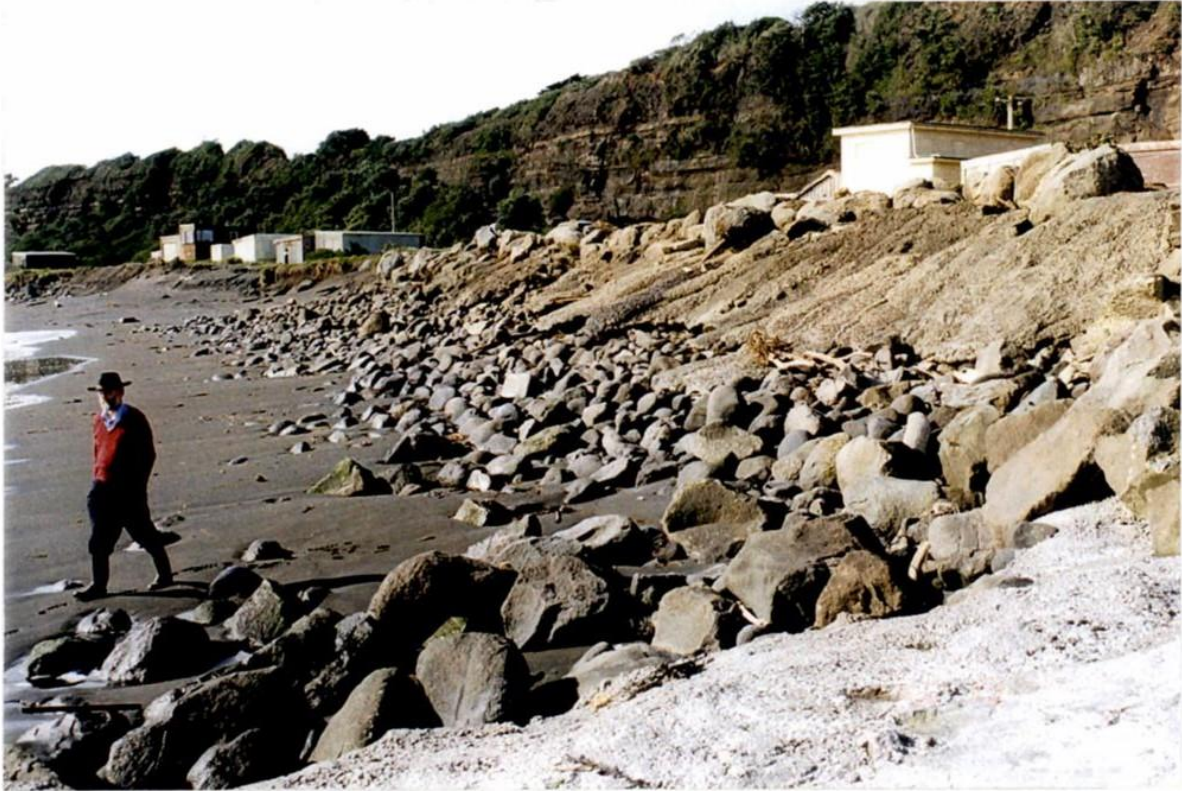
Figure 6: View NW from boat ramp showing the 80m-long concrete and rubble revetment overlying the natural boulder beach (Photo: 14 October 1998).

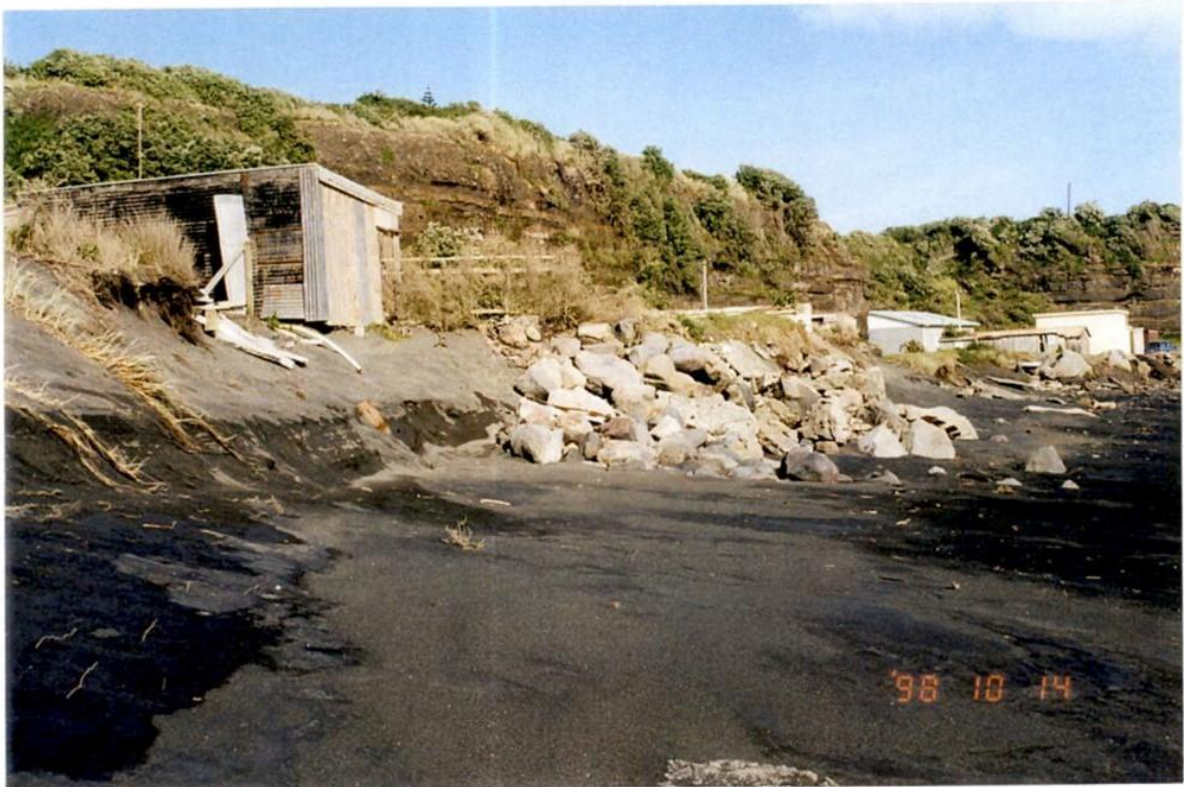
Figure 7: View SE showing the 20m-long rubble revetment which has caused up to 5m outflanking and the undermining of the 2 old boatsheds (Photo: 14 October 1998).

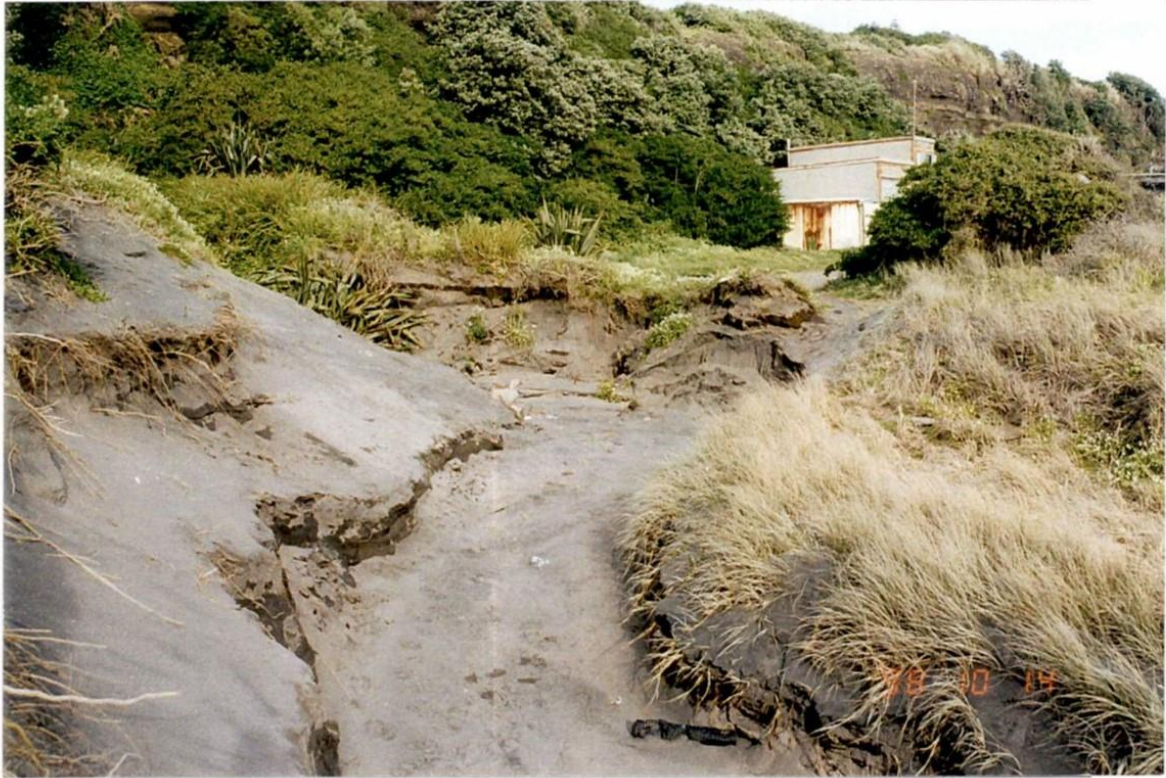
Historically, a central discharge point entered the Bay at the Heaphy Road/accessway intersection (Figures 10 and 11). The 1998 Gibb report noted this discharge was resulting in local foredune erosion (Appendix A, Figure 8), and the council subsequently installed a 450 mm diameter concrete pipe to divert this drainage around the clifftop to the SE discharge point. Now only minor stormwater discharges occur within the central bay; these being from buildings, paving and cliff seepage within the Central and Southern sectors.

Figure 8: Washout in foredune complex from storm water discharging over the seacliffs behind (Photo: 14 October 1998).

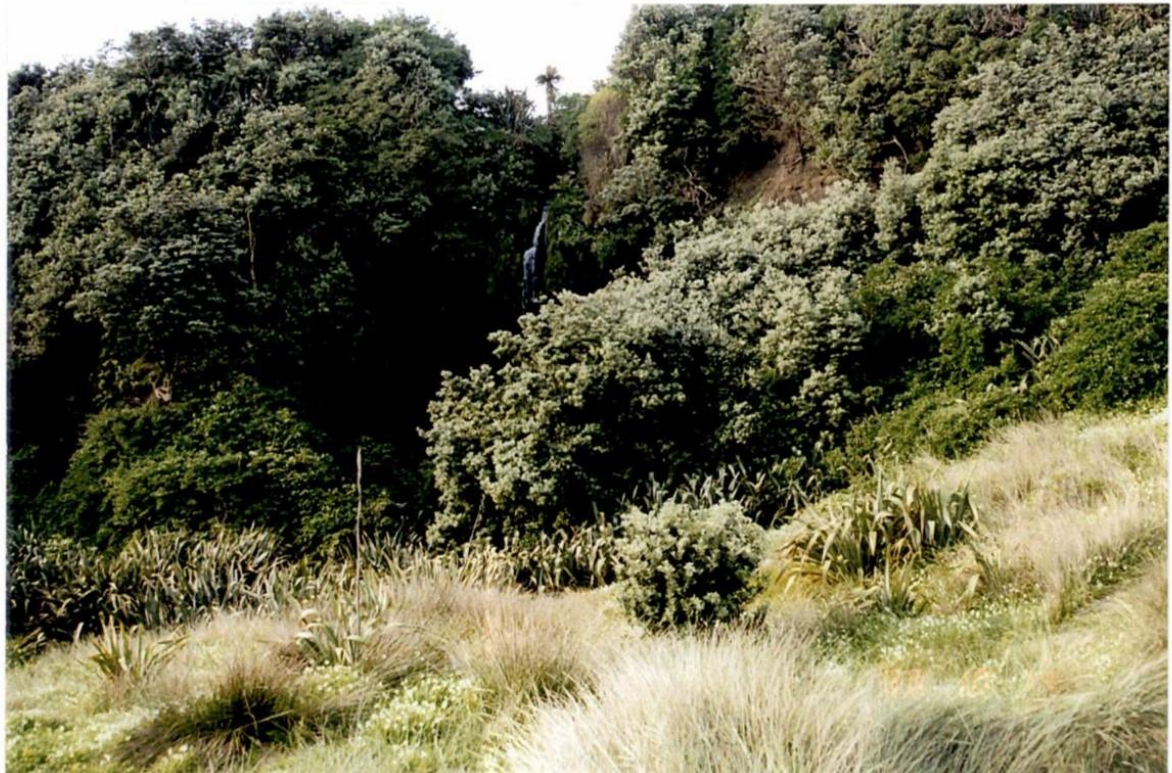
Figure 9: Well vegetated foredune complex and seacliffs at the NW end of the Bay with waterfall from storm water discharge (Photo: 14 October 1998).
