## Options Report for Omokoroa Coastal Walkway

Prepared for  
Western Bay of Plenty District Council  
Prepared by  
Tonkin & Taylor Ltd  
Date  
November 2017  
Job Number  
1002900.3000

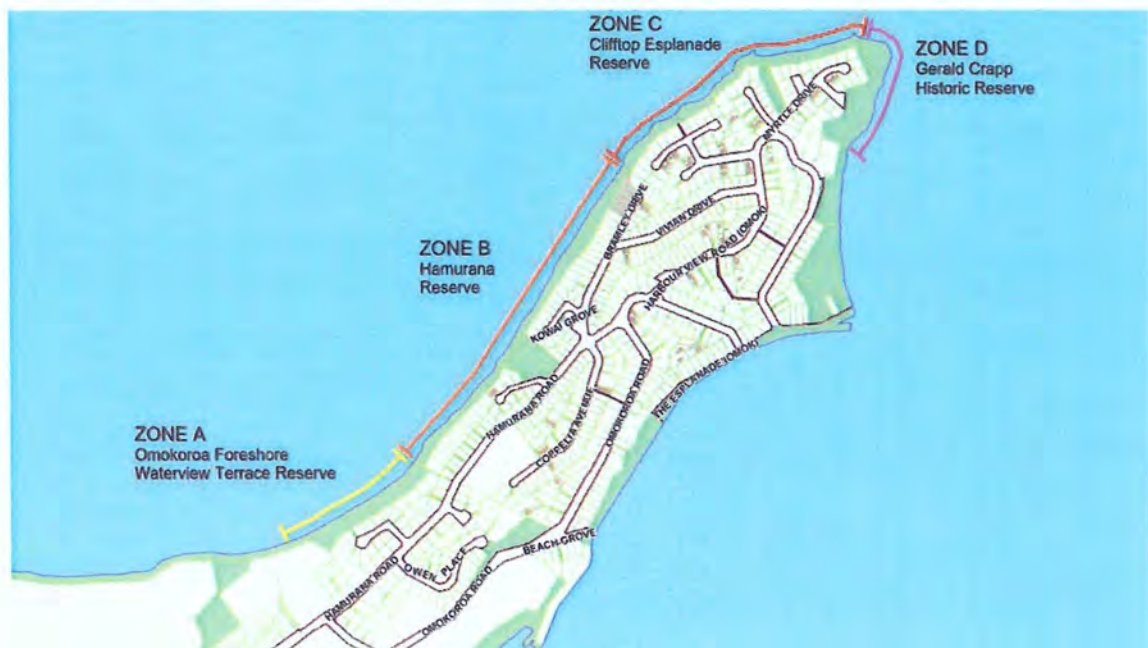
Figure 3.1: Outline of walkway Zones around the western side of Omokoroa Peninsula, modified from WBOPDC GIS viewer, image sourced October 2017.

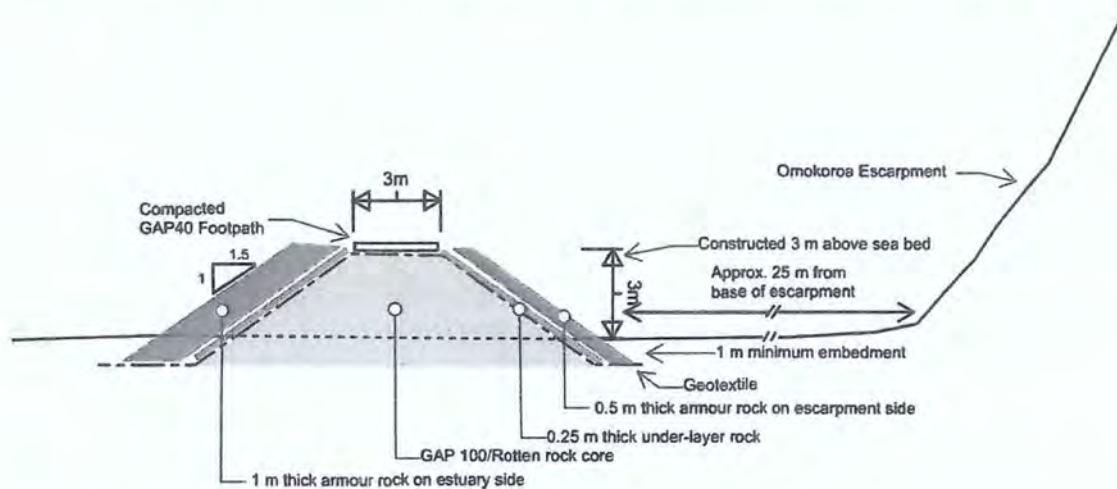
Figure 7.1: Example of a potential rock causeway. Rough order cost estimates have been based on these dimensions.

Construction of a rock causeway that is offset from toe of slope would provide both a walkway platform above high tide as well as acting as a debris containment bund for debris that may occur from future landslips. We understand the minimum preferred width of the walkway is 3 m to allow access for small construction plant (i.e. small excavators and small tip trucks) to enable maintenance of the causeway.

Based on recent landslip run out distances (i.e. below No. 37 McDonnell Street), our suggested offset (from the toe of the coastal cliffs) to avoid overtopping, would be approximately 25 m. To provide freeboard in the order of 0.5 m above the mean high water springs (MHWS) level, the crest of the rock causeway would need to be approximately 3 m high (i.e. 3 m above the existing sea floor) at this location to achieve a crest level of approximately 2.6 to 3.0 mRL. We understand that the crest level height can be increased to allow for sea level rise throughout the lifetime of the structure. The rock causeway would likely consist of a central core of GAP 100 rock wrapped in geotextile, overlain by a layer of larger under armour rock which would be overlain with an outer layer of armour rock with side slopes of between 1.5H:1V and 2H:1V. The top of the causeway would be overlain with a nominal 300 mm thick layer of compacted aggregate (i.e. AP20 or AP40) over its 3 m (minimum) width. The geotextile wrapped core would prevent fines from slip debris to wash through the rock structure. To prevent undercutting of the rock structure during storm surges, the seaward side of the causeway would need to penetrate the sea floor in the order of 0.5 to 1m.

Figure 7.1 presents a cross section through the rock causeway (not to scale). We note that a rock structure of this scale, off set from the coastal cliffs will have a significant visual impact on the foreshore. Rough order construction cost estimates are in the order of \$10,000/ lineal metre.

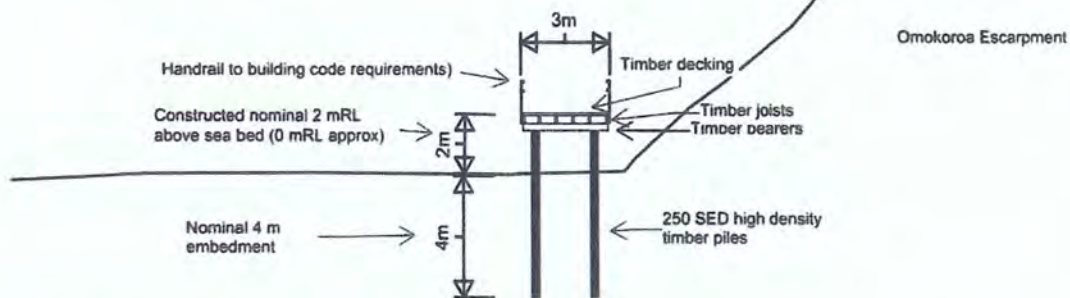
Figure 7.2: Sketch of a timber board walk.

A typical timber boardwalk structure supported by 150SED to 250SED poles could be constructed near to the base of the coastal cliffs (i.e. within say 5 m distance). However, extensive pruning would be necessary over much of the low tide margin where large overhanging pohutukawa trees are established, particularly within Zones A and B. Further to this, a timber board work within this location would be subject to significant structural damage from future landslips due to debris impact strikes. We note that where a person could fall greater than 1 m height, handrails are likely to be required in accordance with the building code.

Rough order construction cost estimates for a timber board walk situated within 5 m distance to the base of the coastal cliffs are in the order of \$5,000/ lineal metre.

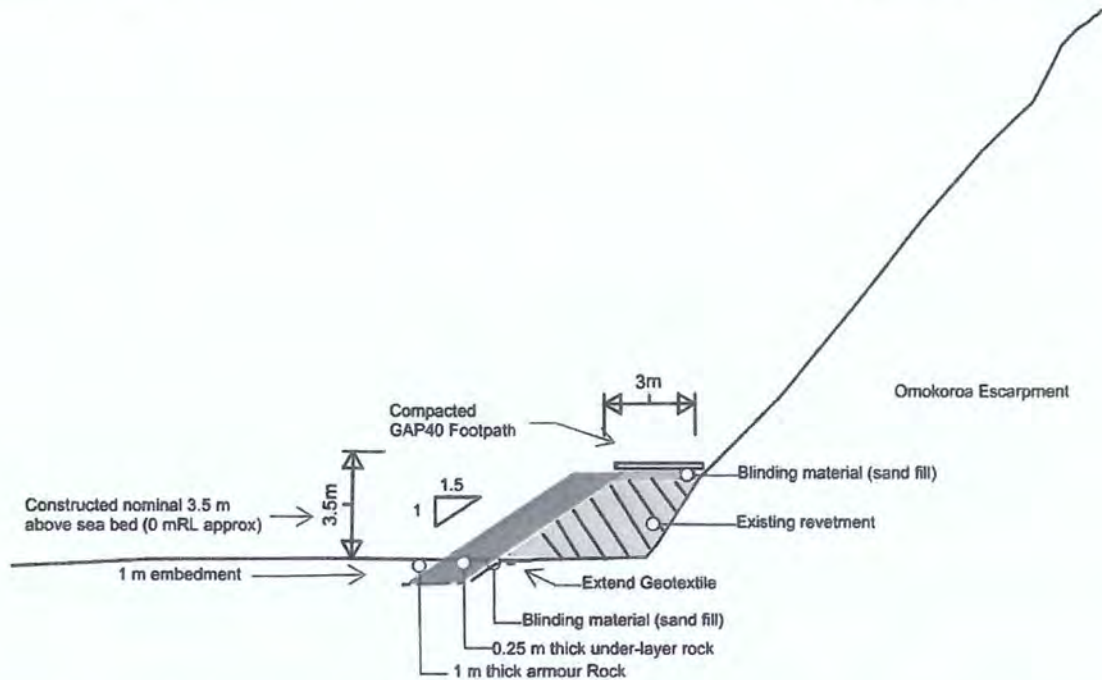
Figure 7.3: Example of revetment extension. Rough order cost estimates have been based on these dimensions.

Figure 7.3 presents a cross section through a revetment extension. Rough order construction cost estimates are in the order of \$3,000/ lineal metre. We note, where the existing walkway remains intact, at its existing higher level, this option is not considered critical but could be considered as part of long term planning.

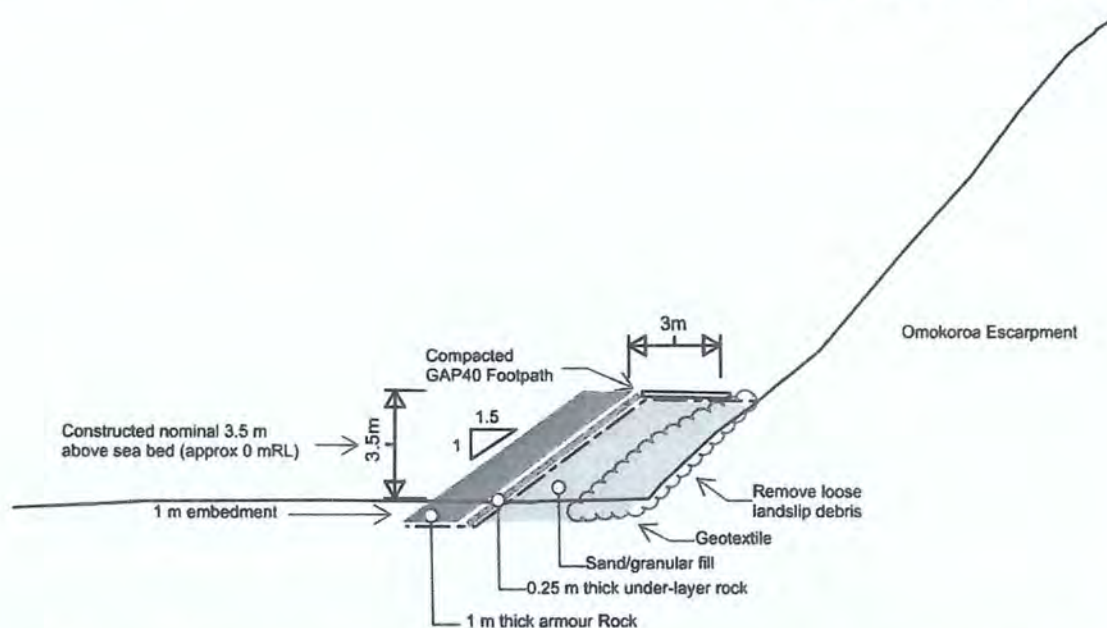
Figure 7.4: Example sketch of a new rock revetment. Rough order cost estimates have been based on these dimensions.

The slope of the revetment would be roughly a 2H:1V slope down to the beach. For this type of heavy construction on soft beach sands, it is likely that the structure should be embedded a minimum of 1.0m into the sands to act as a founding layer.

Figure 7.4 presents a typical cross section through a rock revetment (not to scale). It is likely that the revetments would be 0.5 to 1 m above high tide level to allow for the forecast sea level change in the future.

Rough order construction cost estimates are in the order of \$6,000 / lineal metre.
