Papamoa East Coast Care

Impact of subdivision development in 1958

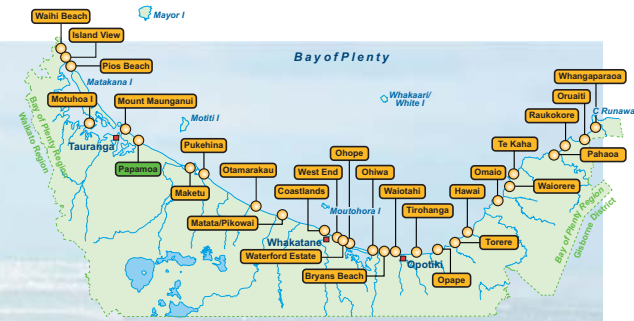
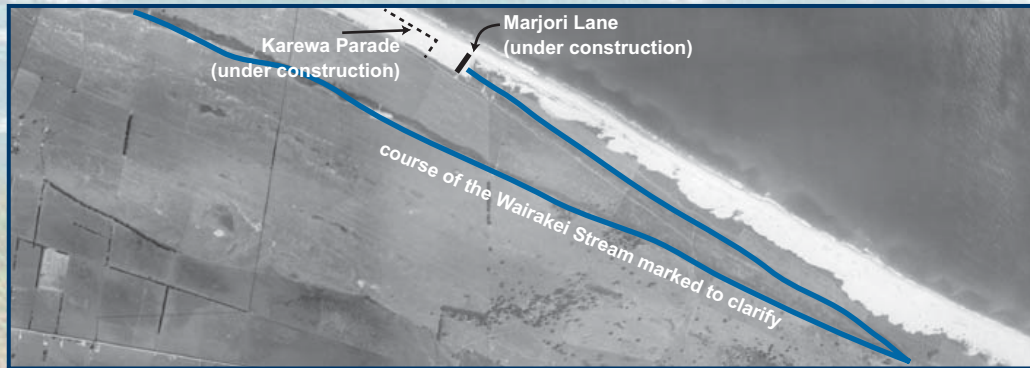
Wairakei Stream used to exit on the beach, but was blocked by developers at Marjori Lane. The front dune was destroyed by being bulldozed back into the stream to create more building sections. Karewa Parade is being formed by machinery in the white sand area to the left of Marjori Lane. Water from the stream system can now only reach the sea by flowing through the sand under the houses.

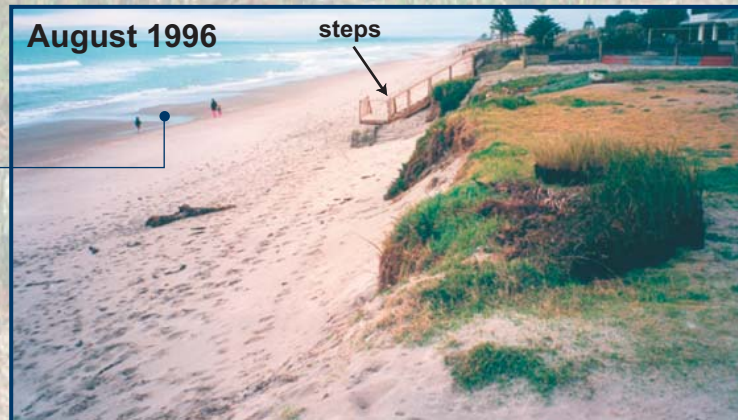
(low tide photo)
The heavily modified "dune" front is very unstable. The now dominant Kikuyu grass is not able to perform the accretion function of native dune plants. Water from the Wairakei Stream system is visible on the beach in this photo. This water saturates the sand, making it very prone to erosion.

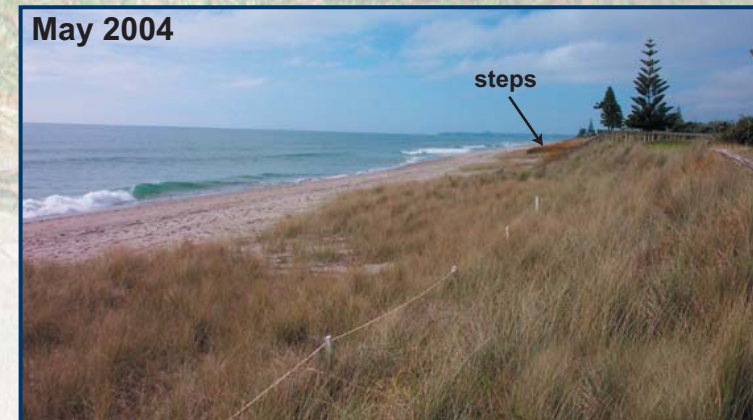
(high tide photo)
The first year plantings did not succeed. Subsequent plantings of vigorous hardened-off plants in 1998 and 1999 have produced these results. Photo was taken after the impact of 10m waves from Cyclone Ivy in February. The restored front dune is now functioning reliably. Remnant Kikuyu will be replaced by native mid and back dune species.
