KENEPURU HEAD ESTUARY

Broadscale Habitat Mapping 2018

Prepared for: Marlborough District Council

SLR Ref: 740.10043.00100
Version No: -v2.0
April 2018

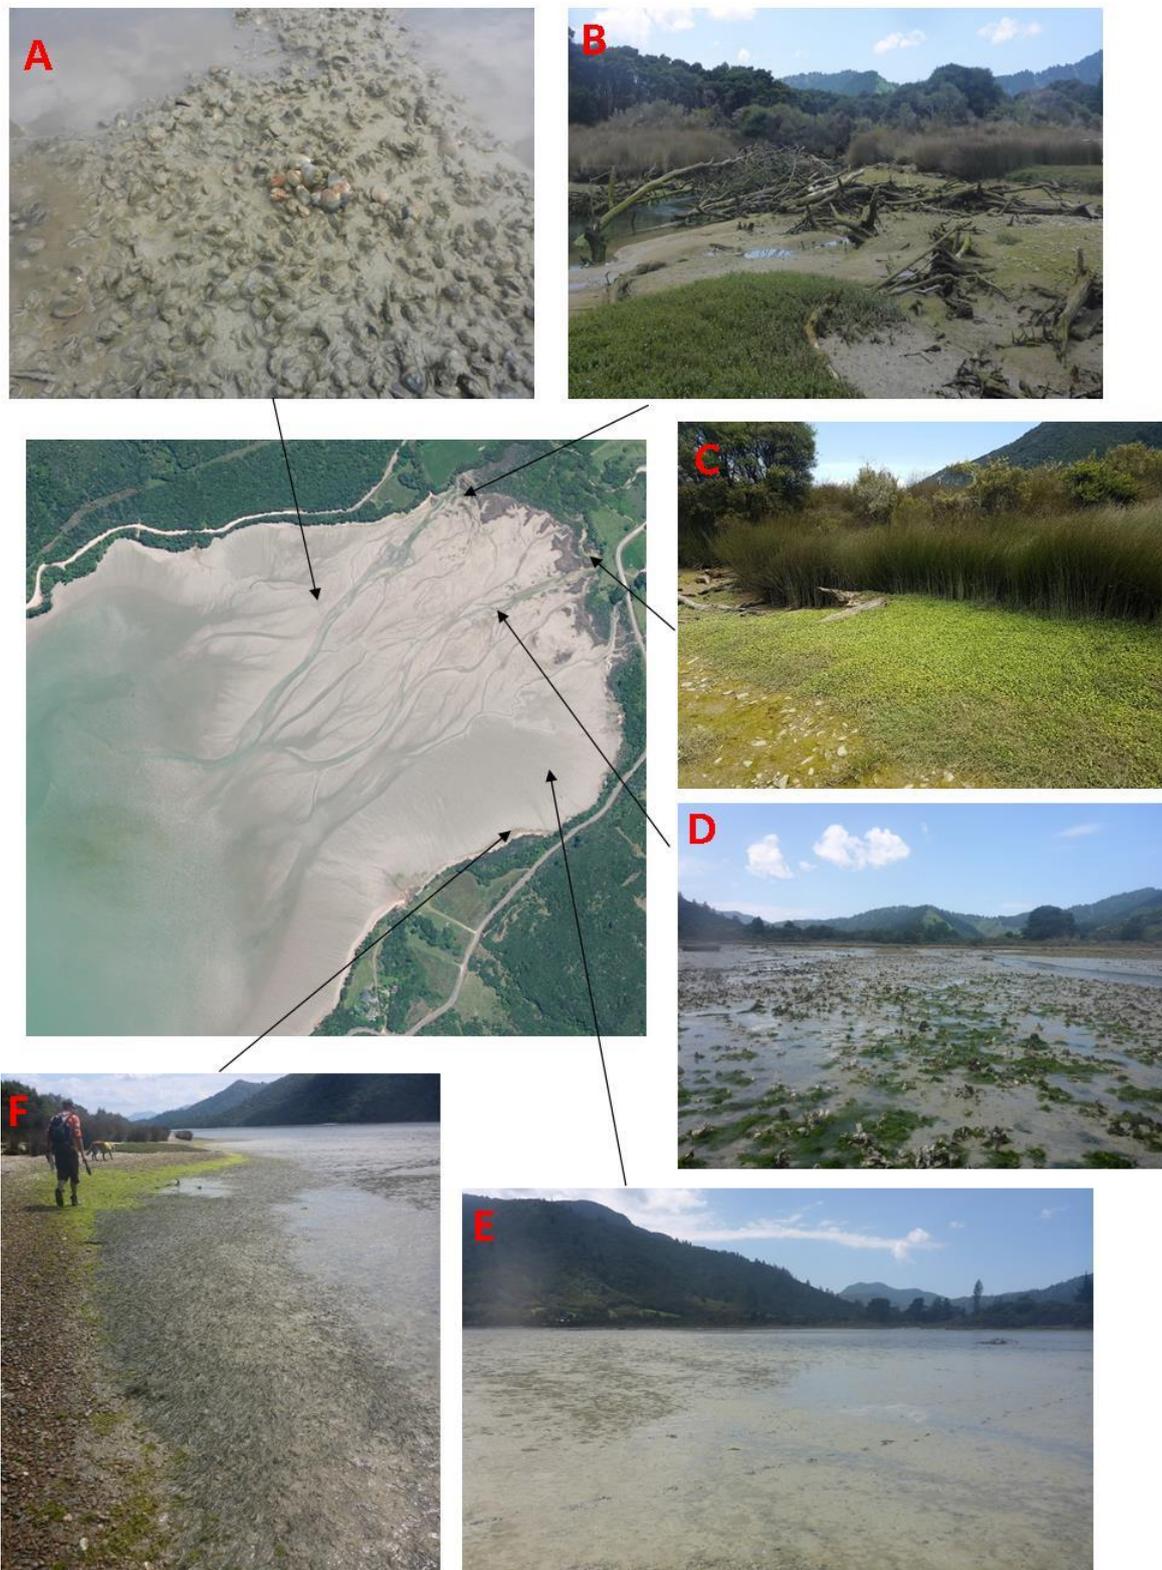
Figure 2 Representative habitats in different regions of Kenepuru Head Estuary. A: soft mud with cockle bed; B: wood debris, herbfield and muddy sand; C: herbfield and saltmarsh; D: soft mud, oysters and *Enteromorpha* sp.; E: Soft mud; F: gravel/cobbles, seagrass and *Enteromorpha* sp. at edge of estuary and bordered by soft muds.

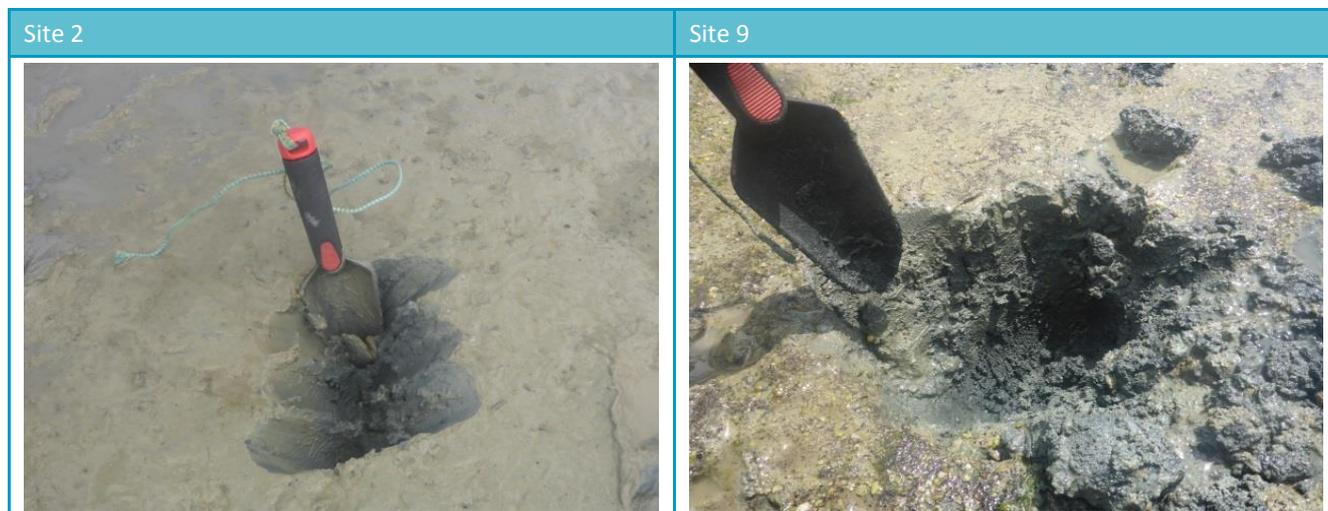
Figure 6 Examples of subsurface sediments photographed in shallow pits at stations within Kenepuru Head Estuary showing the presence of aRPD layers.

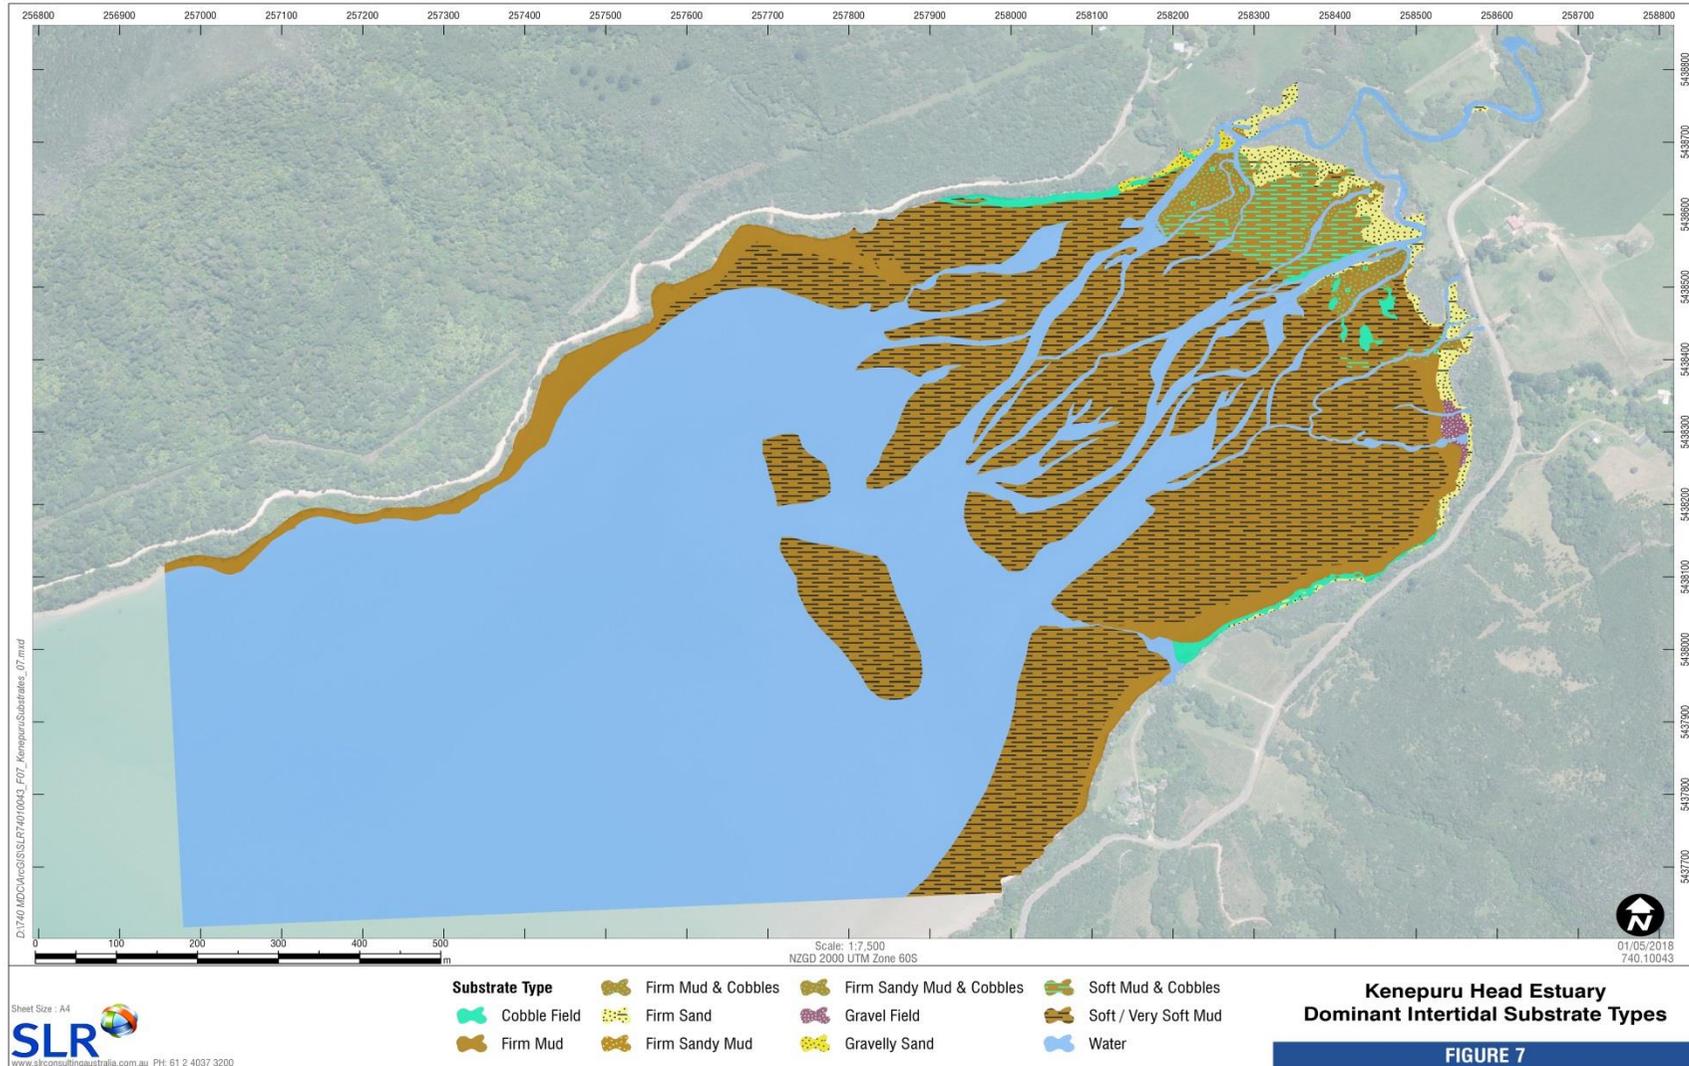
During the 2018 survey the intertidal area of the Kenepuru Head Estuary was found to be dominated by soft/very soft mud (77.1%), firm mud (9.3%), and soft mud and cobbles (4.6%) (**Figure 7, Table 2**). Firmer mud sediments generally occurred towards the upper parts of the intertidal zone around the edge of the estuary, often in areas where macroalgae and saltmarsh vegetation were present. Soft mud and cobbles was found largely towards the north-eastern corner of the estuary around the areas where the major creek system entered and around the edges of where the freshwater streams began to meander across the higher areas of the soft mud substrates. **Figure 8** shows two examples of the typical soft/very soft mud habitats encountered in Kenepuru Head Estuary in 2018.

In accordance with Robertson *et al.*, (2016), when the percentage of the intertidal area covered in soft mud exceeds 15%, the estuary is classified as being **high risk** (BAND D). There is likely to be significant persistent stress on a range of aquatic organisms as well as local extinctions of keystone species and loss of ecological integrity (Robertson *et al.*, 2016). Thus in 2018 Kenepuru Head Estuary would be classified as having a **HIGH** risk rating.

Figure 7 Substrates present within the intertidal area of Kenepuru Head Estuary

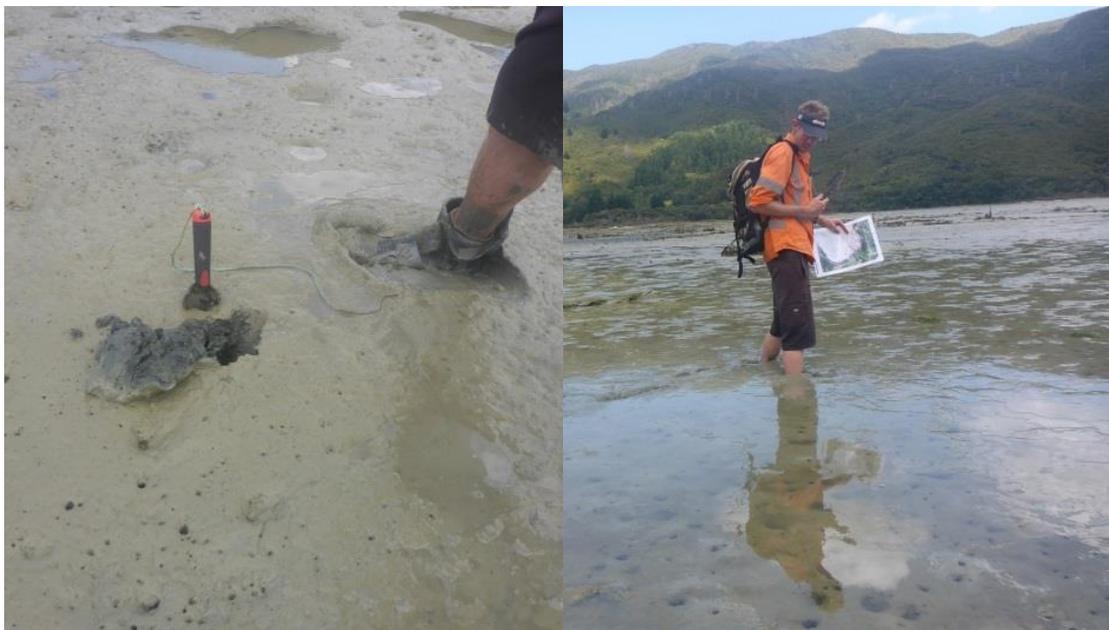
Figure 8 Soft mud habitats in Kenepuru Head Estuary

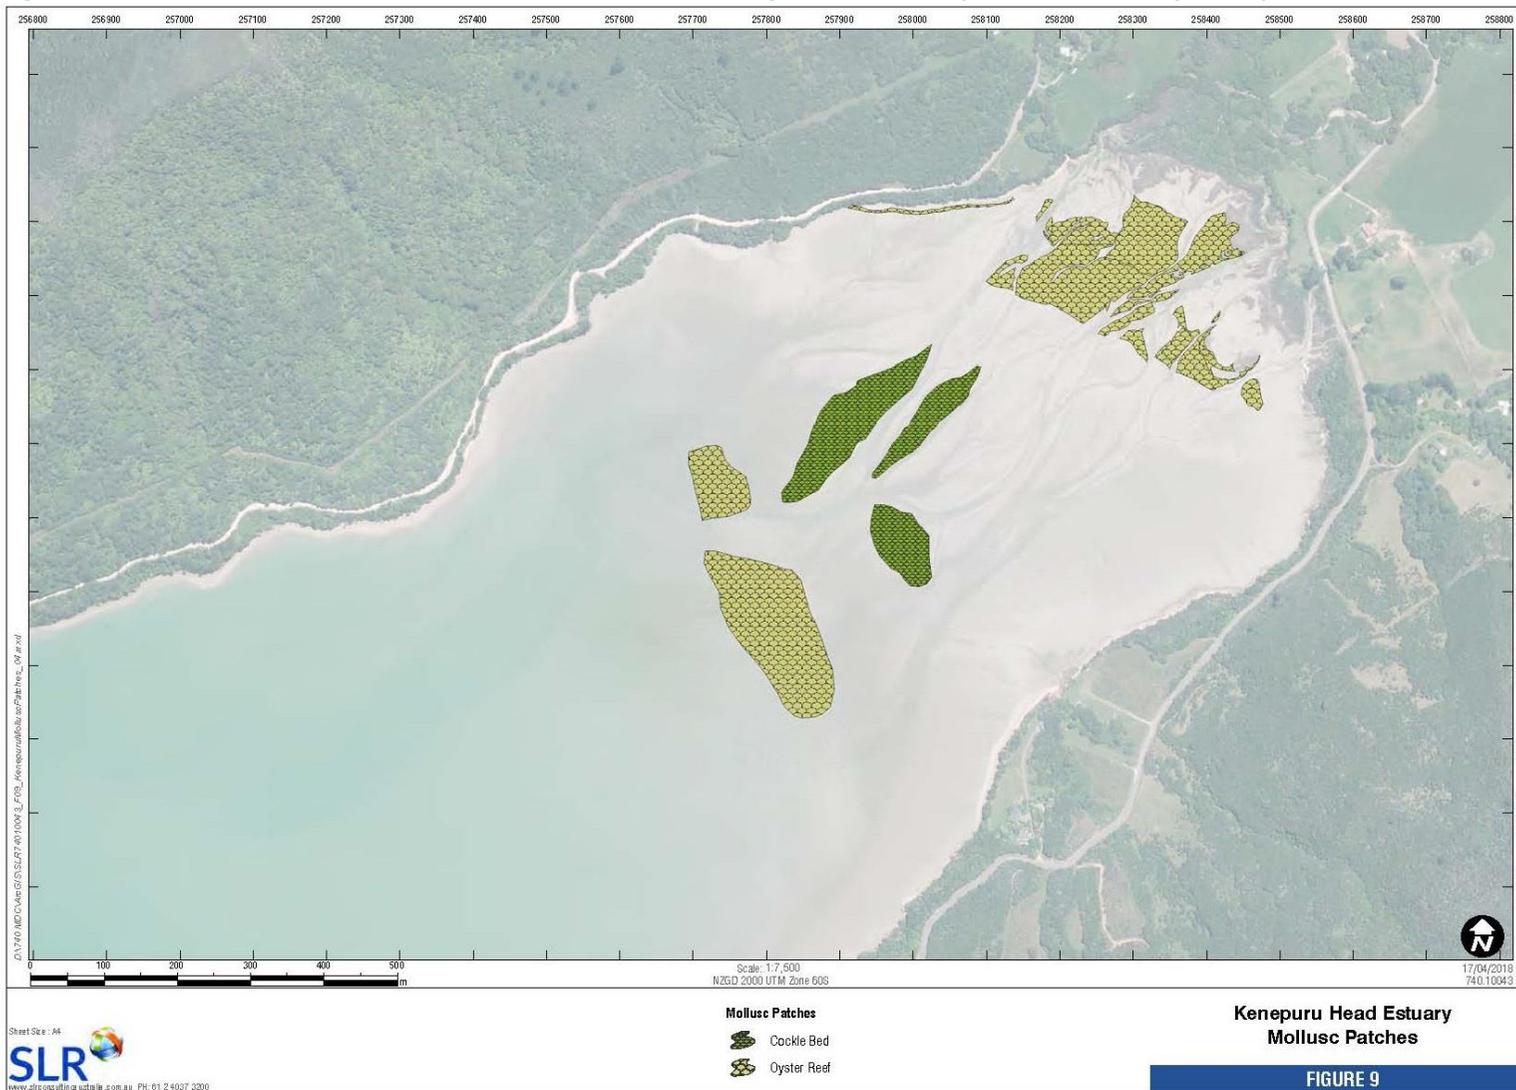
Several distinct areas of mollusc beds were observed during the 2018 survey, including oyster and cockle beds (**Figure 9**). In total, mollusc beds were found to cover 20.39% of the intertidal area of Kenepuru Head Estuary. While mapping the location and extent of the cockle beds a sample of the cockles living within these beds were collected, washed and photographed (**Figure 10**). Average sizes of the cockles appeared to be relatively small (10-20 mm) and many of the cockles had barnacles attached to their shells. The cockle beds observed in 2018 were situated in/on very soft mud substrate. While cockle beds are found on intertidal flats of mud and fine to coarse sand (Morton and Miller, 1968), and can tolerate sediment mud contents up to 85%, their optimum range is usually sandier sediments (0-10% mud)(WRC, 2018). Sediments within and around the cockle beds observed in 2018 were soft/very-soft muds with a layer of this fine mud observed to be covering the beds, High levels of fine sediments can impact the delicate breathing and feeding apparatus possessed by filter feeding organisms such as cockles. In healthy estuary systems where cockle beds exist in firmer sandy sediments, there are often large areas where dead cockle shells are present on the sediment surface. During this survey there were no obvious large areas of empty shells; all cockles, living and dead, were covered by a fine layer of soft mud. In a recent study prepared for MDC (Barrett *et al.*, 2017) showed that cockles were able to resurface relatively quickly from under significant amounts of deposition (up to 25 cm) and were resilient to low levels of repeated deposition such as light daily re-burial. Thus although there is a high proportion of soft mud sediments in Kenepuru Head estuary the existing cockle beds appear to be surviving and unless large increases in fine sediment deposition occur in the future these beds should hopefully be able to continue to survive.

Figure 9 Location and extent of mollusc beds identified during the 2018 Kenepuru Head Estuary survey.

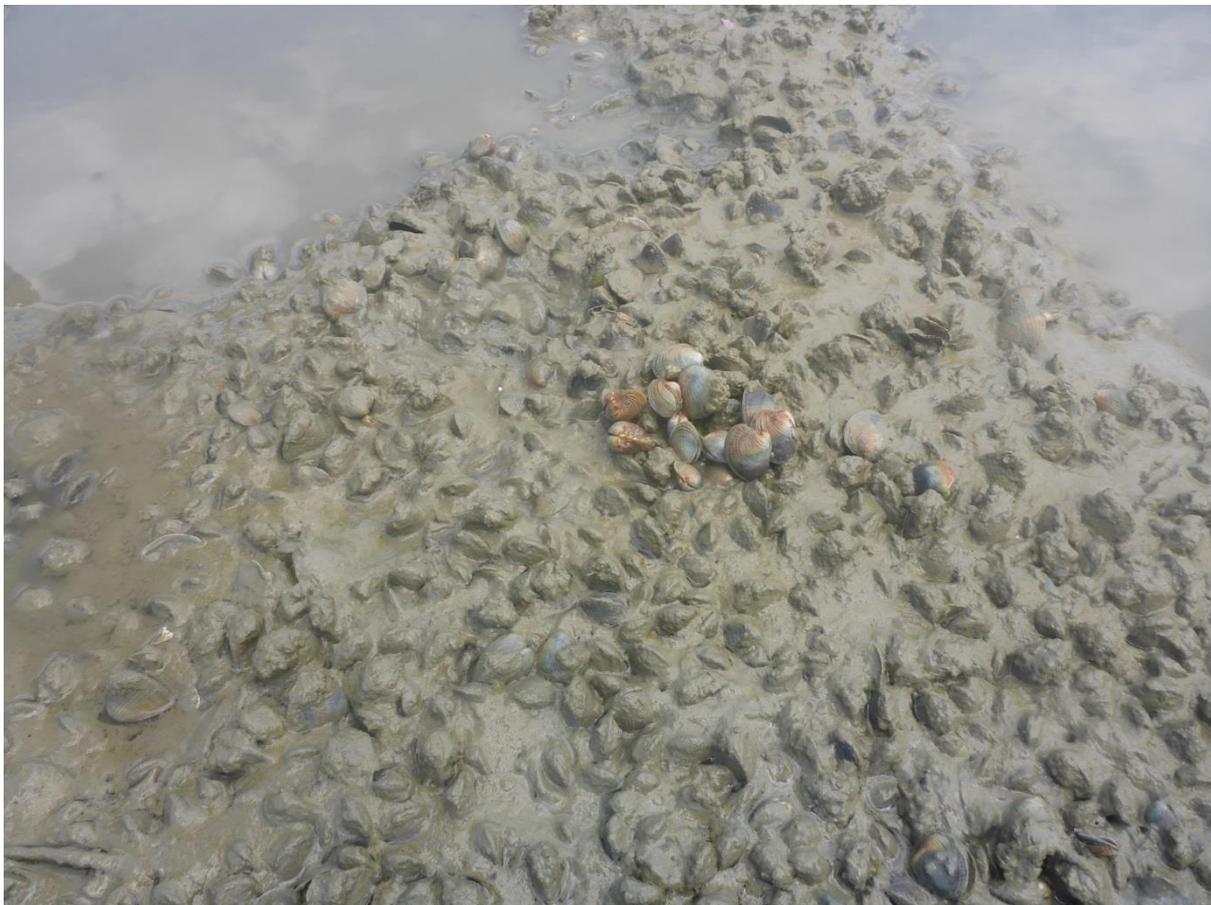
Figure 10 Cockle beds observed in Kenepuru Head Estuary during the 2018 survey. Note that the small number of cockles in the middle of the image have been removed and washed of the soft mud covering the bed to more clearly show average sizes.

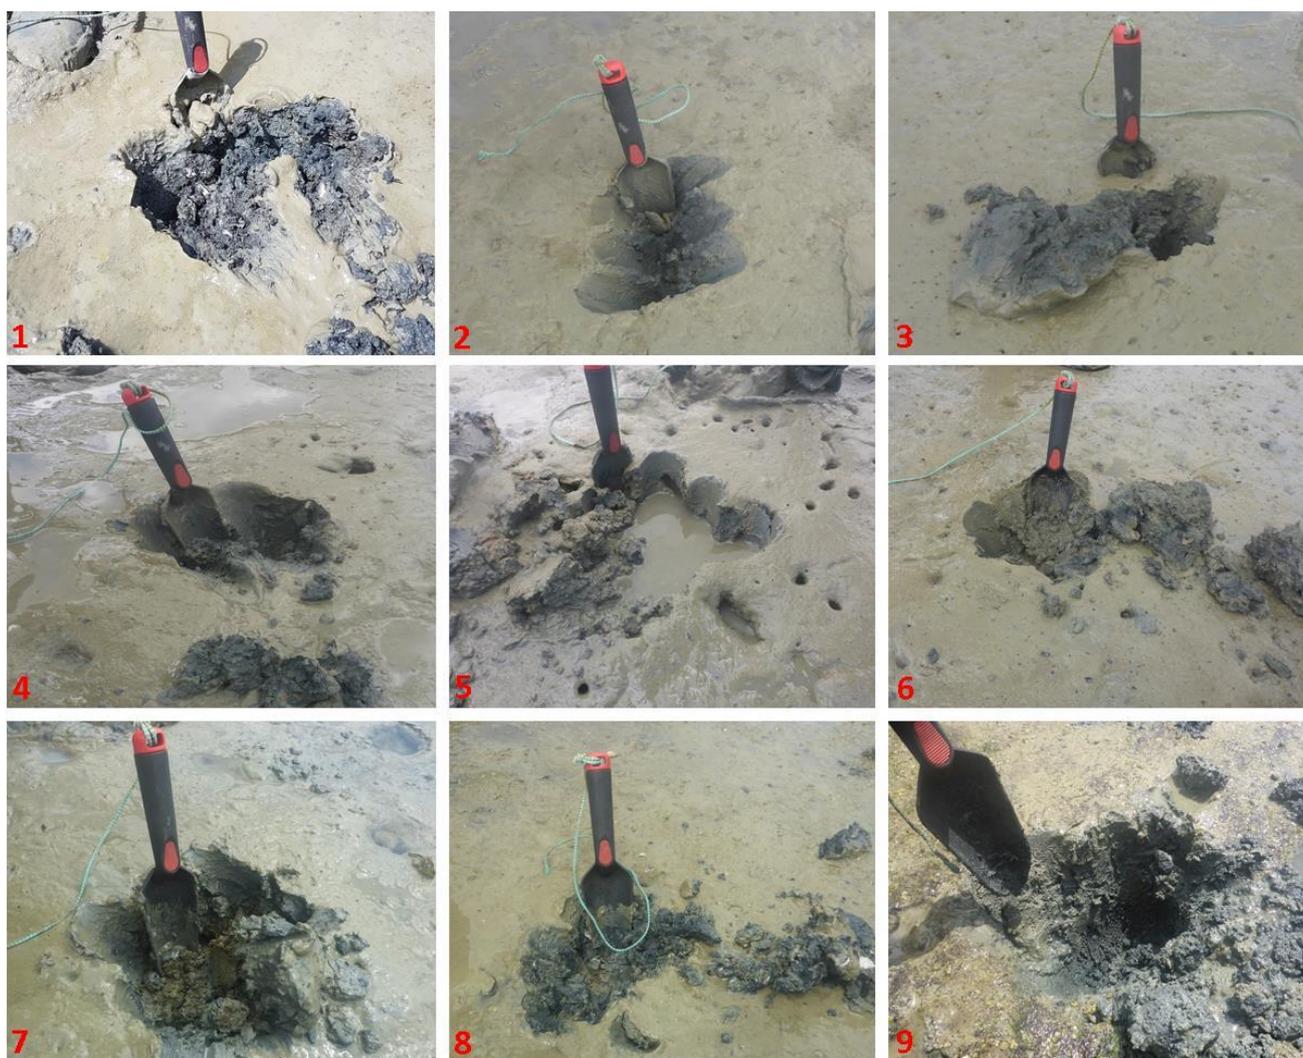
APPENDIX A

Images of shallow pits dug across estuary to investigate sediment stratigraphy.
