Wharves At The Edge Of The World: Physical Modelling Of Zero Maintenance Breakwaters In Remote Locations

Conference Paper · May 2018

IAN COGHLAN¹, MATT BLACKA¹, TOM SHAND², MARK FOSTER², JAMES CARLEY¹, DAN HOWE¹ & BEN MODRA¹

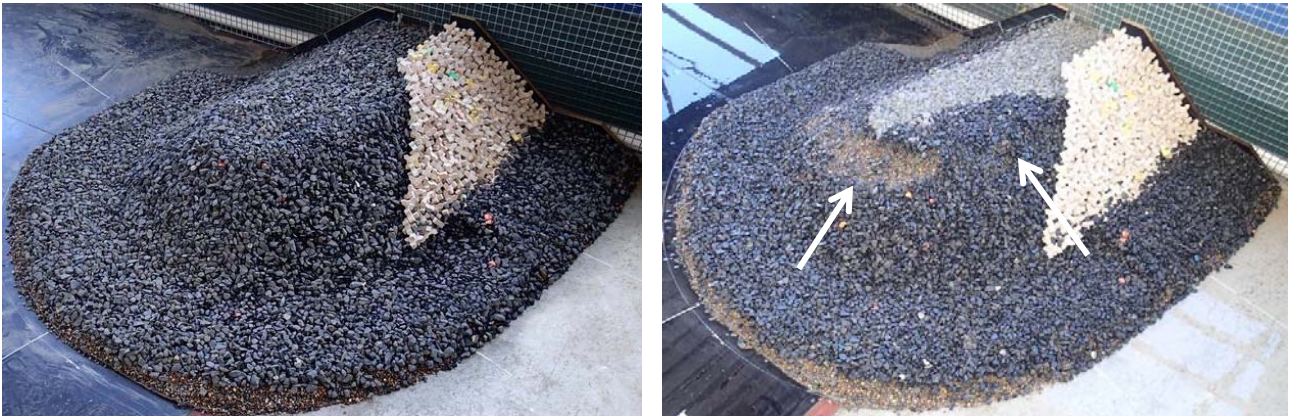
Figure 4. Secondary Armour Stability During Construction: Before (Left) and After (Right) Testing. Arrows indicate filter layer visible at the breakwater head and the end of the trunk.

Four Q3D tests with gradually increasing H_s were carried out on a structure in an “under construction” state (Figure 4).

While the Xbloc® primary armour was verified to withstand the design event, the secondary armour layer will withstand a lower threshold wave height before damage begins to occur. Using a typical ambient swell peak wave period of 13.0 s and a high tide water level (0.5 m MSL), an “under construction” breakwater model was built and tested with progressively increasing significant wave height from 0.55 to 1.20 m. Damage to the 120 kg secondary armour layer began at $H_s = 1.0$ m (initiation of movement) and significant reshaping occurred at $H_s = 1.2$ m with the underlying filter layer becoming exposed around the breakwater head (Figure 4). The extent of wave overtopping halfway across the 2.5 m MSL secondary armour crest level for $H_s = 1.2$ m can also be seen in Figure 4 (right).

The construction engineer on the project witnessed the Q3D secondary armour stability tests with the breakwater in an “under construction” state. Given that low swell waves would persist throughout construction, observing these tests provided insights for construction planning and repair methodologies in a very remote location. The threshold for initiation of movement of the 120 kg secondary armour, $H_s = 1.0$ m, matched well with the preliminary estimate. This significant wave height is exceeded approximately every two weeks for a duration of 1-3 days at the wharf location.

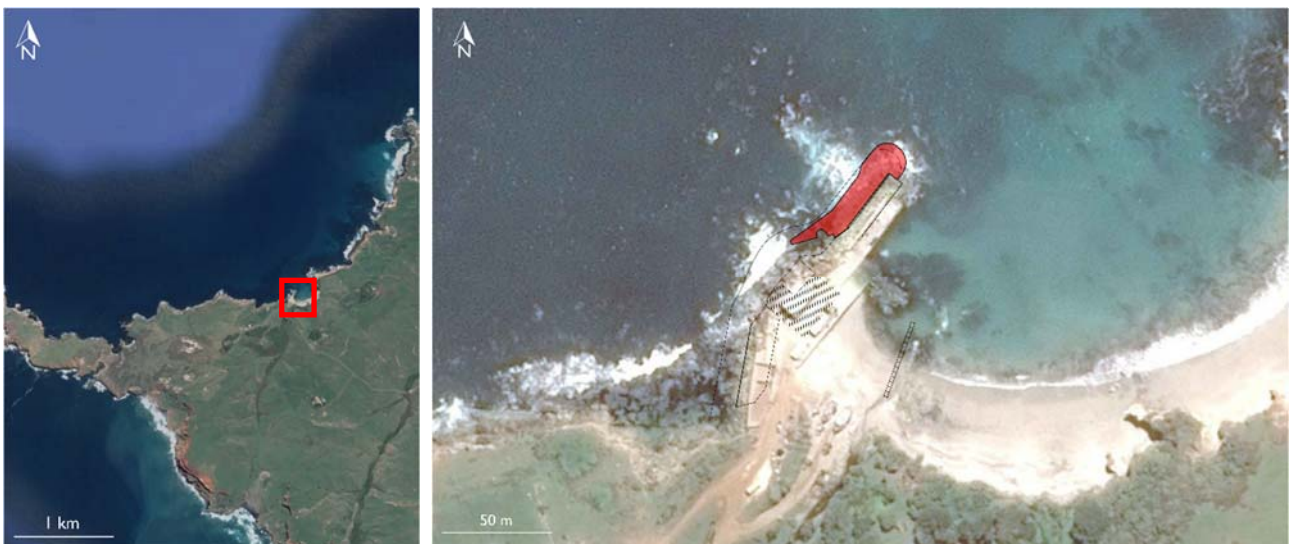
Figure 5. Existing Pitt Island Wharf and proposed breakwater upgrade (red shaded area in right panel).

The existing wharf on Pitt Island was constructed in 2014 and consists of a concrete decked, vertical sheet pile structure with a 1.5 m high concrete crown wall. The seaward side of the wharf is protected by an ad-hoc rock rubble revetment that consisted of widely graded limestone rock (with many rocks only 0.2-0.4 m in diameter) on a flat slope overlying a shallow rocky reef (Figure 5). Shortly after construction of the ad-hoc revetment in March 2015, Cyclone Pam mobilised rocks in the revetment and caused damage to the wharf, highlighting its lack of resilience to large storm events. Wave motions on the leeward side of the wharf, due to waves refracting and diffracting around the end of the breakwater and overtopping the wharf, were also often unsafe for functional operations while vessels were at berth.
