# **State of the Environment Monitoring of Waimea Estuary: Broad Scale Habitat Mapping 2007**

Prepared for  
Tasman District Council and Nelson City Council

Clark K, Gillespie P, Forrest R, Asher R 2008. State of the Environment Monitoring of Waimea Estuary: Broad Scale Habitat Mapping 2007. Prepared for Tasman District Council and Nelson City Council. Cawthron Report No. 1473. 24 p

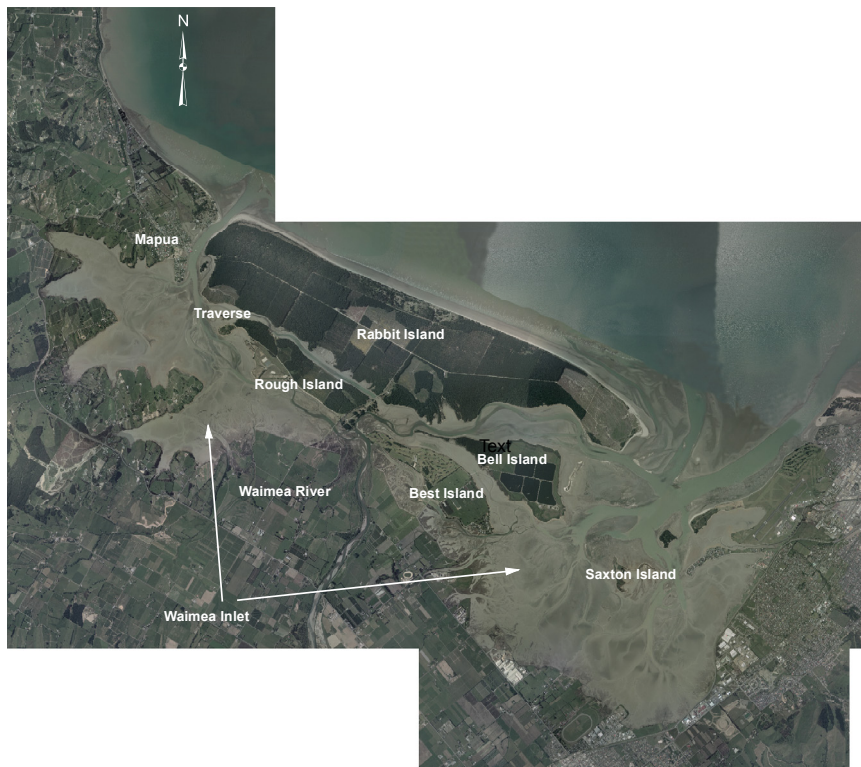
Figure 2. Expanded map of Waimea Inlet and key features.

The Traverse area, between Rabbit and Rough Islands (Figure 2), has changed markedly over the last 20 years. Prior to 1998, causeways between Rabbit and Rough Islands blocked each end of the Traverse with pipe culverts, allowing only restricted tidal movement of water. The lagoon within the Traverse consequently had limited water exchange resulting in growths of large mats of *Enteromorpha* sp. and the development of shallow muddy ponds dominated by thick growth of *Gracilaria* sp. (Gillespie & Asher 1997). In late 1998, the causeway across the western end of the Traverse was removed, enabling greater flushing at the western end. The road which previously ran parallel to the Traverse on the Rabbit Island side, cutting off several embayments, has gradually eroded. Terrestrial vegetation (mainly pine trees) has been removed from the embayments allowing the estuary edge to extend further inland in several places.

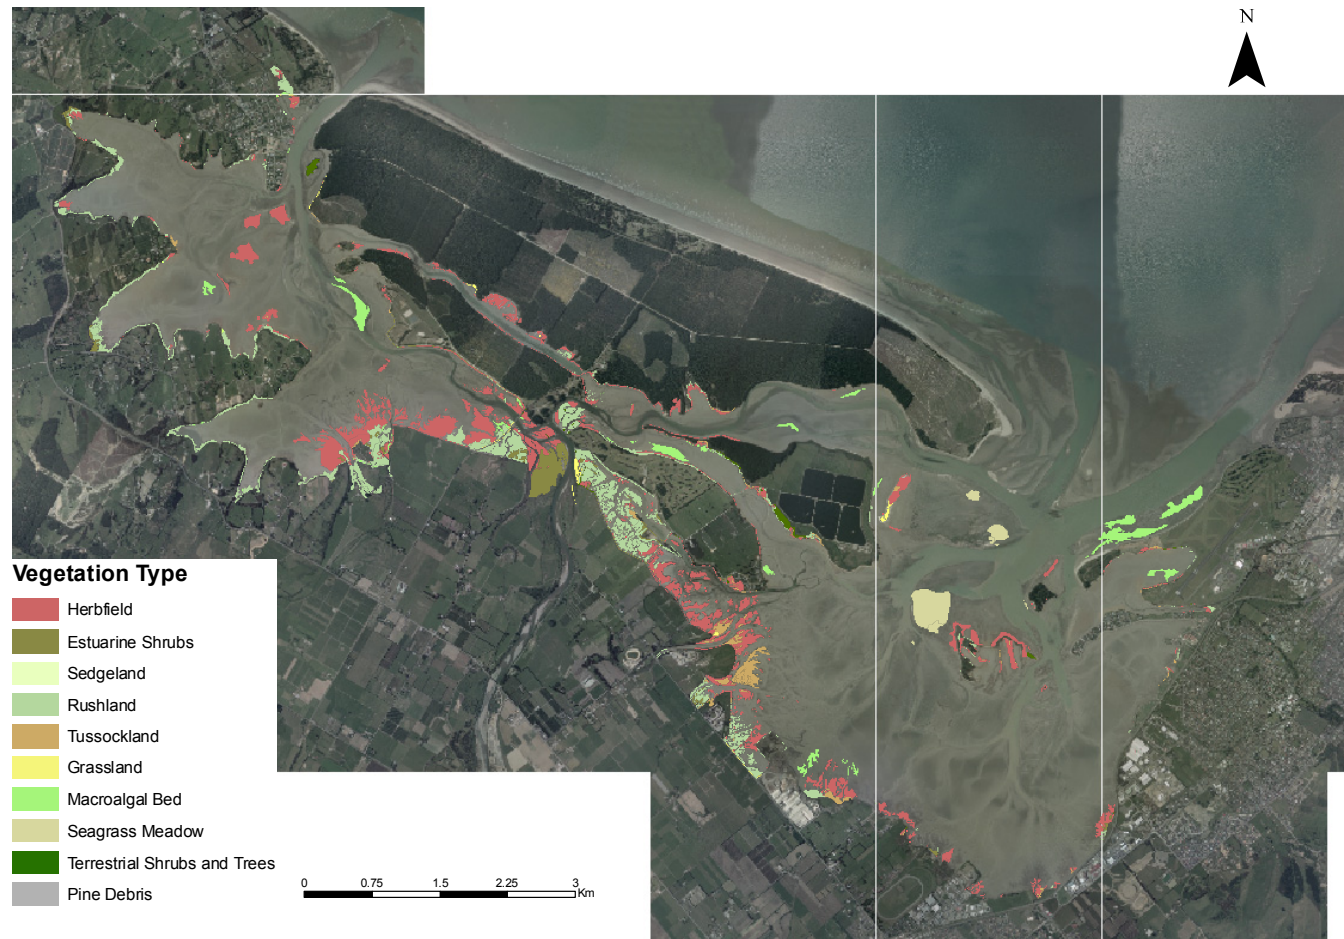
**Figure 4.** Aerial photograph of Waimea Inlet showing vegetation present in November 2006.

Vegetated habitats within and surrounding the estuary showed considerable complexity with most classification categories present; including Grassland, Shrubland, Tussockland, Rushland, Herbfield, Eelgrass meadows, Sedgeland, Estuarine Shrubs and Terrestrial Shrubs and Trees. Within the vegetated habitats, the most common classification was Herbfield (154 ha, 43%), with the dominant species being *Sarcocornia quinqueflora* (glasswort) found mainly along the estuary margins. Also very common was Rushland (101 ha, 28%), dominated by *Juncus kraussii* (searush) and *Leptocarpus similis* (jointed wirerush). Macroalgal beds, dominated by *Enteromorpha* sp and/or *Ulva* sp. and *Gracilaria chilensis*, covered a moderate area at the time of the survey (33 ha, 9%), however it must be recognised that coverage of these species can fluctuate considerably over the short term (*i.e.* weeks to months). Eelgrass meadows (*Zostera* sp.), although relatively less abundant, covered an ecologically significant area of 21 ha or 5.8% of the vegetated substrata.
