# Waiau (Te Waewae) Lagoon 2011

## Fine Scale Monitoring and Macrophyte Mapping

Prepared  
for  
**Environment  
Southland**  
March  
2011

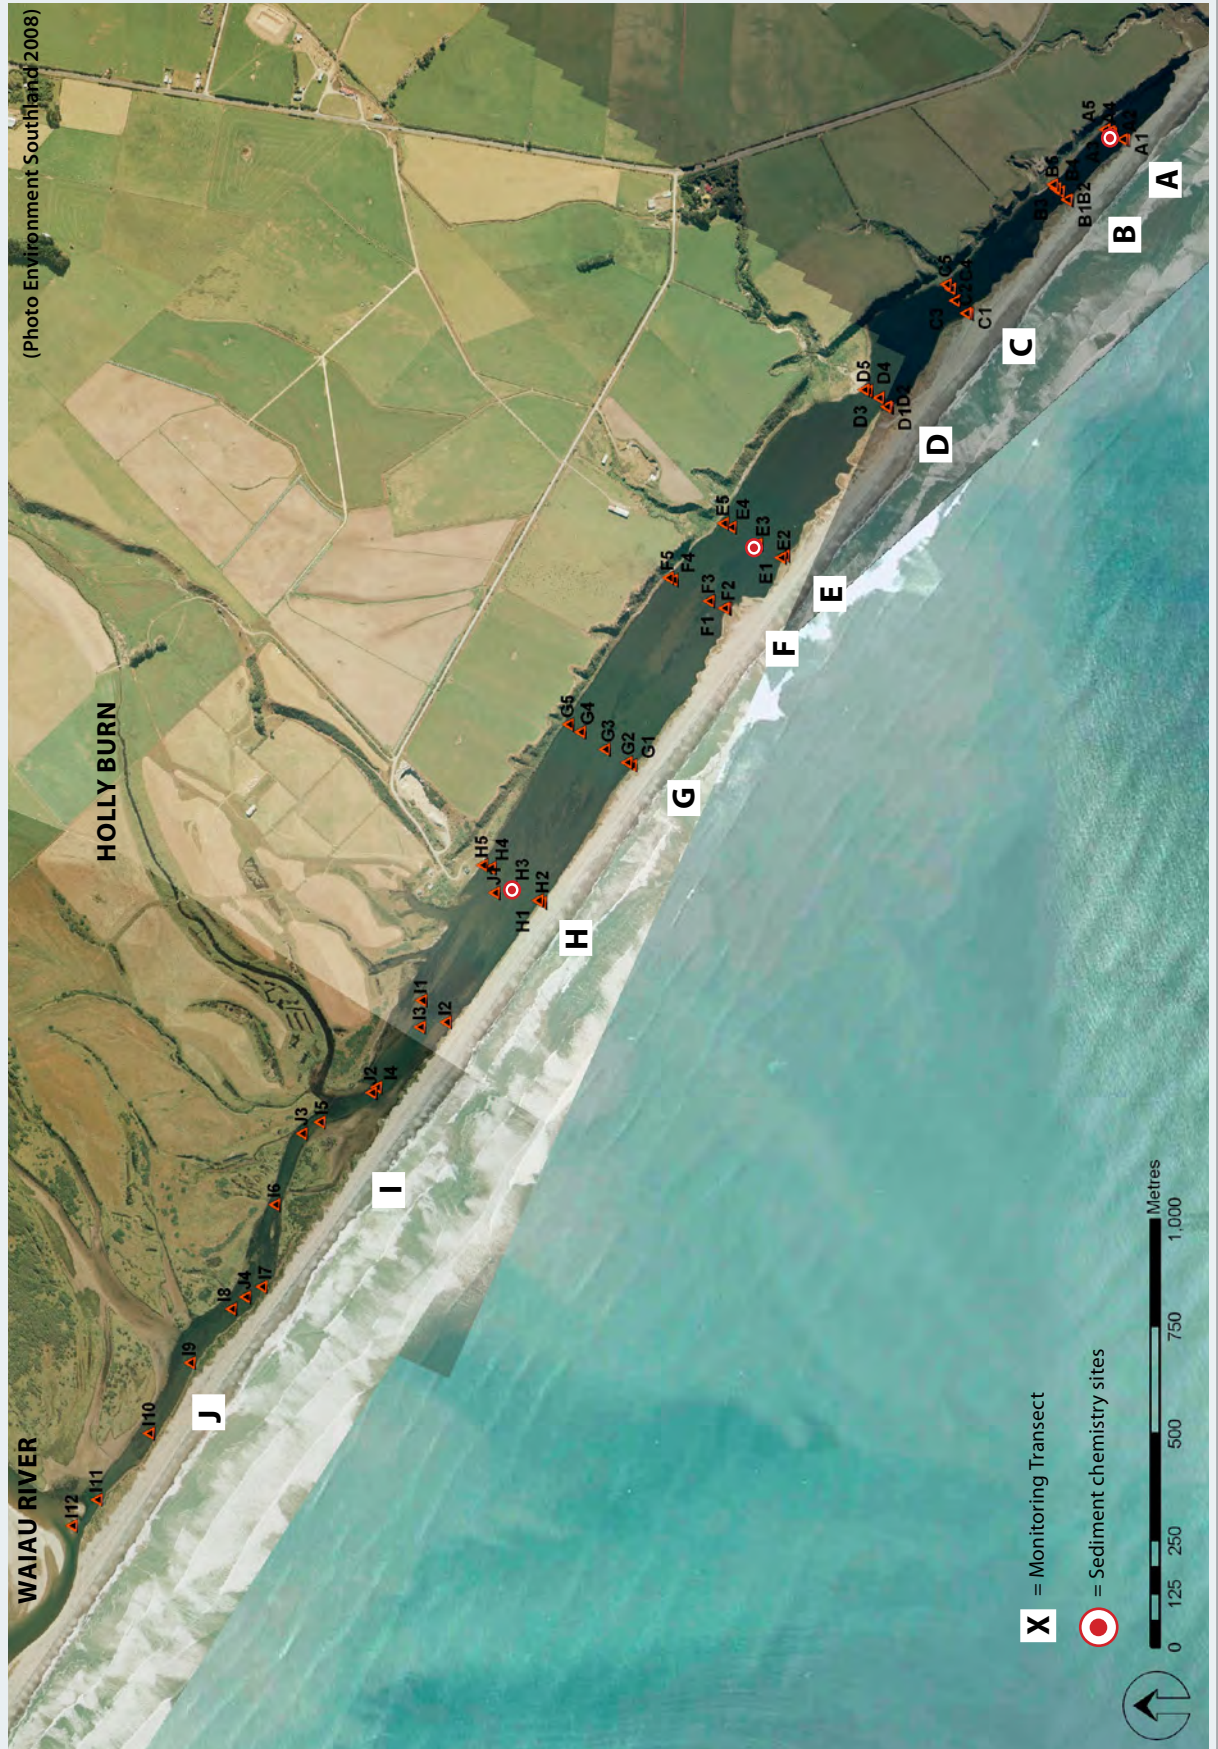
Figure 4. Location of sampling sites, Waiau/Te Waewae Lagoon February 2011.

Nine previously established transect sampling sites in Waiau/Te Waewae Lagoon (Robertson and Stevens 2009) are shown in Figure 4 covering a representative cross section of conditions throughout the estuary. They were visited by two scientists on 26 February 2011 when the lagoon was open to the sea. At each site, sampling was undertaken for key indicators of estuary condition as described below. The purpose was to collect information which, through repeat sampling, can be used as a rapid and robust method to indicate change within the estuary.

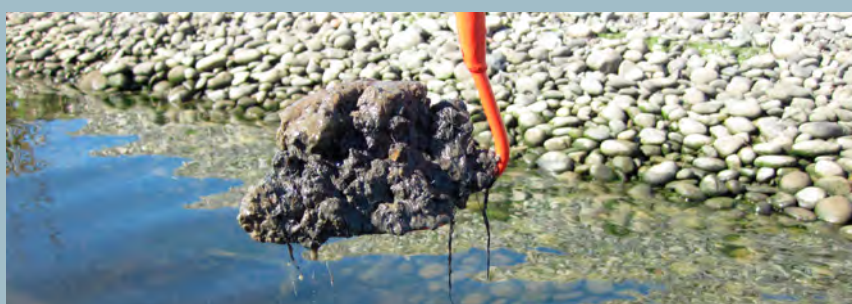
Well oxygenated cobble margins and moderately oxygenated muds in the middle estuary

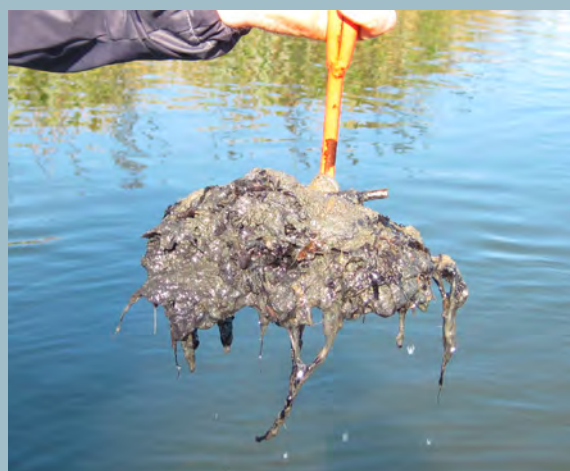
Anoxic sulphide rich sediment associated with decaying vegetation - 3m depth.

Figure 6. Examples of sediment oxygenation, Waiau/Te Waewae Lagoon, 26 February 2011.

Surface sediments within the lagoon were generally oxygenated in 2011 (RPD depth range >5cm to 1cm), and slightly improved on those observed in 2010. Black sulphide-rich sediment was present near the surface under rotting macroalgae and macrophytes (Figure 8) in localised areas, but this was not widespread.

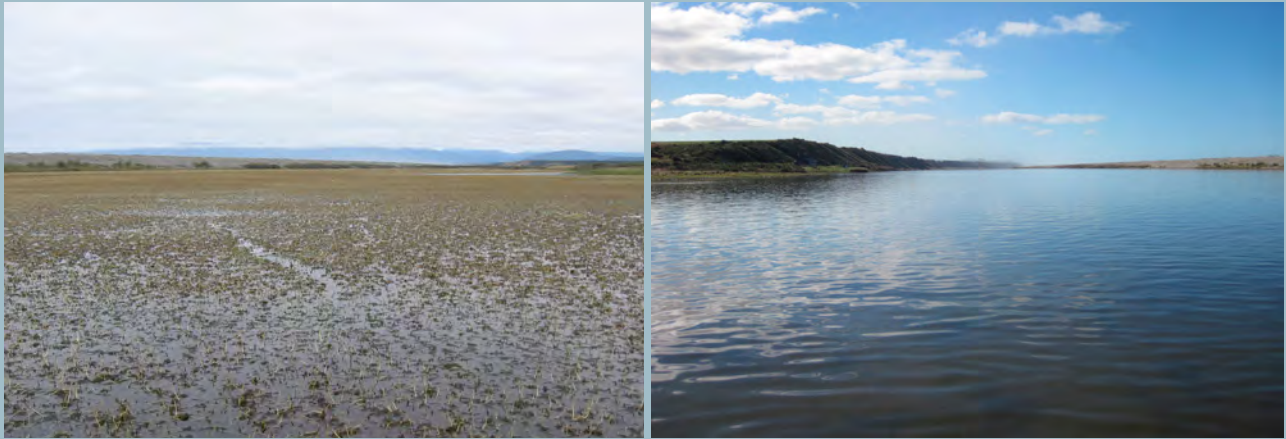
Although visually striking, the apparent reduction from 2010 to 2011 in extensive surface growths of *Potamogeton crispus* just east of the Holly Burn mouth (Figure 11) does not reflect a significant reduction in nuisance growth. The February 2011 cover of *P. crispus* remained at a very similar level to 2010, the only difference being plants were not reaching the surface.

Figure 11. Waiau Lagoon - extensive choking surface growth of *Potamogeton crispus* just east of the Holly Burn mouth in 2010 (left) and the same area in 2011 (right) where subsurface growths remain similar, but are not reaching the surface.
