# PORIRUA HARBOUR SURVEY REPORT OF SURVEY

# Contract No. P31657

**Report Prepared for Porirua City Council**

# Surveyed by Discovery Marine Ltd.

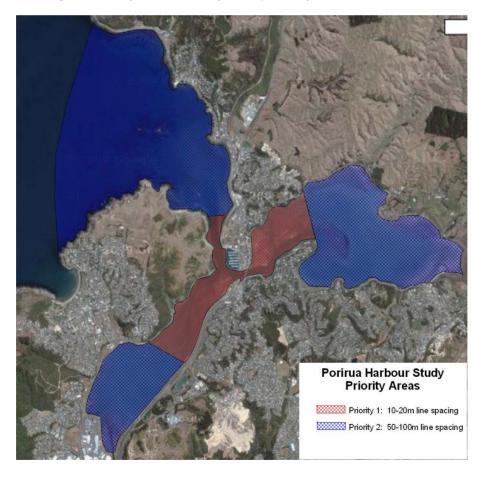
2.3 Based on information supplied by consultants to PCC, the survey area was afforded two distinct density level areas, which ultimately determined the sounding density. The red areas, being more critical to the modelling requirements required 10-20m line spacing whilst the blue areas identified regions that required less density (50-100m line spacing). The two areas were assigned 'Priority 1' and 'Priority 2' respectively.

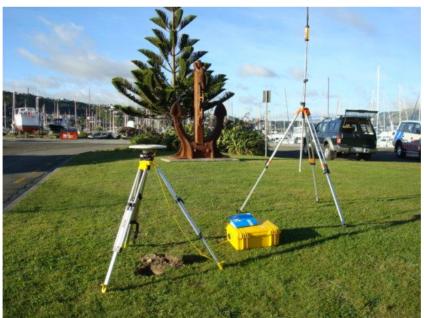
RTK Base Station at BM DML1- Entrance to Mana Marina

3.3 Two new temporary survey marks were installed, consisting of buried 1.5" iron tubes, for use as RTK Base Stations. The two marks (DML1 and DML2) are located in vicinity of the Mana Marina and Ngatitoa Domain foreshore respectively. These marks were used in the local network.

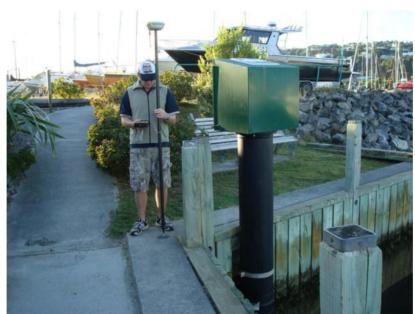
RTK Fixing of BM at Mana Tide Gauge Site

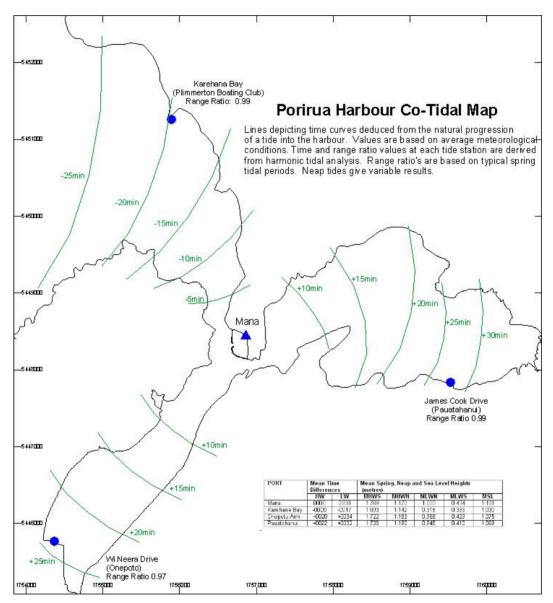
4.12 A simplified co-tidal diagram, illustrating the time differences throughout the harbour are shown overleaf:

4.11 Whilst there is a datum issue to be addressed, the final dataset which accompanies this report is currently reduced for tide, using a co-tidal model referenced to Mana, adopting the existing LINZ value for CD (Mana). The co-tidal model applies a geographical weighting to depth reduction, whereby raw depths are reduced for tide based on specific areas selected for each tide station. This has improved the final accuracy of soundings as without the co-tidal model, depths reduced for tide based on Mana tide readings only result in vertical errors of up to 0.25m. The error was quite noticeable at the head of Onepoto Arm and Pauatahanui Inlet which is expected due to typical constriction effects which results in considerable tide time delays.

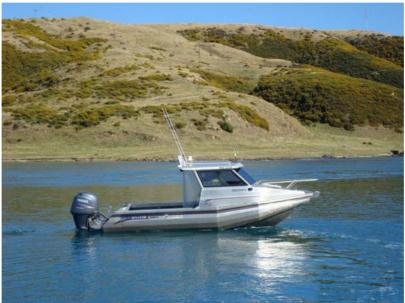
SMB Discovery at Mana

5.1 DML's 7m Senator inshore survey boat '*Discovery*' was used for all boat sounding. Being a pontoon design, she is a very stable platform for inshore hydrographic surveys. With a shallow draught of 0.4m, she was also an ideal vessel for working the shallow inlet areas and sounding could be undertaken with less than 30cm of clearance under the keel.

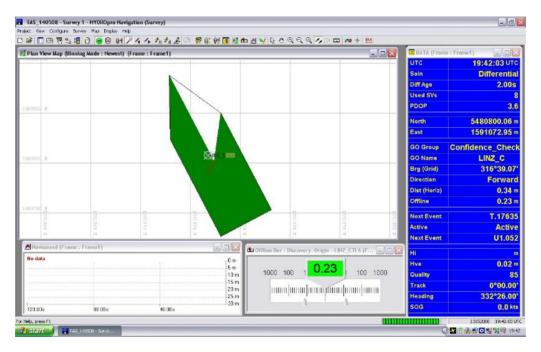
Example of Positioning Check against a known survey mark

5.4 All equipment was checked, calibrated and operated in accordance with accepted industry procedures. The echo sounder was calibrated daily for vessel draught and sound velocity using the bar check method and verified with a Sound Velocity Probe (SVP). The accuracy of the vessel positioning system was also checked daily by undertaking a static position check against the survey mark (Terrier Bolt) within the Mana Marina. These checks confirmed a horizontal positioning accuracy of better than +/-1.2m at the 95% (2-sigma) confidence level.

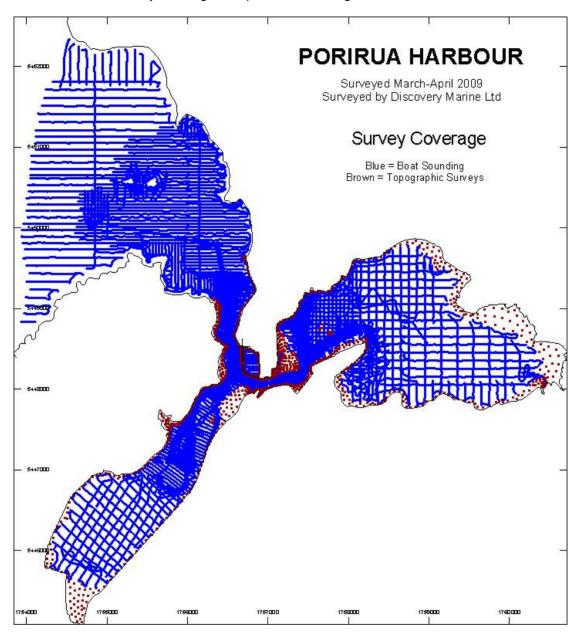
6.4 The final survey coverage is depicted in the image below:

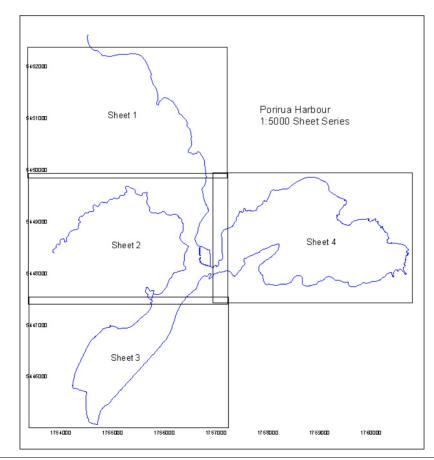
7.5 The 1:5000 sheet series is illustrated below:

7.4 Within Terramodel, the final depth layer was thinned to approximately 15m intervals to create a 1:5000 sounding sheet series. A 'shoal bias' was used in the thinning process ensuring that shallows are correctly depicted. However, minor channels and runnels are less conspicuous, although the accompanying 2D images do provide the best 'picture' of general seabed topography. The A1 sounding sheets accompany this report.

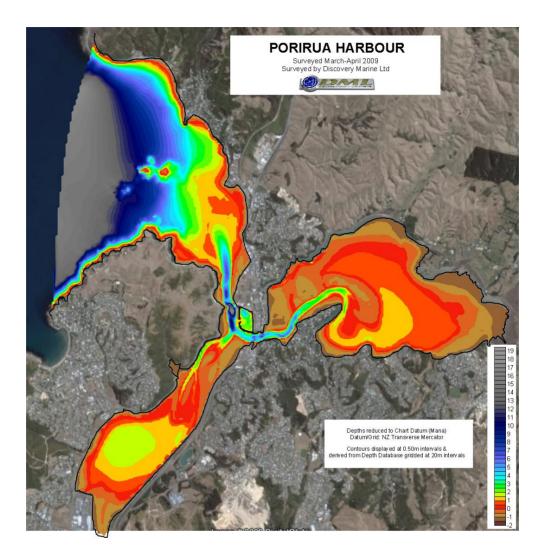
2D Colour Image of Area Surveyed
