THE 1855 WAIRARAPA, NEW ZEALAND, EARTHQUAKE - ANALYSIS OF HISTORICAL DATA

ABSTRACT

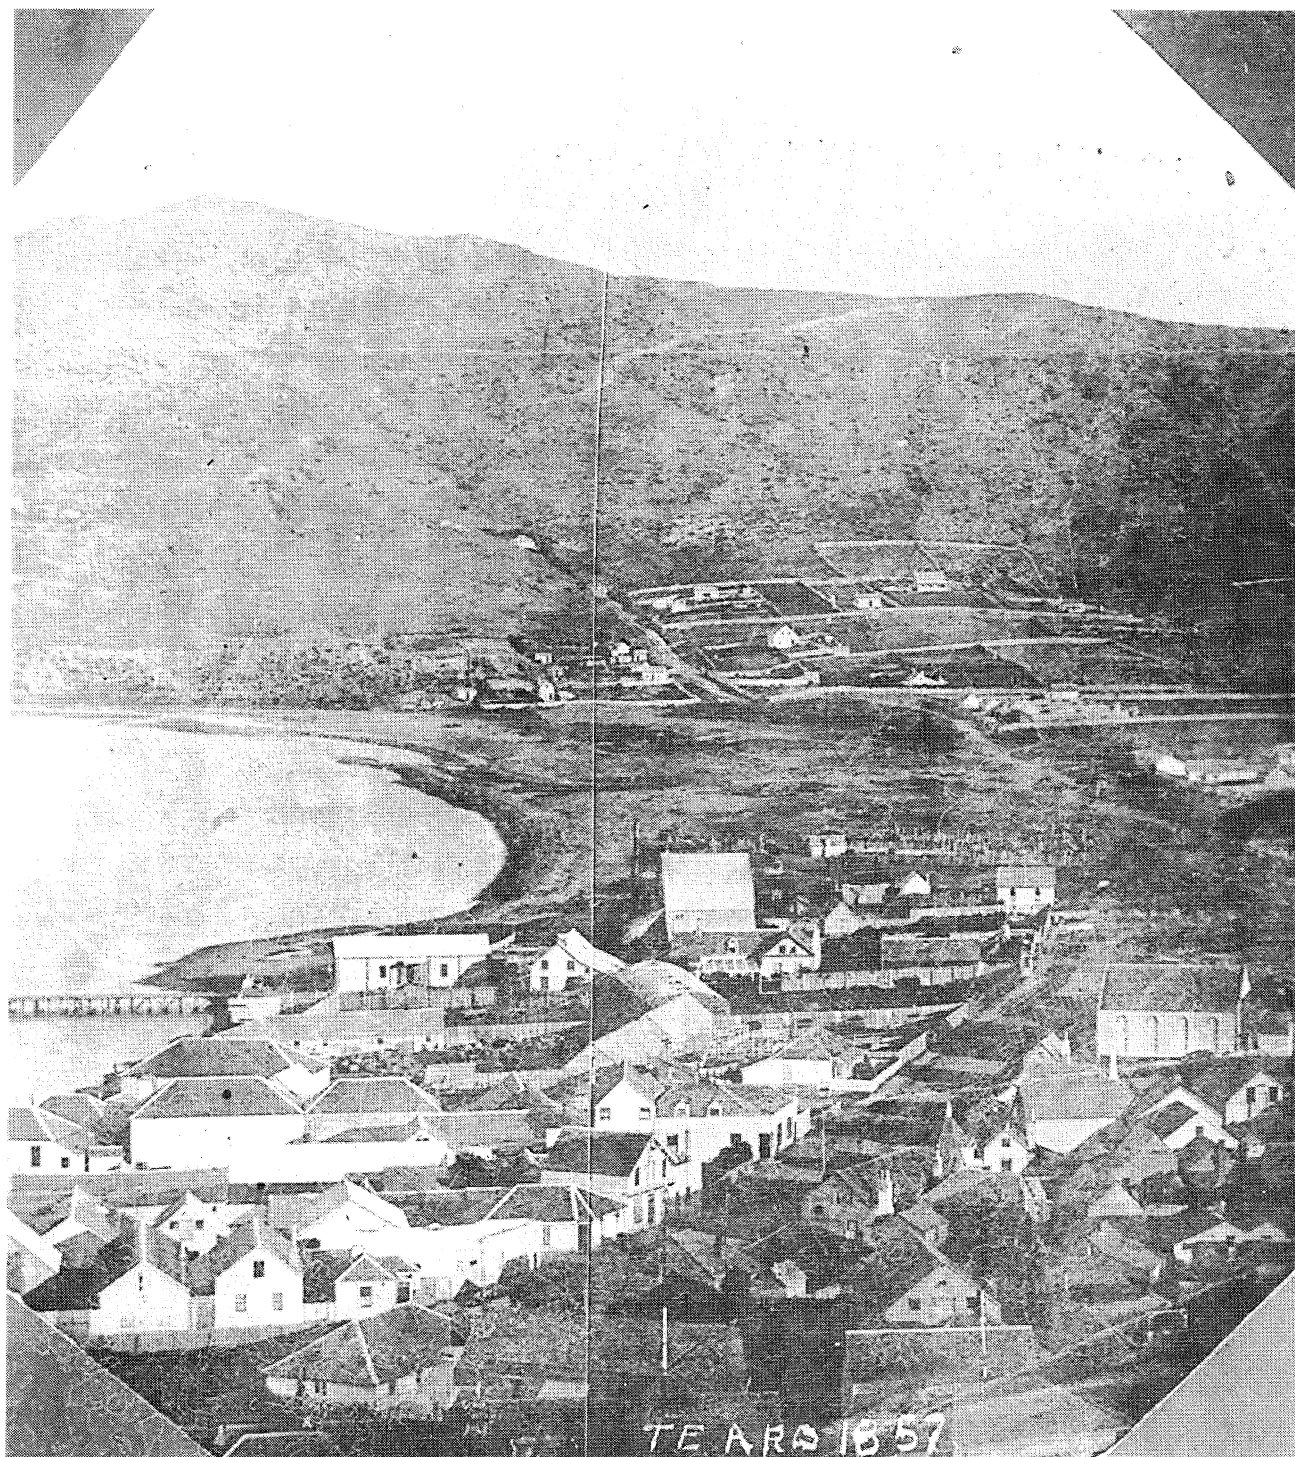
Fig.18. Photograph by F. J. Denton (c.1857) looking east towards Mt. Victoria and the Te Aro foreshore, Wellington, and showing the widened area of beach exposed by about 1.5m of uplift during the 1855 earthquake. The post-1855 high tide mark can clearly be seen (see text). (Ref. No. F145534¹/₂, Alexander Turnbull Library, NLNZ).

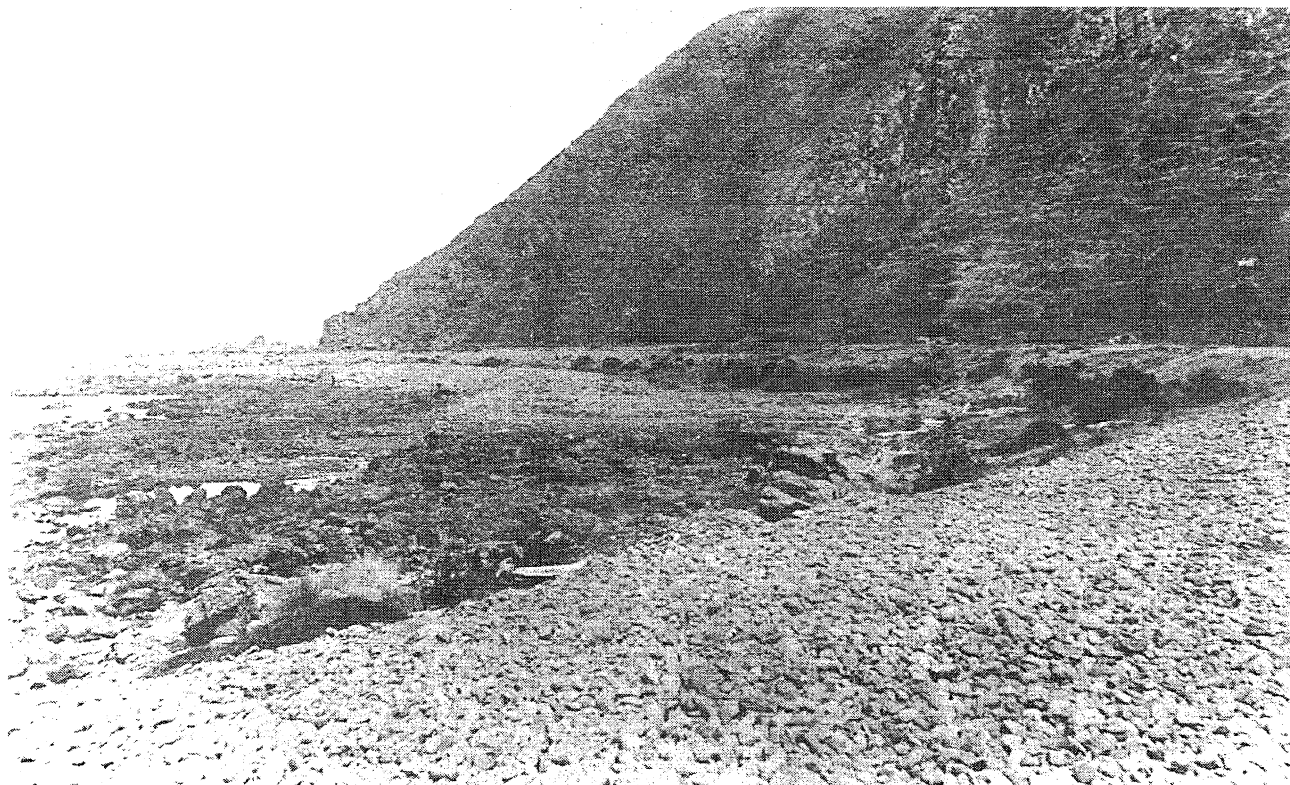
Fig.22. Photo taken by Sir Charles Cotton in 1919 of Reef Bay, south Wellington coast, showing the 1855 uplifted beach. Photo taken at extreme low tide showing uplifted rock platform. (Geography Department, Victoria University of Wellington).

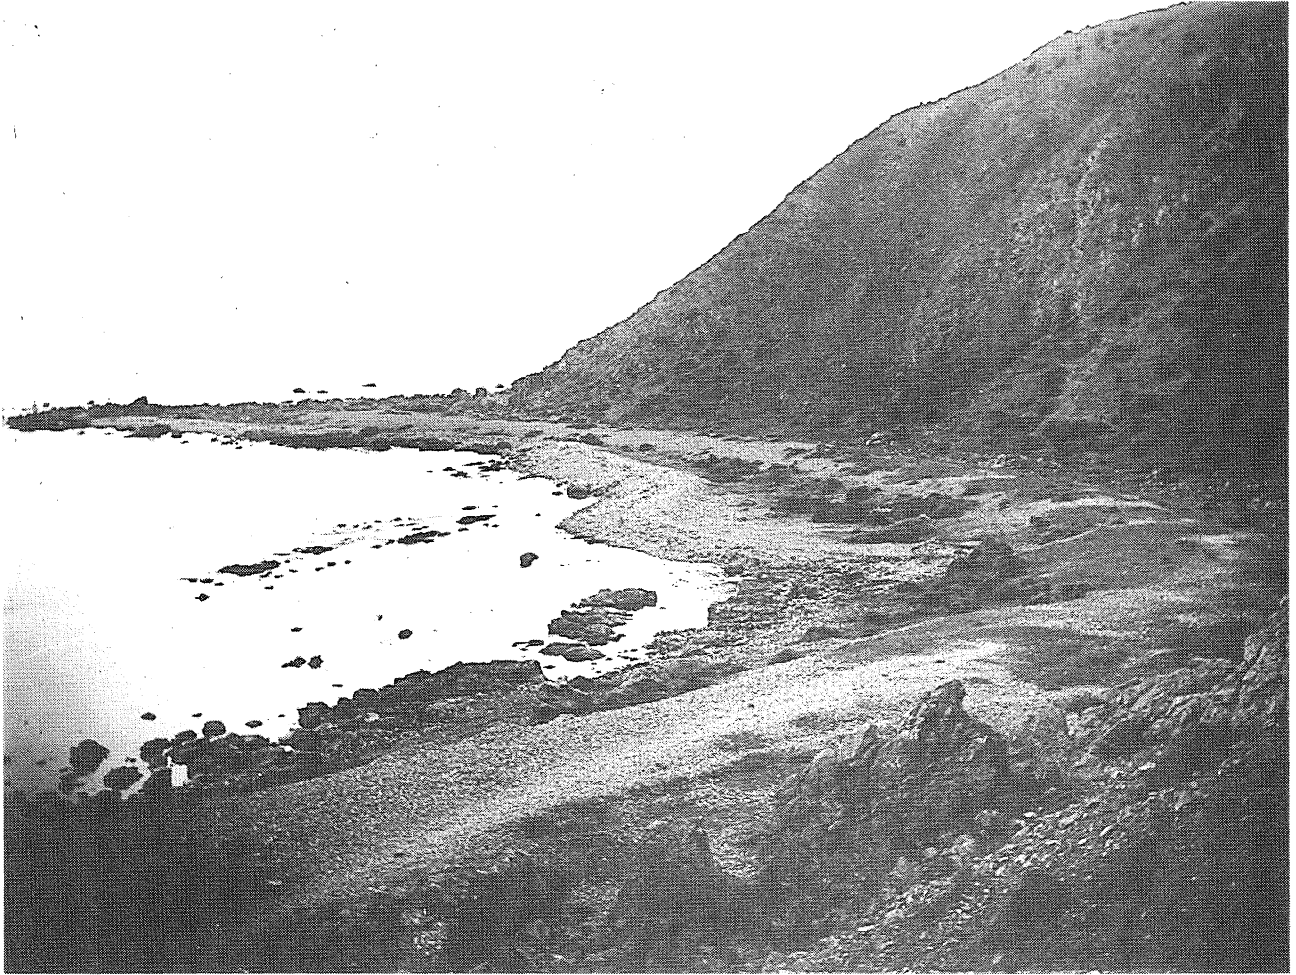
Fig. 23. Photos taken by G. L. Adkin in the early 1920's showing the 1855 uplifted beach, south Wellington coast; a Reef Bay (same locality as shown in Fig. 22; taken at half tide); b Palmer Head. (Neg. Nos. B21094 and B20937, Hector Library, Museum of New Zealand, Wellington).

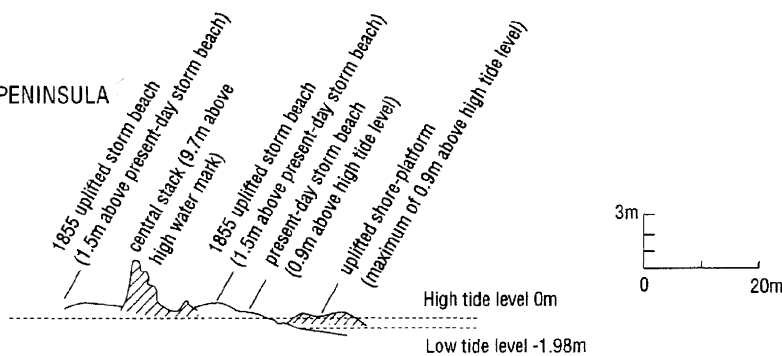
Fig.24. Map and section profiles of the 1855 uplifted beach ridge, stacks and rock platform between Breaker Bay and Lyall Bay, south Wellington coast (after Adkin, unpublished notebooks 1957, 1955, 1956).

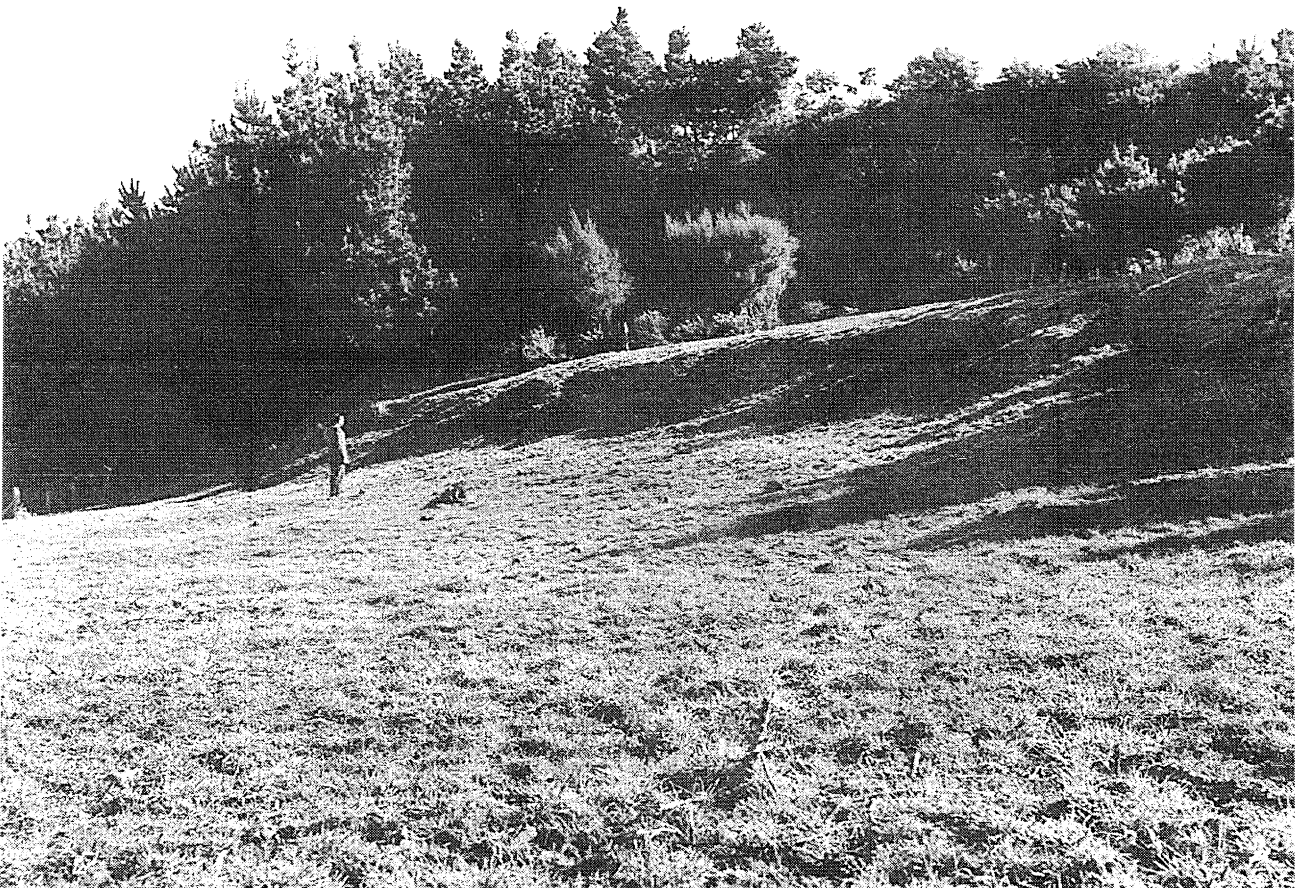
Fig. 35. The c.1.6m high scarp of the 1855 uplift viewed from the east near Pigeon Bush, south of Featherston, Wairarapa. (Photograph by Professor E. L. McKenzie, Victoria University of Wellington, 1959).

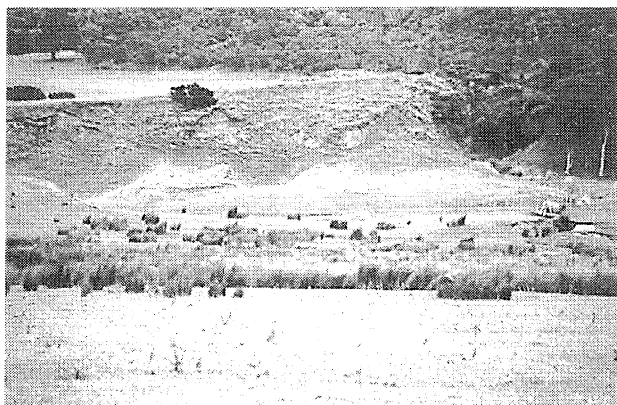
Fig.40. a. Photograph looking west with near vertical scarp of the Wairarapa Fault in the background and two stream channels beheaded at the fault scarp (Pigeon Bush, locality 4 in Fig. 37). The channels were the continuation of the bushclad stream cut in the upthrown (west) side of the fault scarp (right side of photo). The channels illustrate dextral displacement as a result of two earthquakes, the last in 1855 which resulted in the stream channel in the centre of the photograph being displaced to the left (southwest) by 12m relative to its incised continuation on the NW side of the fault. (Photo by R. Grapes 1990).

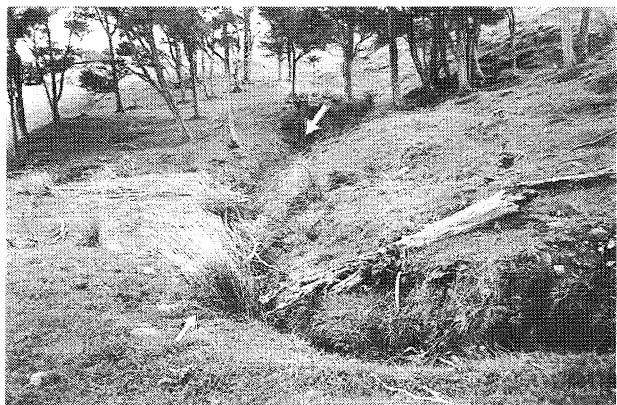
b. Photograph looking SW along the line of the 1855 rupture (arrowed) and showing dextral displacement of a stream by about 12m (Pigeon Bush, locality 5 in Fig.37). (Photo by R. Grapes 1988)

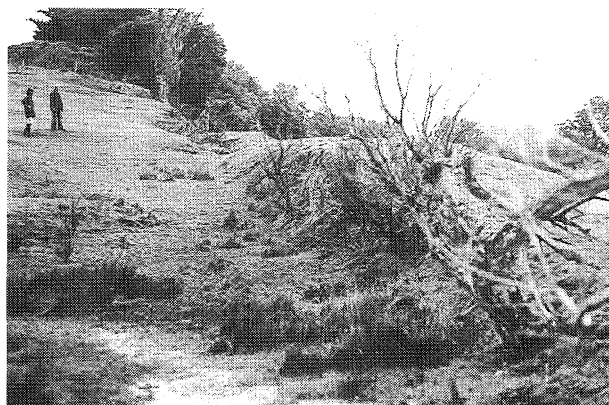
c. Photograph looking NE along the line of the Wairarapa Fault and showing an example of a protruding half-scarp caused by dextral displacement in 1855. Two figures are on the upthrown (west) side of the fault trace and the ridge on the right (east) side of the fault has been moved dextrally, i.e. towards the observer resulting in an apparent reversal of vertical displacement (i.e. on the east side rather than the west side of the fault). Matching the end of the ridge slope (partly covered with dead wood) on the east side of the fault with its equivalent on the west side of the fault (about where the figures are standing) indicates that the 1855 dextral displacement was about 12m (south of Tauharenikau River, locality 6 in Fig. 37). (Photo by R. Grapes 1988).

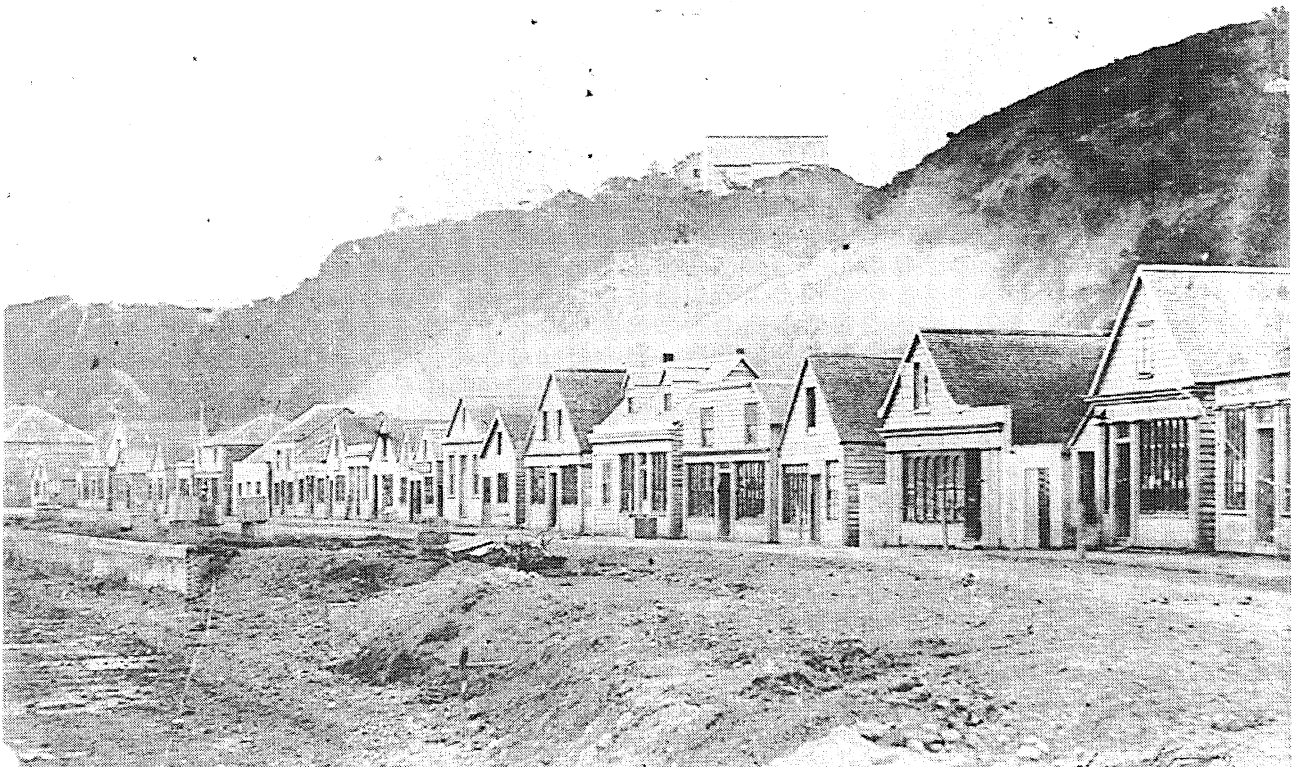
Fig 43 a. Post-earthquake (1860) photograph of Lambton Quay. Typical wooden houses are shown together with the fill (earthquake debris?) behind the uncompleted sea wall that was presumably abandoned after uplift made it unnecessary. The cutting shown in the central part of the photo is the location of the present cable car (Ref. No. B3926-1/2, Alexander Turnbull Library, NLNZ).
