**Report on South Canterbury  
Coastal Flooding Event,  
19-22 July 2001.**

**J. Cope and B. Young  
December 2001**

**Technical Report No. U01/101**

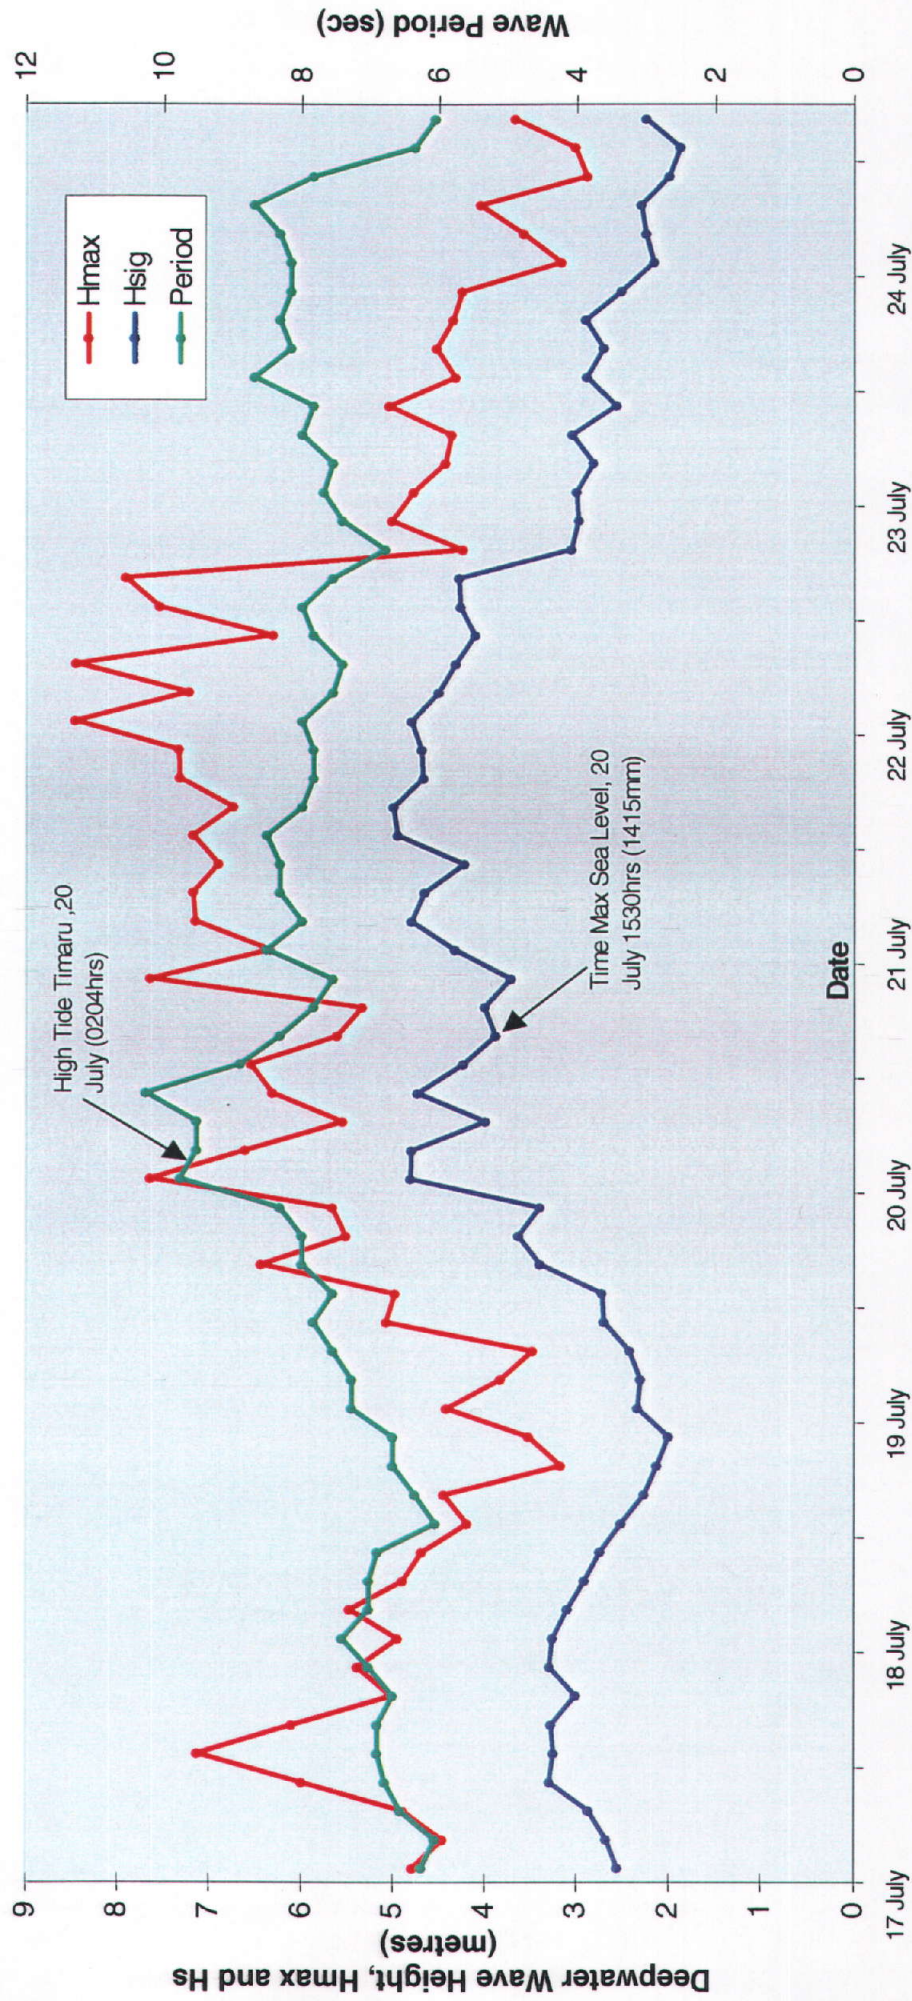
Figure 4.2: Deepwater Wave Conditions 17-24 July 2001 (3 hourly intervals)

Data from the joint Ecan/NIWA directional wave rider buoy is presented in Figures 4.2 and 4.3. The wave buoy is located in deep water, 17 kilometres offshore of Le Bons Bay, Banks Peninsula. It is believed that deep water wave conditions between South Canterbury and east of Banks Peninsula will not have been significantly different during this storm event. From Figure 4.2 it can be seen that following several days of moderately high swell conditions on the 17 and 18 July, waves built steadily during the day on July 19 to reach a peak ( $H_{sig}^1$  of 4.8m with  $H_{max}^2$  of 7.7m) immediately after midnight on 20 July. This peak in wave activity corresponded with high tide on the south Canterbury coast (0200 hrs). Wave period also reached a peak during the early morning of July 20 (Figure 4.2). Eyewitness reports also indicate that this early morning period, where high tide and a peak in swell height and period combined, was the time in which the most severe beach overtopping and coastal hinterland flooding occurred. Heavy swells continued through until the evening of July 22 when they began to die away. Significant deepwater wave height generally remained between 4 and 5 metres for the duration of the storm event with maximum wave heights generally remaining above 7 metres. The highest waves recorded during the storm were 8.5 metres during the early morning of July 22.

Breaker heights can however be estimated theoretically from the deepwater wave data using mathematical formulae. From the deepwater wave conditions described in Section 4.3 and in figures 4.2 and 4.3 and using the methods described in the Coastal Engineering Manual (2001) the estimated breaker height based on wave

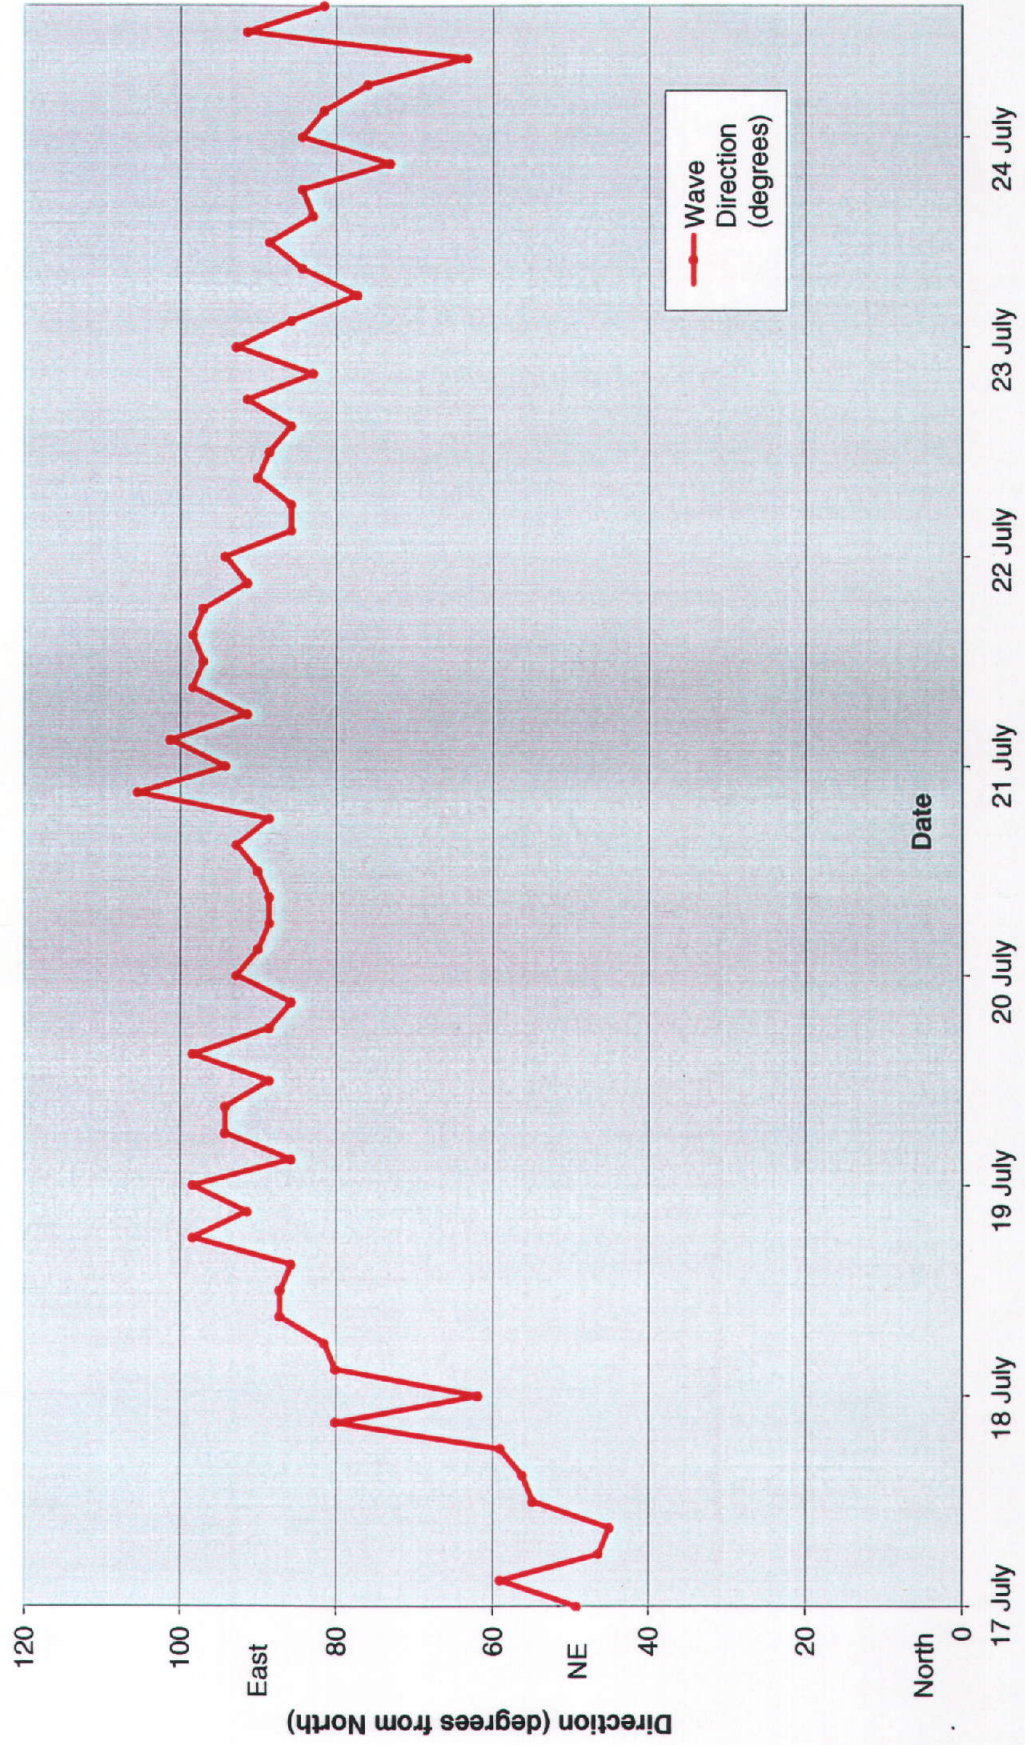
Figure 4.3 shows the direction of swell during the storm event. The storm had a significant easterly component with 77% of the three hourly recorded directional averages arriving from 10 degrees either side of due east (80-100 degrees).

Figure 4.3: Deepwater Wave Direction 17-24 July 2001 (3 hourly intervals)

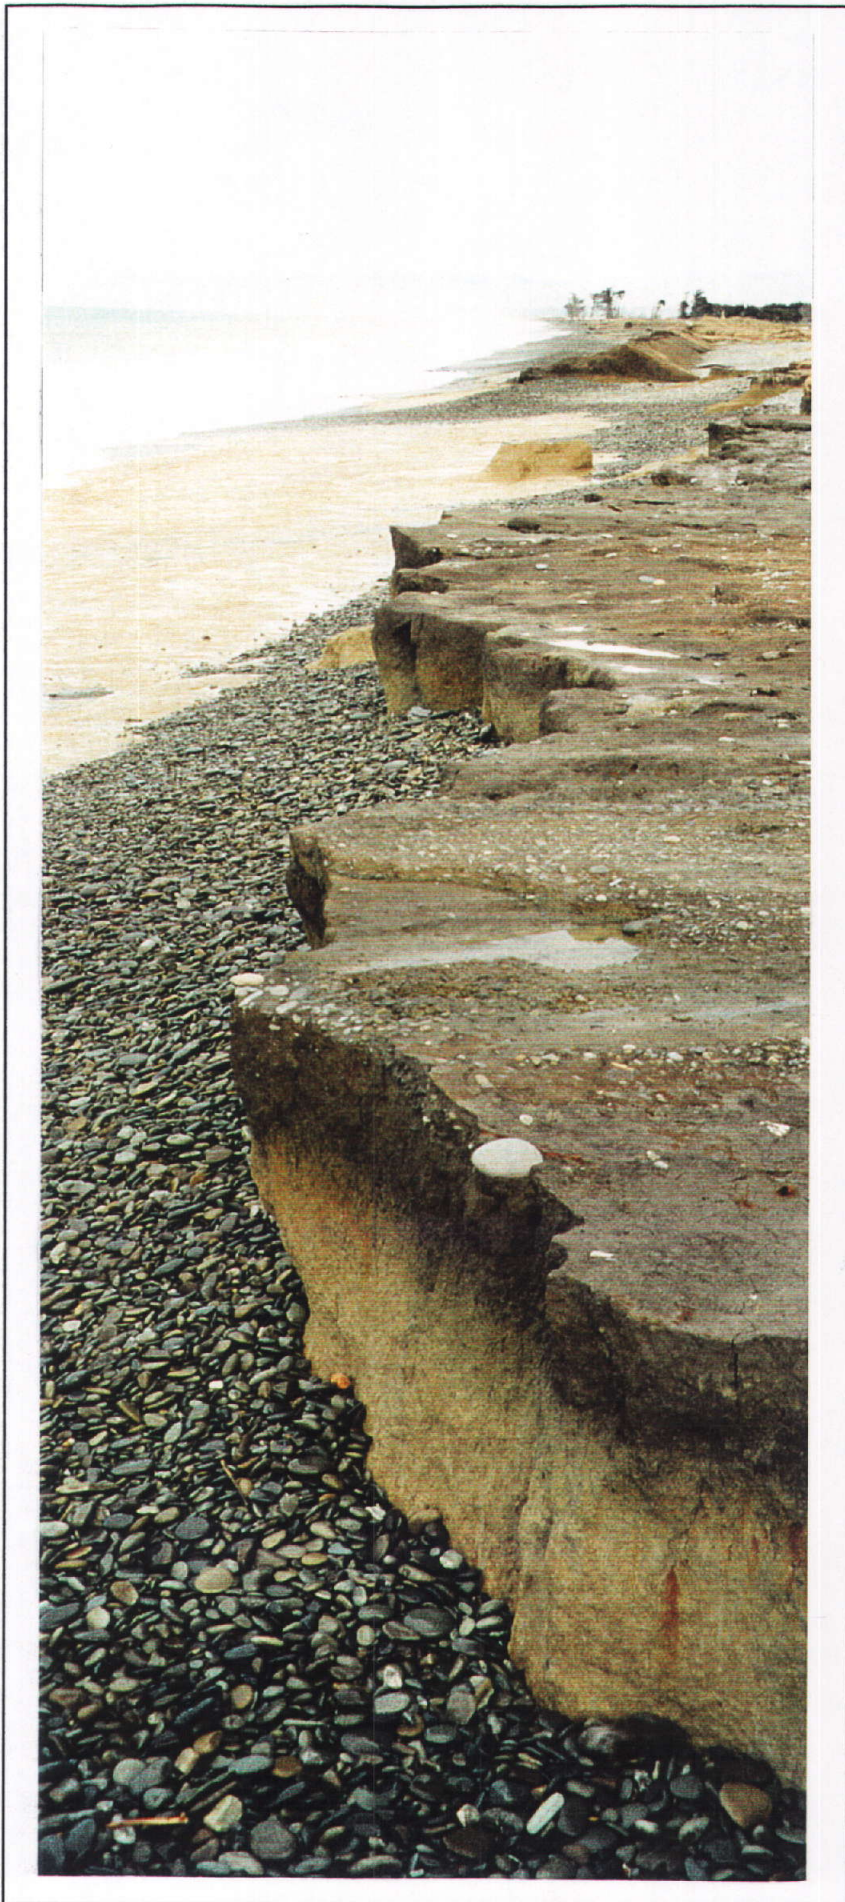
Figure 6.1 Significant Erosion of Old Coastal Stopbank at Connolly's Rd.

As can be seen in Table 6.1 the beach sections north of Timaru all experienced a landward retreat of the beach crest position. All but one section had significant volume losses, with the beach at the southern end of Washdyke lagoon (section S1175) undergoing significant loss of beach sediment (48.9 m<sup>3</sup>/m) as well as 13 metres of erosion at the beach crest. At Connolly's Rd (S0081) there was significant erosion of the old stopbank that had previously contained the beach (see Figure 6.1). The top of the old stopbank was eroded back over 5 metres and was reduced in height by 2 metres. The toe of the beach is now at the base of the new stopbank that was nearly overtopped by floodwater (Figure 6.2). Water reached a RL of 6.05m MSL, only 0.5m from the top of the stopbank. Beach gravel was deposited on the carpark area up to a depth of 0.5m. Much of the beach gravel was stripped from the beach leaving only basement material exposed (Figure 6.3).

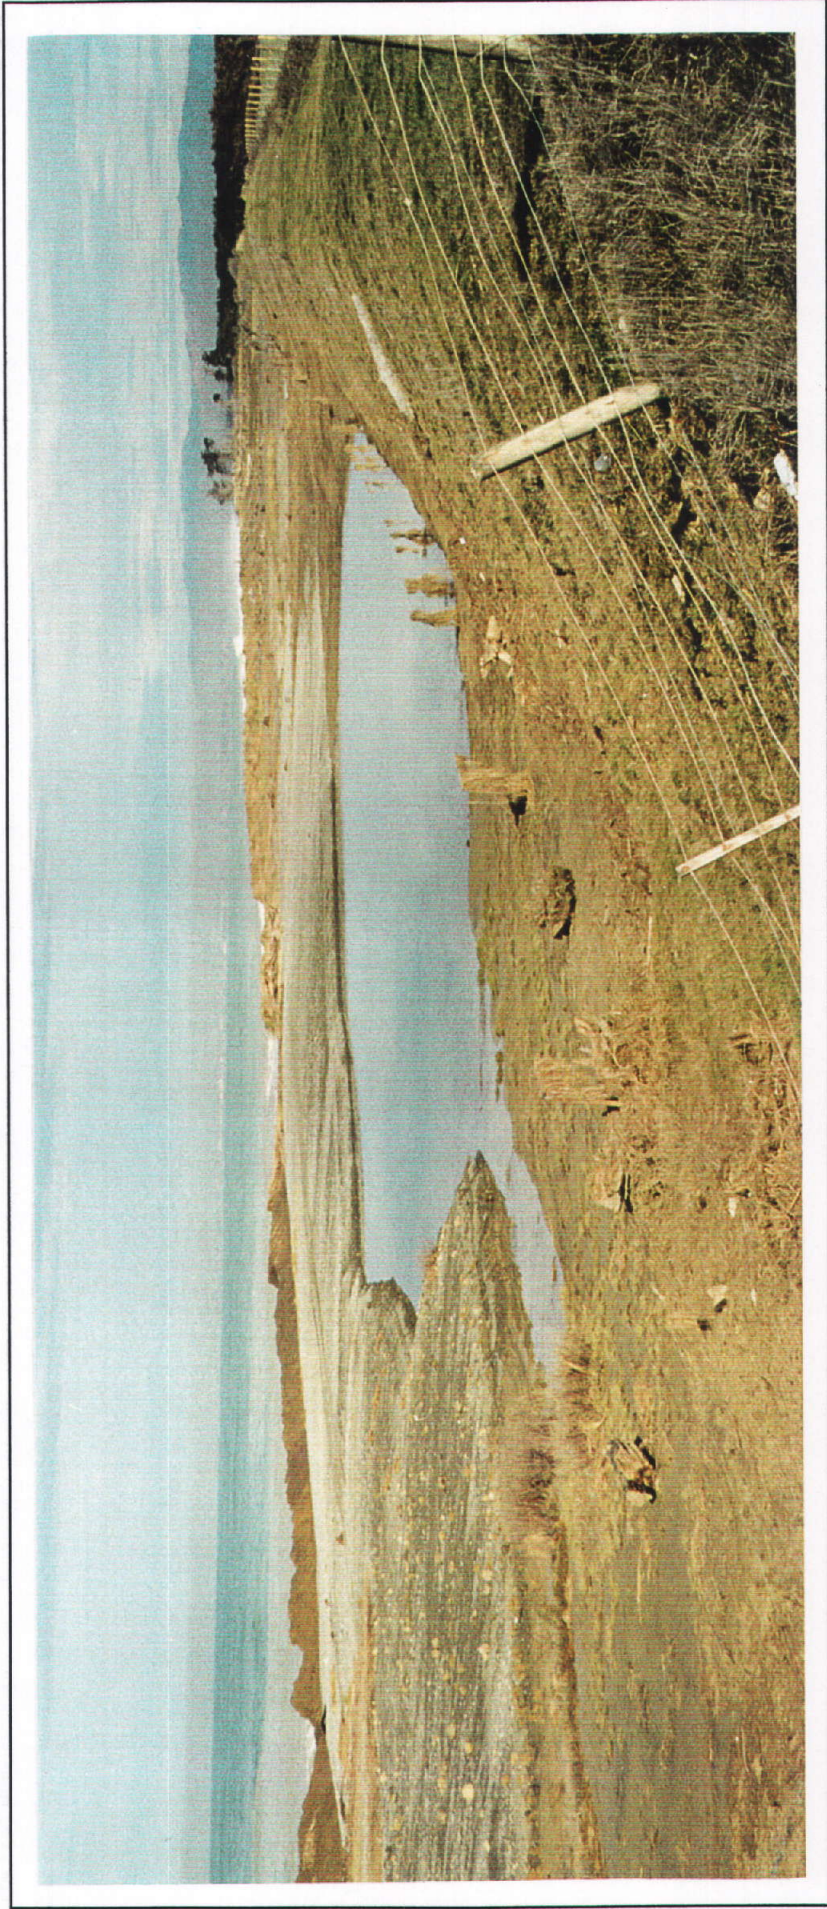
Figure 6.2 Beach Toe position now at the base of the New Stopbank at Connolly's Rd. Note also the flood debris line near the top of the bank.

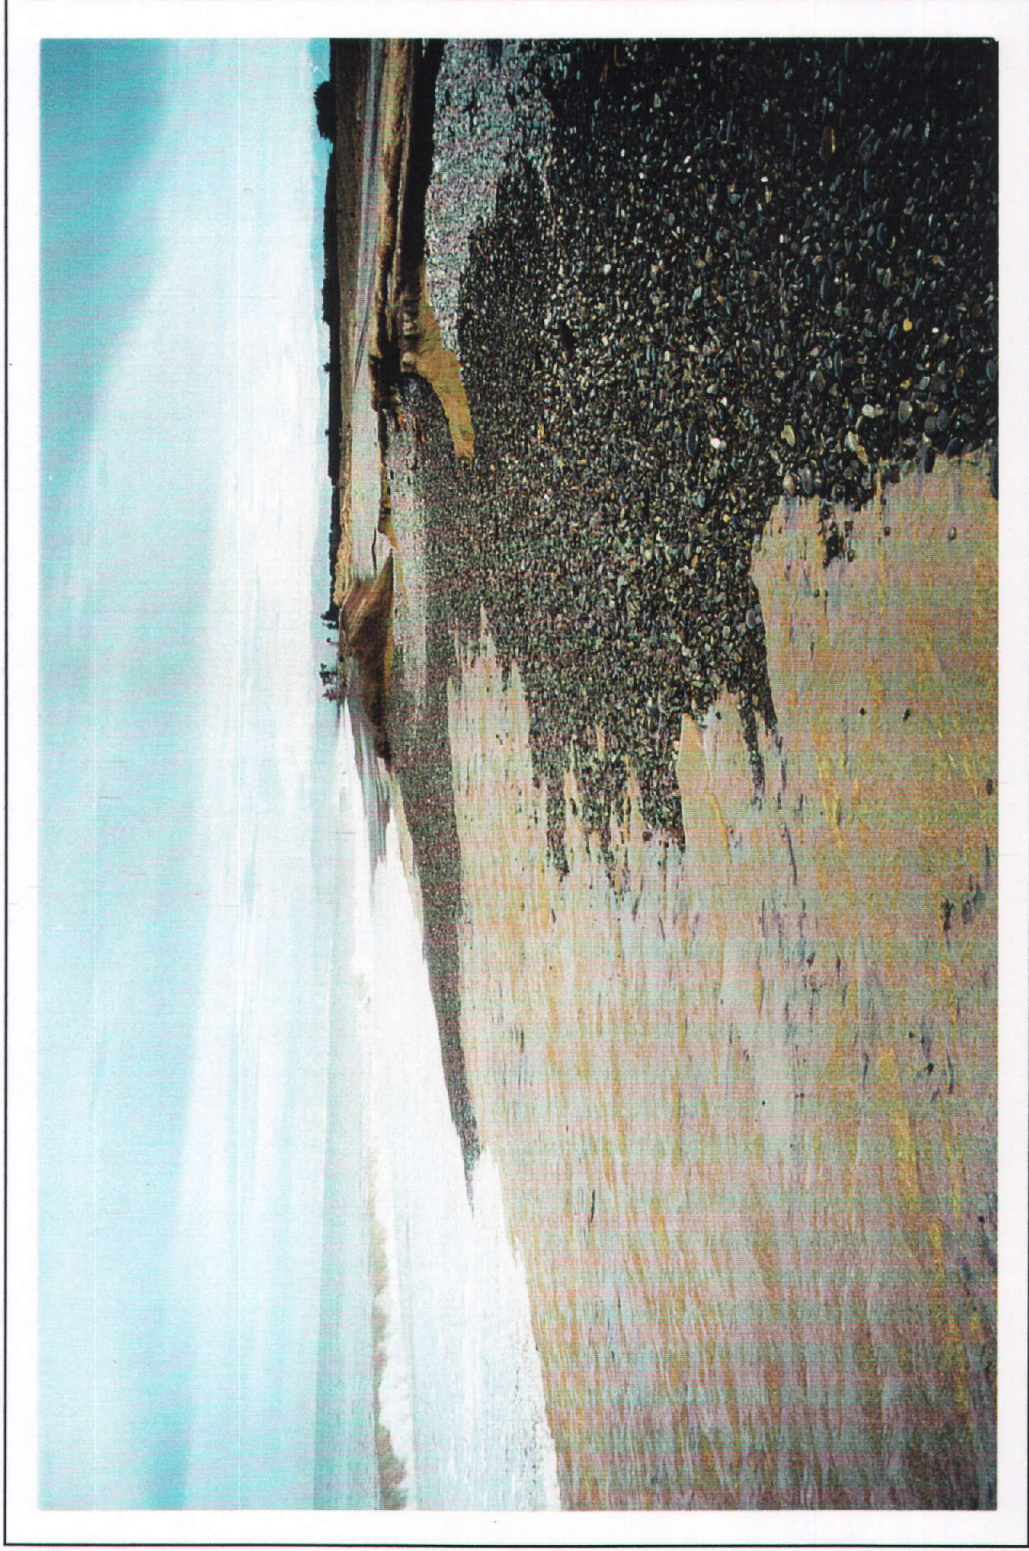
Figure 6.3 Beach gravel stripped to expose basement material at Connolly's Rd.

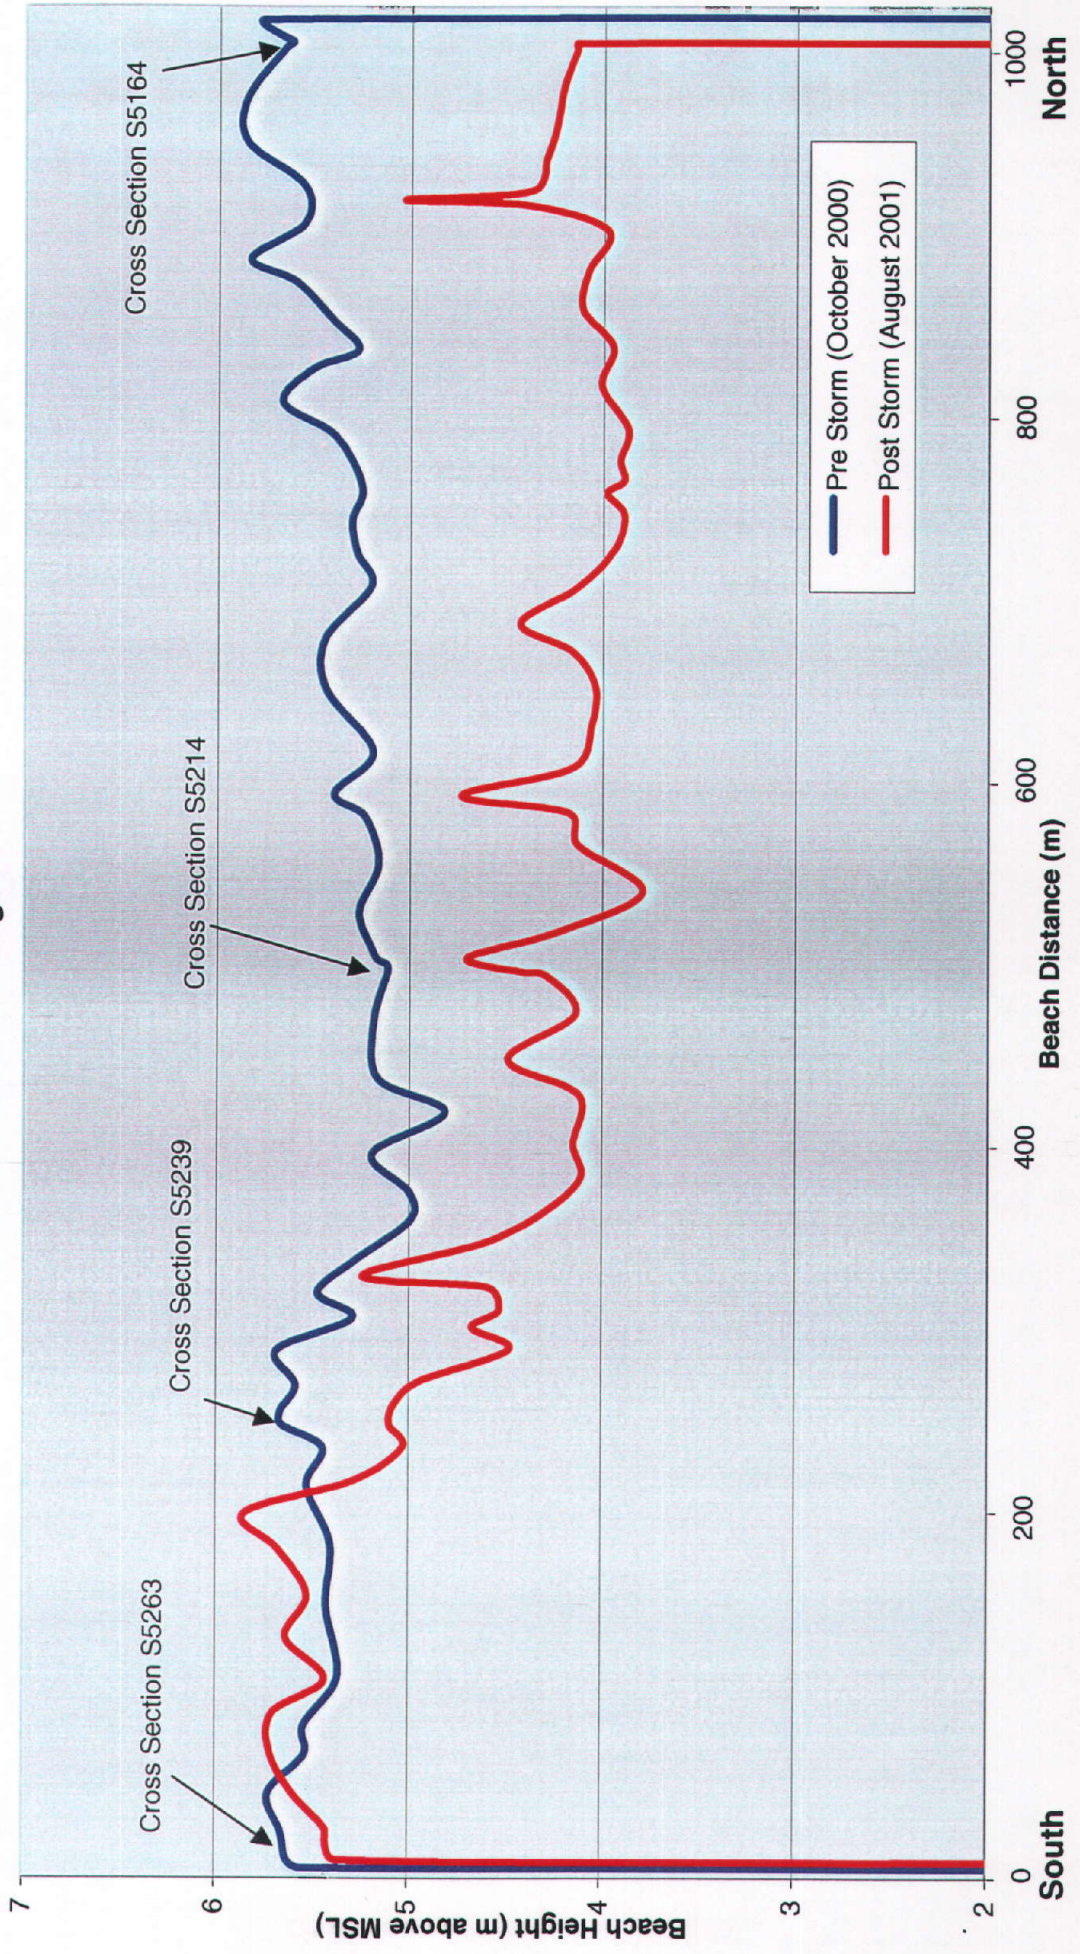
Figure 6.4: Comparison of Longitudinal Cross Section Surveys, Pre and Post July 2001 Storm, Wainono Lagoon

The most significant impact of the storm on the beaches south of Timaru was the overtopping and lowering of over 1km of gravel beach along Wainono lagoon. The location and extent of the beach lowering can be seen in Figure 7.9. It is believed that sea water pouring in over this breached section of coast contributed extensively to the hinterland flooding described in Section 7. Figure 6.4 is a longitudinal survey of the beach crest along the area where the beach was lowered. On average the elevation of the beach was reduced by 1.0 metres from its original height (as surveyed in October 2000) with a maximum height reduction of 1.90 metres. Beach gravel was washed over the crest and deposited on the landward side of the barrier beach, burying the access track to a depth of 0.5 metres in some places (see Figure 7.1). During the storm of July 1985 a 1.5 km section of beach was lowered to a similar degree along Wainono Lagoon, however, this took place further south of the present breach (Figure 7.9)

Table 6.2 shows a summary of beach movement as a result of the July 2001 storm for coastal cross sections south of Timaru. All sections, except at one location along the Wainono lagoon barrier, experienced erosion of the beach crest. Erosion of the beach crest varied between  $-1.1$  metres and  $-8.2$  metres. The majority of sections lost sediment volume and elevation. A typical example of storm induced beach erosion can be seen in Figure 6.5 This example is section S5214, one of the sites along the Wainono lagoon that experienced considerable overtopping by storm waves. Note the landward retreat and reduction in elevation of the beach crest and the increase in sediment volume on the landward side of the beach as sediment was washed over the crest by waves during the periods of overtopping.

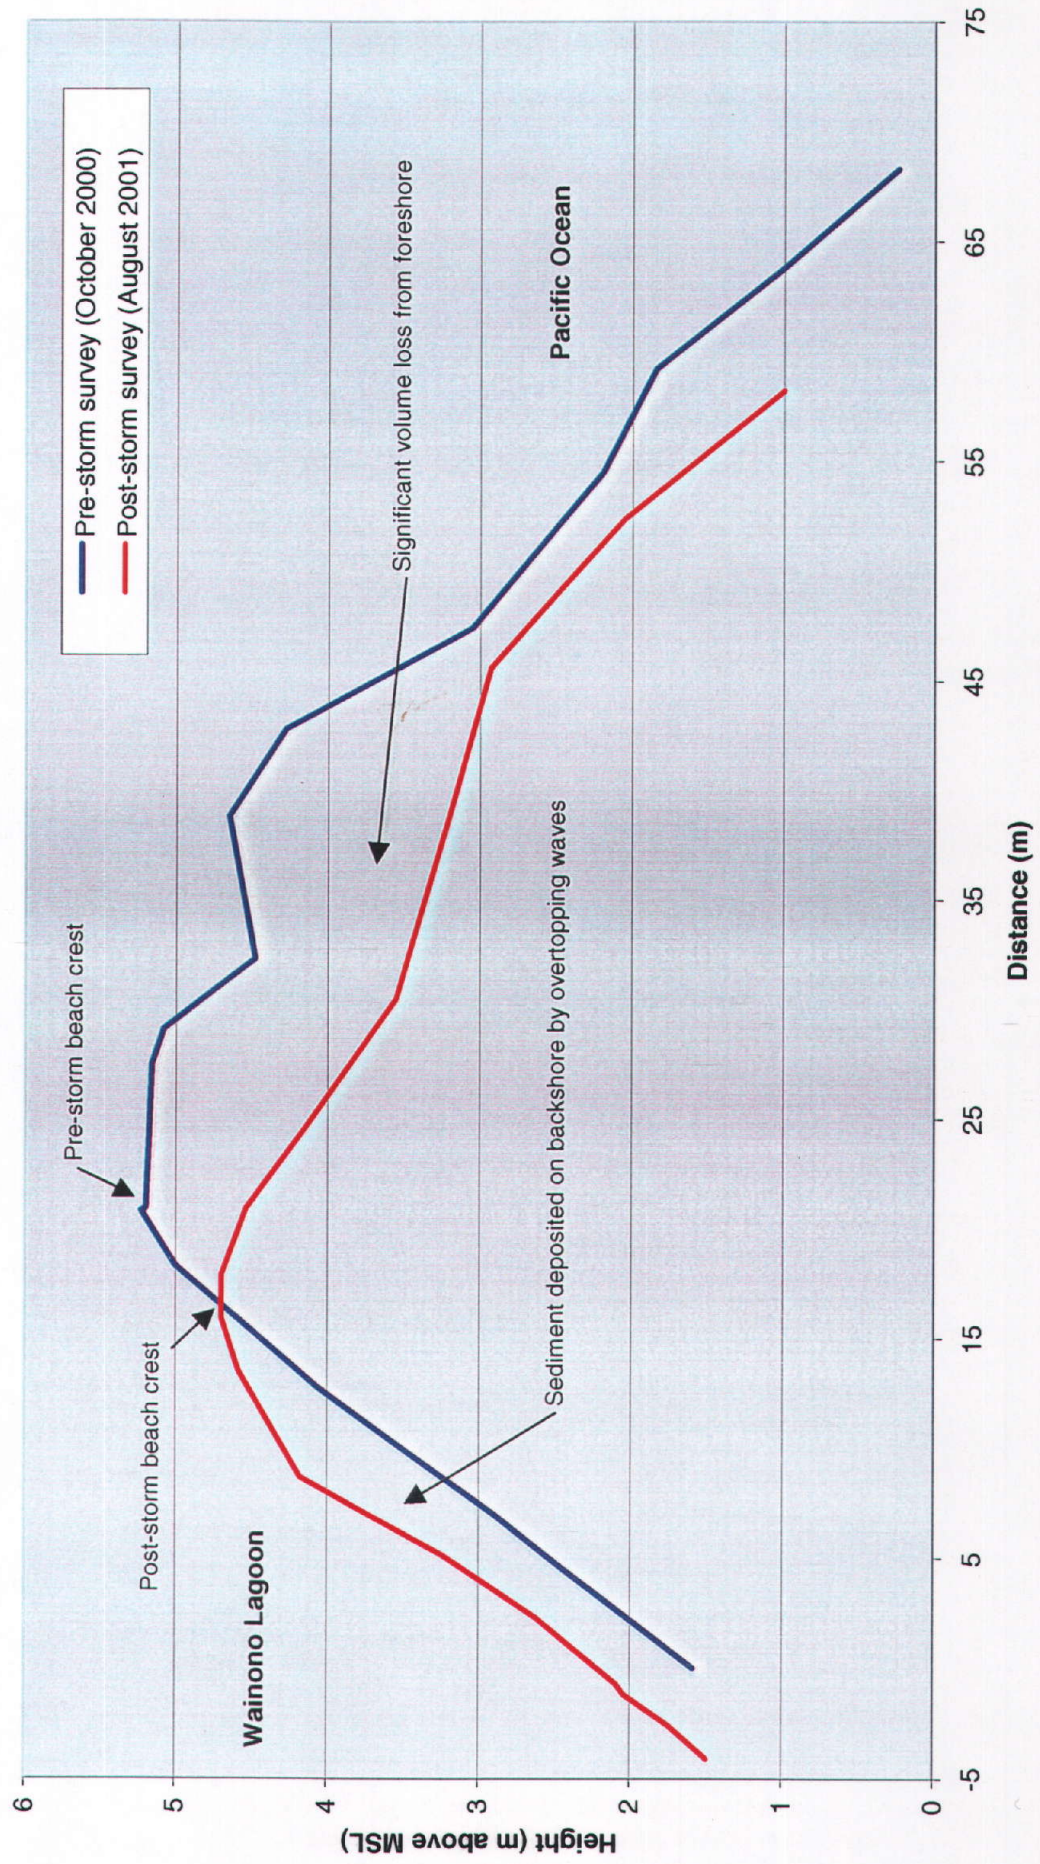
Figure 6.5: Cross section S5214, Wainono Lagoon. Pre and post storm surveys

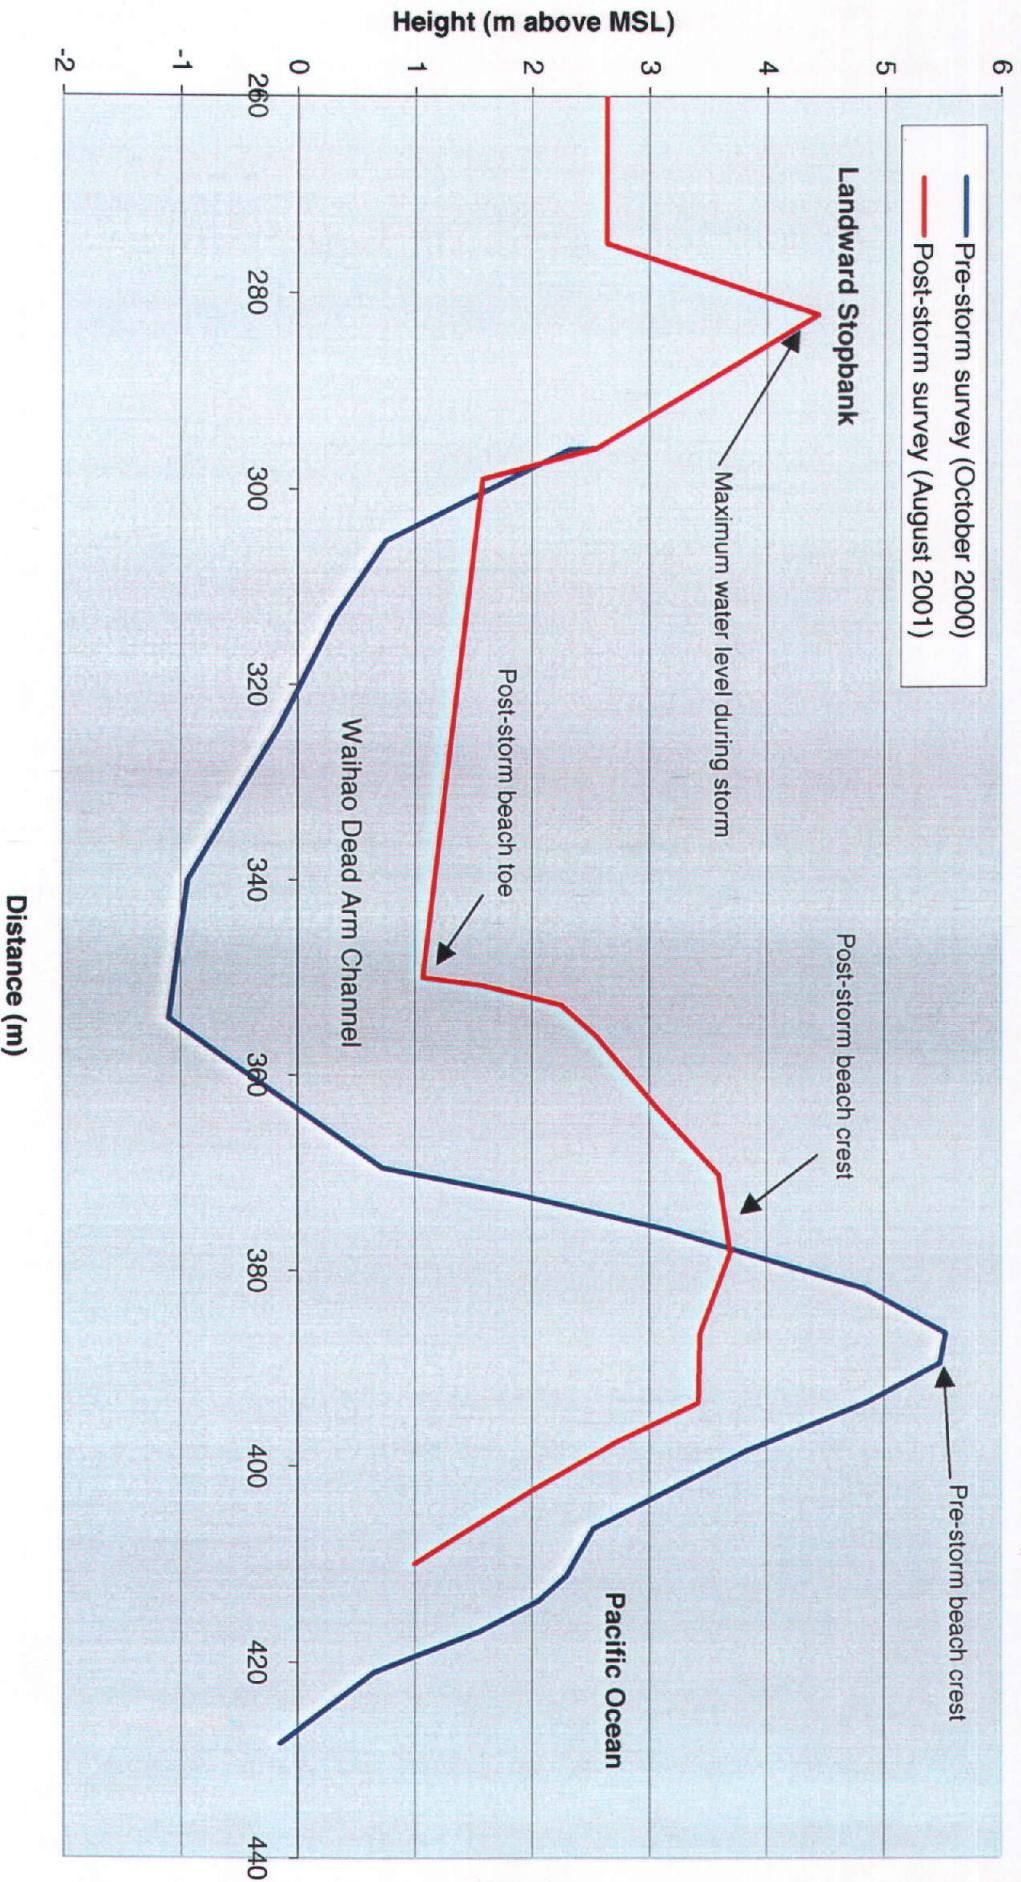
Beaches fronting the Waihao dead arm were also significantly affected by the storm. Figure 6.6 is cross section S5800 (see Appendix 2 and Table 6.2) adjacent to Lows Road and provides a good example of the changes to the beach along the dead arm. The beach crest was significantly lowered and sediment was pushed back into the dead arm, significantly reducing the capacity of the channel and in some places blocking the channel altogether. Figure 6.6 shows the landward toe of the beach has moved nearly 20 metres into the dead arm channel behind the barrier as a result of overtopping. A debris line only centimetres from the top of the stopbank (RL 4.4 metres above MSL) landward of the dead arm indicates the height to which flood waters reached during the storm (Figure 6.7). Flooding may well have been worse in this area if the water levels had exceeded the capacity of this stopbank.

**Figure 6.6: Cross Section S5800, Lows Road. Pre and post storm surveys**

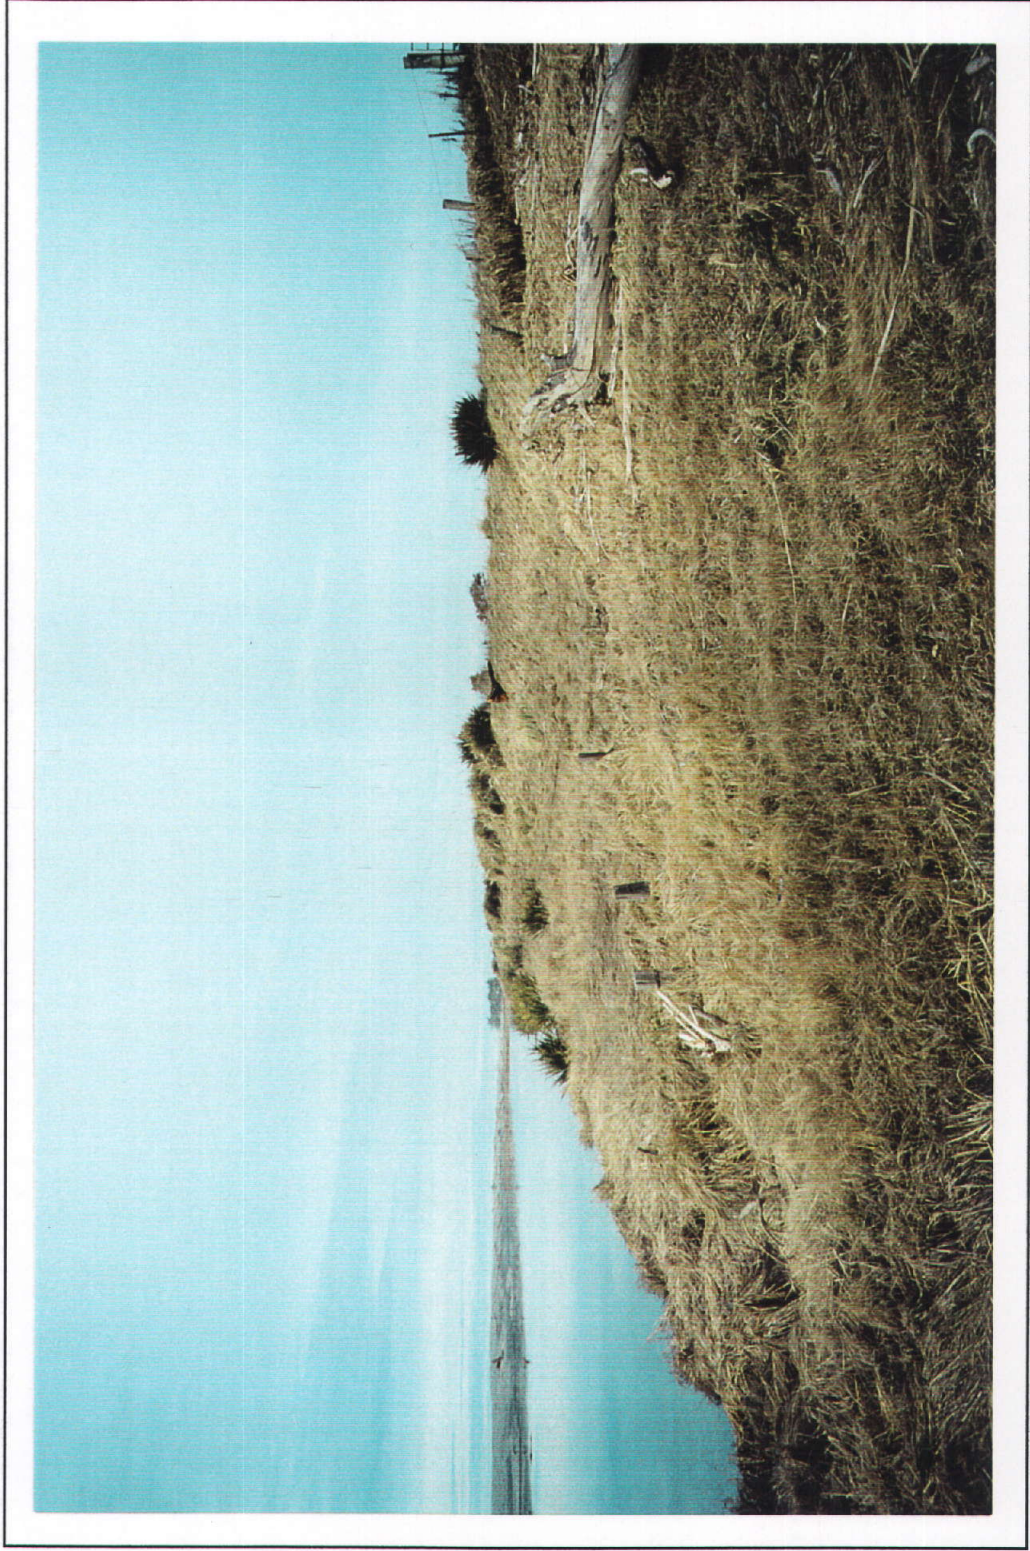
Figure 6.7 Debris line very close to the top of the stopbank along the Waihao Dead Arm.

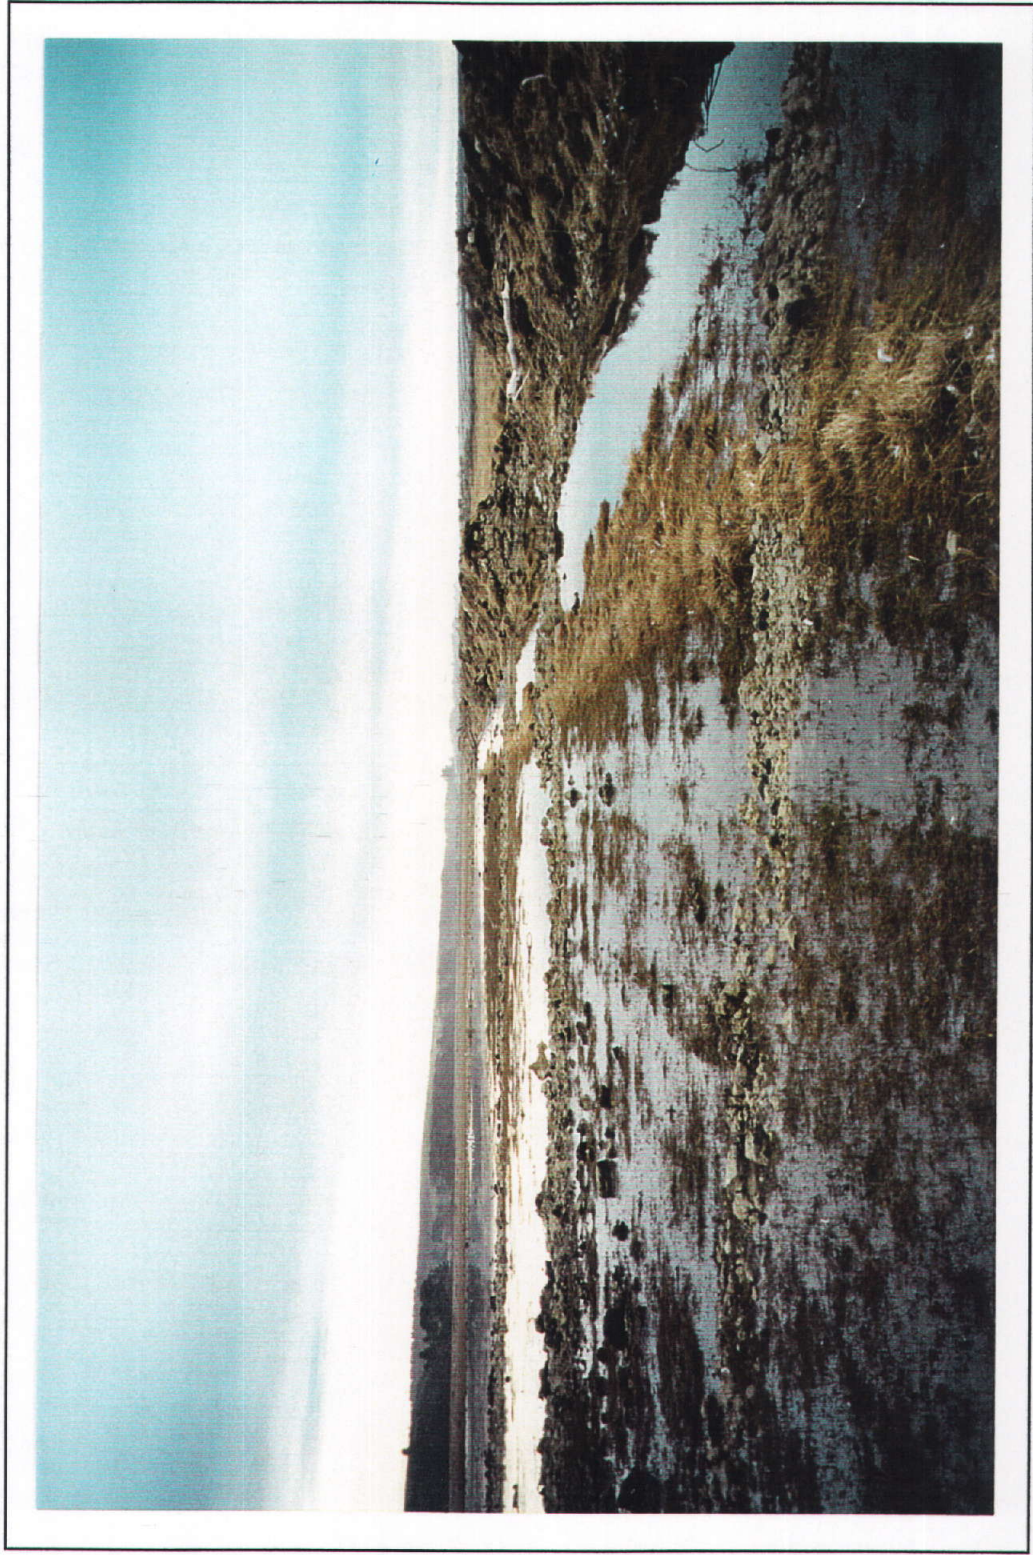
Figure 6.8 Significant damage to unconsolidated stopbanks south of Otaio River.

A series of small stopbanks built along drainage channels immediately south of the Otaio River (Figure 7.6) suffered significant damage during the storm event. These largely unconsolidated stopbanks were built primarily to assist with the control of drainage, however, waves overtopping the beach crest blew many holes in them and scattered the remnants throughout the adjoining paddocks as the land behind became flooded (Figure 6.8)

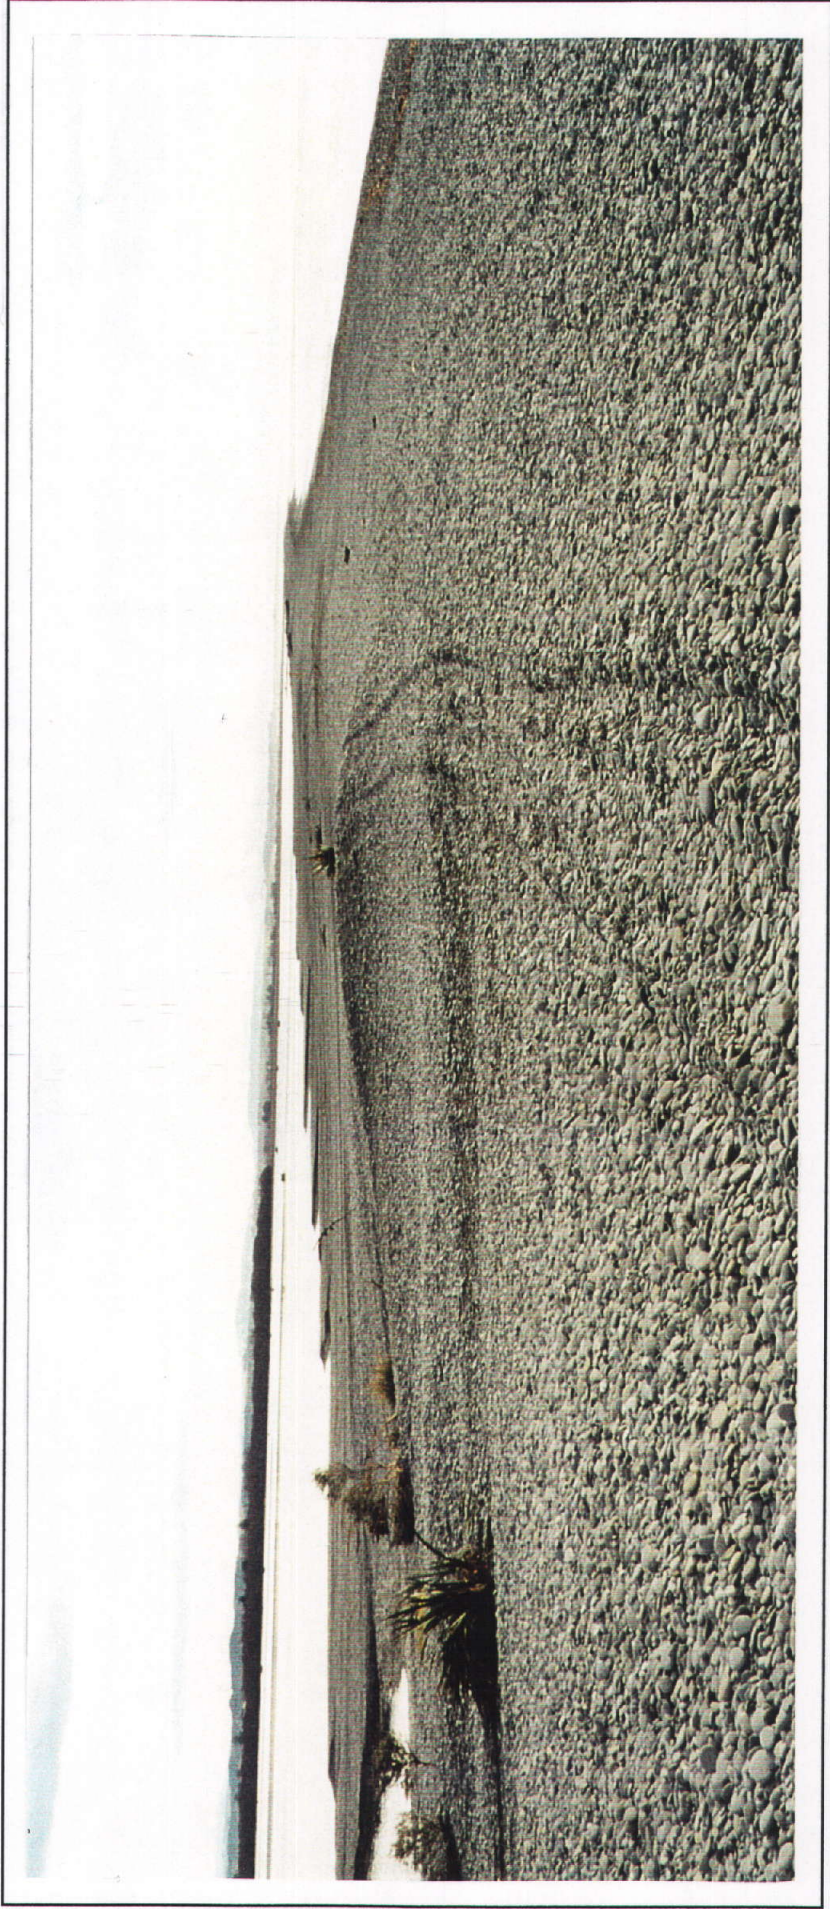
Figure 7.1 Significant beach lowering along the Wainono Barrier.

As discussed in Section 6.2 above, adjacent to the Wainono Lagoon the storm reduced the elevation of the barrier beach by an average of 1.0 metres from its original height, with a maximum height reduction of 1.90 metres. It is considered that the majority of the seawater that flooded the margins of the Lagoon came through this breach. Figure 7.1 shows the lowered part of the barrier after the storm. The following Figures 7.2 – 7.10 are the results of the mapping exercise discussed in Section 5. Below is a brief description of each of these figures:
