# Empirical modelling of run-up and overtopping at a boulder beach, Raglan, New Zealand

Tom D. Shand<sup>1</sup>, Richard A. Reinen-Hamill<sup>1</sup>, Roger D. Shand<sup>2</sup> and Wouter Viljoen<sup>3</sup>

<sup>1</sup>Tonkin & Taylor Ltd. Auckland, NZ. [tshand@tonkin.co.nz](mailto:tshand@tonkin.co.nz), [rreinenhamill@tonkin.co.nz](mailto:rreinenhamill@tonkin.co.nz)

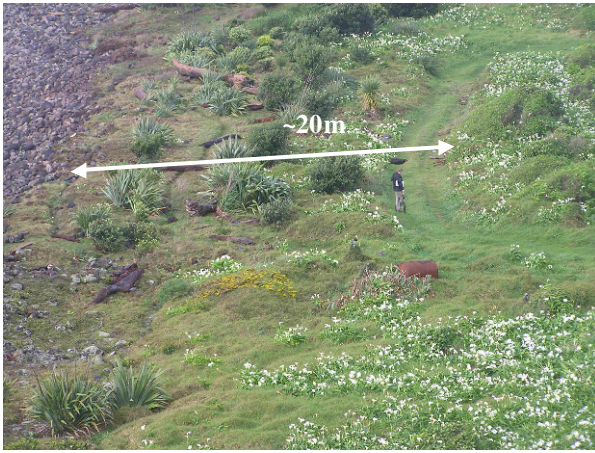
Figure 6 Distance from crest to over-wash debris from the September 2005 storm event. Photo: Eco Nomos Ltd

Observation showed that some overtopping of the boulder bank crest occurred (refer Figure 6). However, there was a general lack of damage to vegetation beyond the crest, and minimal die-back subsequently occurred; both of which suggest that only a few waves actually overtopped the crest.

These values agree reasonably with the observed distance that material was transported by overtopping

during the storm event as described by Eco Nomos, 2005 (refer Figure 6).
