Geomorphological Baseline Assessment in the vicinity of the Whanganui Rivermouth

A report prepared as part of the Wanganui District Council's
Lower Whanganui River Management Strategy

Client Report 2016-06 CRep_Prif_Geom Assess

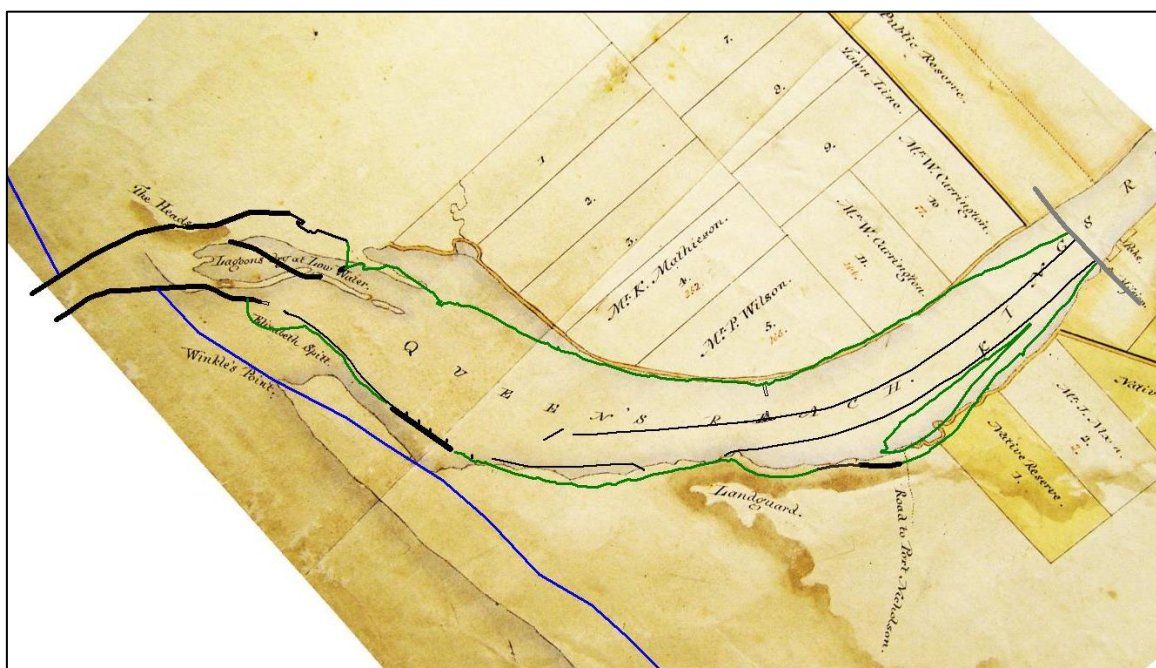
Figure 1 The NZ Company 1842 Land Settlement Plan is the earliest detailed map of the lower Wanganui River including South Spit and coastline. Marked are: the Cobham Bridge in grey, the 2013 riverbanks in green, the 2015 structures in black, and the 2013 coastline in blue.

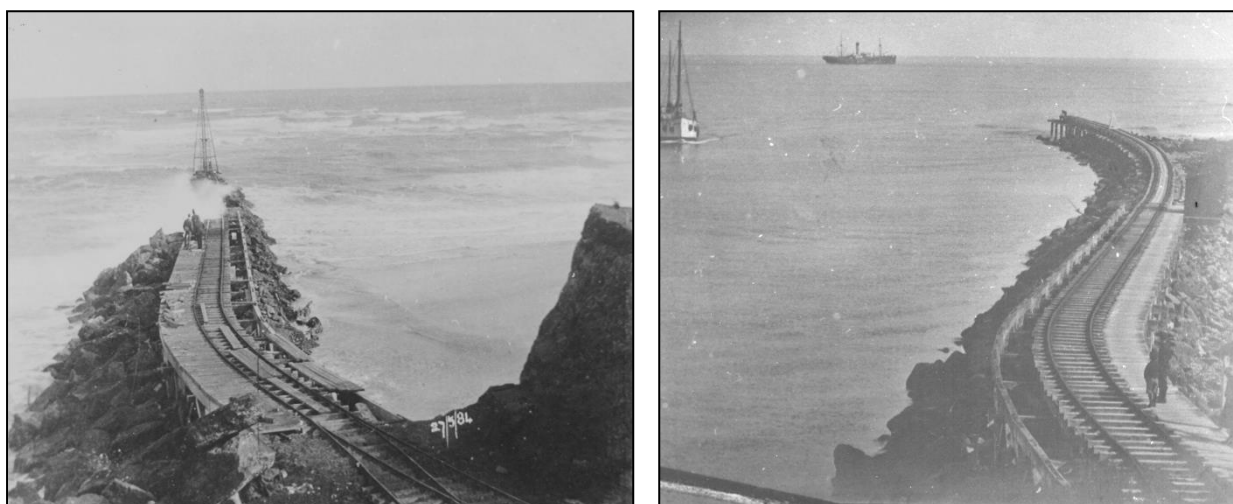
Figure 4 Construction of the original North Mole underway in 1884 on left, and the final structure curving into the prevailing wave direction several years later on the right. Note the beach accretion against the northern (right hand) side of the mole.

The final Stage 1 work was construction of a North Mole in 1884-85. This mole was raised to spring high tide level and was designed to turn the ebb flow into the direction of predominant wave approach (to assist navigation), and to concentrate the flow to ensure maximum scour on the bar located some 500 m out from the heads. However, the original plan was for a 900 m long structure that tapered in height down to low tide level and would terminate at a depth of 4.25 m below low water. The eventual structure was 260 m long (Figure 4) and while reducing lateral migration of the channel, would have had only limited effect on bar scour. The Stage 1 works remained largely unaltered until the onset of Stage 2 in 1908 with investigations beginning in 1894.

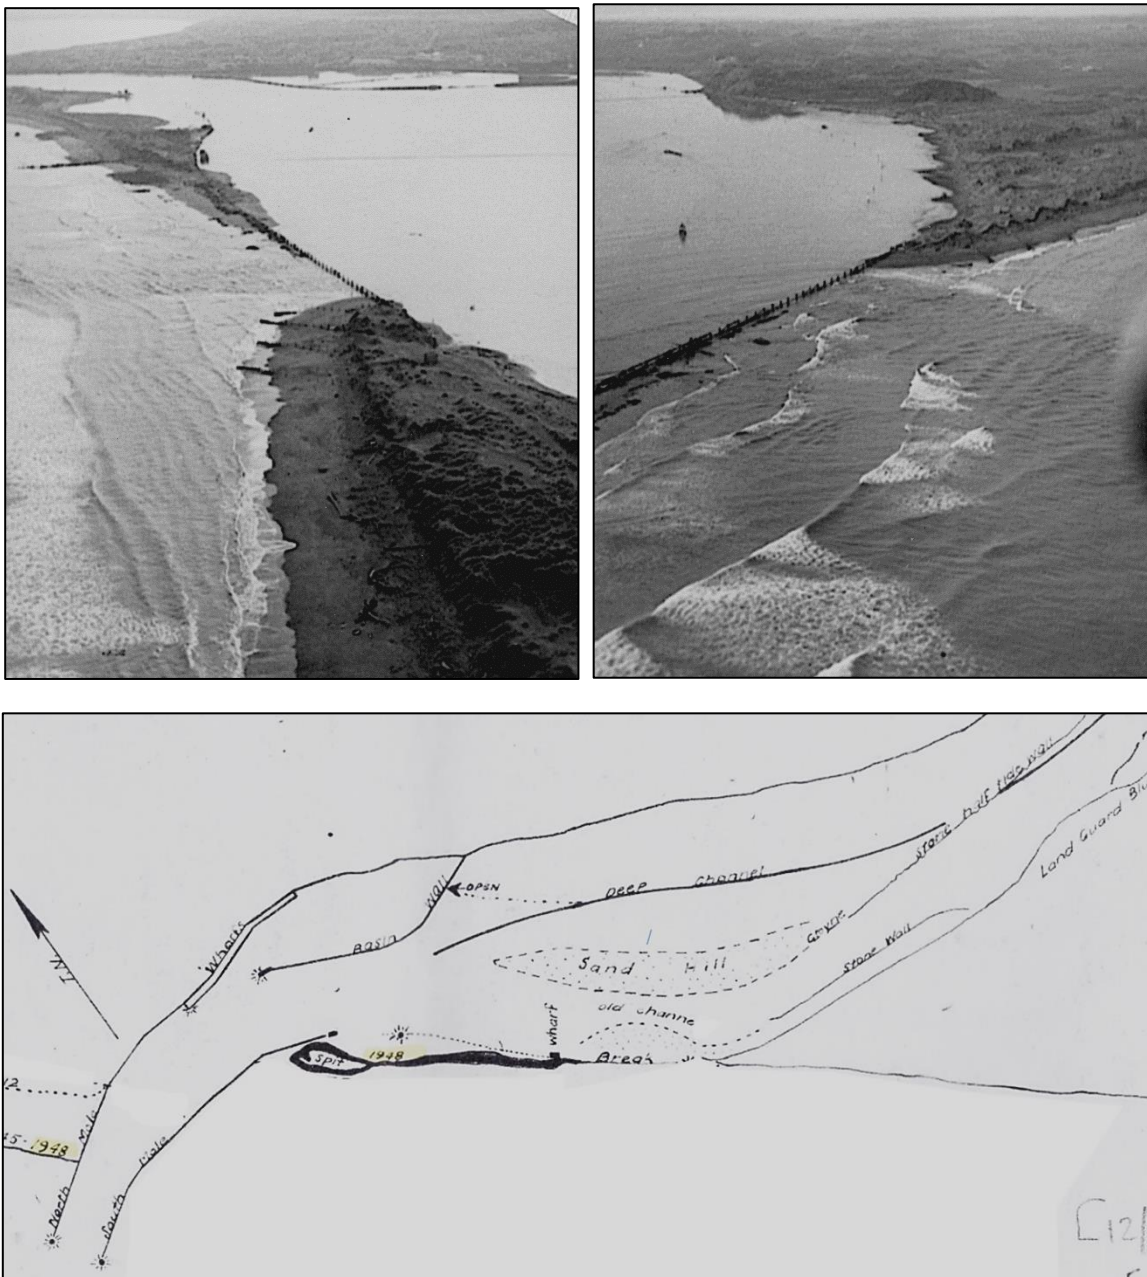
Figure 9 South Spit Breach on 5-7-1947 (upper photos) taken at high/ebbing tide and as sketched by Harbour Board staff in 1948 (lower) with surrounding morphological features referred to in the text having been marked.

By the end of 1946 the situation had worsened and the Public Works Department (PWD) offered assistance. Renewed breaching occurred in July 1947 (Figure 9 shows aerial views at high tide) with overwash sand creating a delta which crossed the navigation lead line in the Main Channel. It is noted that the late 1940s was a period of relentless storms and high seas, likely an El Nino event. In January 1948, the PWD had taken over work closing the breach by constructing a continuous wall using 3 to 5 ton blocks of concrete. By May 1948 the navigation channel had reduced to “gutter” and a large dome-shaped shoal (described by the Harbour Master as an “island”, and by the Supervisor as a “sand hill”) had formed opposite the breach. River flow was carrying littoral overwash sand as far as the Basin. Shipping to town was now via a new landward channel (the Balgownie or North Channel) around the landward side of the “island” which is henceforth referred to as the *Dome Shoal or Dome*.

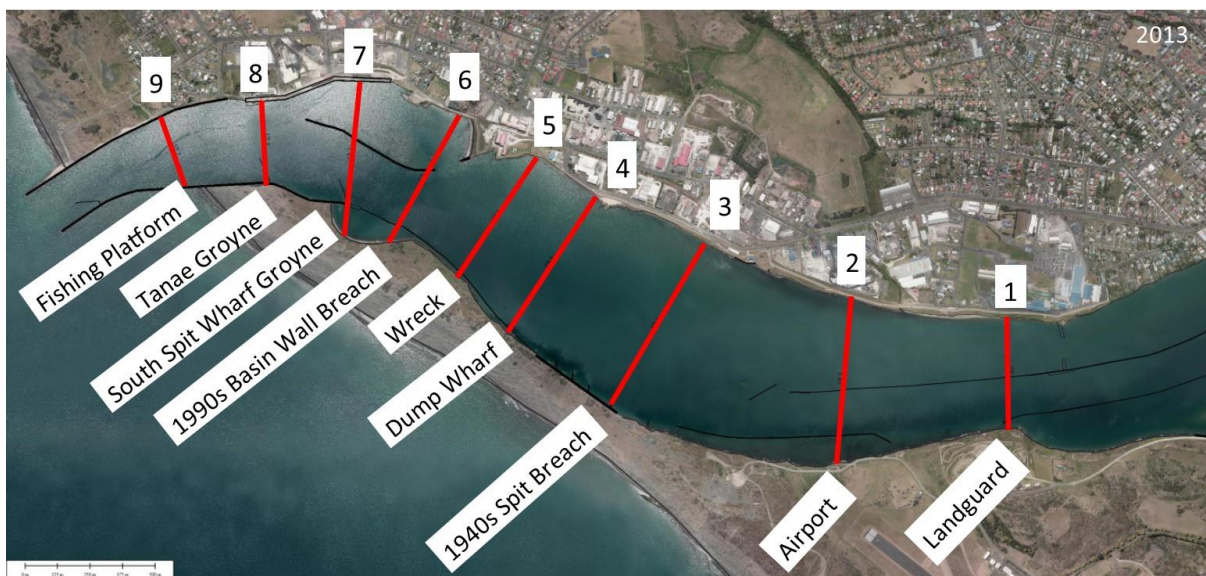
Figure 15 Section locations (red lines), numbers and names superimposed upon a 2013 aerial photograph. Black lines locate river control structures.

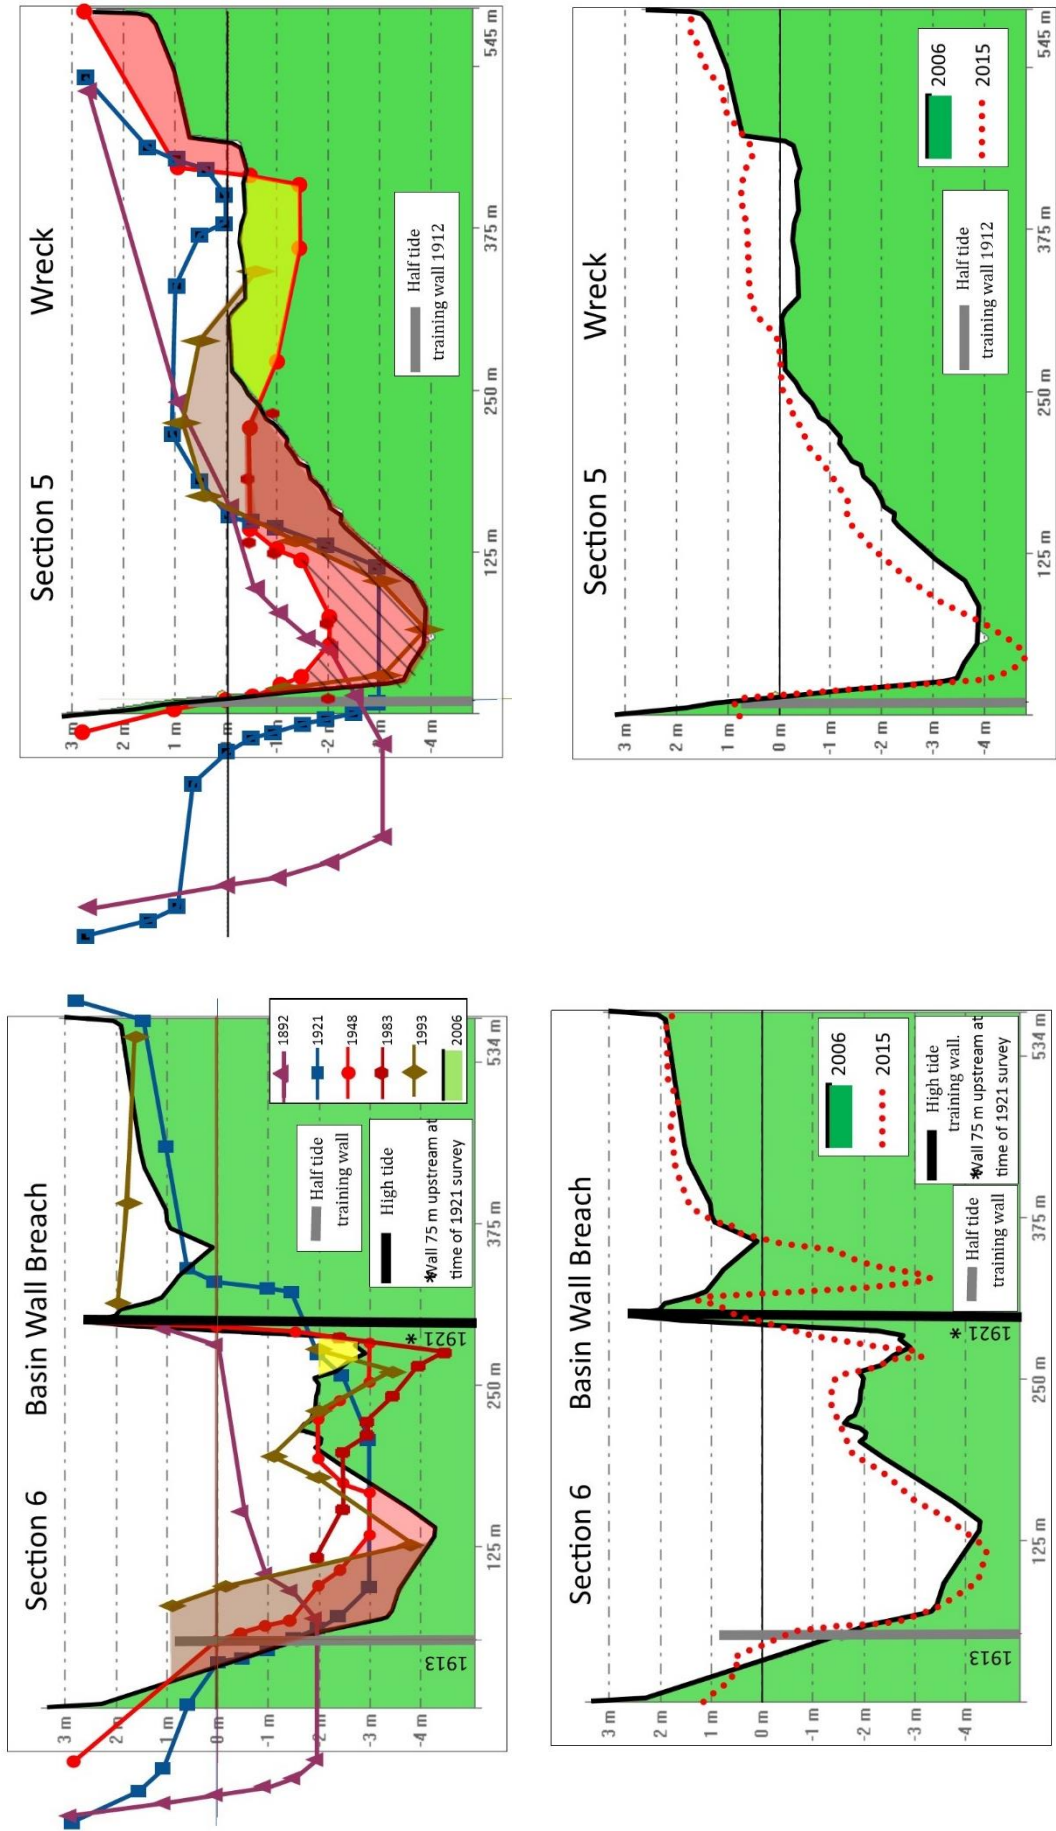
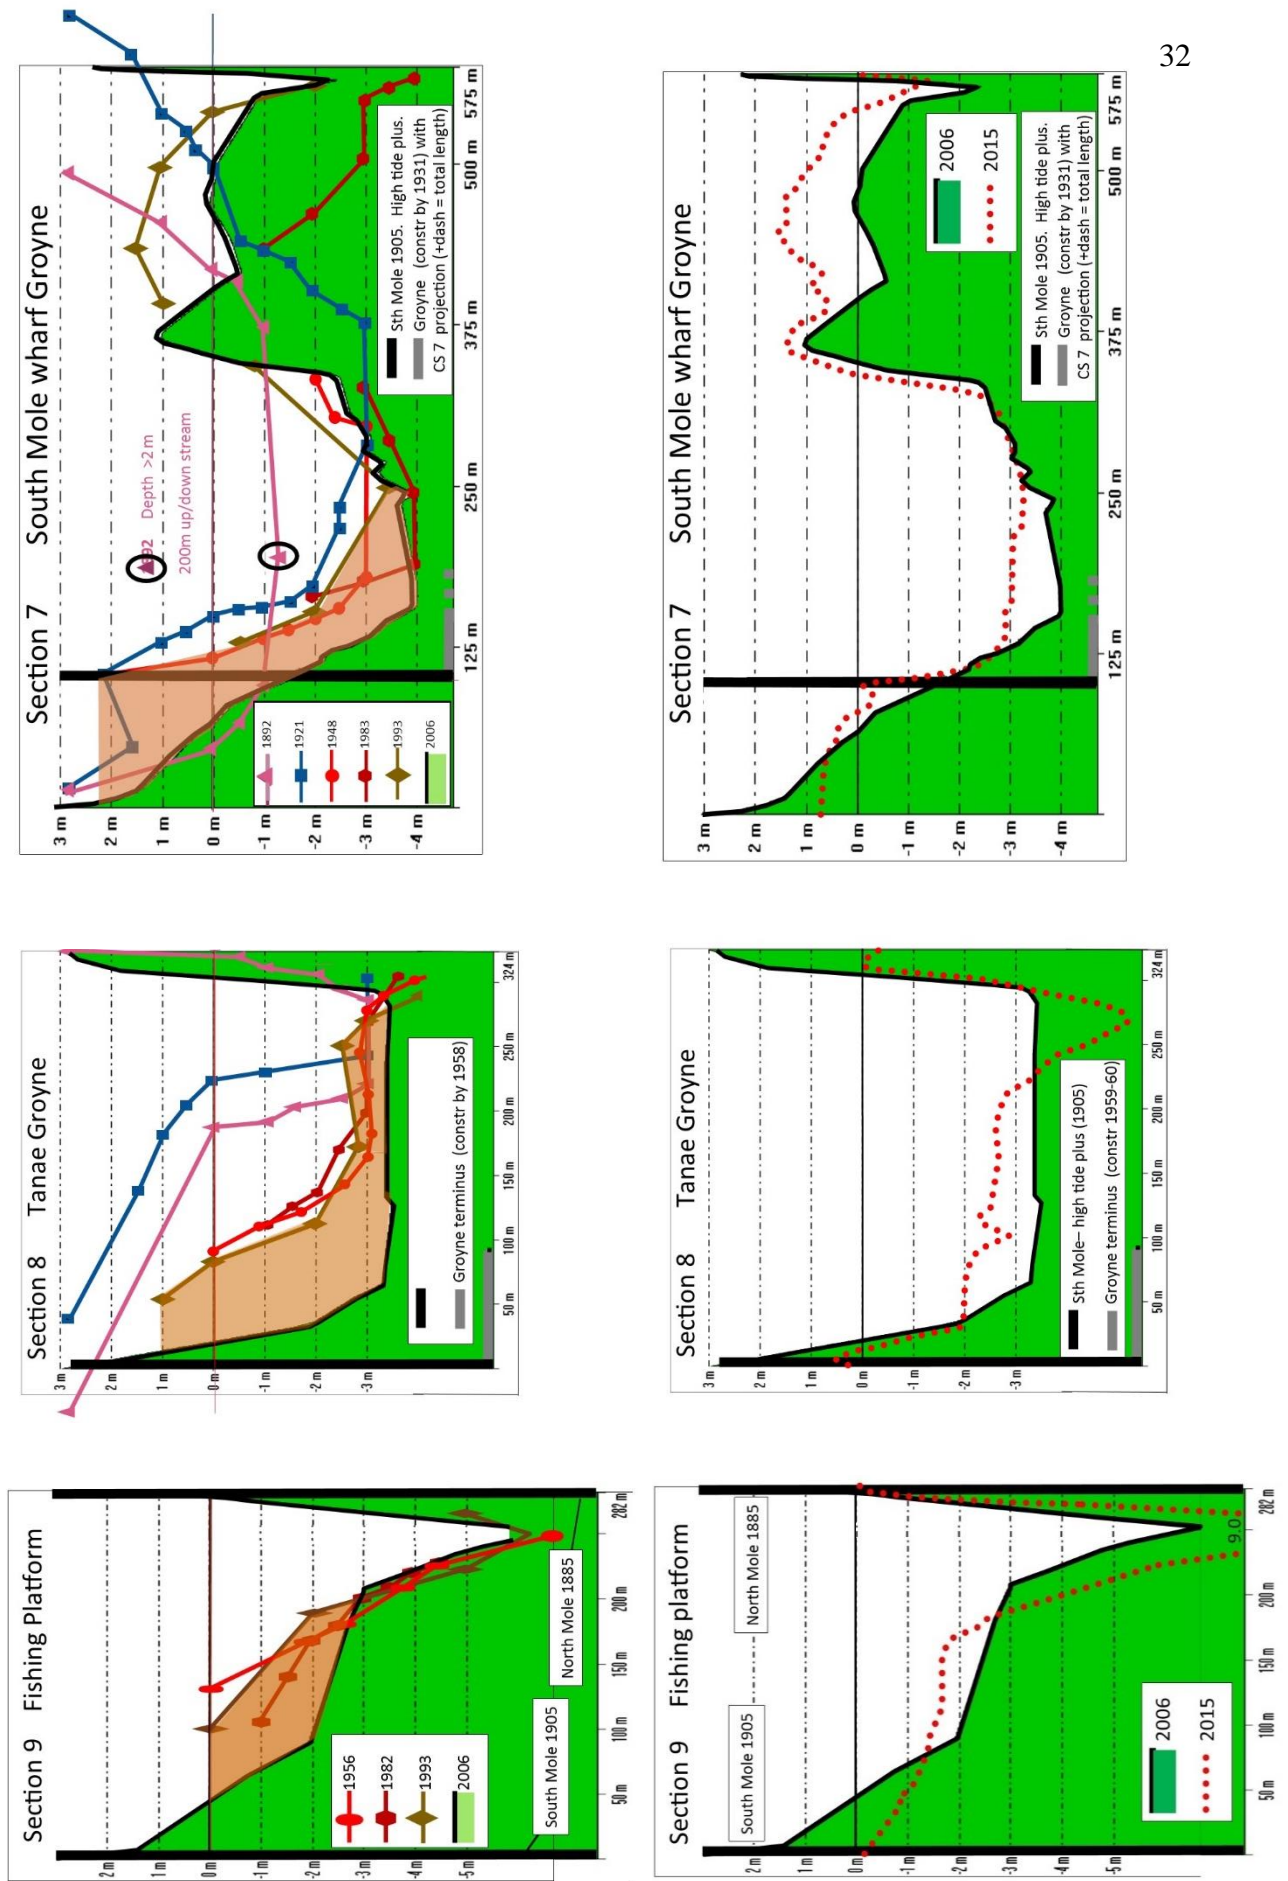
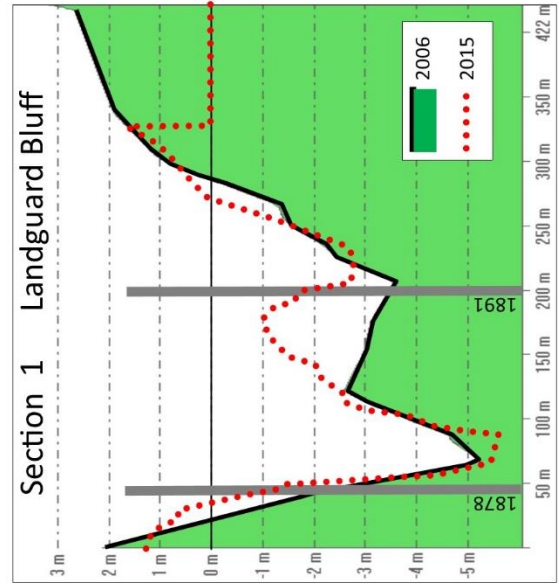
Figure 16 Section graphs superimposed upon the 2006 bathymetry on left, and 2015 bathymetry superimposed upon 2006 on right. Note constant scales in all graphs enable direct comparisons.

At the time of the initial analysis, only the 2006 bathymetry was available digitally as x,y,z data points, the remainder being contour maps which were found to be too spatially inaccurate for direct digitization. The alternative was to locate transects or cross-sections (referred to hereafter as *sections*, which best represented the available data coverage and the apparent range in morphology (form). Each bathymetric sample was georeferenced at each section thereby deriving acceptable spatial accuracy (+/- 2.5 m). The location of the 9 sections are depicted in Figure 15, and the profiles at each section have been superimposed upon the corresponding 2006 profile in Figure 16.

The 1948 profile in Figure 16 shows a substantial shoal has replaced the well-defined channel depicted by the 1921 profile, with shallower channels occurring on each side of the shoal, and the North Channel being substantially larger than the southern channel (referred to as the Main Channel). The shoal appears to be a continuance of the large dome-shaped sand-bar which formed opposite the South Spit Breach (clearly defined in Section 3 profiles). This feature was referred to as an “Island” in Harbour Board records and is referred to as the Dome Shoal or just the Dome in this report. The 2006 profile shows a return to pre-breach (1921) form (1948 to 2006 change is shaded red), but the double channel is still discernible with the northern (right) side being the larger.

The 2015 profile (Figure 16) is dominated by significant accumulation of sediment between the training walls with depths below Chart Datum having more than halved (to about 1 m) since 2006. Bedforms between the southern half-tide training wall and riverbank do not indicate a dominant transport direction. The main channel now clearly lies on the landward side of the northern training wall with minor erosion (<0.5 m) across the adjacent Northern (or Balgownie) Bank (or Flat). Flow concentration into the centre of the river and across the Balgownie Bank appears to be driven by upstream accumulation processes described above in Section 1 as well as outgoing flow deflection of Landguard Bluff coupled with likely ongoing subsidence of the northern training wall following its artificial lowering in the late 1940s. Bedforms across the Balgownie Bank are indicative of net downstream sediment transport.

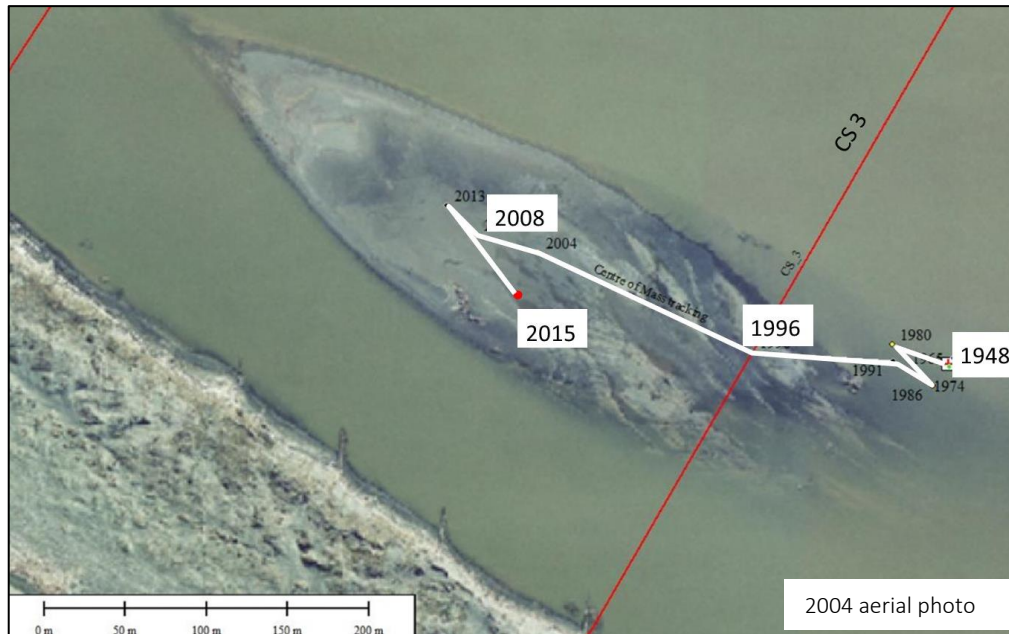
Figure 18 Migration tracking of the Dome-Shoal based on aerial photo centres of mass between 1948 and 2015 superimposed upon the 2004 aerial photograph

The Dome's most recent upstream-directed centre of mass relocation appears to reflect change in the wider sediment transport regime (rather than depicting a change in net sediment transport direction), and while this change may be ongoing/systematic, it may alternatively have been triggered by the June 2015 flood. It is noted that while the flood caused significant flooding upstream of the Cobbam Bridge, it was relatively insignificant in the Estuary due to coastal control parameter values, e.g. neap tide range. However, sustained moderate events are capable of driving significant morphological change in coastal settings.

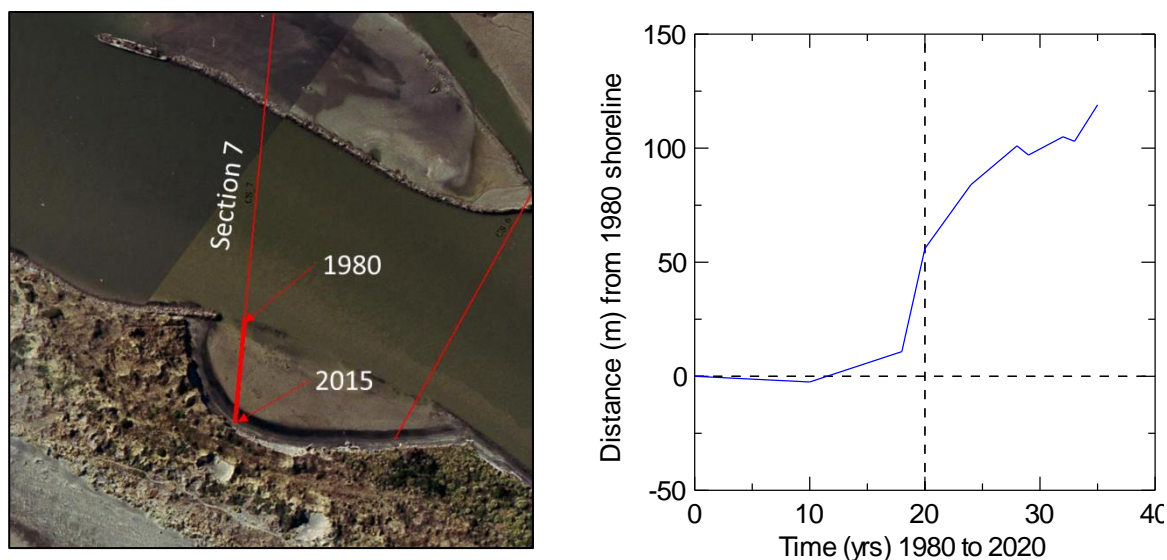
Figure 20 South Mole Embayment on Transect 7 (left), and shoreline graph for the HWM as defined on aerial and satellite image between 1980 and 2015 (right).

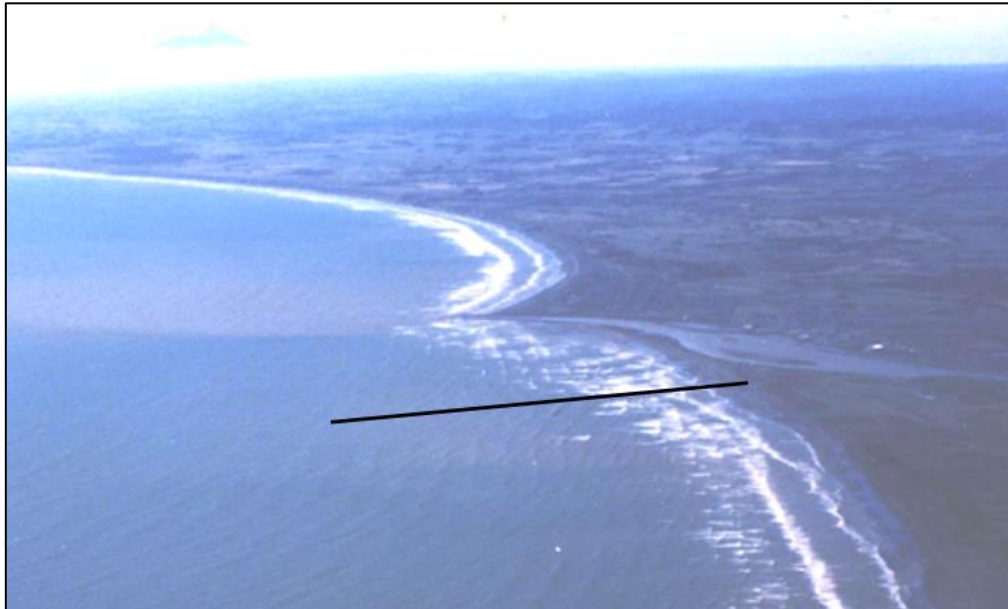
Figure 24 Wanganui coast (1993) with marine outfall (approximately) located. Linear bars and troughs (2D morphology) are evident on the far side of the rivermouth (Castlecliff coast). Two-dimensionality is also evident in bottom of photo (beyond 4 km from rivermouth), with transverse (three-dimensional) morphology from the rivermouth to beyond the marine outfall.

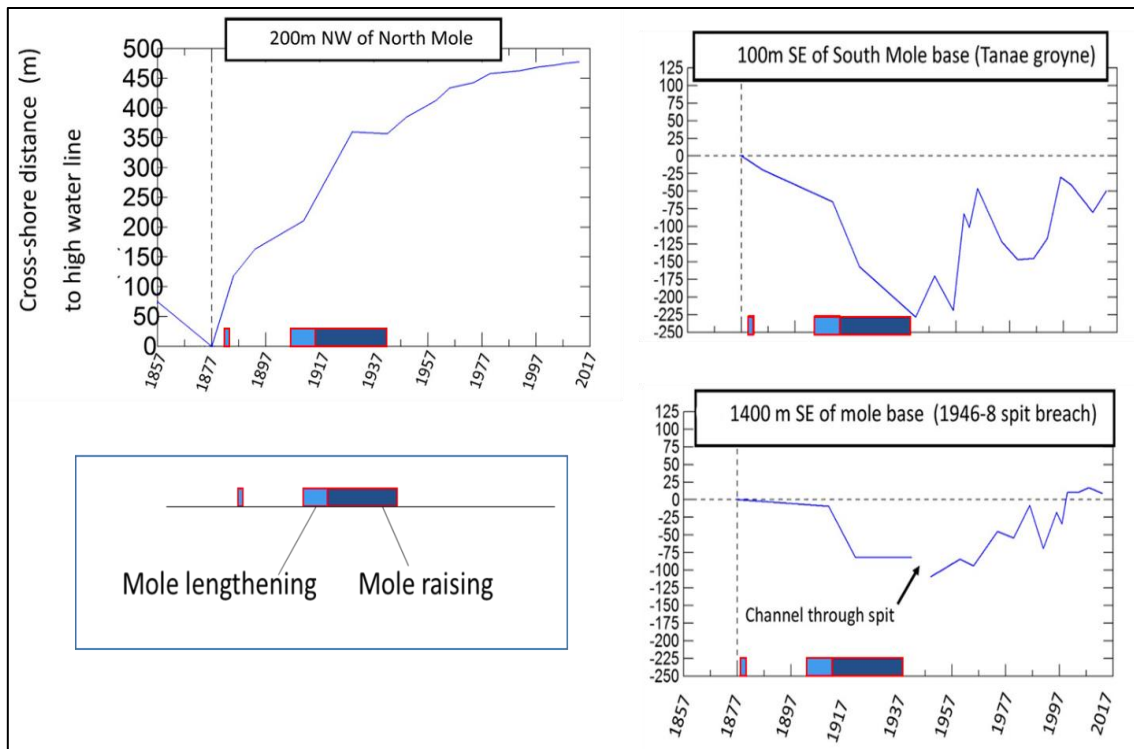
Figure 27 Coastal shoreline behavior from 1877 to the present for three coastal sites. North Mole development is marked along the baseline of each graph. Note the graphs for the South Spit sites have the same vertical axis scale so are directly comparable.

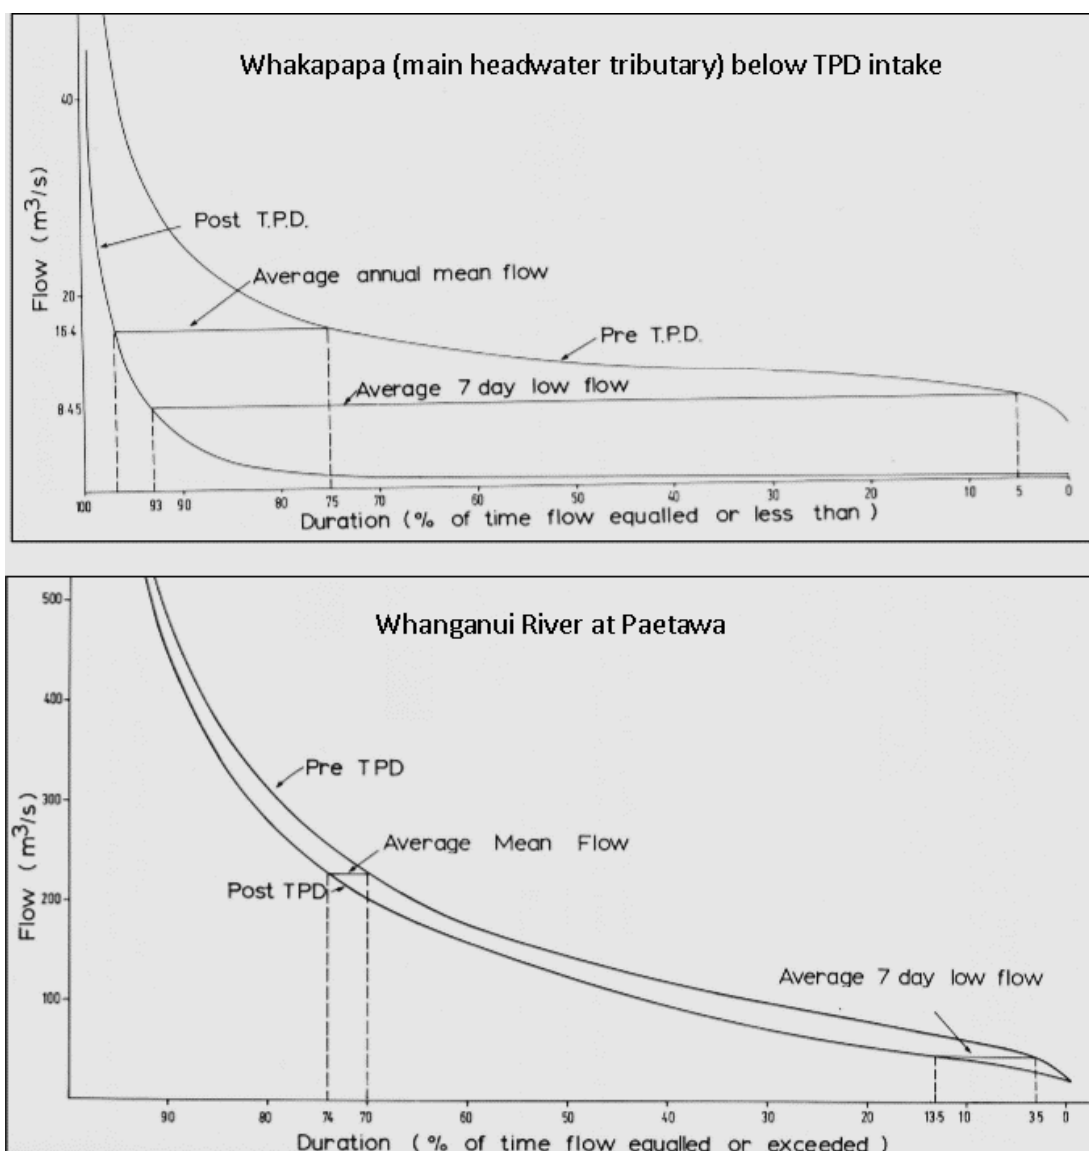
Figure 34 Flow duration curves for Whakapapa, the main mountain tributary, are shown in the upper graph, and for Paetawa above the tidal reach in the lower graph. Pre and post TPD curves are superimposed with parameter differences marked by horizontal lines.

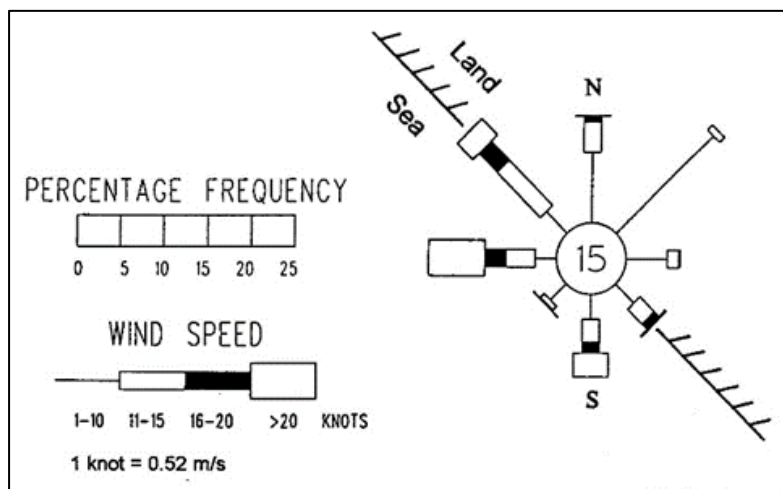
Figure 36 Wind rose for Wanganui Airport data 1.1.90 to 1.7.95
Source: NIWA

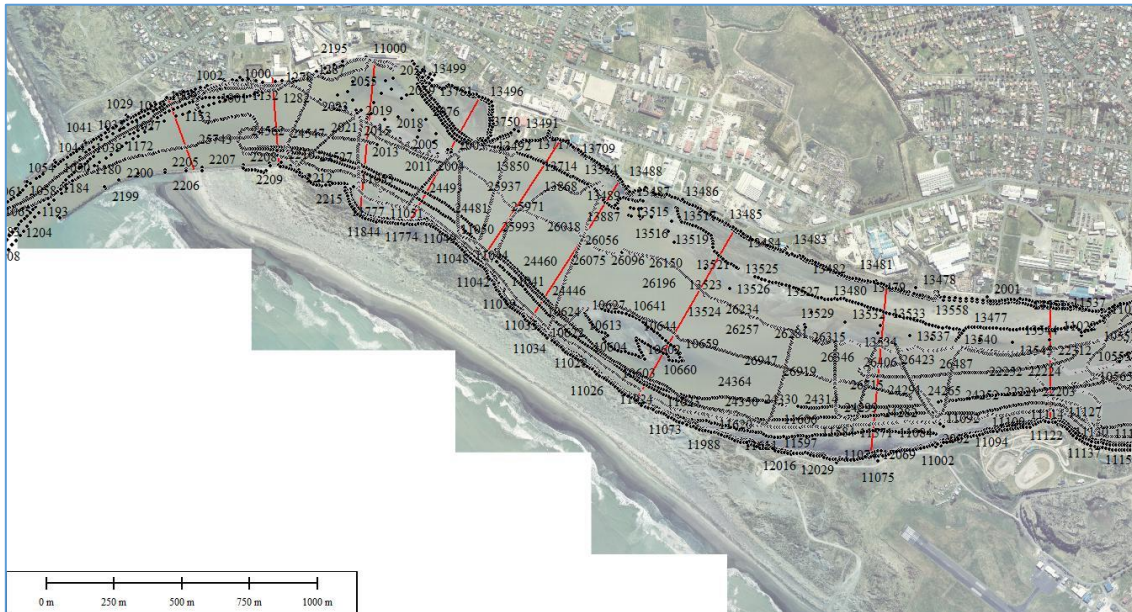
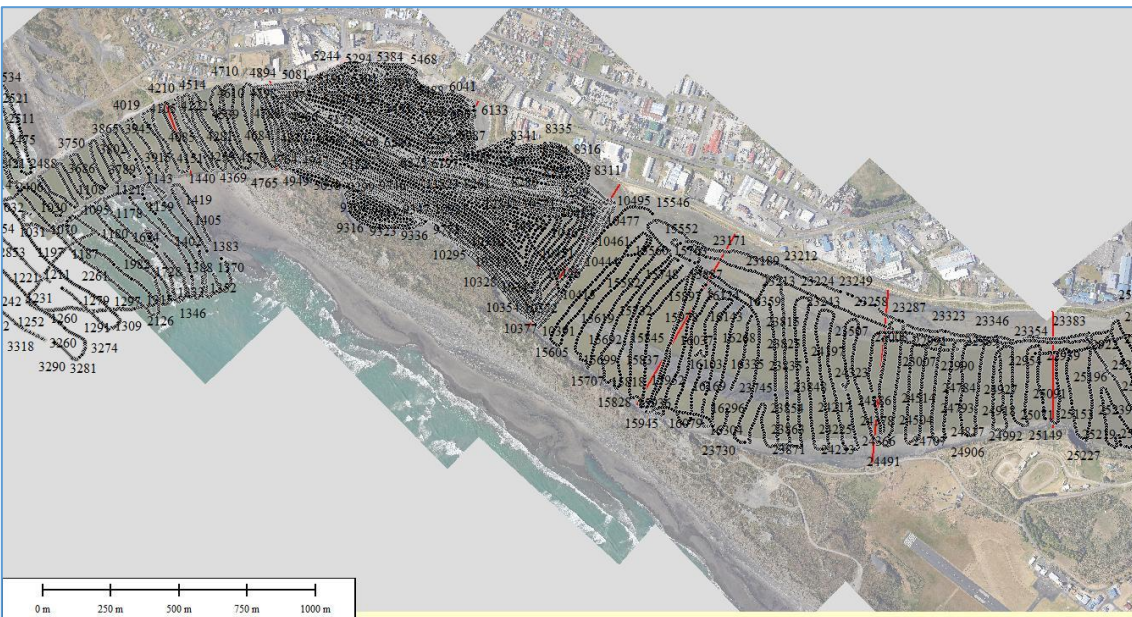
APPENDIX E Sampling points for the 2006 and 2015 bathymetric surveys
 Superimposed upon 2004 aerial photos (upper) and 2015 lower.
