Proposed Golf Links:

Muhunoa Road West, Ohau:

Coastal Processes and Vegetation –  
Opportunities & Constraints

# 709 Muhunoa Road West: Coastal Processes and Vegetation

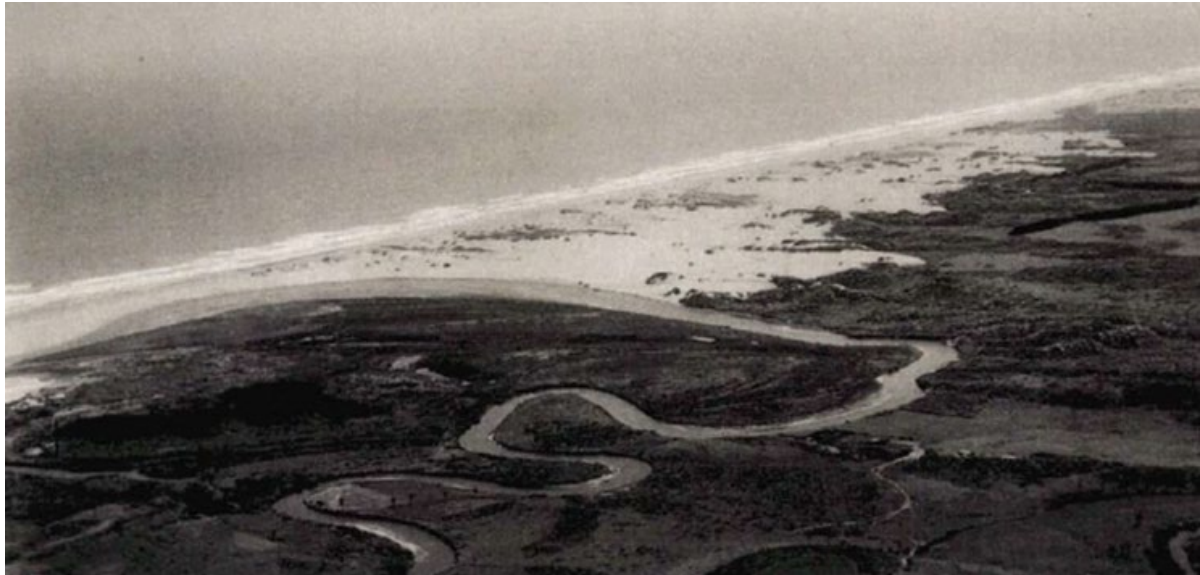
Figure 3: Aerial view of the site taken somewhere between 1942 and 1948. (Source: Figure 4.17 of Smith, 2007).

Available aerial photography for the property indicates widespread dune destabilisation in the 1940's, the site characterised by extensive areas of migrating sands with only pockets of vegetation (Figure 3). Over following decades, the more seaward dune areas gradually became more vegetated (Figure 4). However, the transgressive dunes (migrating sand sheets) persisted until at least the early 1980's (Figure 4). These areas were later stabilised and established in pines, probably involving marram planting (to stabilise the dunes), planting of wind and salt protection (in this case macrocarpa), and the use of exotic nitrogen fixers (e.g. yellow tree lupin) followed pine planting. The pines were removed and replaced by pasture circa 2013-14.

As noted in Section 2, the property was largely characterised by severe wind erosion and migrating dunes/sand sheets in the 1940's (Figure 3). This advancing coast has been characterised by intermittent periods of natural transgressive dunes over the Holocene, with intervening periods of stabilisation and vegetation (see Section 2.2 above). However, it appears likely that the destabilisation evident in the 1940's was largely human-induced; associated with over-stocking and burning of previously stabilised dunes, which caused widespread issues with migrating sands along this coast (McKelvey, 1999). In particular, this is suggested by the natural re-vegetation and stabilisation of the coastal margin in the following decades; even though transgressive dunes remained active further inland (Figure 4) until stabilised by exotic forest.

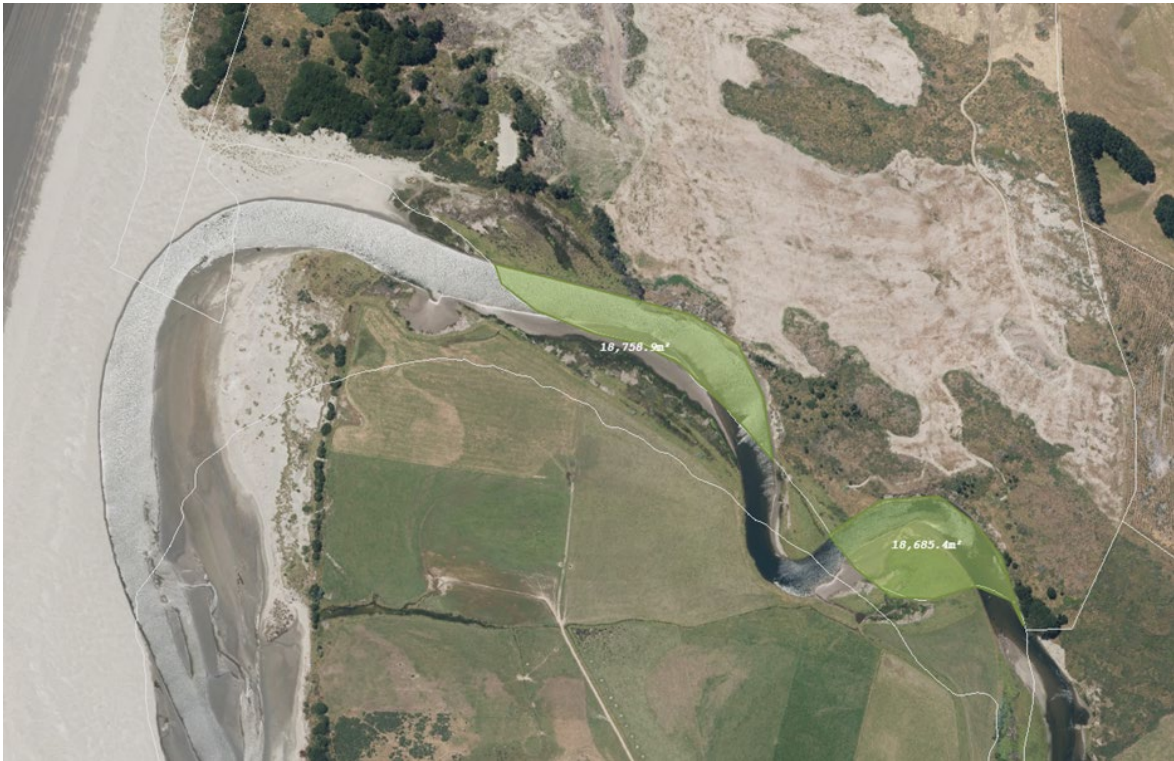
Figure 5: View of river margin of property showing (light green shading) the location and approximate area of bank erosion since 1975.

In recent decades, the erosion appears to be continuing, with the highest erosion (as expected) near the apex of meander bends. For instance, in the period since 1975 (when the current property boundaries were surveyed), there has been moderate erosion on the outside of the two river bends adjacent to the property (Figure 5); with average erosion of about 80m (over 235m length) on the upstream bend and about 50m (over 375m length) over the length of the downstream bend.

This indicates, average erosion in the order of 2m/yr (approximately) on the outside of the upstream bend, and about 1.1-1.2 m/yr along the outside bank of the downstream bend; when averaged over long periods of time. However, it is important to appreciate that river erosion is episodic, occurring primarily during river floods. Accordingly, the erosion is likely to be very irregularly distributed in time; with potential for significant bank erosion (possibly 5-10m) in major floods, interspersed with long intervals in which there is little erosion. Similarly, the erosion will not be regularly distributed spatially, tending to be most serious near the apex of the meander bend and areas just downstream.

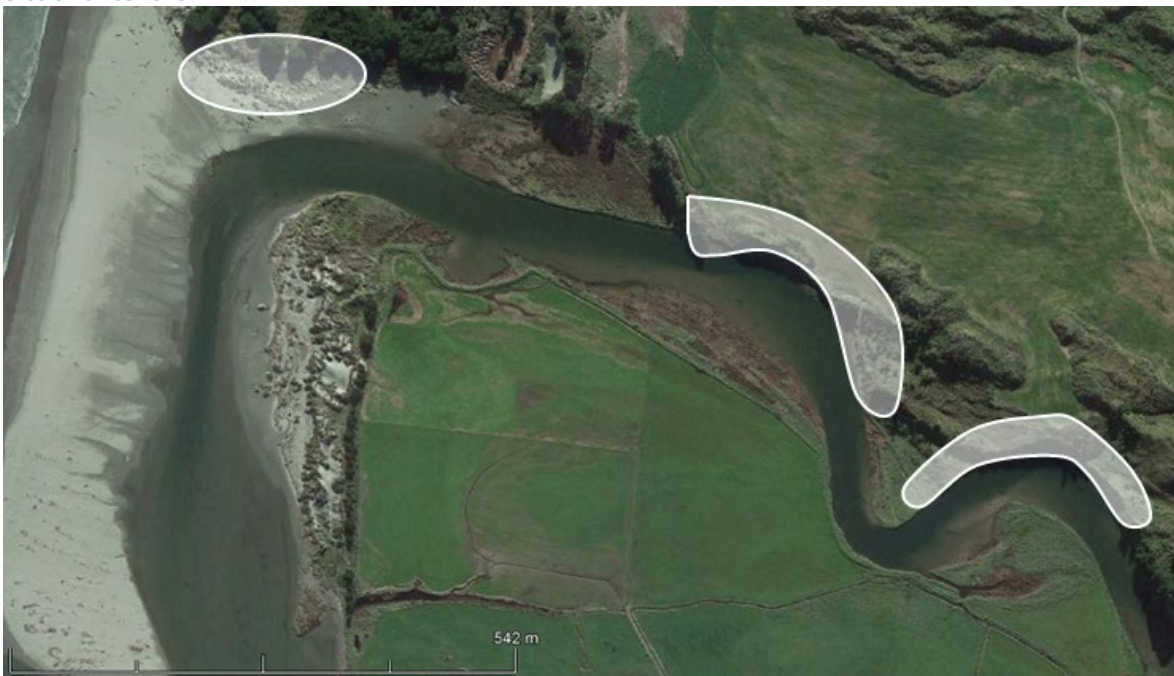
Figure 6: Diagram showing (approximately) the areas assessed as most likely to be affected by river erosion with present river morphology

The areas assessed as being most likely to be affected by river bank erosion on the basis of existing channel morphology are shown approximately in Figure 6.

Obviously, any parts of the Links course (fairways, tees etc.) located close to the river margin (particularly the areas shown in Figure 6), may periodically need to be moved due to erosion. However, given the relatively simple nature of such action, this does not preclude location of parts of the course in these areas.

However, while such longshore migration primarily affects areas to the south, there is potential for the river to break out more directly during major floods, which might potentially affect near entrance areas of the property (Figure 6). The river has broken directly seaward in the past,

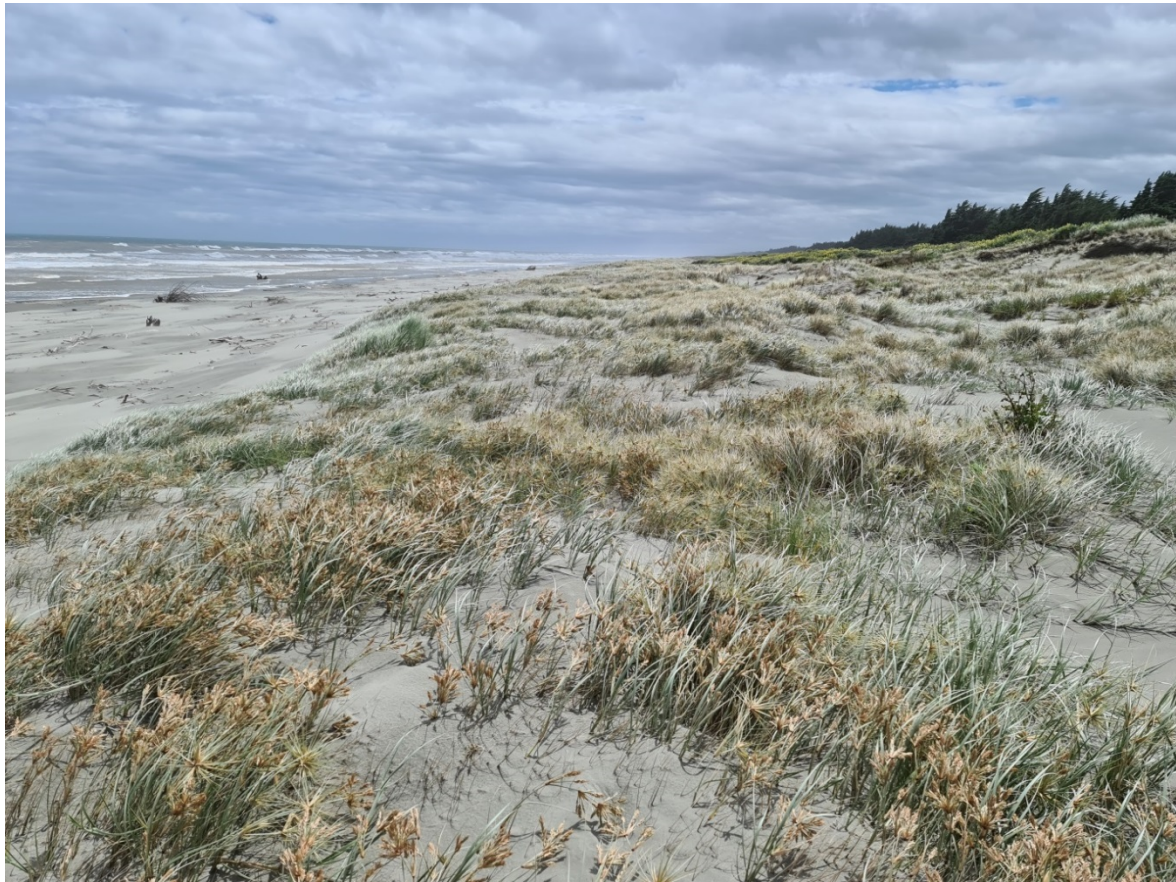
Figure 8: View of spinifex-dominated zone at seaward edge of dunes

In the more seaward areas (typically varying in width from 12-20m), the vegetation on this frontal dune is dominated by vigorous spinifex (*Spinifex sericeus*) (Figure 8). This is a critically important zone on this coast, as disruption of this vegetation can lead to serious wind erosion and migrating sand issues over time. Notably, only very limited areas of pingao (*Ficinia spiralis*) occur in this area, though it was very likely a significant (possibly up to 10-20%) component of the spinifex zone prior to human settlement. The present absence likely reflects historic degradation by human activities, including grazing by stock and introduced animal pests (pingao is very palatable species). There are also isolated patches of the exotic marram grass (*Ammophila arenaria*), which is widespread on the Manawatu coast from earlier dune stabilisation work. Any restoration of this area should focus on spraying out the remnant areas of marram and expanding the pingao component (ideally to at least 10% of the dune cover on the most seaward 10-15m of the dune). It is also important to manage any beach access to prevent damage to this vegetation which is very vulnerable to trampling and vehicle damage.

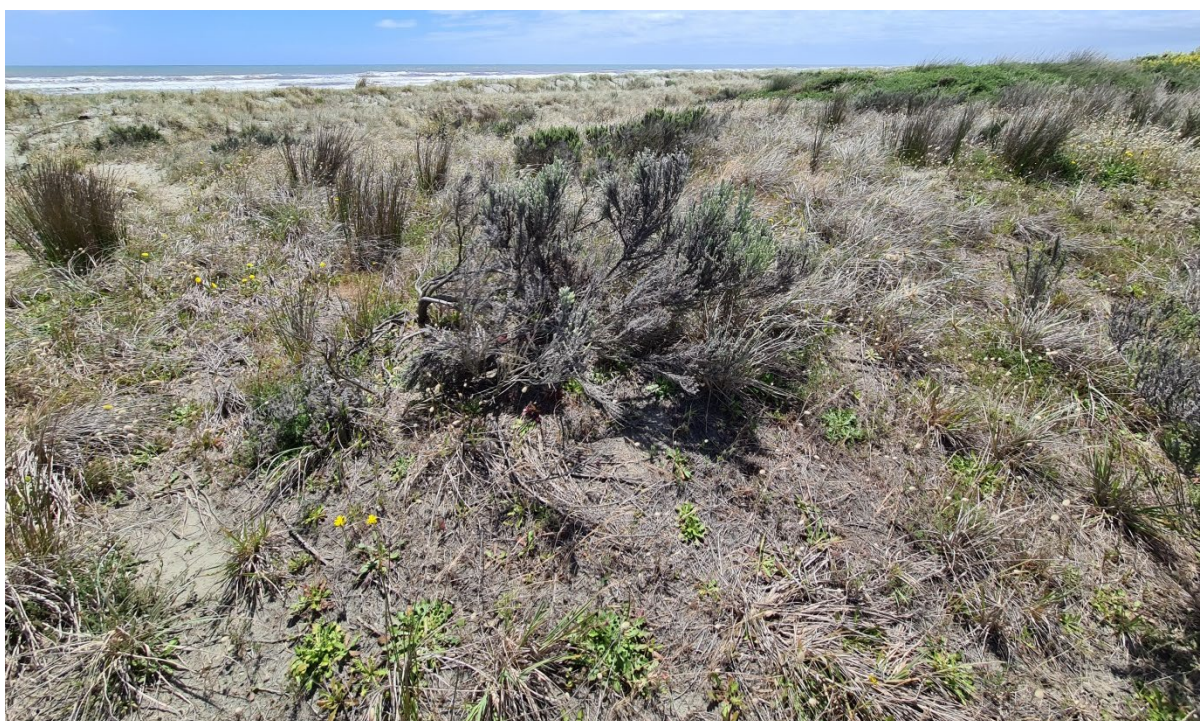
**Figure 9: View of more landward areas of the spinifex zone, where spinifex is less vigorous and gradually being replaced by other species.**

With increasing distance landward, the spinifex generally becomes less vigorous (except in areas subject to disturbance) and there is increased native diversity, reflecting early successional

replacement of the spinifex (a pioneer stabiliser) (Figure 9). While spinifex often remains the dominant cover in this area (which commonly extends up to 30m inland from the seaward toe of

dune), it is markedly less vigorous than in the more seaward areas. Other native dune species occurring in this area are most commonly tauhinu (*Ozothamnus leptophyllus*) and knobby clubrush (*Ficinia nodosa*), though both species are typically sparse. Patches of sand daphne (*Pimelea villosa*) also occur in this area, an “At Risk – Declining’ species. In a previous inspection of this area in 2010,

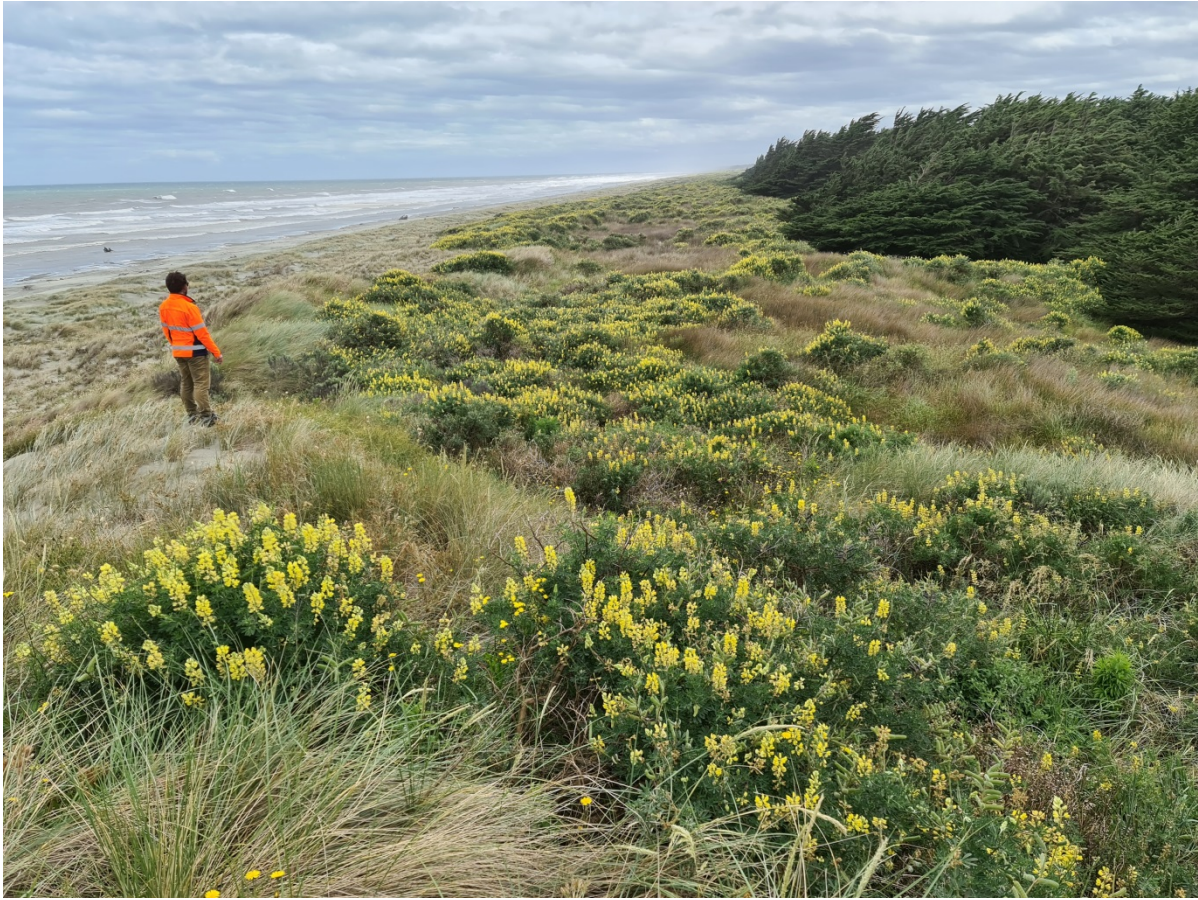
Figure 10: View of knobby clubrush zone, now increasingly dominated by yellow tree lupin.

Further landward, the knobby clubrush gradually becomes the dominant native plant community and extends back to the seaward edge of the macrocarpa shelter belt (Figure 10). This native plant community is now very extensively invaded by yellow tree lupin. The invasion by the lupin is markedly more widespread than observed in my earlier October 2010 site inspection.

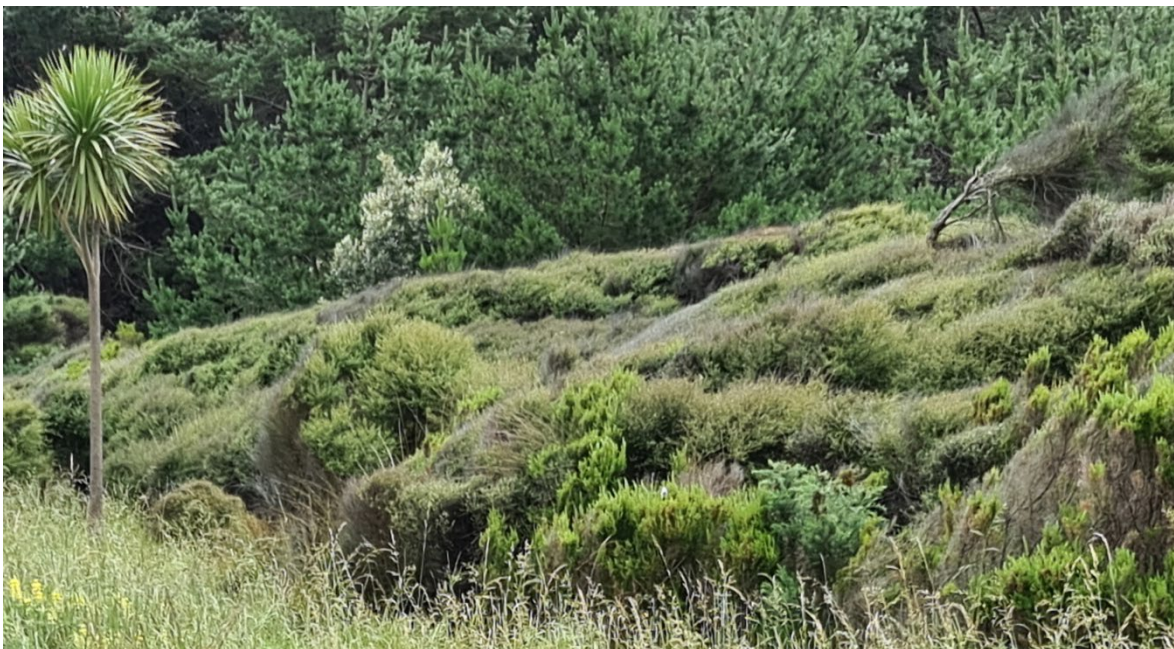
Figure 11: View of part of the area of Kanuka shrubland.

However, further landward, in isolated, low-lying areas there are notable patches of kanuka (*Kunzea ericoides*) shrubland, discussed also by Dayly (2020). Limited flax (*Phormium tenax*) and cabbage tree (*Cordyline australis*) also occur in association, reflecting the relatively damp environment (at the time of the field inspection, the ground was generally quite wet in the areas of kanuka). This shrubland has been significantly modified by historic stock access but can be readily restored over time. Areas of native dune shrubland such as this are now very rare on this coast and it is desirable to maintain and enhance these areas and minimise disturbance.

The kanuka shrubland within the property was identified as a constraint in the original design, with the course designed to minimise damage to this vegetation to the maximum possible extent. Most of the existing areas of kanuka shrubland have been retained and incorporated into the design of the course. Where small areas of the kanuka are removed, it is recommended that these be balanced by further planting, ideally adopting a 2 for 1 ration between the area replanted and the area lost.
