Douglas Golf Links, Ohau: archaeological assessment of  
proposed construction

Report to Grenadier Limited, C/- Land Matters

Mary O'Keeffe  
Heritage Solutions  
Wellington

December 2020

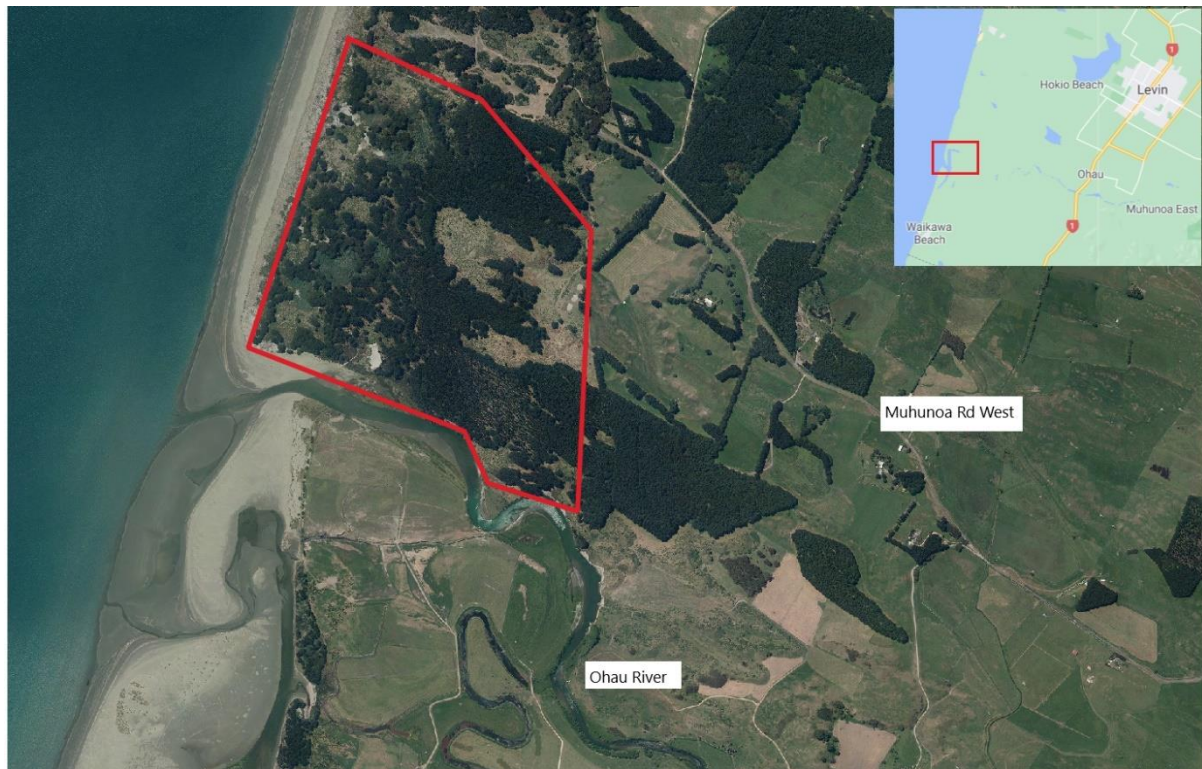
**Figure 1: Location of area of proposed work**

The land as shown above in Figure 1 is coastal, and is a mixture of high dunes with broad flat expanses between the dunes. The lower areas are grassed with weeds and low scrub. The dunes are covered in wilding pines and very thick vegetation such as lupins and blackberry.

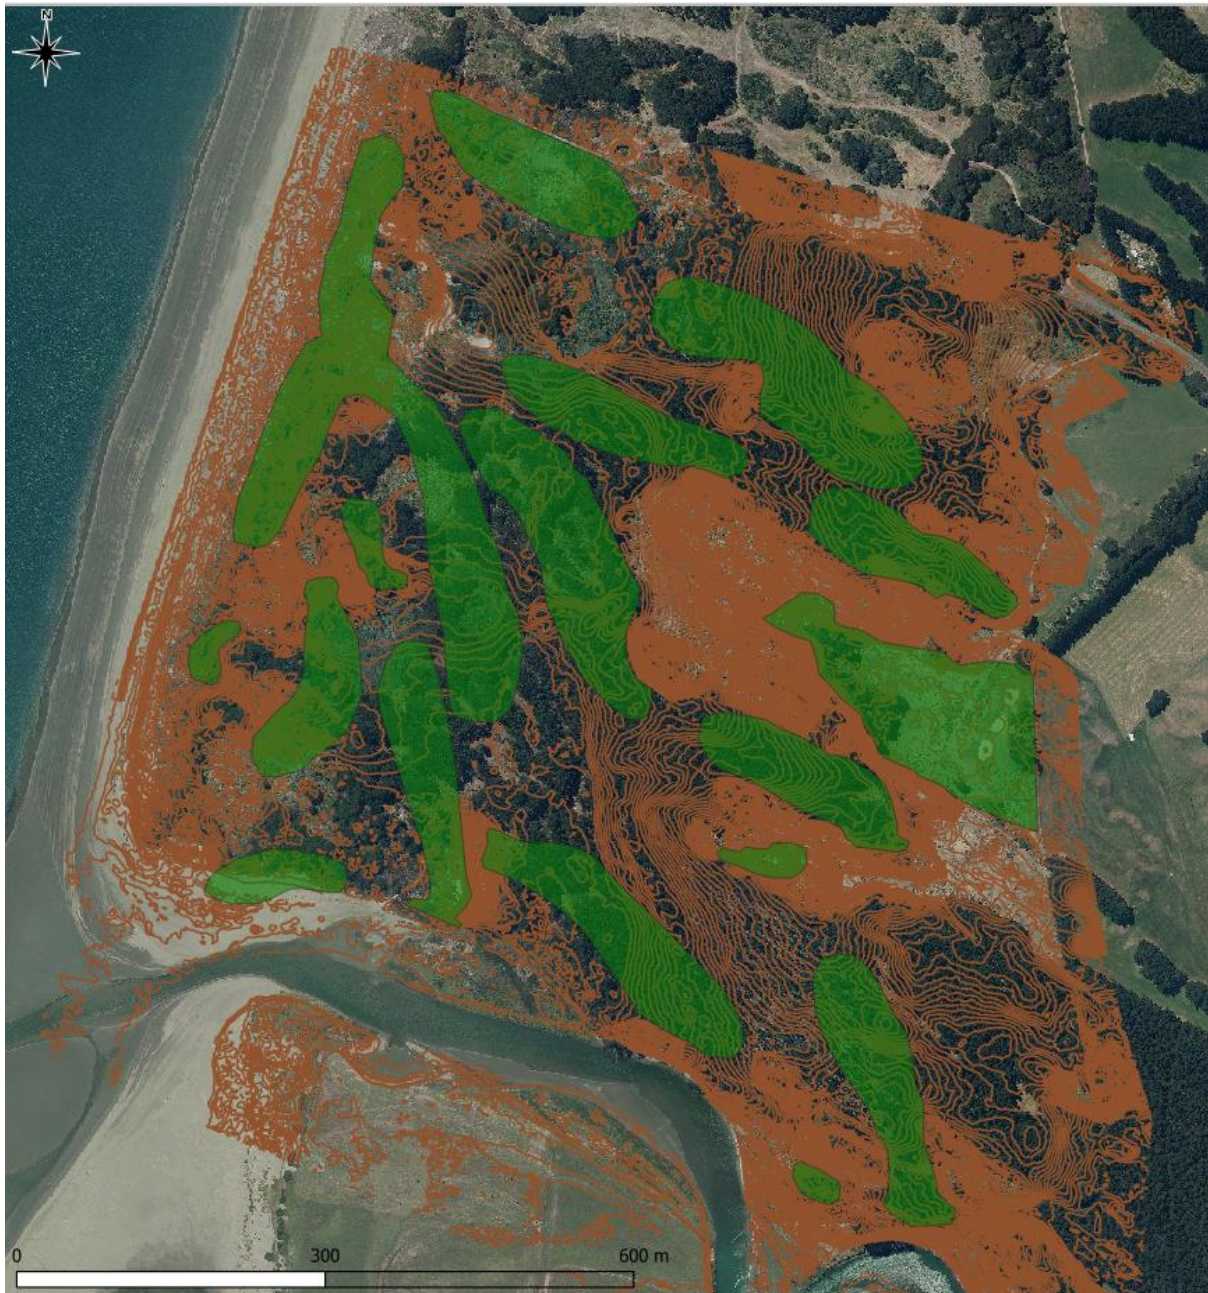
**Figure 4: Course layout and contours**  
Land Matters

The relationship between the proposed layout and the land contours is shown in Figure 4.

The fairways are largely placed between the dunes, on areas that are already relatively low lying and flat.

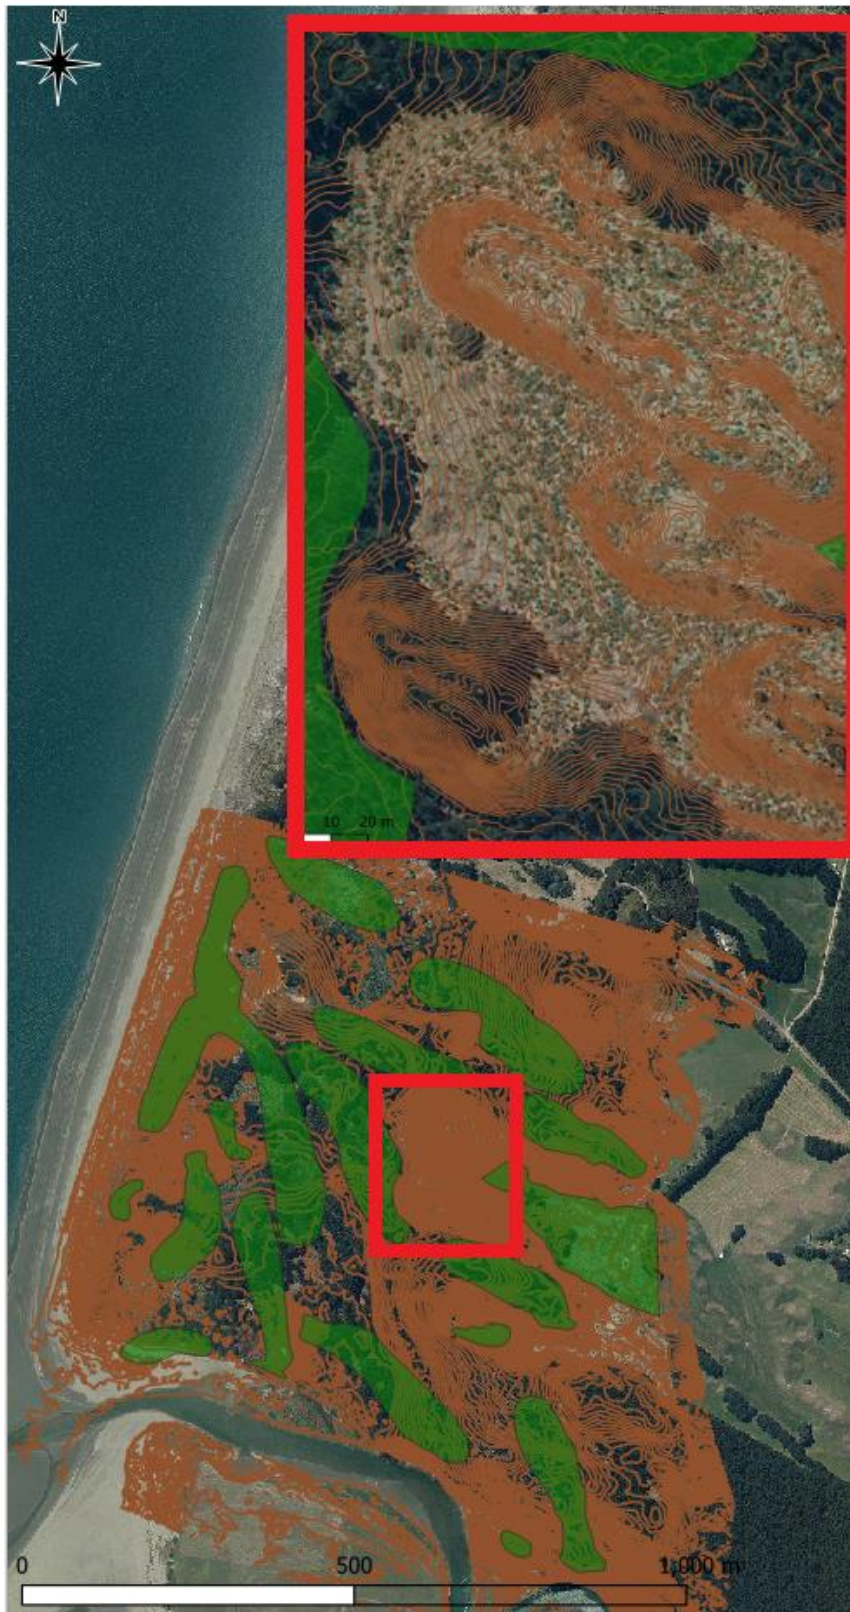
Figure 5: Dune to be reduced

However, the highest dune is to be lowered by about 10m, for placement of the clubhouse, accommodation and utility buildings; this dune is shown in Figure 5.

- Creation of fairways along the western coastal edge of the project adjacent to the coast
- Creation of fairways in the south-west corner of the project, in the vicinity of Tirotiro Whetu
- Lowering of the dune seen in Figure 5

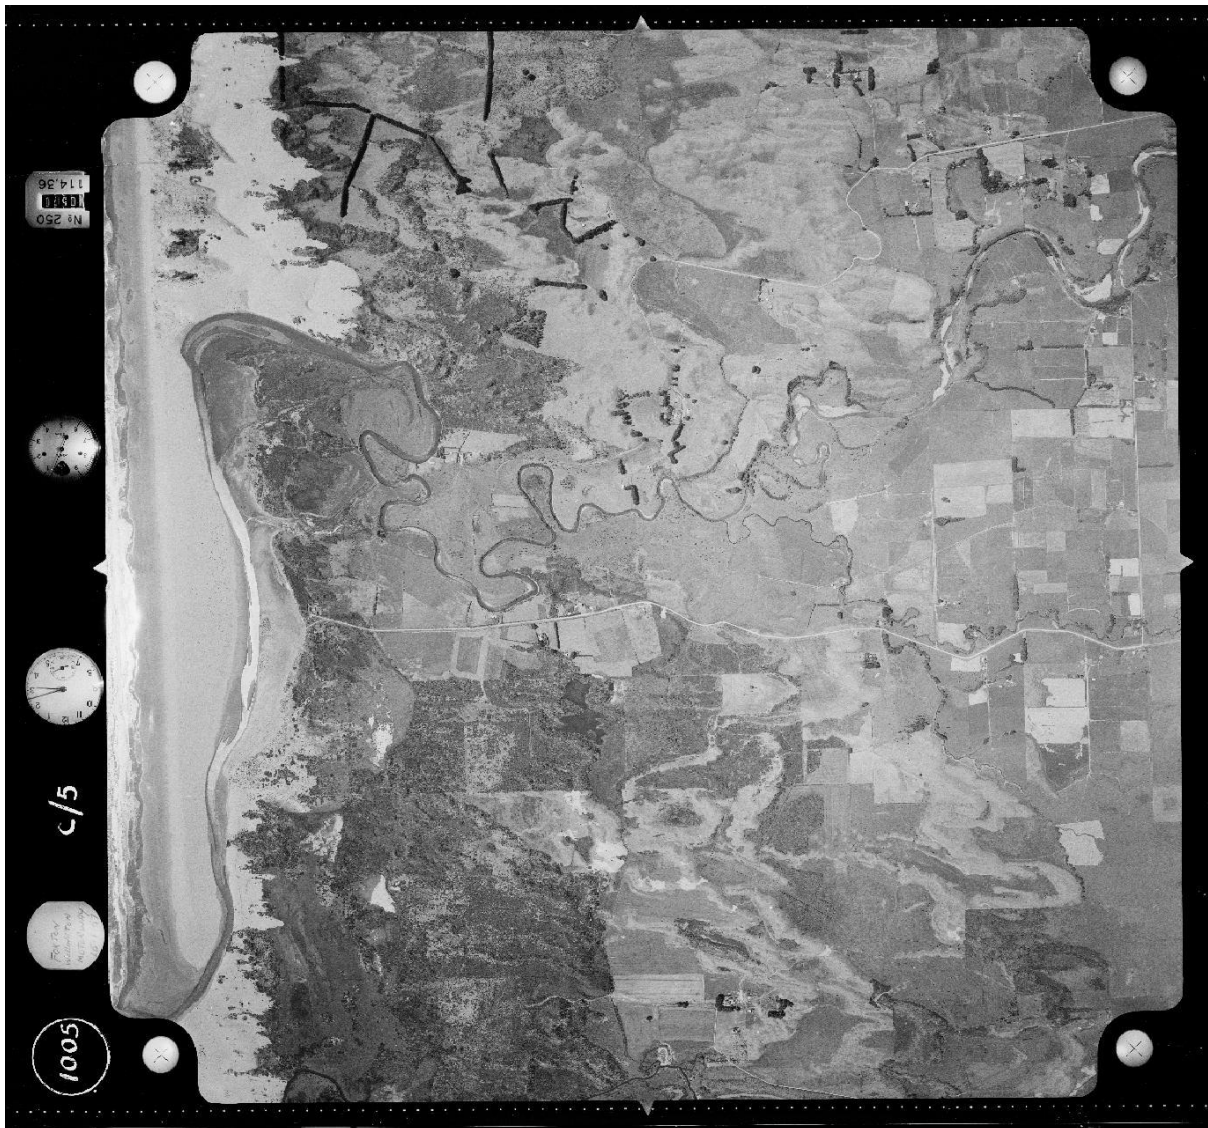
Figure 8: Ohau Coast, 1957  
Survey 1005, run C  
Retrolens

Aerials from a 30-year period demonstrate the dynamic nature of the landscape. The coastal dunes are variously bare and vegetated, and the alignment and location of the river mouth changes. No archaeological sites can be seen in the aerials. Notably, no forestry is shown.

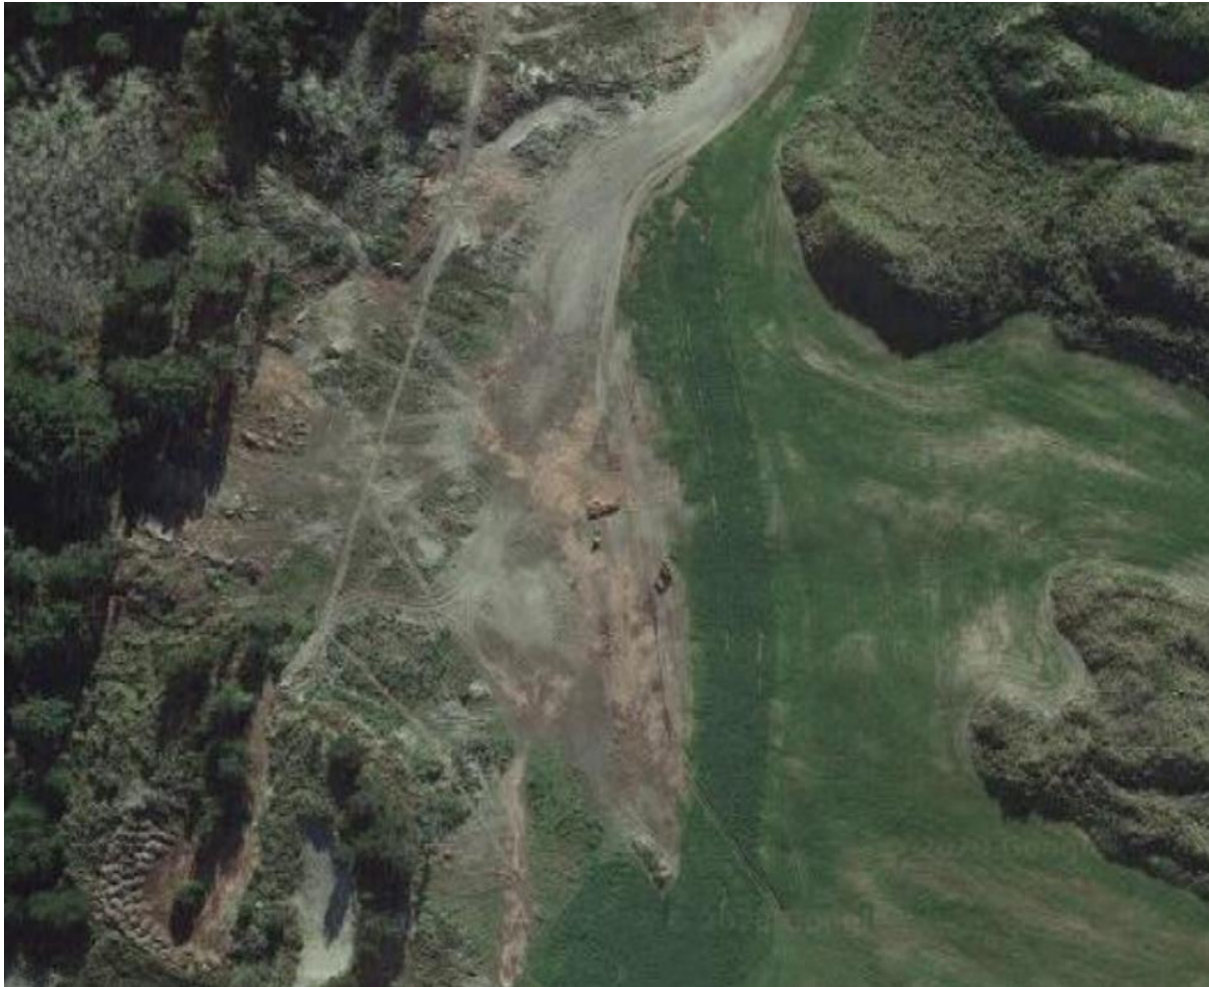
**Figure 13: Google maps image, date unknown**  
Google maps

However, the Google maps image of the area (Figure 13) appears to show post-harvest residue and recent grass sowing following forestry harvesting.

Pine harvesting, including pulling the stumps, will have destroyed any sites that may have been present in the planted areas. The action and effect of pulling stumps has been observed by the author; this work “explodes” and destroys middens.

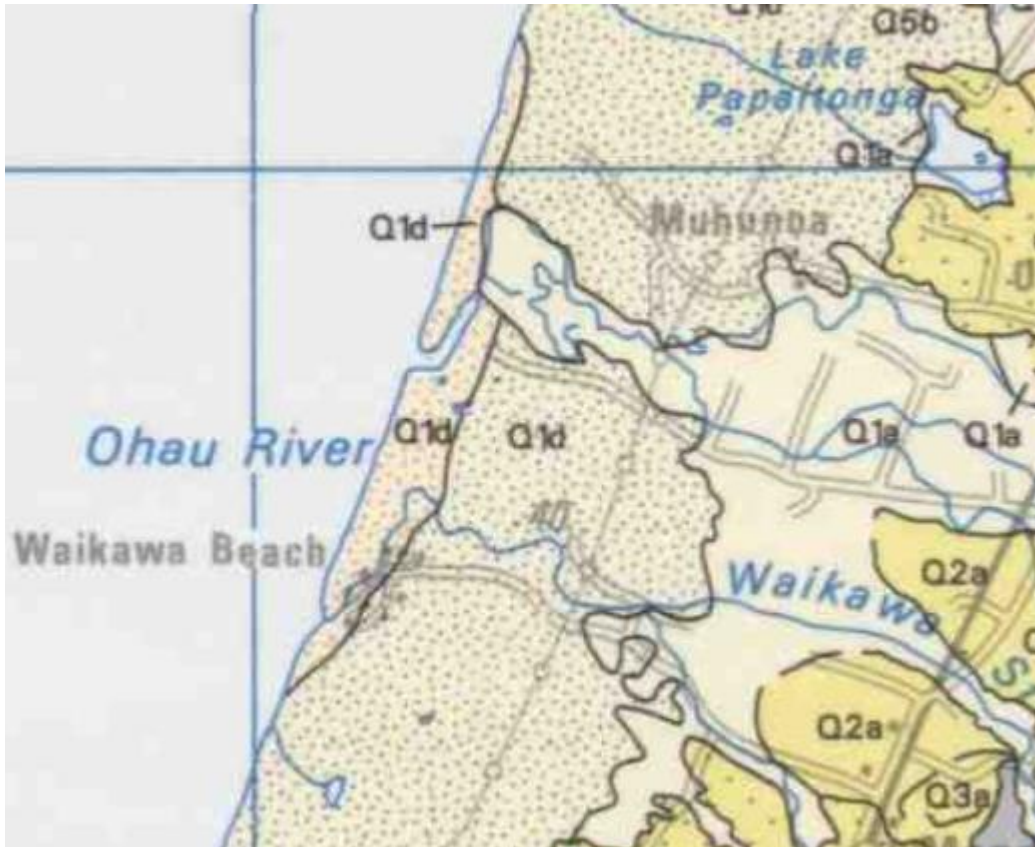
**Figure 14: Geology of assessment area**  
 IGNS, 2000

The assessment area lies within geological areas Q1a and Q1d: Q1a are alluvial deposits comprised of well-sorted floodplain gravels; Q1d are aeolian (wind deposited) dunes<sup>3</sup>. Both these geological units suggest a reasonably dynamic landscape, being moved by wind and river action. Inland are geological areas Q2a and Q3a, which are poorly to moderately sorted gravels with minor sand or silt underlying aggradational and degradational terraces.

In summary, there are unstable dunes on the coast, which are formed by coastal deposition and shaped by wind action, with more stable deposits further inland.

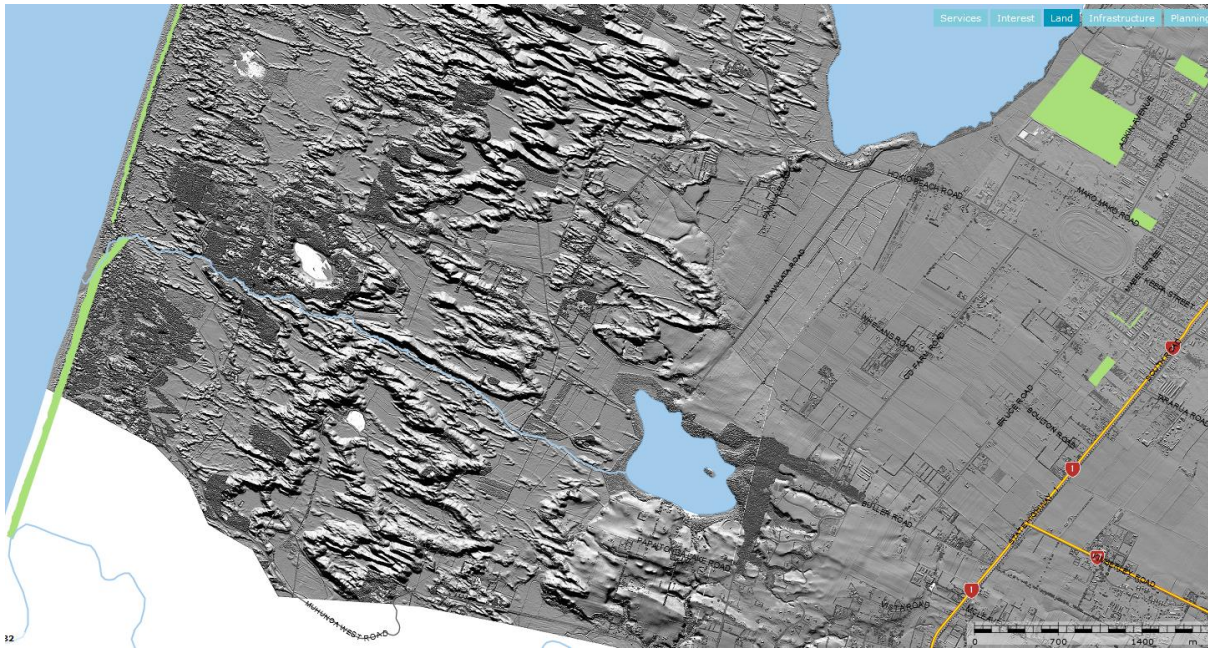
**Figure 15: LiDAR imagery of area north of Muhunua Rd West**

Muhunua Rd West at bottom of image

Lake Papatonga shown at top of image

The imagery shown in Figure 15 shows the dynamic landscape, and especially the effect of wind on the landscape: sand deposited onto the coastline by the various rivers along the coast (Ohau, Otaki, Waikanae and Manawatu Rivers) has been spread along the coastal edge by longshore drift, and has created successive bands of linear sand dunes parallel to the coast. Offshore winds have shaped the previously linear dunes into parabolic curves. Areas of wetlands have formed between the dune bands.

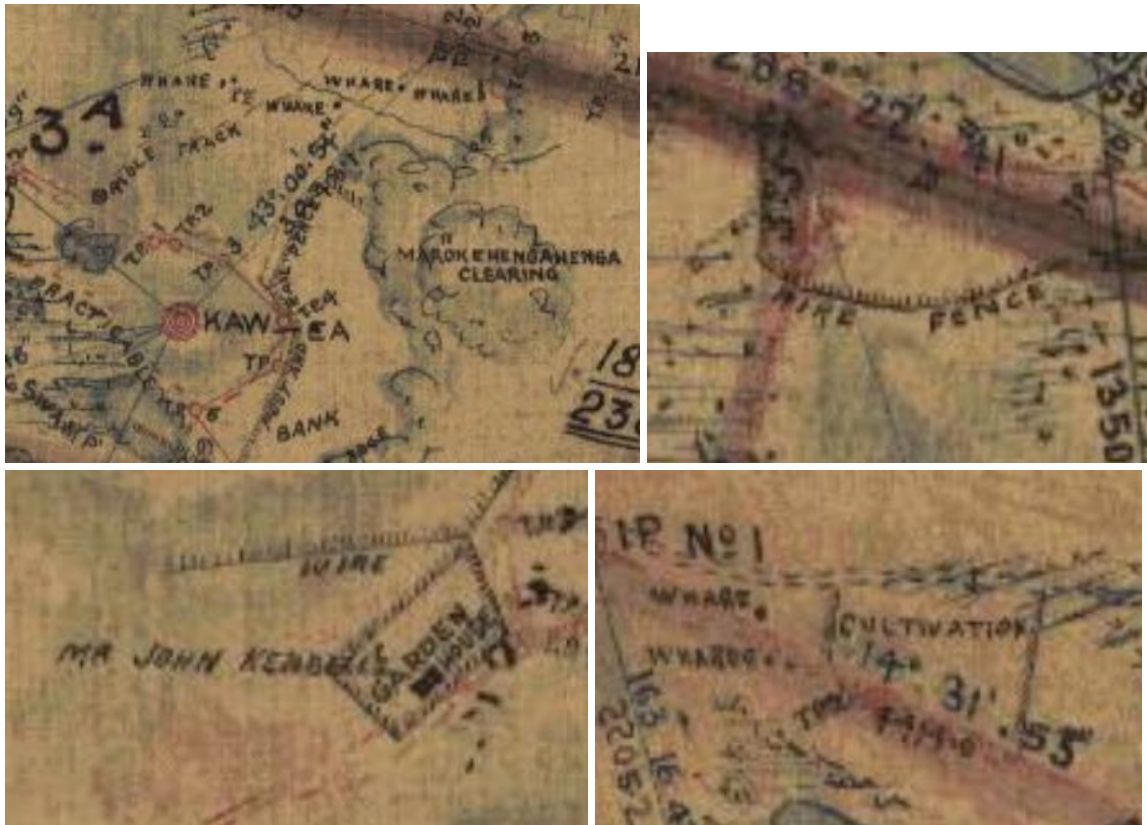
Figure 17: Detail of occupation from ML 364

ML 364 (1879, Figure 16), shows Muhunua blocks 3a and 3b. The landscape includes a lake, dunes, and wetlands between the dunes. Some indication of occupation and land use is shown through notations of whare, a bridle path, a wire fence, a European house and garden belonging to settler John Kebble and an area of cultivation. None of these features are within the proposed area of work, but they indicate semi-permanent occupation of the area by the 1870s.

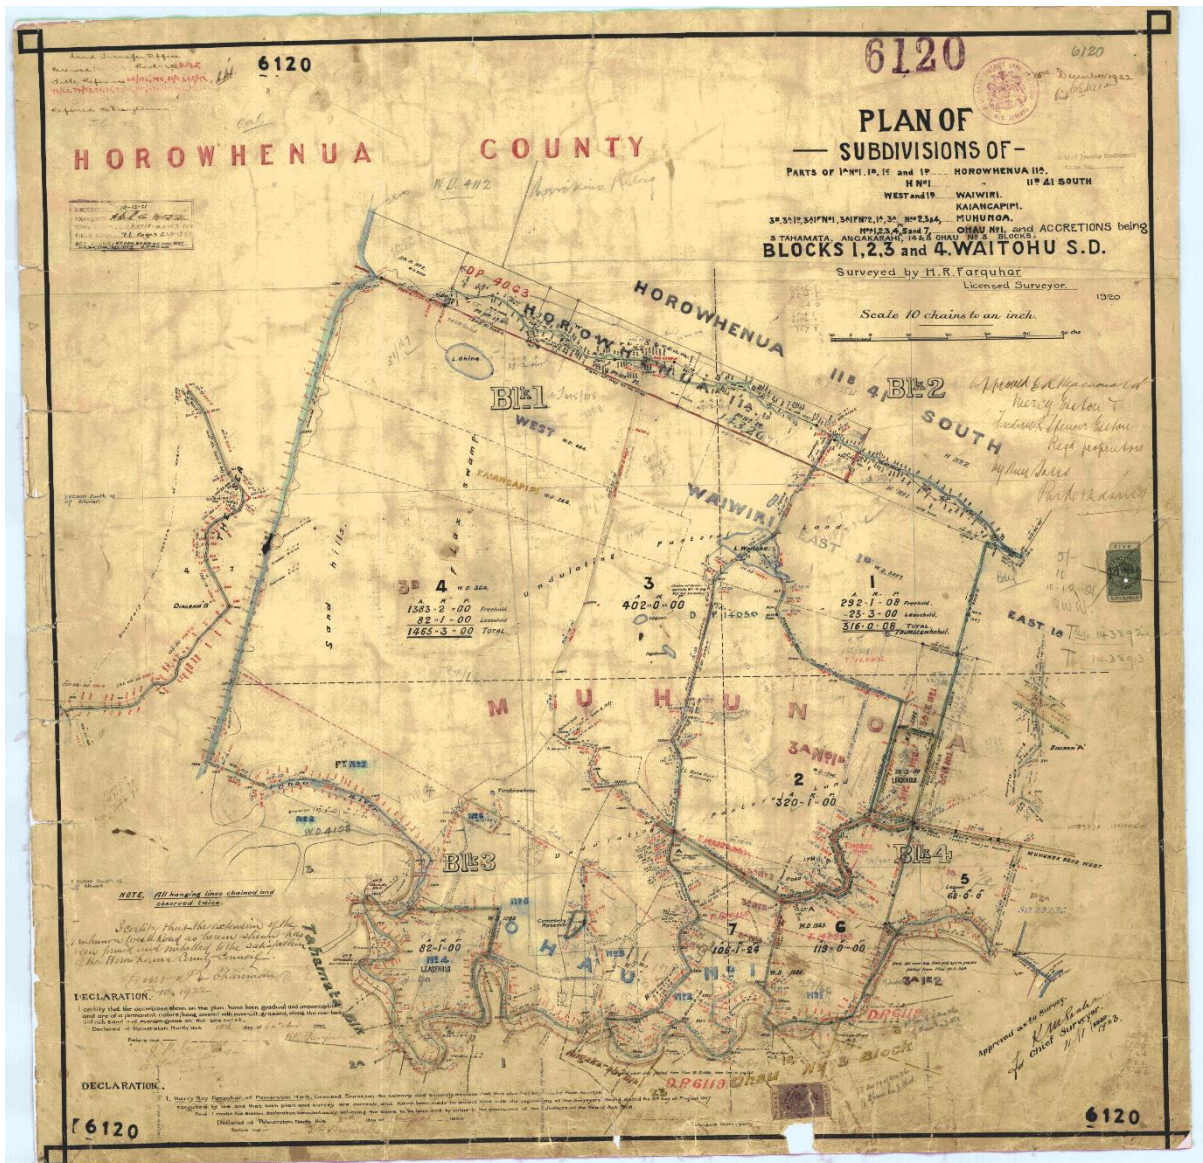
Figure 24: DP 6120, 1920  
Quickmap

DP 6120 (1920, Figure 24) shows the land in the early 20<sup>th</sup> century. Areas of rolling dunes and swamps are shown; some lagoons are marked as having been drained. A cemetery reserve south of Muhunua Rd West is shown. Kebble's homestead and outbuildings are still present.

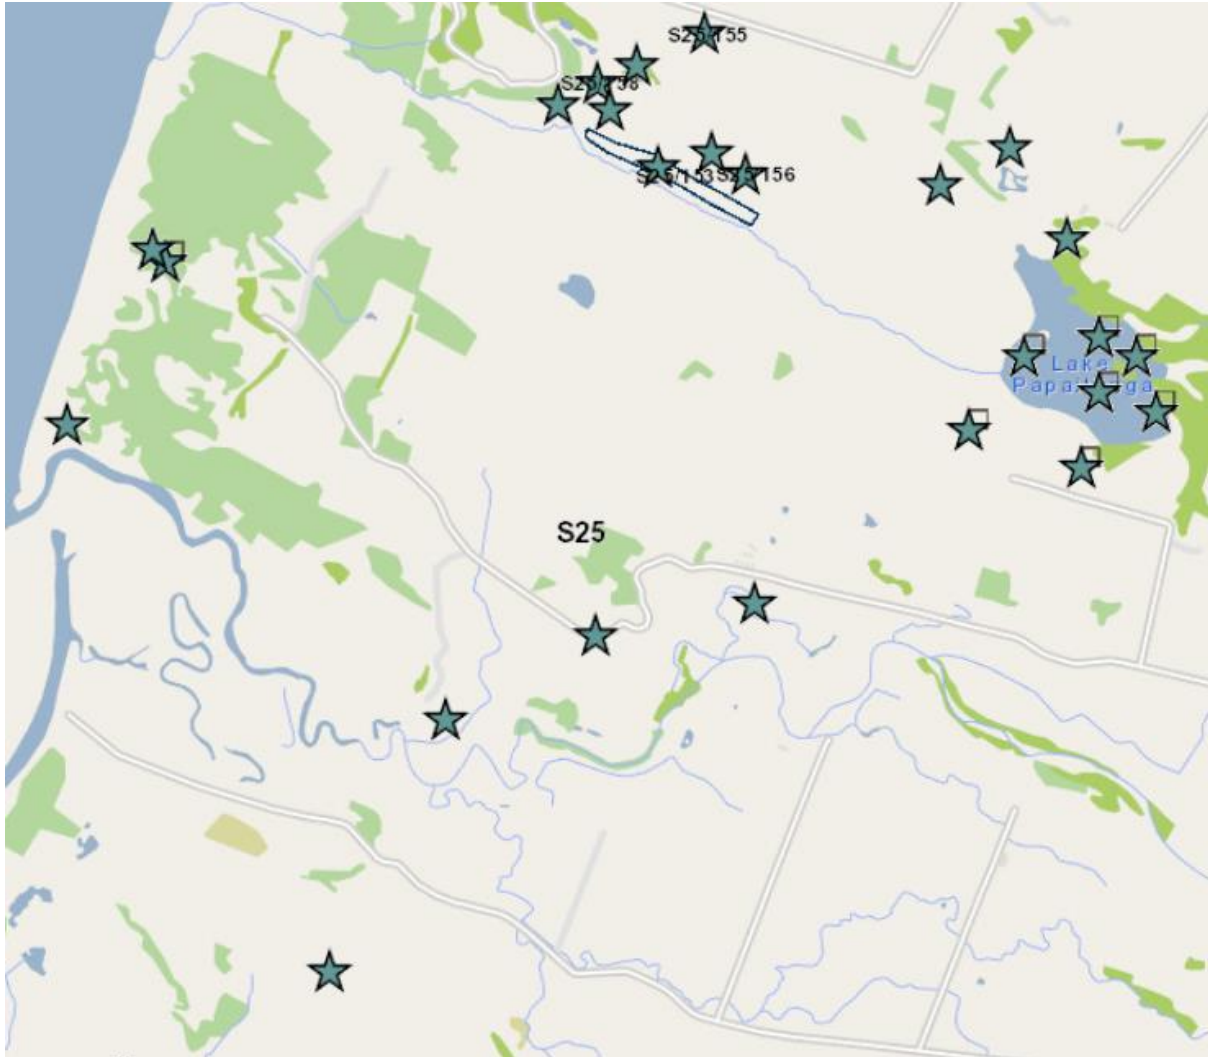
Figure 30: Recorded archaeological sites in the vicinity of assessment area  
ArchSite

Figure 30 shows the recorded archaeological sites in the vicinity of the assessment area.

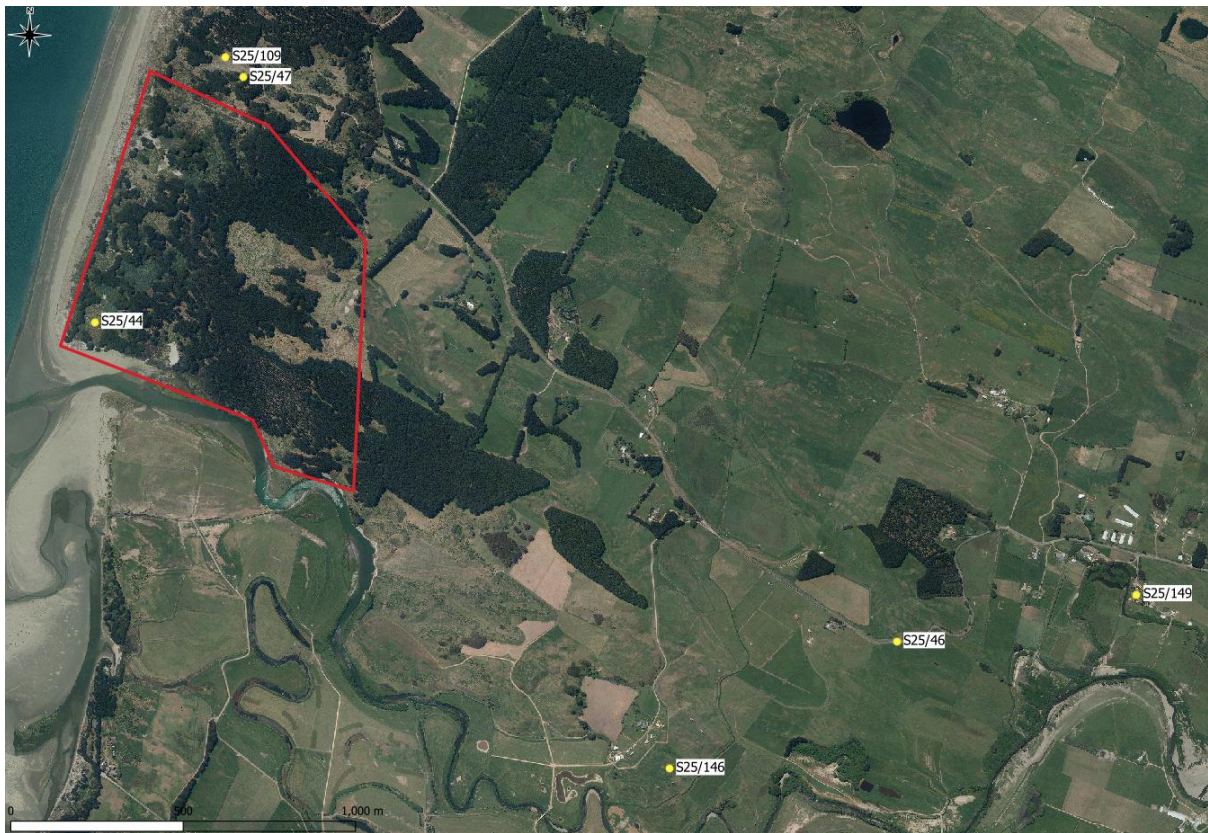
**Figure 33: Recorded sites and area of work**

Yellow dots: recorded sites  
Red outline: project boundary  
Sites sourced from ArchSite

One site – S25/44 is within the area of proposed work.

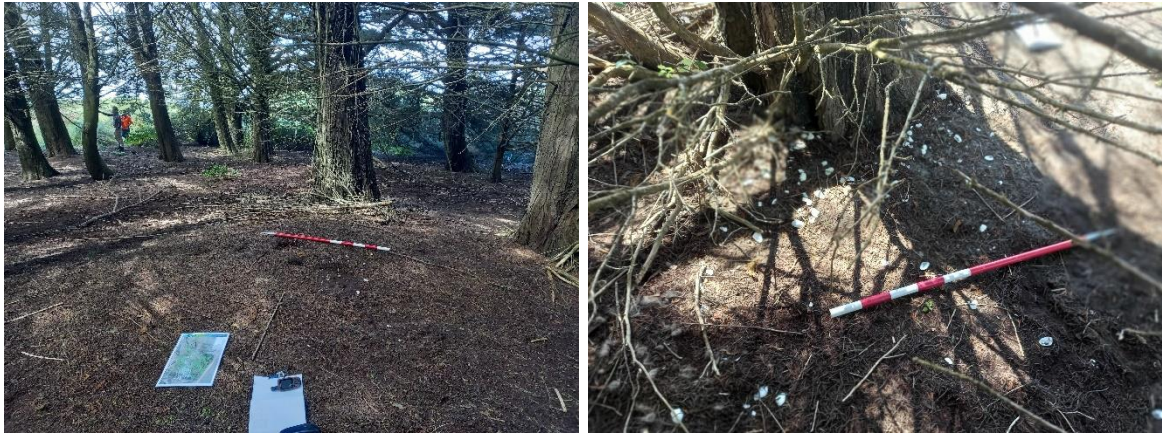
**Figure 34: Sites recorded in site visit**

Two new middens were recorded during this visit. They have been entered into ArchSite as S25/174 and S25/175.

Both sites are shell middens, being scattered areas of shell on the ground surface beneath pines or macrocarpas. No source of lens of shell was visible. In each case

pine and other vegetation dross is covering the ground surface, possibly obscuring the source lens.

L: S25/174; R: S25/175

Figure 36 shows that three sites (S25/44, S25/174, S25/175) are within the area of proposed work. Two of the sites, S25/174 and 175, are within areas of proposed fairways.

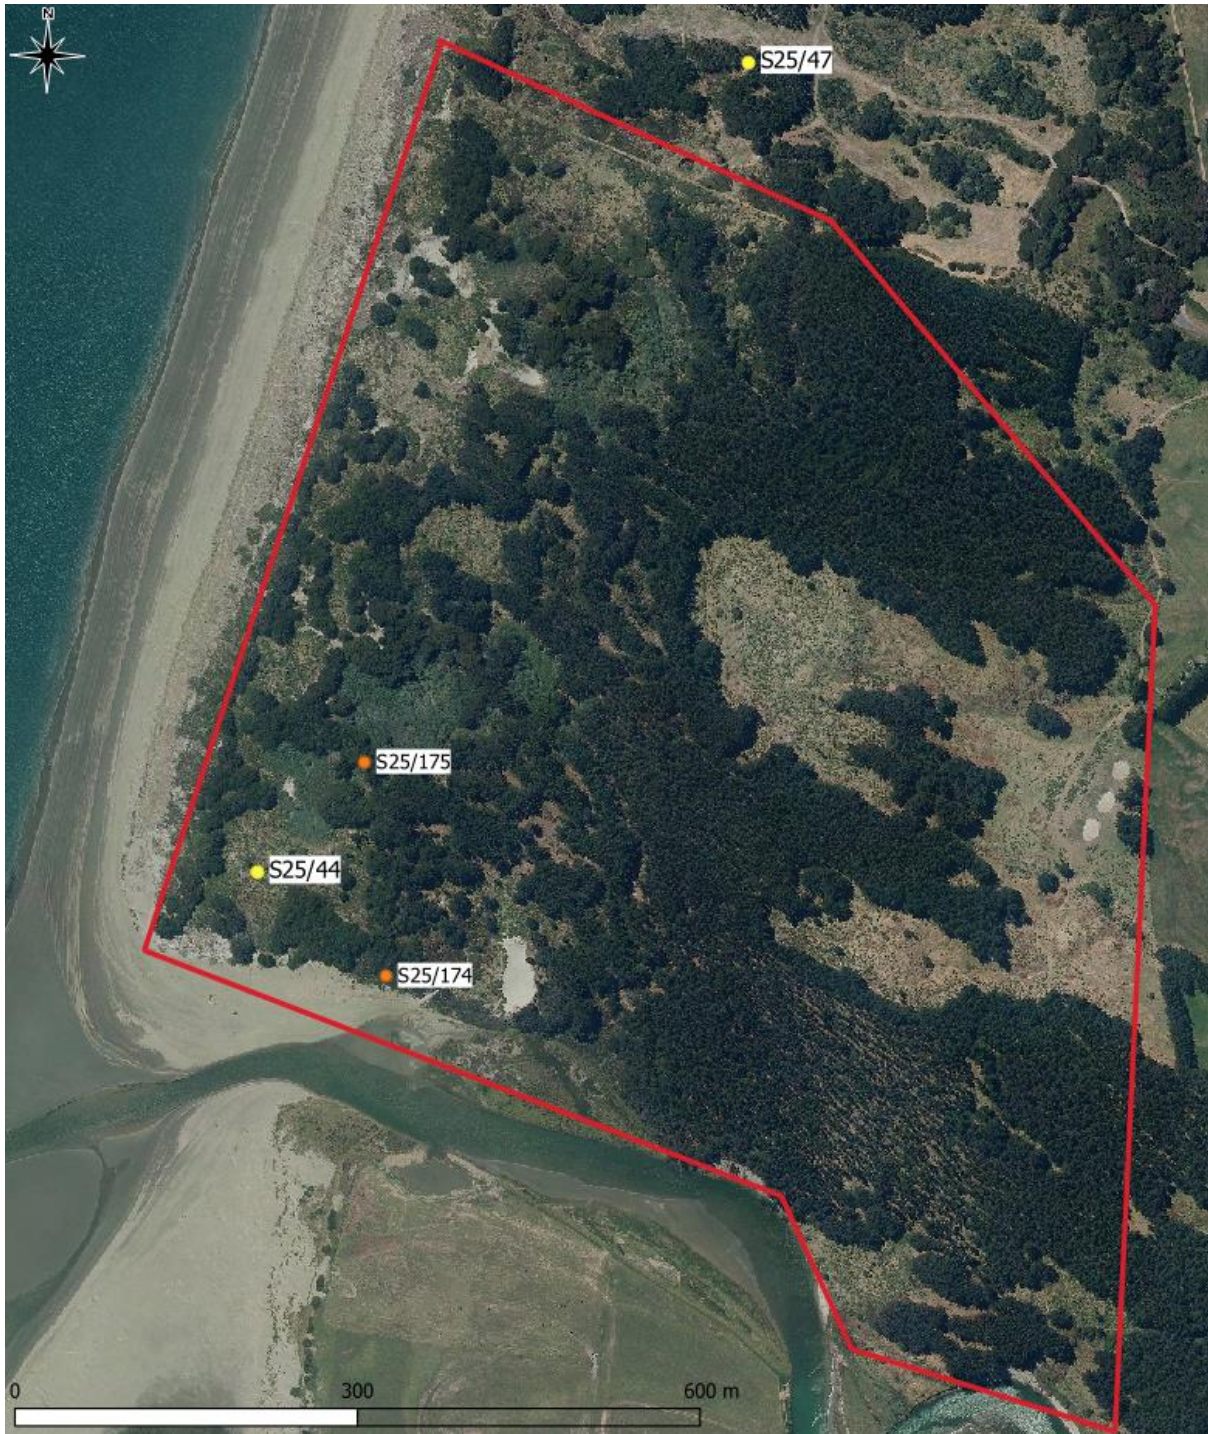
**Figure 35: Sites and project area**

Orange dots: sites recorded in November 2020 site visit

Yellow dots: sites previously recorded

Red outline: project boundary

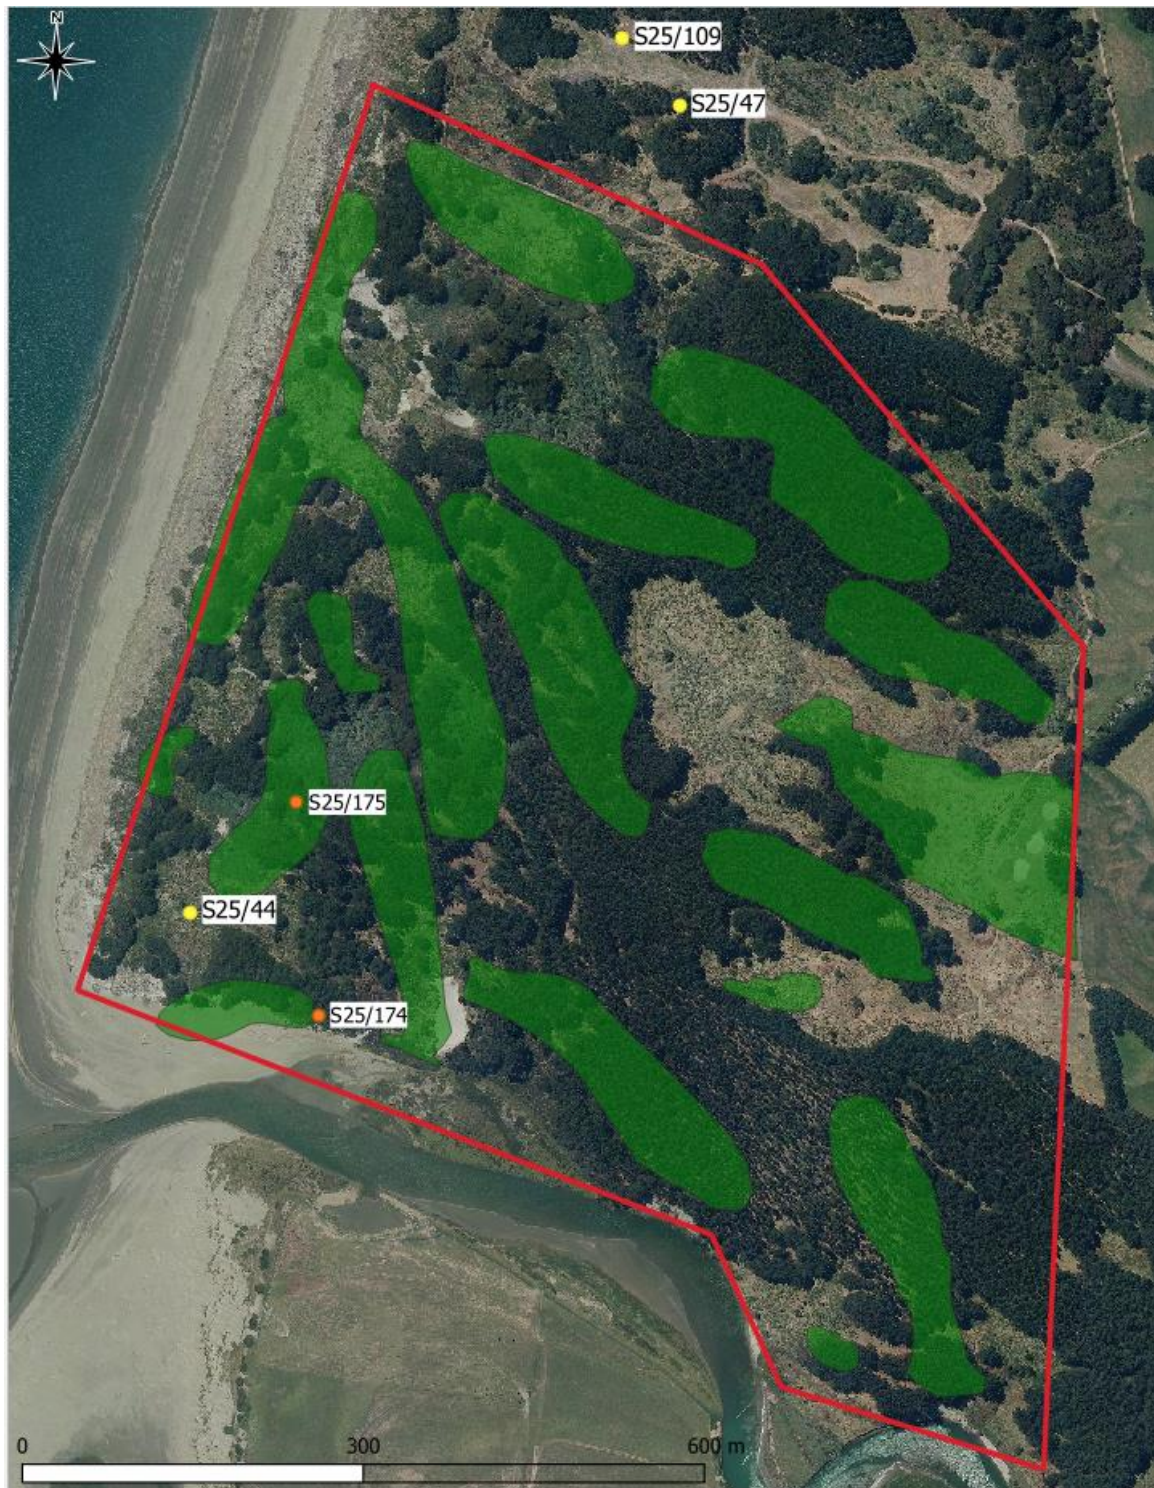
Figure 36: Course layout and recorded sites

As most fairways are located between the dunes on areas of already modified land, the majority of fairways have little potential to adversely affect potential unrecorded sites.
