Restoration of Foredunes and Transgressive Dunefields: Case Studies from New Zealand

Chapter 5

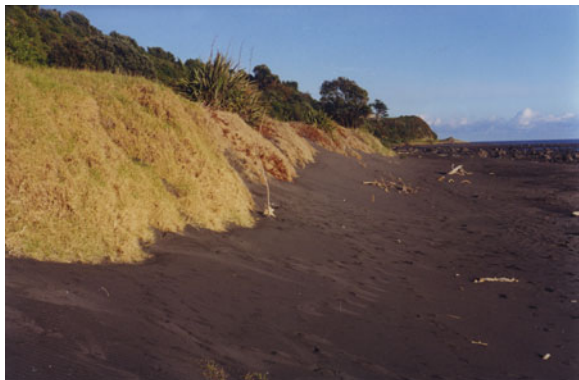
Fig. 5.2 View of the Oakura Beach site prior to restoration

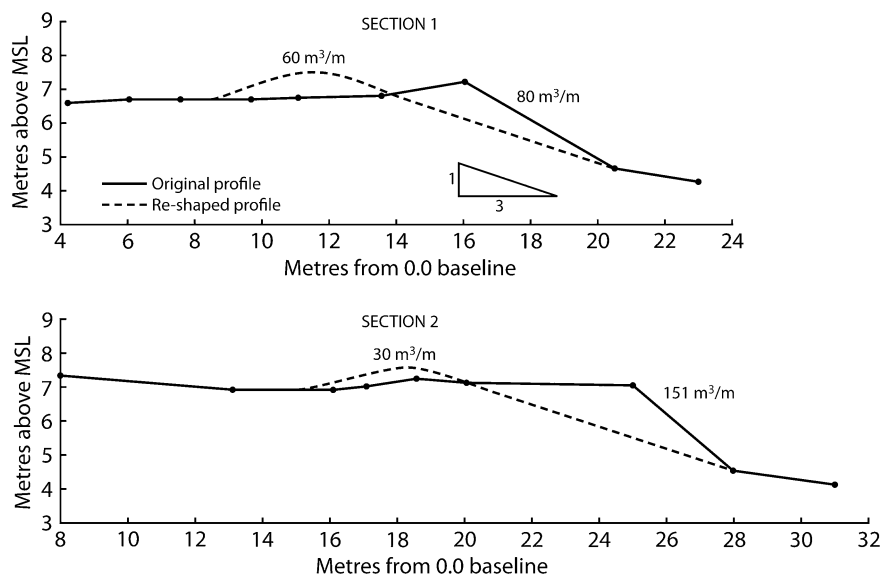
The approximate volume of sediment (per meter alongshore of the dune) required for reshaping is indicated in Fig. 5.3. The volumes required to construct the desired dune profile ranged from 1,200 to 2,700 m³/m depending on the location alongshore. There was a greater amount of sediment available in the northern section of the area to be reshaped and a deficit in the southern area. That is, the amount of material required to produce a minimal dune shape in the southern section was less than that available from the excavated area. Since it was desirable to build the reshaped foredune as large as possible, and since there was more sediment in the northern area, some of this northern sediment was transported to the southern area to make up the deficit.

Fig. 5.3 Cross-sections of the original dune terrace, and the design foredune at two locations along the dune

Given these constraints, the very limited availability of sediment from other sources, and the potential for storm wave erosion, the reshaped dune profiles were constructed with a stoss (seaward) slope of around 18° (1:3) (Fig. 5.3). The dune height was maximized where possible to heighten the dunes a small amount while still conserving sediment. The dune lee slope was constructed with a slope of around 20° and, while it was desirable to produce a lower lee slope, dense planting and fencing ensured the stability of the slope.

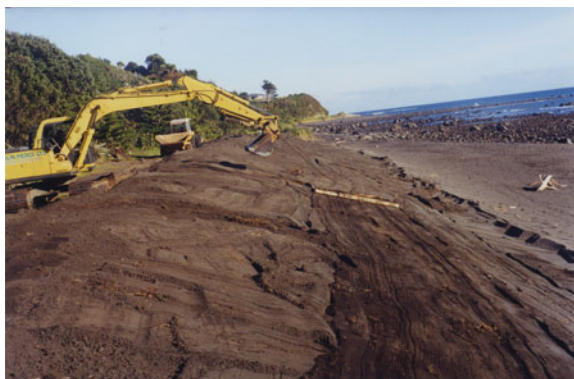
Fig. 5.4 View of the heavy machinery reshaping the foredune. The former clay surface and fill have been removed, and sand from the northern end of the beach has been transported to the site to increase the dune volume

Prior to dune reshaping and planting the kikuyu grass was eliminated by spraying it three times with RoundupTM at 8-week intervals (Bergin et al. 2000). The dune was reshaped, restored to a relatively natural profile (Fig. 5.4), and mostly planted

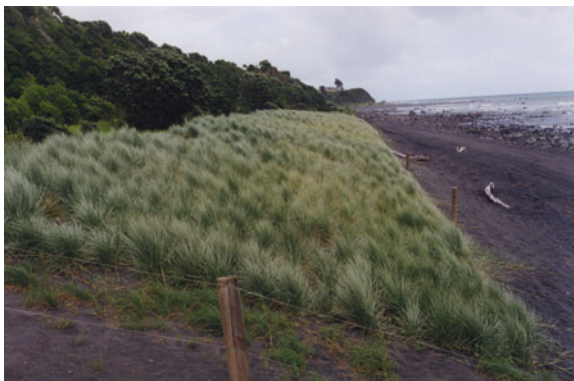
Fig. 5.5 View of the reshaped foredune in 2000, principally planted with etc., *Spinifex sericeus*, the native pioneer species for the region

with *Spinifex sericeus* (primarily raised from seed) at a spacing of 50–70 cm. This close spacing was desirable because the operation of high-energy, west-coast, “roaring forties” winds in this region means that there is a considerable chance of aeolian erosion occurring following planting. Some limited planting of *Carex pumila* plants was also undertaken as a trial to examine how well this native plant might survive in this environment (Bergin et al. 2000). The surface was fertilized with two slow-release NPK fertilizers at planting. A three-wire fence was erected along the front and back of the dune to restrict pedestrian access, and signs were erected to inform the public of the works. The plants grew rapidly and the dune displayed a high percentage of cover after 6 months (Fig. 5.5).

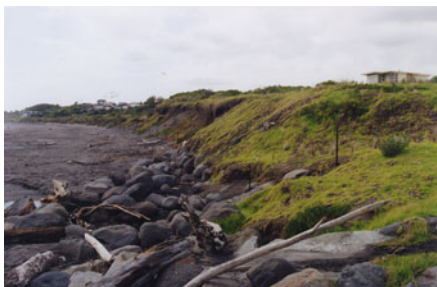
Fig. 5.6 View of the East End foredune prior to restoration

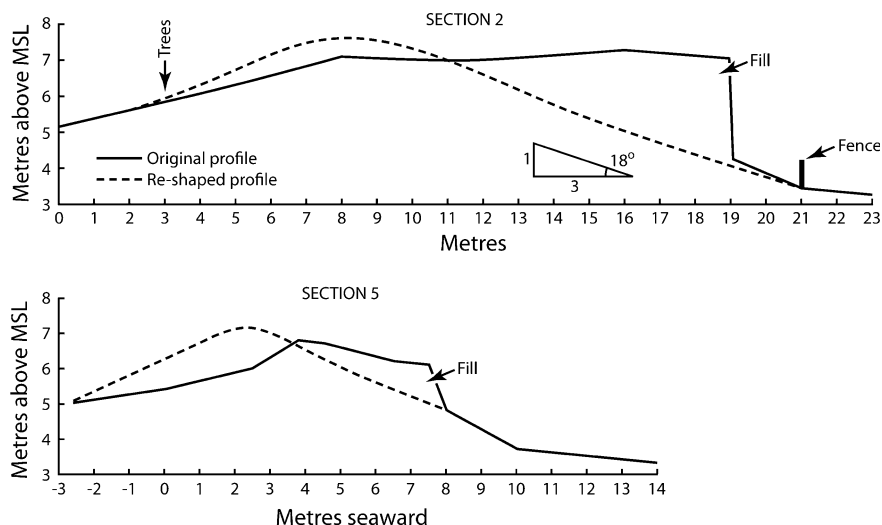
Fig. 5.7 Two cross-sections (Sect. 5.2 [southerly] and Sect. 5.5 [northerly]) of the foredune illustrating the pre- and post-restoration morphologies

The selected foredune section was situated just north of the main walkway onto East End Beach adjacent to the East End Surf Life Saving Club. Two typical topographic profiles are shown in Fig. 5.7, including the typical reshaped dune profiles. As in the case of Oakura, at East End there were four factors that limited the dune reshaping work:

Given these constraints, the very limited availability of sediment from other sources, and the potential for storm wave erosion, the reshaped dune profiles were constructed with a stoss slope of around 18° (1:3) to 22°. The dune height was maximized where possible to heighten the northern section of dunes a small amount, while still conserving sediment.

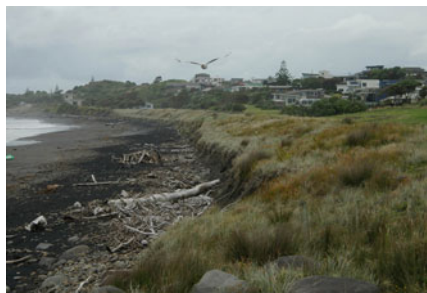
Fig. 5.8 The foredune at East End following restoration

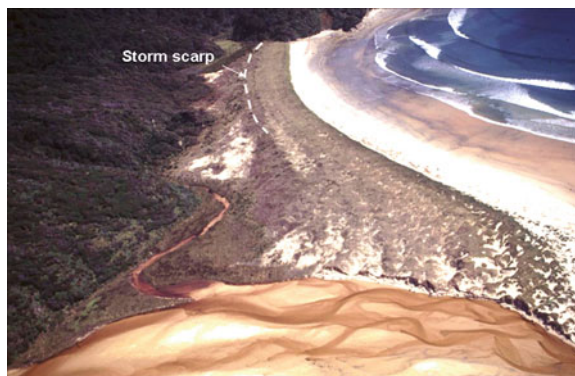
Fig. 5.10 An aerial oblique view of the southern barrier. The “scarp” separates the prograded foredune barrier associated with marram, which formed after the first aerial photograph was obtained in 1958 from the pre-marram dune system. The latter contains remnant blowouts and parabolic dunes

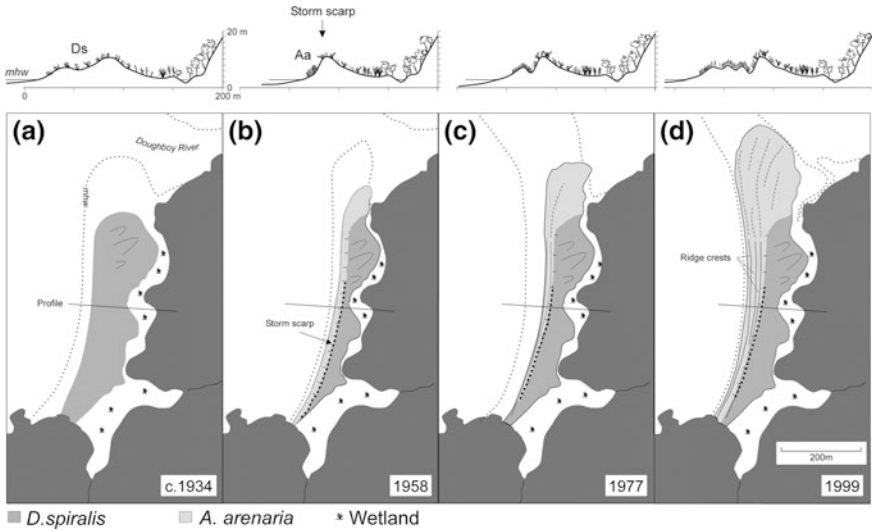
Fig. 5.11 Barrier and dune system development, 1934 to 1999 (Hilton et al. 2009)

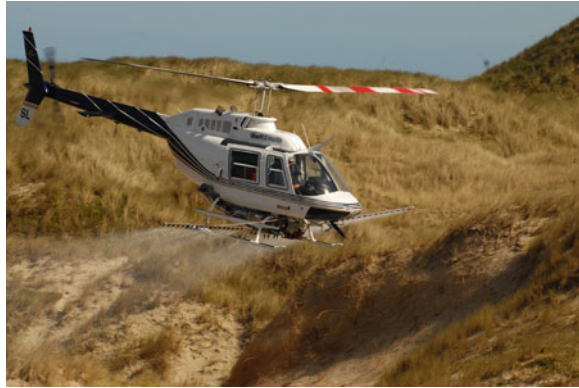
Fig. 5.12 A Jet-Ranger helicopter equipped with a spray boom, engaged in marram control operations, Mason Bay, December 2010

The Department of Conservation commenced aerial (helicopter) operations in Doughboy Bay in February 1999. By this time marram had produced a dense cover over the northern and southern barriers and was rapidly invading the central dunes. The area of dense marram, associated with the four foredune ridges described above, an area of approximately 7 ha, was sprayed with the herbicide Gallant NFTM using a Robinson-22 helicopter in February (mid-summer) 1999. Helicopters have since been used to spray large areas of marram grass, particularly marram growing in the foredune environment, primarily using Jet-Ranger aircraft (Fig. 5.12). The 1999 helicopter operations on the southern barrier at Doughboy Bay were repeated in 2000 and 2001. The initial results were spectacular—complete necrosis of leaf material was observed 4 months after the first helicopter operation. However, numerous shoots had established from surviving rhizome by late spring. The helicopter was used to spray this regrowth in February 2000. Further regrowth was sprayed during the summer of 2000/2001 using a 500 liter pump unit mounted on an ARGO amphibious vehicle (Fig. 5.13). Subsequent regrowth, primarily from in situ seeds, has been sprayed using the ARGO or with knapsacks, or hand-pulled during systematic search and destroy operations in the

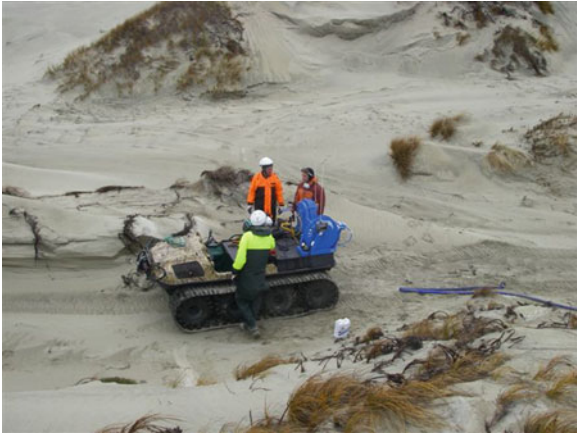
Fig. 5.13 Department of Conservation rangers spraying marram grass using an ARGO all-terrain vehicle equipped with a 500 liter spray tank and two 50 m hoses

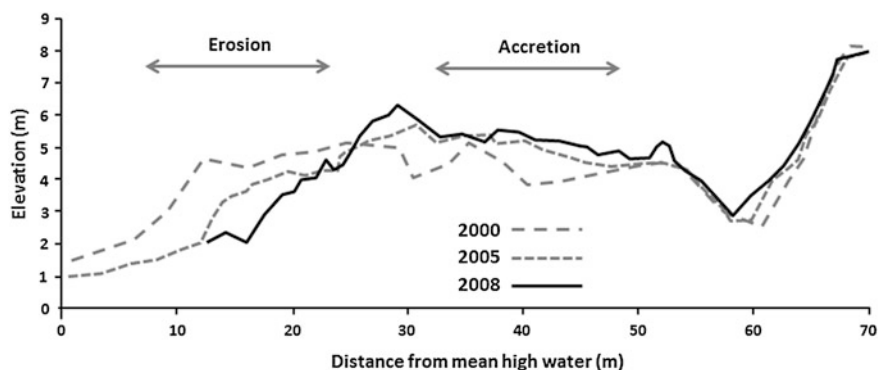
Fig. 5.15 A comparison of the first (2000), 2005 and most recent (2008) profiles surveyed across T4. Erosion is occurring seaward of 25 m. Landward of 25 m the barrier is accreting (Konlechner and Hilton 2010)

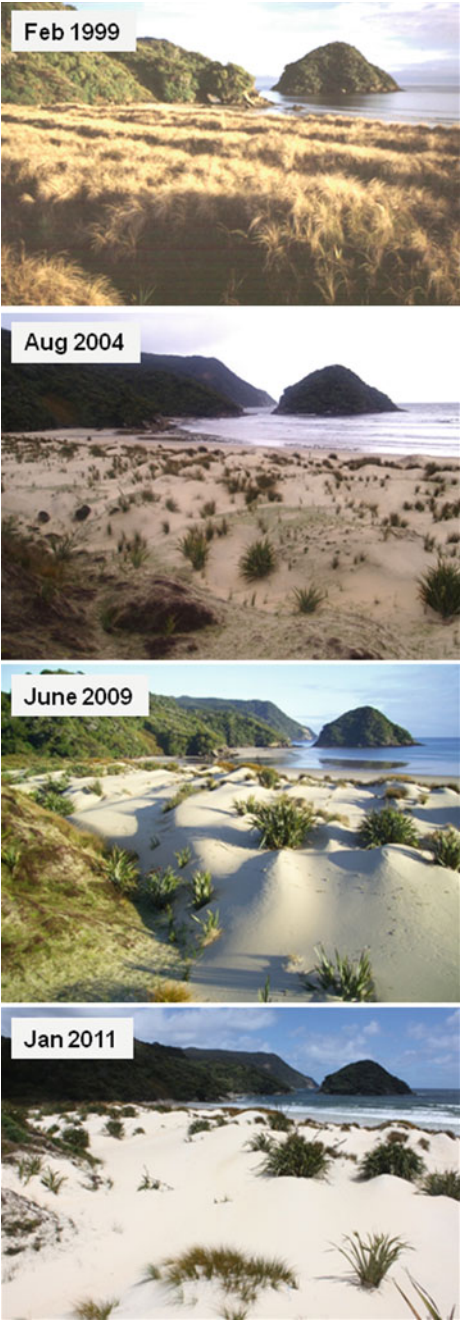
foredune has experienced some minor erosion. The zone of active sedimentation reached the relict storm scarp south of T3 (Fig. 5.16) in 2010. This sandsheet should overtop the relict scarp before 2015. In general, the dune ridges of the northern section of the barrier are eroding relatively rapidly, fueling downwind sedimentation and the development of a slip face. This feature is advancing landward (i.e., to the east).

Fig. 5.16 A sequence of photographs from between T3 and T4, showing the initial marram cover and progressive de-vegetation and sandsheet and nebkha development (1999–2011)

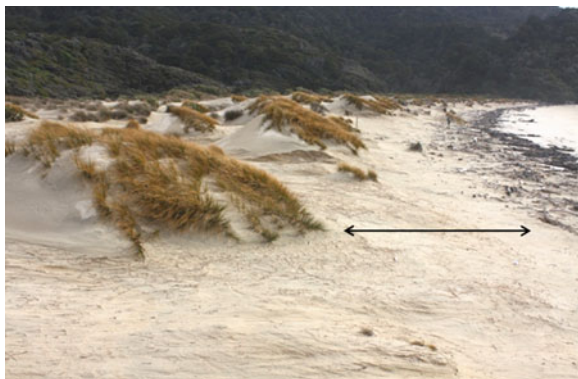
Fig. 5.17 The stoss face of the foredune after marram eradication. The arrow indicates where most marram seedlings have emerged, on an annual basis, since 2005. The shadow dunes have formed under pīngao, planted by the Department of Conservation in 2003

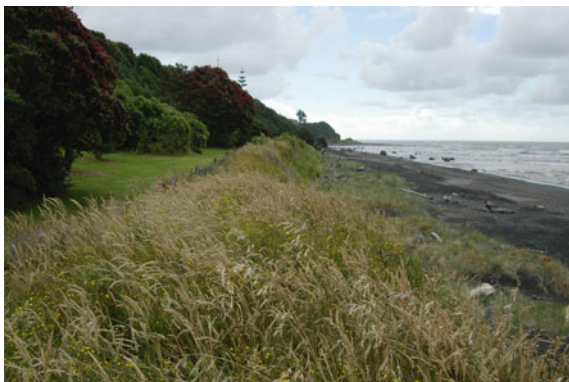
Fig. 5.18 View of the Oakura foredune in 2008. The dune displays a prominent scarp, and has been invaded by a variety of weed species

In the case of the Oakura restoration, by 2008, the dune had been scarped by waves on numerous occasions (as expected given the very limited or negative sediment budget), but had also lost around 8 m in width. The dune had also been seriously invaded by weed species (Fig. 5.18). This may be, in part, a response to over-fertilizing, which happened at least once, but also to the fact that the spinifex senesced to some degree following dune stabilization. Like many pioneer species, spinifex requires sand deposition to drive growth. On a beach such as this, with very limited sand deposition onto the middle to upper stoss slope and crest, secondary native plants should have been introduced to mimic the natural successional tendencies in such areas. In the case of the East End restoration, the dune appears to be functioning naturally and while there is occasional wave scarping, the sediment budget on this beach is such that scarp filling and re-establishment of scarp and beach cover by native species occur.
