**Tsunami evacuation: Lessons from
the Great East Japan earthquake and
tsunami of March 11th 2011**

**GNS Science Report 2012/17
April 2012**

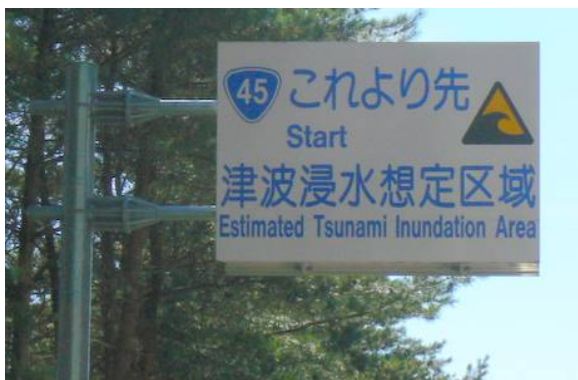
Figure 15 A sign displayed above the road indicating to drivers that they are entering an estimated tsunami inundation area. These signs were seen on roads within Kamaishi district.

Road signs indicating the estimated extent of tsunami inundation zones (Figure 15 and Figure 16) are present along the coast in Kamaishi district. On roads out of Tarō, similar signs mark the extent of inundation in the 1933 Shōwa tsunami.

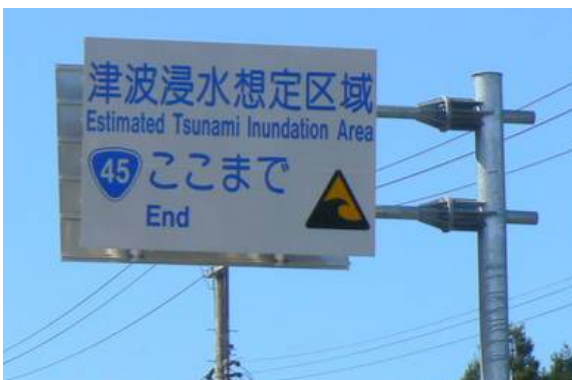
Figure 16 A sign displayed above the road indicating to drivers that they are exiting an estimated tsunami inundation area. These signs were seen on roads within Kamaishi district.

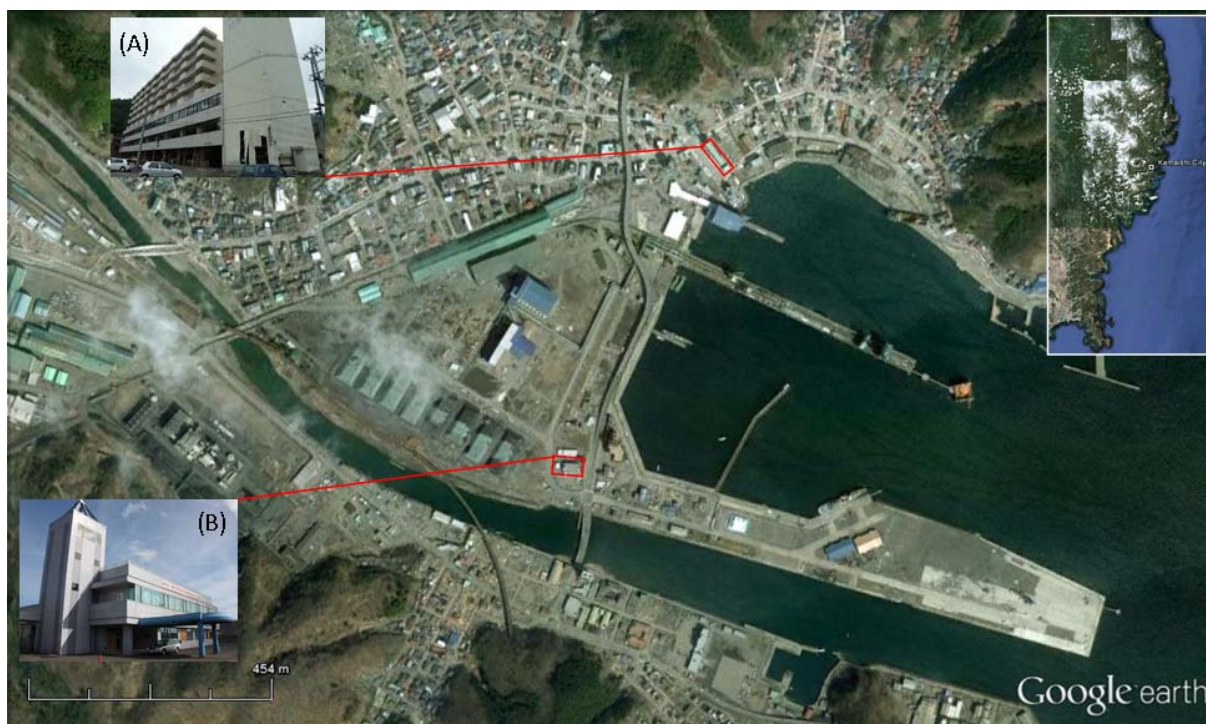
Figure 34 Designated evacuation locations in Kamaishi City. An estimated 50 people evacuated to this apartment block (A) and government offices (B). The entire area shown was inundated; inundation depth was 8 m in the vicinity of building (A).

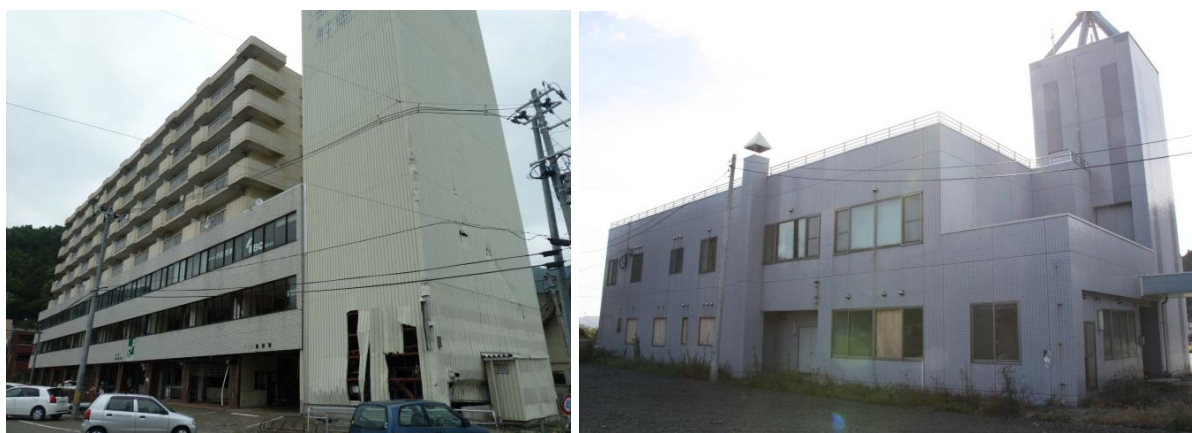
Figure 35 Apartment block in Kamaishi City, which was inundated to the 3rd storey

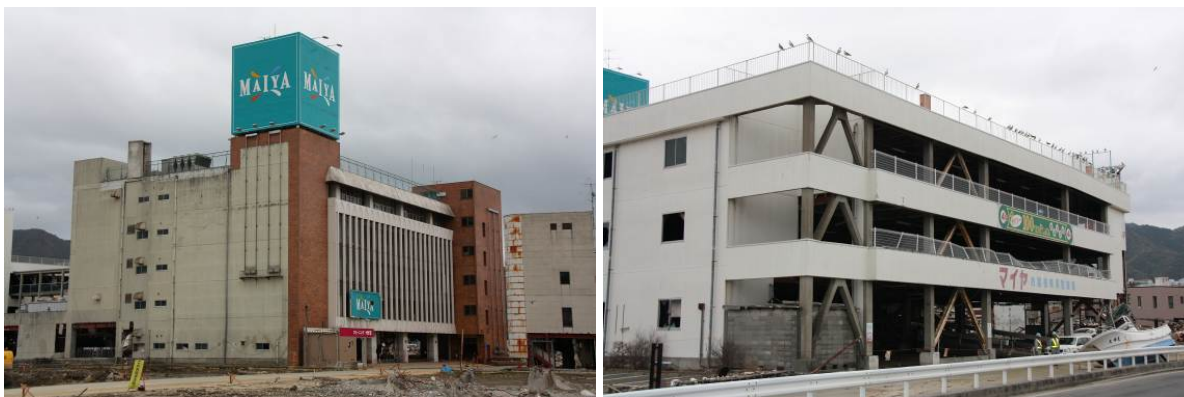
Figure 39 Maiya shopping centre, which was inundated to the 3rd storey

Figure 40 Maiya multi-storey car park showing damaged railing at the 2nd storey.

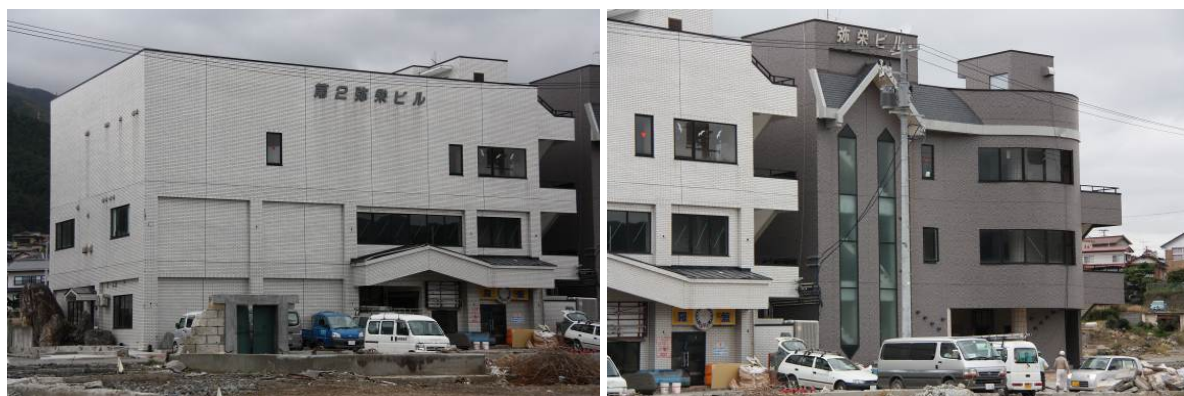
Figure 41 Yasuka private commercial and apartment block number 1 shows very little exterior damage.

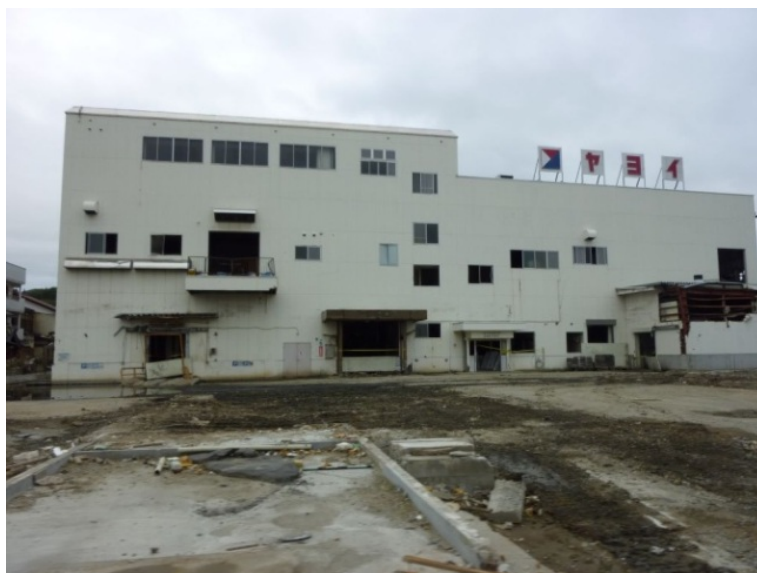
Figure 47 The Yoyoi food factory, where 400 people took refuge. Inundation height was around 8 m here.

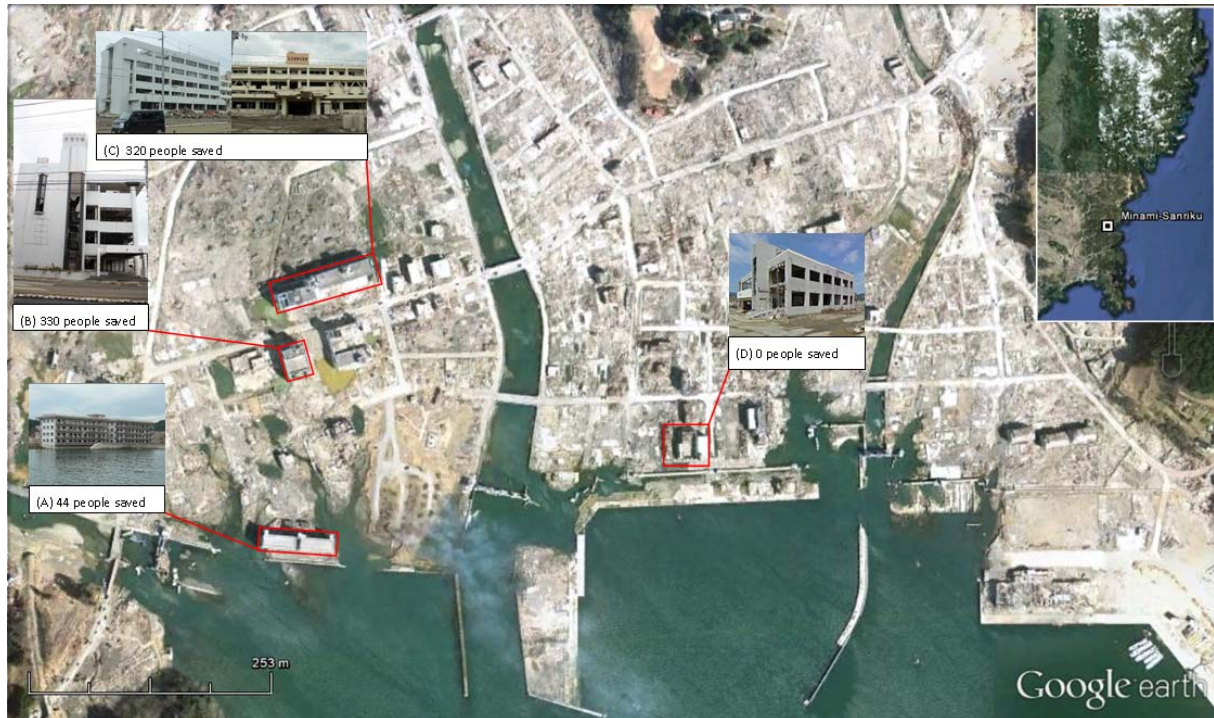
Figure 54 Locations of designated tsunami evacuation buildings in Minami-Sanriku Town: (A) Matsubara apartments; (B) Takano Kaikan building; (C) Shizugawa Hospital; (D) Fisheries Co-operative. Significant scour can be seen where seawater is encroaching around building (A) and to the east of building (D).

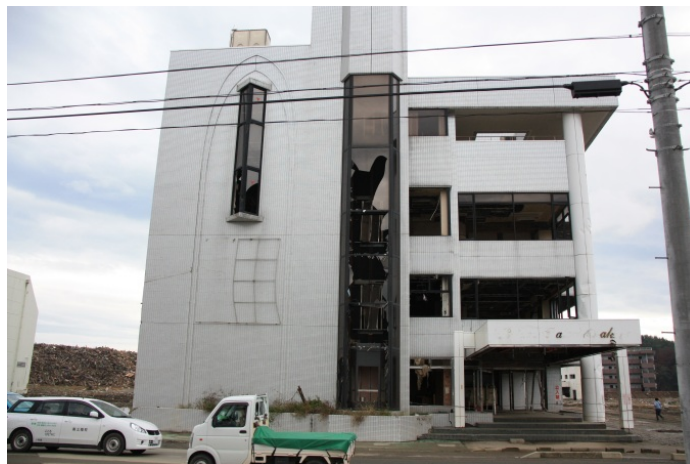
Figure 56 The Takano Kaikan building 160 m inland of the Matsubara apartment block. Little damage aside from glazing was observed here, despite heavy damage and collapse of RC buildings immediately seaward.

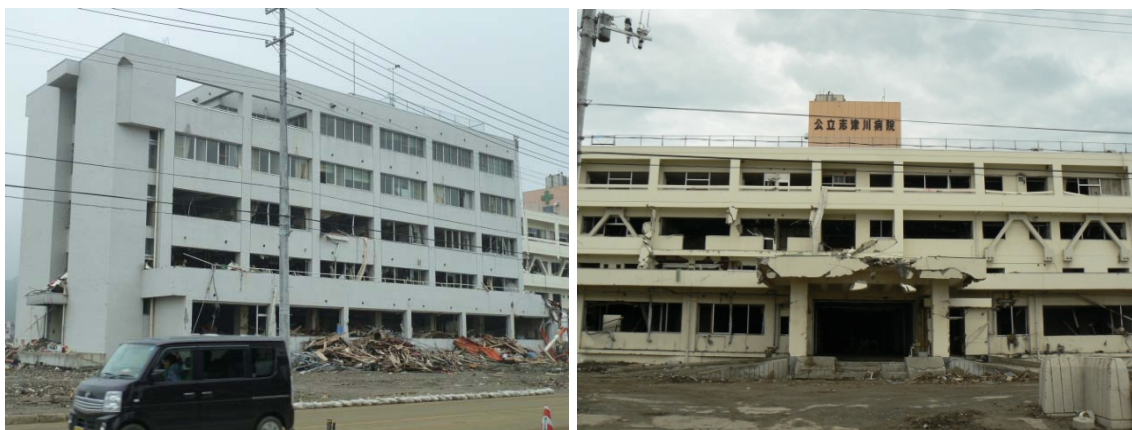
Figure 57 Shizugawa Hospital (west building) – the taller of the 2 hospital buildings at 5-storeys, this section suffered less debris damage than the east building.

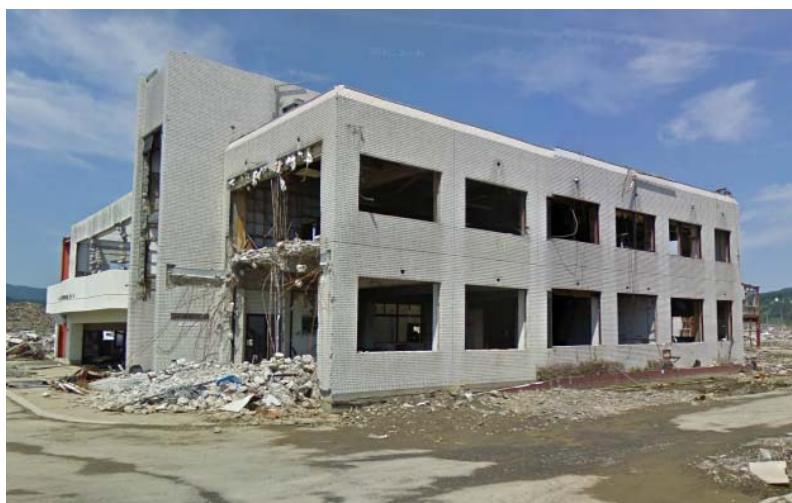
Figure 59 Minami-Sanriku fisheries co-operative building which was overtopped on March 11th. Image credit: Google Streetview, August 2011.

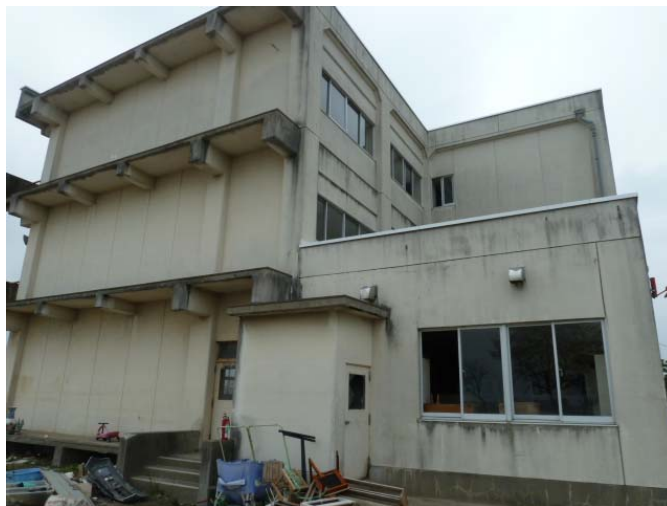
Figure 67 Yuriage Junior High School is constructed on ground which is raised 1.8 m above the surrounding fields. This helped to mitigate damage from the tsunami flow and only contents damage was observed (EEFIT, 2011). 823 people took refuge here.
