**ASSESSMENT OF POTENTIAL ECOLOGICAL  
EFFECTS FOR THE PROPOSED RESTORATION  
OF TE POUARUHE WETLAND COMPLEX  
AT LAKE ŌNOKE, WAIRARAPA**

## **Contract Report No. 4976c**

October 2021

Department of Conservation

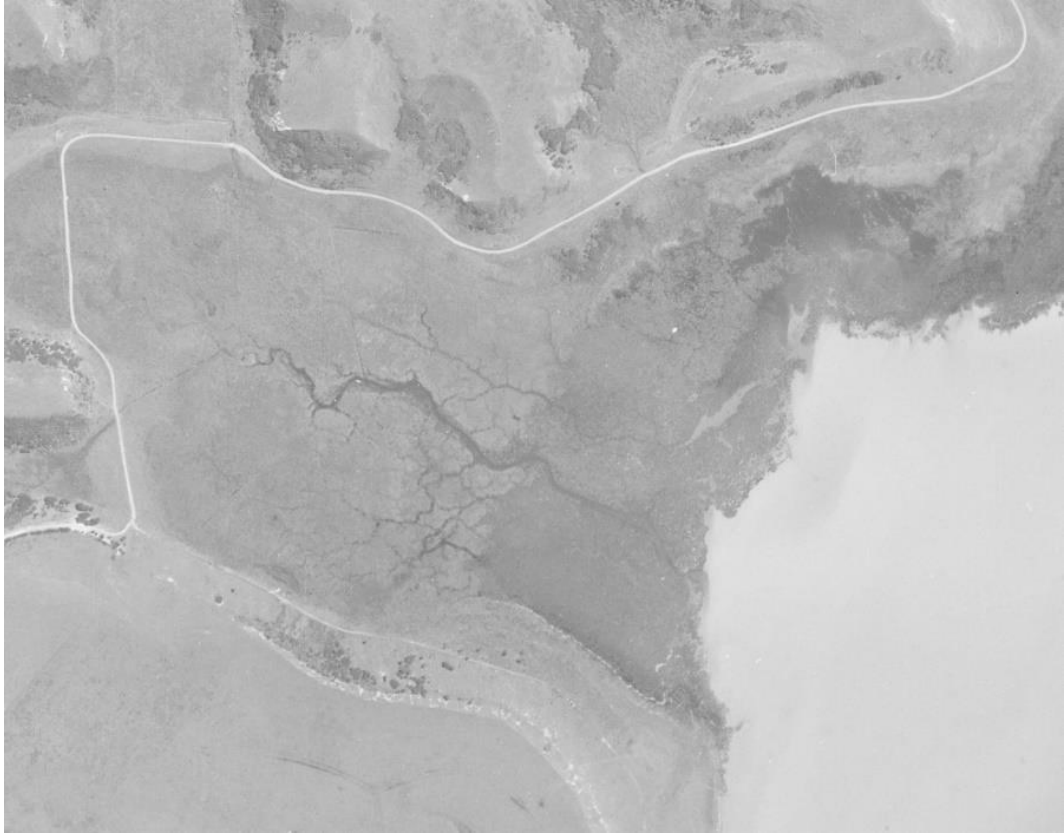
Plate 1: Te Pouaruhe wetland 1941. Image courtesy of Retrolens.

The restoration plan proposes the diversion of streams back into Te Pouaruhe, along routes similar to the original paths seen on historical aerial photographs (e.g., Plate 1), with existing diversion channels and other side channels to be partially infilled (Graeme and Dahm 2018). These works are designed to encourage water to flow into Te Pouaruhe, rather than diverting around the project area through perimeter channels. These hydrological changes are to be accompanied by pest plant control and the restoration of vegetation communities.

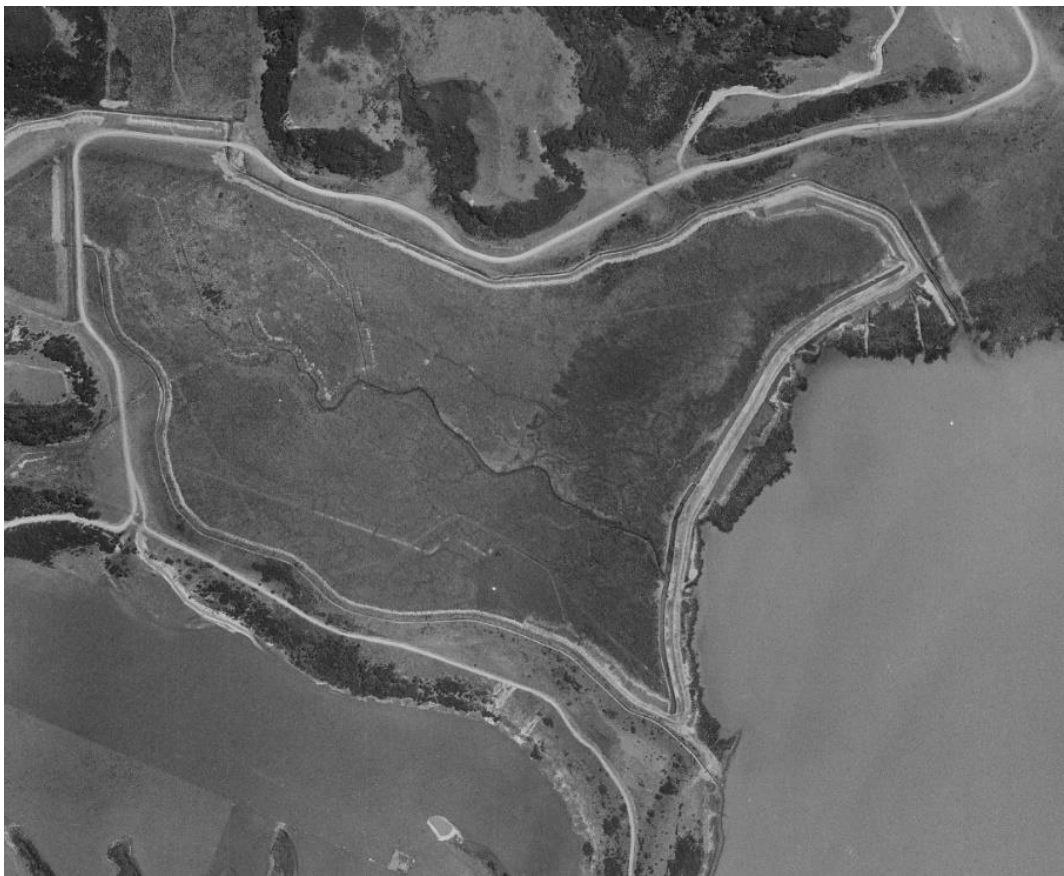
Plate 2: Te Pouaruhe wetland 1961. Image courtesy of Retrolens.

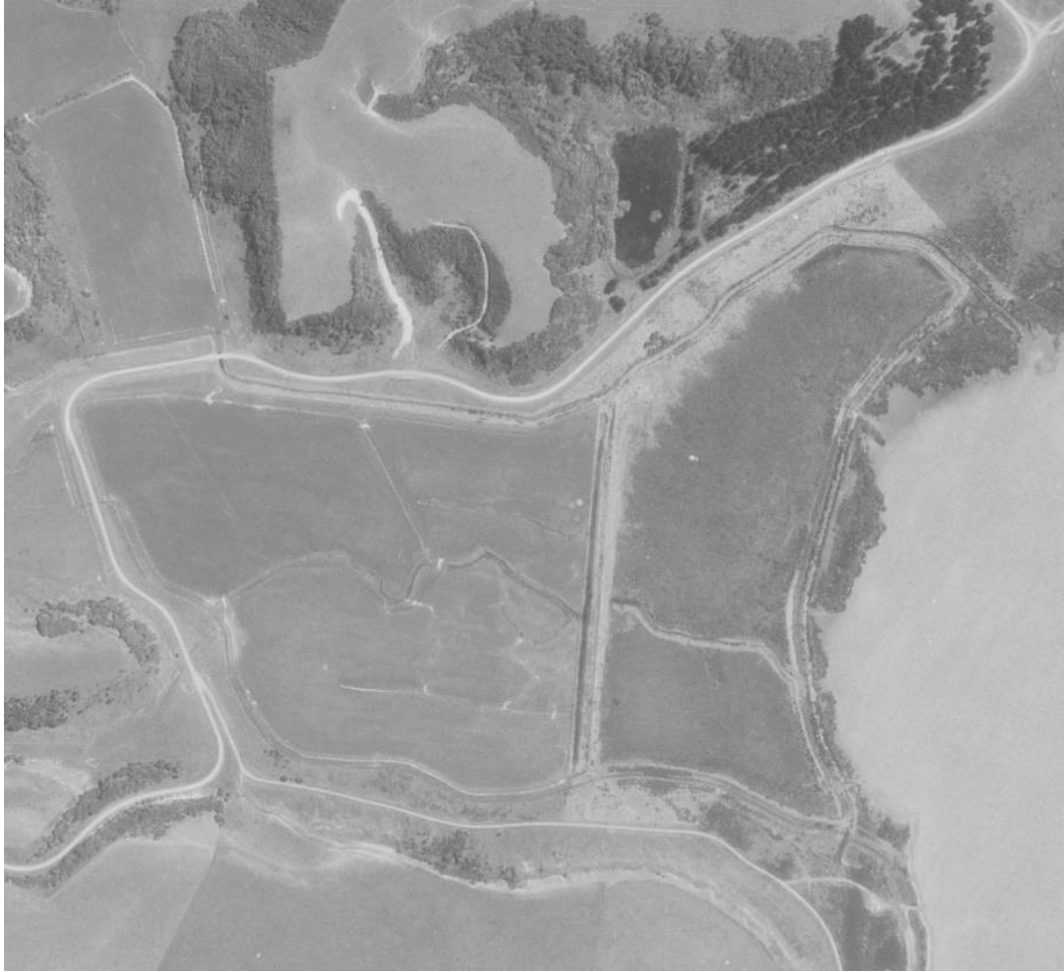
Plate 3: Te Pouaruhe wetland 1988. Image courtesy of Retrolens.

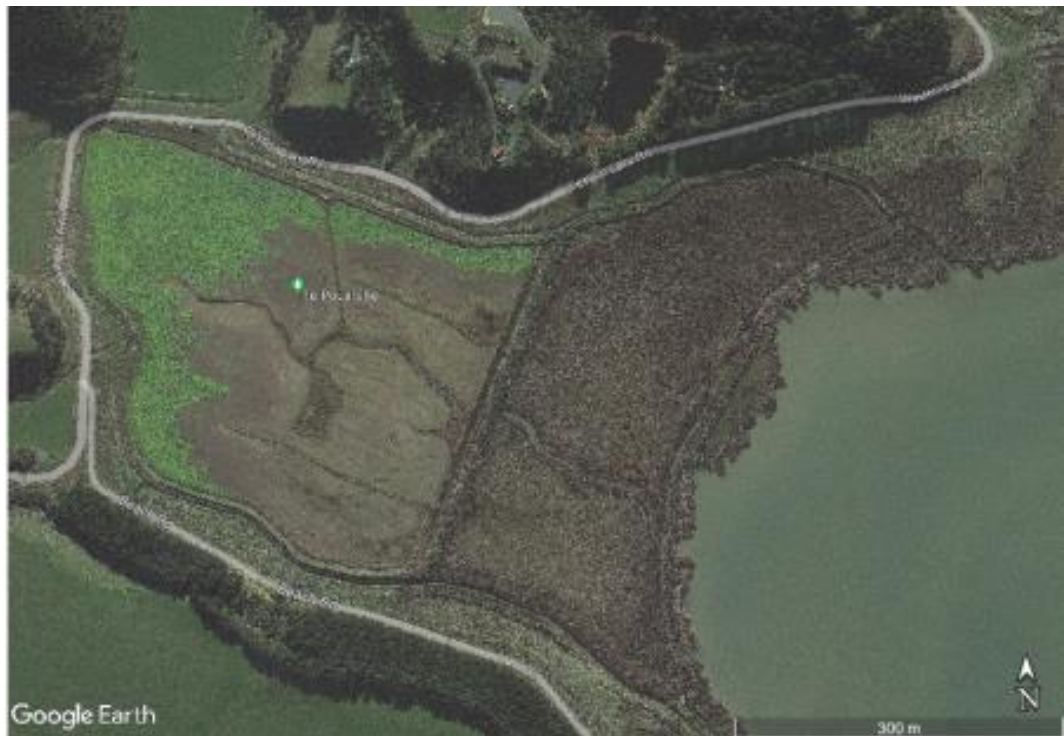
Plate 4: Te Pouaruhe wetland 2021. Image courtesy of Google Earth.

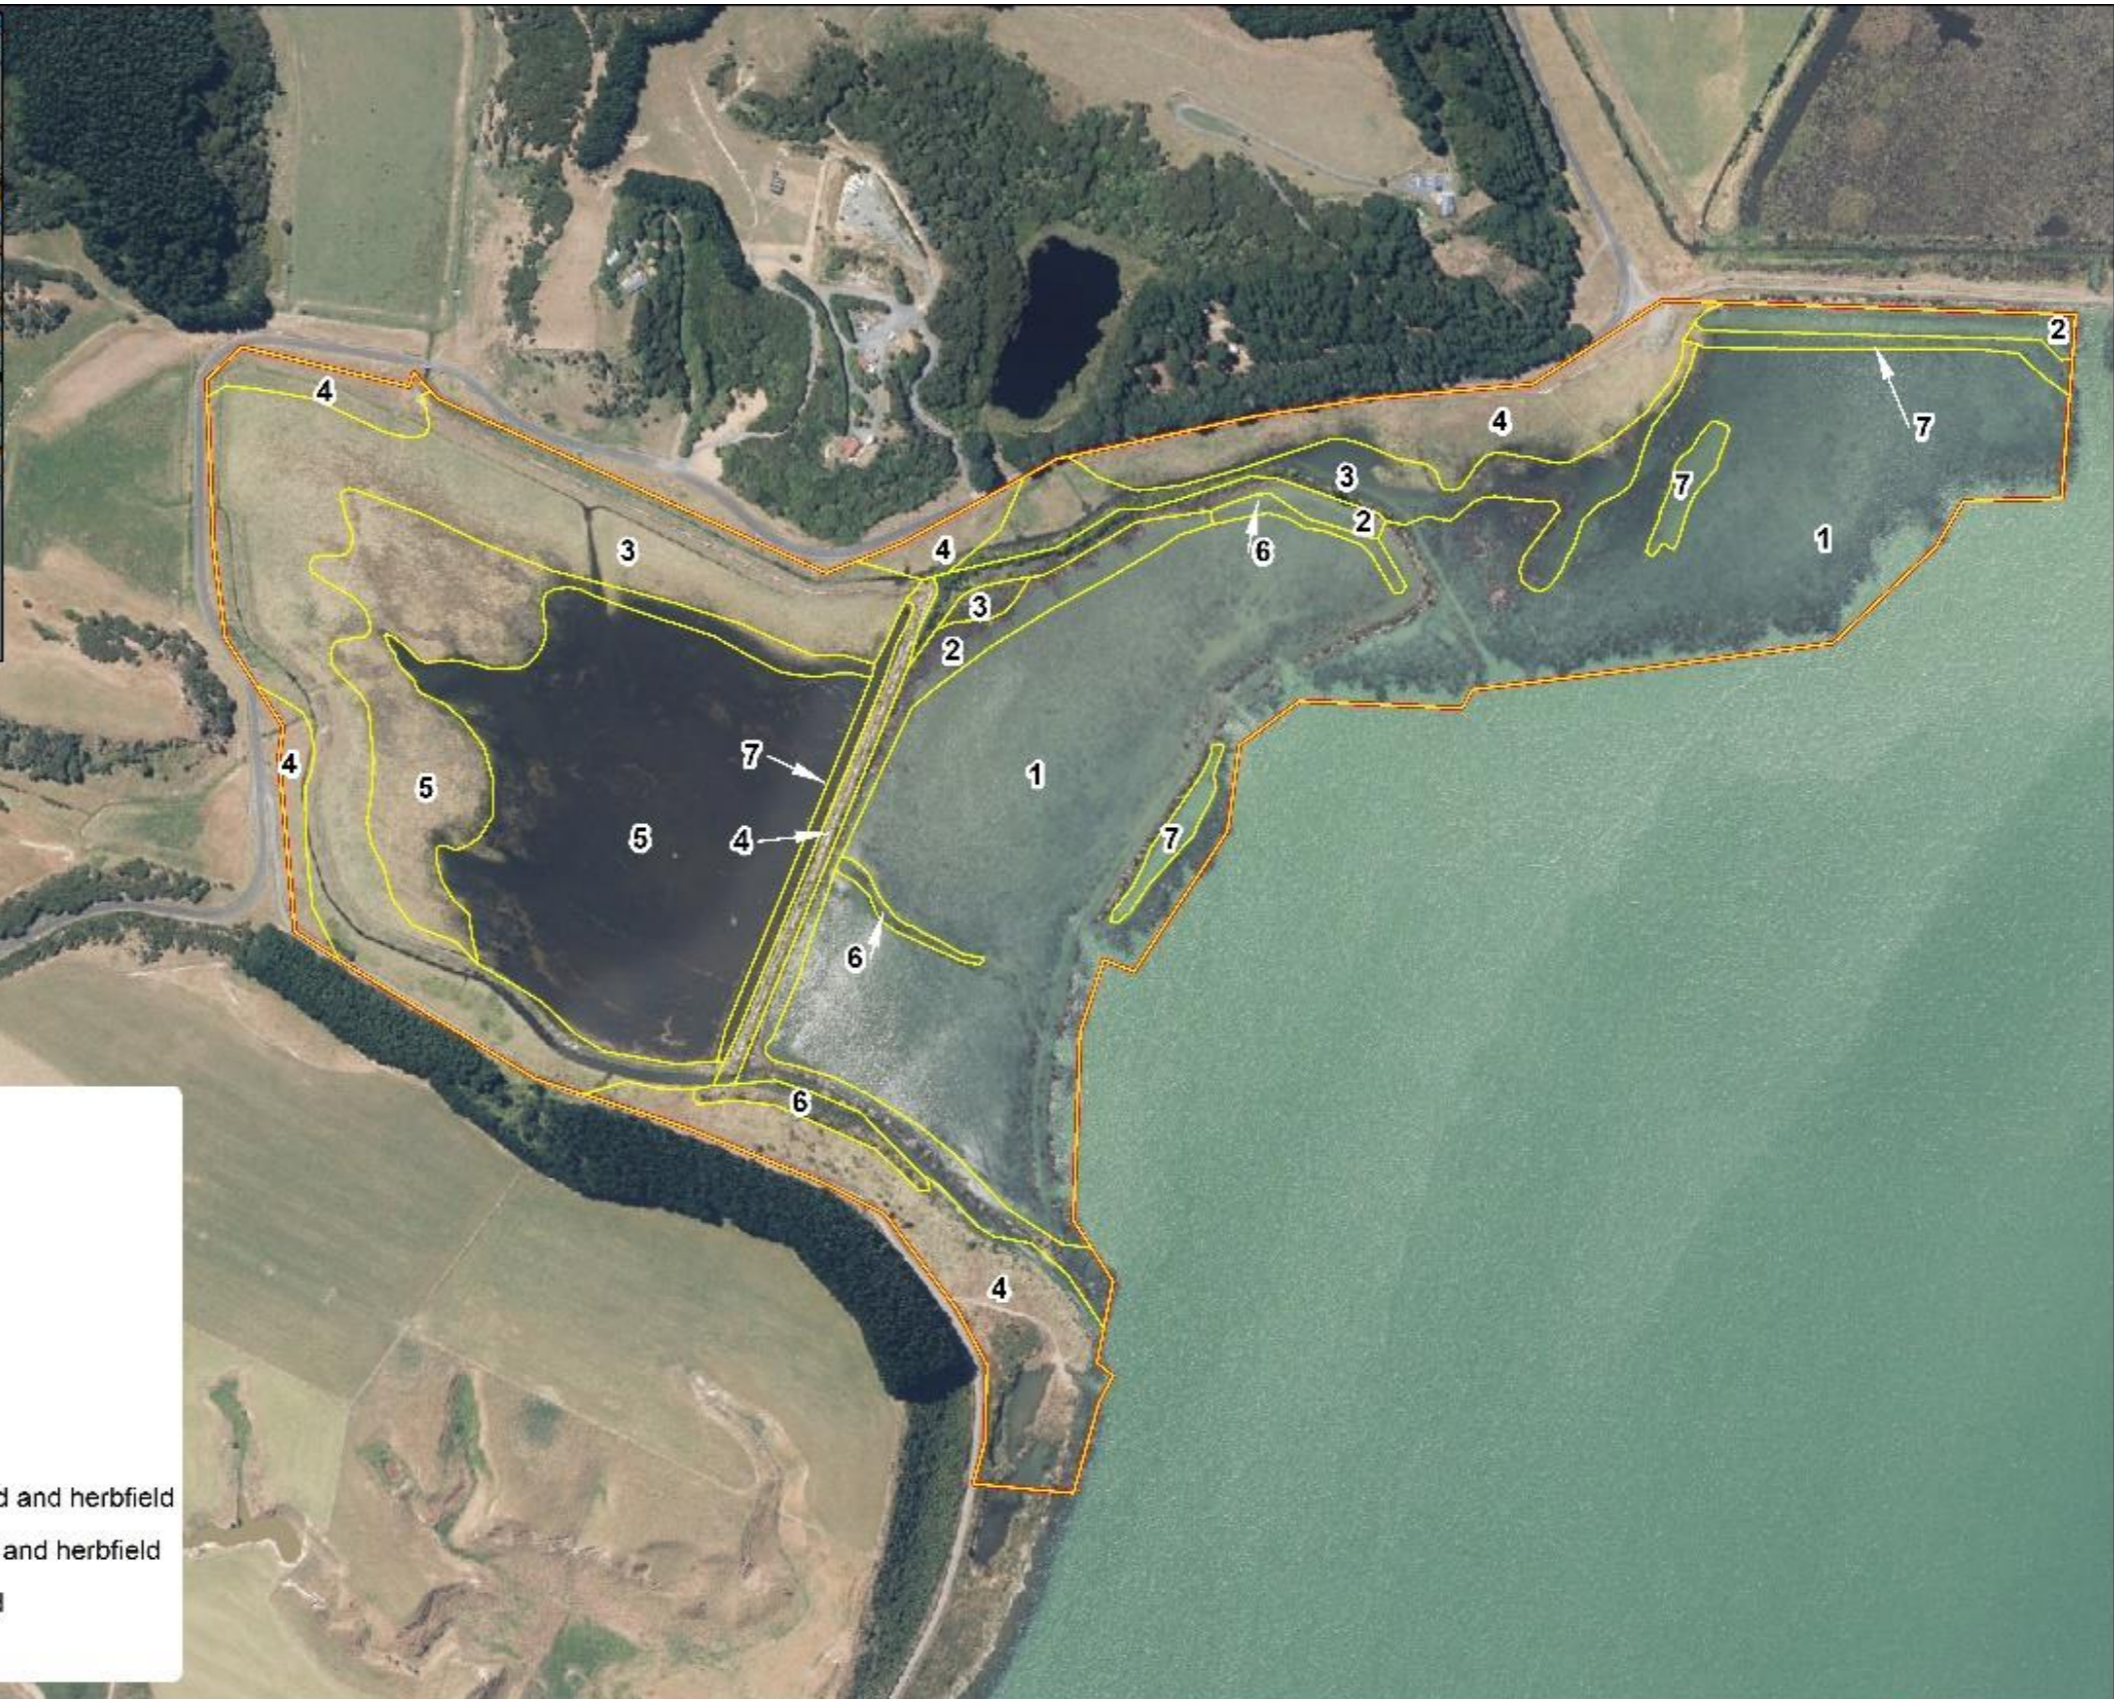
- Te Pouaruhe boundary
- Vegetation and habitat types**
- 1. Oīoī-wīwī rushland
- 2. Saltmarsh ribbonwood shrubland
- 3. Wet exotic grassland
- 4. Dry exotic grassland
- 5a. Mixed indigenous-exotic grassland and herbfield
- 5b. Mixed indigenous-exotic rushland and herbfield
- 6. Indigenous regenerating shrubland
- 7. Open water

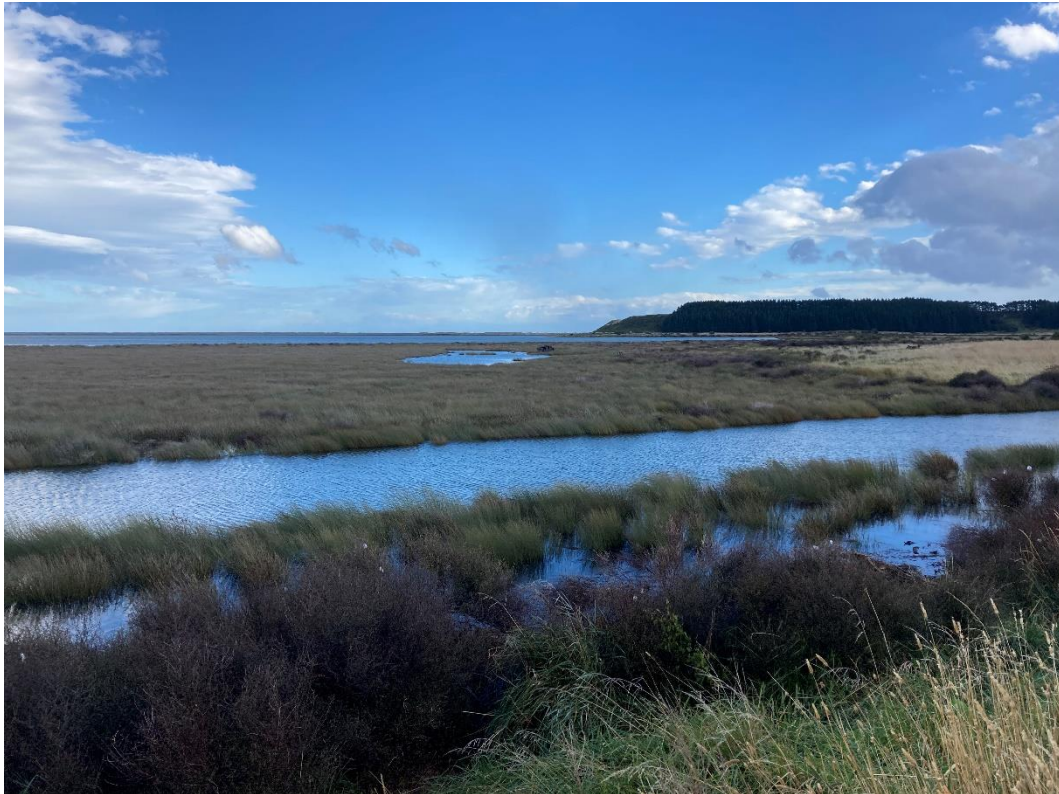
Plate 4: Oīoī-wīwī rushland, bordered by saltmarsh ribbonwood shrubland.  
March 2021.

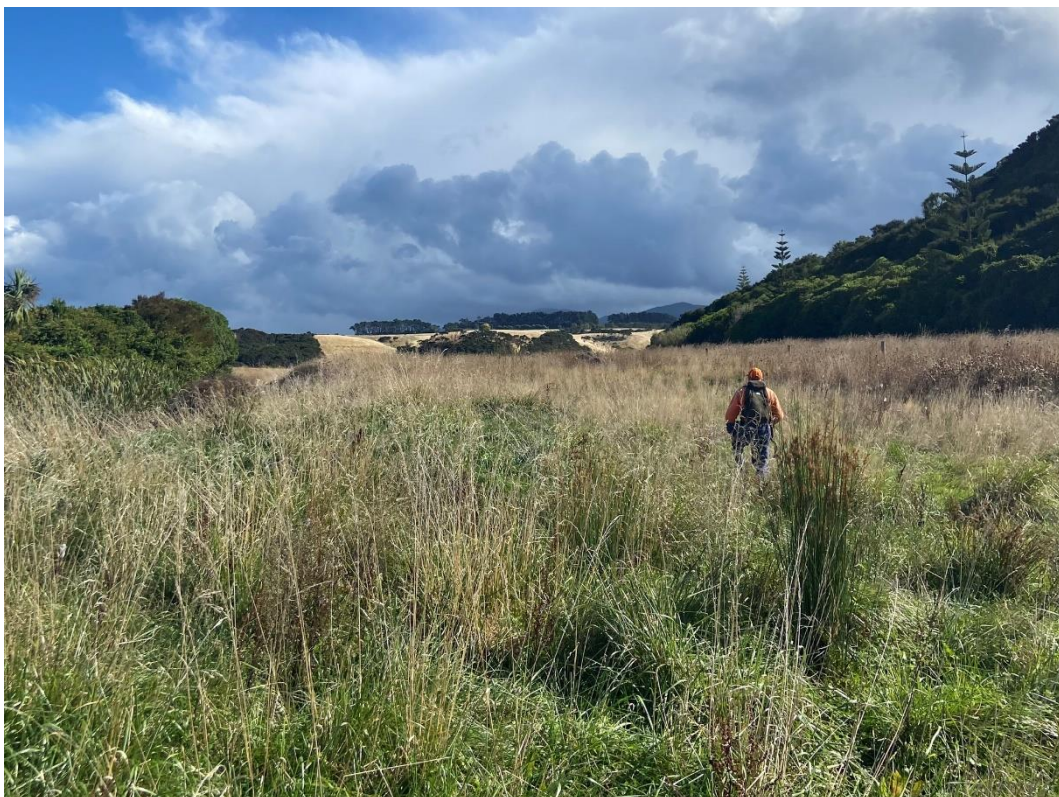
Plate 6: Wet exotic grassland. March 2021.

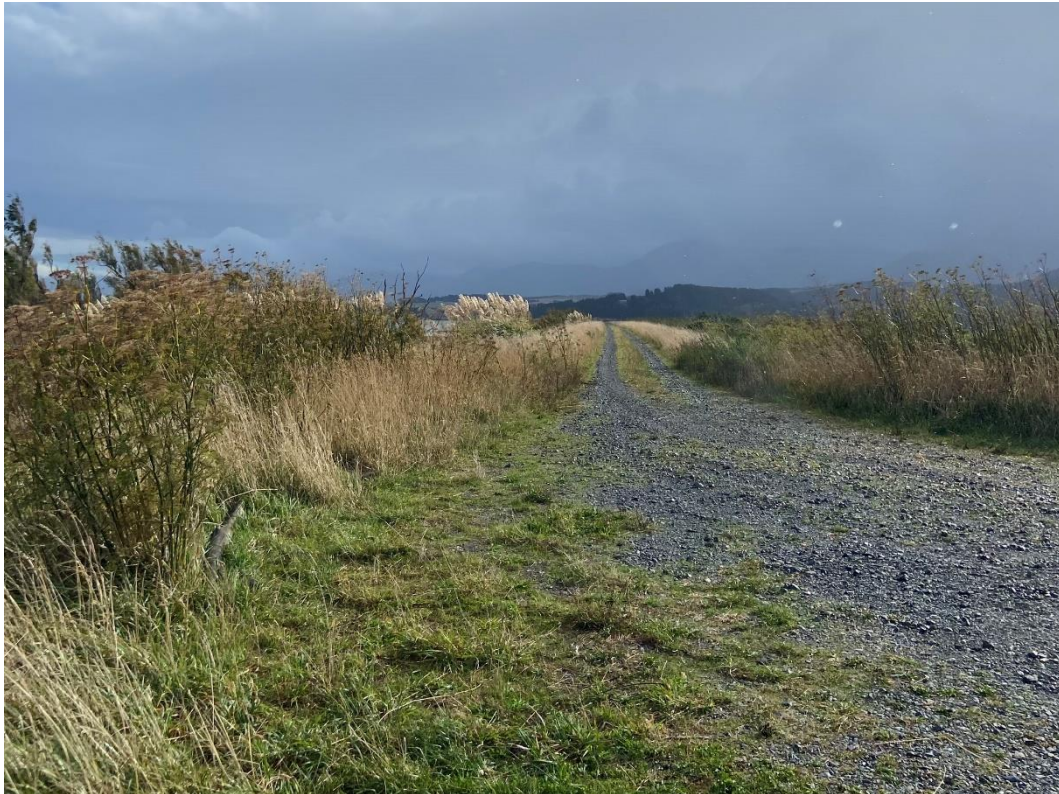
Plate 7: Dry exotic grassland on Stopbank A. March 2021.

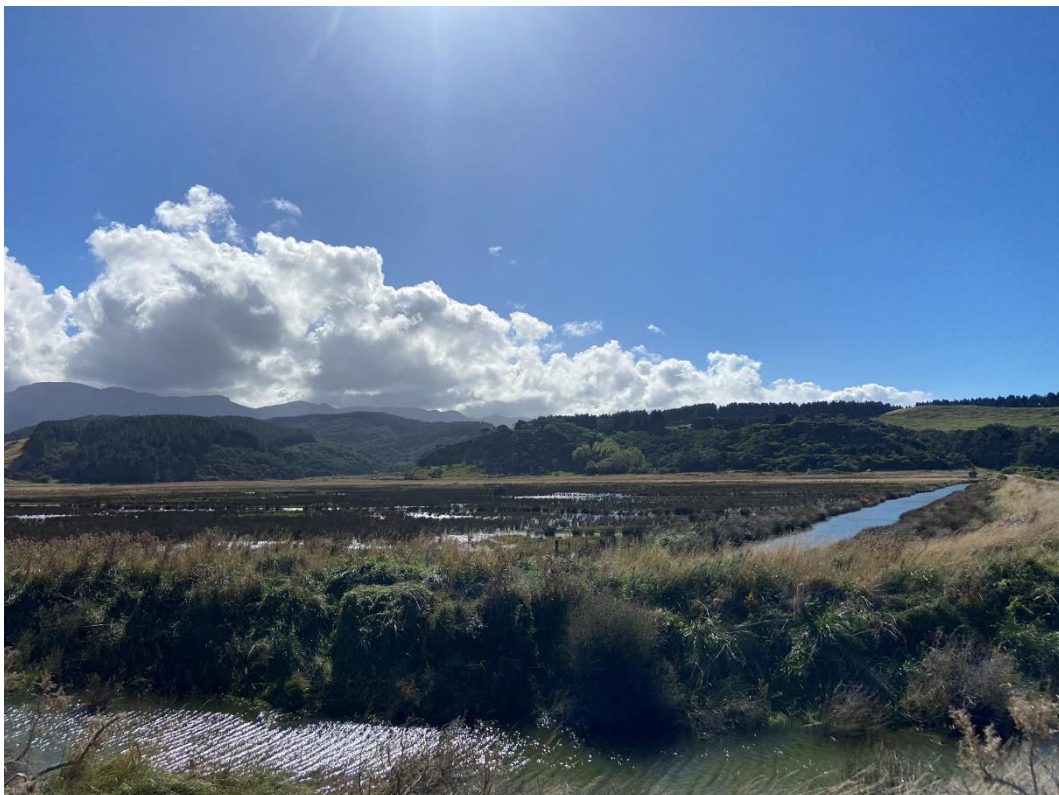
Plate 8: Mixed indigenous rushland and herbfield, with open water and dry exotic grassland in the foreground. March 2021.

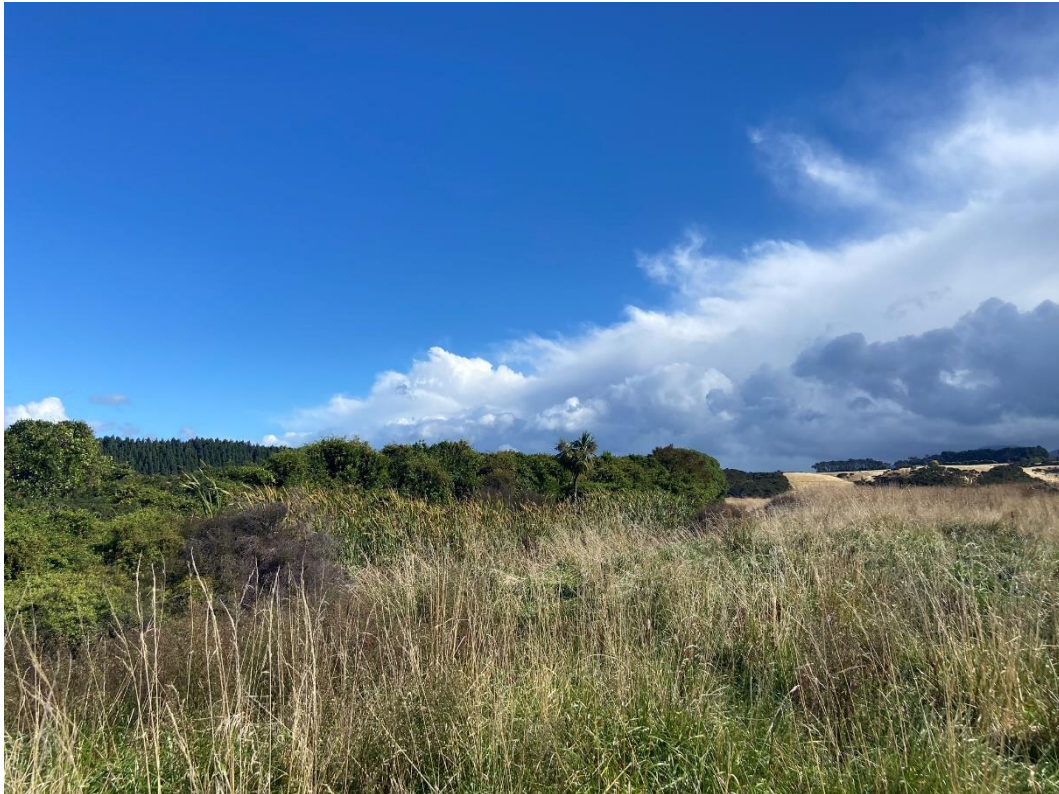
Plate 9: Indigenous regenerating shrubland and wet exotic grassland.  
March 2021.
