Waituna Lagoon 2009

Macrophyte (*Ruppia*) Monitoring

Prepared
for
Department
of
Conservation
June 2009

Barry Robertson and Leigh Stevens

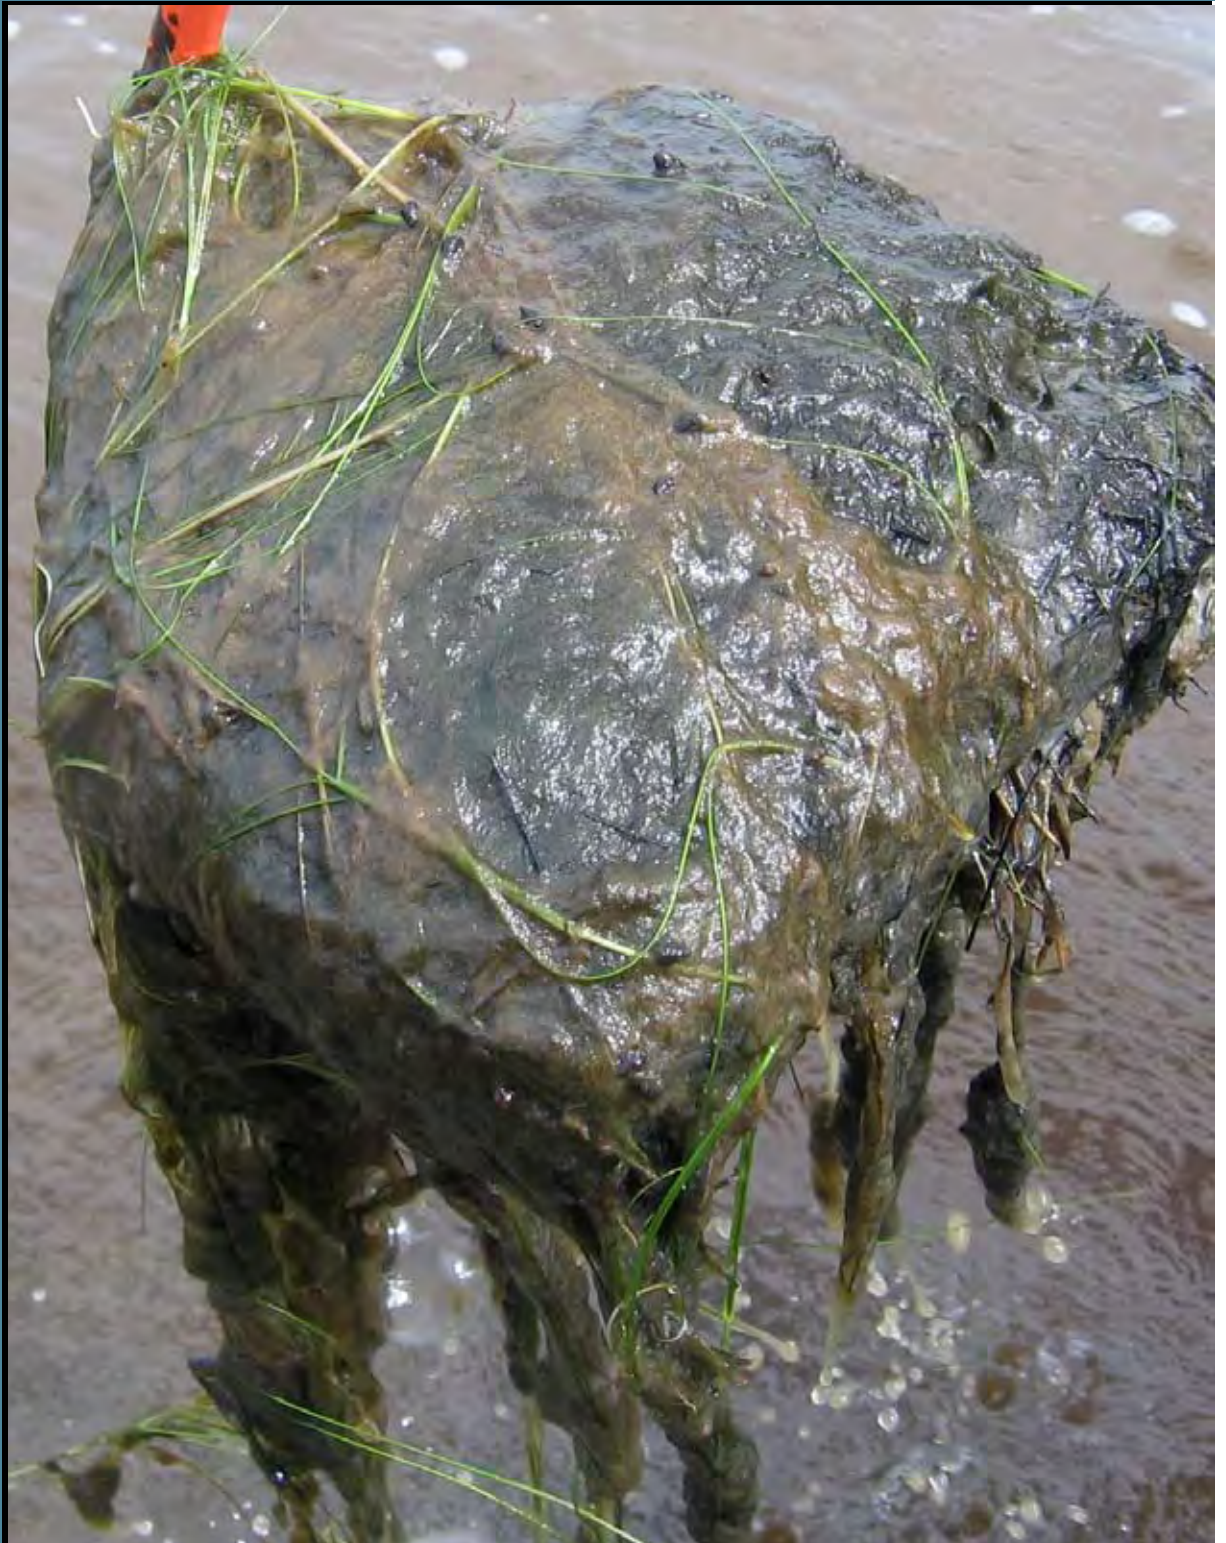
Cover Photo: Waituna Lagoon - typical bottom sample showing dense brown slimy macroalgal layer (*Bachelotia antillarum*) and *Ruppia*.

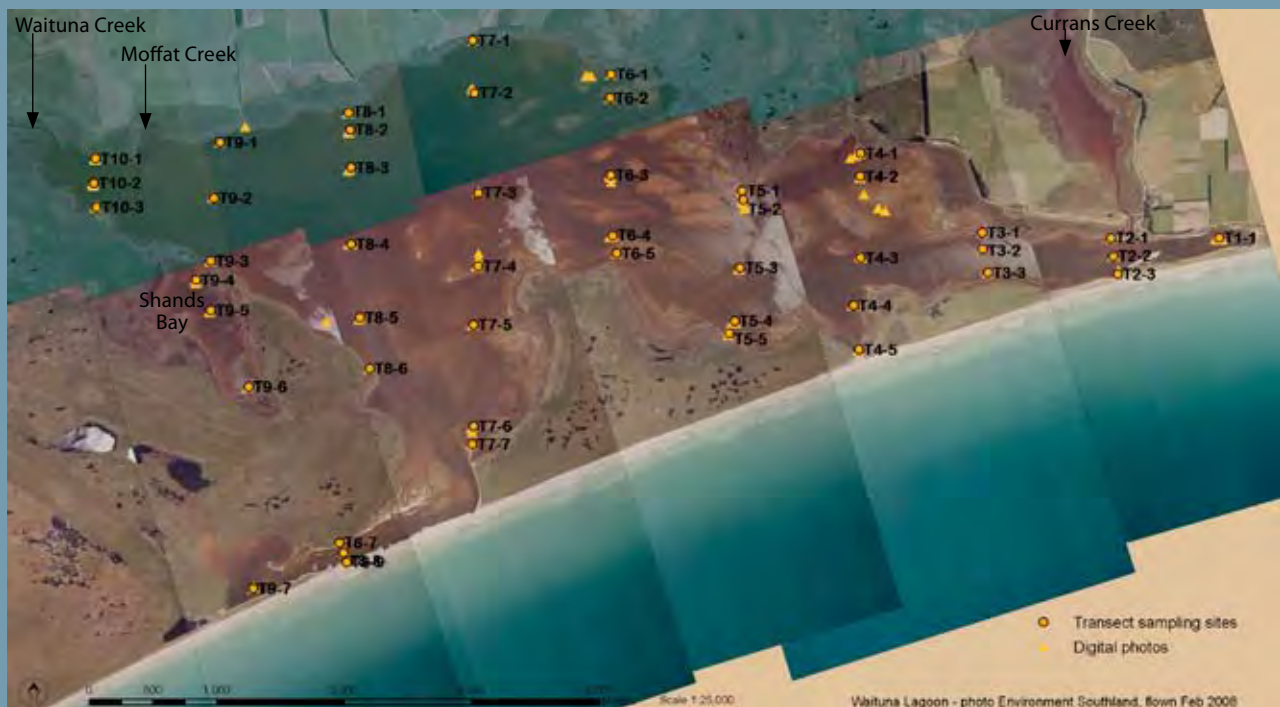
Figure 1. Waituna Lagoon showing transect sampling sites and digital photo locations.

Waituna Lagoon (1350ha), located within the Waituna Lagoon Scientific Reserve, and associated wetland (~2,200ha) is centred in Toetoes Bay in Eastern Southland (Figure 1). It is a large, brackish intermittently open/closed “coastal lake or lagoon” type estuary fed by three streams; Currans Creek, Waituna Creek and Moffat Creek, which pass through highly developed pastoral land and peat bog wetlands. It is separated from the sea by a spit or barrier beach, and the lagoon drains to the sea through a gap at the western end when the lagoon is open. The lagoon also drains through the gravel bar at low rates when closed. Historically, the lagoon was surrounded by a huge peat bog wetland (area approximately 20,000ha stretching from Fortrose Estuary to New River Estuary) whose drainage gave the lagoon water its characteristic clear brown humic stain, low nutrient status, and low pH.

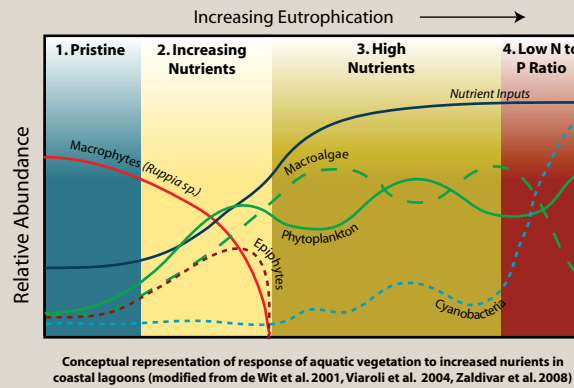
FIGURE 2. COASTAL LAGOON RESPONSE TO INCREASING EUTROPHICATION

Stage 1. Pristine.

In their pristine state, the net nutrient inputs to such coastal lagoons are low and they are dominated by extensive meadows of macrophyte species (e.g. *Ruppia*), which take advantage of nutrient supply from the sediment. Under these conditions water clarity is high. If such lagoons are closed to the sea (as in the case of Waituna Lagoon in 2007 and 2009), the nutrient supply must be very low to maintain pristine conditions compared with lagoons that are open to the sea.

Stage 2. Increasing Macroalgae, Declining *Ruppia*.

As nutrient levels increase to a moderate level, the estuary tips into a stage where nuisance macroalgae, phytoplankton and epiphyte growth increases, and *Ruppia* growth, sediment oxygenation and water clarity declines. In lagoons like Waituna, even a small nutrient increase is enough to cause this shift.

Stage 3. *Ruppia* Absent, Nuisance Macroalgae Dominant .

When nutrients reach high concentrations, *Ruppia* is lost from the lagoon and replaced with nuisance short-lived macroalgae and phytoplankton. Water clarity is low, sediments are anoxic close to the surface and sulphide rich, and sediment macrofauna is dominated by high numbers of a few tolerant species only.

Stage 4. Nuisance Cyanobacterial Blooms Dominant.

At the fourth stage, the nitrogen to phosphorus ratio declines to low levels and results in nuisance cyanobacteria and toxic bloom events. Sediment macrofauna are often absent, but nuisance short-lived macroalgae. (e.g. *Bachelotia* and *Enteromorpha* sp.) and phytoplankton are still present. Water clarity is low and sediment quality poor (mud content is increasing, anoxic, and sulphides high).

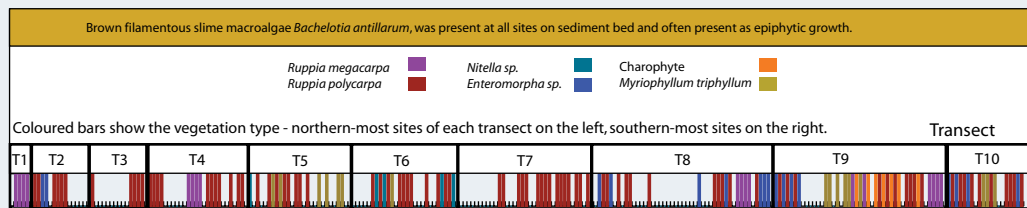
Figure 3. Aquatic vegetation type along the 10 transects on 25 February 2009.

The survey results showed that the macrophyte community was dominated by *Ruppia polycarpa*. *Ruppia megacarpa* was also present but only at a few sites. The only other macrophyte which was relatively common (but in isolated patches only) was the water milfoil *Myriophyllum triphyllum*. Figure 3 presents the species composition at each site while Figure 4 summarises the percentage cover and distribution of *Ruppia* across the lagoon in relation to water depth.

Perhaps the most important result of the survey was the widespread occurrence of nuisance macroalgal growths. In particular, the filamentous slime macroalgae, *Bachelotia antillarum*, growing on the sediment surface (and as epiphytic growth on macrophytes). In addition, locally abundant beds of *Enteromorpha* sp., a green filamentous macroalgae, were also present in shallow margin areas. Various charophyte species, including *Nitella* were also locally abundant in some areas.

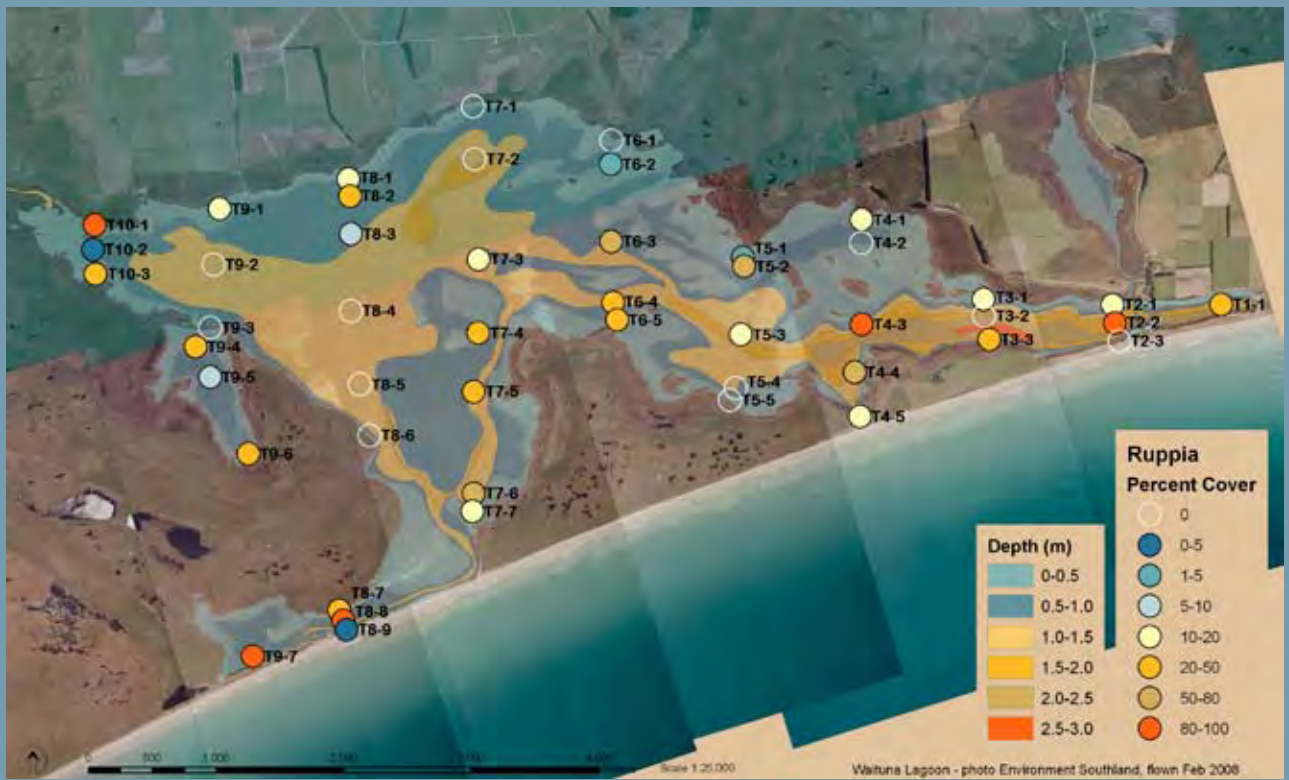
Figure 4. Percent cover of *Ruppia* (mean of 4 replicates) along the 10 transects on 25 February 2009.

Approximate lagoon water depth is shown in Figure 4 and at each site in Figure 5. Sampling depths were relatively shallow and varied from 30cm near the margins to 2.1m in the channel at the east end. The lagoon water level was 1.057m above msl on the day of sampling.

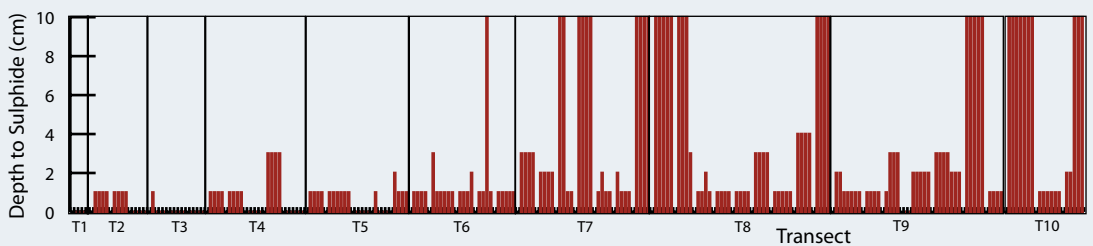
Figure 6. Depth to black anoxic sulphide layer along the 10 transects on 25 February 2009.

The depth to the black anoxic sulphide layer varied between sites (Figures 6 and 7). It was in the 0-3cm range at the majority of sites, which is indicative of low sediment oxygenation. However, it was also noted that this anoxic layer was often near the surface only, adjacent to the rotting mass of decaying macroalgae (primarily *Bachelotia*) lying on the sediment surface.

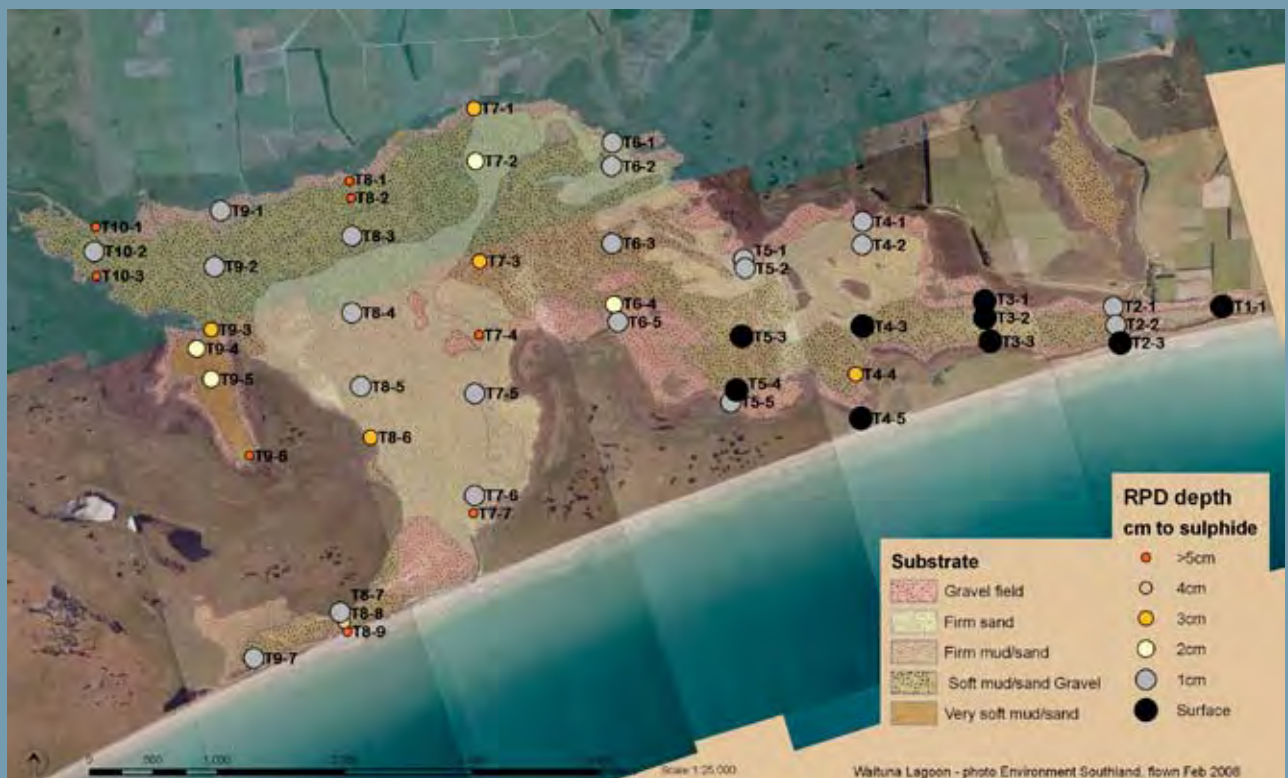
Figure 7. Depth to sulphide (RPD) layer (mean of 4 replicates) along the 10 transects on 25 February 2009.

The broad relationship between RPD depth underlying substrate type (mapped previously by Stevens and Robertson 2007) is shown in Figure 7. Overall, the RPD tended to be closer to the surface in finer sediments, although there was significant localised variation depending on the extent of decaying macroalgae present. Anoxic surface sediments were primarily located in the narrow eastern arm of the lagoon.

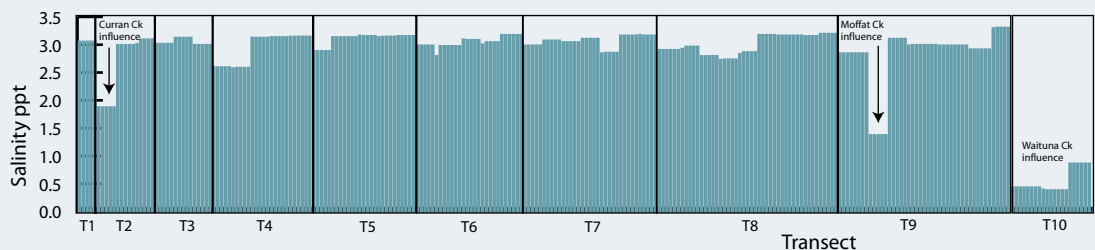
Figure 8. Water salinity at each site and replicate along the 10 transects on 25 February 2009 (surface and bottom measures are included).

The lagoon was brackish (Figure 8) with a relatively constant salinity of around 3ppt, except near the mouths of the three input streams (Waituna, Moffat and Curran Creeks) where the salinity dropped closer to that of freshwater (0.5 to 2 ppt). The data show little difference between surface and bottom salinities, indicating that the lagoon waters were well-mixed.

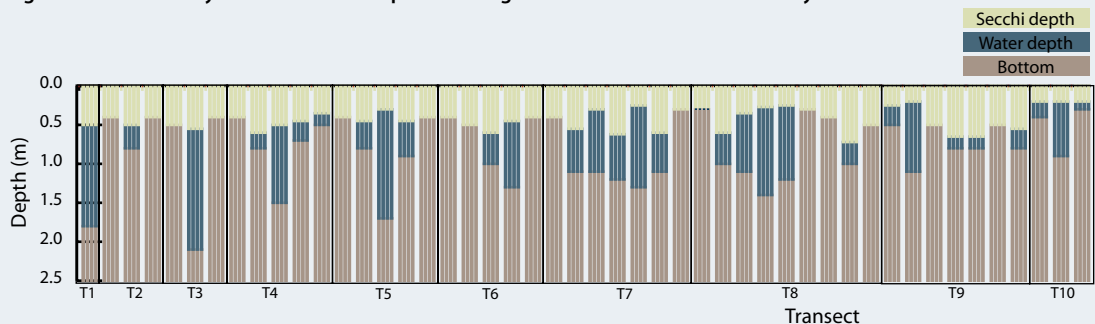
Figure 9. Water clarity at each site and replicate along the 10 transects on 25 February 2009

Secchi disc clarity (Figure 9) was low throughout the lagoon (0.2-0.7m) with the lowest values measured near the Waituna Creek input and the highest values near the seaward spit at the western end of the lagoon. Such low values meant that a limited amount of light was reaching the bed over much of the lagoon.

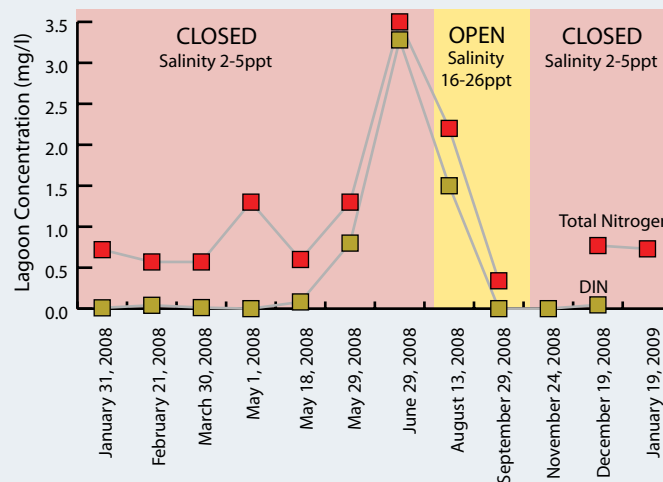
Figure 10. Measured nitrogen concentrations in Waituna Lagoon 2008 and 2009.

The other approach to lagoon restoration is to increase flushing and dilution by increasing the period when the lagoon is open. Figure 10 shows a buildup in N concentrations during the colder winter months (likely attributable to lowered plant uptake and increased inputs from the catchment), followed by a large decline (3 mgN/l to less than 0.5 mg/l TN) when the lagoon was opened on 25 August 2008.

After it closed again 43 days later on 7 October 2008, the lagoon N concentrations remained low (likely attributable to high nuisance plant uptake). By February 2009, the lagoon had widespread nuisance macroalgal growths and anoxic bottom sediments.

The question therefore arises, if the lagoon mouth was opened in January and left open till March (i.e. during the main growing season), would the lagoon be restored to good condition and nuisance macroalgal growth return to low levels? Without much doubt, the answer would be that the lagoon response would be; dilution of the brackish lagoon water with low nutrient seawater, loss of nutrients to the sea via tidal exchange, and consequently less N available in the lagoon for nuisance plant growth.

However, such an approach is likely to risk damage to the *Ruppia* beds through excessive salinity effects and exposure of some of the beds. Recent Environment Southland monitoring (Figure 10) shows that salinities during the last 43 day opening were high (16-26 ppt, note that 33ppt is full strength seawater) throughout the lagoon. Various studies indicate that optimum salinity range for *Ruppia* seed germination, establishment and growth is 4 to 8ppt so extended periods of lagoon opening may expose *Ruppia* to suboptimal conditions (Schallenberg and Tyrrell 2006). In addition, Stevens and Robertson (2007) showed that the exposure of the lagoon bed, as a result of prolonged opening, would decrease the likely area of *Ruppia* cover in the lagoon by approximately one third. Therefore there are likely to be high risks to the continued success of *Ruppia* and the Waituna Lagoon ecology if the increased lagoon opening option is taken.

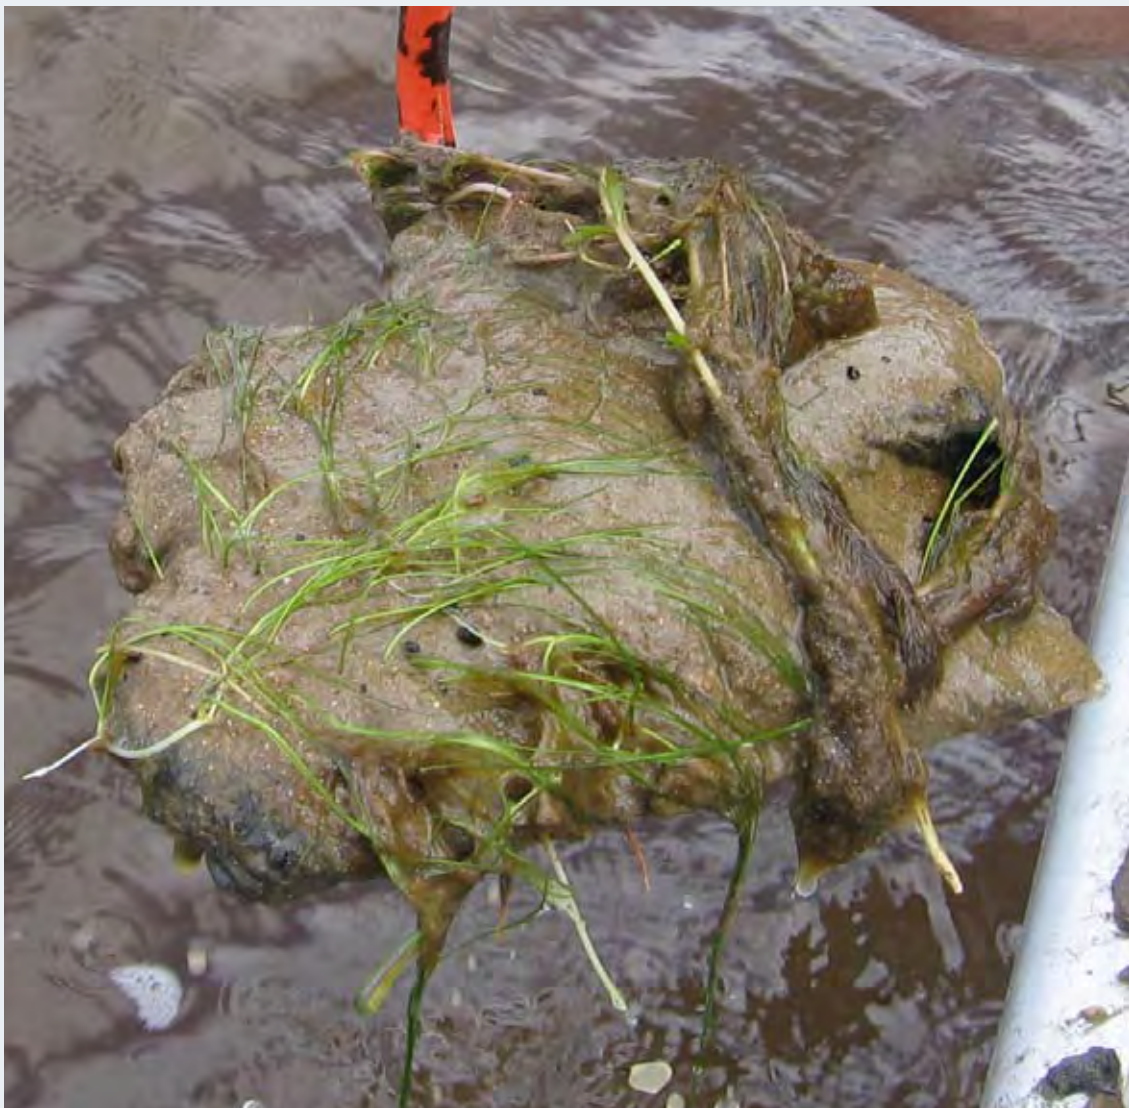
Aquatic Vegetation, and Site Details Waituna Lagoon 25 February 2009

Note: Dense bloom of brown filamentous macroalgae, *Bachelotia antillarum* also covered the bed of almost all sites, and was not present on most photographs because it had slid off as it was brought above the surface.
