Location and productivity of īnanga (*Galaxias maculatus*) spawning grounds in the Arahura catchment

Technical Report · July 2020

Prepared for
Department of Conservation
July 2020

Report WL20062 for Department of Conservation
© Copyright Waterlink Ltd

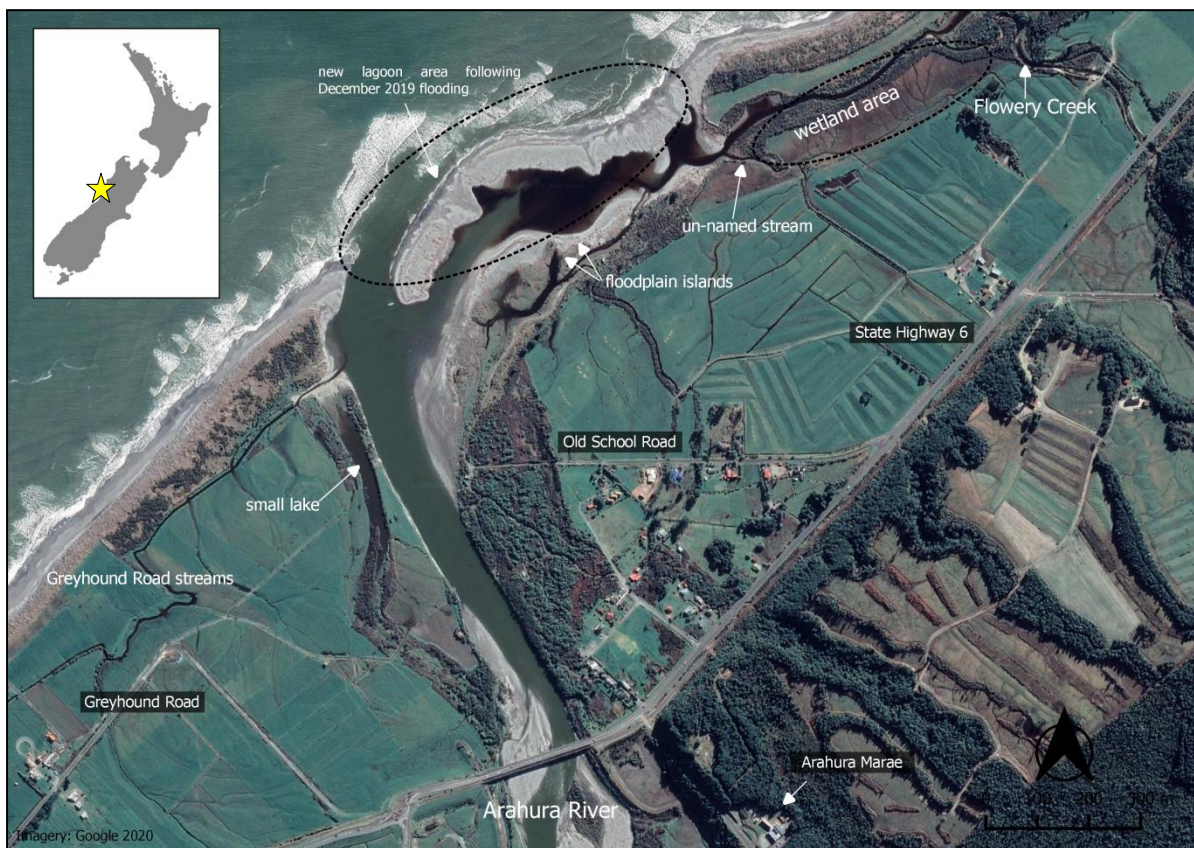
Fig. 1. Overview of the Arahura River lagoon system showing major water features visible in recent aerial imagery. Extensive changes have occurred since December 2019 in the area indicated, illustrating the dynamic nature of the rivermouth system. See imagery comparisons in the results section below.

Investigations were undertaken to characterise the tidal range and locate spawning sites to provide a baseline for future monitoring and support restoration work. Prior to this project, there were no previously reported spawning sites in the river system despite there being an abundance of suitable habitat for adult fish. This is provided by an extensive lagoon complex of lowland waterways, small lakes and associated wetlands that extend both north and south from the Arahura River mouth (Fig. 1).

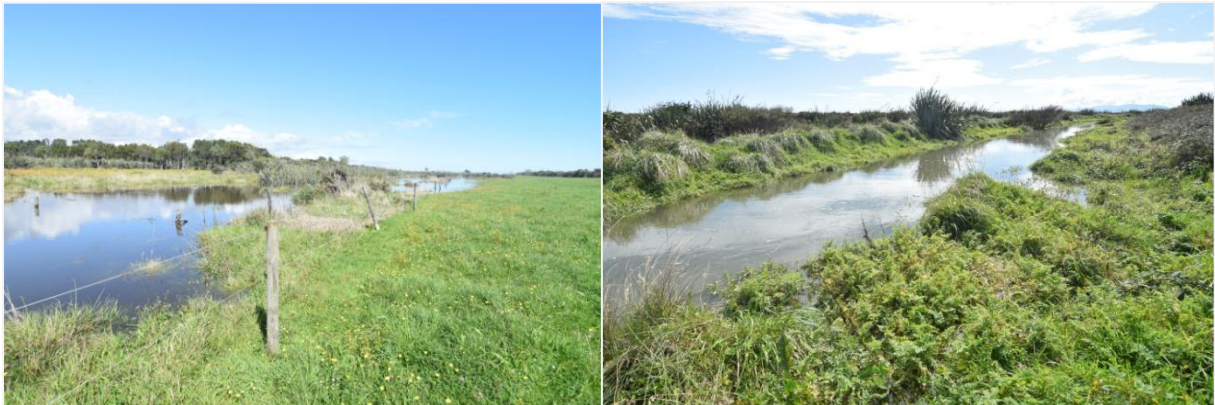
Fig. 2. (a) Water levels on the peak of the tide on 10 March in the northern tidal creek above the Flowery Creek junction were sufficient to inundate pasture on the DOC land boundary. (b) view of the southern tributary near Greyhound Road.

The salinity survey was completed on a relatively large tide (Table 1) combined with a moderate fresh in the river. The survey was conducted on two days to help address the large area involved, with the northern lagoon and waterways surveyed on 10 March and the southern tributaries the following day (Fig. 2).

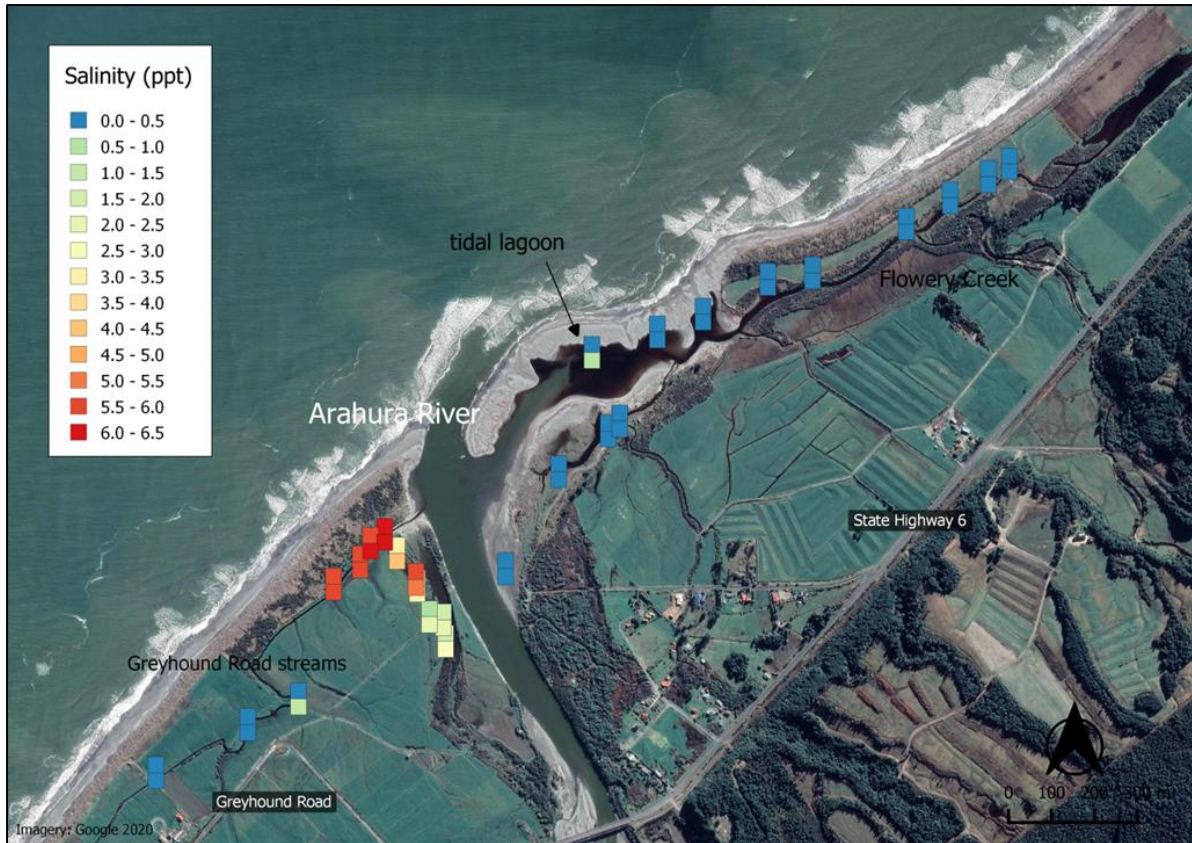
Fig. 3. Maximum salinity recorded on the spring high tides of 10-11 March 2020 at the Arahura River. At each monitoring point the bottom icon is bottom salinity, and the top icon is salinity measured 10 cm from the top of the water column.

The salinity survey was completed on 10-11 March 2020 with the objective of establishing the upstream limit of salt water intrusion and estimating peak salinity values at as many locations as possible across the lagoon system. The survey was timed to follow the incoming tide upstream following Orchard & Hickford (2018). At each monitoring site, measurements were taken at the bottom and 10 cm from the top of the water column. Salinity monitoring sites are shown in Fig. 3.

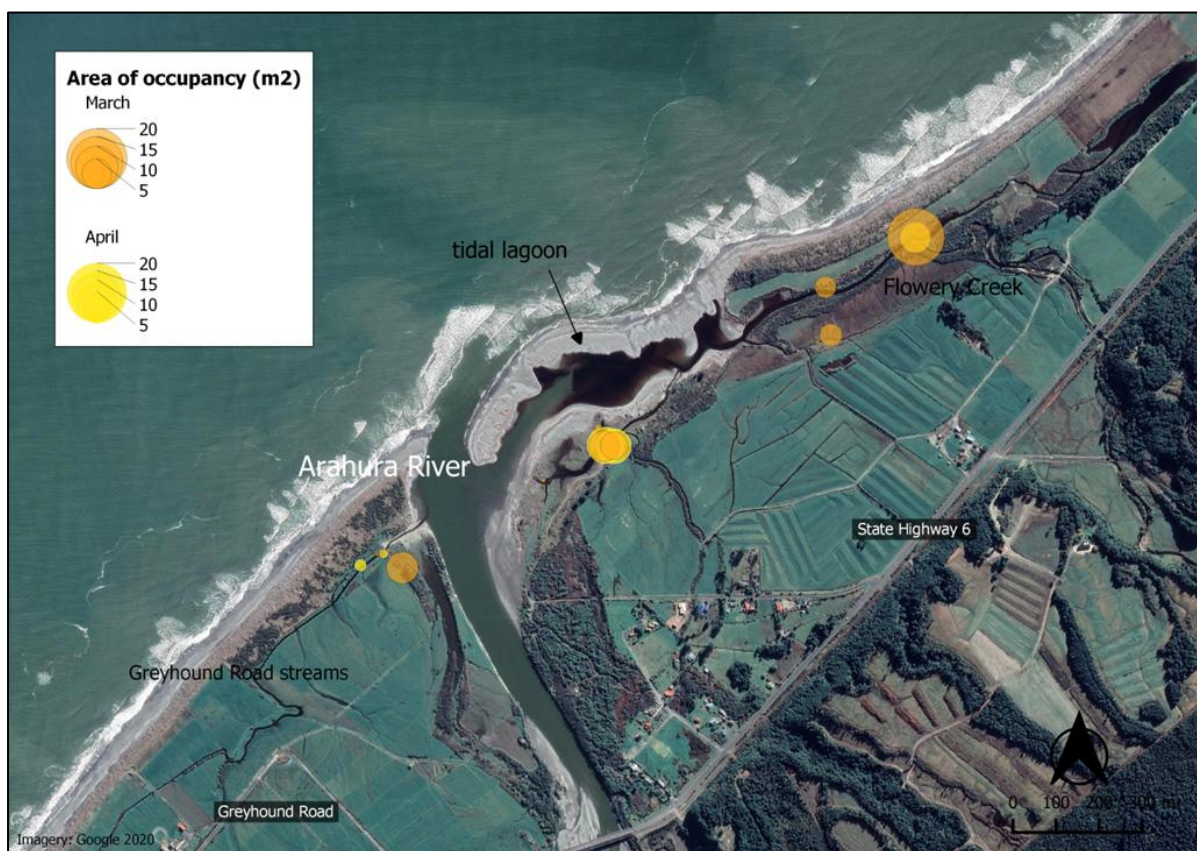
Fig. 5. Location and size of Īnanga spawning sites in the Arahura catchment in March and April 2020.

The total area of occupancy (AOO) of spawning sites was 46.0 m² in March and 17.5 m² in April (Fig. 5). Due to repeat use of three sites between months, there were a total of 15 individual sites recorded overall.

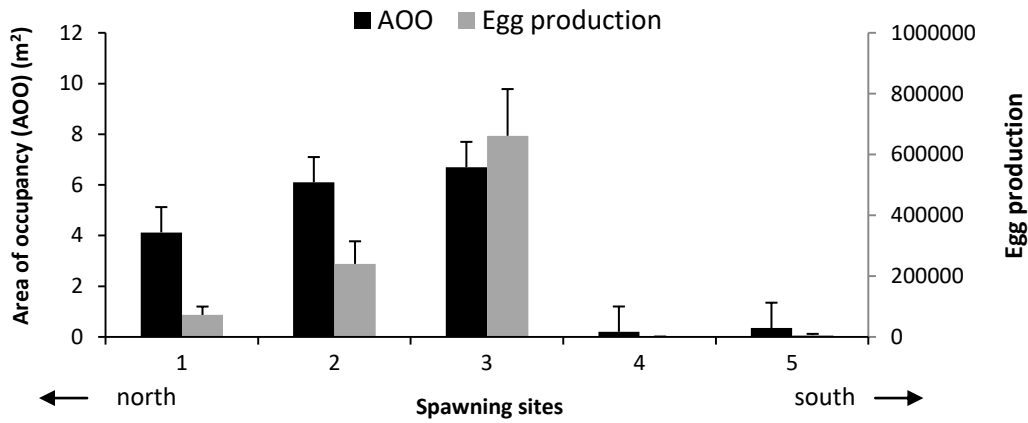
Fig. 8. Area of occupancy (AOO) and egg production of Īnanga spawning sites in tributaries of the Arahura River in April 2020. Errors bars are standard error of the mean.

In April, the overall spawning activity was less, with just under 1 million eggs recorded across five sites (Fig. 8). The Flowery Creek site was much smaller than in March (4.1 m²) and also had lower egg densities resulting in a total of 72,000 eggs. However, the two repeat-use sites in the floodplain island area were both more productive than in March, with 240, 000 and 660, 000 eggs respectively (sites 2 and 3 in Fig. 8). Egg densities at the latter were the highest recorded at any site over both months of the survey, with 9.9 eggs / cm². These sites are in the same vegetation patches as March site numbers 5 and 6 (Fig. 7).

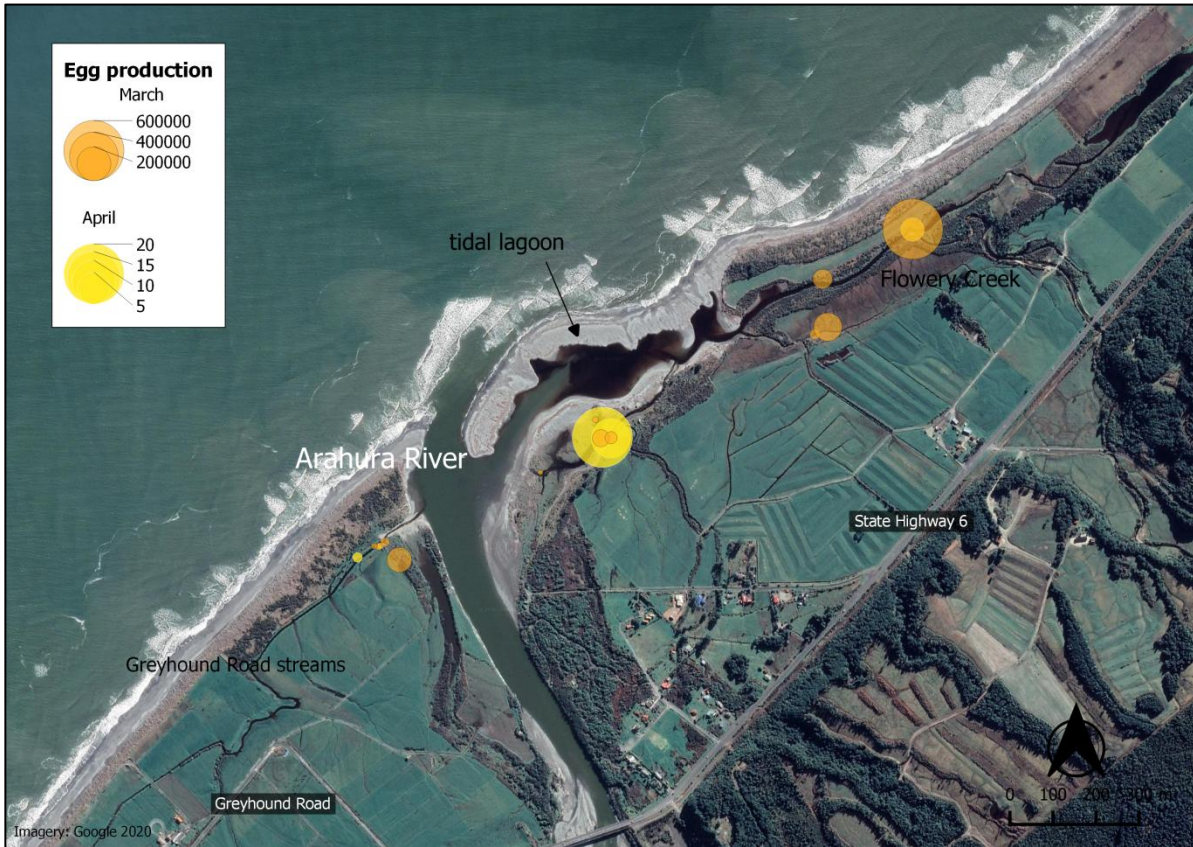
Fig. 9. Map of egg production in tributaries of the Arahura in March and April 2020.

A breakdown of egg production across the two months for the four areas described in Section 3.2.1 is provided in Table 4, and a map of the egg production trends in Fig. 9.

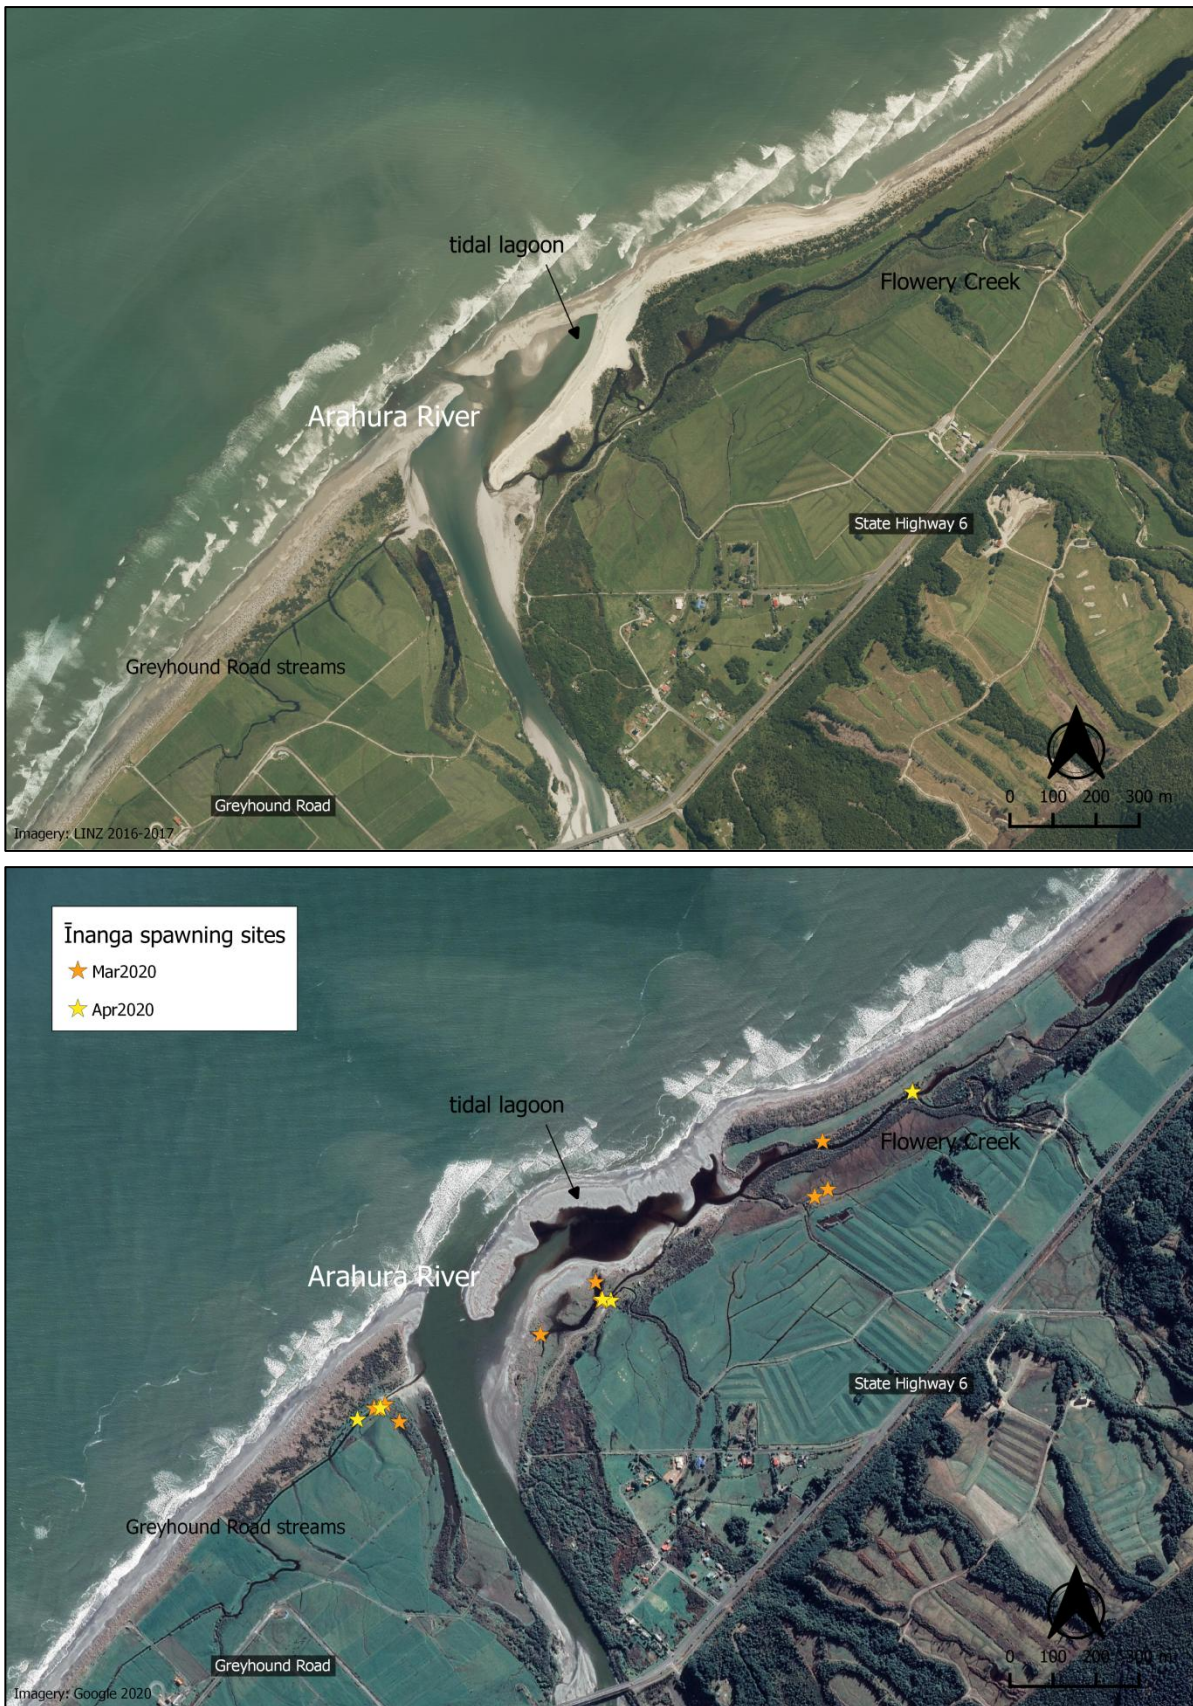
Fig. 10. Changes to the tidal lagoon system between the summers of 2017 (top) and 2020 (bottom), as seen in satellite imagery. The location of Īnanga spawning sites recorded in 2020 is shown for comparison in the lower image. Note changes in connectivity to the Flowery Creek tributaries associated with major erosion and enlargement of the tidal lagoon on its eastern shoreline.

In general, the lagoon area contains a complex network of waterways that include established tributaries with base-flows (e.g. Flowery Creek) and remnant channels on the floodplain that are currently cut-off from surface water flowpaths to various degrees (e.g. the small lake on the south bank), but may be reactivated in high water events. Local knowledge sources also indicated that there had been major changes since a series of large storms in December 2019 that caused extensive coastal erosion around the main lagoon. These changes were visualised in a satellite imagery comparison between 2017 and 2020 (Fig. 10).

Some of the key aspects include re-routing of lower Flowery Creek and associated changes to the channel network in the vicinity of the floodplain islands. These changes have created a much more direct connection between lower Flowery Creek and the open water of the main lagoon. Other pre-existing channels and a considerable area of riparian vegetation were also removed by this erosion event (Fig. 10).

connections in this location (Fig. 10). As was found in Christchurch following earthquake-induced morphological changes, spawning sites can migrate to entirely new locations following major disturbance events (Orchard et al. 2018a). Where this occurs, spawning sites may be exposed to new threats relating to human activities in the vicinity of the new sites, and conversely, these movements may also present new opportunities for protection or restoration work.

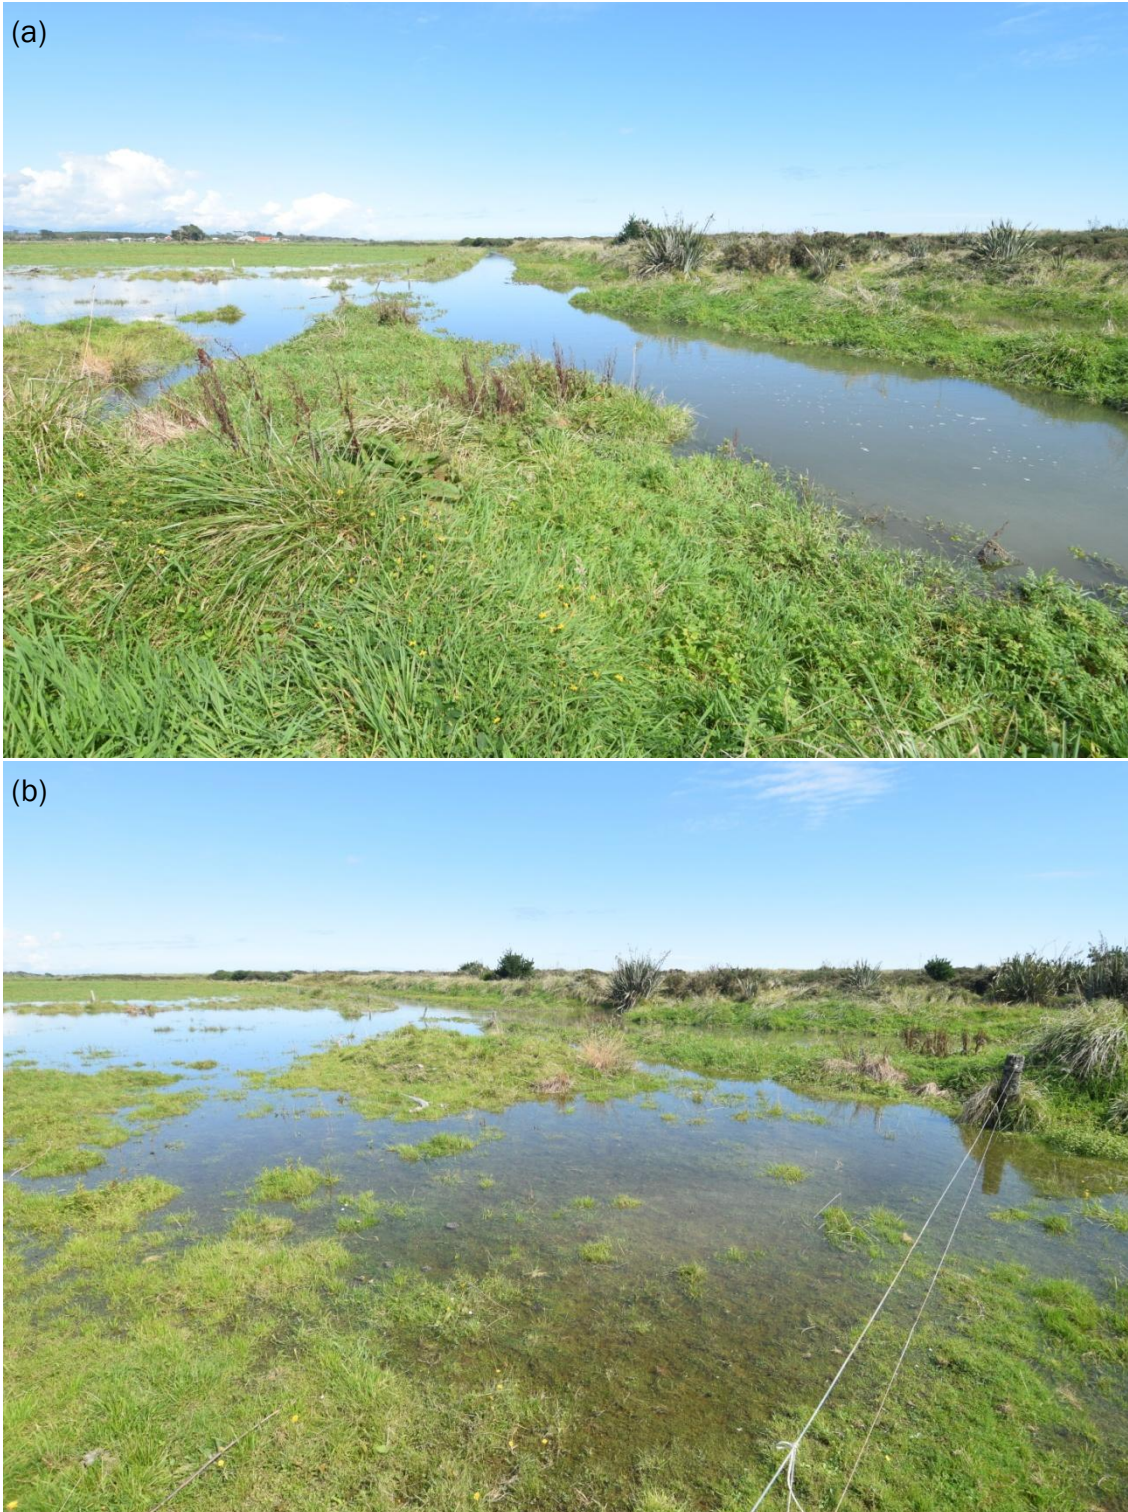
Fig. 11. Two views of tidal flooding into low-lying areas of pasture adjacent to the Greyhound Road on the spring high tide of 11 March 2020.

During this survey, the observed tidal inundation was generally higher than expected in consideration of the position of fencelines. Peak water heights were sufficient to inundate pasture land in several places. Fig. 2 shows one example from the northern tidal waterway. Other examples were seen in the southern tributaries near Greyhound Round where a series of old side-channels lead to riparian wetlands within pasture areas and are inundated on high tide (Fig. 11).

As noted in section 3.3, there are several areas of pasture that appear to be regularly inundated on high tides. In most cases, remnant riparian wetlands are also present at these locations (e.g. Fig. 11). These sites present good opportunities for riparian restoration. Potential benefits include improving water quality through more effective set-backs to high intensity land-uses, and wider biodiversity gains through the enhancement of riparian vegetation.

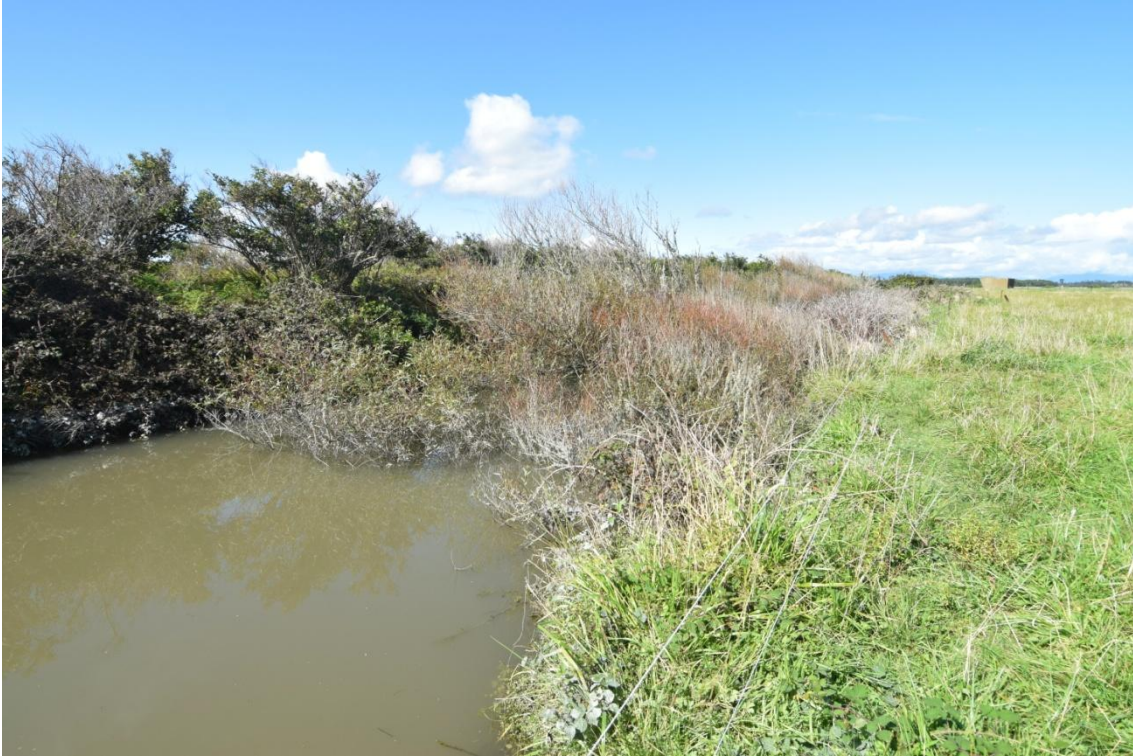
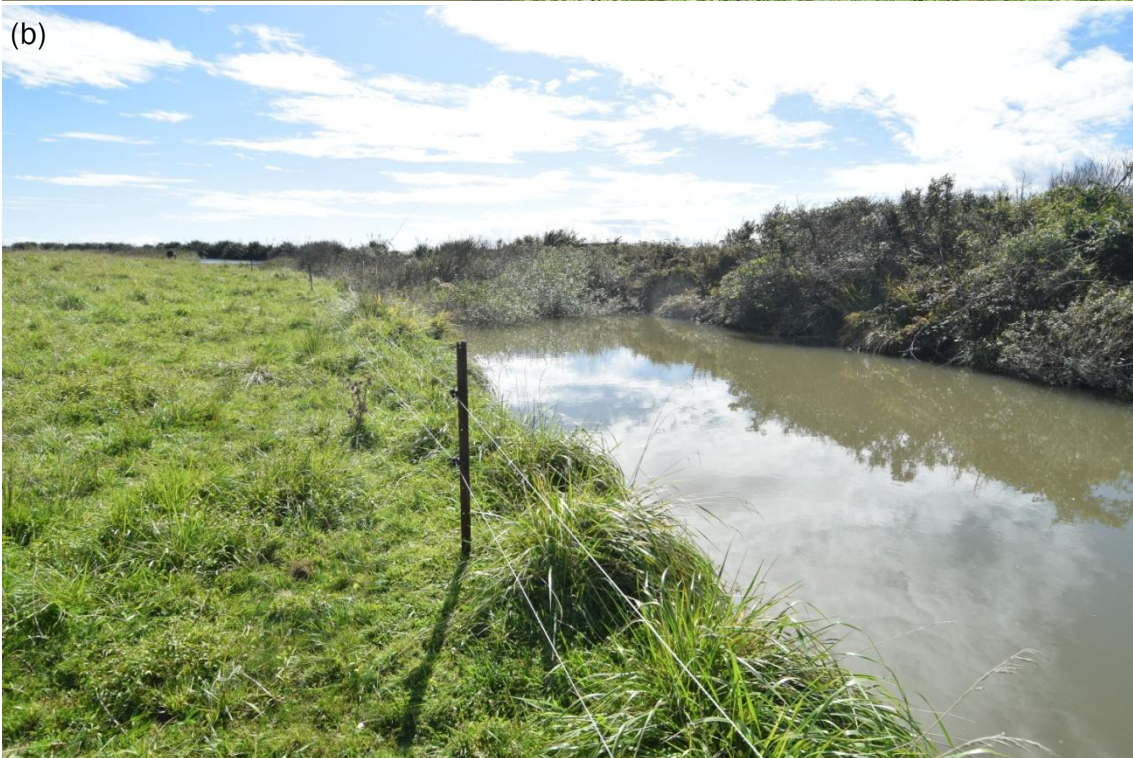
Fig. 12. Two views of the small lake that occupies an old flood channel on the south bank.
