Punakaiki River restoration project: hydrological aspects, ecological engineering and planning framework

Technical Report · May 2020

Department of Conservation
West Coast *Tai Poutini* Conservancy
May 2020

Report WL20031 prepared for Department of Conservation
© Copyright Waterlink Ltd

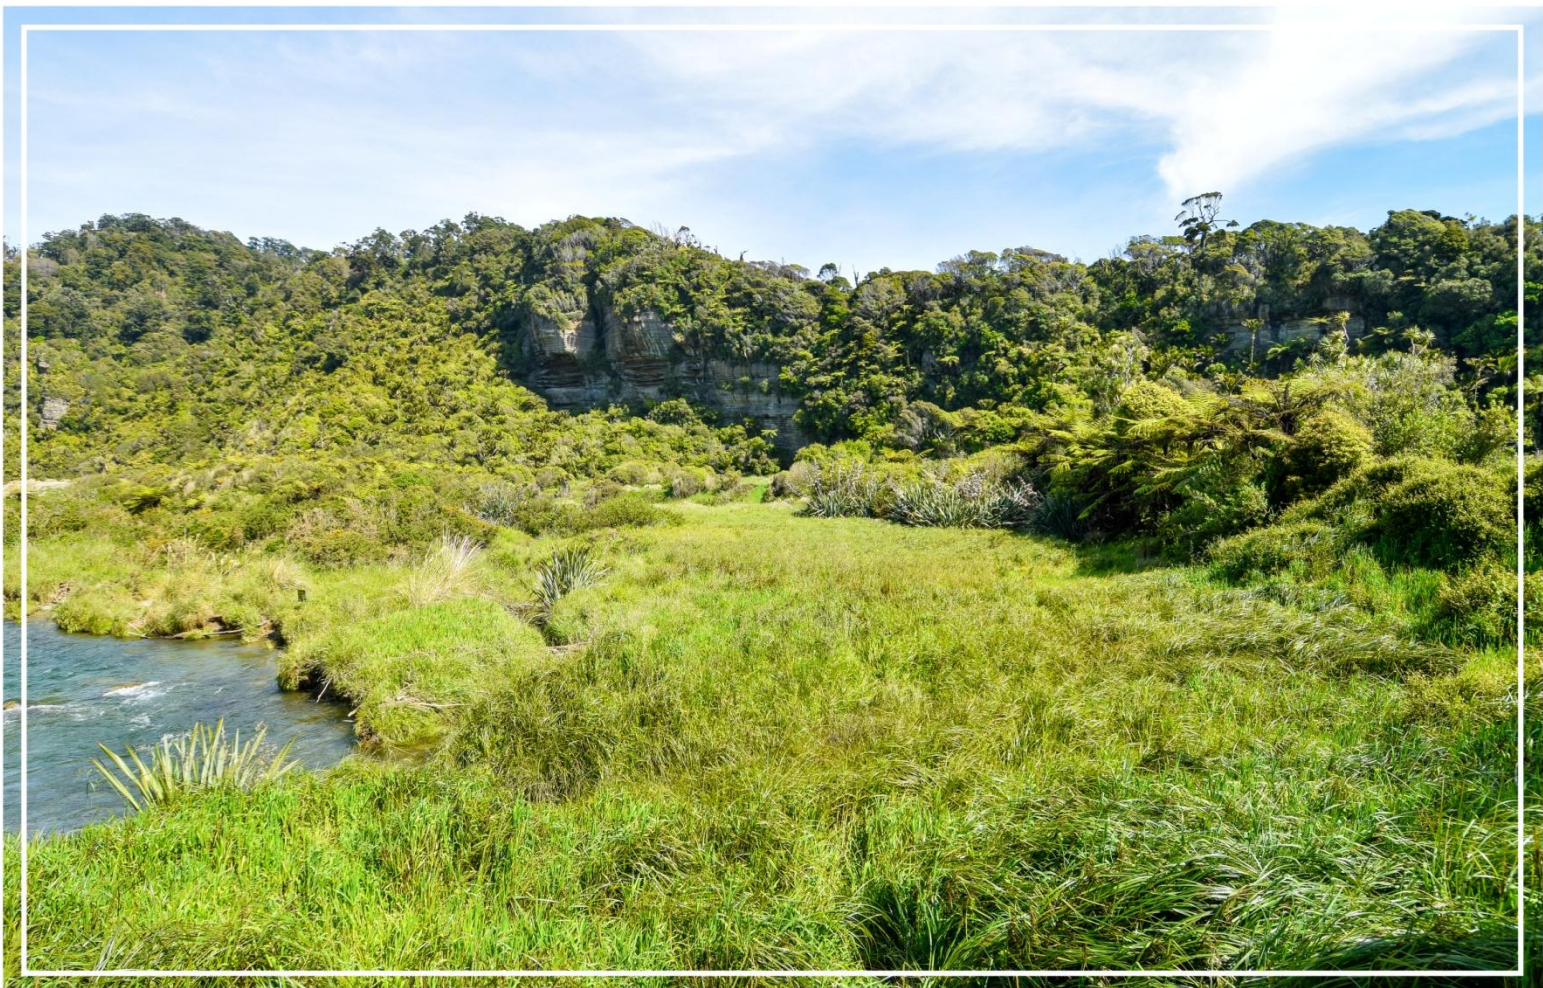
Cover photograph:
Overview of the project site at the Punakaiki River on the South Island's West Coast.
Photo: S. Orchard

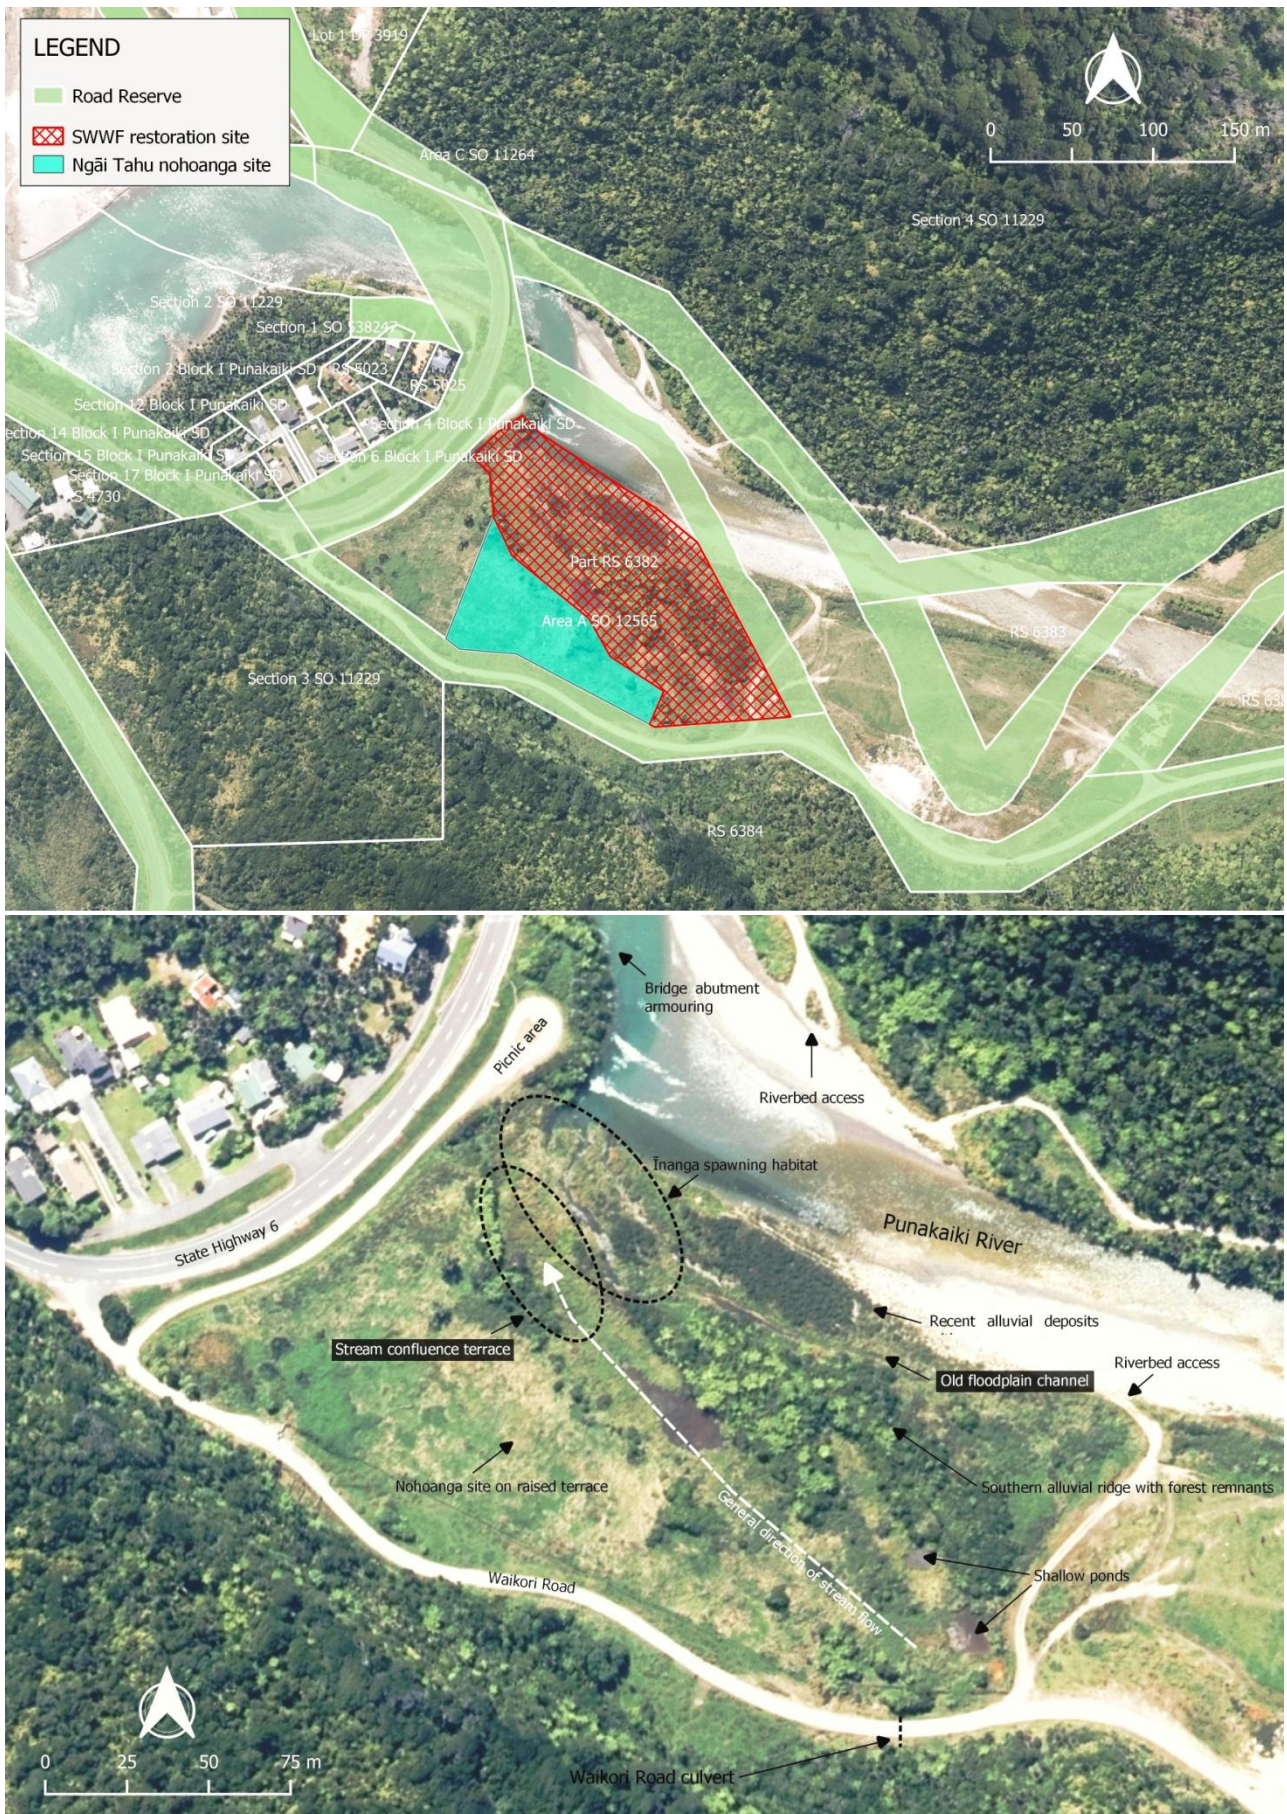
Fig. 2. (a) cadastral boundaries. (b) natural features of the restoration site.

Waikori Road provides the main access route up-valley for mountain bikers, trampers and climbers (Fig 2b). Other visitor activities include a horse trekking operation in area and the paddocks along Waikori Road are regularly used for grazing. However, the wetland is relatively unaffected by anthropogenic disturbance due to the uneven ground the dense vegetation which discourages foot access.

The restoration site is situated along a small stream that originates from a nearby subterranean source to the south. It runs beneath Waikori Road via a highly perched culvert (ca. 1m) before spreading out into a series of meanders that merge with old floodplain braids of the main river (Fig. 3a). The stream features a series of pools and shallow ponds that have likely been formed by periodic sedimentation events in the main river channel and habitat-forming properties of wetland vegetation. In flood events a prominent back-eddy forms at the stream confluence as the main channel runs up against the State Highway 6 embankment and is redirected by rock armouring at the bridge abutment (Fig. 3b). The eddy is a natural deposition area for fine sediments and woody debris. It grows in size at higher water levels including under the influence of spring tides. Spring tides will lift the water level > 1m in this reach. This location is also the inland limit of saltwater under most conditions due to an increase of the river gradient a short distance upstream.

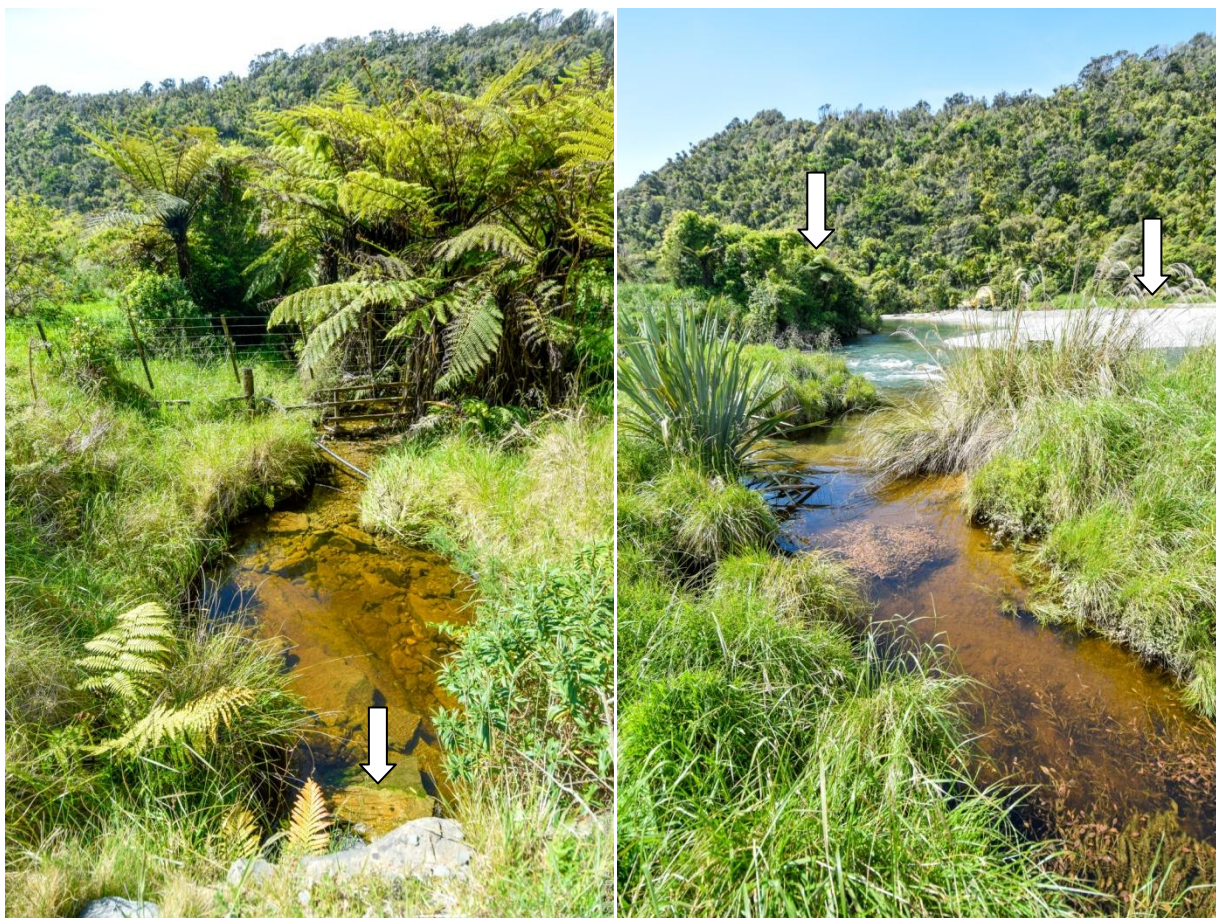
Fig. 3. (a) Pool below the perched culvert (arrowed) at Waikori Road. (b) Stream confluence with the Punakaiki River showing position of bridge abutment armouring (left arrow) and gravel extraction activities (right arrow).

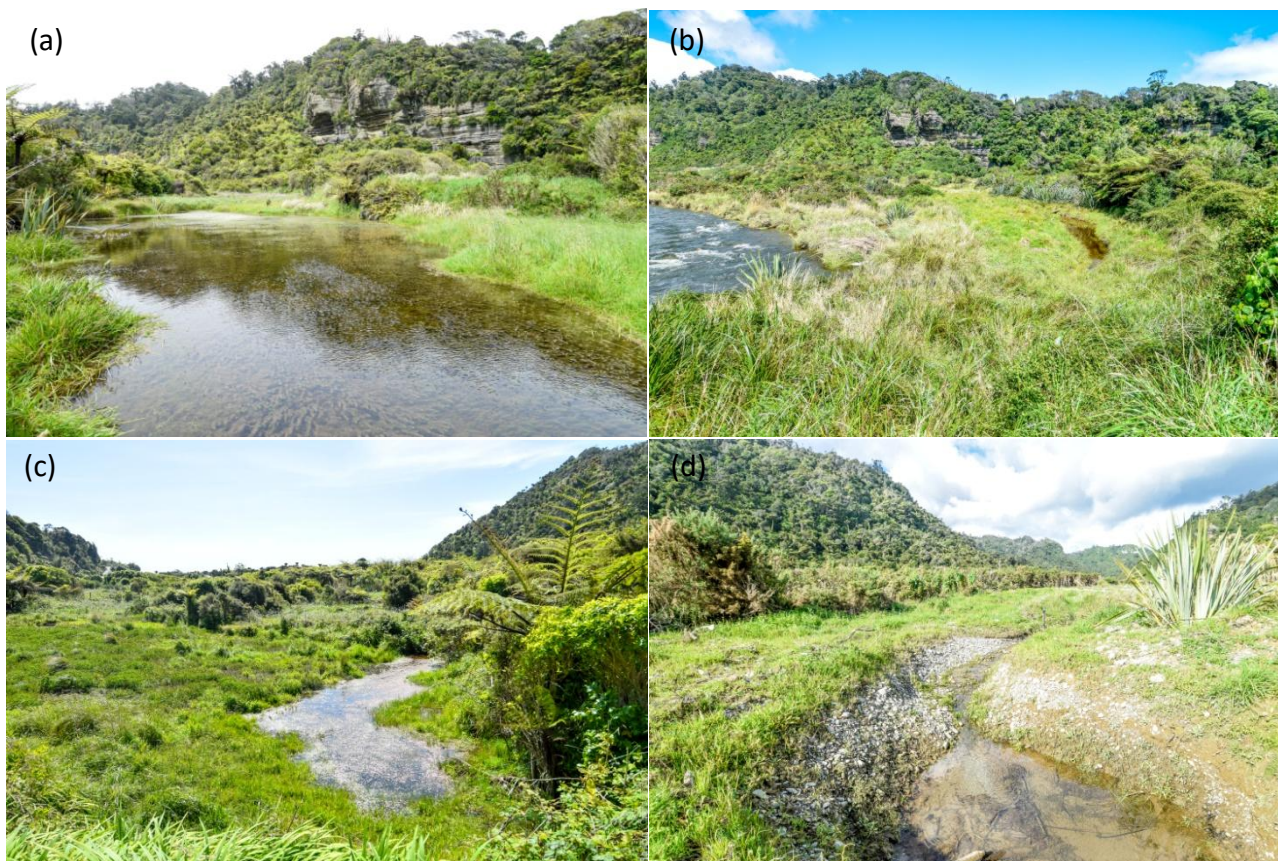
Fig. 4. (a) one of several pond features impounded by sediment accretion in the main deposition area. (b) overview of the wetland system that occupies the outside bend of a former river channel as viewed from the picnic area near the State Highway bridge. (c) meandering stream channel and riparian wetlands downstream of Waikori Road (d) old flood channel located between the two gravel ridges on the southern floodplain. A series of seeps emanating from in the hyporheic zone of the main river channel can be seen discharging from the gravel bank on right.

The meeting of river and tidal waters creates regular backing-up into the stream confluence and associated deposition area. During flood event, sediment-laden waters can be observed to enter the wetland complex where they are intercepted by an extensive area of *Carex* sedgeland that promotes sediment trapping and accretion. Repeat cycles of these events have formed a sill that is probably the main feature responsible for the development of a wetland system in this area. The sill plays a key role in spreading out the stream base-flow across a relatively wide area leading to the impoundment of a series of ponds that are connected by network of small incised waterways (Fig. 4a).

Other topographic features include the remnants of old flood channels and gravel ridges that represent previous alignments of the river (Fig. 4b). These gravel features form the southern boundary of the contemporary wetland complex (Fig. 4c). However, hydrological connections include sub-surface flows through these barriers from the main river channel with the floodplain gravels retaining braid-like characteristics despite the various overlaying sediments and vegetation cover (Fig. 4d). Two prominent ridges are present. The most southerly of these (furthest from the main river channel) is well vegetated with indigenous forest species such as mahoe, five-finger, and nīkau. This area of raised ground provides excellent opportunities for low maintenance foot tracks from the south. The approximately parallel ridge closer to the river is a historically younger feature that is likely to be reworked in flood events. It is currently covered in gorse and blackberry and is a good candidate for restoration planting (see below). It is also suitable for development of foot access routes that could link with the existing forest remnant. A loop walk linking the two ridges offers excellent opportunities for self-guided nature walk with informative viewpoints.

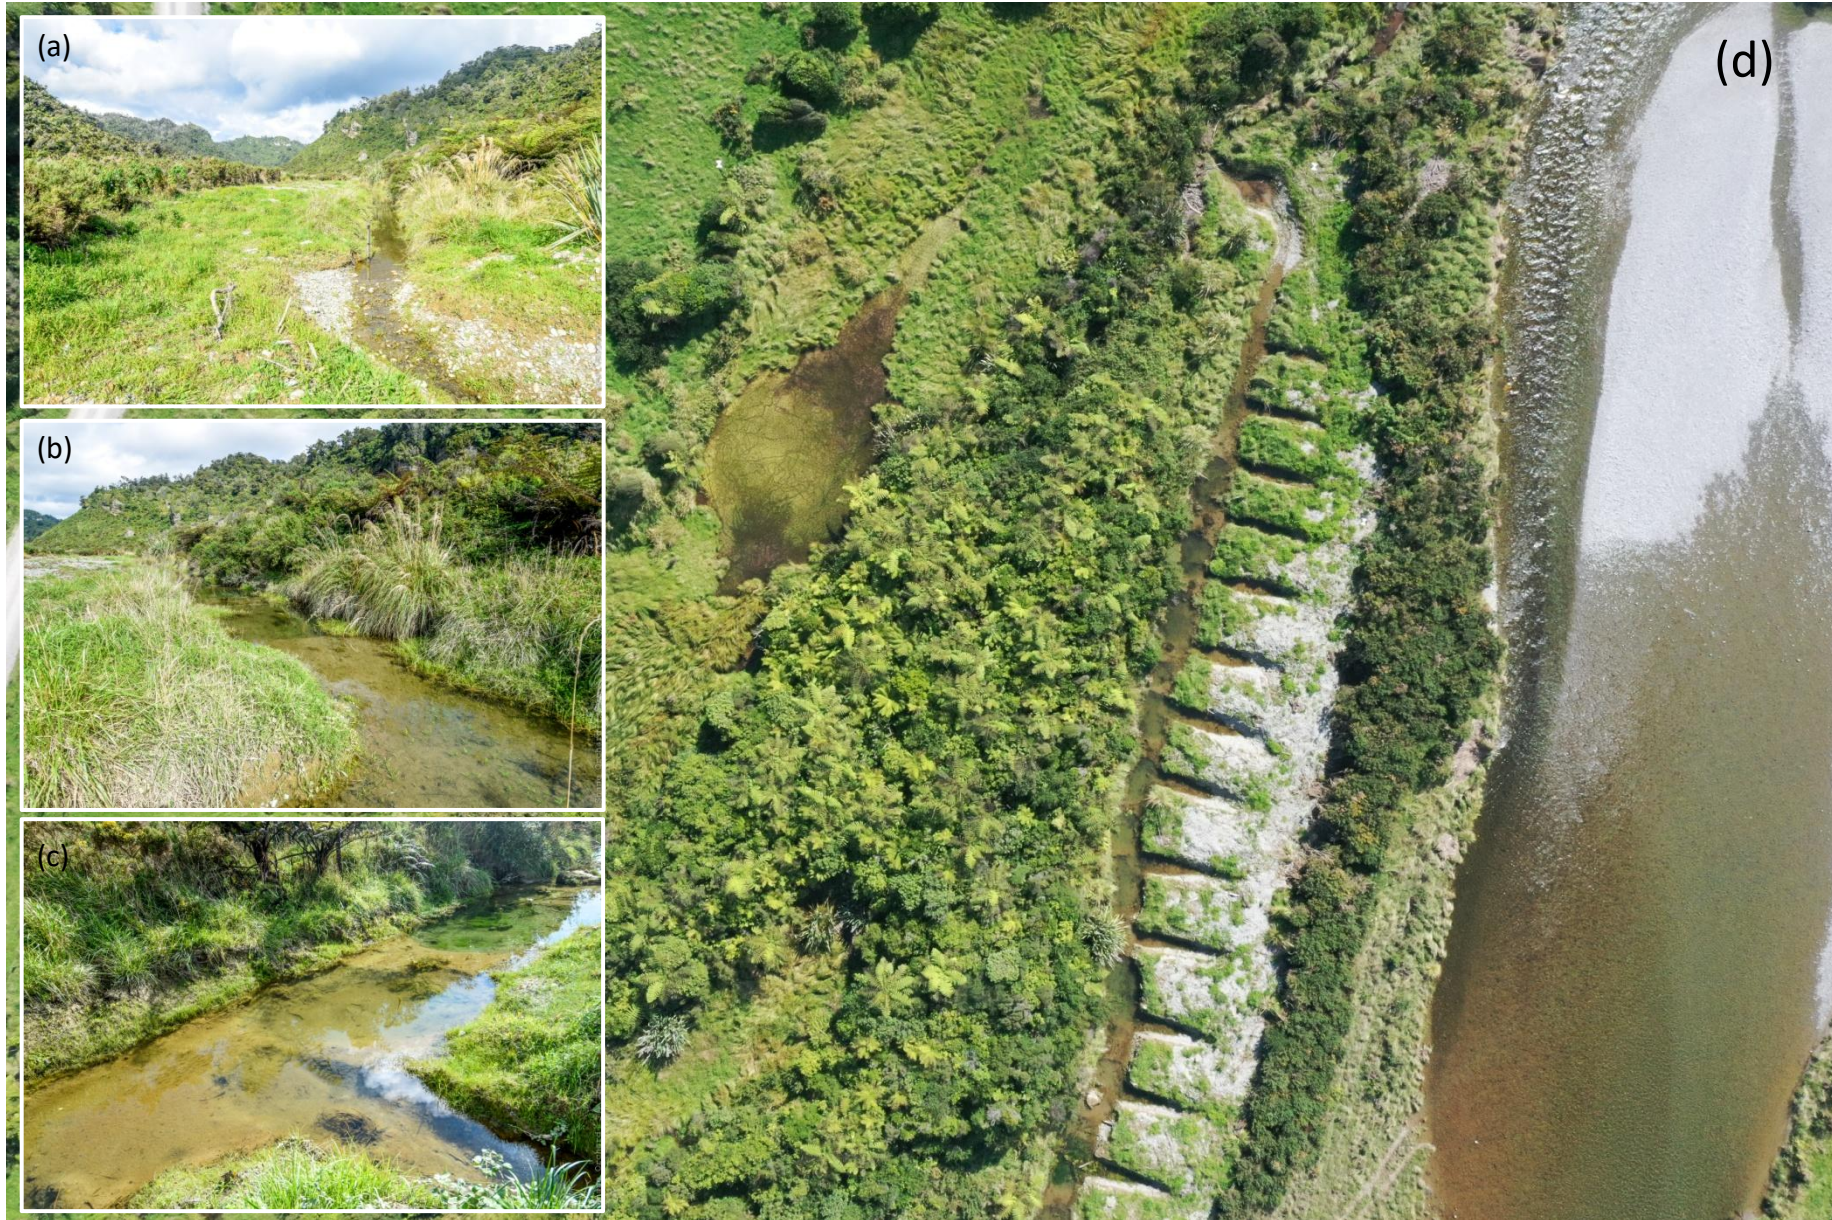
Fig. 4. (a) – (c) three views of the old channel engineering works. (d) aerial view showing alignment of the channel and existing forest remnant on the western bank.

The old floodplain channel that previously featured a shallow stagnant pond was reconnected to an active channel by clearance of material that formed a blockage between the two (Fig. 4). Target design specifications include a bed level that receives water during spring high tides or equivalent fresh or flood flows, and a sill to retain water within the channel when water levels recede in the Punakaiki River mainstem, for example on outgoing tides.

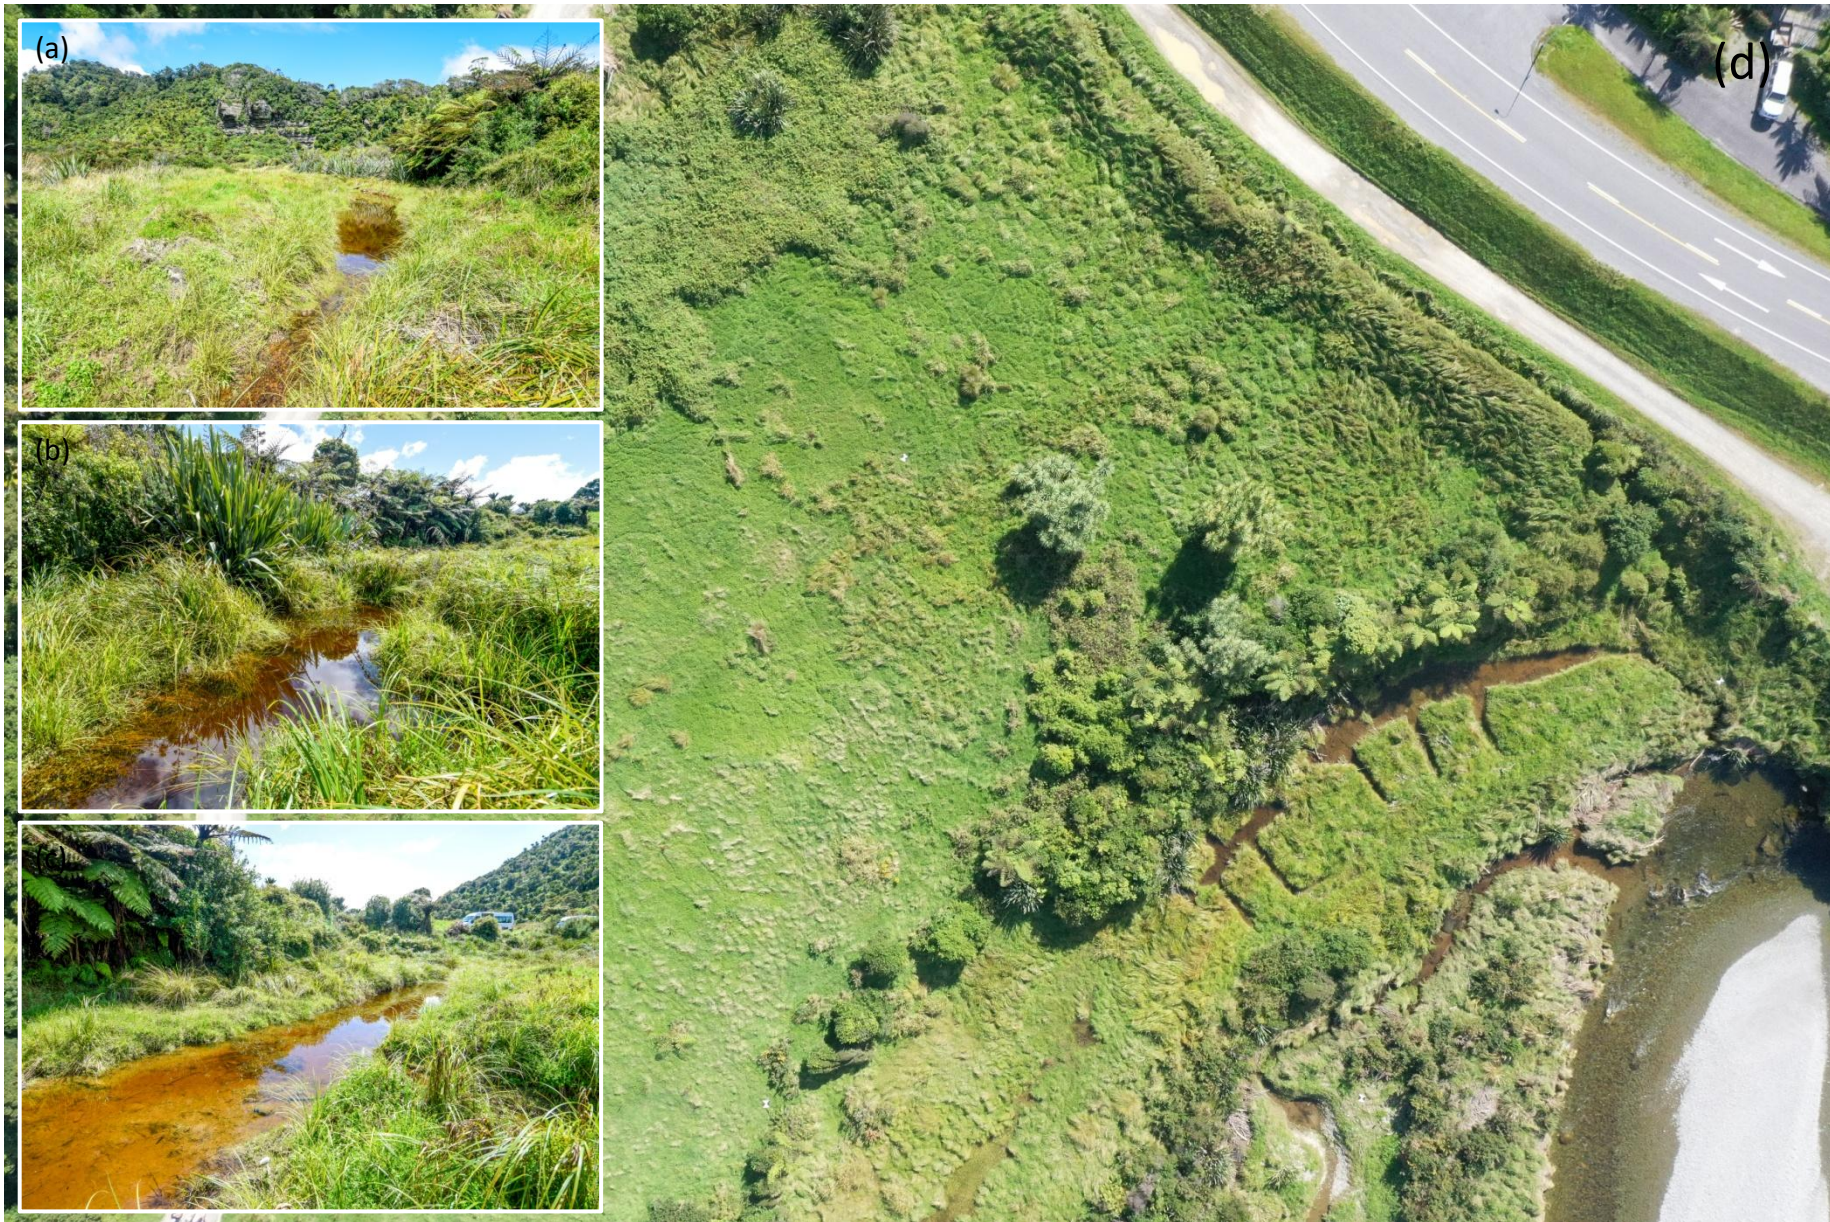
Fig. 5. (a) – (c) three views of engineering works on the stream confluence terrace. (d) aerial view showing location of the works. Note close proximity to picnic area access point to the north.

An additional area of open water was created within the main deposition area on the stream confluence terrace (Fig. 5). Target design specifications include a water depth ca. 50 cm and no change to ground levels near the current stream outlet a short distance downstream. The latter creates a natural sill that retains water and regulates the water table on the wetland terrace. This terrace is perched above the water level in the mainstem and associated side channels in this area and is not typically inundated on high tides. As a result, inundation from the main channel occurs only during flood events or with moderate freshes in combination with spring high tides.

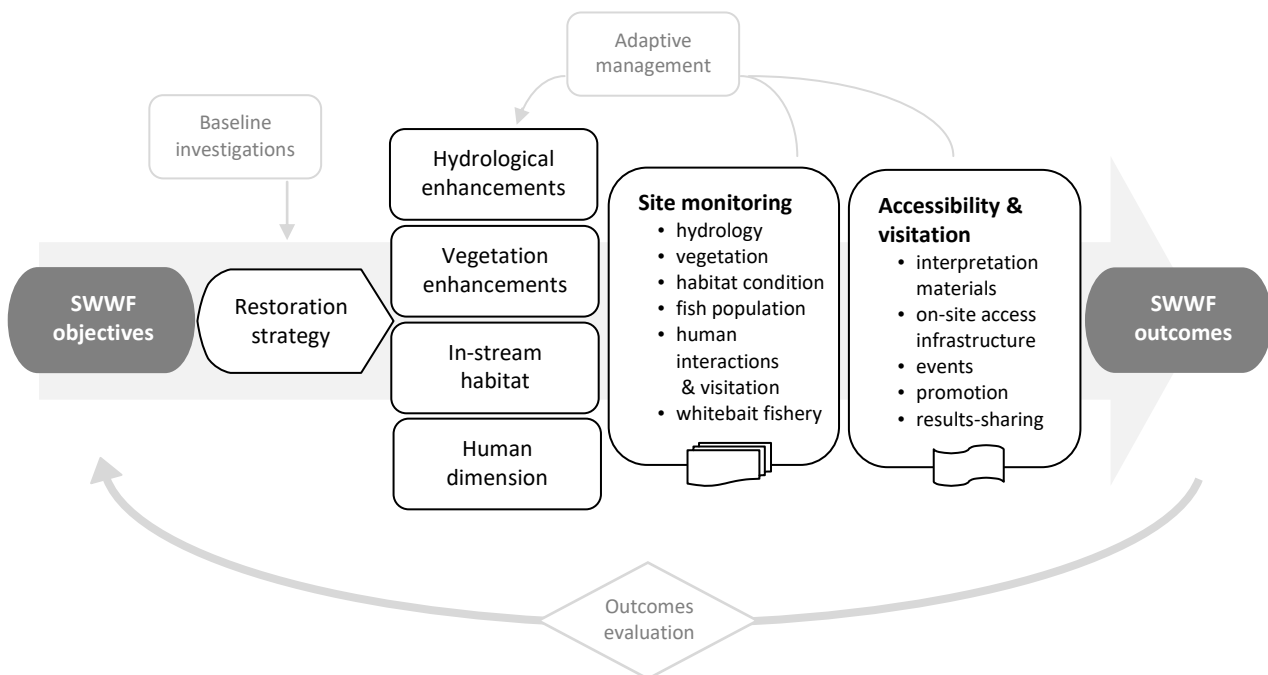
Fig. 6. Conceptual framework for SWWF Punakaiki Restoration project.

The framework is based on the principles of:

- i) strategic planning informed by baseline investigations.
- ii) adaptive management informed by monitoring.
- iii) periodic outcomes evaluation to track progress against the original objectives.

The fourth important aspect involves integration of human dimension in keeping with the intention of producing a demonstration project that is both engaging and informative (Fig. 6). Each of these aspects is discussed briefly in relation to existing knowledge of the site and restoration work completed to date.

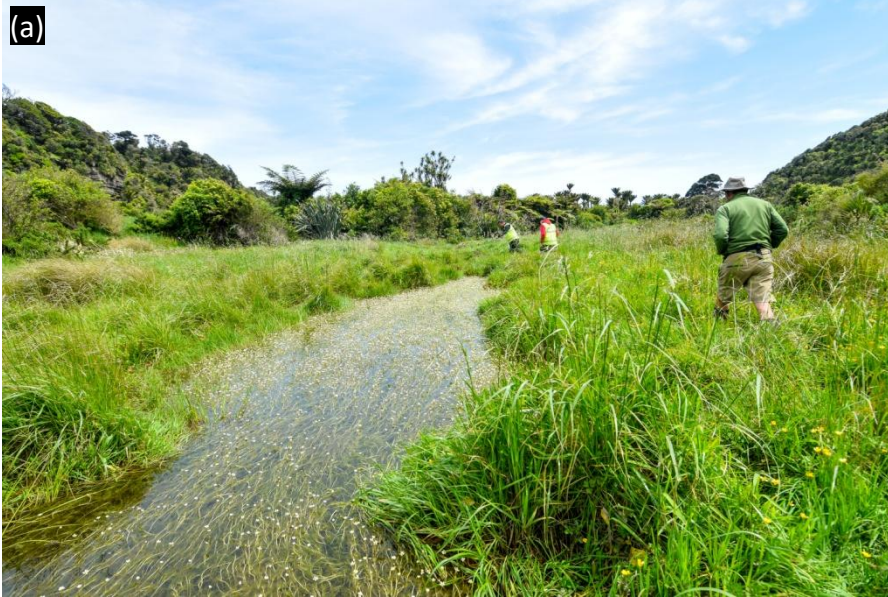
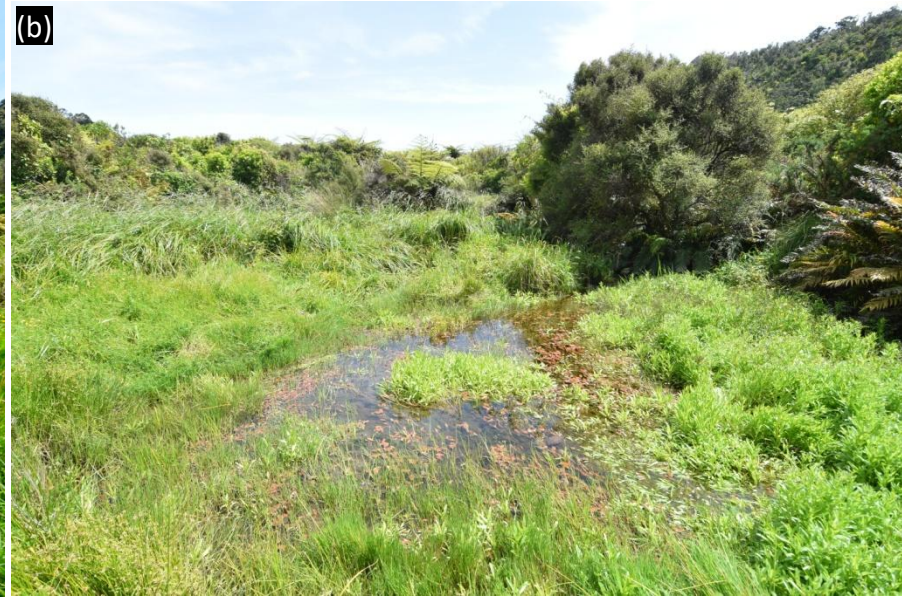
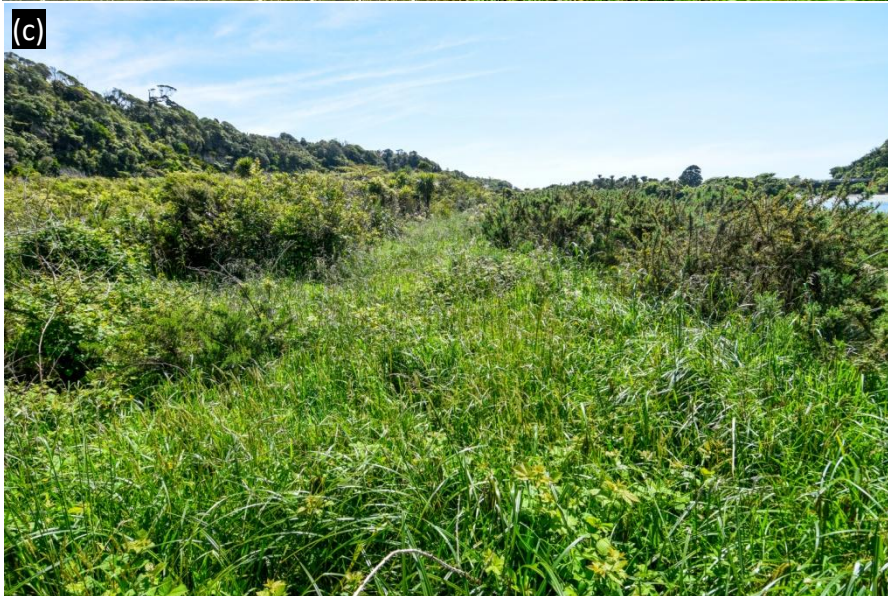
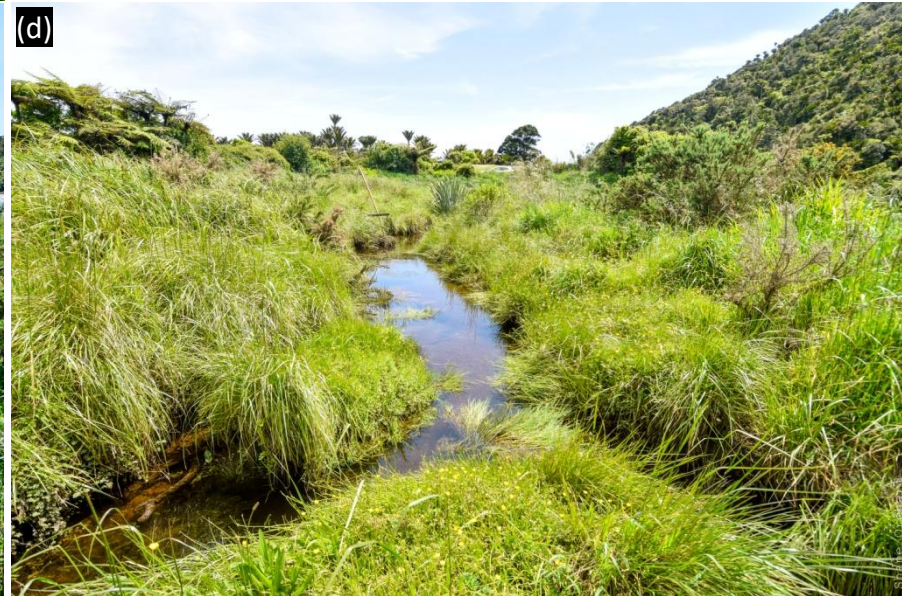
Appendix 1. Site photographs.

(a) view looking downstream through riparian wetlands featuring the white flowers of *Ranunculus trichophyllus* protruding above the water surface in a slow flowing section of the stream. (b) the coppery colours of *Potamogeton cheesemanii* are common within the waterway network. (c) the largely overgrown old floodplain channel prior to excavation. The band of gorse to the right occupies the most recent alluvial deposit that forms a gravelridge running parallel with the main river channel. (d) view of the main īnanga spawning area looking downstream.
