Sustainable Wild Whitebait Fishery: habitat mapping in the Waimangaroa, Jones Creek and Whareatea catchments

Technical Report · April 2020

Department of Conservation
West Coast *Tai Poutini* Conservancy
April 2020

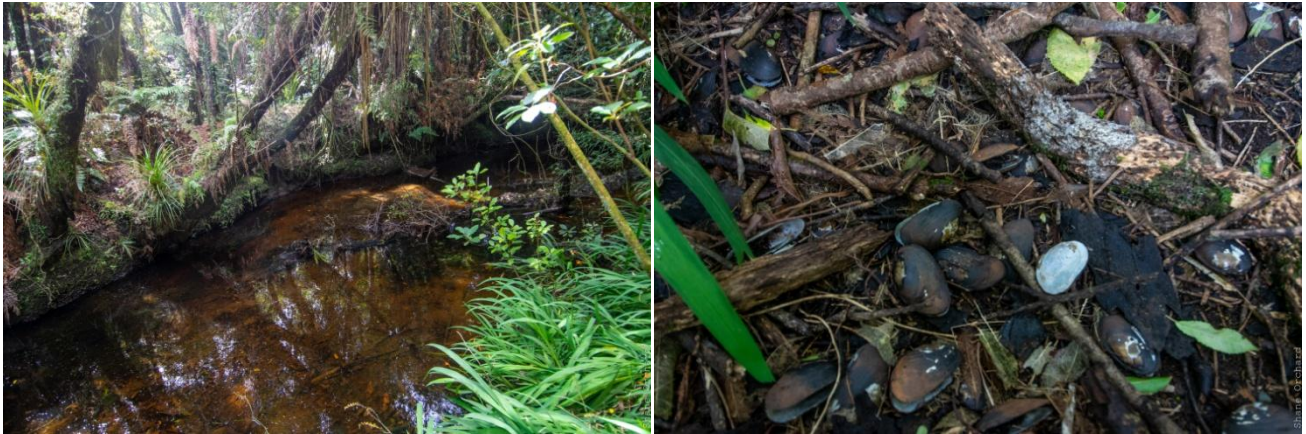
Fig. 3. (a) large numbers of dead freshwater mussel / kākahi were found in the bush tributary stream. (b) close-up of dead kākahi on the riparian margins of the stream.

A large number of dead freshwater mussels / kākahi were observed in the bush tributary - both within the waterway channel and scattered throughout the floodplain forest nearby (Fig. 3). Several searches were conducted for living specimens and none found. Although the timing of the mortality event is unknown, monitoring is recommended to establish the severity of impacts and potential for recovery of the population.

- monitor recovery of kākahi population.
- ascertain potential role of fish populations in kākahi recruitment, plus the potential for recruitment issues if insufficient adult shellfish have survived.

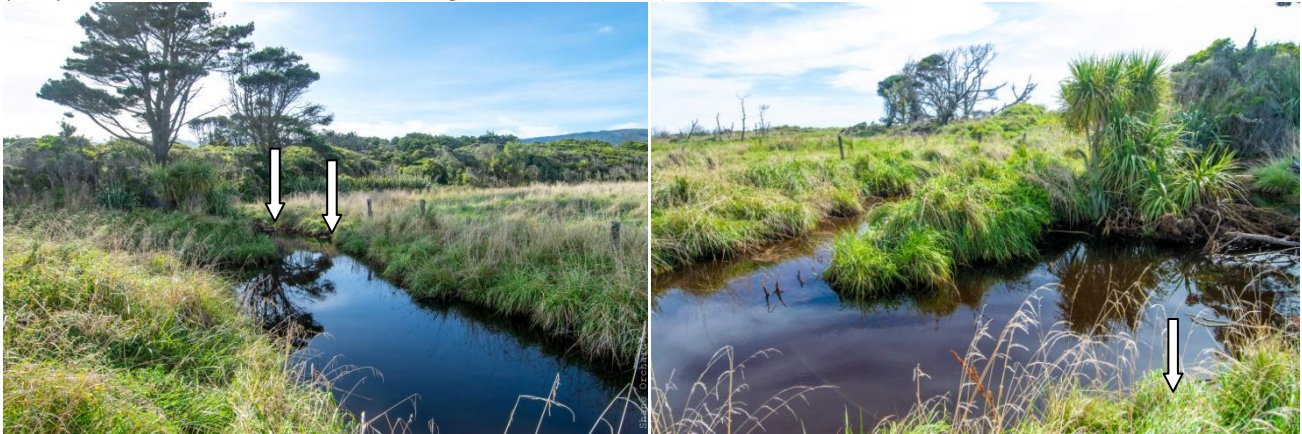
Fig. 5. Two views of the stream confluence area where two spawning sites were found (arrowed). Both views are looking upstream with the bush tributary on the right.

- no additional fencing is thought necessary to protect īnanga spawning habitat. The old stock crossing point downstream is no longer in use and has been fully fenced.
- monitor potential for stock access from the (unfenced) stock crossing point near Collins Road – however the natural topography of the stream channel is likely to provide sufficient protection.

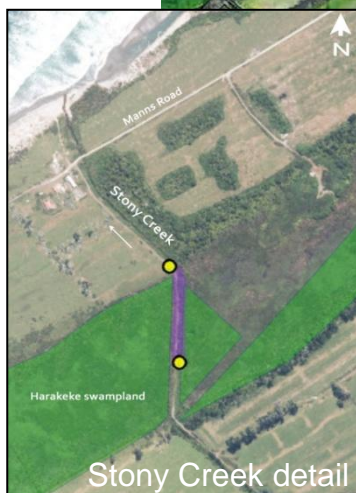
Fig. 6. 2009 Department of Conservation maps showing location of Public Conservation Land, and previously recorded inanga spawning sites at Jones and Stony creeks. Yellow dots show the approximate location of previously reported spawning sites. Purple shading in Stony Creek denotes an area of willow control completed March 2019.

Previously reported spawning sites in this area include three sites in Jones Creek as detailed in Stengs (2007), and two in Stony Creek (Fig. 1) The sites in Jones Creek comprise of two locations on Public Conservation Land upstream of Cains Road, and another 500 m downstream adjacent to an area of farm land, all on the true right (Fig. 6). An area of crack willow (*Salix fragilis*) is present in the riparian wetland upstream of Cains Road on the true right. Another infestation is present in the vicinity of the upstream spawning site in Stony Creek (Fig. 6).

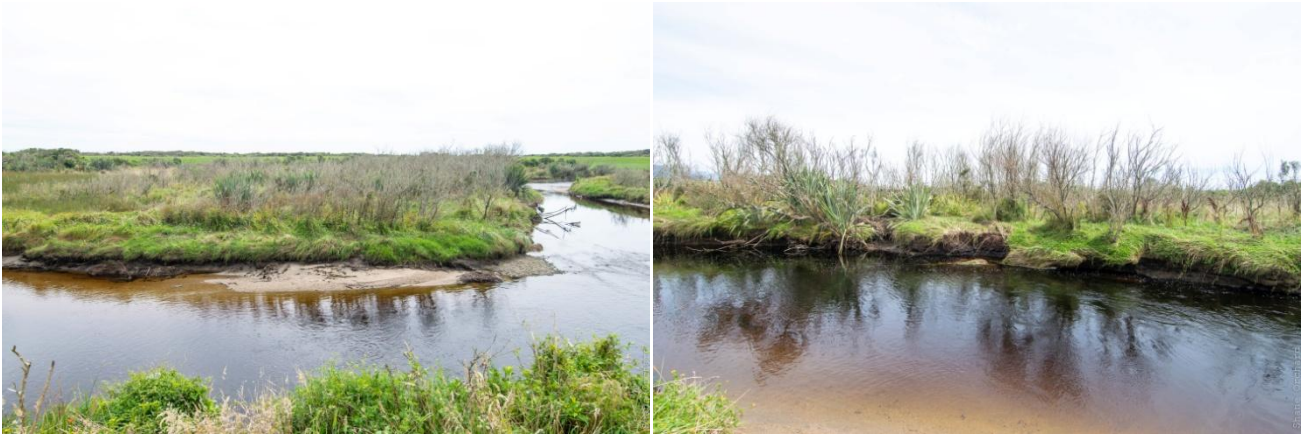
Fig. 7. Two views of the area of crack willow (*Salix fragilis*) infestation upstream of Cains Road on the true right.

Assessment of the crack willow infestation above Cains Road (Fig. 7) showed that a considerable die-off of trees has occurred naturally. Information received from the landowner provided useful on these events which were observed to occur shortly after the Cyclone Fehi storm and may be associated with salinity effects. Very high water levels and tidal surges were observed in Jones Creek at that time. Currently, many of the willows are in the early stages of resprouting.

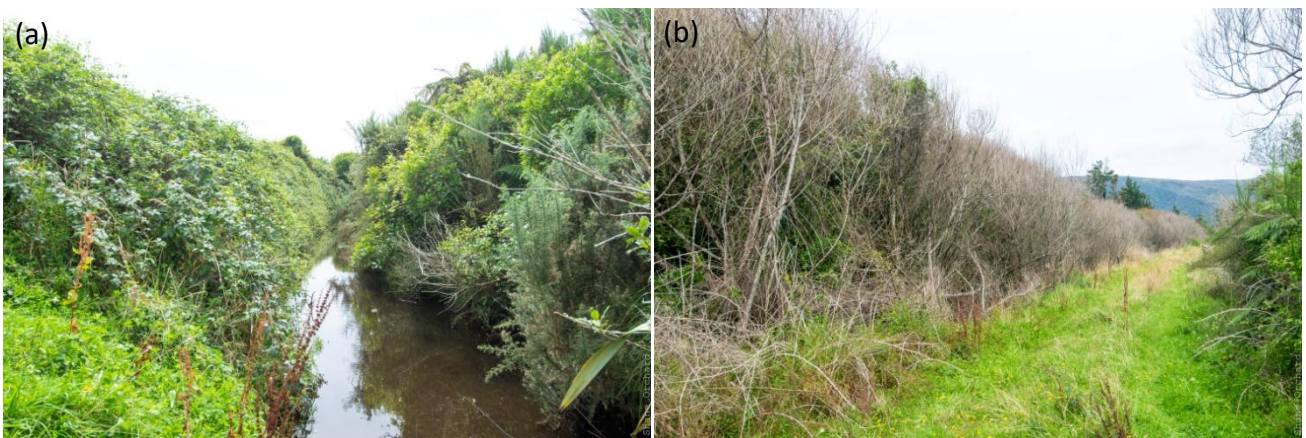
Fig. 8. Two views of the lower reaches of Stony Creek. (a) the reach upstream of Manns Road is heavily channelised with abundant blackberry (*Rubis fruticosus*) patches on the true left bank. This view is looking downstream from a small clearing. (b) typical view of the section adjacent to a large area of flax swamp (to the right of the frame) showing crack willow (*Salix fragilis*) trees lining the waterway. The grassed area is an embankment. The location of a previously reported spawning site is in this vicinity.

In Stony Creek, the survey area extended from the confluence of Jones Creek (which is currently located on the open coast beach) to the furthest upstream of the two previously reported Īnanga spawning sites. Above the Manns Road culvert the banks are typically steep with extensive blackberry patches on the true left adjacent to the farmland area (Fig 8a). The previously reported willow infestation is located further upstream adjacent to the flax swamp and consists mostly of a line of willows on the stream margins (Fig. 8b).

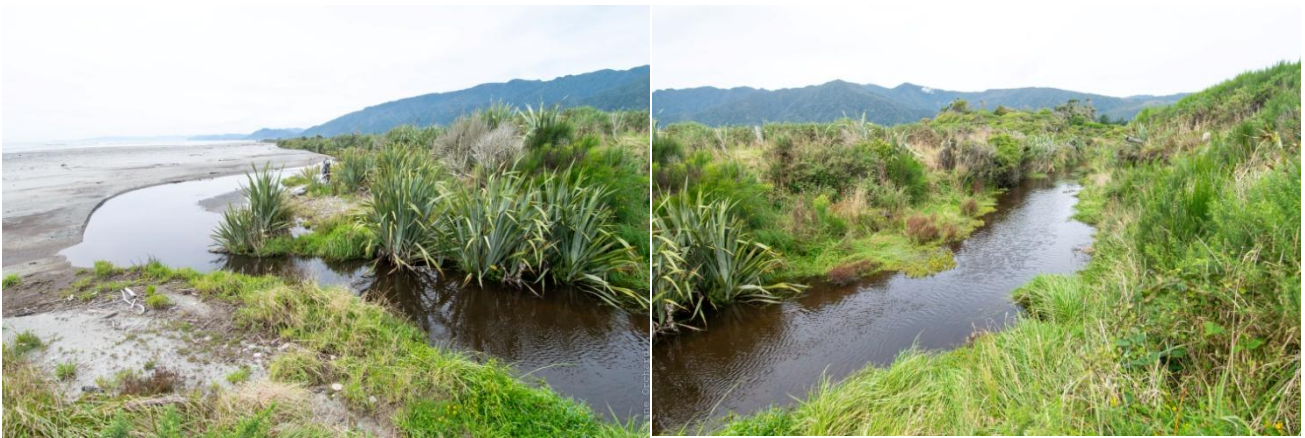
Fig. 10. Two views of Stony Creek from the point at which it emerges onto the open coast beach. (a) looking north towards its confluence with Jones Creek. (b) looking upstream towards the Manns Road culvert. This area is considered to be the most likely location of īnanga spawning in the Stony Creek catchment.

High quality *inanga* spawning habitat is found in the relatively short section of waterway between the Manns Road culvert and the open beach. There are also a few additional patches of suitable spawning habitat interspersed with flaxes on the true right of the stream as it meanders across the open beach towards its confluence with Jones Creek (Fig. 10).

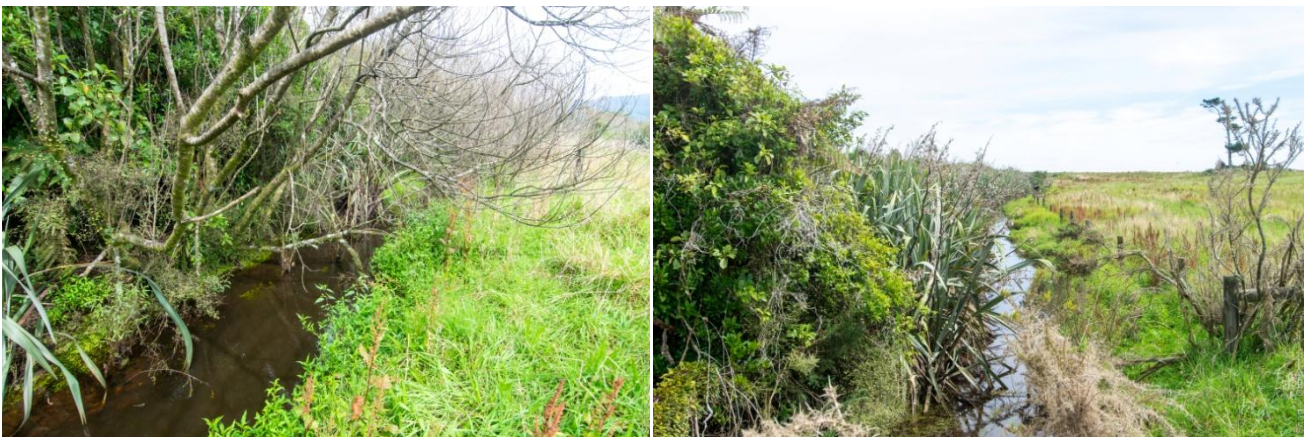
Fig. 11. Two views of Stony Creek near the upstream limit of the area surveyed in this project. (a) typical view of the crack willow (*Salix fragilis*) infestation in the Stony Creek channel showing close proximity of indigenous vegetation. The grassed area to the right is an embankment that separates Stony Creek from an extensive area of flax swampland (looking upstream). (b) view of the boundary drain between farm land and the large flax swamp (looking southwest) taken from the embankment beside Stony Creek.

In the reach upstream of Manns Road, the crack willow infestation (subject to control work in March 2019) was considered to pose little risk to īnanga spawning habitat, partly as a result of the above observations (Fig. 11a). Some re-sprouting was observed. There is an abundance of indigenous biodiversity in close proximity to these willows, and therefore ground-based methods would be preferred for any follow-up control work. A lack of hydrological connectivity between the stream and large flax swamp (Fig. 11b) was also noted in this vicinity. Information provided by the landowner suggested that connections may be present further upstream. Establishing the current status of these is recommended for potential relevance to objectives of the SWWF.

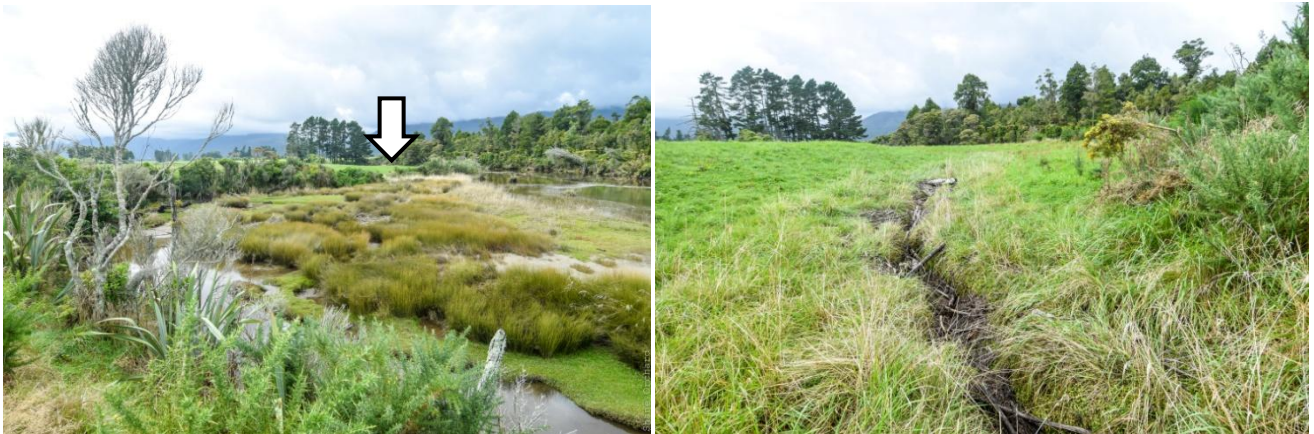
Fig. 14. Two views of tidal wetland on the true right of the Whareatea mainstem where spawning activity was reported by Stengs (2007). (a) view of the saltmarsh area looking upstream with location of the tidal channel and stock access point arrowed. (b) short tidal channel located at the back of the wetland.

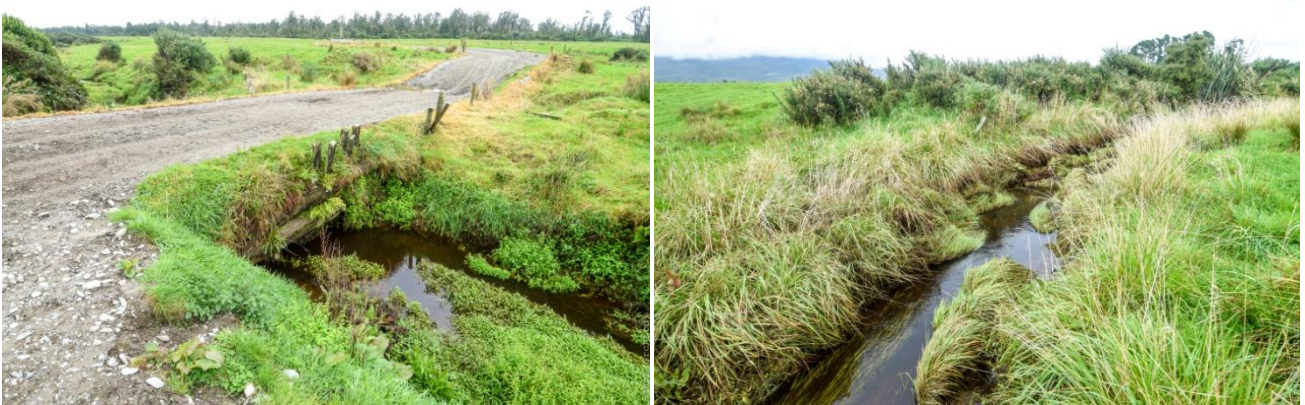
Fig. 15. Two views of northern tributary stream a short distance from the farm buildings shown in Fig. 12.

The 'northern tributary stream' (shown in Fig. 13) drains an area of relatively open farmland that is generally characterised by narrow riparian strips featuring gorse and scattered *Carex* with a mixture of fenced and unfenced sections (Fig. 15). Rapid Stream drains a network of sub-catchments originating on the Denniston Plateau and foothill terraces. In many places the riparian margins support overhanging vegetation cover and regenerating forest (Fig. 16).

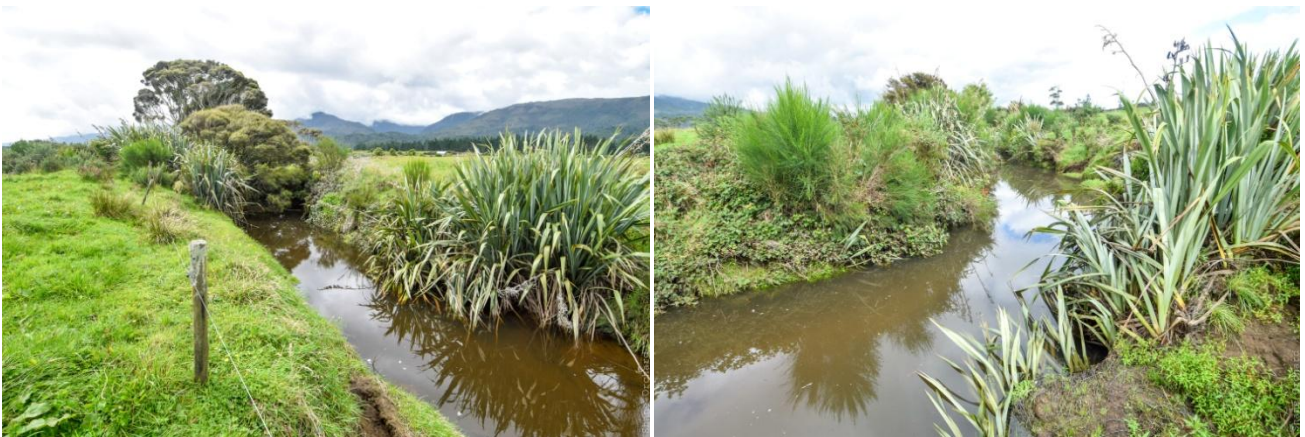
Fig. 16. Two views of Rapid Creek within the survey area showing typical riparian vegetation.

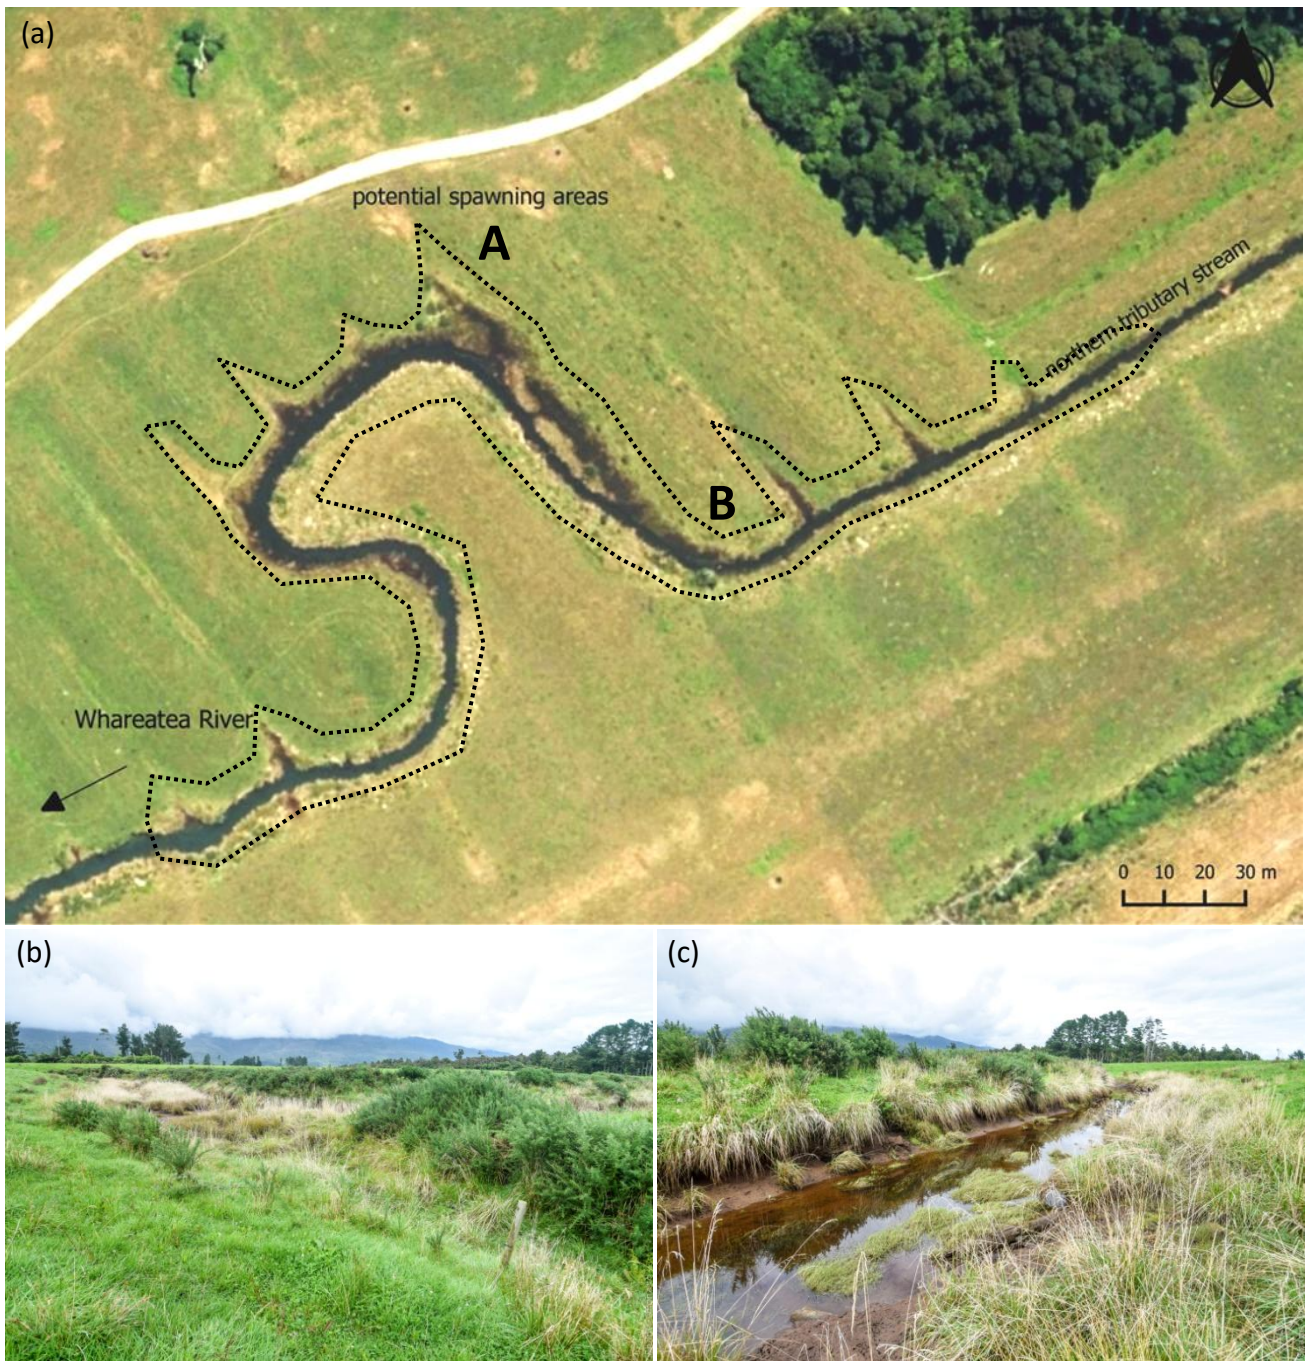
Fig. 18. (a) Approximate location the area of potential spawning habitat that is recommended for further investigation. (b) view looking upstream from point A showing the boundary with farmland. A few old fence posts are present in this vicinity though no fencelines are currently in place. (c) view looking downstream from point B.

- i) confirming the nature of spawning activity (if any) this site, including the upstream and downstream extent of spawning if possible.
- ii) discussing options for a collaborative project with the local landowner. The key protection mechanism involves fencing as the area is open to stock access. However, stock damage was not observed at the time of the field survey and as a result the riparian vegetation is currently in good condition. In this

case fencing of the site appears to be relatively straightforward and the primary objective would be to isolate tidally inundated area from the adjacent farmland (Fig. 18).

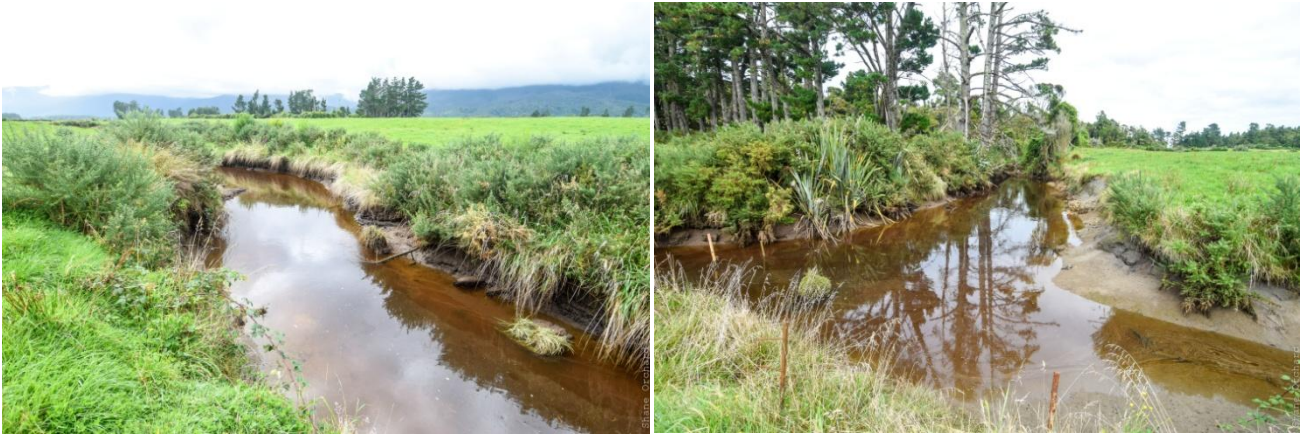
Fig. 19. The lower section of the northern tributary stream a short distance upstream from the Whareatea confluence showing typically steep banks within the tidal range.

Overall, there is an abundance of high quality spawning habitat in this waterway, primarily provided by tall fescue and creeping bent. There is a considerable area of high quality spawning habitat that is situated on a prominent bend within the area of tidal influence (Fig. 18). Although actual spawning in this location is yet to be unconfirmed it is considered to be highly likely. This area is recommended for further investigation with a view to establishing a potential intervention such as a protected area under the auspices of the SWWF. Downstream of this area the lower stream (near the Whareatea confluence) is characterised by high banks that are often undercut with sparse vegetation in the vicinity of the high tide waterline (Fig. 19).

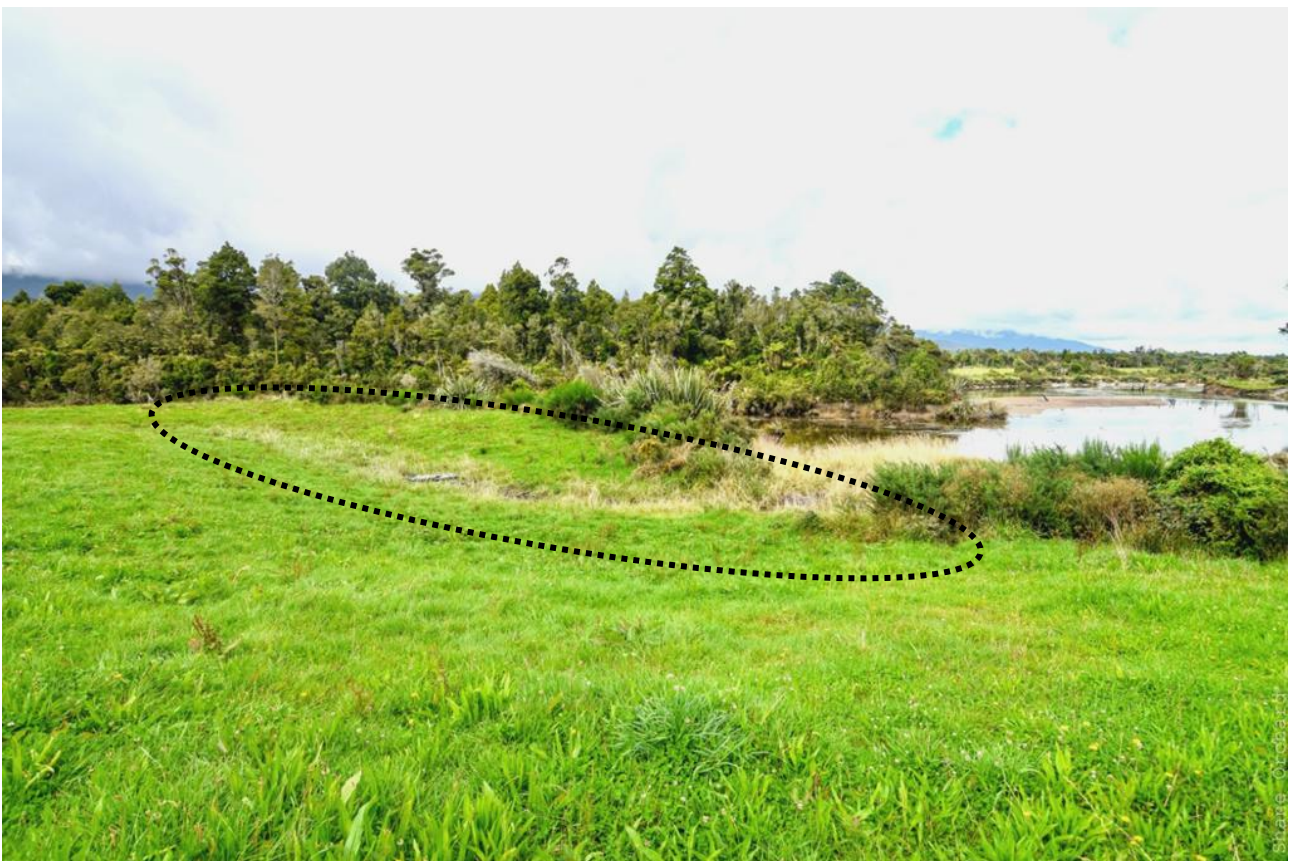
Fig. 20. Orientation of a small tidal channel (circled) that enters farmland behind a saltmarsh area on the true right of the lower Whareatea.

The saltmarsh in the Whareatea mainstem further downstream also provides high quality spawning habitat though it is expected to be of less importance than the area detailed above. Further investigations there should focus on landowner preferences for fencing the stock access point, which could include the small tidal channel that connects with a drainage swale in the adjacent paddock. The orientation of these features is shown in (Fig. 20).

- consider extending protection to saltmarsh site on the Whareatea mainstem. Although this site is thought to be less important than the above for provision of īnanga spawning habitat, stock are able to freely access the estuary through gaps in the fenceline at present.
- willow control work is not expected to enhance the quality of spawning habitat in the areas surveyed. However, the modest number of individual trees present suggests that ground-based control would be relatively easy to achieve and is recommended.

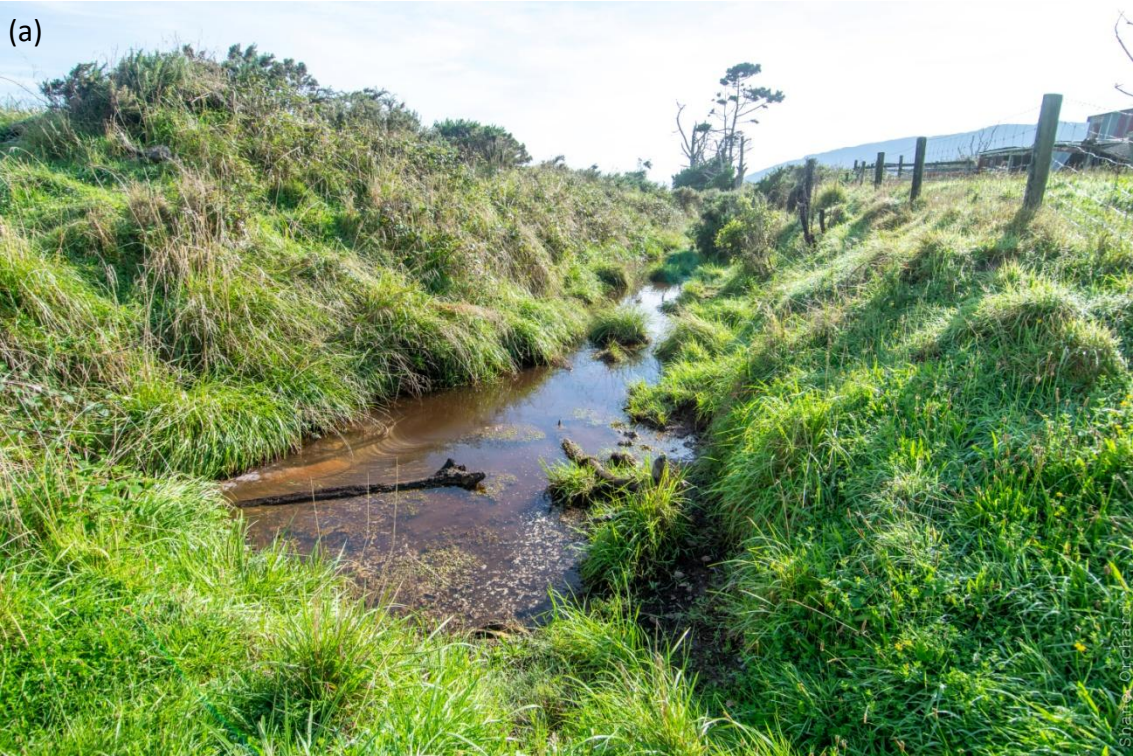
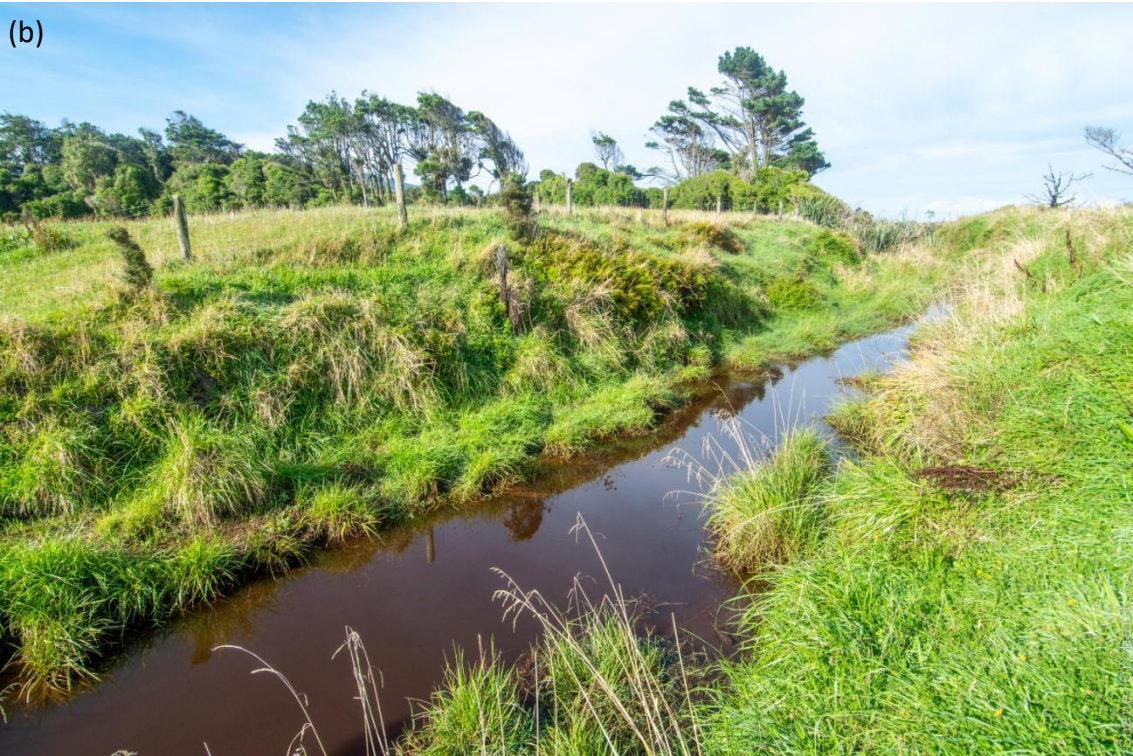
Fig. A1.1 Two views of the tributary downstream of Collins Road (a) looking upstream from the stock crossing culvert. (b) looking downstream.

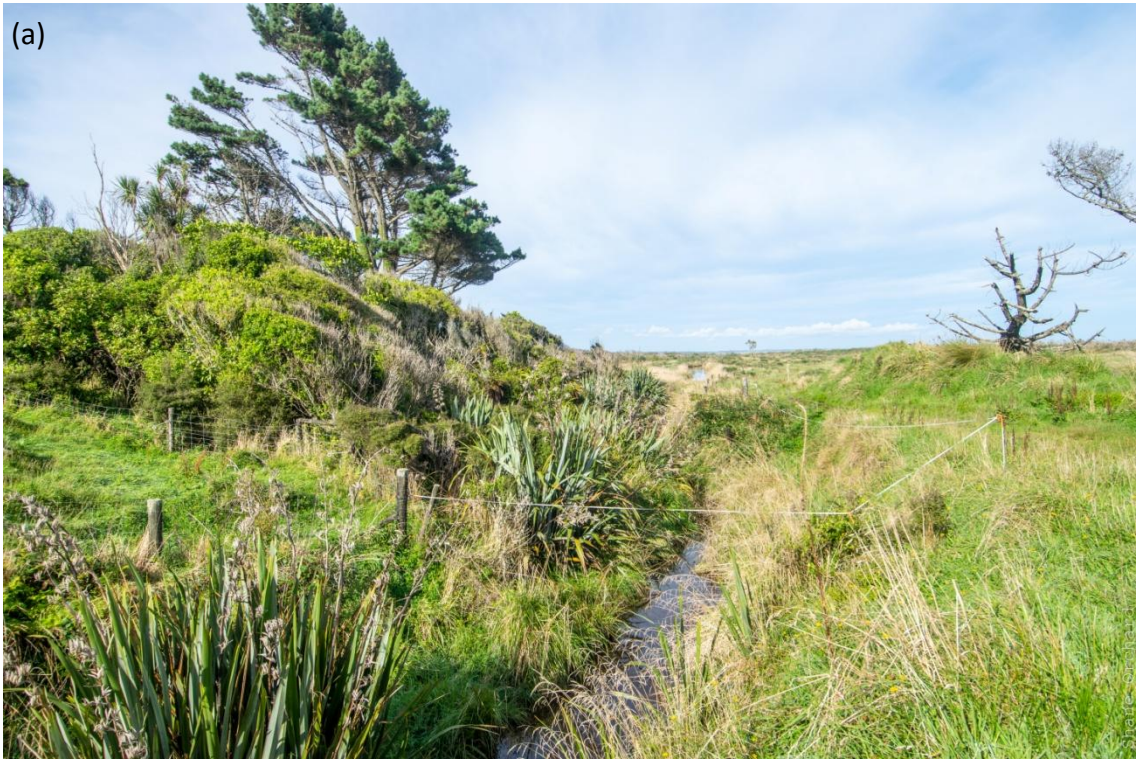
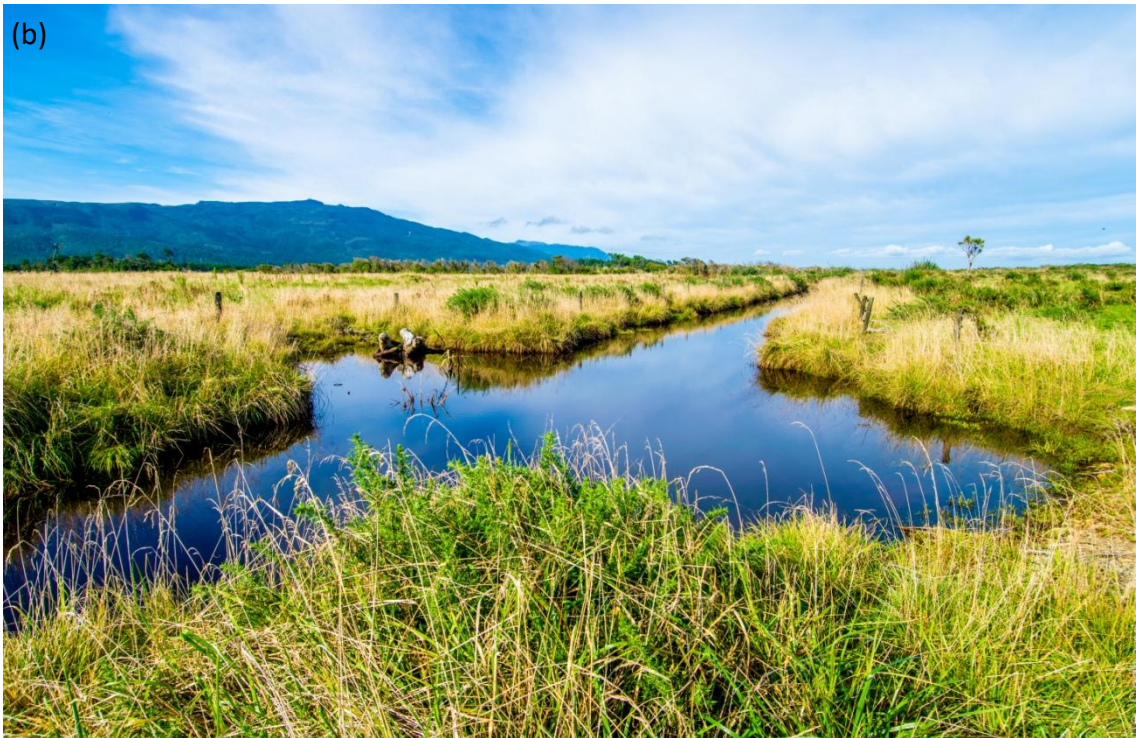
Fig. A1.2 Tributary downstream of Collins Road. (a) looking downstream towards the forest remnant and confluence with the bush tributary. Note hotwire in place. (b) old stock cross point (now fully fenced) looking downstream.

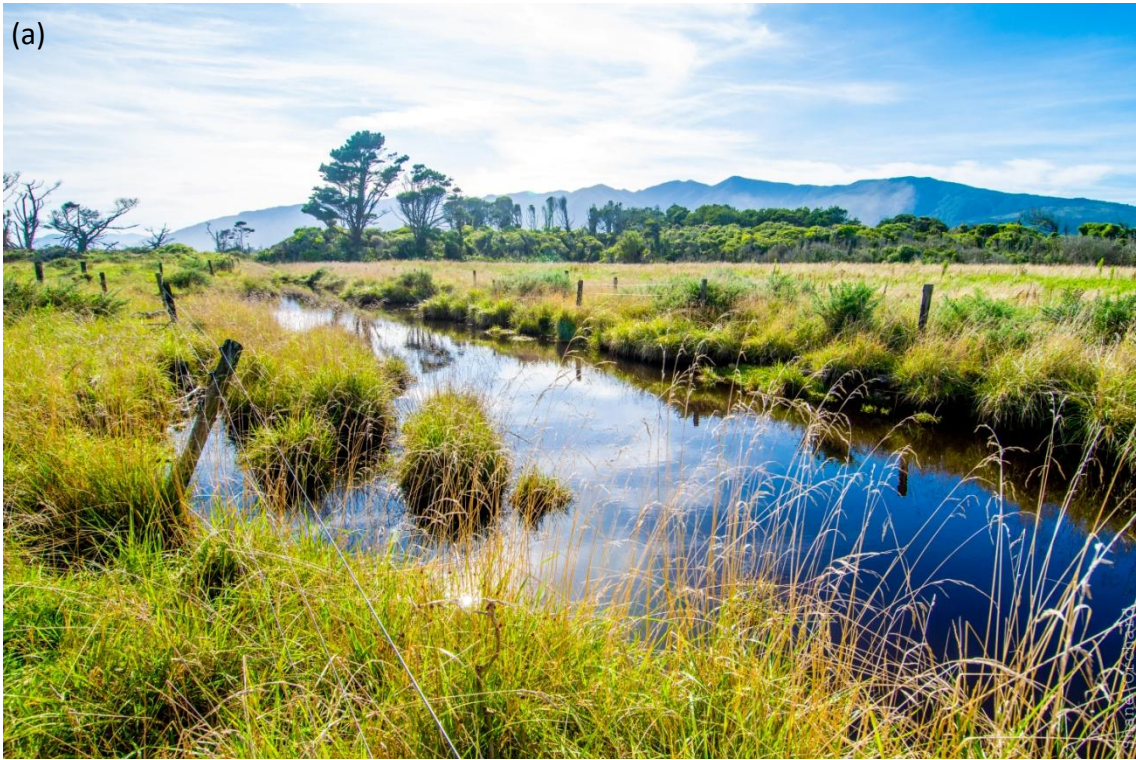
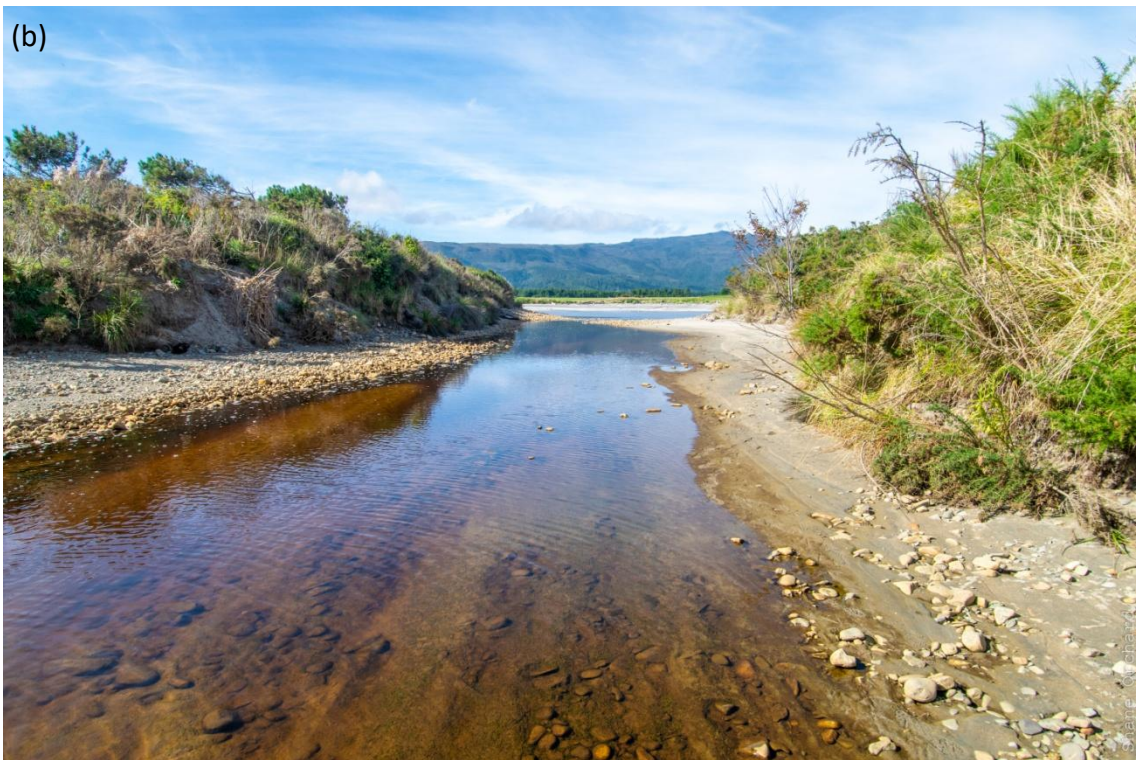
Fig. A1.3 (a) lower section of stream downstream of the old stock crossing point. (b) view of the lower stream and confluence with the Waimangaroa River.

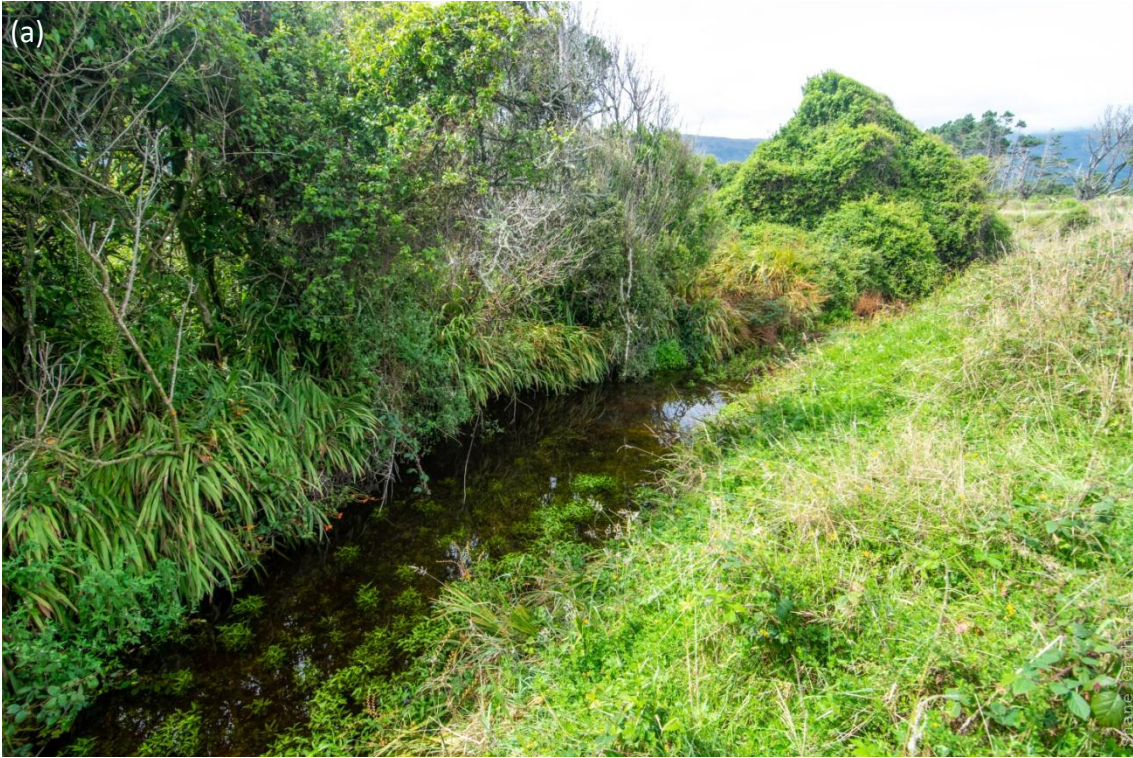
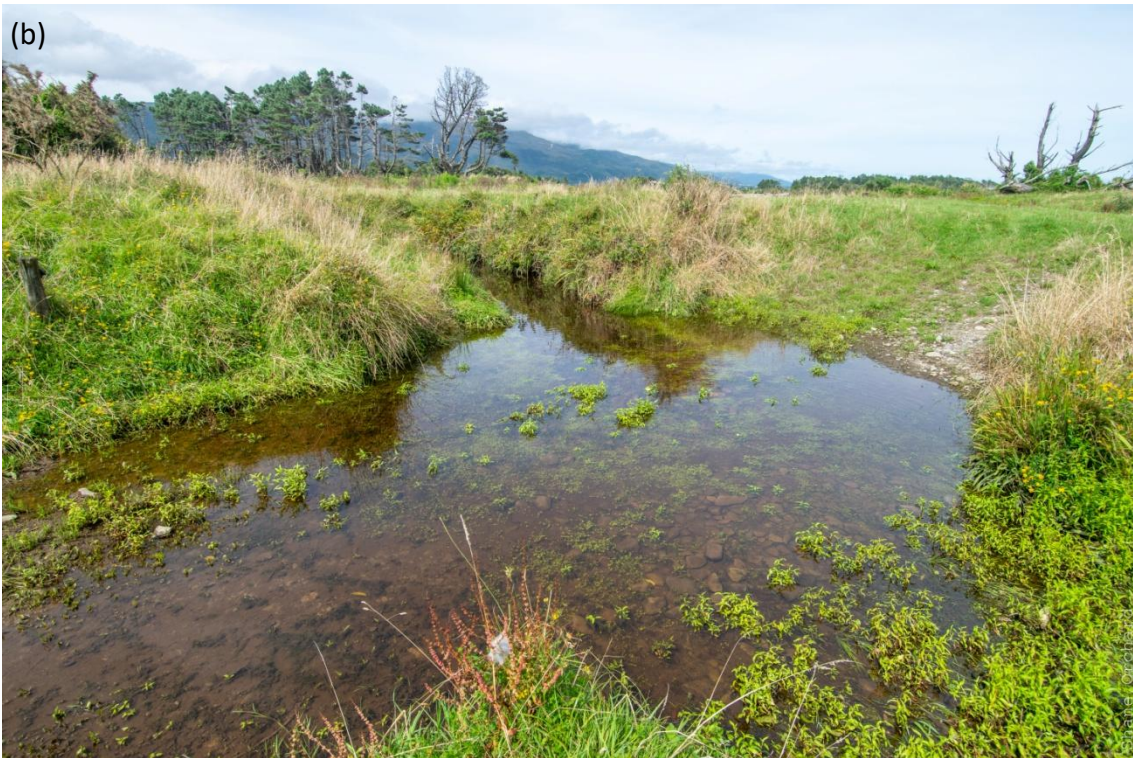
Fig. A1.4 (a) bush tributary where it enters the forest remnant. (b) stock crossing in farmland upstream of the forest remnant.

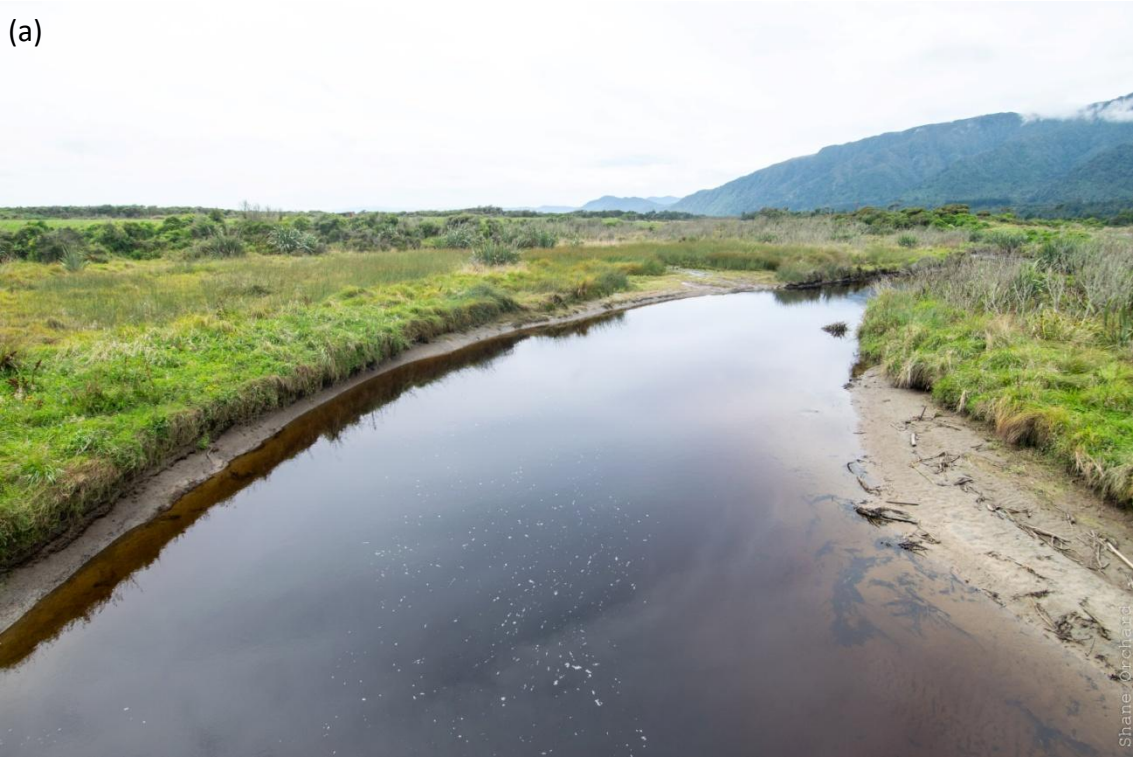
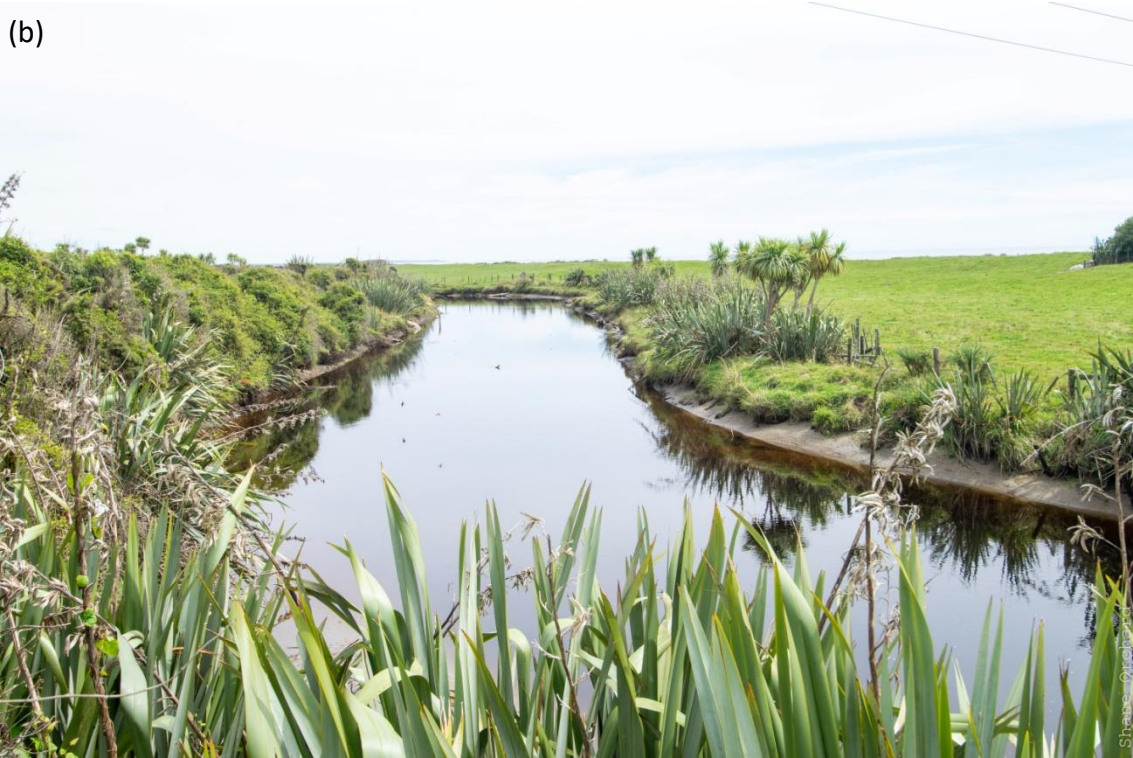
Fig. A2.1 Jones Creek as viewed from the Cains Road bridge. (a) looking upstream with the area of tidal wetland visible centre left. (b) looking downstream showing steep banks and scrub cover on the true left bank, and fenced margins adjacent to farmland and the true right.

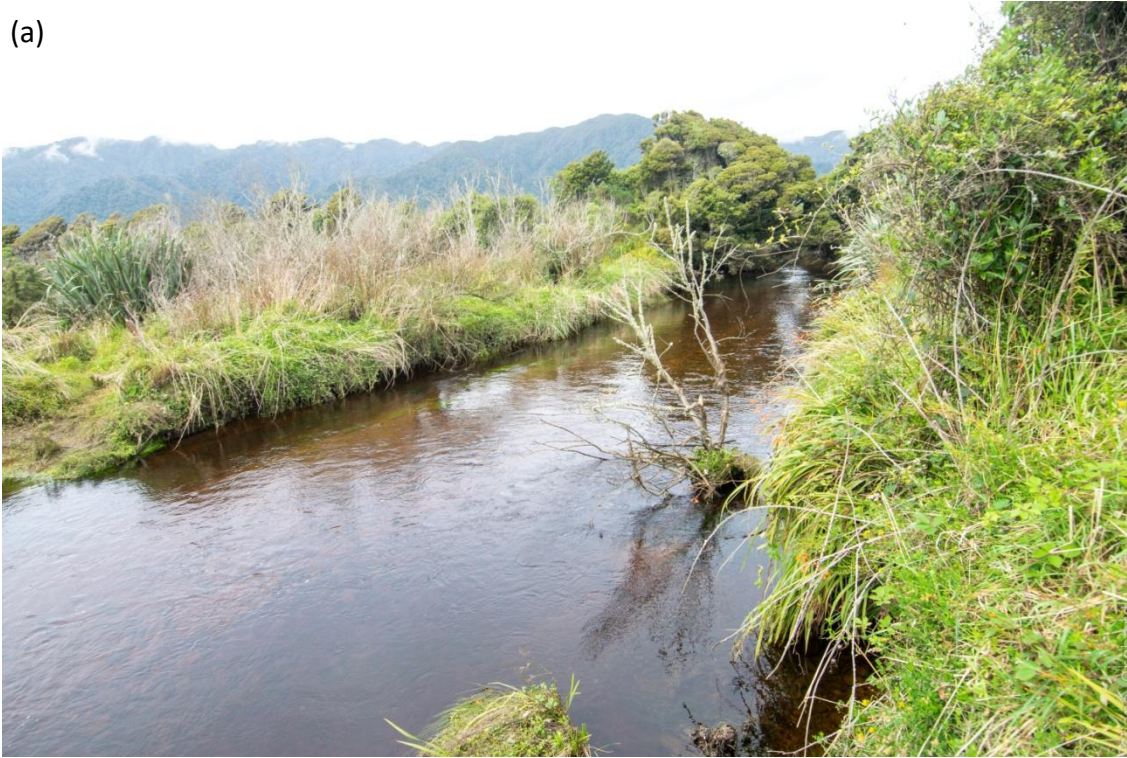
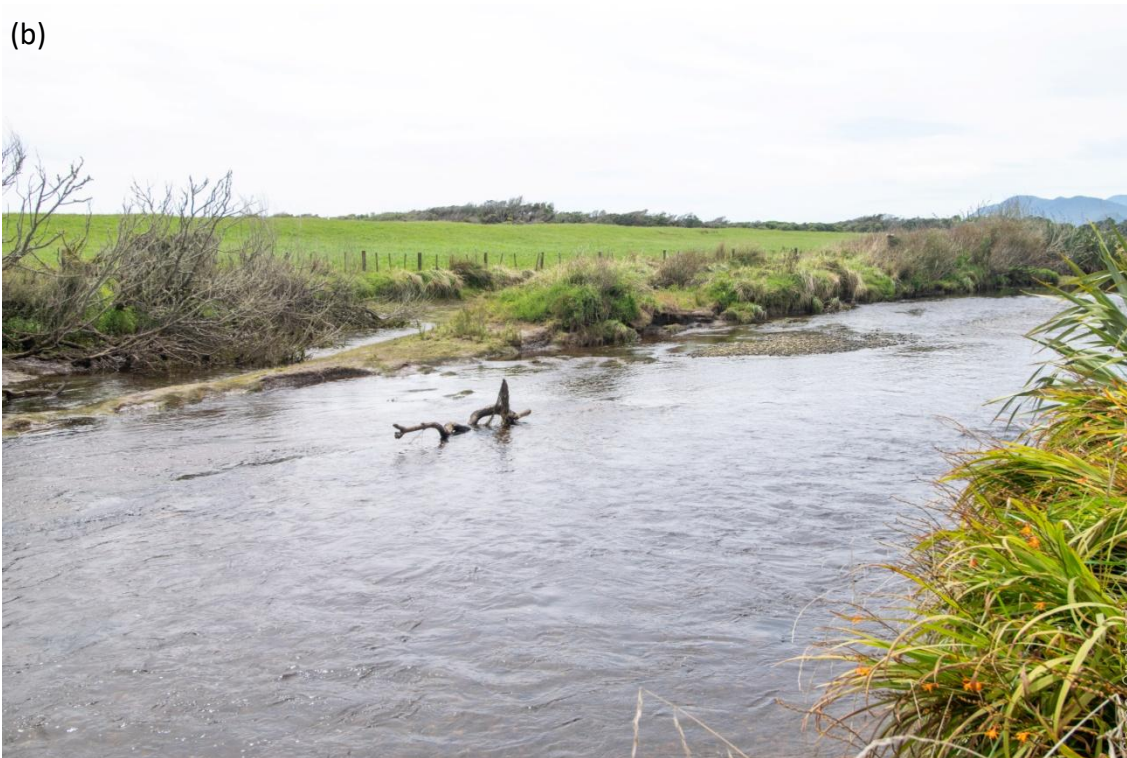
Fig. A2.2 (a) Fan Creek near its confluence with Jones Creek. (b) Jones Creek a short distance below the fan Creek confluence (looking upstream) in the vicinity of a previously reported *īnanga* spawning site on the far bank.
