Sustainable Wild Whitebait Fishery: habitat mapping in the Waimangaroa, Jones Creek and Whareatea catchments

Technical Report · April 2020

Department of Conservation
West Coast *Tai Poutini* Conservancy
April 2020

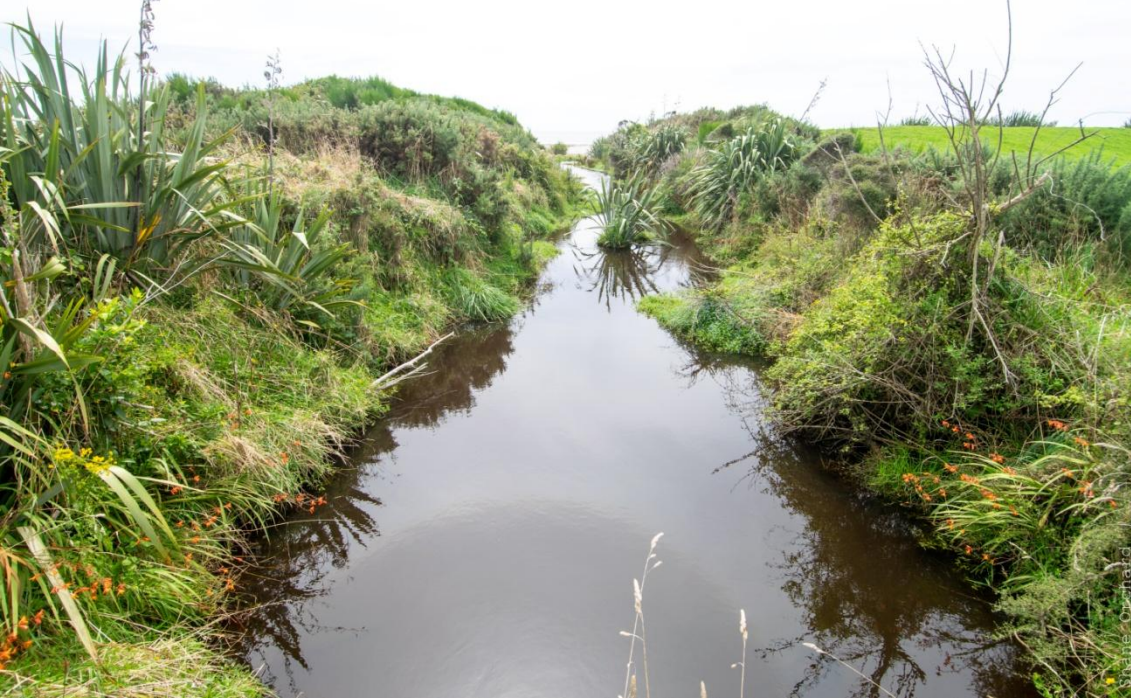
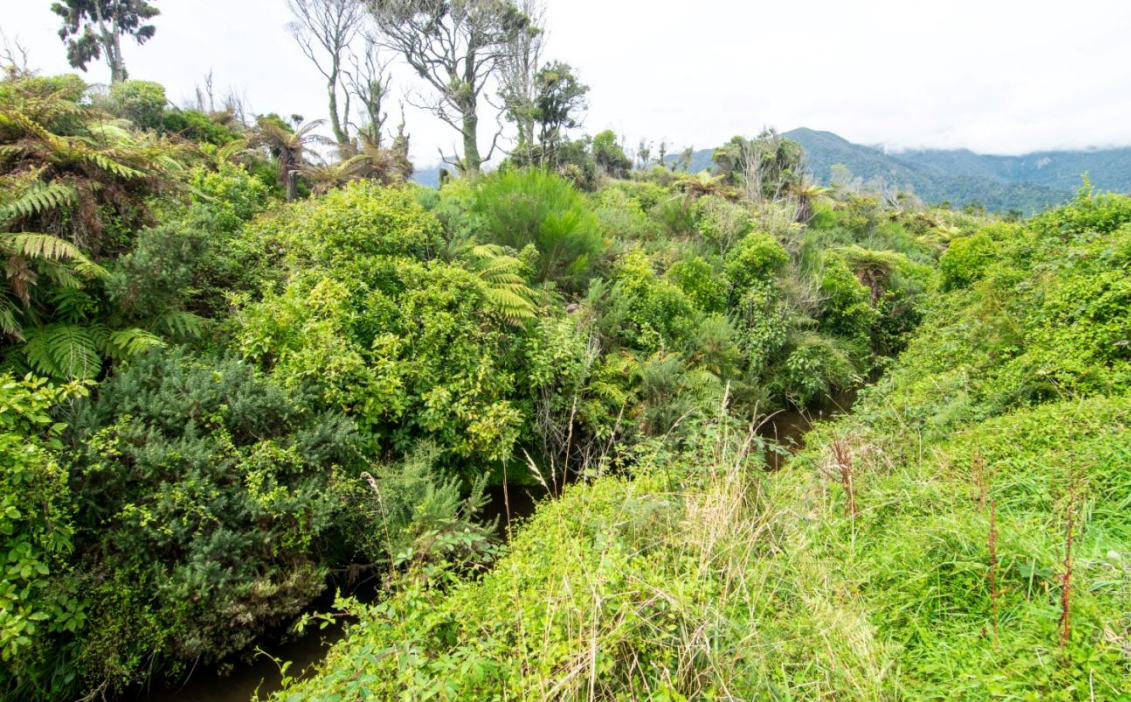
Fig. A2.3 (a) Stony Creek looking downstream from the culvert at Manns Road. (b) established forest cover on the true right bank of Stony Creek upstream of Manns Road.

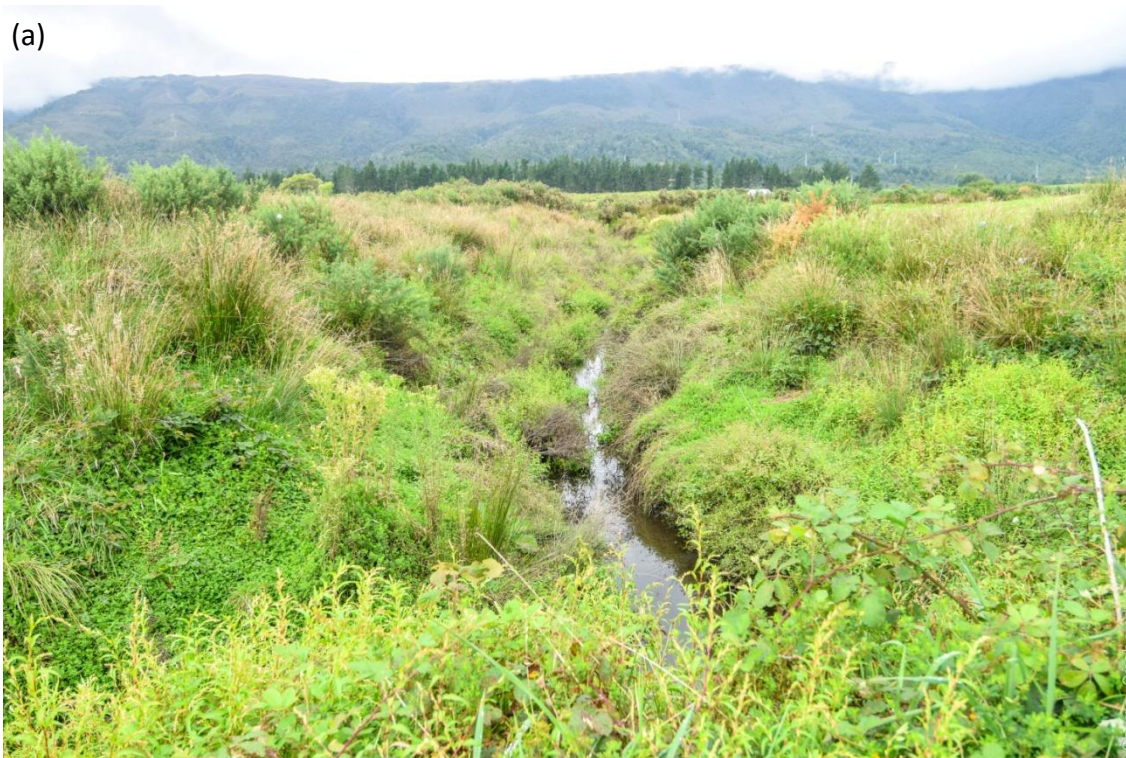
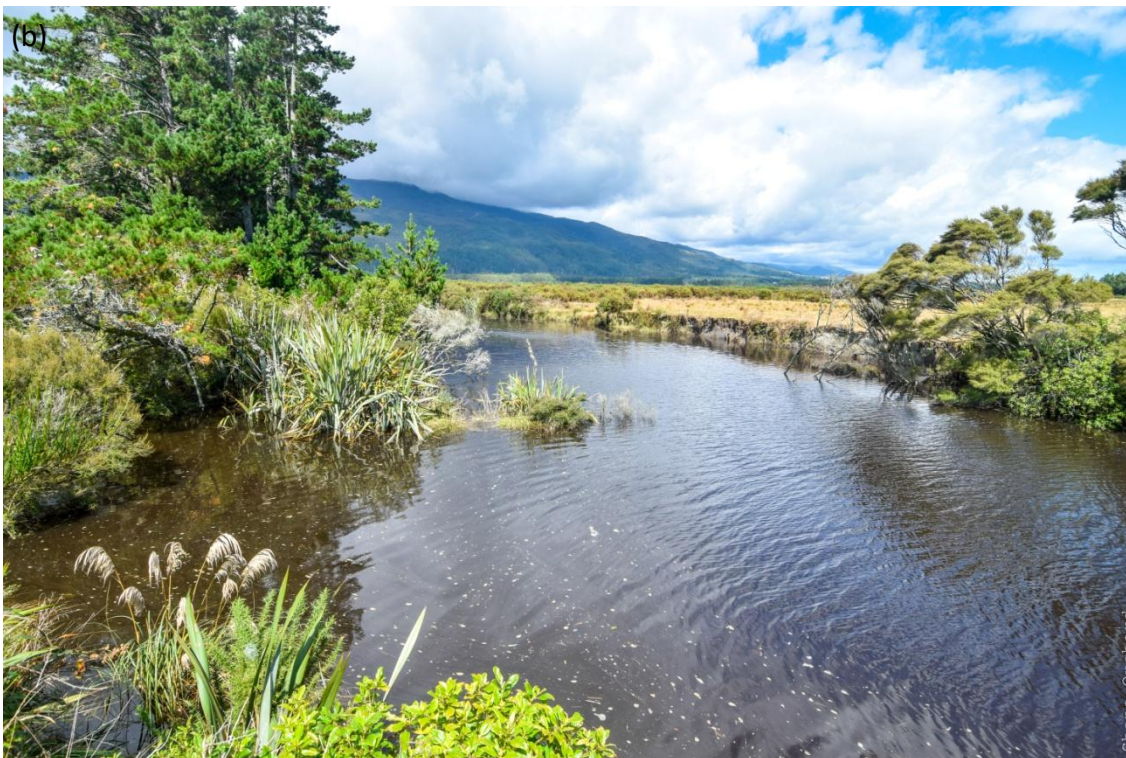
Fig. A3.1 One of the farm drains that connects to the Rapid Creek catchment. Many of these established drains are protected from stock grazing and are likely to support fish populations. (b) view of the Whareatea River mainstem looking upstream from its confluence with Rapid Creek (left foreground).
