Connectivity assessment for migratory fish in the Middle Creek catchment, Kaikōura coast

Technical Report · April 2021

Environment Canterbury

Report WL21041 for Environment Canterbury

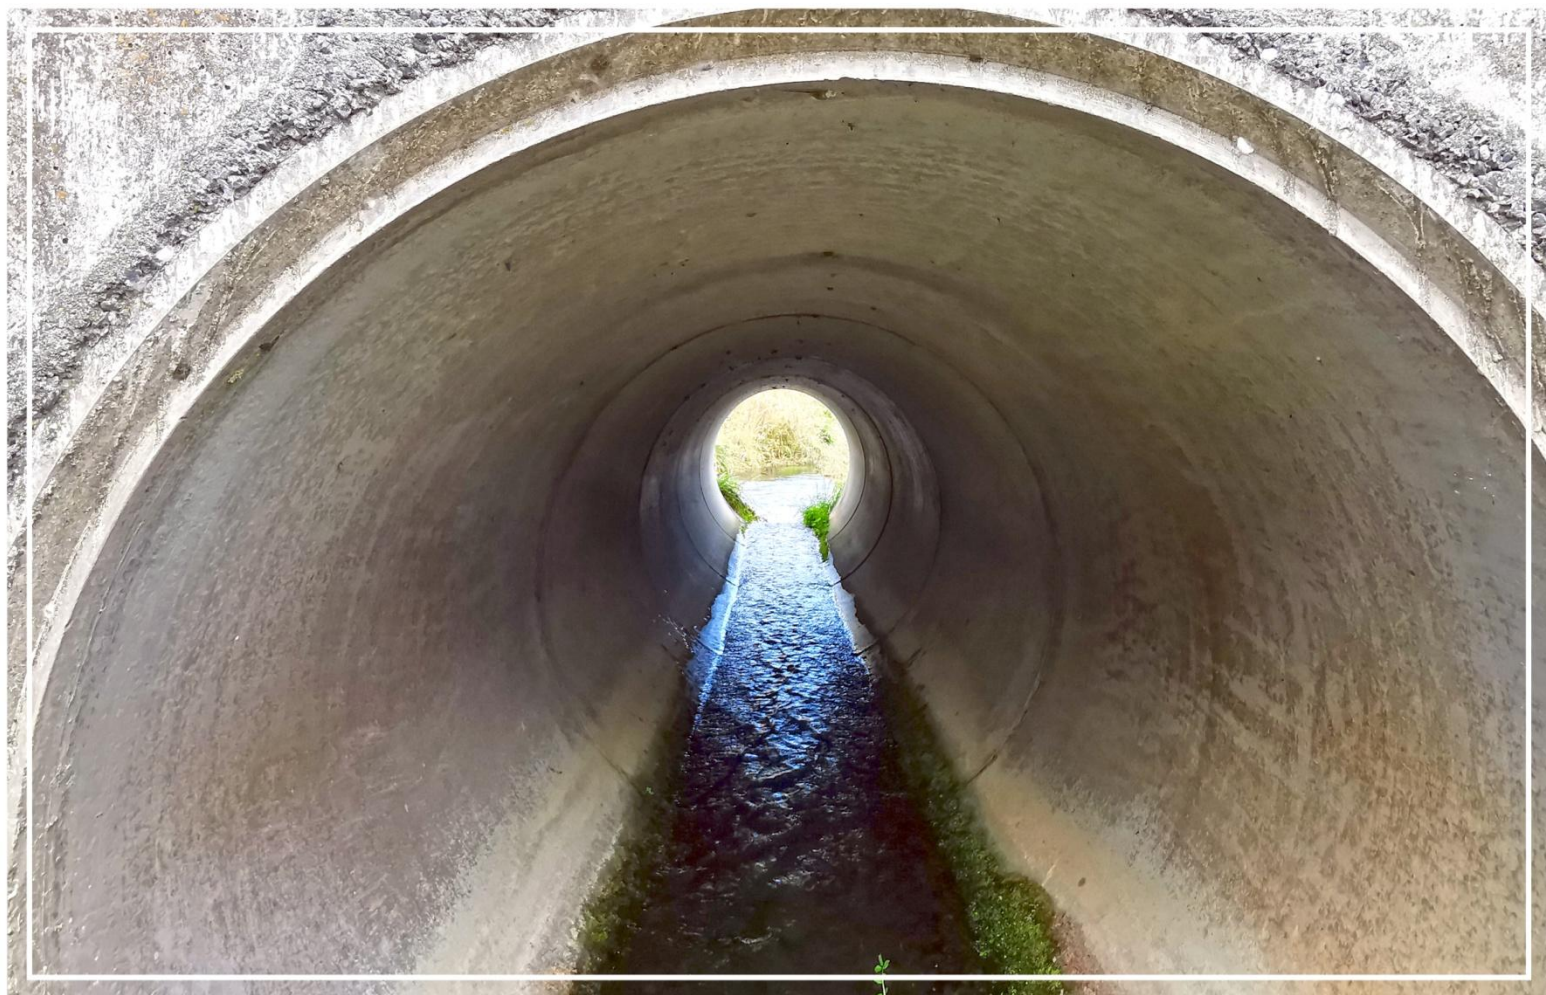
Schoolhouse Road culvert on Luke Creek in the Middle Creek catchment, Kaikōura Plains.

This perched pipe end is relatively straightforward to remediate by building upon the existing rock protection nearby. Placement of a line of additional large rocks in the pool immediately below the pipe end, including one large partially embedded boulder either side, should be sufficient to enable a short rock ramp to be built around the pipe end. As the free-fall drop was observed to be only 10-15 cm in typical flows, this ramp only needs to be 1 - 2 m in length to assist fish access to the barrel of the pipe.

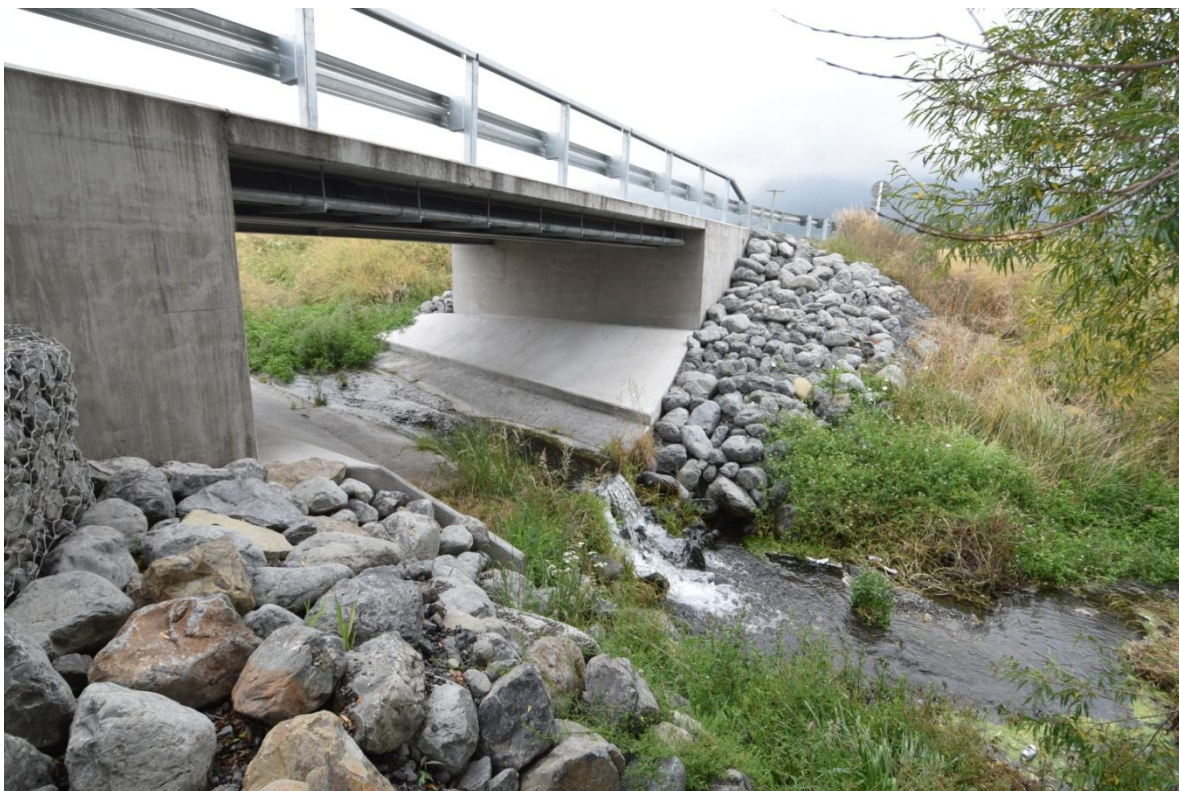
Fig. 2. A suspected fish passage barrier at Mt Fyffe Road bridge associated with a vertical headwall.

The recommended option involves construction of a ‘bottom ramp’ (constructed rapid) using local rock. The configuration of the streambed downstream of the barrier suggests this would be relatively straightforward since there is ample room for attaining a suitable finished gradient (e.g., 1:15).

Following guidance in FAO (2002), a boulder bar construction is recommended in view of the ample room available (Fig. A1). In this design, the rock ramp is broken into sections by boulder bars to form a pool-drop configuration. This creates excellent resting places for fish migrating up the ramp and can help to retain sediment on the ramp as a whole which is important to assist the build up of fines to plug the gaps between the placed rock. The main engineering requirement involves construction of a low-flow channel that retains water on the ramp e.g., by using larger rocks on the flanks. Other construction points include the need to embed a series of large rocks (e.g., either side at the position of each of the boulder bars) to anchor and protect the entire structure against movement during high flows (FAO 2002).

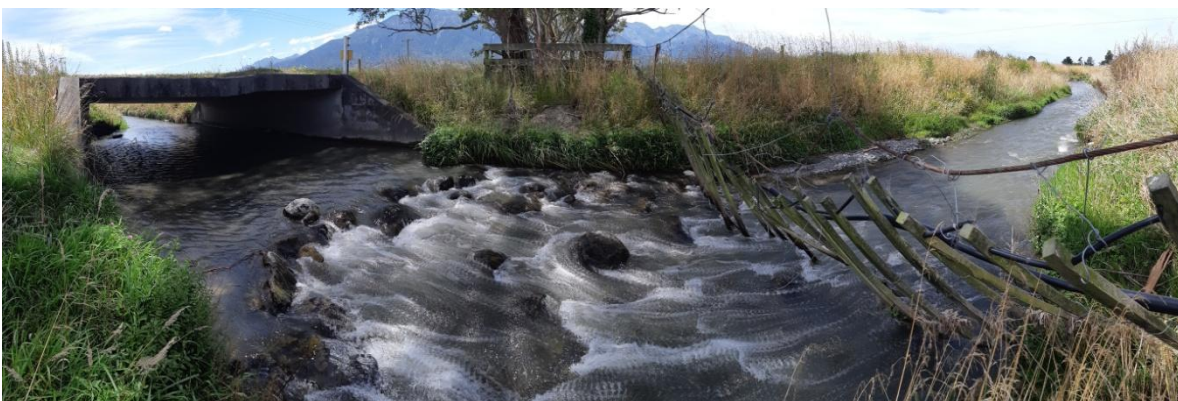
Fig. 4. A remediated section of Middle Creek where a bottom slope was installed at a small pour-over downstream of the State Highway 1 bridge. Photo: Heath Melville.

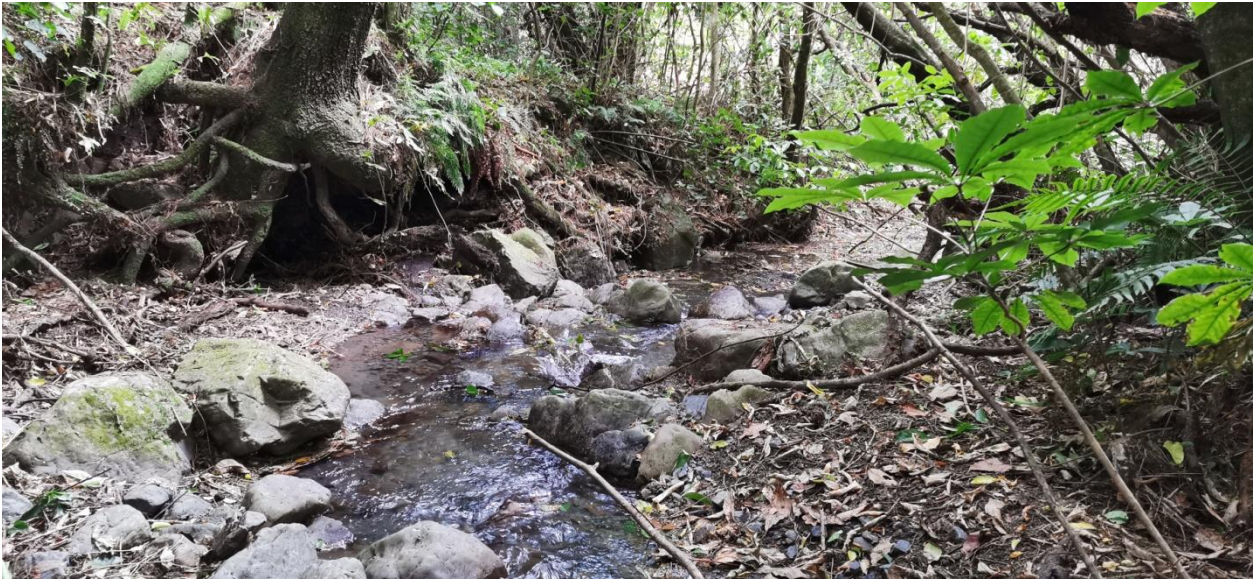
In Middle Creek, only one fish (a longfin eel) was caught above the obvious barrier at Mt Fyffe Road. There were no fish caught in either of the upper tributary reaches of Middle Creek (sites 7 and 8) despite the presence of suitable habitat for migratory species such as banded kōkopu (*Galaxias fasciatus*) which was considered to be potentially present prior to this project (Fig. 6).

Fig. 6. (a) Upper reaches of Middle Creek at the foot of the Seaward Kaikōura range.

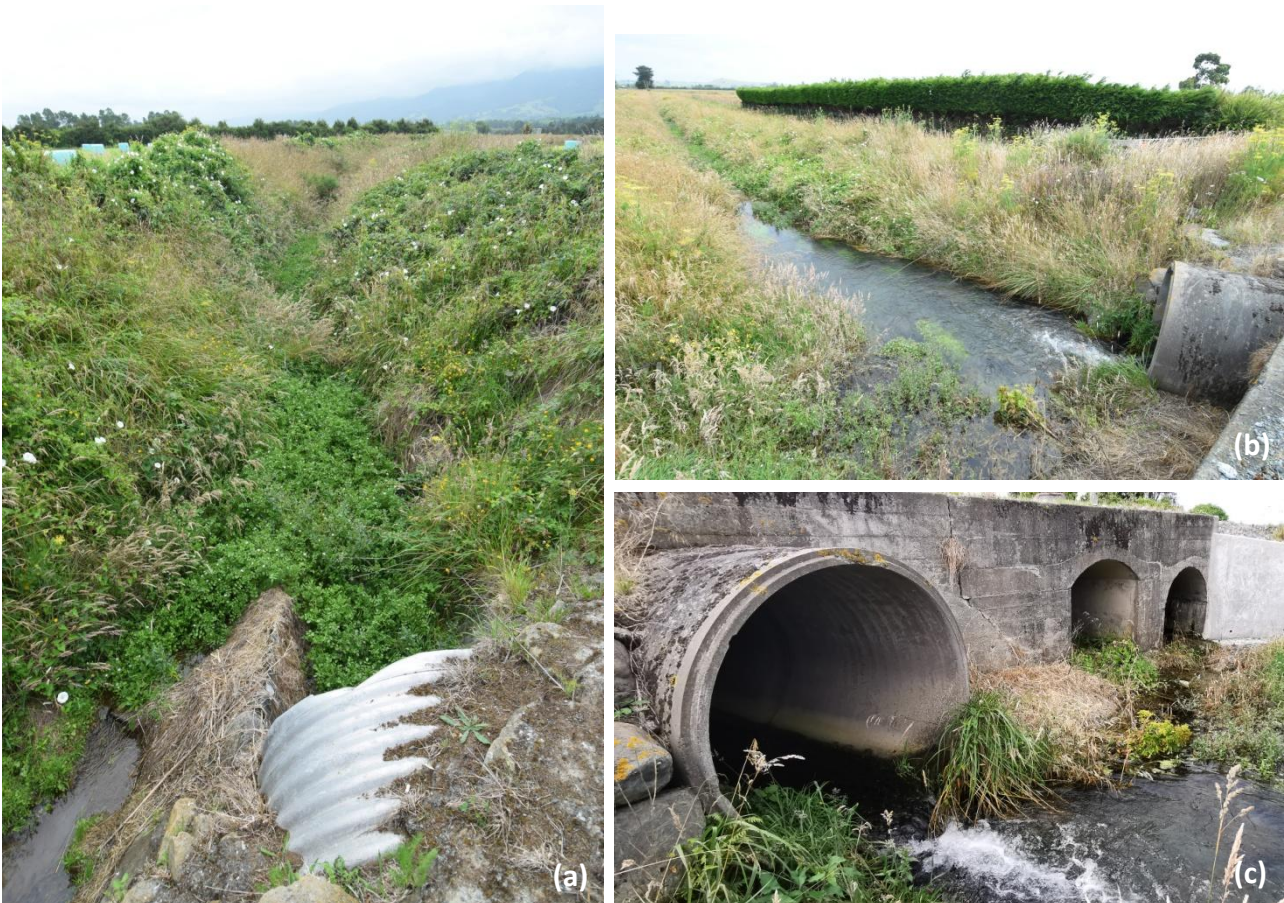
In Luke Creek, no fish were caught upstream of the potential barrier at Schoolhouse Road (Fig. 7a) despite the presence of suitable habitat for species such as īnanga. This includes a series of spring-fed farm drains featuring dense overhanging vegetation (e.g., *Carex* species) along the margins (Fig. 7b, c).

Fig. 7. (a) Luke Creek upstream of Burrells Lane. (b) and (c) two views of the culvert in Luke Creek at Schoolhouse Road.

Field observations also suggested that the combined effects of current speed and pipe length may prove to be a further limitation for weak swimmers such as īnanga. However, it is recommended that the perched pipe end be remediated as the initial priority followed by re-assessment of this aspect to determine if any further enhancements are necessary (or otherwise). Overall, this should present a relatively straightforward opportunity to improve connectivity for migratory fish.
