Response of īnanga spawning habitat to riparian vegetation management in the Avon & Heathcote catchments

Christchurch City Council
June 2017

Waterlink Ltd

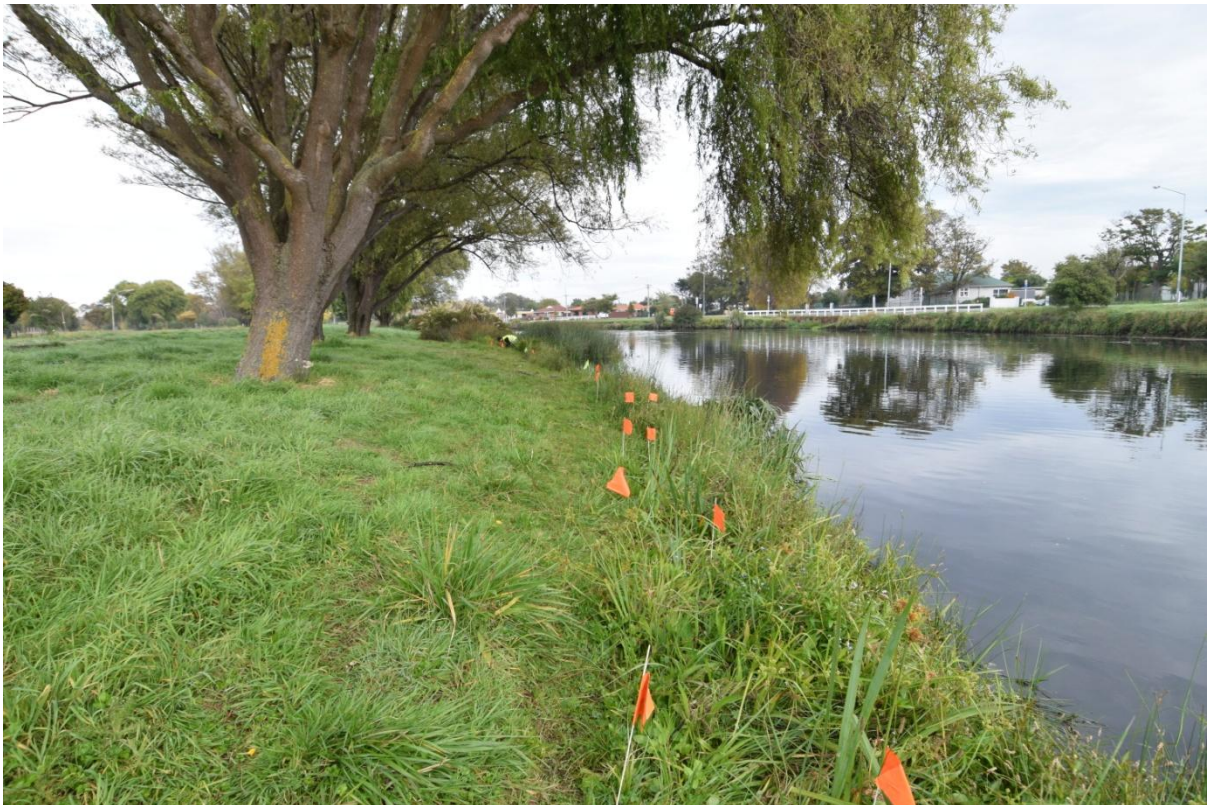
Figure 4. īnanga spawning at a site that was regularly mown prior to the CCC trial.

In the Avon/Ōtākaro four sites were found in Corsers Stream, all above the tide gate. This is the first time spawning has been recorded here. These sites were found outside of the original survey area for this study and there may be other sites upstream in this tributary. The area searched in this study only covered the lower part of the stream on the true left. Many of the other new sites occurred in previous gaps in the known post-quake distribution, in some cases showing an obvious response to improved riparian vegetation. An example from upstream of Avondale Road bridge on the true right is shown in Figure 4. This site occurred in an area that was previously mown to the water's edge. Although the mowing line was relaxed only a short distance it was sufficient to accommodate the position of the high water mark on the spawning tide.

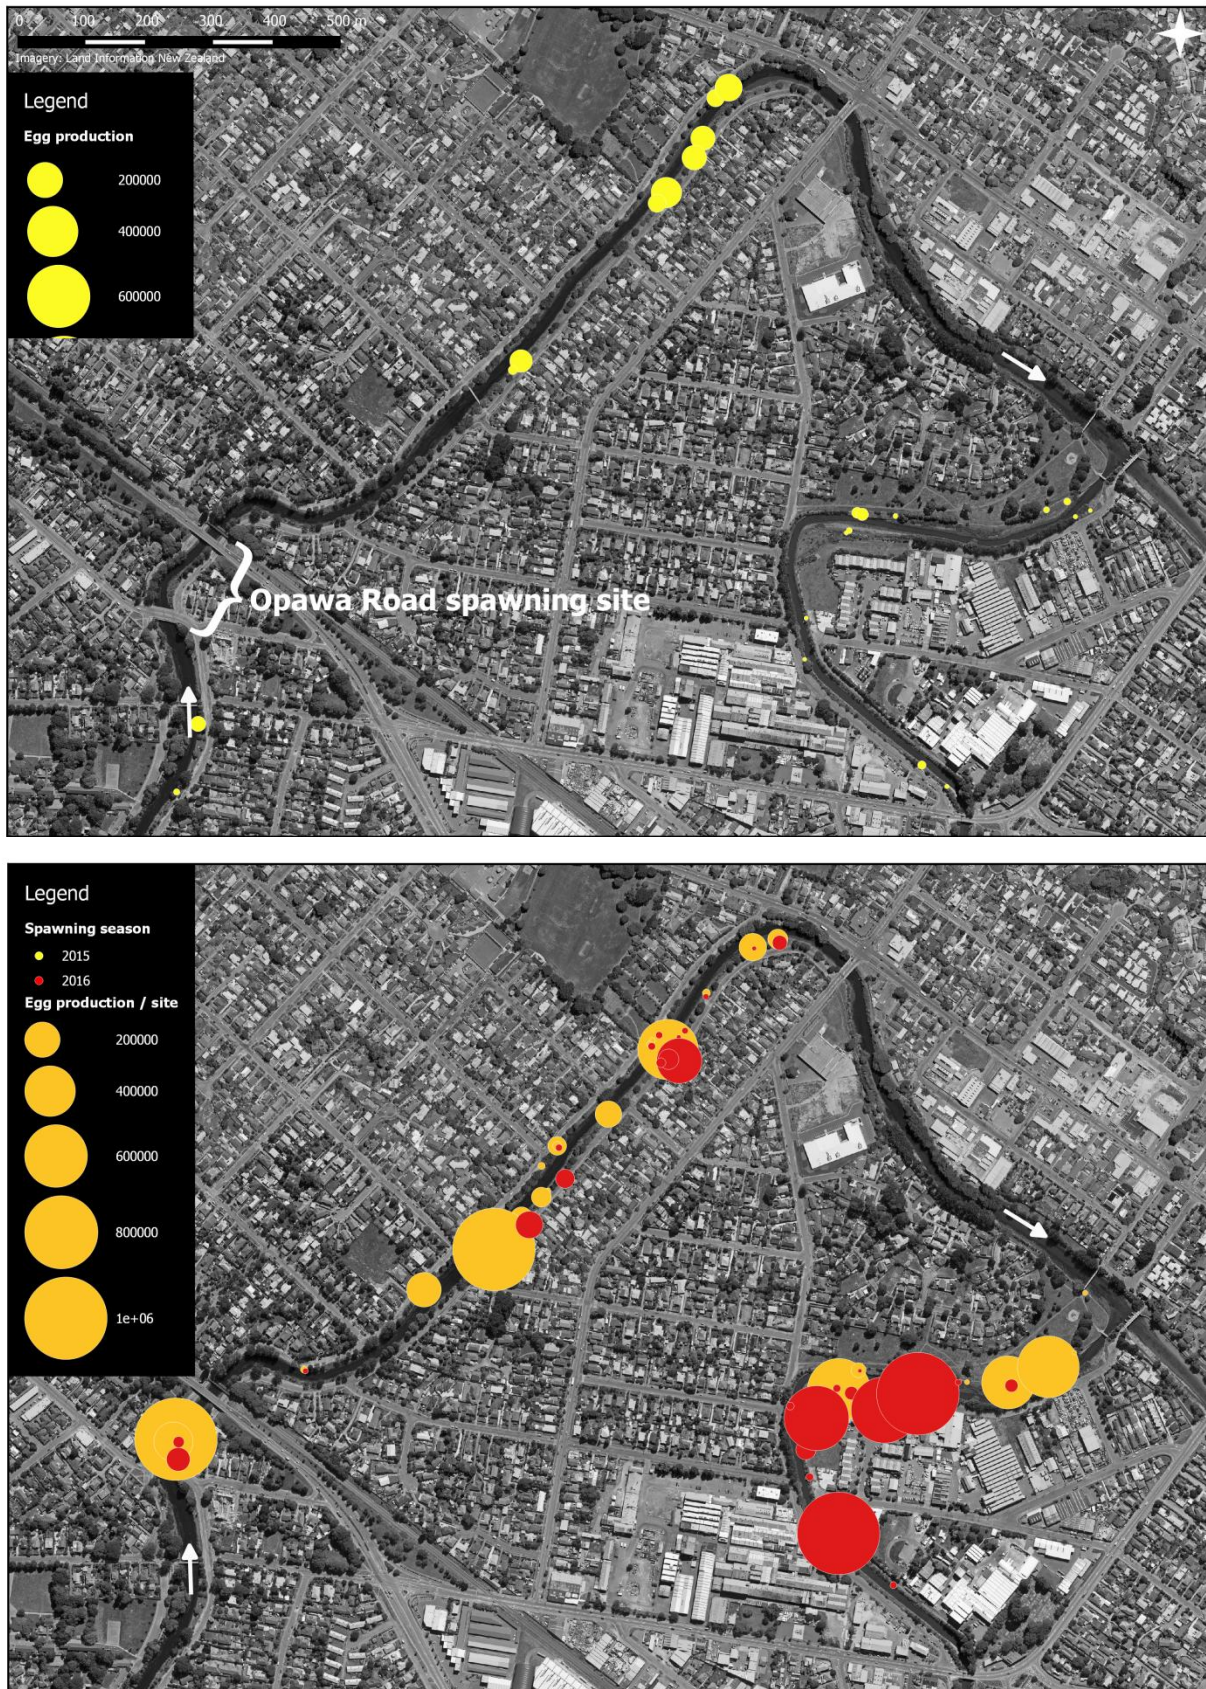
Figure 8. Egg production in the Heathcote/Ōpāwaho. (a) Egg production recorded at each site in this study. (b) Total egg production at spawning sites recorded in 2015 and 2016.

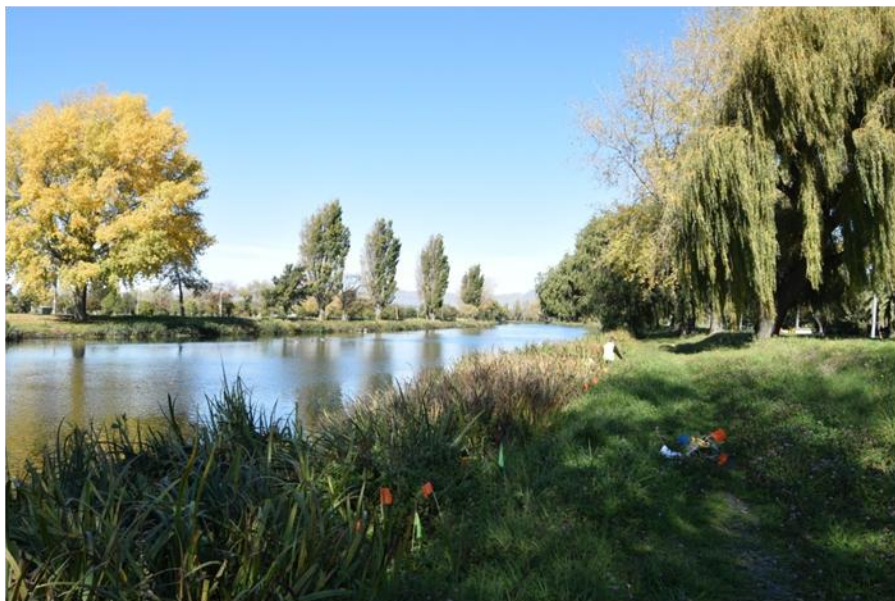
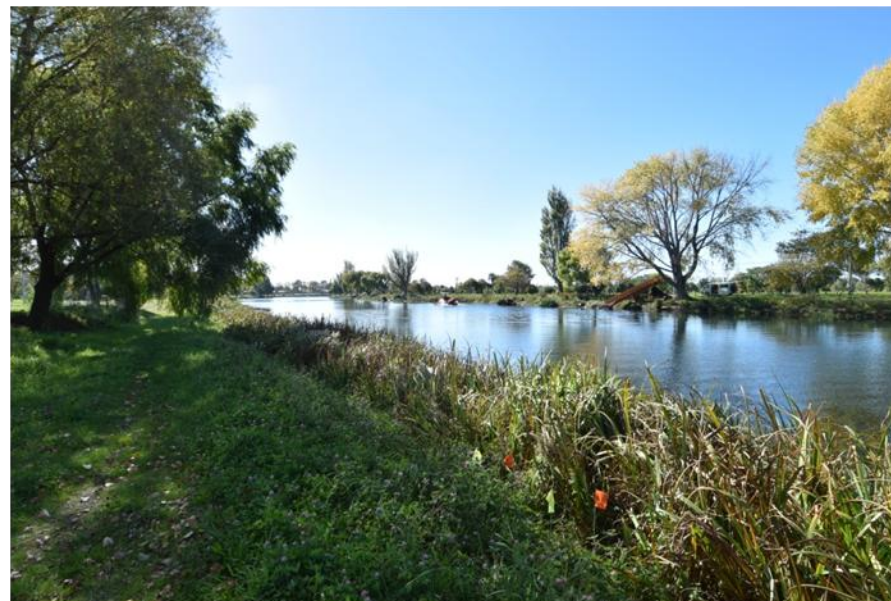
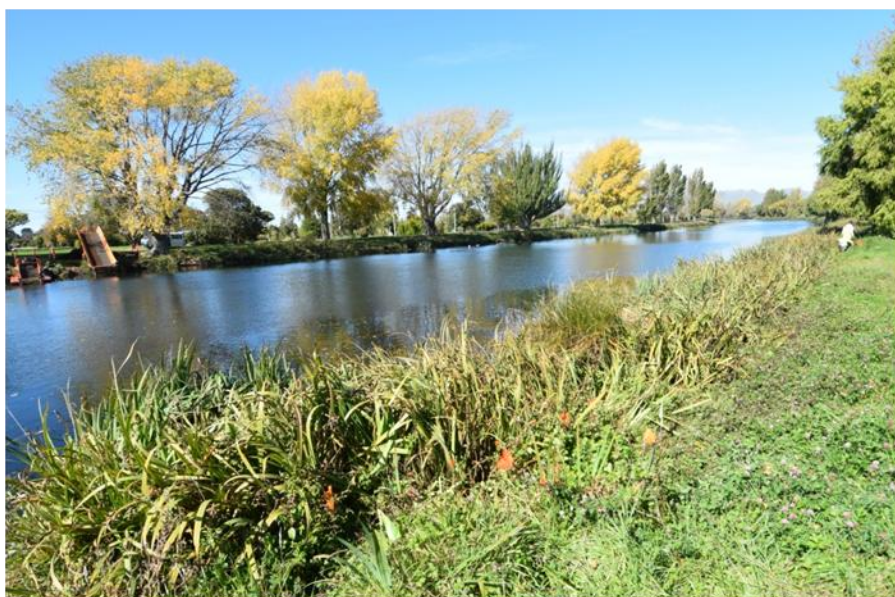
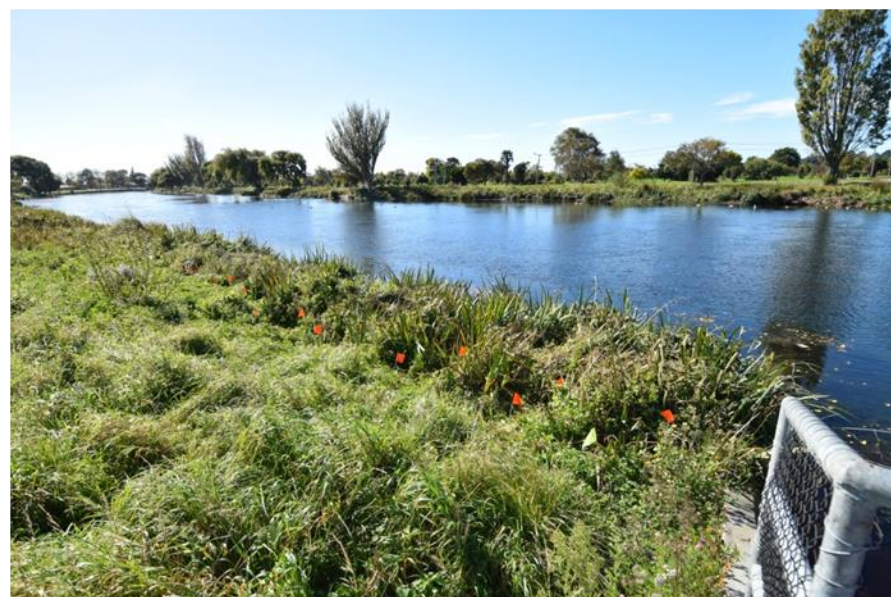
Appendix 1. Examples of spawning sites in the Avon / Ōtākaro catchment. (a) sites along Locksley Terrace on the true left bank.
Note: yellow flags are used to mark the upstream and downstream limits of the spawning site in all photos.

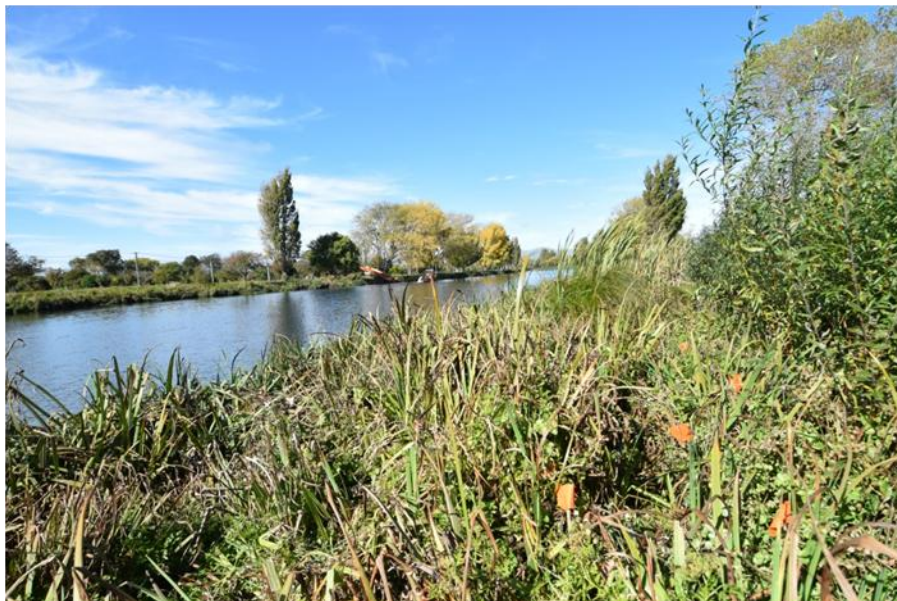
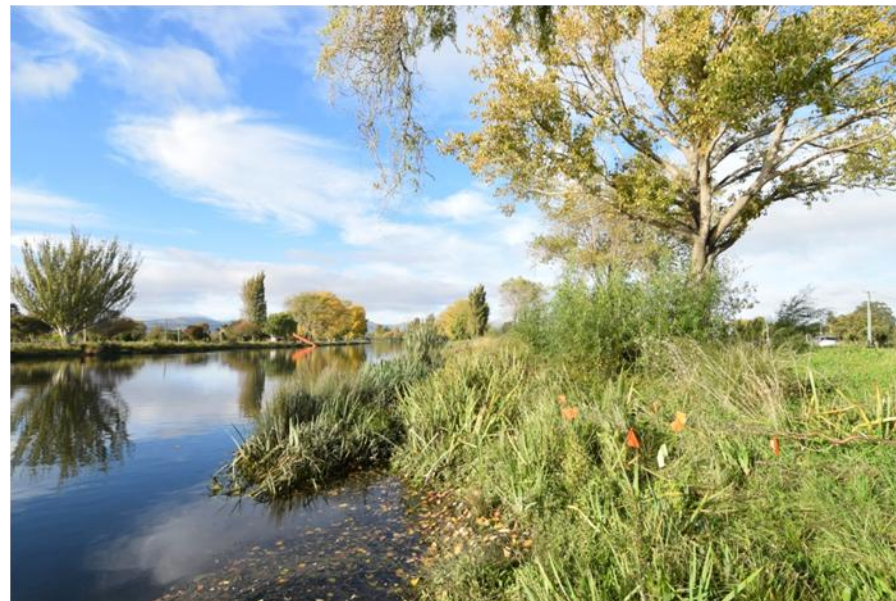
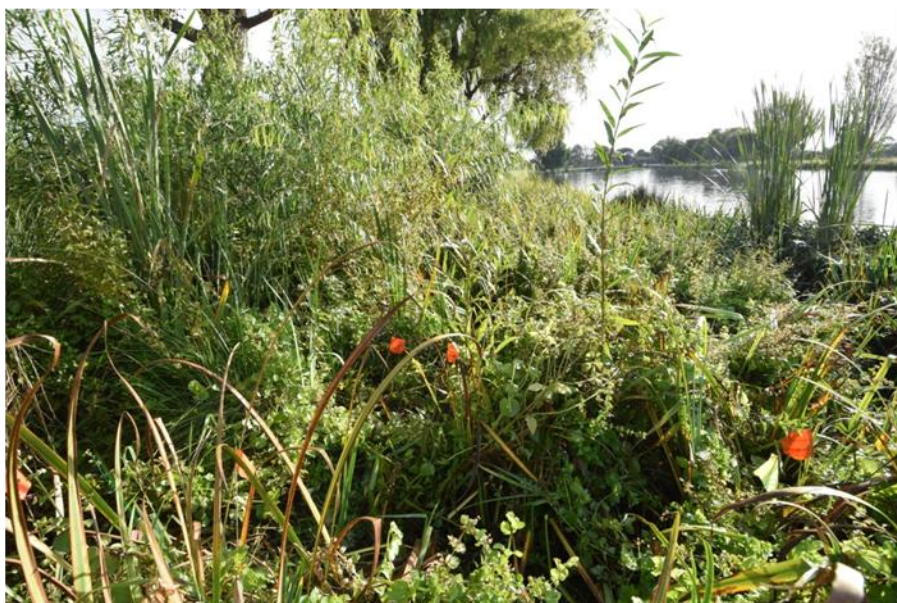
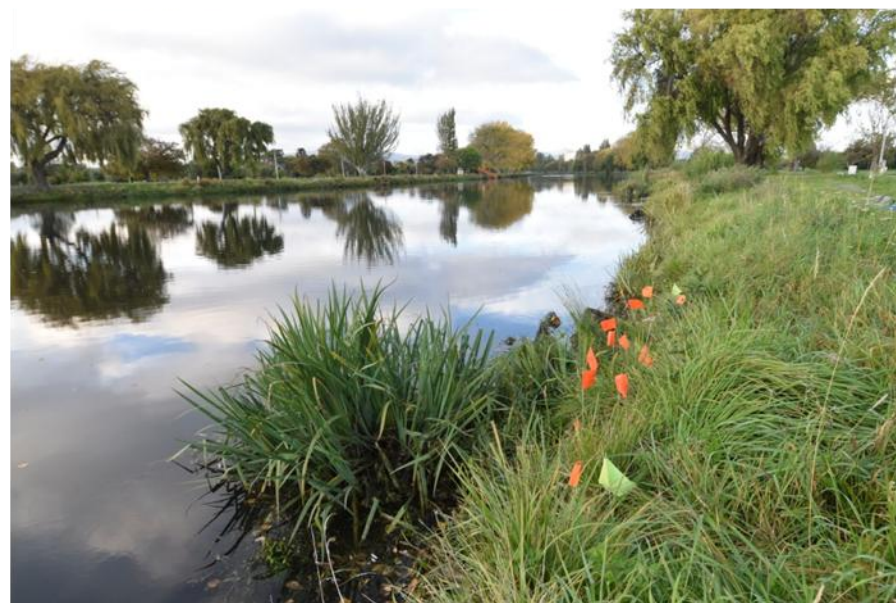
Appendix 1. Examples of spawning sites in the Avon / Ōtākaro catchment. (b) sites above the Horseshoe Lake/Waikākāriki confluence along New Brighton Road on the true left bank.

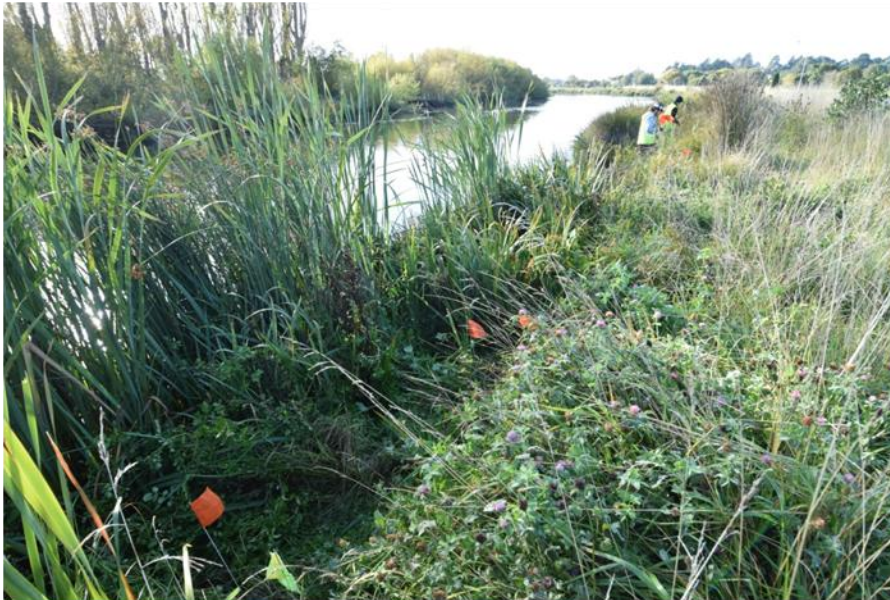
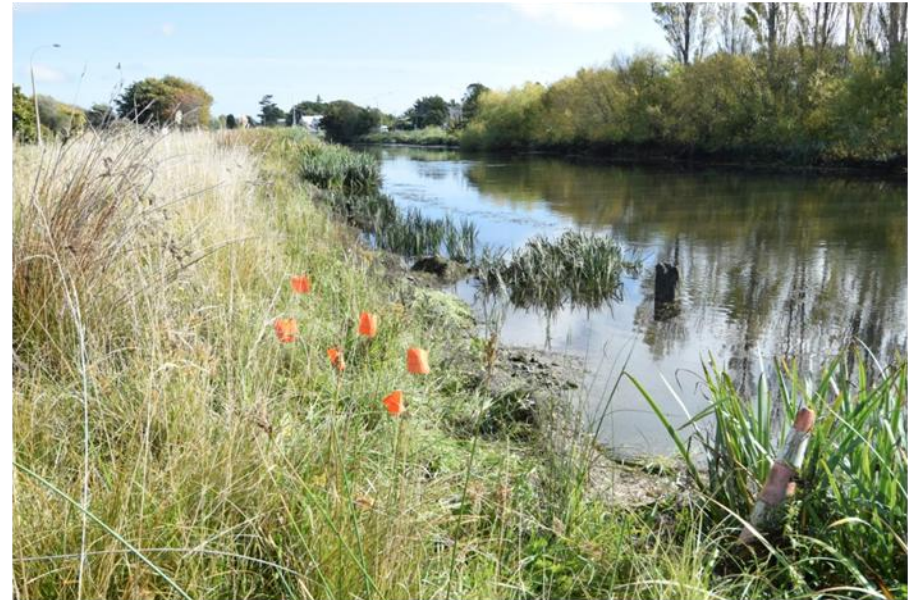
Appendix 1. Examples of spawning sites in the Avon / Ōtākaro catchment. (d) sites upstream of the Avondale Road bridge on the true right bank along Hulverstone Drive.

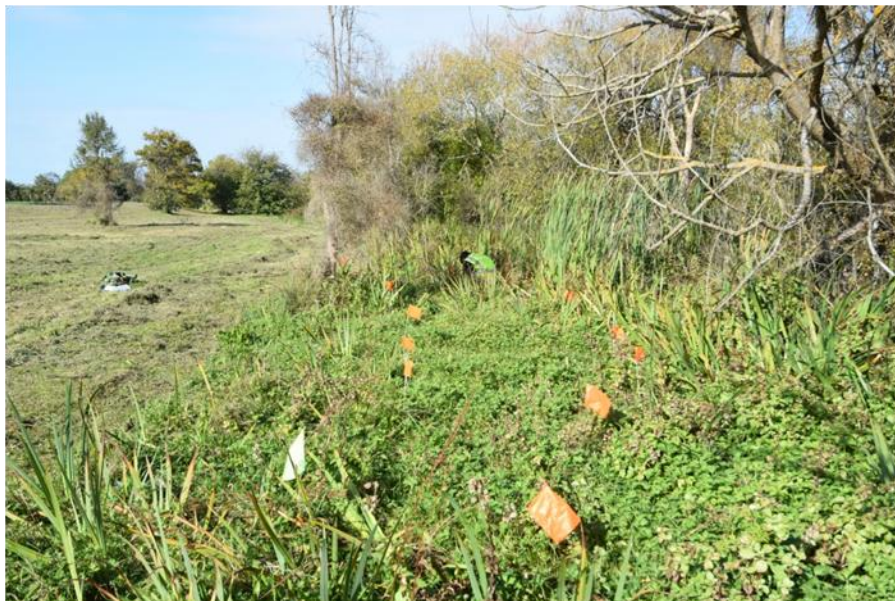
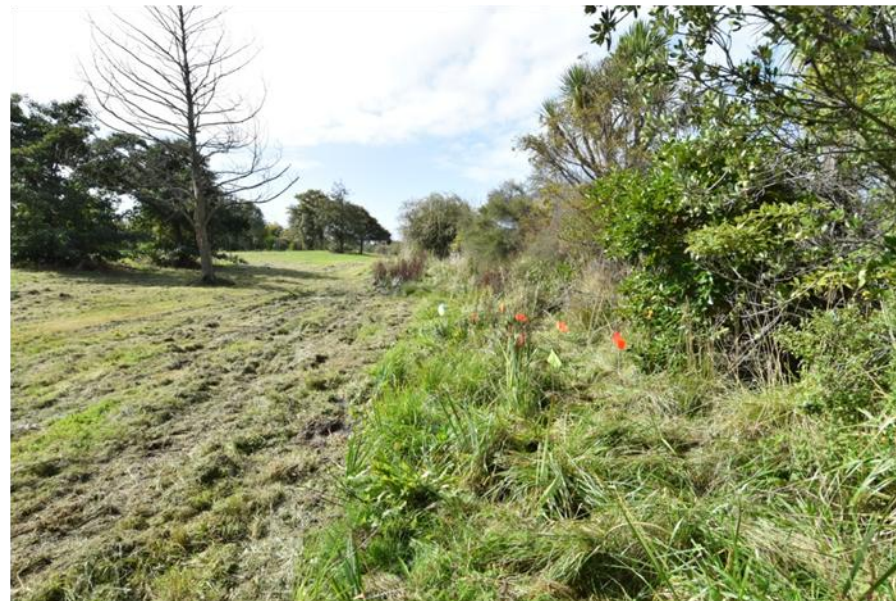
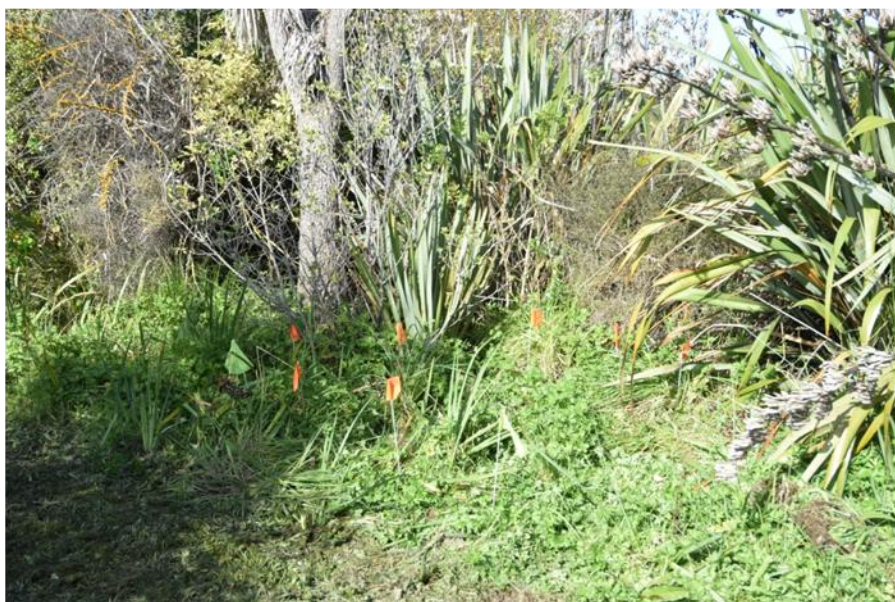
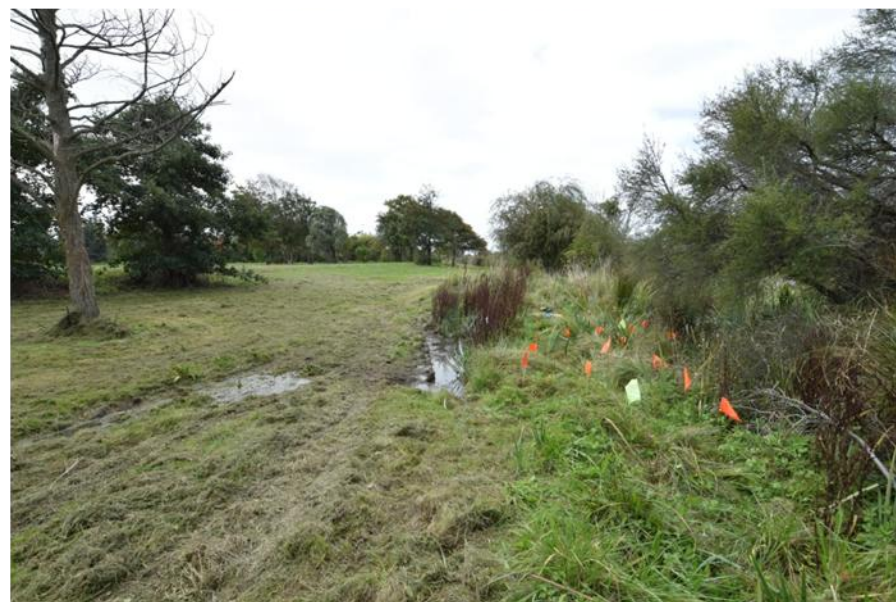
Appendix 1. Examples of spawning sites in the Avon / Ōtākaro catchment. (e) sites downstream of the Avondale Road bridge on the true left bank in Amelia Rogers Reserve.

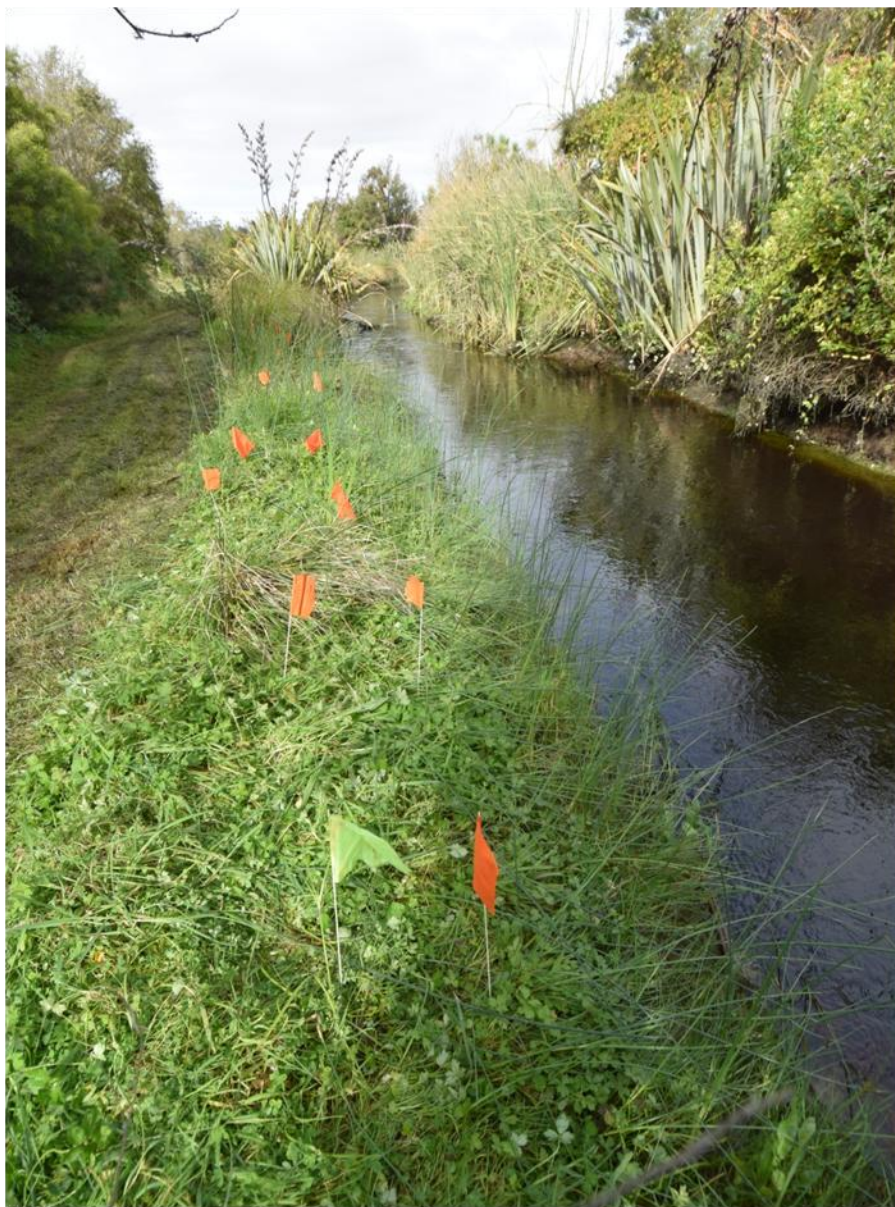
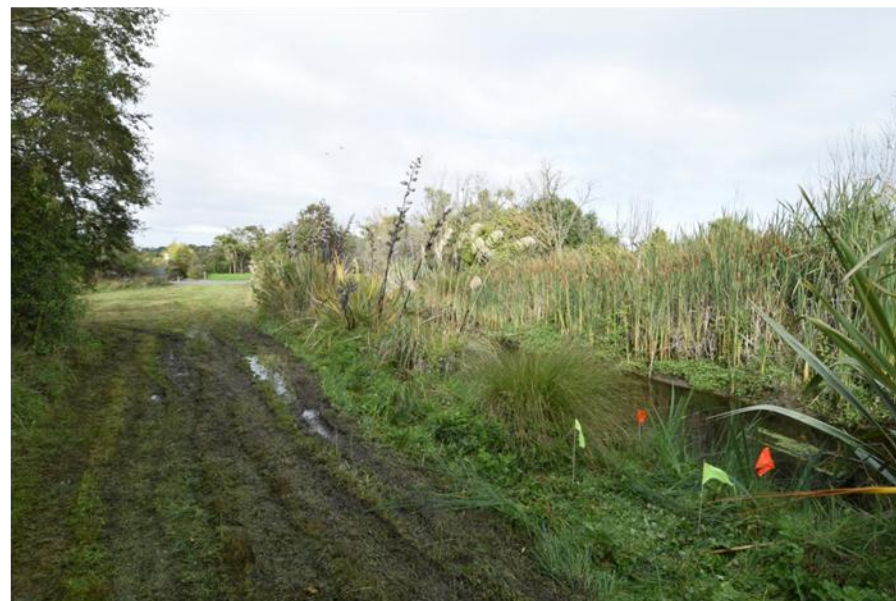
Appendix 1. Examples of spawning sites in the Avon / Ōtākaro catchment. (f) sites on the true left bank of Corsers Stream above the tide gate.
