Coastal Hazard Risk Assessment for Clifftop Developments Ltd., Wanganui

Report prepared for Glasson Potts Fowler on behalf of
Clifftop Developments Ltd – Wanganui

October, 2005
Client Report 05/3

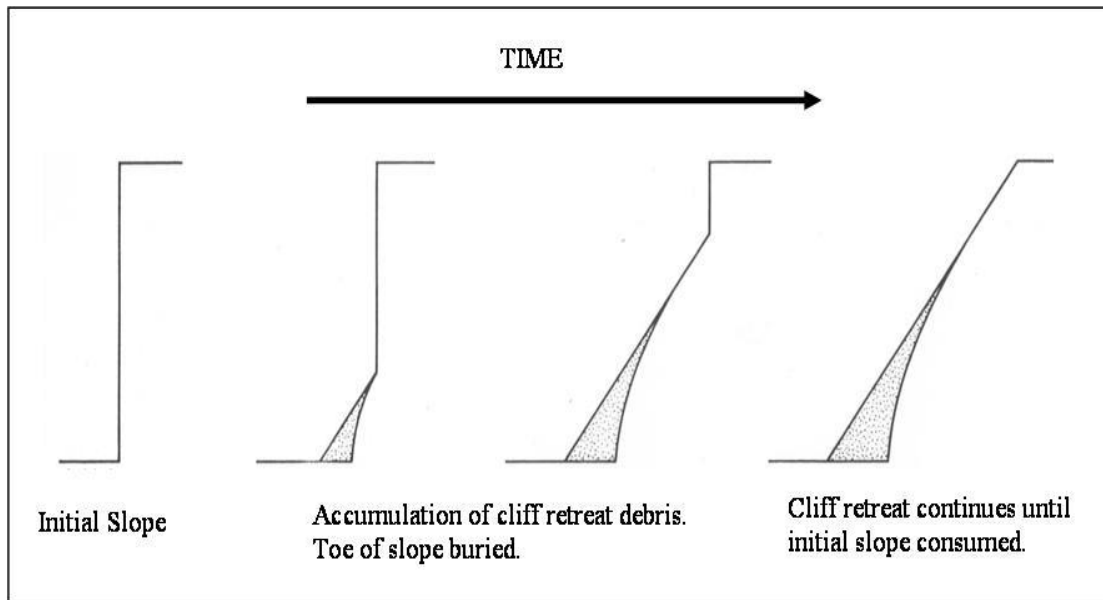
Figure 6 Fisher-Lehmann slope replacement conceptual model

For a cliff-face with a protected base, and given the physical and biological characteristics at the study site, it is appropriate to apply the 'Fisher-Lehmann slope replacement model' to represent the process of slope evolution. This model is conceptually depicted in Figure 6. An initial steep slope (> 40 deg), referred to here as a 'free-face', undergoes parallel retreat above an extending debris slope and eventually disappears with the debris slope covering the entire face. Note that debris slopes have approximately constant angles. The overall uniform slope on some cliff locations at the study site (e.g. Fig 4B), provides evidence that the model does apply to the study site, and, at least for some locations, the adjustment is well advanced. Slope replacement theory also has the debris slope ultimately being replaced by a still gentler slope produced when the transport of increasingly weathered debris extends a new depositional unit from the slope foot. However, once vegetation has established, as has occurred at the study site, subsequent change to the debris slope angle should be minimal.

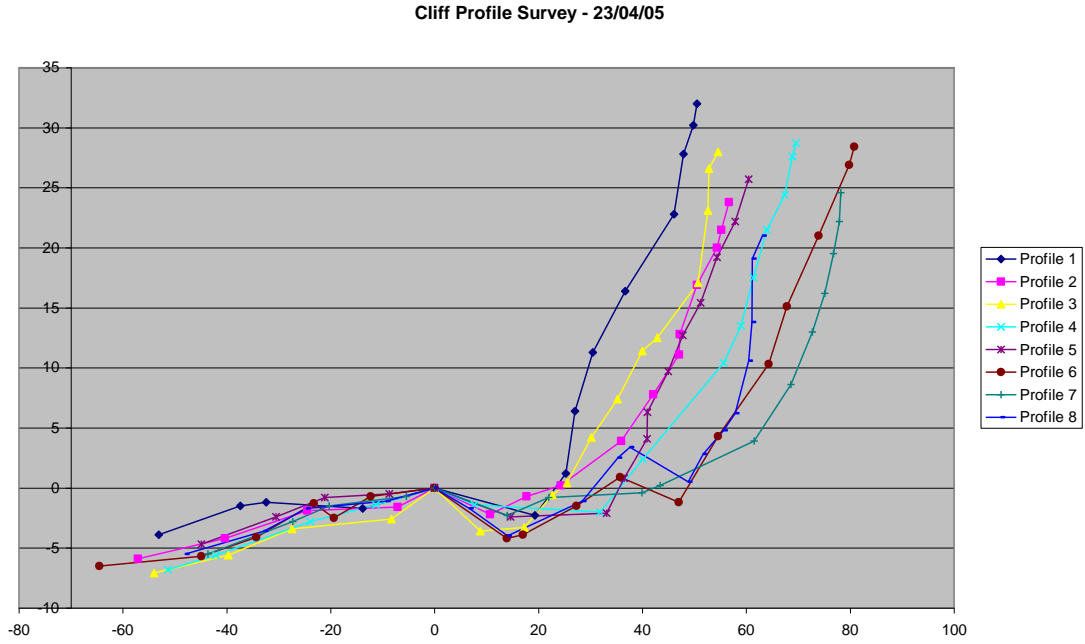
Figure 8 Superimposed dune/cliff profiles using the dune-crest as the elevation and distance datum.

The eight surveyed profiles are depicted in Fig 8. The slope angles for each profile segment were calculated and, as an example, are marked on profile 1 in Figure 9. Arrows delineating the debris slope are also shown in Fig 9. The debris slope angle for each profile is listed in Table 1 along with the general cliff morphology in terms of promontory, inter-promontory or uniform topography. While promontory profiles 1 (P1) and 8 (P8) had similar values (30.2° and 32.3°) to the four non-promontory profiles (27.7° to 33.8°), in the other two promontory cases (P3 and P5) their values (37.1° and 38.7°) were significantly greater. Because the higher values lead to more conservative (smaller) cliff-top retreat values, only the four non-promontory (inter-promontory and uniform) profiles were used as a basis for calculating debris accumulation adjustments and retreat distances.

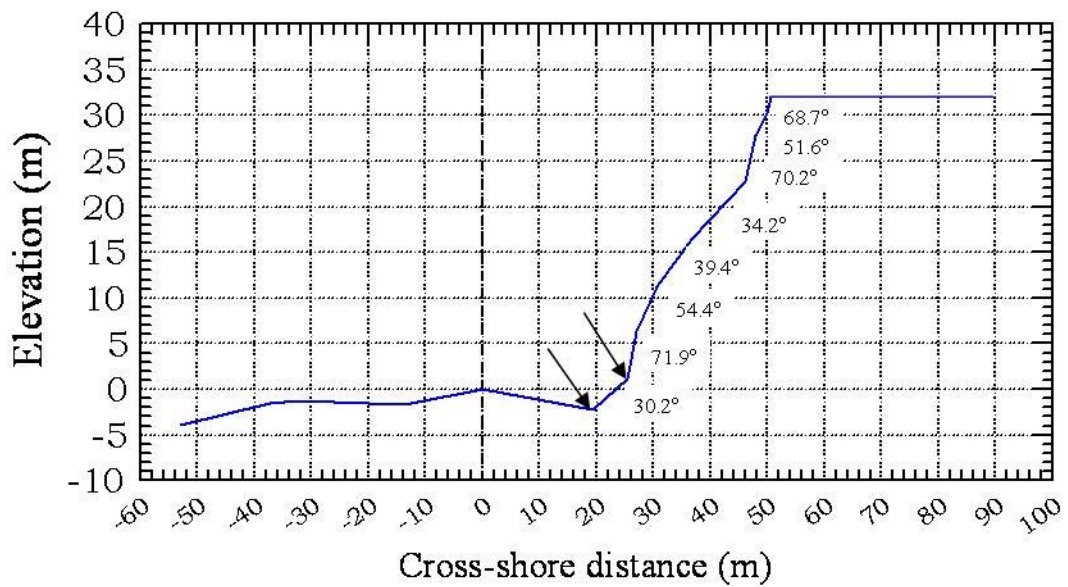
Figure 9 Profile 1 (for example) showing slope segments. Arrows define the debris slope.

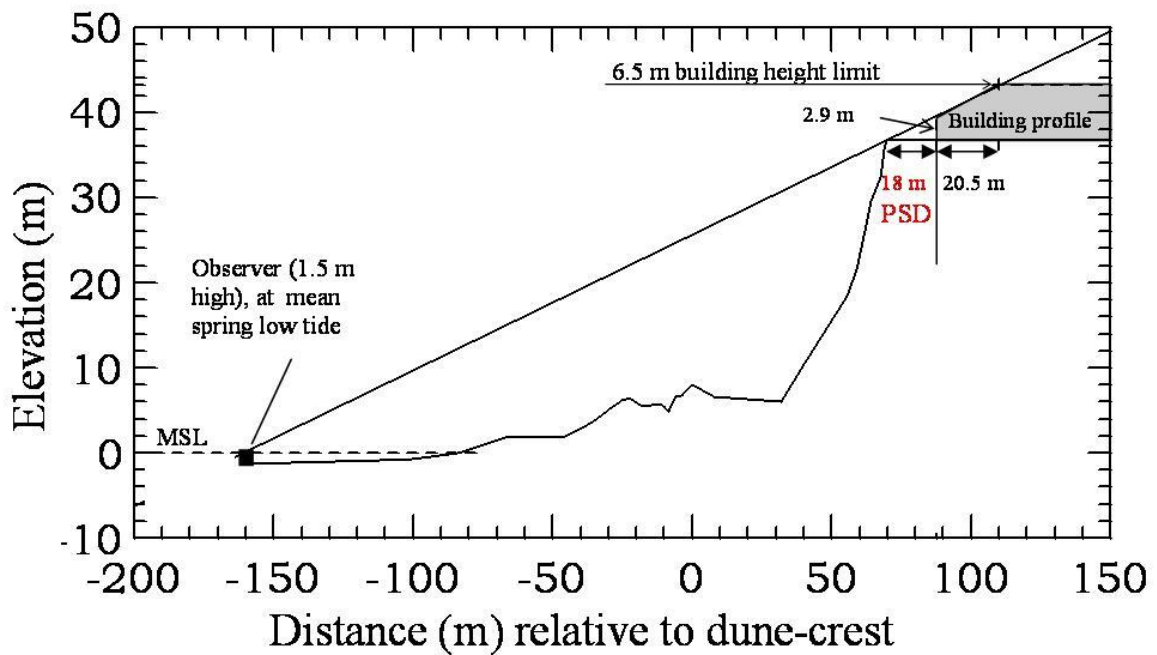
Figure 11 Viewing geometry, primary set-back distance and building height restrictions to hide development from beach observer locator directly in front of cliff.

To determine the effect that the 18 m PSD will have on dimensions of residential buildings if the building is not to be visible from the beach, a profile extending from the spring low tide mark to inland of the cliff-line was analysed. Because the beach width can vary substantially, the average width at spring low tide was used, this being based on several years of profile data collected by the author. The visibility condition may be required to minimise development impact on the natural character of the coast. The profile, and eye-line of a 1.5 m high observer standing at spring low tide, are shown in Fig 11. To remain hidden from the beach observer, a building must be lower than 2.9 m at the PSD. In addition it can be seen that a 6.5 m high building, this being the proposed maximum for the development, will need to be located 20.5 m inland from the PSD.
