**IN THE MATTER OF** Proposed South Taranaki District Plan – Coastal Environment and Natural Features and Landscapes

**FOR SUBMITTER** **Meridian Energy Limited** (Submitter 26 and Further Submitter 26)

**STATEMENT OF EVIDENCE BY ROGER DUNCAN SHAND**

South Taranaki District Council Hearing, 27-28 June 2016

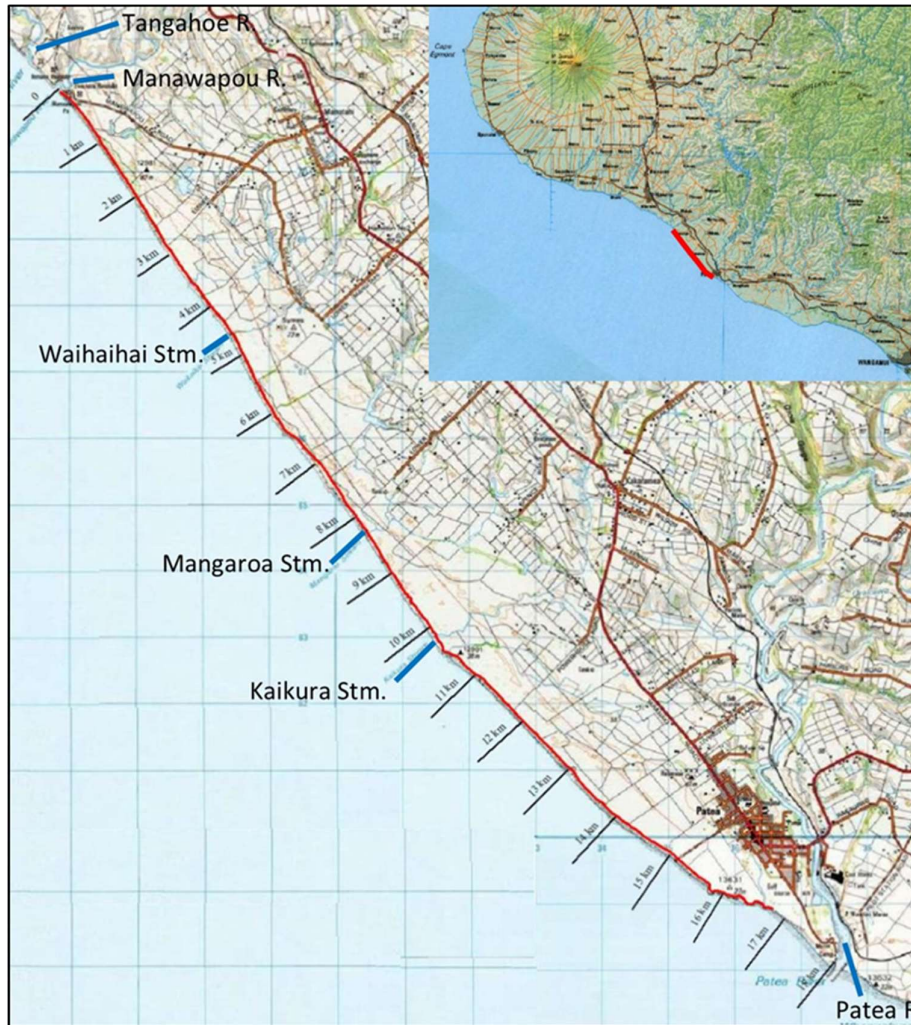
**Figure 1** Location map with the red shoreline locating the 16.5 km long section of coast under review. Map compiled using the NZ Topographical Map series 260-R21 and R22

5. In this matter, I have been engaged by Meridian Energy Limited ("Meridian") to provide a cliff hazard assessment for a 16.5 km section of coast north of the Patea Rivermouth (Figure 1) which informs the definition of the Coastal Environment under the Proposed Plan. My involvement followed on from an earlier assessment of coastal erosion rates at this site by Tonkin and Taylor Ltd (T+T). The T+T report (included in my evidence as Appendix A) concluded that to accurately derive future coastal erosion hazard distances or zones, the nature of cliff instability and future sea level rise should be taken into account and a geologist should inspect the cliffs. Obtaining LIDAR (high resolution three-dimensional data which also captures aerial photography at the same time) was also recommended.

11. The 16.5 km coastline faces the southwest with its alongshore alignment averaging 315 degrees (northwest). The shoreline has a broad convex shape with maximum offset = 1.14 km. This shape is evident in Figure 1 which includes 1 km graduations that will be used throughout my evidence to identify different areas of the coast. Cliff height ranges from less than 20 to over 50 m above MSL (heights from LIDAR) with the highest cliffs (e.g. Figure 2 upper photo) occurring toward the northern end of the site and the lowest cliffs (e.g. Figure 2 lower photo) in the mid/south.

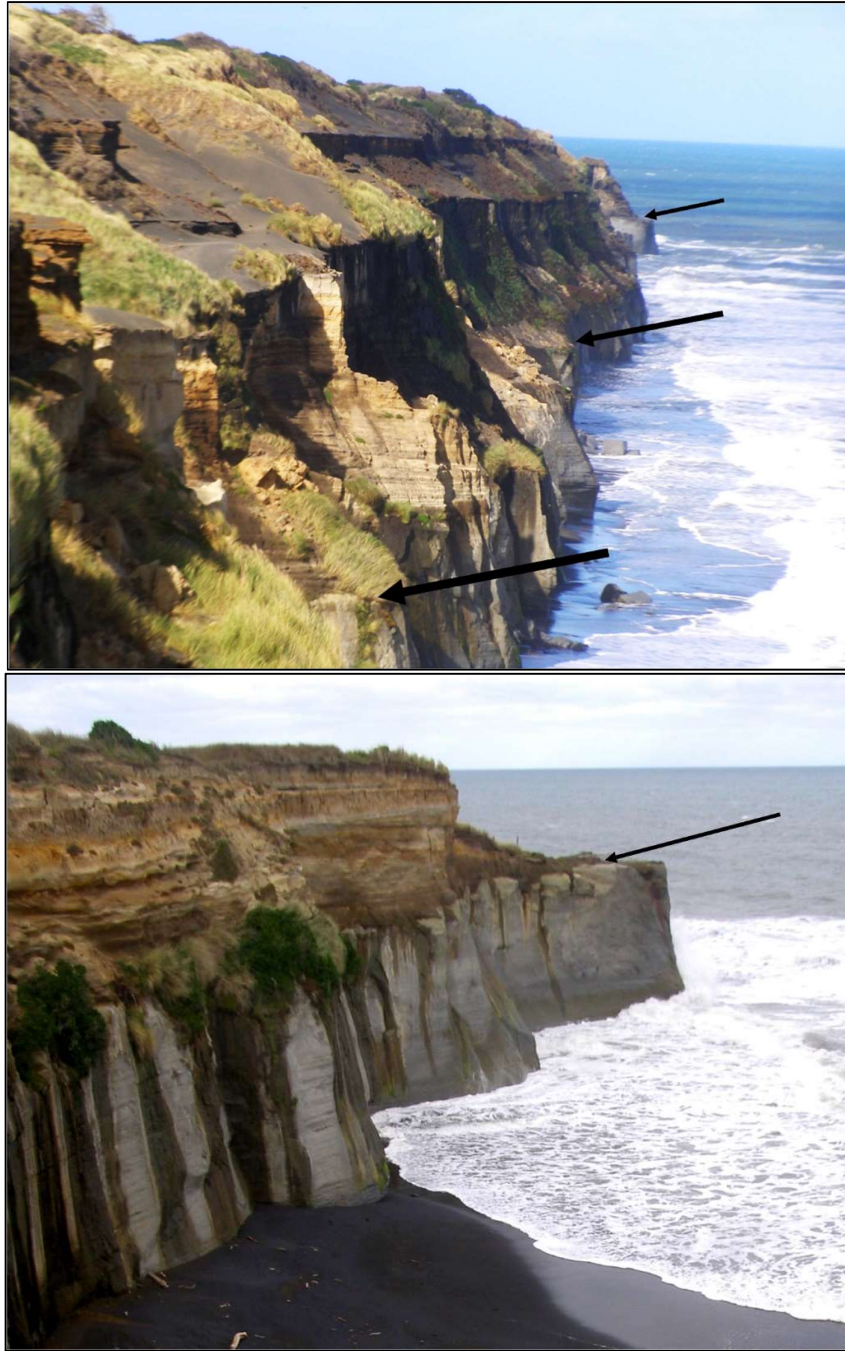
**Figure 2** Upper photo depicts the northern cliff (km 4 to 5) approximately 40 m above MSL and displaying a relatively complex profile. The arrows locates the upper surface of the basal Pliocene massive siltstone (about 12 to 13 m above MSL) with less resistant marine and beach deposits above and capped by mobile dune sand. The lower photo depicts the lowest cliff (<20 m above MSL) located at 12 km. In this case a bluff and bay morphology occur and the cliff has a simple profile with the (arrowed) basal mudstone exposed at the bluff end. Both photos taken by myself on 28 April 2016.

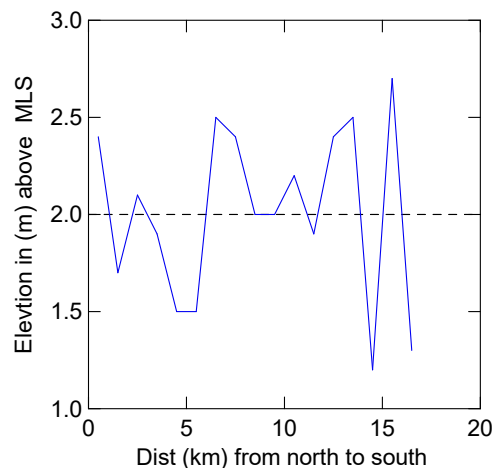
**Figure 4** Elevation of beach sand against cliff base at 1 km averages based on 2016 LIDAR. Mean value is 2.0 m and there is no statistically significant alongshore trend.

23. LIDAR analysis demonstrates alongshore variation in beach sediment levels with cliff-base levels averaged along 1 km sectors varying between 1.2 m and 2.7 above MSL (Figure 4) with considerable within-sector variation (0.3 to 4 m). The sampling excluded bluff and bay locations where water levels fronting bluffs could reach the limit of LIDAR measurement (-1.0 m) and elevation along the bluff to bay wall and in the embayment itself was typically zero.

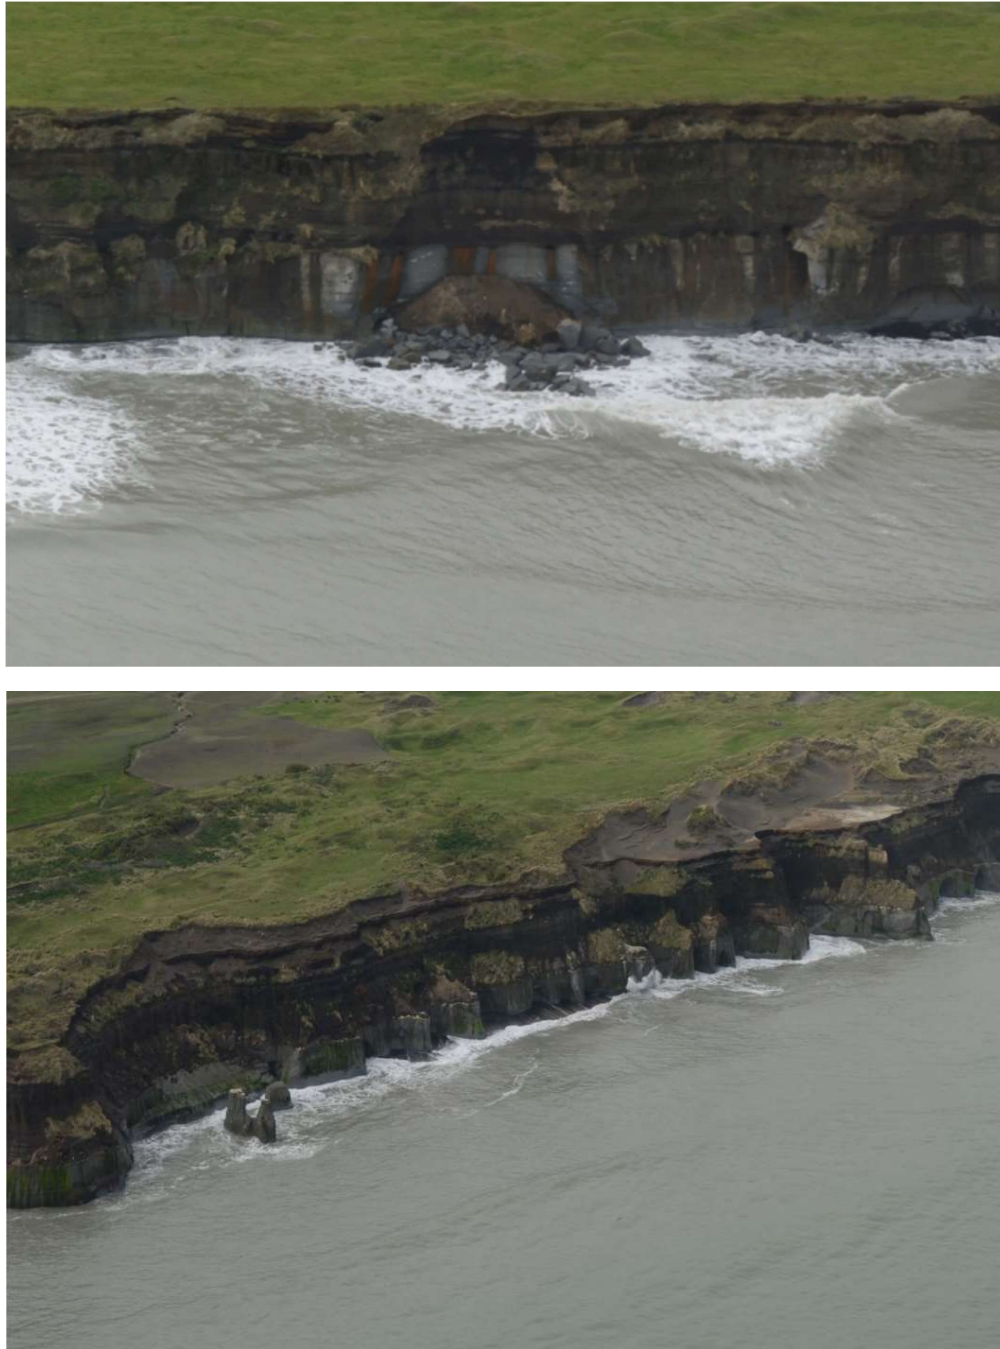
**Figure 5** Upper photo (km 13) illustrates the basic cliff recession process where waves have eroded the basal support and material above has collapsed onto the beach where it provides temporary wave protection to the cliffbase before it is removed by waves and currents. The lower photo (km 3.5 to 4) illustrates bluff and bay erosion whereby waves first excavate caves from areas with local weakness (joints), the wave action expands the caves to form bays separated by bluffs and these are subsequently reduced to island remnants (stacks) before complete disappearance. Note the eroding cliff top sand dunes - their instability initiated by cliff erosion. These photos were provided by the STDC and I understand they were taken in 2014.

26. The cliffs along the entire study area are active (eroding) and two mechanisms are evident.
- i. The first occurs on most cliffed coasts with the base eroded by wave action and this removes support for material above which consequently slumps or slides down the face and onto the beach, platform or into the sea if neither exist. The resulting debris accumulation at the base is subsequently removed by waves and currents and the base is once more exposed to direct wave attack thereby completing the cycle (Figure 5A).

Above the basal strata a similar process of erosion and collapse of material above occurs. Terrestrial processes weaken (weather) and remove material preferentially from less resistant formations and, as occurs at the cliff base, support is thus removed from materials above and collapse follows. As different materials succumb to different processes, complex cliff profiles can occur (Figure 2 upper photo). Furthermore, as strata beneath the dune sand capping collapses, dune erosion occurs with drifts extending along the cliff top and inland (illustrated in Figure 5B).

- ii. The second mechanism of cliff erosion occurs where the basal formation comprises relatively resistant material containing fractures and joints. The process begins with wave excavation of caves which increase in size and facilitate collapse of cliff material above (as by the first process), to form a localised embayment. Adjacent bays are separated by a bluff which subsequently narrows under wave action often forming islands (stacks) that eventually disappear (Figure 5B).

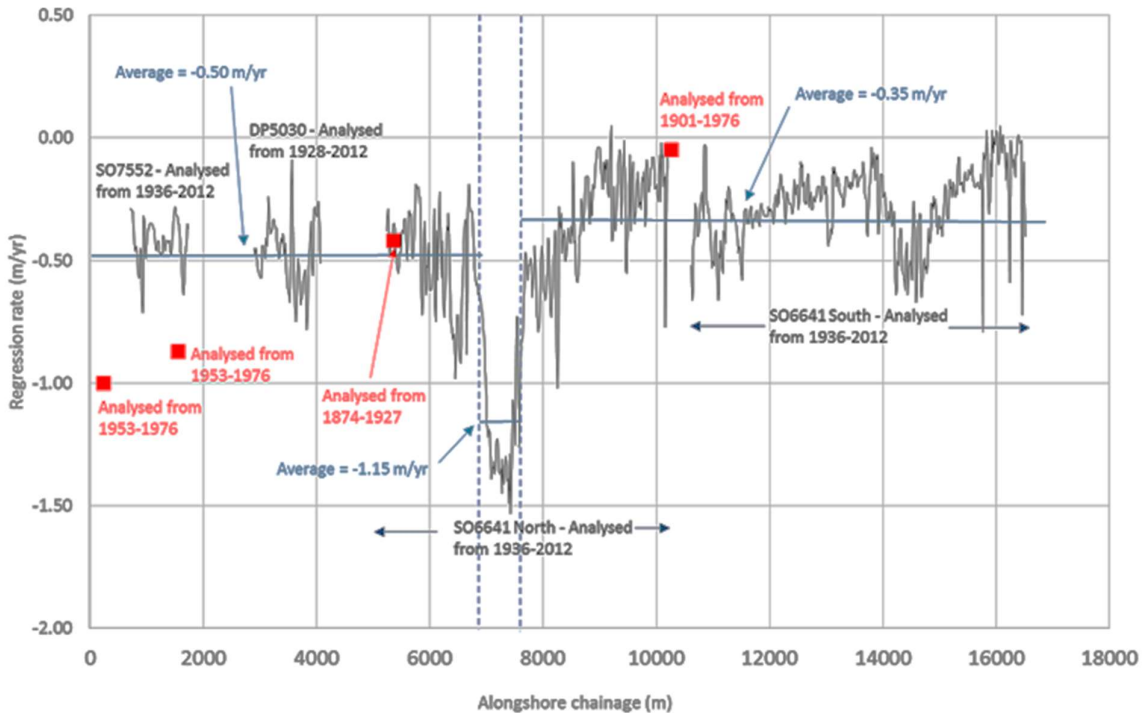
**Figure 6** Calculated historic recession rates between 2012 and stipulated earlier survey years. Note the SO6641 plan was surveyed 1927 not 1936 as marked; however, the corresponding average rates were correctly calculated. The red squares relate to discrete measurements from Gibb (1978) for the stipulated time spans. This figure is reproduced from the T+T report (Appendix A).

27. Historical change in cliff location was defined in the recent T+T study (Appendix A) by comparing the cliff top (edge) from survey plans (1927 to 1936) and from 2012 aerial photos. The early survey plans gave 78% cover of the site and this provides an adequately sample for defining long-term erosion. The cross-shore change was determined every 10 m alongshore and the average rate of change computed over the 76 to 85 yr inter-survey period. The T+T results here reproduced as Figure 6.

29. The earlier study by Gibb (1978) provided 4 spot erosion rates along this coast and these are marked by the red squares in Figure 6. The Gibb rates at kms 5.6 and 10.1 are in close agreement the T+T rates and it is noted that their inter-sampling periods were 53 and 77 years respectively. However, Gibb's other two erosion rates are significantly greater and were based on only a 23 year inter-sampling difference. These variations illustrate the potential error when using short-term data to infer long-term change. As discussed below,

30. The rate of change results show considerable fluctuation, typically ranging over +/-0.3 m/yr, and this was found to be associated with changeability in location of bluff and bay topography which is in keeping with the dynamical cliff erosion process described earlier. However, spatial averaging compensated for this effect and two main suites were identified by T+T and marked in Figure 6 by the straight horizontal line segments.
  - 0.5 m/yr of erosion along the northern sector (0 to 6.7 km), and
  - 0.35 m/yr or erosion along the southern sector (7.6 to 16.8 km).

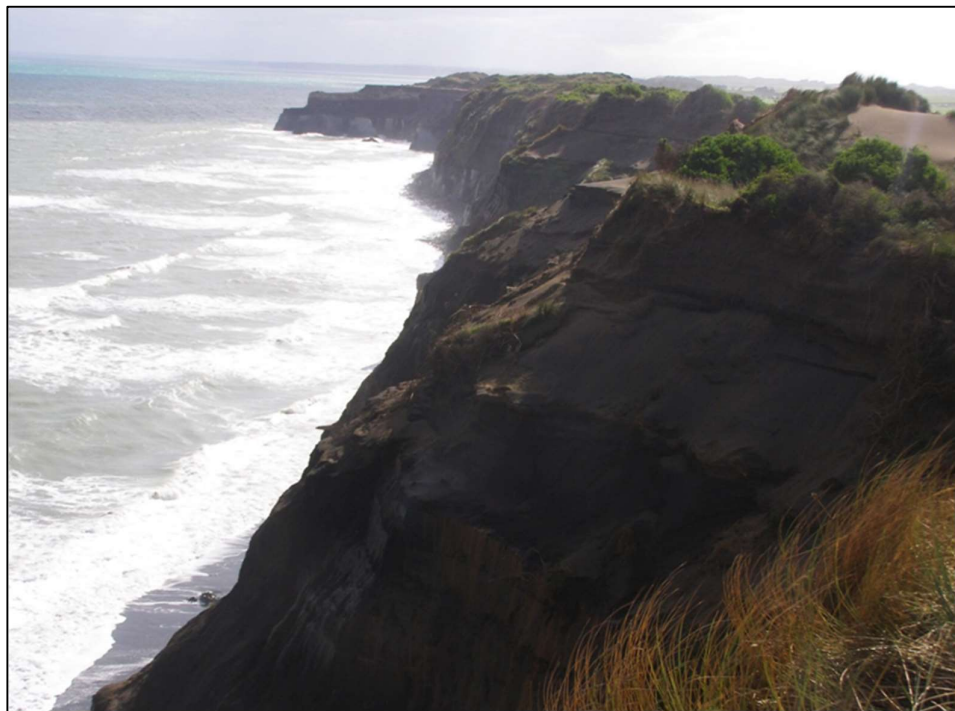
**Figure 7** The high erosion reach (6.7 to 7.6 km) with the bluff-headland responsible for driving the erosion in the distance. I took this photograph on 28 April 2016.

32. Regarding the higher erosion rates between these two sectors, i.e. the 1.15 m/yr across the 6.7 to 7.6 km reach, his location lies close to the Whangamomona Anticline and northern side fault. As noted earlier, upward folding of the underlying stata very likely results in areas of fracture and jointing of the massive siltstone and this in turn makes the area more prone to bluff and bay development. The high erosion rates were immediately downdrift (south) of an area of very well developed bluff and bay morphology (Figure 7) which could be expected to effect

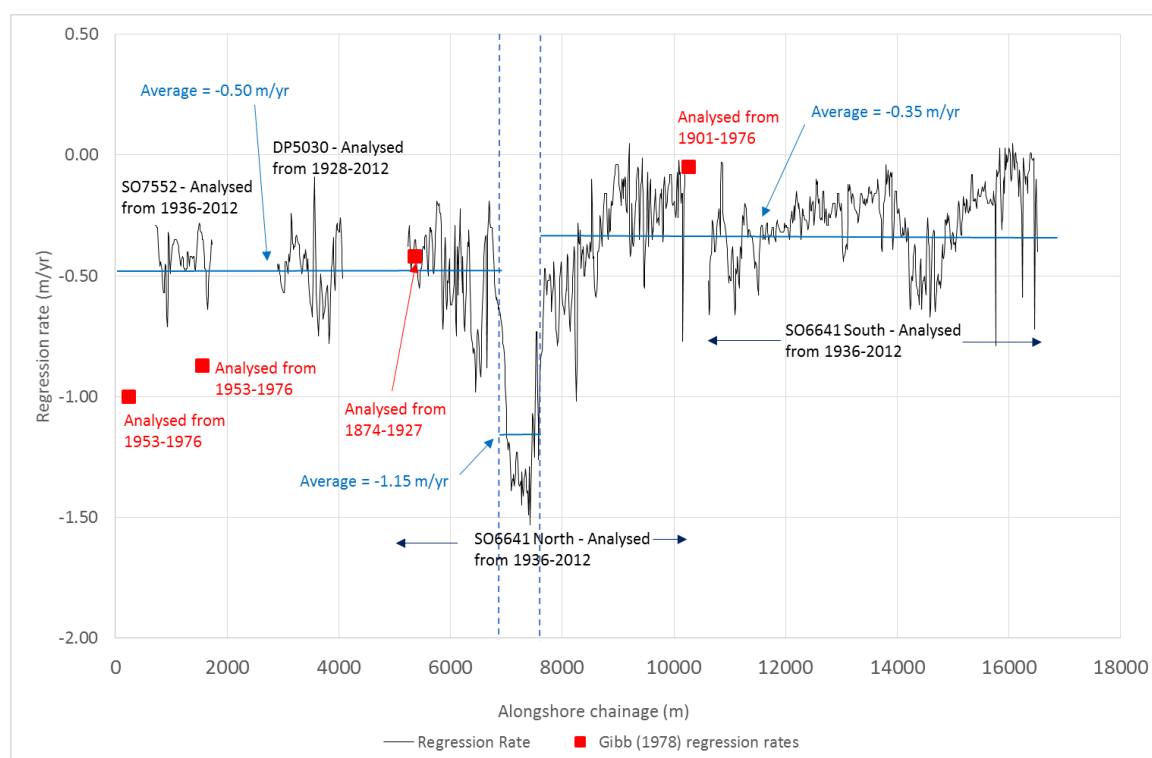
Figure 2 Calculated historic regression rates and historic rates found by Gibb (1978)

- -0.5 m/yr in the north
- increasing to an average of -1.15 m/yr along Lower Ball Rd
- decreasing to an average of -0.35 m/yr in the south.

The calculated regression rates south of Lower Taumaha Rd (Ch 0 and 1.5 km) are slightly less than the erosion rate found by Gibb (1978) of -0.9 to 1.0 m, likely due to the short length of record used by Gibb (23 years). Gibb's assessment in other locations based on longer record lengths are similar to findings of this analysis, except that there is significant variation in the erosion rates either side of Gibb's assessment positions which are not allowed for.

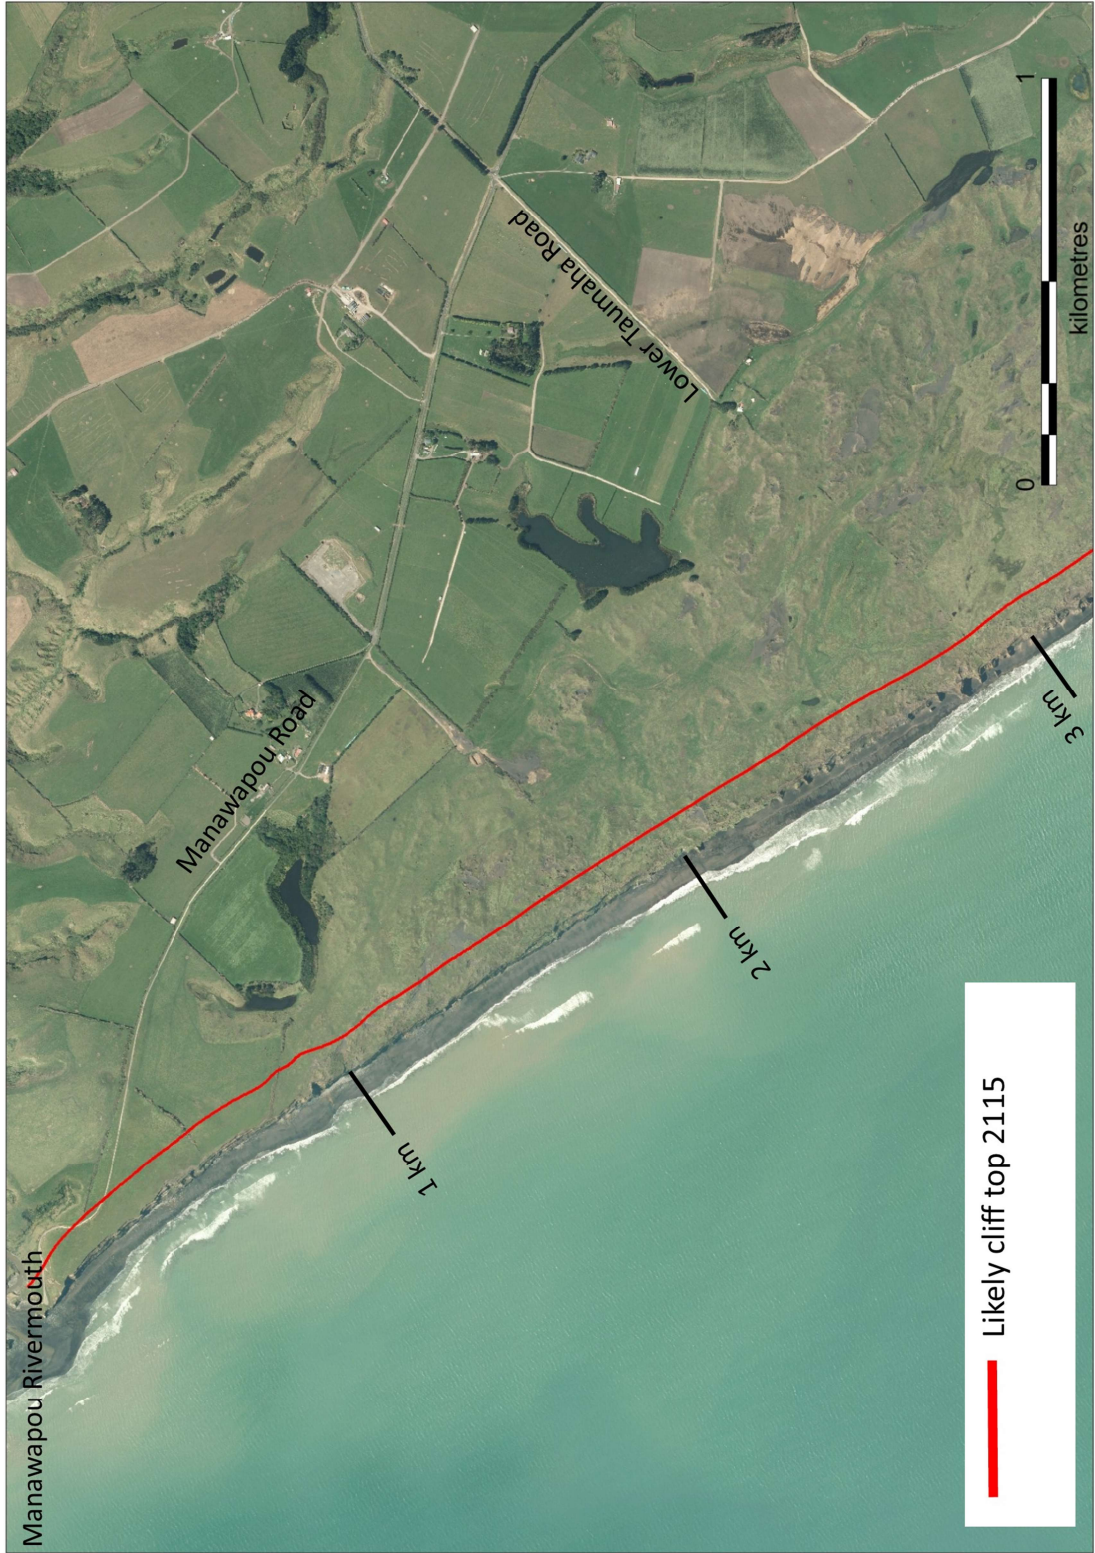
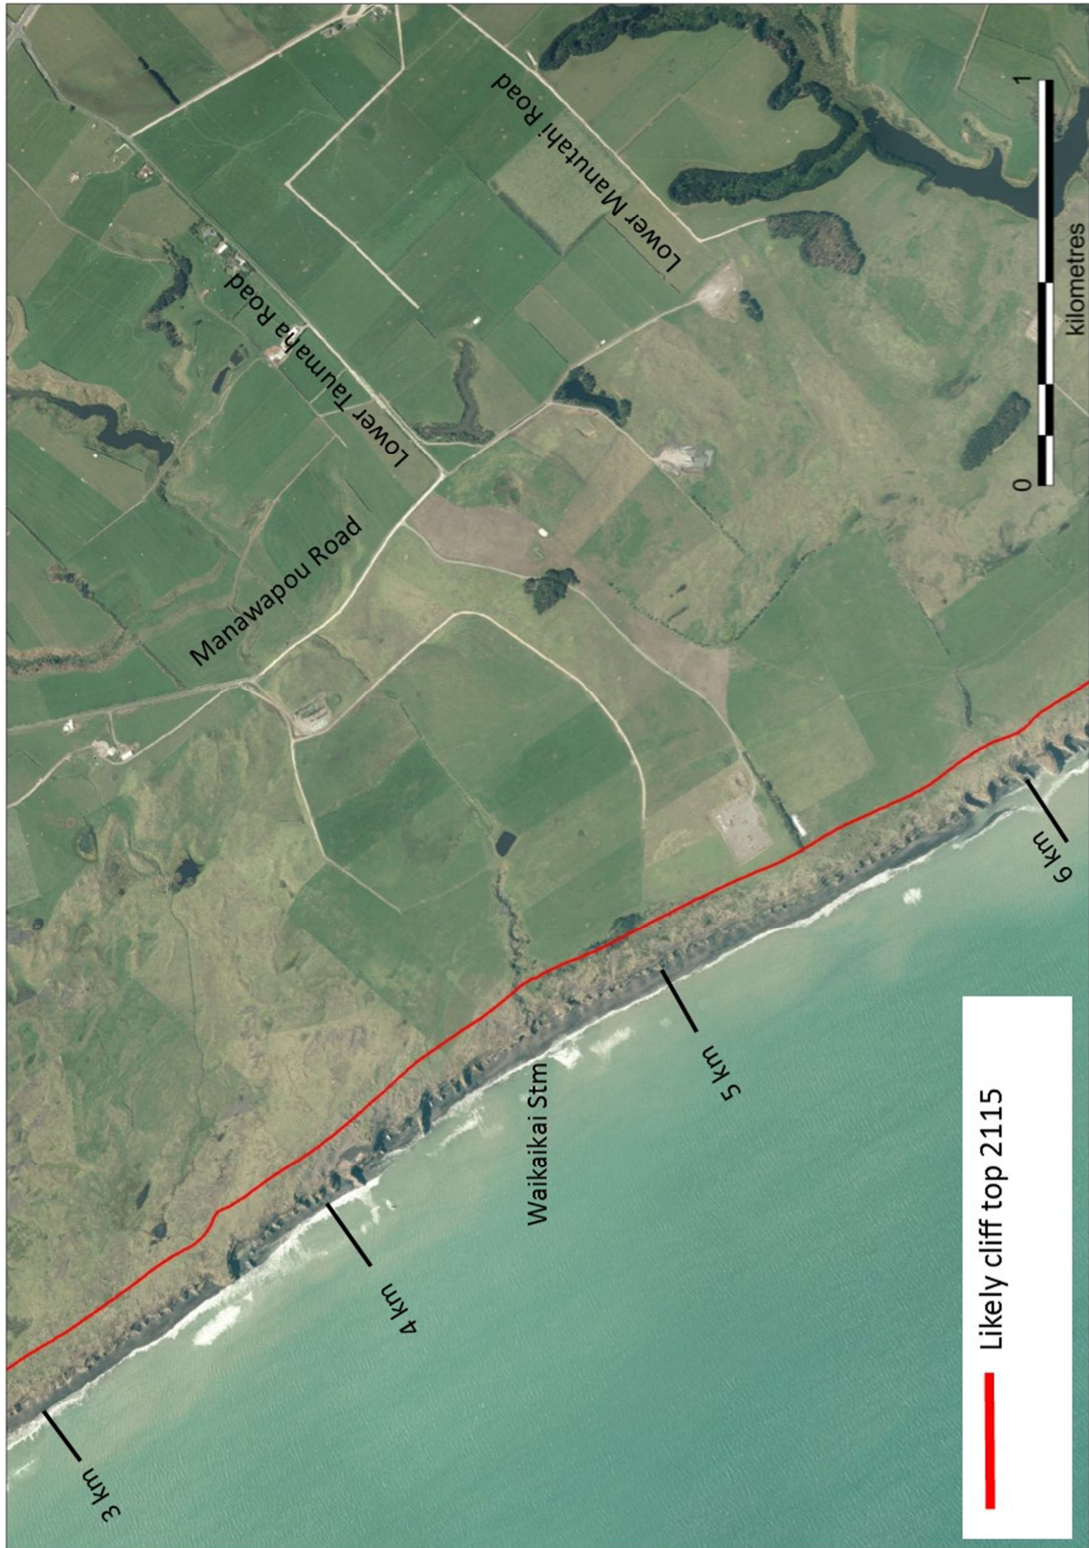
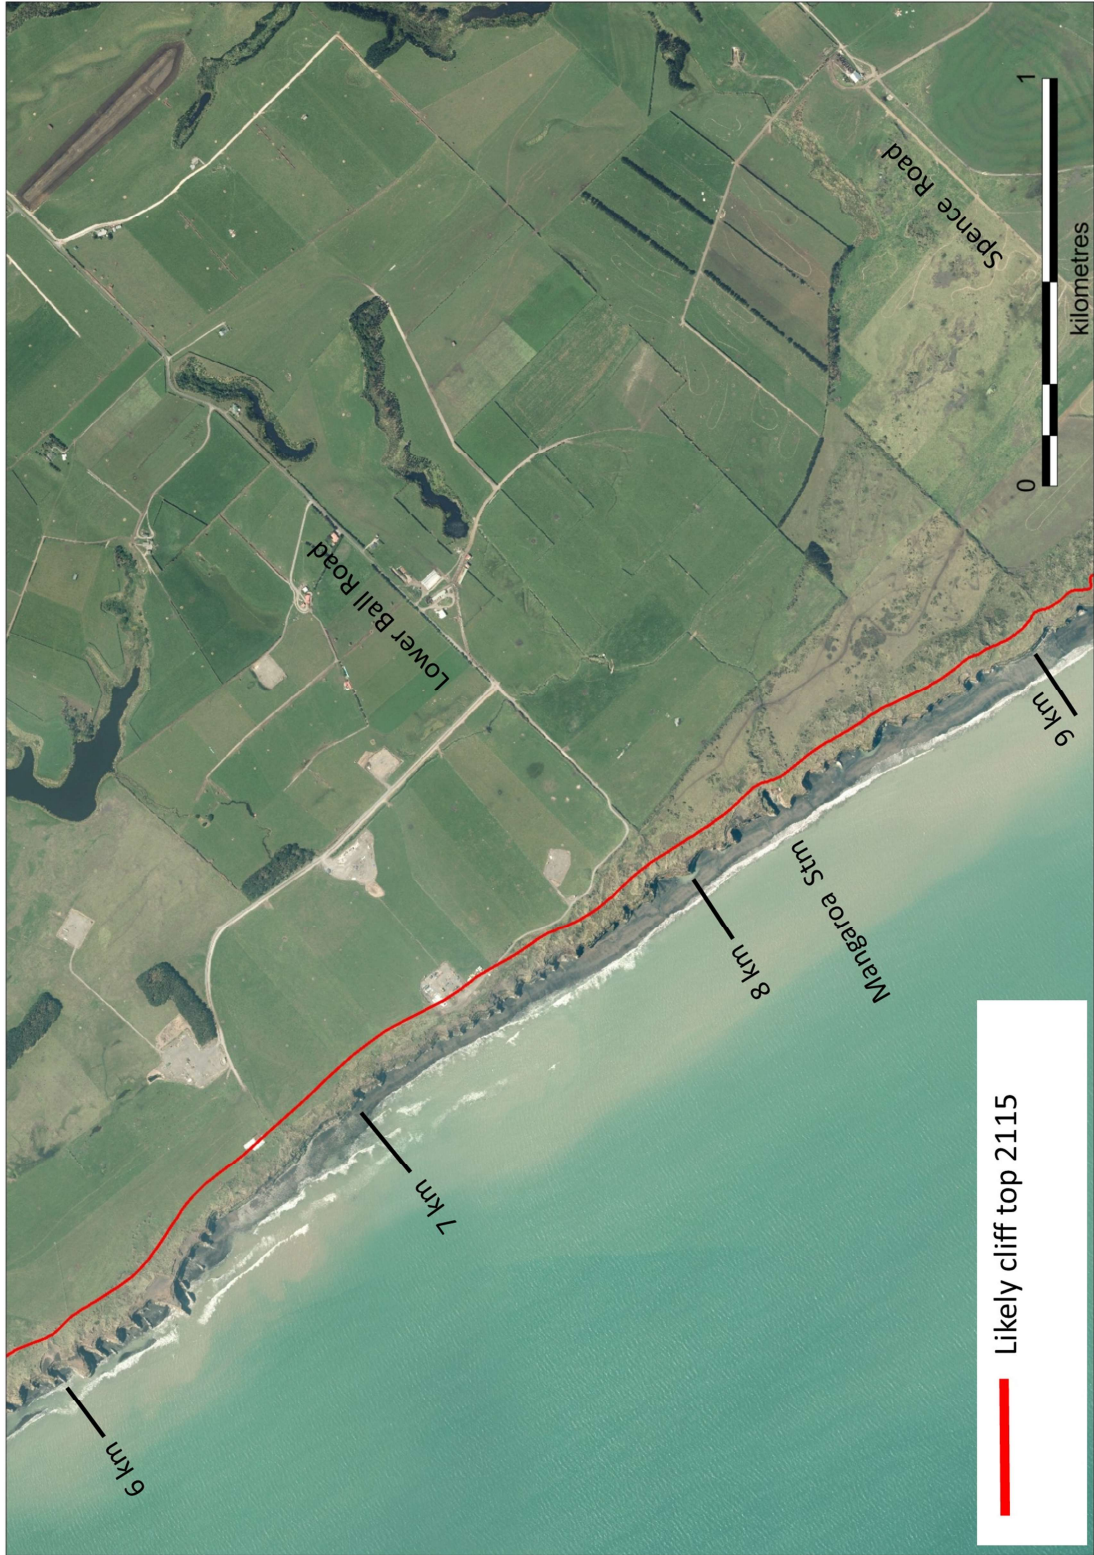
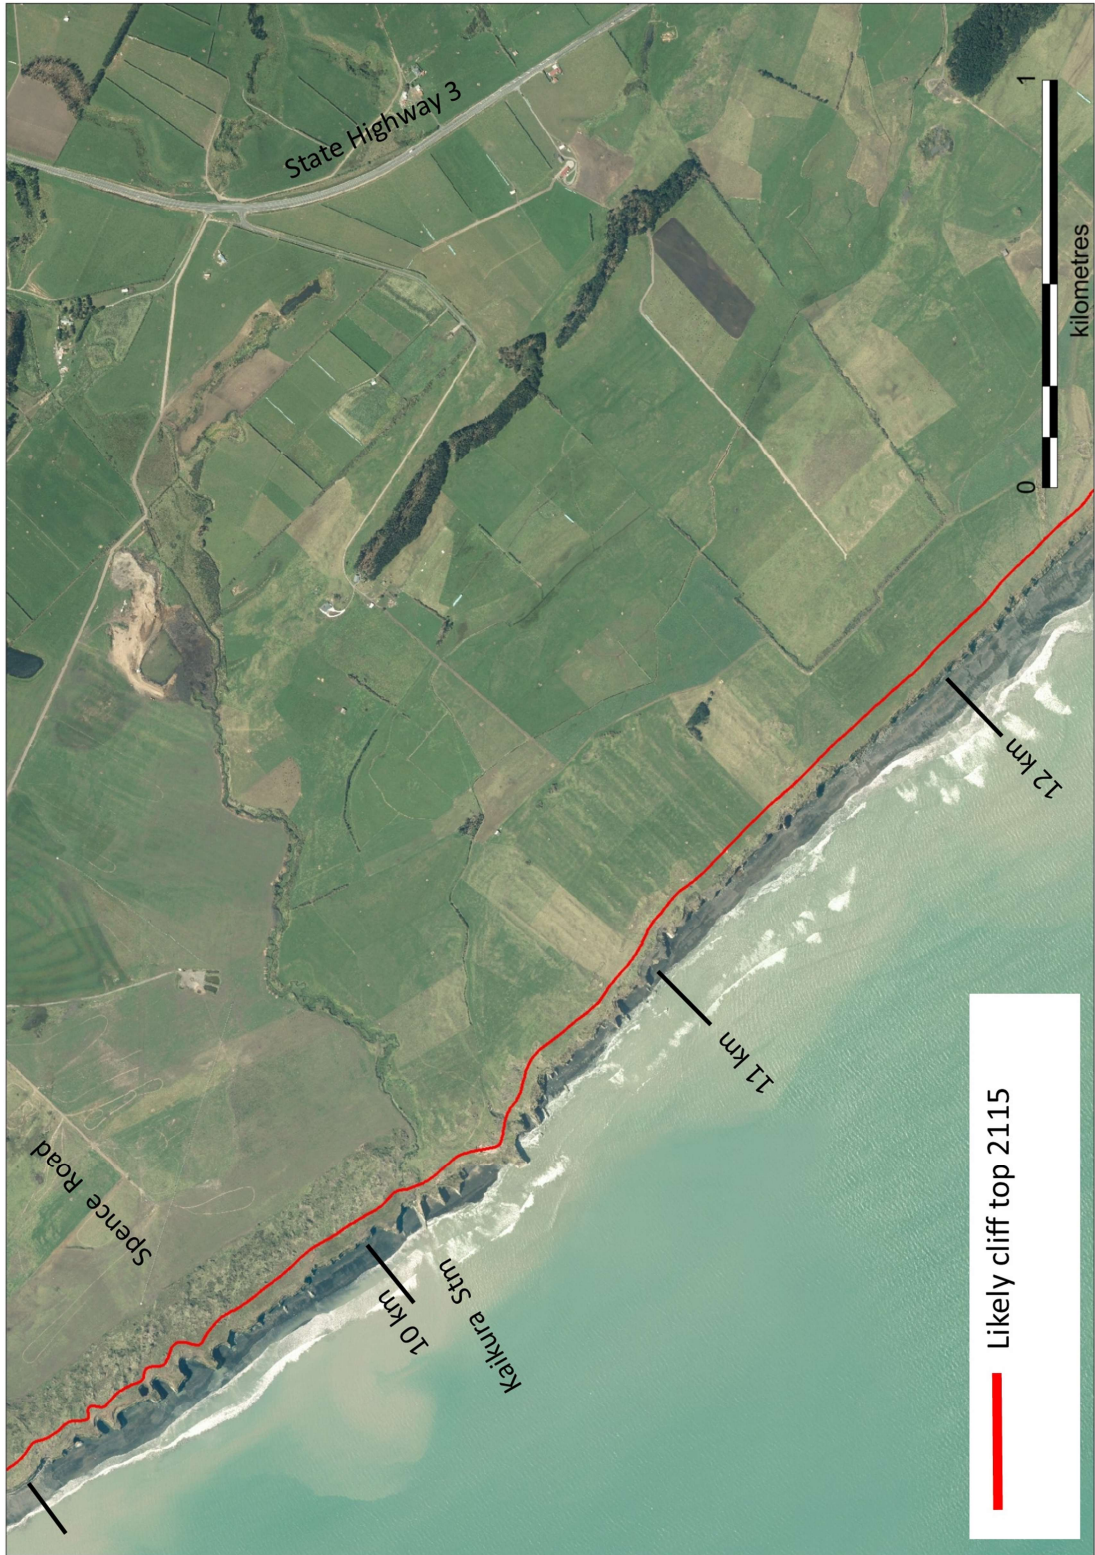
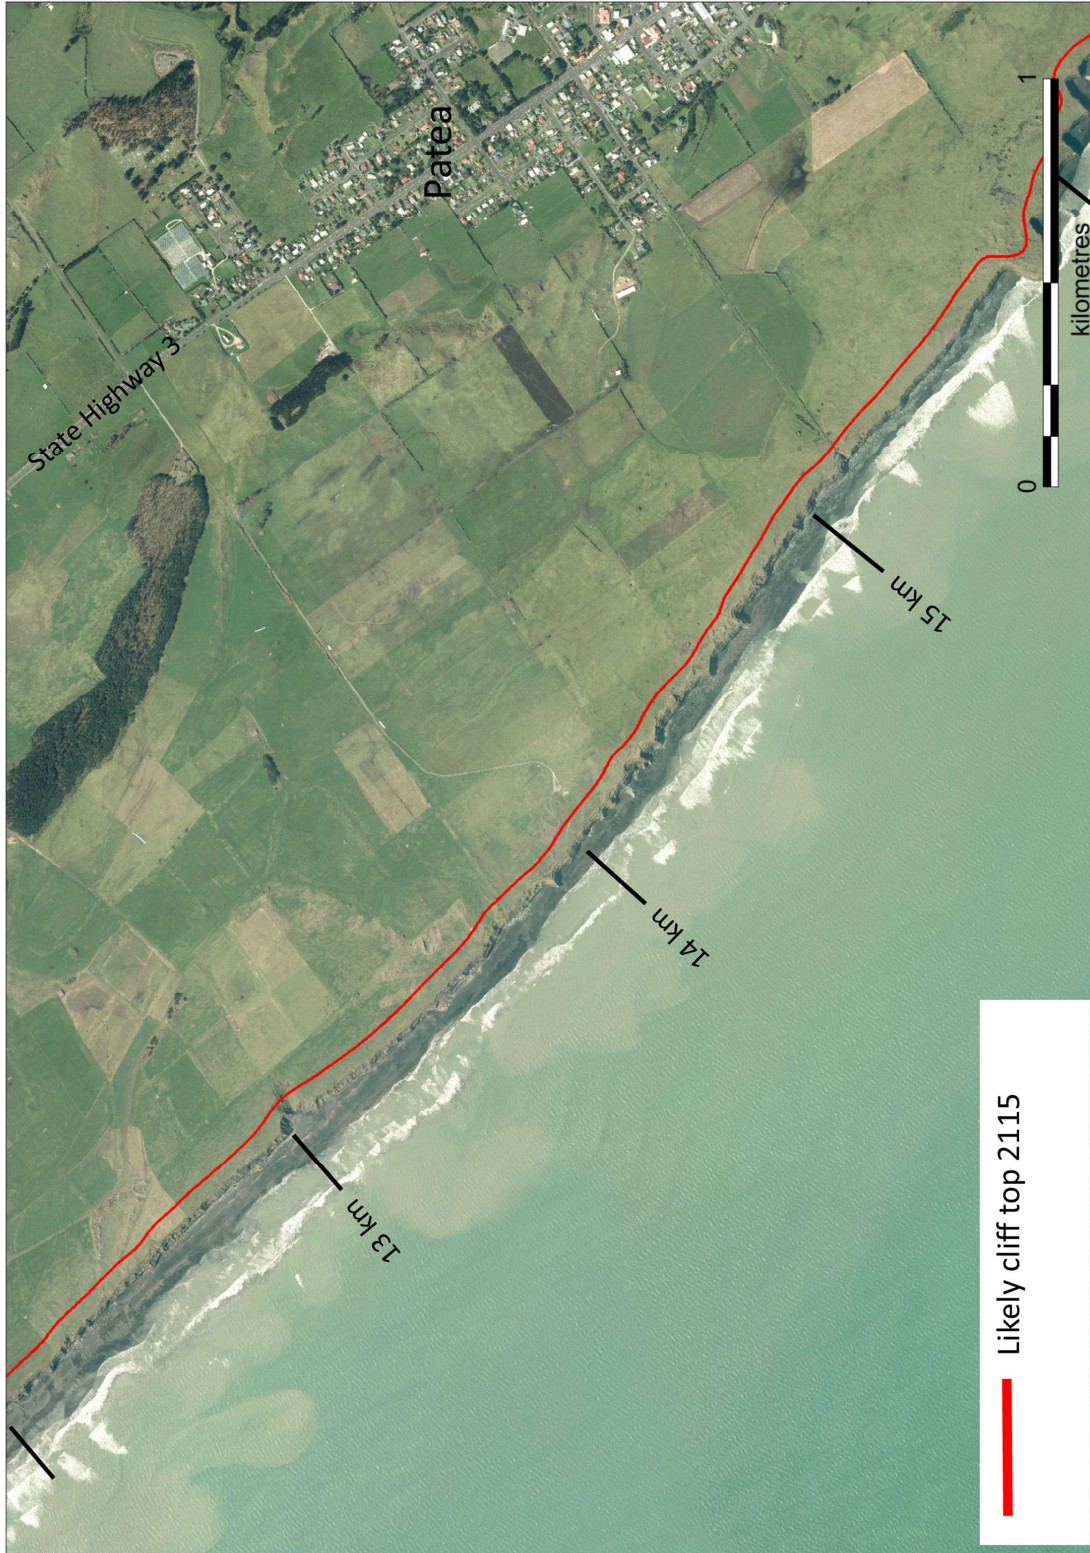
**APPENDIX B** Likely erosion hazard line (78% probability of exceedance) superimposed on 2012 vertical aerial photograph.

Likely boundary lines (66 and 90% probability of exceedance) can be located from the differences in Table 3.

Distance markers at 1 km intervals as in Figure 1.

48. The likely (78%) erosion hazard line is depicted in Appendix B. The likely bracketing lines (66% and 90%) can be located by offsetting the differences from Table 3.
