Erosion Assessment & Management Options for Wilkinson Beach (West Rangiputa) Northland

A report prepared for the Department of Conservation

COASTAL SYSTEMS Ltd

Reference	2018-12 CRep
Version	1.1 FINAL
Status	For client use and release
Date	6 November, 2018

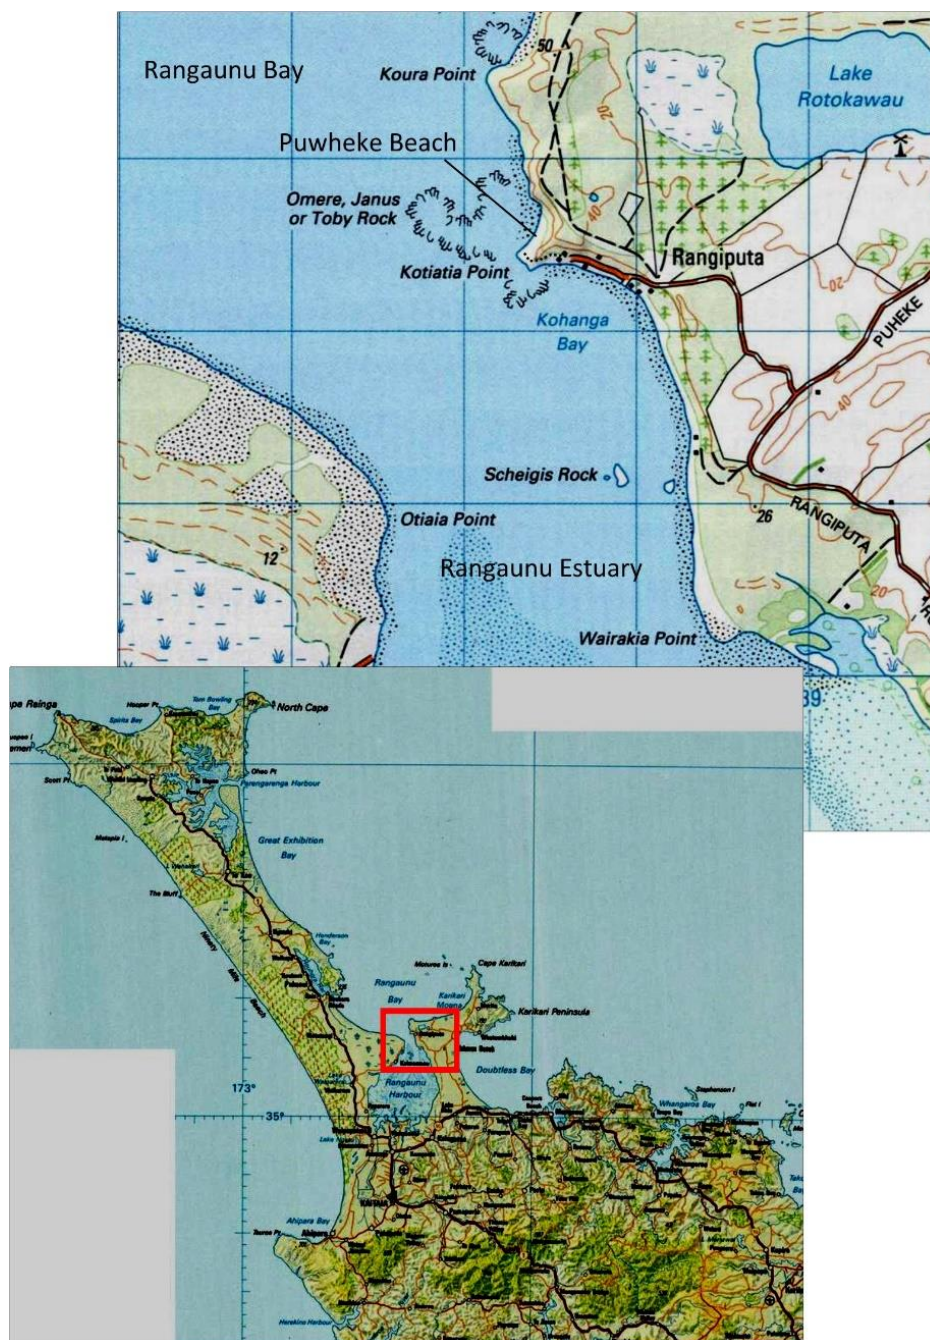
Figure 1 Location diagram showing Rangiputa and Puwheke Beach on the eastern side of the Rangaunu Estuary's mouth

In August 2018, Coastal Systems Ltd (CSL) was contacted by DOC Northland staff about erosion threatening the access road to popular Puwheke Beach in Northland (Figure 1). While erosion at this location had been noted for some time, the 3-5 January 2018 storm had had a significant impact (Figure 2) and staff now wanted to consider management options and environmental implications.

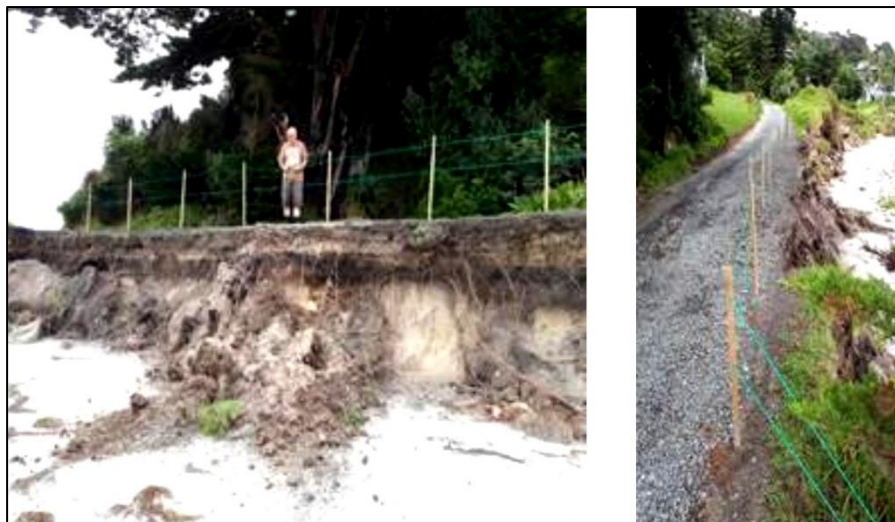
Figure 2 *Post-storm erosion threatening DOC access road between Rangiputa settlement and Puwheke Beach, Northland* *Photos supplied by DOC staff*

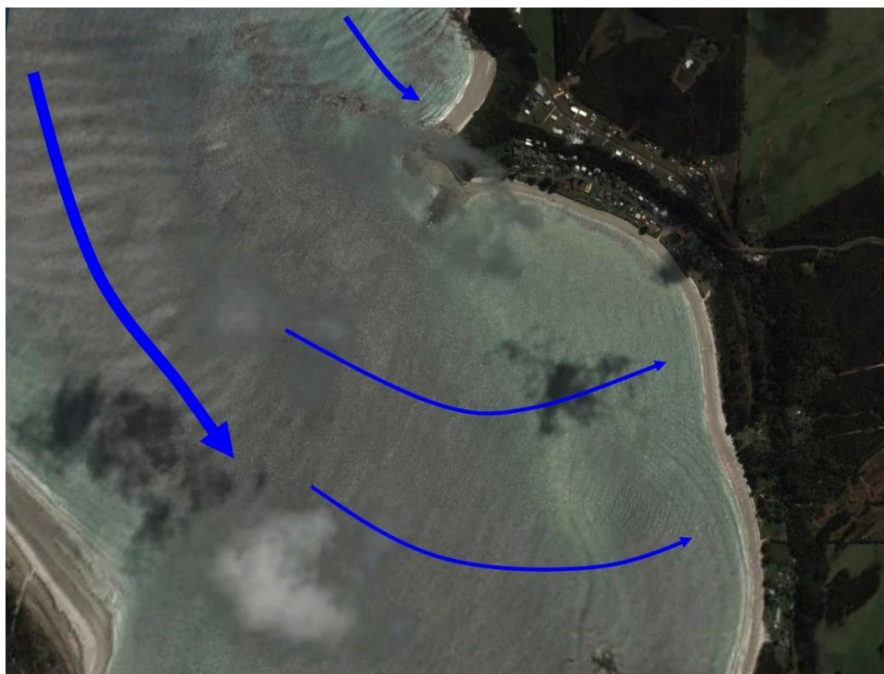
Waves generated across Rangaunu Estuary by predominant S-SW winds can also reach the study area. Using Young and Verhagen's (1996) wave generation model and assuming a 3 to 10 km fetch, 2 to 6 m water depth and 10 to 25 m/s wind speed, significant wave heights range between of 0.2 m at a 1.9 second period, to 1.0 m at 4.1 seconds. If these waves co-incide with high water levels they may also have an erosive impact on the Wilkinson-Rangiputa shoreline.

Figure 5 Wave transformation during propagation into the estuary. Note the dampening effect of the reefs off Kotiatia point and the particularly sheltered Rangiputa shoreline
Image from Google Earth 2012

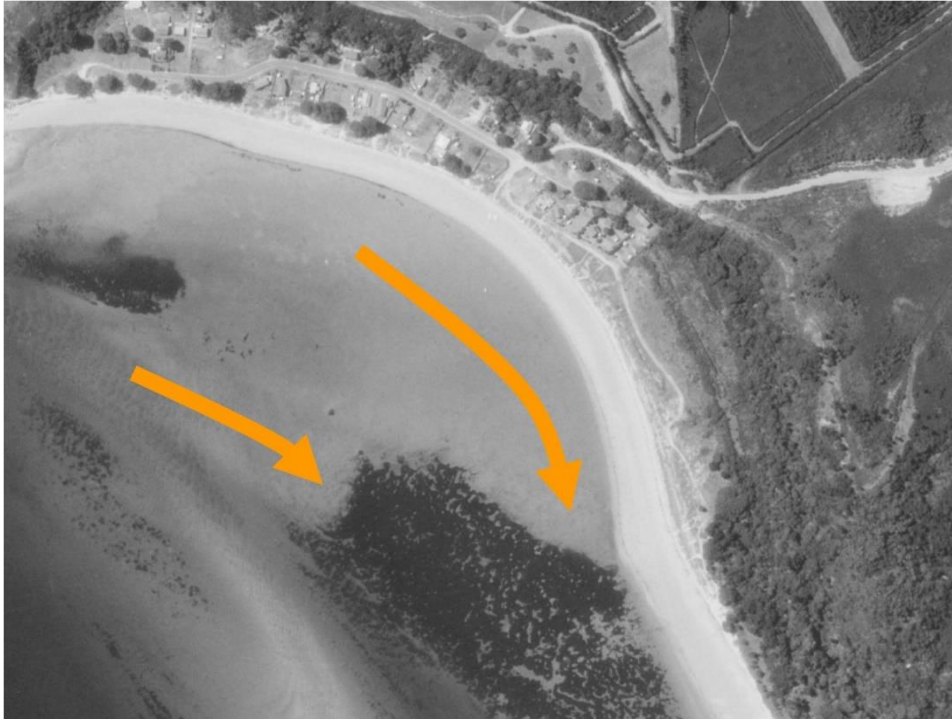
Evidence of periodic sediment migration influxes (i.e. waves or slugs sediment), is burial of a sea grass meadow in the 1984 aerial photograph (Figure 7). Evidence of periodic sediment influx is also indicated by a series of wave-like seabed accumulations in the 1958/1979 bathymetric comparison and encircled red in Figure 8. And yet further evidence are the multiple terminal sand spits some 2 km south of Rangiputa and marked by the asterisk in Figure 4; these latter features indicating a marked reduction in wave/wind/tidal current.

Figure 7 Sediment wave (lighter area) migrating to the south east (arrowed) over (smothering) a sea grass meadow (dark area). 1984 aerial photo

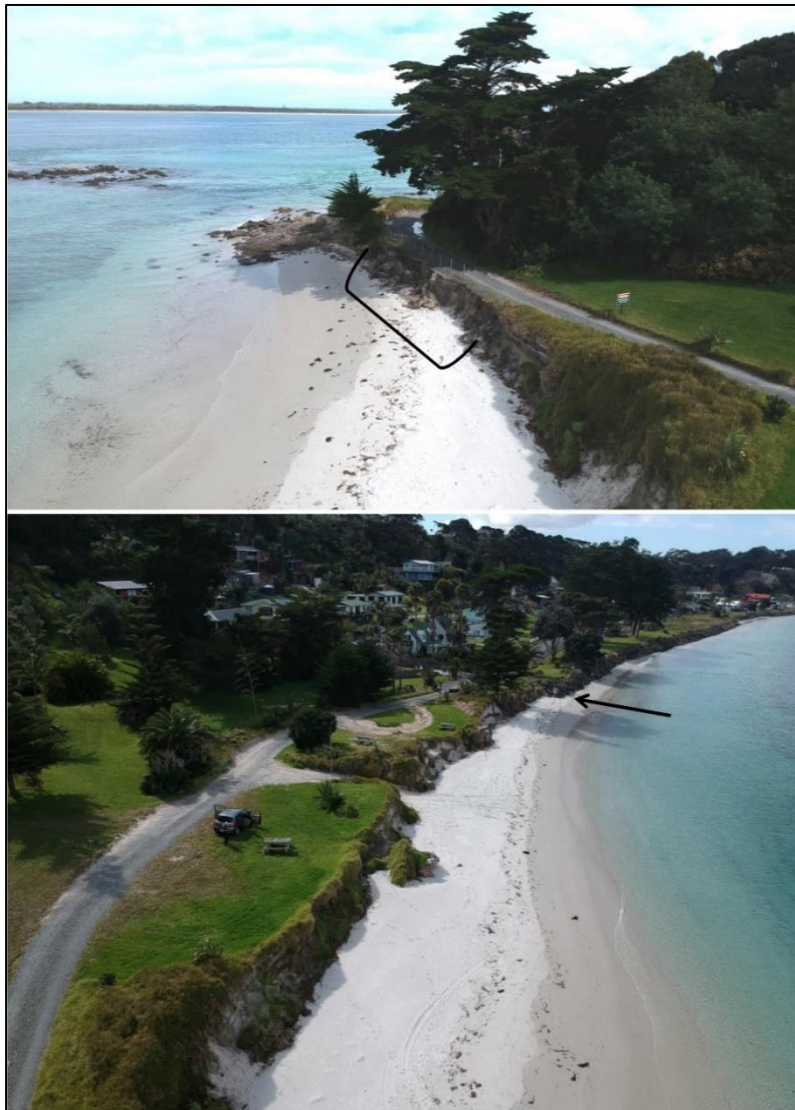
Wilkinson Reserve and Beach are depicted in Figure 9 along with the section of threatened road accessway (bracketed in upper photo) and Rangipotu settlement and seawall (beyond arrow in lower photo). Wilkinson Beach stretches from the rocky headland (110 million year old Cretaceous sandstone with volcanic and metamorphic inclusions of the Mount Camel terrane) to the stone seawall. With hard controls at each end, this is essentially a 140 m long sandy “pocket beach”. Based on measurement from the high resolution (0.1 m) LINZ 2015 aerial photo, the high tide beach can exceed 15 m in width. NRC surveys show the beach slope above MSL is 15 (horizontal) to 1 (vertical), while the adjacent offshore slope is relatively flat (200 to 1) and reaches 4 m below MSL some 700 m offshore. This beach is backed by a 1.5 to 3 m embankment that is freshly scarped in places. Three large makarakapa trees have been affecting the shoreline more recently, with the stump of one now on the beach, the stump of another embedded in the scarp and the third is still

Figure 9 Wilkinson Beach viewed to west (top photo) with the rocky headland (Kotiatia Point) in the distance and the section of threatened access road bracketed. Southern view (bottom photo) shows Wilkinson Reserve in the foreground and the Rangiputa settlement and seawall in the distance (beyond arrow).
CSL 2018 aerial photos

growing on the embankment nearer the seawall. These features are evident in the lower photo of Figure 9, and while they can provide some erosive resistance, once they project beyond the bank they may well exacerbate erosion by increasing local wave turbulence. The bank closer the revetment is given some protection by domestic rubble. Along the scarp can be seen ancient soil horizons interspersed with beach/dune sand and the area is capped by sand dune. Finally, a vehicle accessway for launching recreational boats has been cut through the embankment in the centre of Wilkinson Beach.

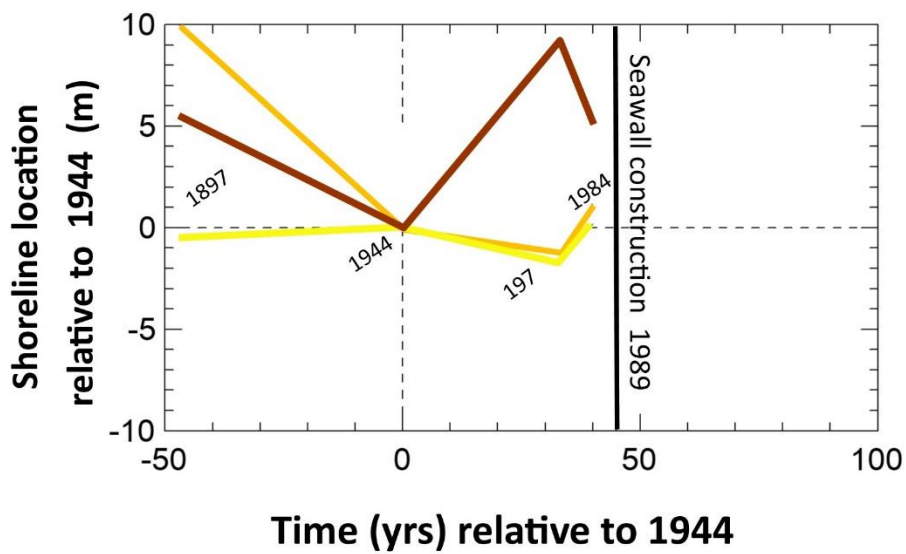
Figure 12 Shoreline time-series graphs for Transects 1 to 8 (see Figure 11 for locations). Time and location datums have been zeroed at 1944 (see text). Note scales are the same on all graphs to assist visual comparison.

The Wilkinson West site (#2) fronting the threatened accessway at the western end of Wilkinson Beach had minimal sediment input 1944 to 1977 and episodically lost sediment thereafter such that the shoreline is now several metres landward of the 1944 position. The location near the headland rocks may experience turbulence which limits sediment accumulation in this area; however, the paleosols (ancient soils) horizons exposed in the escarpment (noted in Section 2.5), show erosion has not reached this far landward for several hundred years.

The eastern end of Wilkinson Beach (Transect #3) shows a particularly large sediment gain for the 1944 to 1977 period. The lack of intermediate samples prevents the identification of any lag between the seaward Puwheke Beach and these internal sites, but some delay would be expected. The eastern Wilkinson Beach site lost sediment after 1977 and, as with the western Wilkinson site, the shoreline is now several metres landward of its 1944 location. This loss of Wilkinson beach sand

As with eastern Wilkinson Beach, the Western Seawall transect (#4) shows a large gain in sediment for 1944 to 1977. The Western Seawall site also lost sediment between 1977 and 1984 with the natural shoreline record ceasing thereafter due to construction of the seawall in 1989 (marked by a vertical dashed line in the Figure 12 graphs).

The graphs show that the Central Seawall transect (#5) and Eastern Seawall transects (#6) have similar pre-structure shoreline behaviours and in contrast to all other transect sites there was a slight loss of sediment between 1944 and 1977 followed by a gain between 1977 and 1984. Such alternating behaviour is a common characteristic along sediment pathways and this is discussed again below.

The site closer to the seawall (75_South) consistently lost sediment after 1944 with the rate increasing after the seawall extension in 2011-2012 to reach 26 m of retreat; this compares with 15 m at Wilkinson Beach, i.e. beyond the northern end of the seawall. While the loss is consistent with the long-term loss being experienced by the ocean beach and western internal sites, the greater magnitude indicating additional seawall effects. Indeed, the contrasting retreats at each end of this seawall is consistent with the expected difference between updrift and downdrift shorelines.

Shoreline behaviour at the more distant transect (285_South) has an interesting contrast to 75_South in that it contains a marked gain in sediment post 1977 with a loss commencing thereafter. This site is close to the migrating sediment wave depicted in Fig 7 and this would account for the rapid gain between 1977 and 1984, while the loss thereafter corresponds to both the general underlying erosional phase behaviour at other sites and also possible seawall effects. It is noted that empirical evidence for oceanic coasts suggests the effected shoreline can extend up to 0.7 @ the length of the seawall: in this case $0.7 * 560 = 392$ m. However, this may be an over-estimate for Rangiputa due to the subdued wave climate.

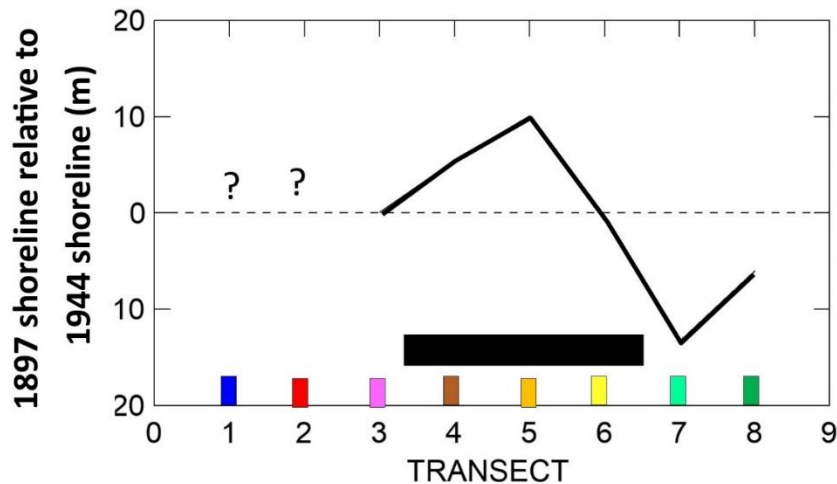
Extending back in time from the 1944 data point provides an indication of earlier shoreline behaviour. These first data points have been plotted on transect graphs 3 to 8 in Figure 13 and indicate shoreline status before, and relative to, 1944. They could not be determined for Transects 1 and 2 as consulting the original surveyors field Book showed that north of the settlement the shoreline location was only estimated rather than directly measured. The result in Figure 13 indicates a positive sediment supply along the central seawall section and a substantial negative status along the southern transects. This supports the earlier comment that alternative erosional/depositional shoreline behaviour can occur along sediment pathways.

Figure 13 1897 shoreline relative to the 1944 shoreline (datum), i.e. the 1897 data points in Figure 12. Horizontal black bar marks the present seawall reach.

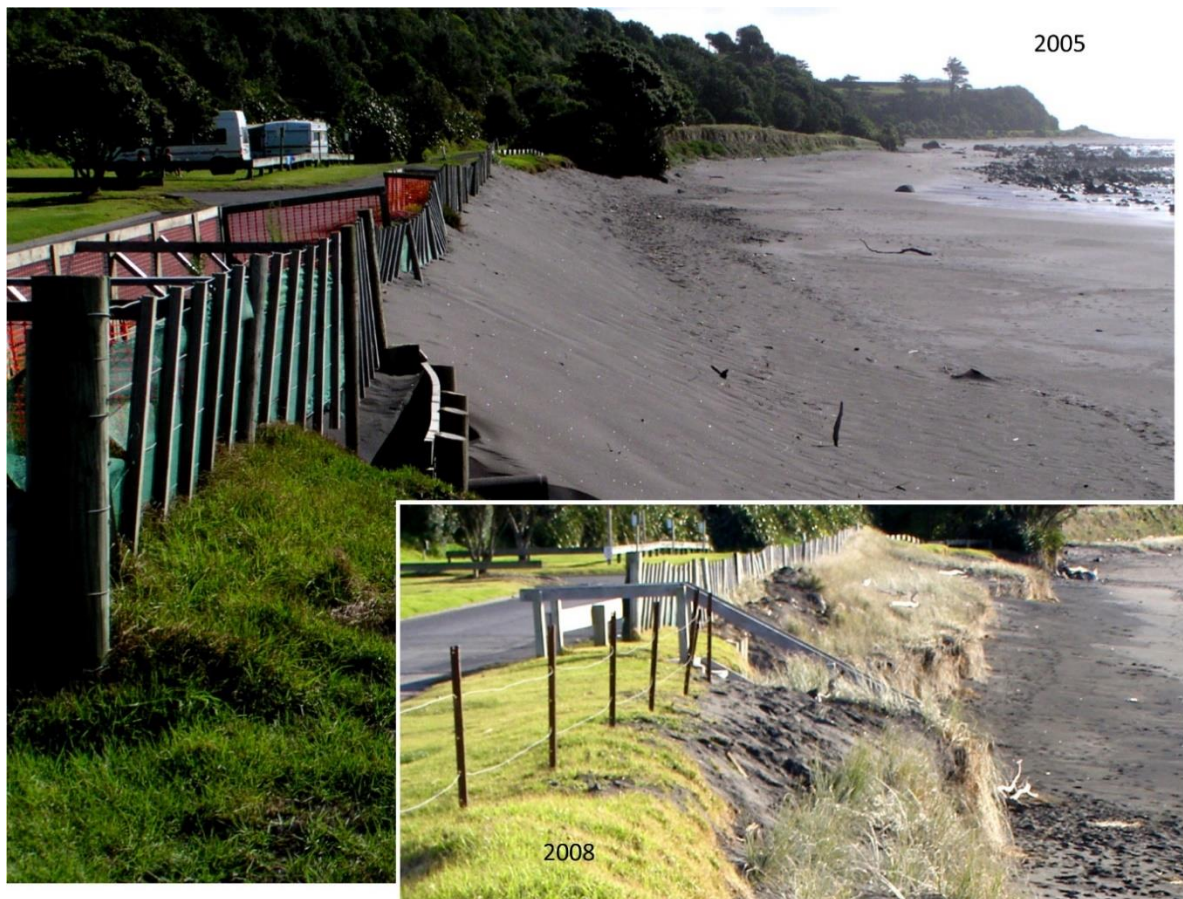
Figure 15 Sand nourishment (push-up) filling the scarped back-shore at Oakura Beach, Taranaki, 2005. A sediment deficit was causing an erosive fluctuation and threatening the motor camp access road. Dune grass was subsequently planted on the push-up to trap wind-blown sand. This management action prevented a significant erosive episode in 2008 reaching the 2005 scarp line (inset).
Photos CSL 2005

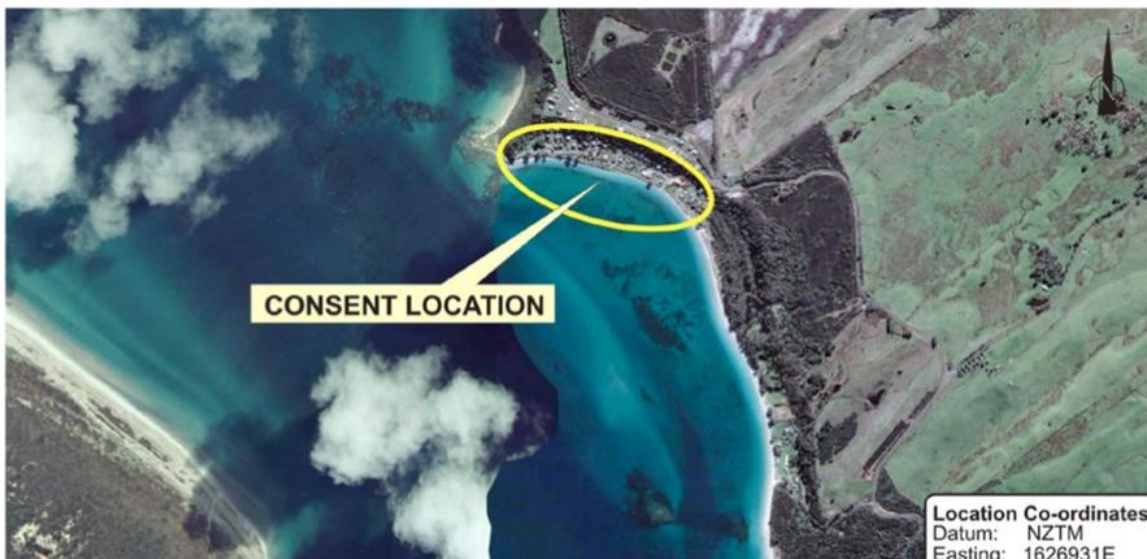
APPENDIX A Plan 4377 accompanying NRC resource consent 23858

<p>RESOURCE CONSENT CON20092385801 for Rangiputa Residents and Ratepayers Association Rock Revetment at Rangiputa, Rangaunu Harbour</p>	Scale: N.T.S.
		Drawn: JAG 03/11
		App'd:
		Plan No. 4377
