Geomorphological Assessment of the Waioeka inlet, Opotiki

A report prepared for Tonkin and Taylor Ltd on behalf of the
Bay of Plenty Regional Council

By Dr Roger D Shand

Reference	2019-01 CRep
Version	1.1
Status	Open
Date	15 March, 2019

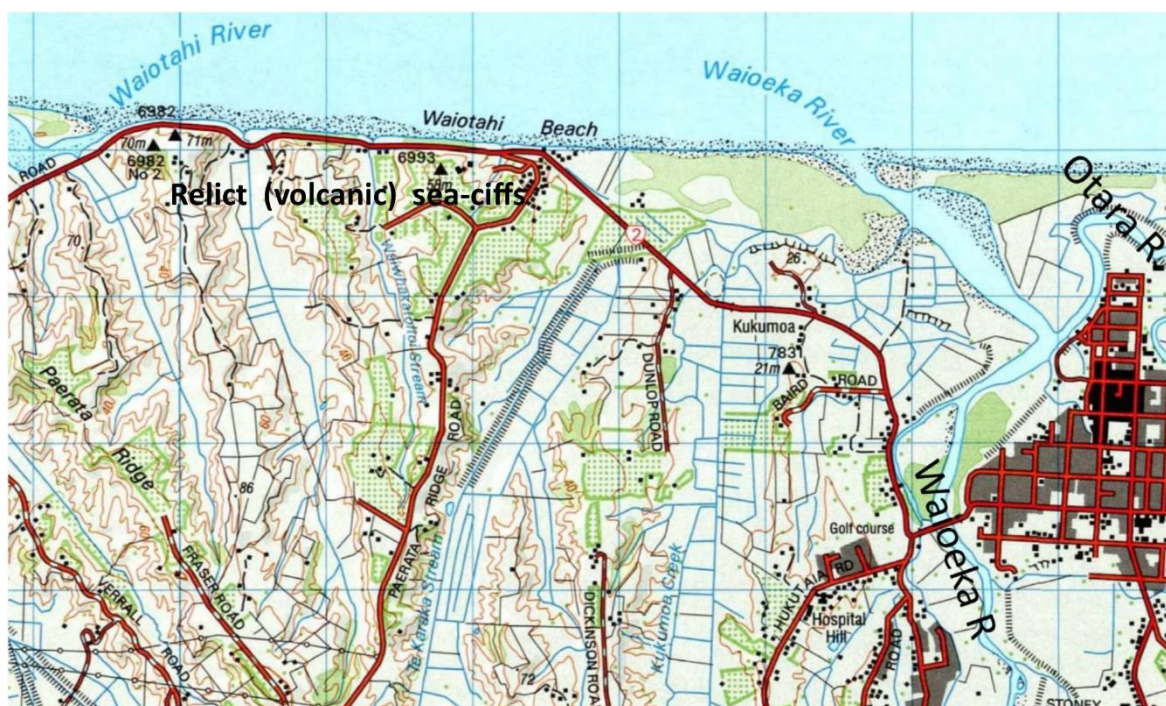
Figure 1 Location diagram. Grid lines are 1 km apart

Tonkin and Taylor are carrying out an erosion hazard assessment for the Bay of Plenty Regional Council (BOPRC) between the Waioeka and Waioeka Rivers (Figure 1). Tonkin and Taylor have commissioned Coastal Systems Ltd to prepare a “Geomorphological Assessment regarding the behaviour of the Waioeka Inlet, with particular focus on how far westward it might migrate before the spit is breached based on historical evidence. And/or how the inlets future behaviour could be incorporated within an erosion hazard assessment given that historic data shows the mouth migrating westward and speeding up”.

The physical characteristics of the inlet and coast have been described by Dahm and Kench 2002, 2004 as follows. The catchment is some 1130 km² which is largely steep and forested hill country with two main tributaries, the Waioeka and Otara Rivers. The confluence is 1.5 km upstream of the throat (this straight reach forming the approach channel to the inlet throat). The annual mean flow in this reach is 43 m³/s with combined spring tide discharge of 60 to 70 m³/s, while the annual flood flow is about 1000 m³/y and combined spring tide discharge of 100 to 150 m³/s. River sediments are medium sand with increasing silt/clay on the margins and gravel within the main channel and western side of the inlet. The annual volume supplied to the inlet by the river is considered to be less than 15,000 m³. Fine to medium sand occurs on the coast beyond the inlet. Net longshore drift is estimated to be in balance with a flux of some 10,000 m³/y. The coast is backed by Holocene sand dunes and swamp. In addition, a relic sea cliff made of volcanic sediments lies some 1.75 km westward of the present Waioeka mouth (see Figure 1).

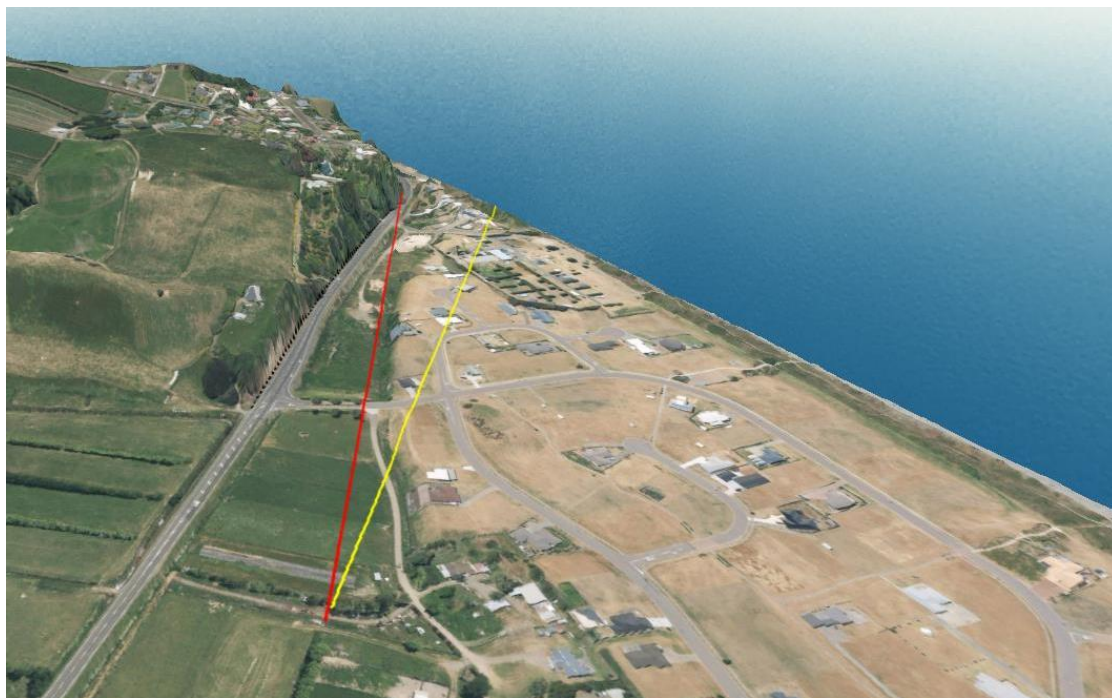
Figure 3 State Highway 2 approaching Waiotahi Beach with old sea-cliff on the left (inland) side of the road. The Waioeku Rivermouth is to lower right off photo (1 km distant). The red line is parallel to the present channel approach alignment (red line in Figure 2), while the yellow line is parallel to the 1985 approach channel alignment in Figure 2. See text for discussion.

Figure 3 provides a 3D view as State Highway 2 approaches Waiotahi Beach. The Waioeka Rivermouth lies approximately 1 km downcoast. The road can be seen to run along the base of the relict (Holocene) seacliff. The orientation of the sea-cliff is interpreted as the westernmost margin of the Waioeka River and preserves an extreme orientation. Also marked in Figure 3 are yellow and red straight lines – these being parallel to the 1985 river alignment and the 2015 river alignments respectively as depicted earlier in Figure 2. The 1985 alignment is approximately parallel to the road (base of relict sea-cliff), while the red 2015 alignment has a greater westward offset than the relict cliff-line. These orientations at least suggest the present offset is greater than that experienced by this river in the past. However, as discussed in Section 2, the present offset may be unduly influenced by river control structures, while the Holocene orientation would relate to a natural system. This evidence and argument are therefore perhaps more of interest than assistance in answering the question relating to westward migration potential of the inlet system.
