Geomorphological assessment, hazard and risk assessments, and mitigation management options for Ōpunakē Bay

A report prepared for the South Taranaki District Council

By Dr Roger D Shand

Reference	2019-11 CRep
Version	3
Status	FINAL
Date	19 December, 2019

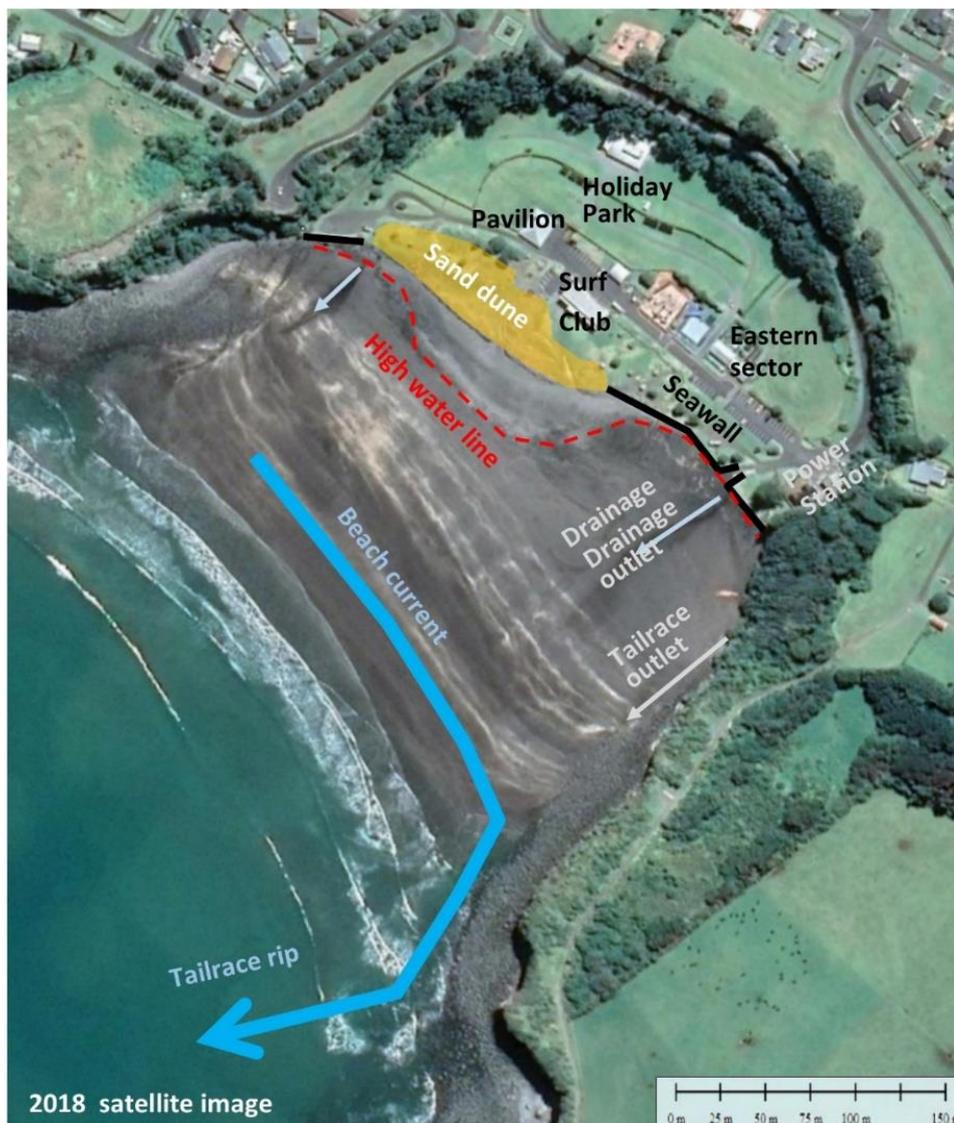
Figure 2 Ōpunakē Bay with marked features referred to in the text.

The lower beach is relatively uniform with no evidence of inter-tidal rip channels apart from a topographically constrained channel at the eastern end (described later) which extends out toward the headland (see Figure 2). It is noted that at over the past year the

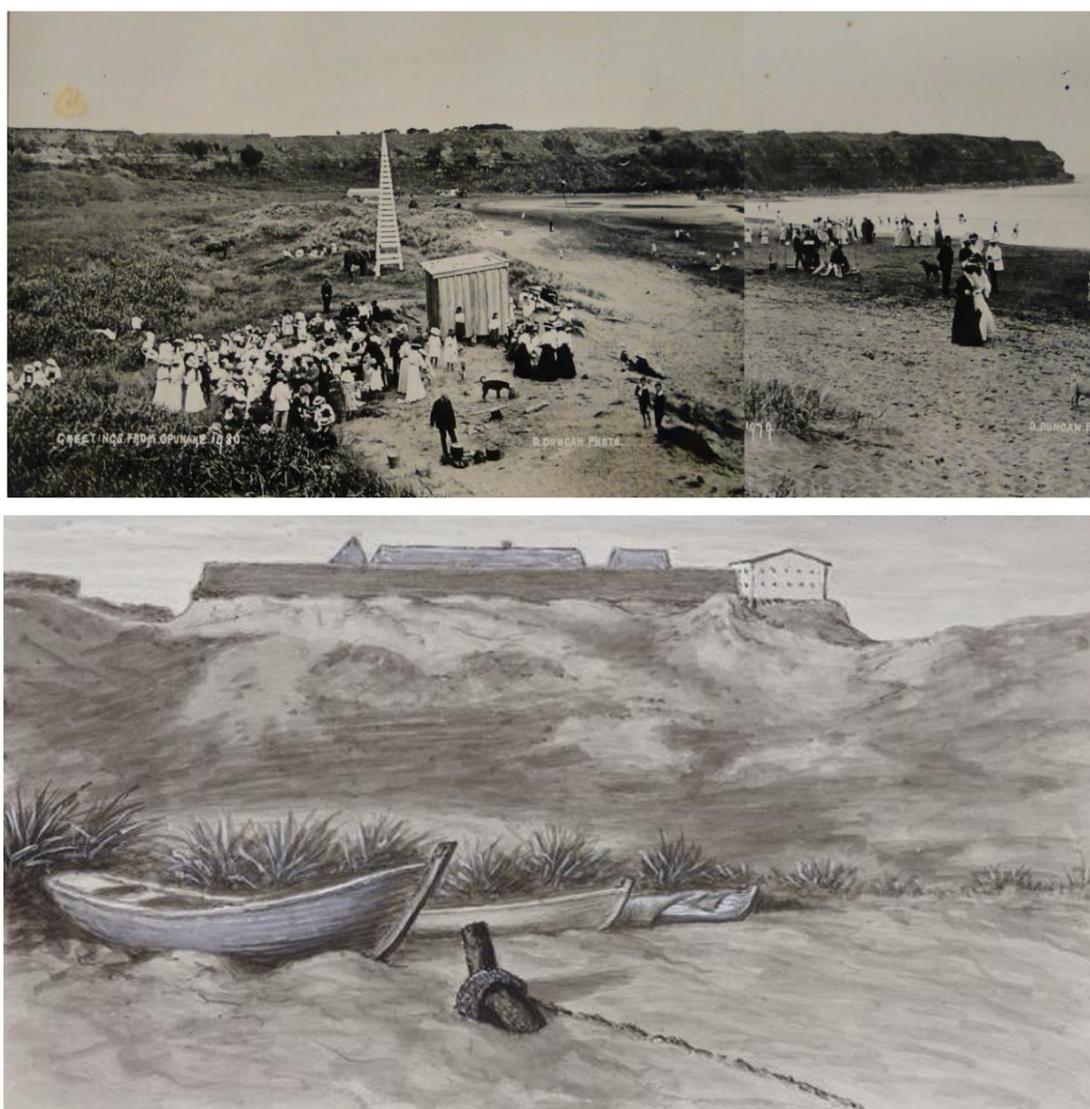
Figure 3 Early imagery of Ōpunakē Beach and environment. Upper: 1908 (merged) photos of D. Duncan shows the beach and landward swamp. The tall structure is the forward navigation beacon, the shed in the foreground is the first changing room and the far building houses the surf boat. Lower: 1882 painting by S. George showing the north eastern corner of the bay, backing cliff and Redoubt. The boats were for negotiating the surf to ships anchored in the roadstead.

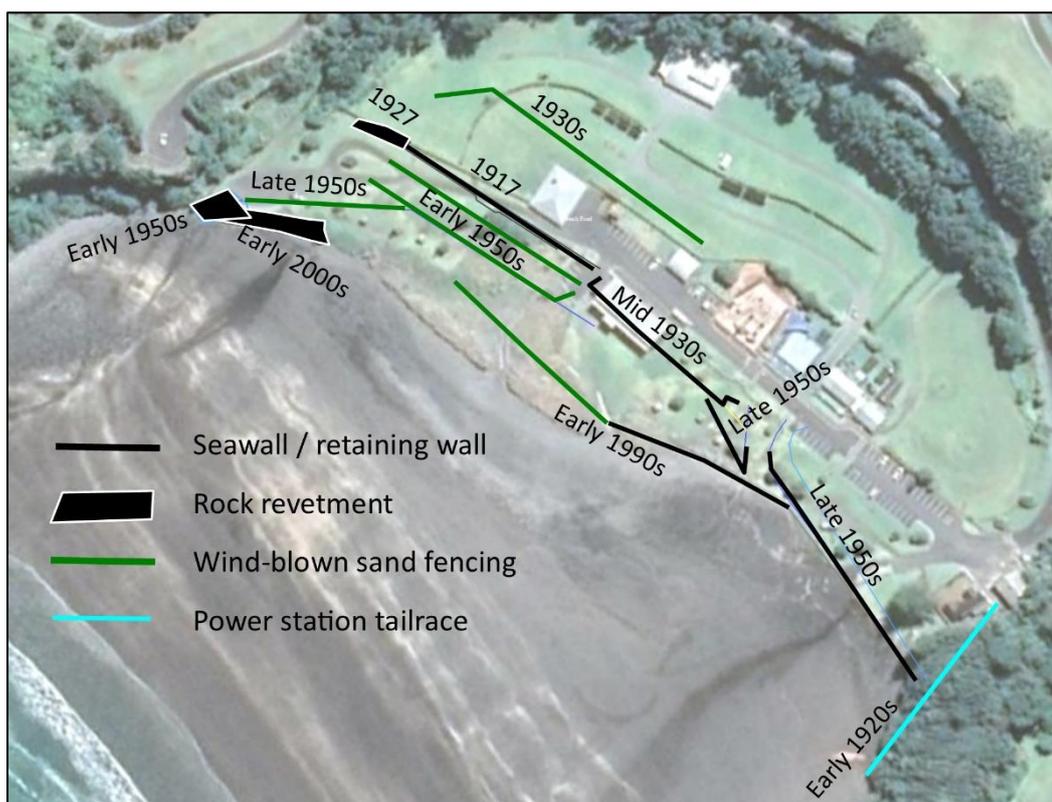
Figure 4 Location of anthropogenic works in Ōpunakē Bay

The Feaver photographic collection of Ōpunakē Bay spans the period 1913 to 1937 and comprise over 50 photographs showing how recreational beach development proceeded during this time interval - appearing to have peaked in the late 1920s and early 1930s. A variety of structures can be identified for erosion and accretion control, fencing and planting for wind-blown sand control, and the breakwater originally extending some 600 feet into the bay. Swamp infill began at the western end and progressed eastward during the 1930s, but was not completed (see Section 3.3). Table 1 lists the various anthropogenic works and Figure 4 locates their positions.

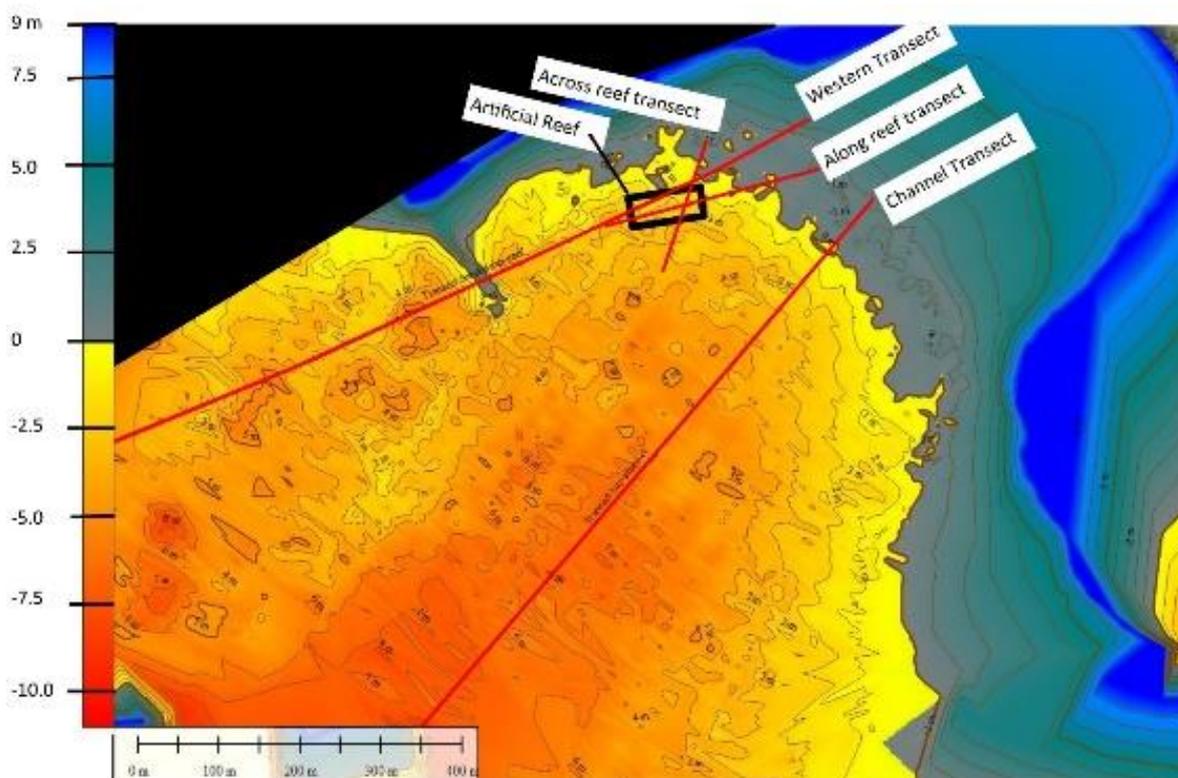
Figure 5 2000 bathymetry with sampling transects marked

To define change during the intervening 114 years, depths along two representative transects were abstracted. One transect is located along the western side of the bay and includes the breakwater and site of the artificial surf reef. The other transect runs out through the centre of the Bay. In addition, the artificial reef's early environmental impact was assessed using along and across-reef transects. All sampling transects are marked in Figure 5 which is underlain by the 2000 DML bathymetry.

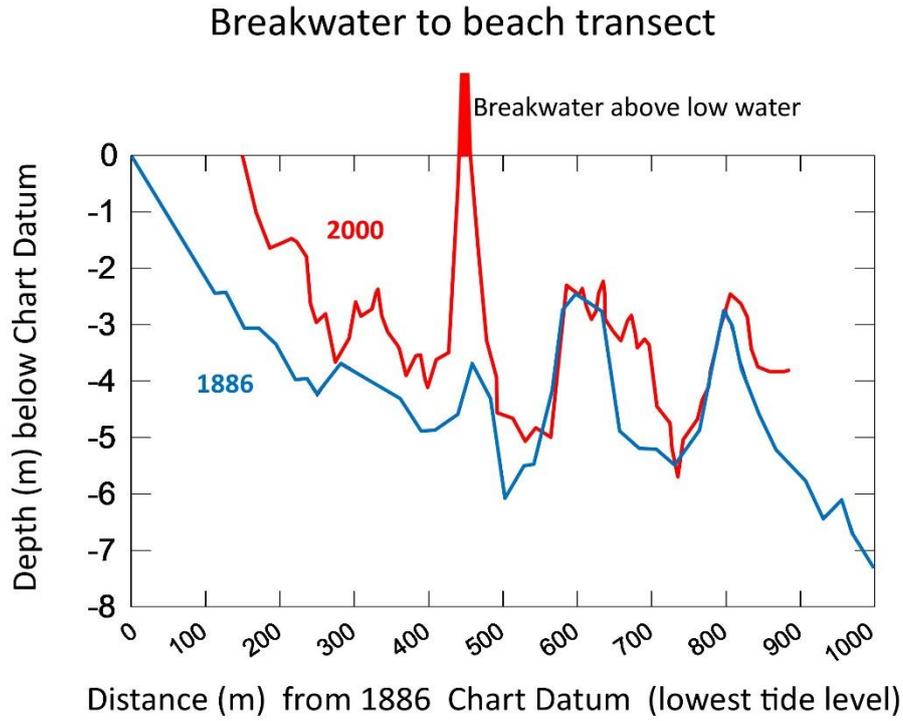
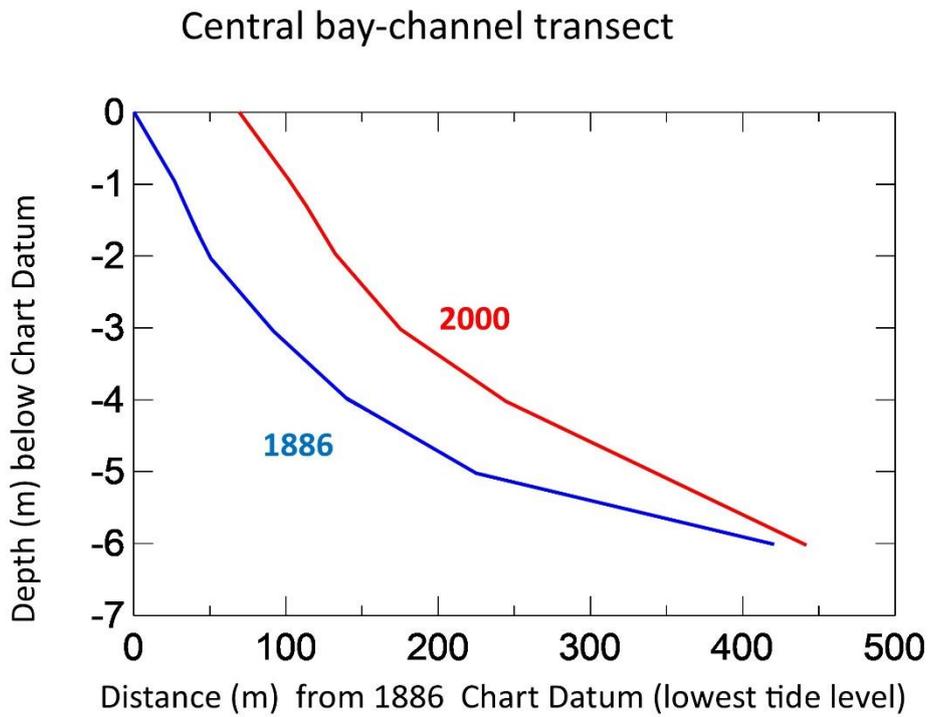
Figure 6A Western and central transect profile comparison 1886 with 2000.

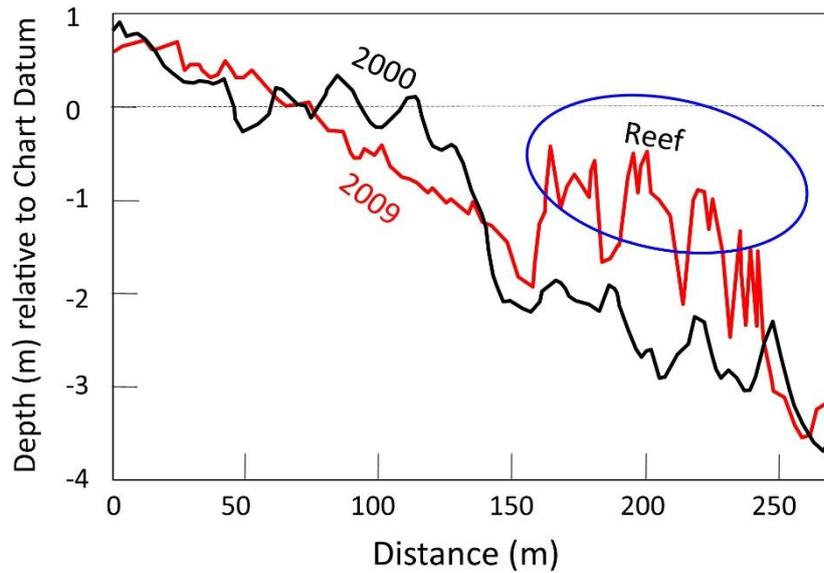
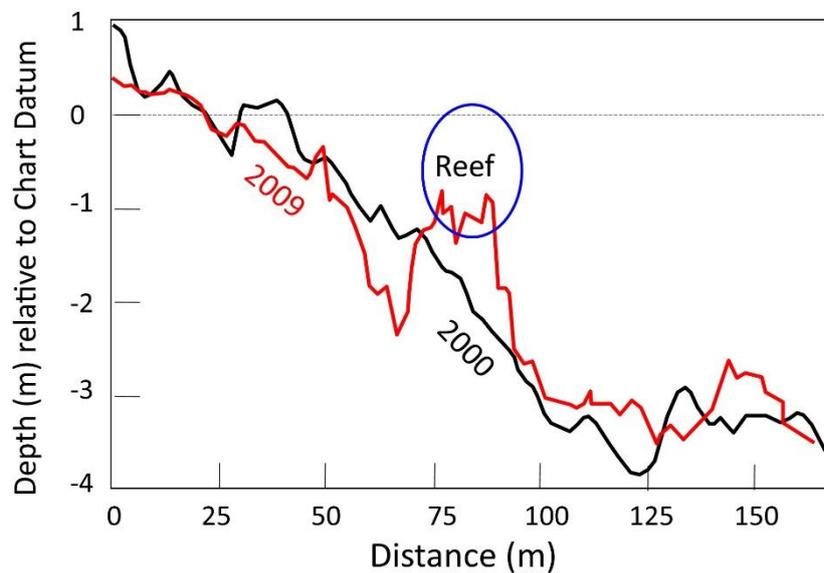
Transect along surf reef to beach

Transect across surf reef to cliff

Figure 6B Along and across-reef profile comparison between 2000 (pre-construction) and 2009 (post construction). Transect locations as shown in Figure 5.

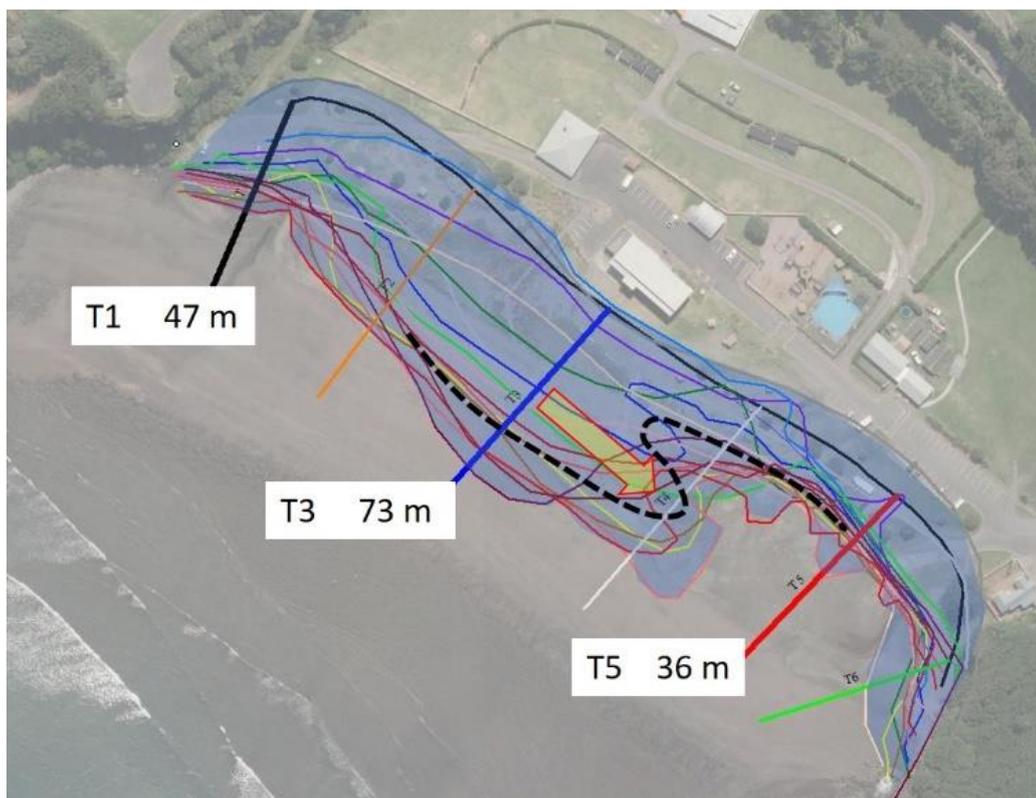
Figure 7 Superimposed HWMSpring shorelines with their envelop shaded blue and envelop widths marked for three transects (1, 3 and 5). The dashed black line locates an overall shoreline shape and the arrow shows the direction of inferred sediment transport.

The set of HWMSpring shorelines are overlaid in Figure 7A with their envelope shaded blue and five cross-shore transects marked T1 to T5. These data show the shoreline extends further seaward in the centre of the bay, narrows slightly in the west and narrows more extensively at the eastern end of the Bay. In addition, the dashed black line depicts an average shoreline shape – a shape that infers the direction of sediment transport is eastward (arrowed). This result being consistent with other observations of net current direction mentioned earlier in Section 2.3.

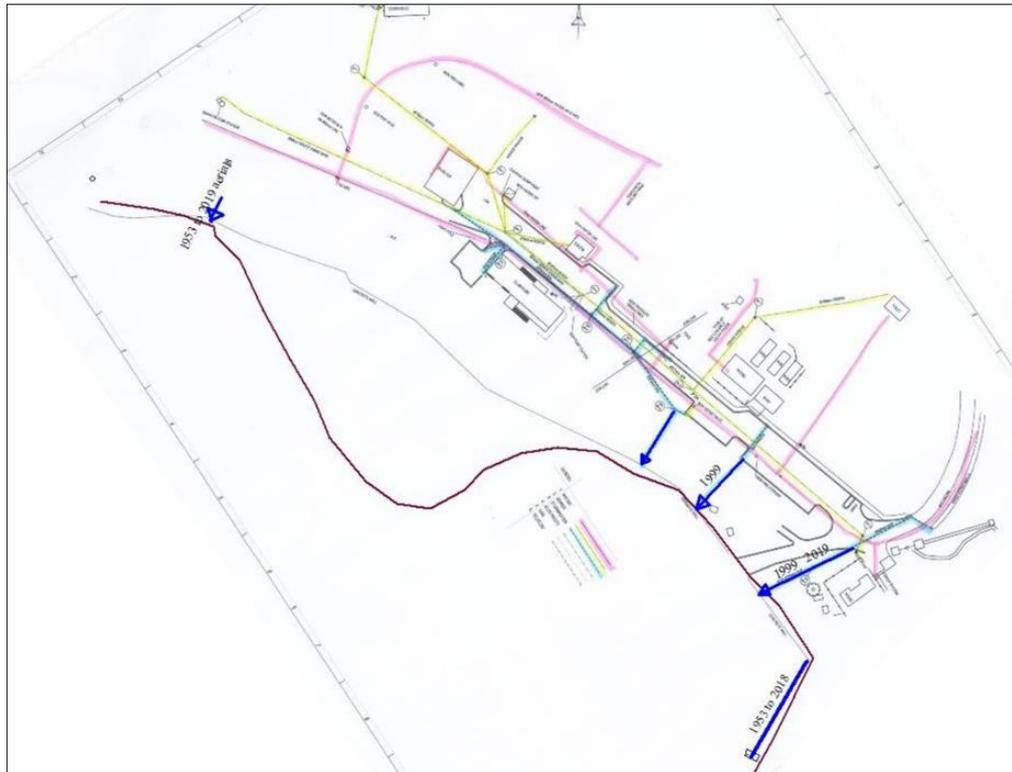
Figure 8 STDC Ōpunakē Beach infrastructure with beach drainage outlets marked by arrows along the (2019) spring high water shoreline.

As noted earlier in Section 2.2, the alongshore variation in shoreline shape is broadly related to the location of drainage outlets onto the beach (Figure 8), with the shoreline being landward where the outlets occur and seaward where they are absent. The beach water table water is raised in the vicinity of drainage outlets thereby increasing the water content in the beach sand which reduces inter-grain resistance and facilitates erosion.

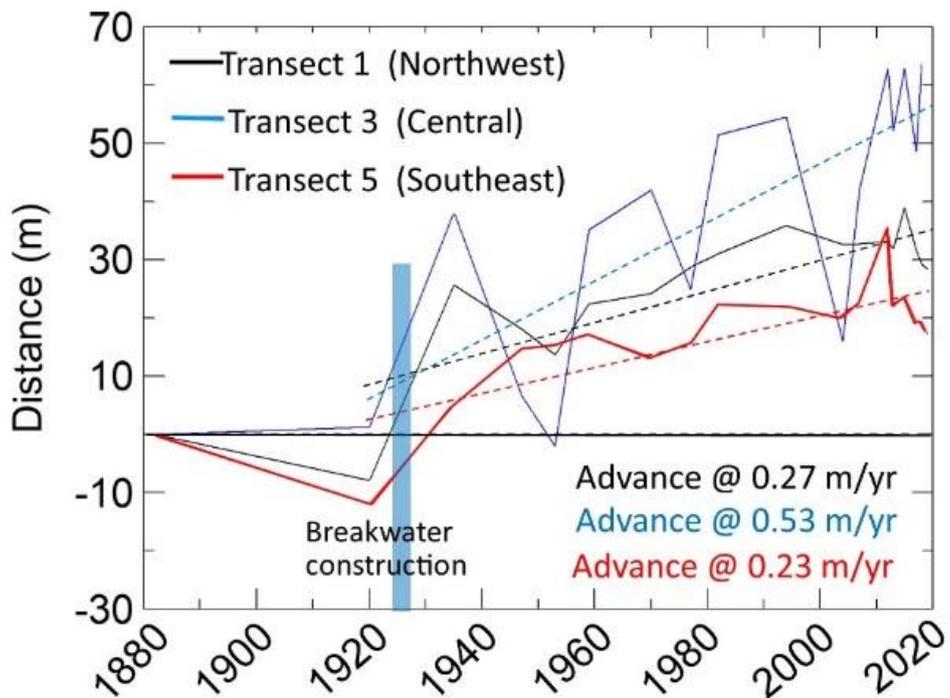
Figure 9 Shoreline time-series graphs for Transects 1, 3 and 5, with linear regression models fitted (dashed lines). The Breakwater construction period is marked by the vertical blue bar

Shoreline behaviour through time is depicted in Figure 9. Only graphs for transects 1, 3 and 5 are included as these were found to adequately represent the beach system. The construction of the breakwater (1924-8) is marked by the vertical bar. While early data points are sparse, the graph indicates a stable/eroding shoreline before breakwater construction, and systematic accretion thereafter. The subdued foredune morphology in the 1882 and 1908 imagery (Figure 3) supports such early shoreline behaviour with the dune possibly being a temporary feature.

Linear regression models have been fitted to the post-breakwater data points (dashed lines in Figure 9) and show average rates of shoreline advance ranged between 0.53 m/yr at Transect 2 in the centre of the bay down to 0.27 and 0.23 m/y at the west and eastern ends respectively.

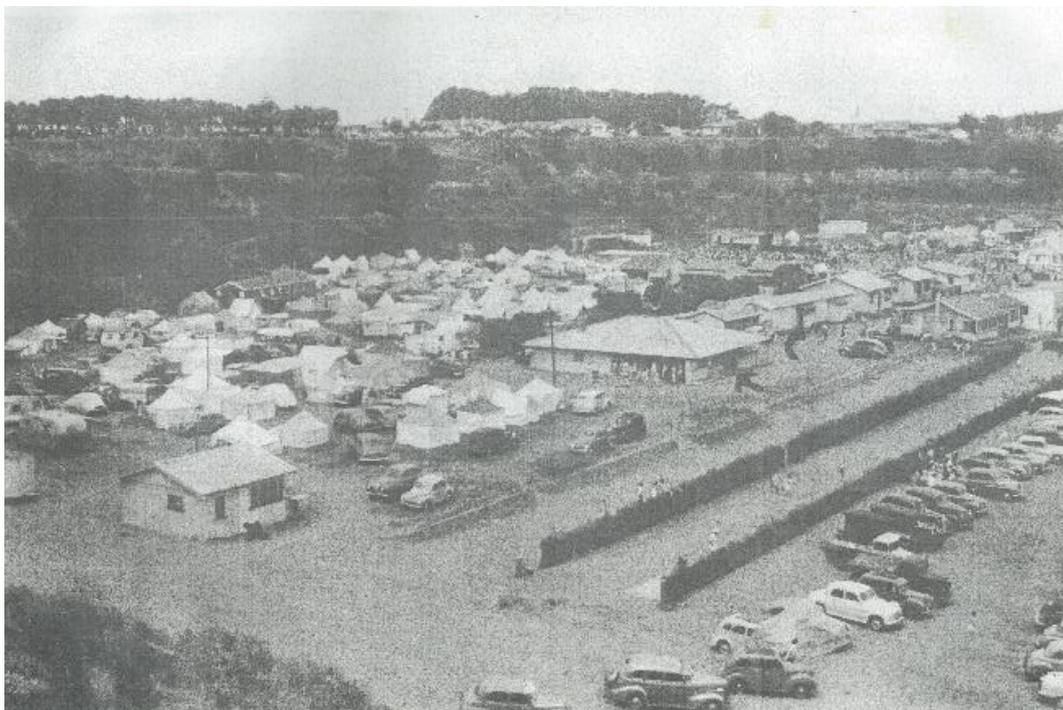
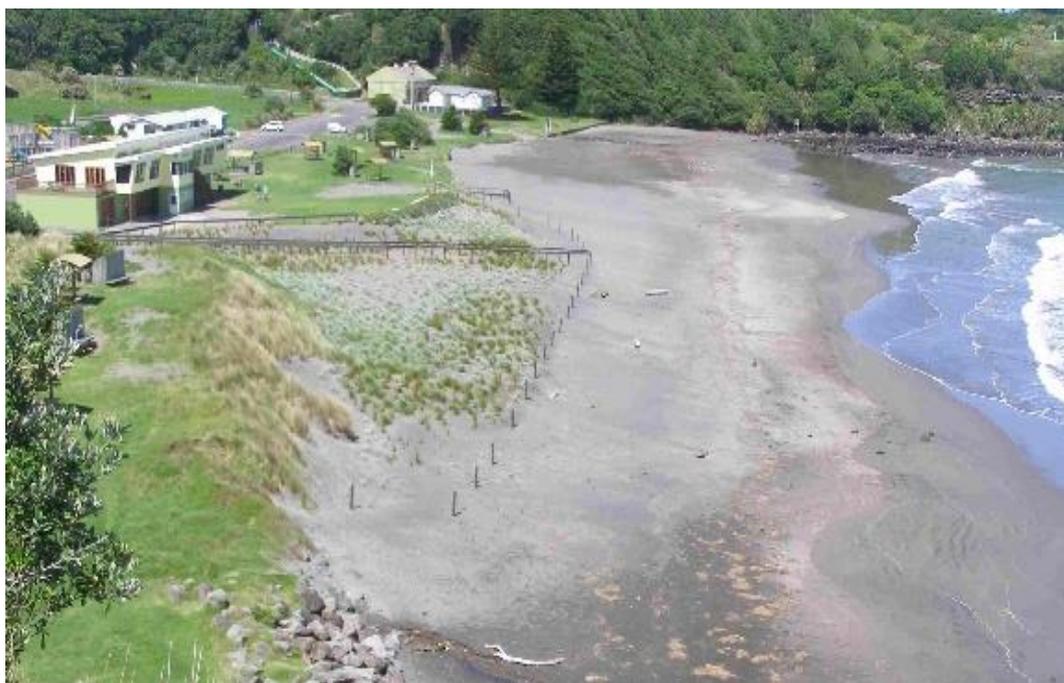
Figure 10 Conservation works to control wind-blown sand. Upper photo: brush fences in the mid 1950s (1917 seawall evident immediately to landward). Lower photo taken in 2011 showing the 2009 planting.

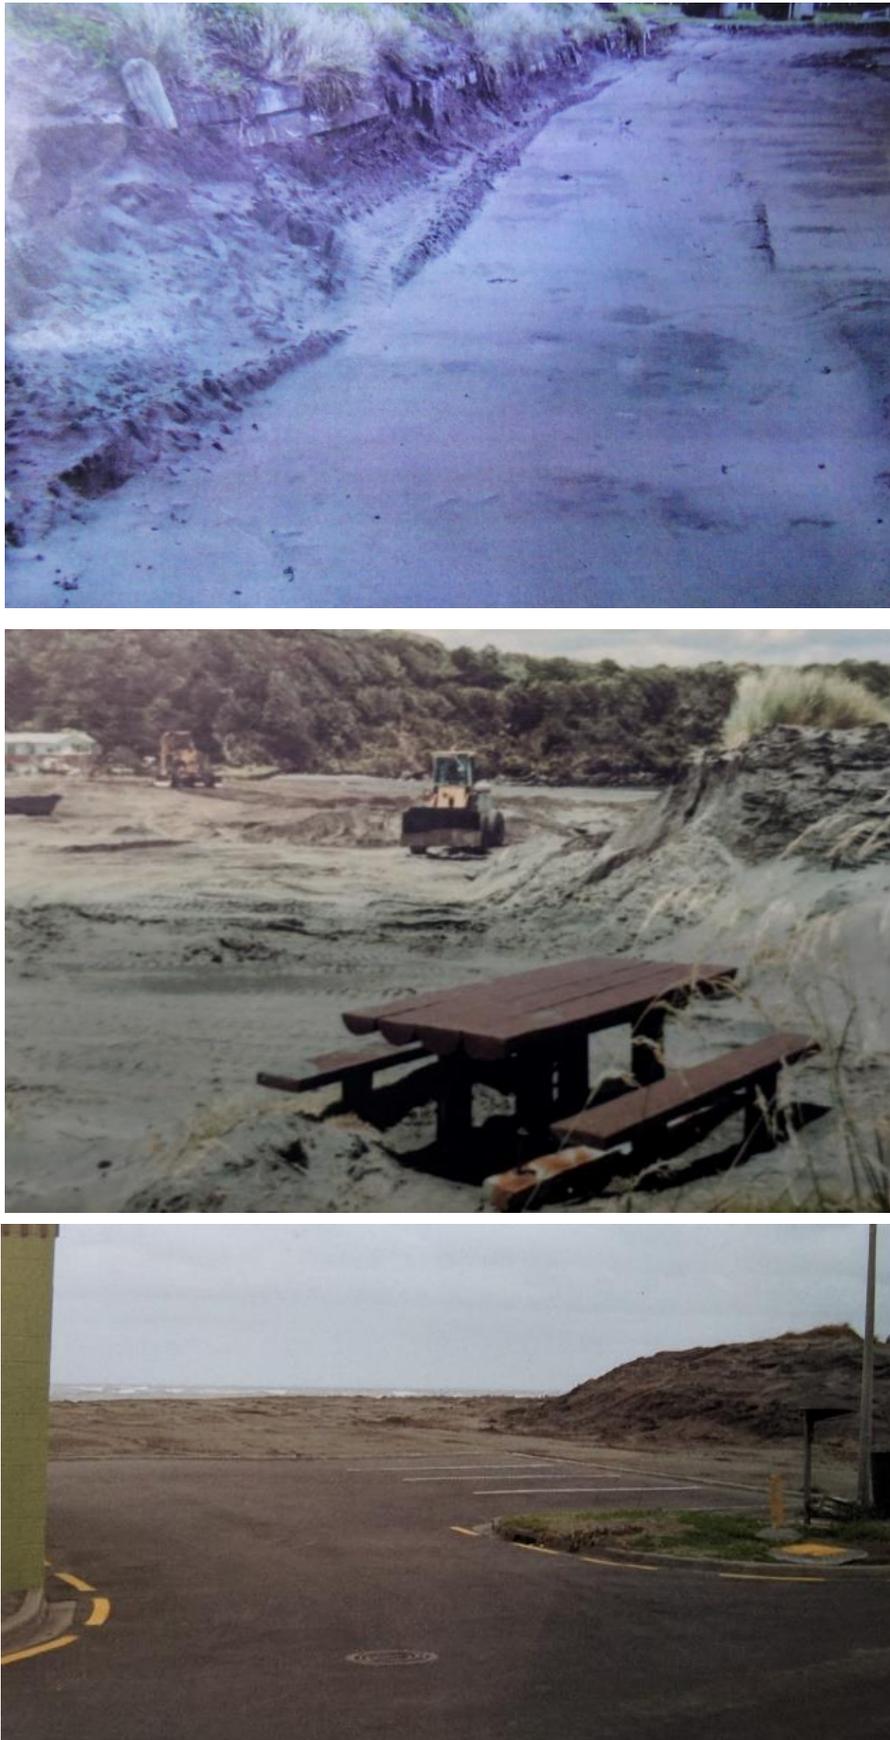
Figure 11 Mechanical sand removal. Top photo: beach scraping 1990s; middle photo: dune removal 1987, and bottom photo: dune removal 1996-1997

abundant sand supply (examples in Figure 11) with sand from the upper beach and dunes often being returned to the beach at low tide as noted in Section 2.3.

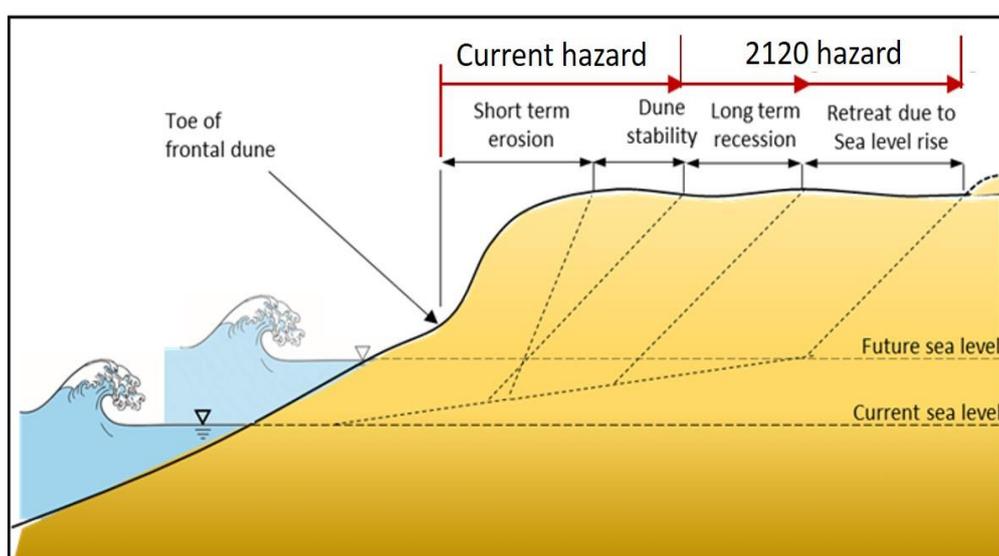
Figure 12 Definition sketch of erosion hazard assessment components for current and future scenarios

Best practice methodology for assessing the coastal erosion hazard for a sandy shoreline involves additively combining 4 essentially independent components (MFE 2008, NIWA 2012, MFE 2017) which are diagrammatically illustrated in Figure 12

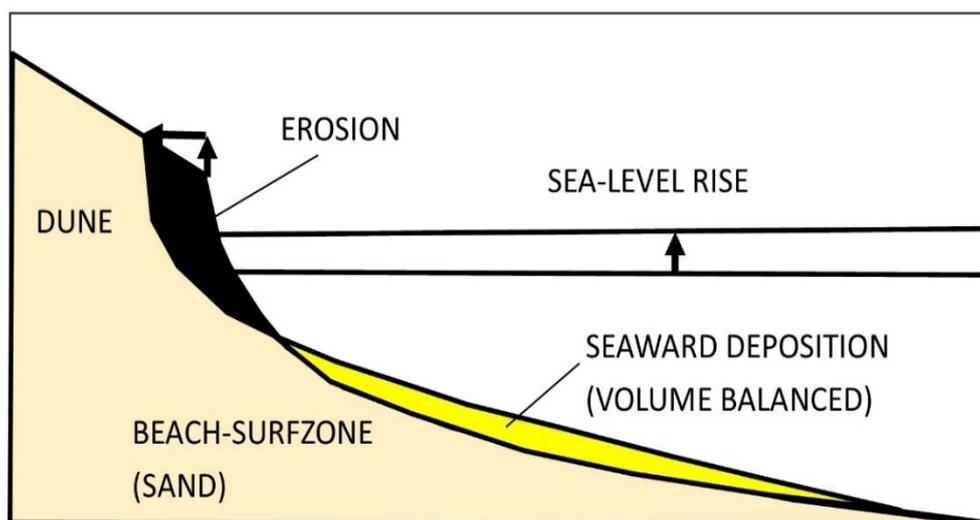
Figure 13 Geometric translation model concept of shoreline response to sea-level rise

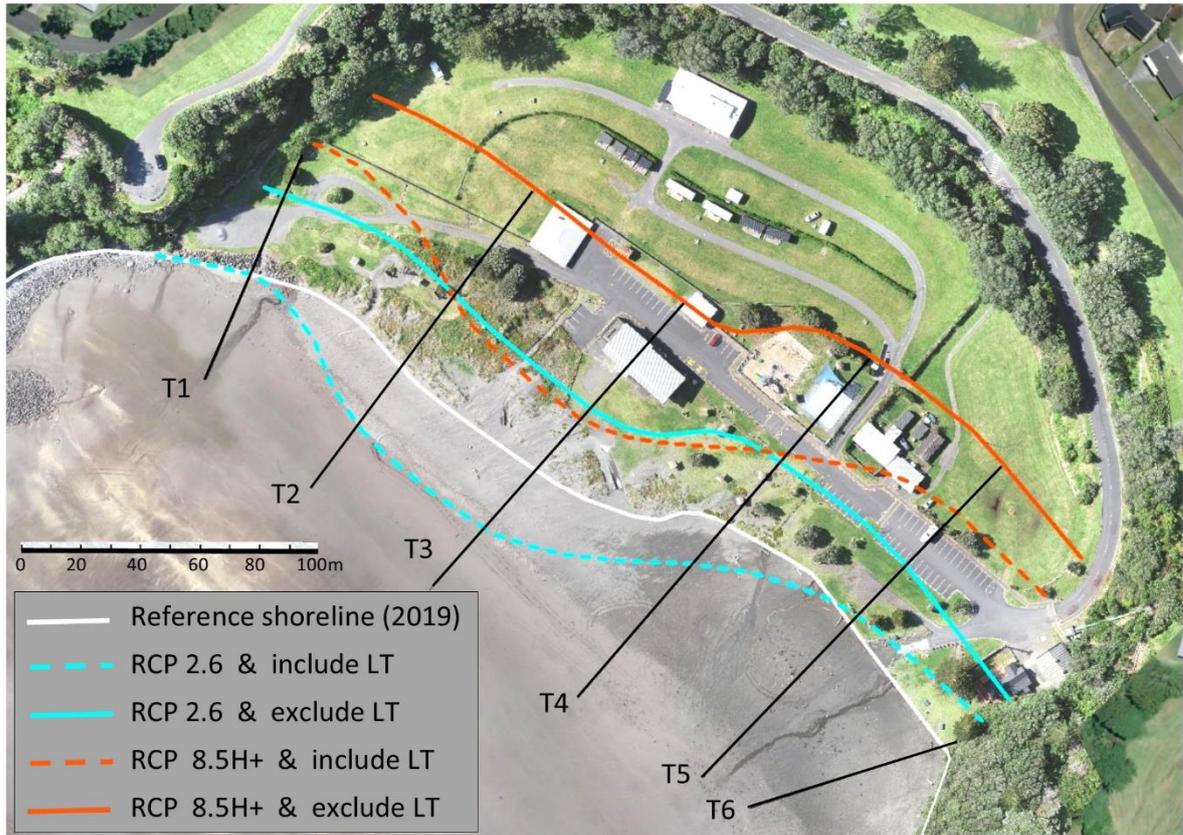
Figure 14 Erosion hazard lines at 2120 – derived by summing values for ST, DS and scenarios for both LT (inclusion and exclusion), and RSLR for the range of RCPs (2.6 and RCP 8.5H+). Component values for each transect are listed in Table 3, and the hazard lines are measured from the 2019 reference shoreline (white): positive values to seaward and negative to landward. The underlying aerial photo is from the November 2019 TPL survey.

Potential erosion hazard distances at 2120 are summarized in Table 3 and the resulting hazard lines are plotted in Figure 14 where the offsets are measured from the 2019 (reference) shoreline.

For RPC 2.6 with historical LT continuing, the hazard line is seaward of the present shoreline for all but the eastward most 30 m. The greatest seaward offset is 26.6 m in the centre of the bay. For RPC 2.6 with no future LT, the shoreline will retreat approximately 28 m along the entire bay.

At the other SLR extreme (RPC 8.5H+), with historical LT continuing, there is retreat of 20 to 30 m in the centre of the bay and about 50 m at the ends. The most extreme erosive scenario occurs under 8.5H+ when no allowance is made for future accretion (a somewhat unlikely situation), with the resulting shoreline being about 75 m to landward.

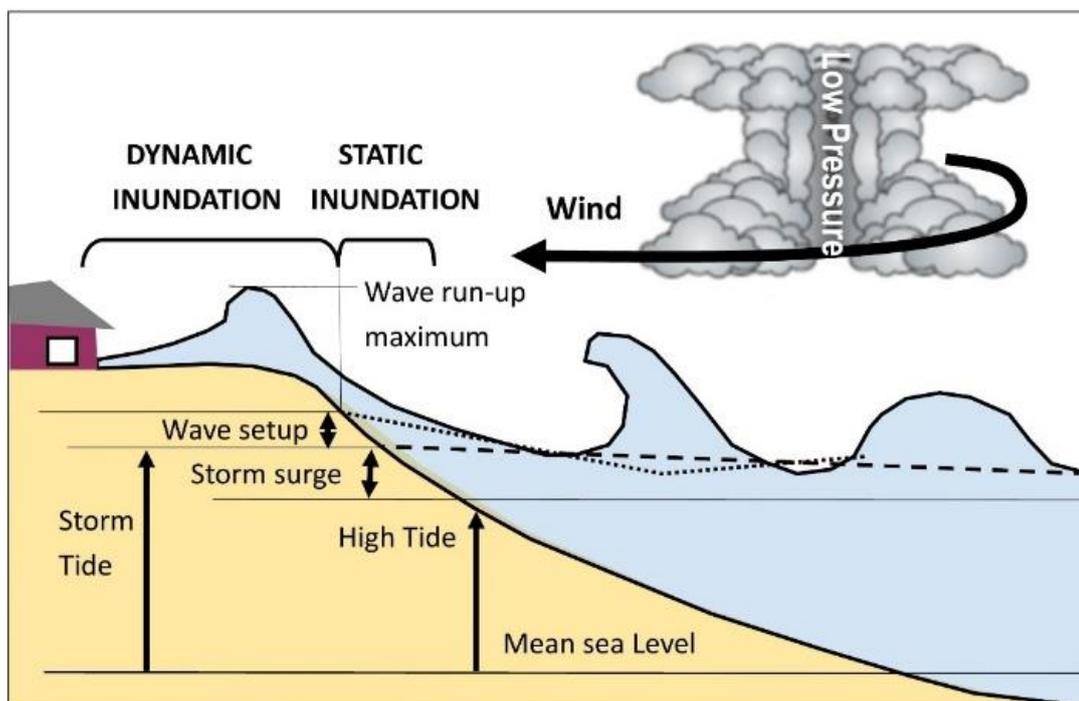
Figure 15 Schematic diagram of tide, wave and atmospheric components driving extreme sea-levels and storm-induced inundation at the coastal margin.

Extreme static and dynamic water levels (Section 5.1, Figure 15) for both the present (2020) and 100 year (2120) time frames and using the recommended RCP-based SLRs are shown in Table 9. In addition, MHWS and SWL are also listed. Results for both 1 and 100 year return periods are given and all levels are based on NZVD16.

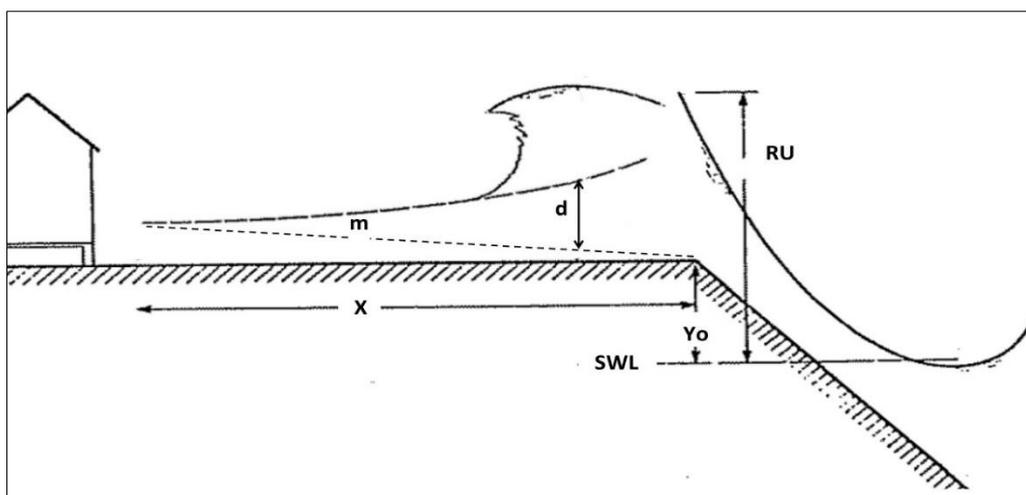
Figure 16 Schematic diagram of overland flow attenuation and illustration of listed parameters used for the computation of equation 9.

TABLE 7 Landward attenuation distance (marked x in Figure 16) at different shore-line locations and run-up elevations. All dimensions in metres with heights relative to NZVD16.

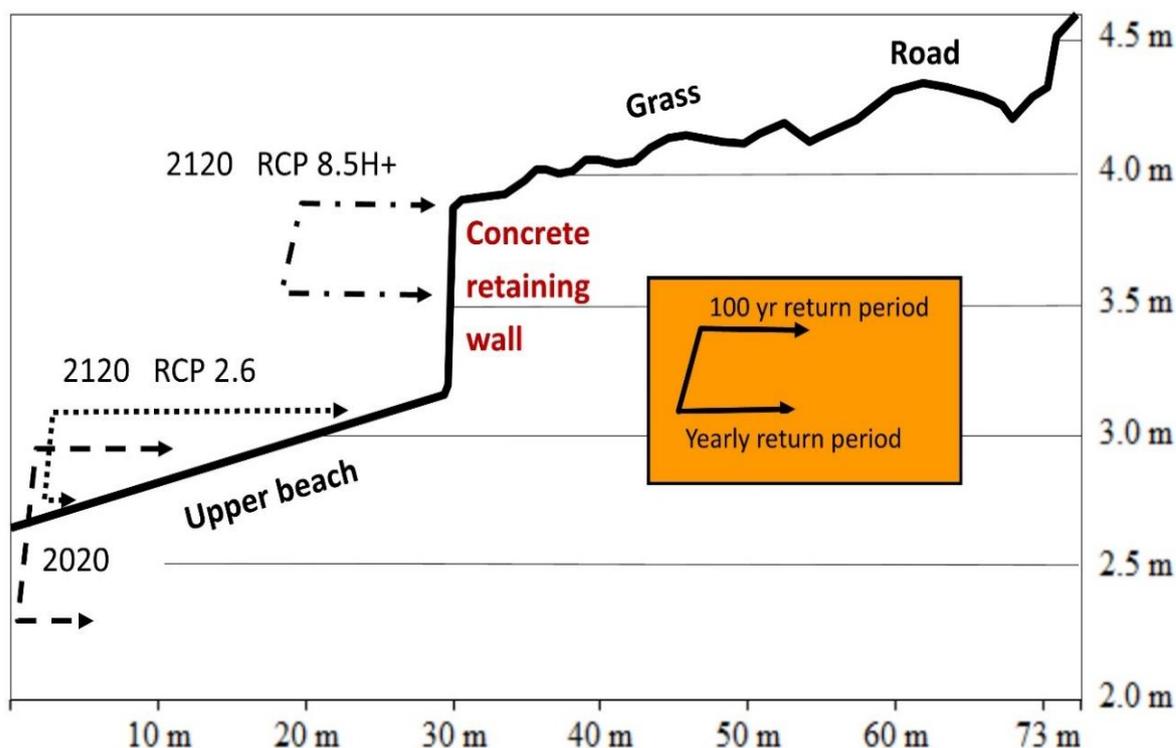
Figure 17 Static extreme water levels (still water level plus storm surge) for bracketing scenarios along the transect marked in Figure 18.

The inundation extents of the extreme static water levels are depicted graphically in Figure 17 which shows a cross section at the eastern end of the beach (transect line is marked blue in Figure 18), this being the most vulnerable location. Overtopping occurs a little under 4 m, but only under the most extreme SLR scenario and highest return period is this level reached.

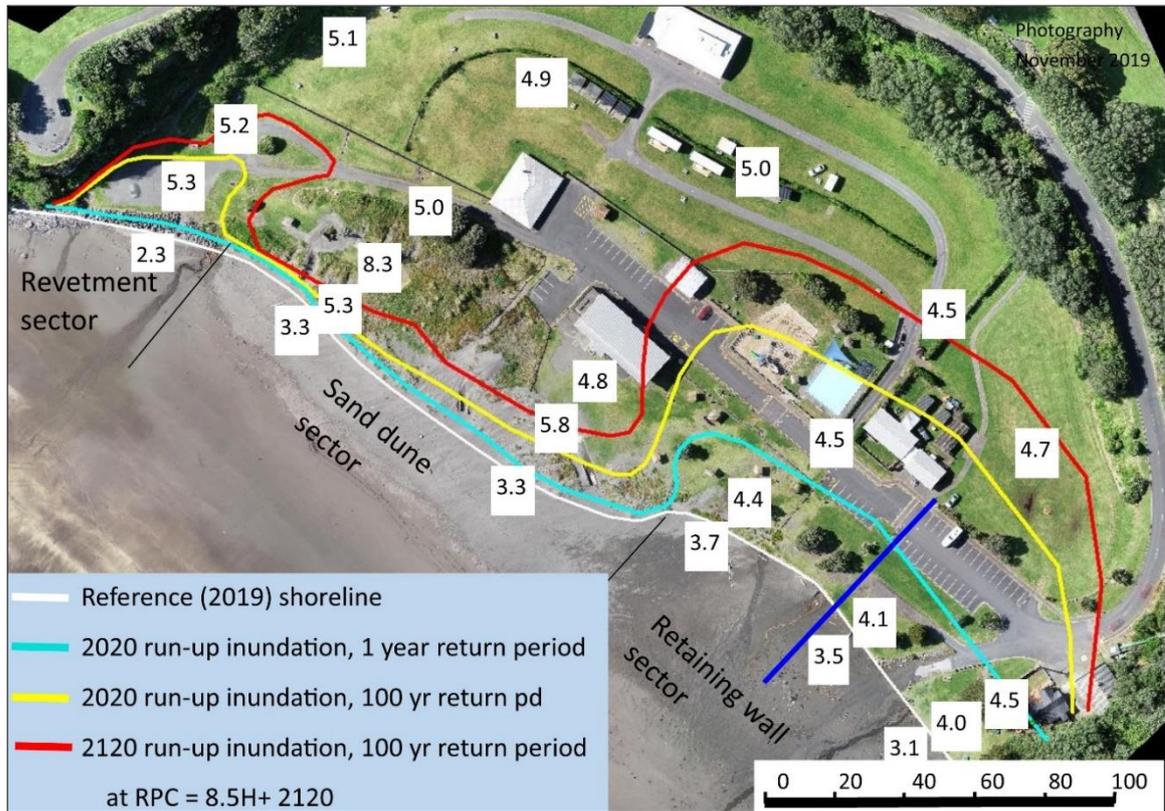
Figure 18 Dynamic extreme water level inundation extents depicting 2020 for 1 and 100 year return periods, and 2120 for the RPC 8.5H+ option with a 100 year return period. Spot levels are in NZVD16 and the aerial photo is from the November 2019 TPL drone survey. The blue line defines the transect used in the set-up profile shown in Figure 17.

The inundation extents of extreme dynamic water levels are depicted in Figure 18 which maps the overland flow limits (to 0.1 m depth which is considered “tolerable”) for present (2020) and future (2120) time frames. Values are based on Table 7 (modelled attenuation distances for existing ground cover), and then adjusted for topography using the 2019 TPL 3D digital elevation model. Of particular note is the effectiveness of sand dunes along the central sector in mitigating run-up extent.

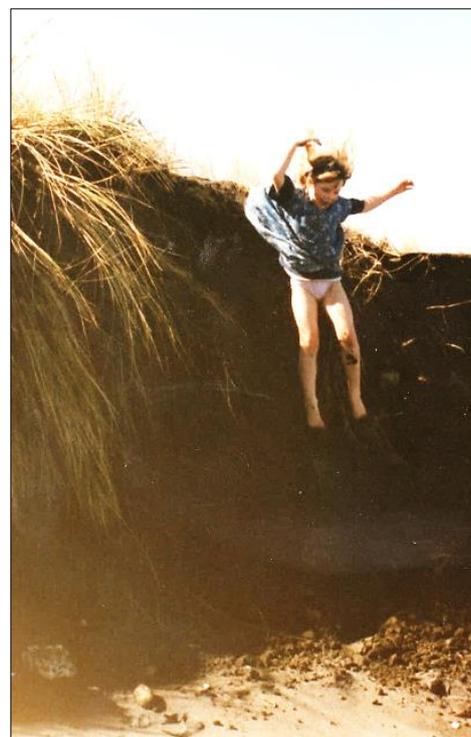
Figure 19 Foredune escarpment (post-storm) with potential collapse and burial hazard

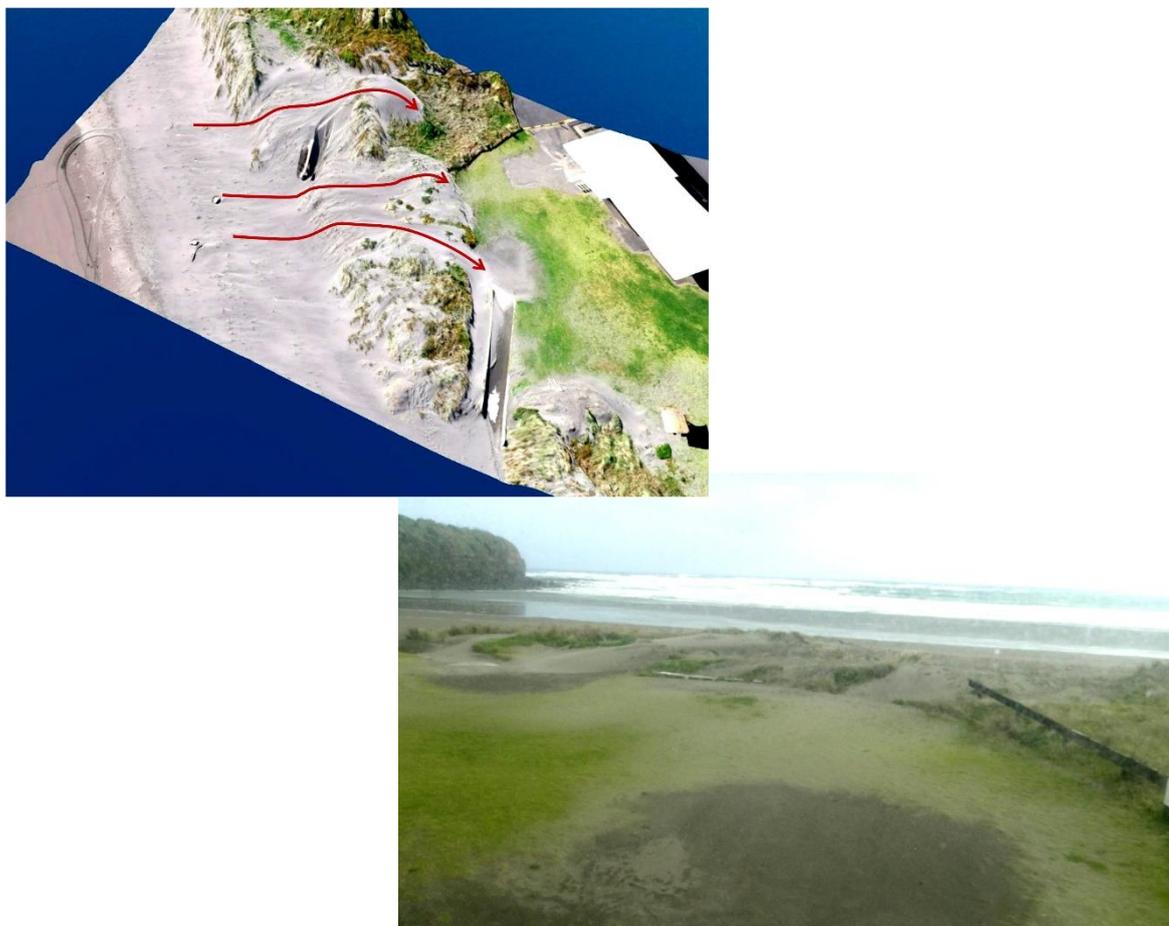
Figure 20 Extreme episode of wind-blown sand on 2 October, 2019. At this time it was not possible to be outside and this photo was taken from the upper story of the Surf Club. The foredune had been lowered (topped) in November 2018 and not replanted. As evident in the upper photo (12 November 2019), gutting is now occurring on the bare dune face and sand has overwhelmed rear dune vegetation with parabolic dune formation occurring.

Vision impairment and/or skin burn to people can occur during periods when bare sand is exposed on the beach, (vulnerability increasing during times of sediment surplus) and/or devegetation of the dunes (because of cliffing or artificial reshaping if carried out periodically for surf lifesavers) are coupled with strong wind (> 25 knots). Property burial and sandblast (including vegetation desiccation) also occur during these conditions. The unlikely occurrence of these events results in a **low** risk at the present time. However, the risk will increase to **high** under climate change as both extreme wind and dune cliffing (bare sand exposure) are expected to occur more often.

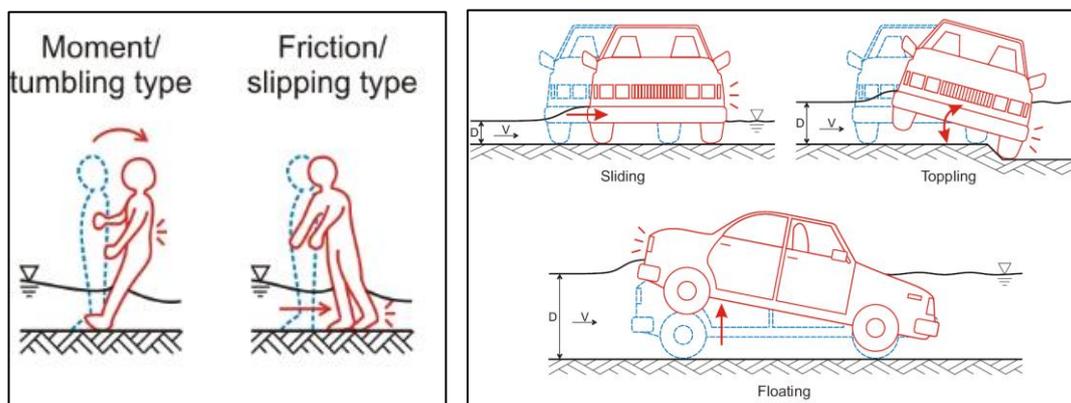
Figure 21 Typical modes of human and vehicle instability (Shand et al., 2010).

Once wave-driven flow depths exceed about 0.5 m for children and 1 m for adults they are susceptible to destabilization (Figure 21) and injury (Shand et al., 2010). At present, under extreme (very unlikely) conditions in the eastern sector these depths can be exceeded for about 30 m inland resulting in minor injuries and presenting a **very low** hazard risk to people. Under future SLR scenarios the distance inland experiencing critical depths and flows approximately doubles making for medium consequences and **low** risk.

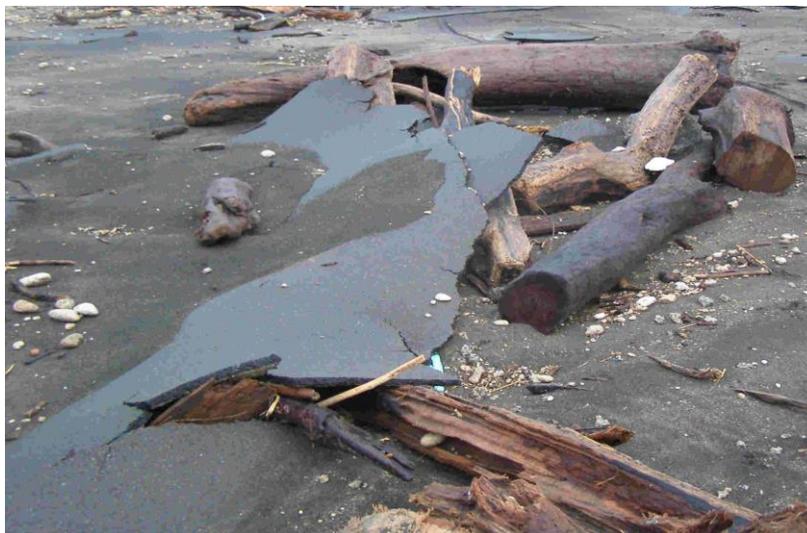
Figure 22 Delamination of road paving by dynamic inundation flow.

Once wave-driven flow depths exceed 0.3 to 0.5 m vehicles become unstable and paving can delaminate. Under the current regime the likelihood of such inundation extending far enough inland for this to occur is very low, consequences medium and the associated risk is **very low**. However, under SLR scenarios dynamic inundation the consequences increase to major as virtually all the infrastructure, buildings and vehicles may be impacted, making for a **moderate** hazard risk.
