Geomorphological assessment, hazard and risk assessments, and mitigation management options for Ōpunakē Bay

A report prepared for the South Taranaki District Council

By Dr Roger D Shand

Reference	2019-11 CRep
Version	3
Status	FINAL
Date	19 December, 2019

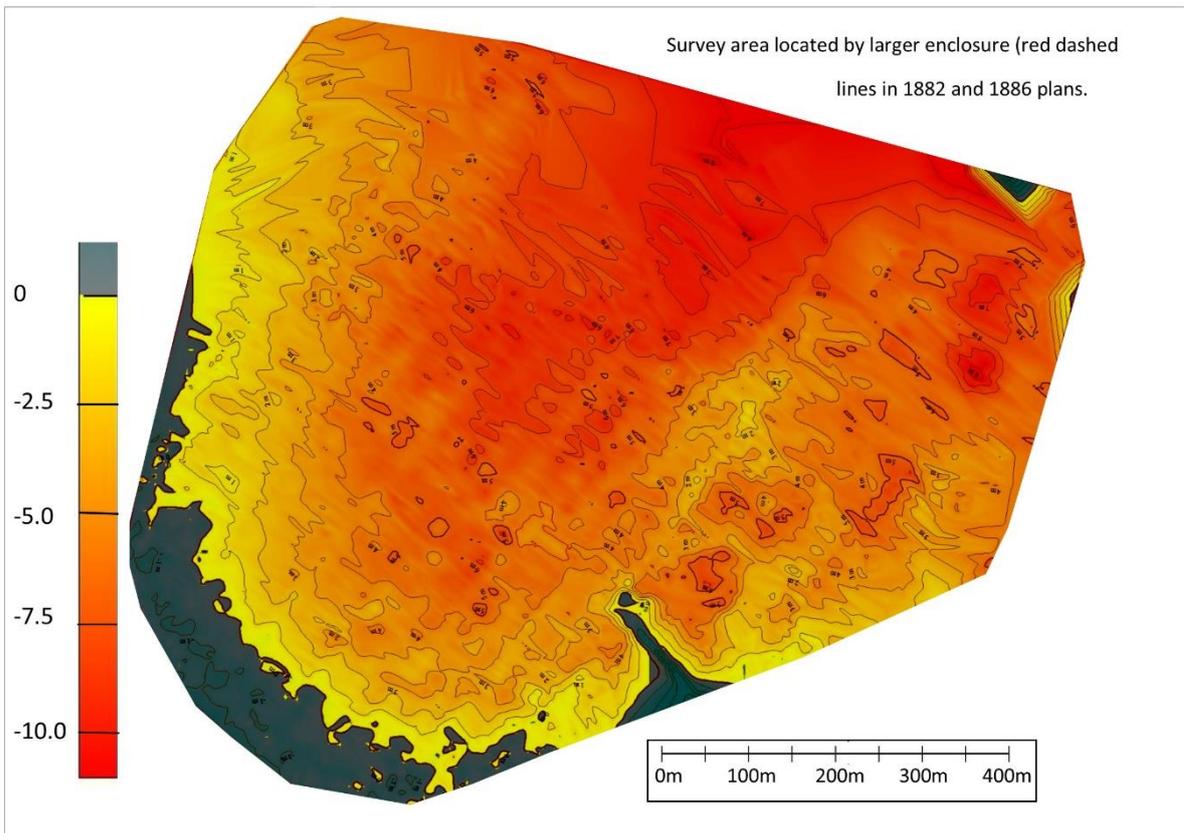
2009 Bathymetric survey of western Opunaki Bay area. ASR survey. CSL mapping

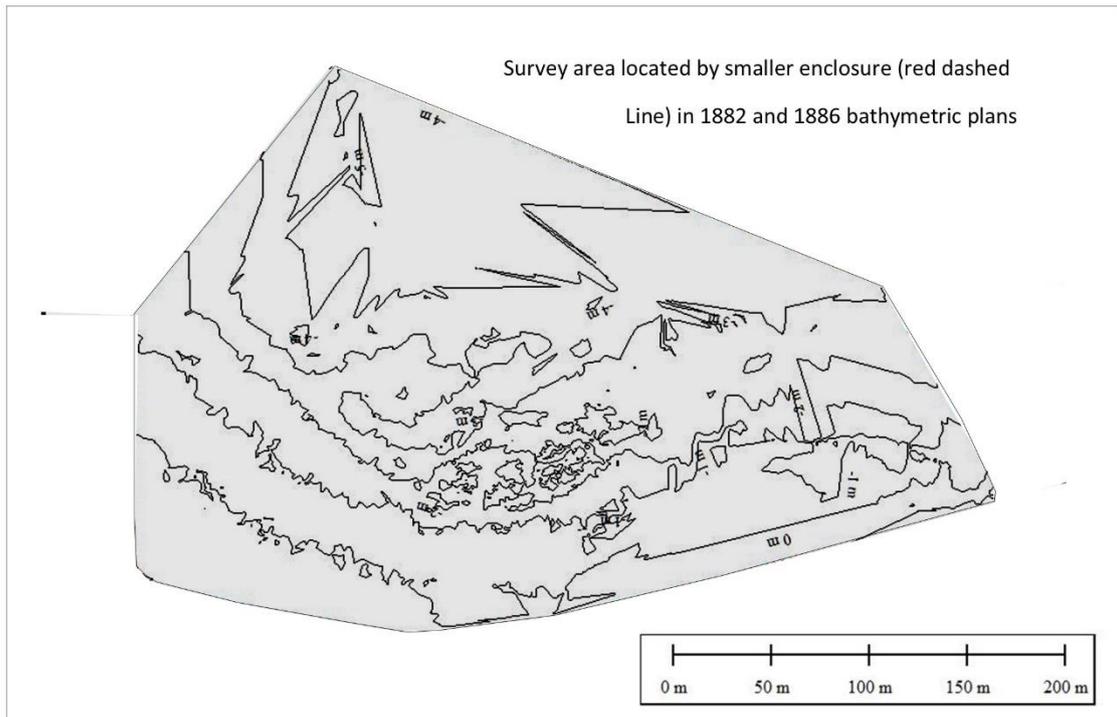
2017 Drone-based 3D survey

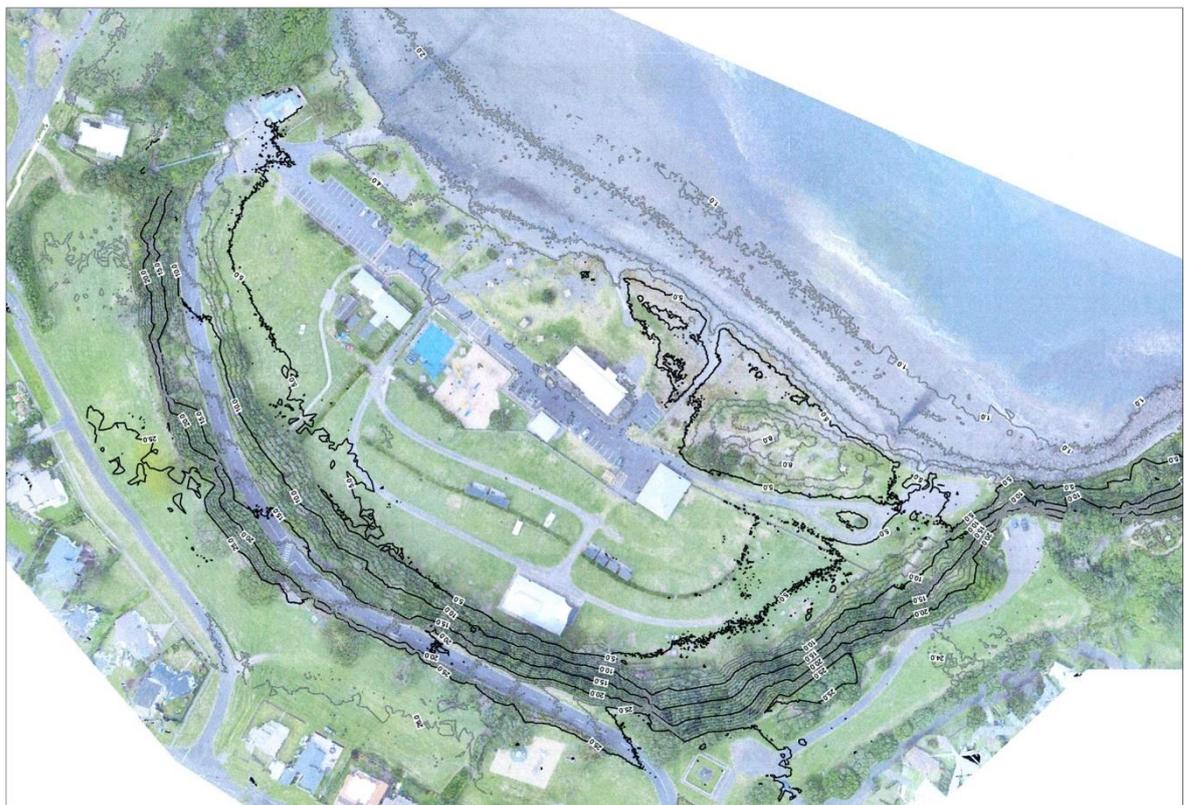
2019-11-12 Drone-based 3D and survey transects Taylor Patrick Ltd

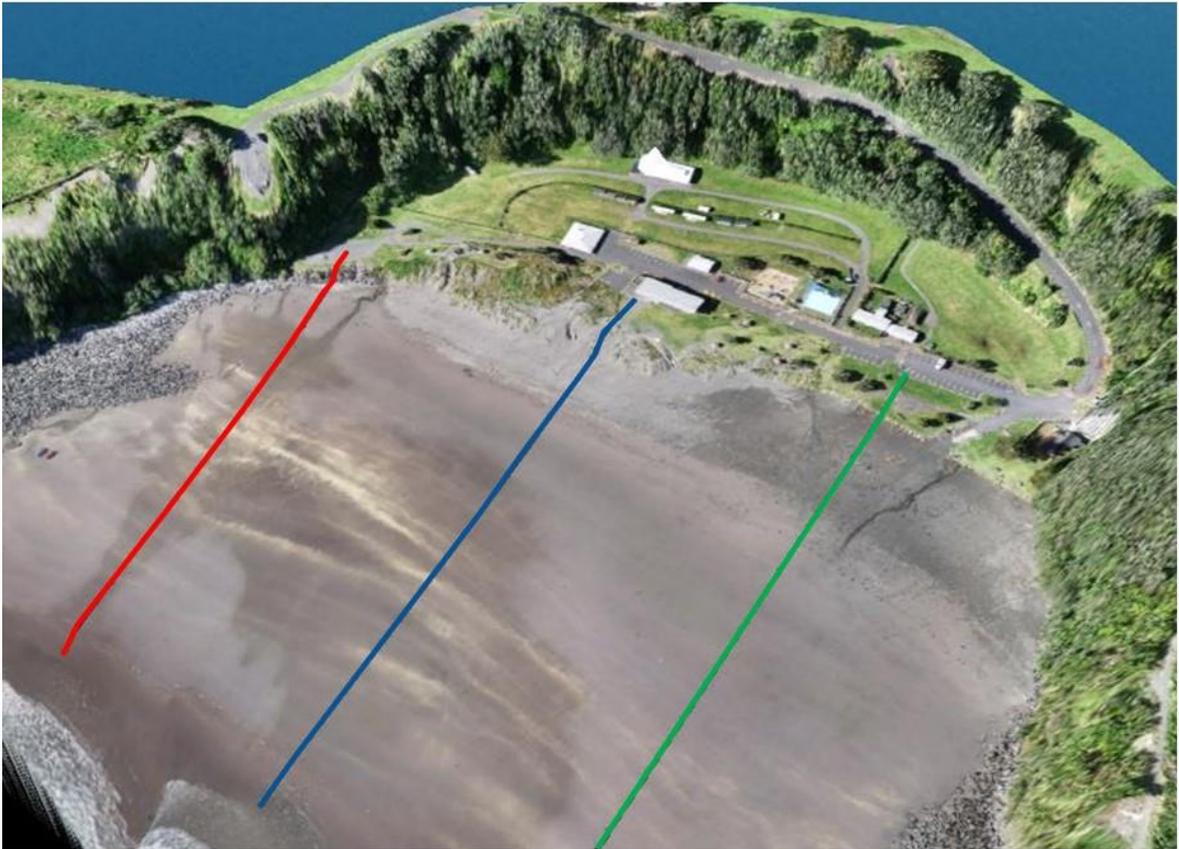
2019-11-12 Profiles surveys Taylor Patrick Ltd
